Building Inspection Report

Inspection Date: Thu, 9 Apr 2026

Property Address: 12/46 Military Rd, West Beach SA 5024,
Australia

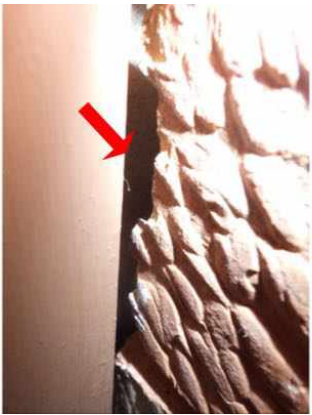
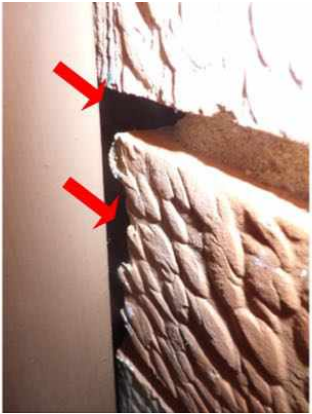
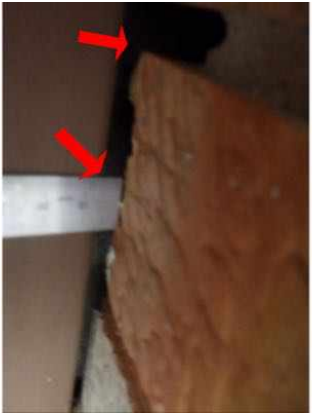
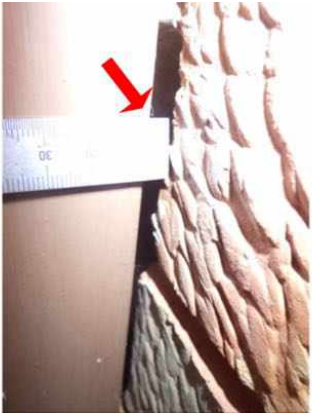
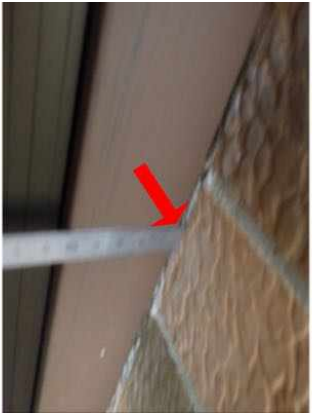
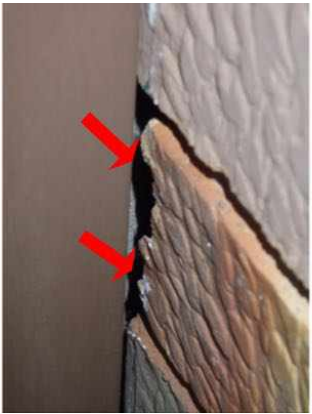
Defects 3.01

Breakage occurs generally when the building materials have either aged and decayed, or as a result of damage (accidental or deliberate).

Repair and/or replacement of broken elements is advised to ensure that additional secondary defects do not arise as a consequence. Such works are necessary, as all building elements play a key role in the operation and function of the overall structure and its performance.

A relevant tradesperson should be appointed to repair or replace the affected building element prior to any subsequent damage being caused.

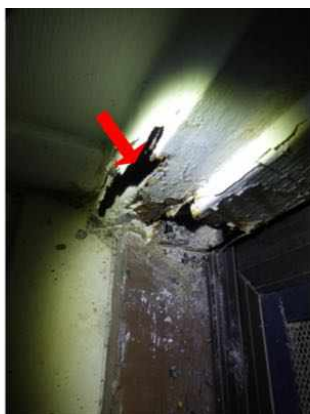
Defects 3.04

Building:	Building 1
Location:	All Internal Areas
Finding:	Entry area- Door jamb - Damaged at lower base
Information:	At the time of inspection it was noticed that entry door jamb is damaged in this lower base.

Breakage occurs generally when the building materials have either aged and decayed,

or as a result of damage (accidental or deliberate).

Repair and/or replacement of broken elements is advised to ensure that additional secondary defects do not arise as a consequence. Such works are necessary, as all building elements play a key role in the operation and function of the overall structure and its performance.

A relevant tradesperson should be appointed to repair or replace the affected building element prior to any subsequent damage being caused.

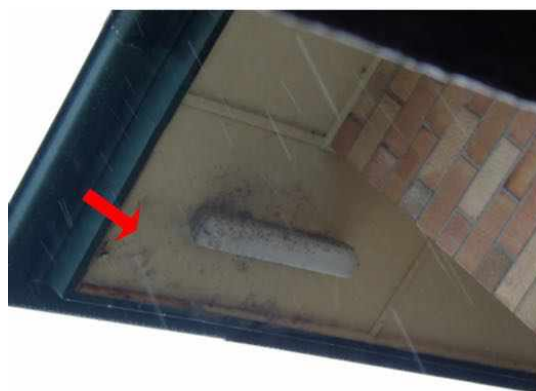
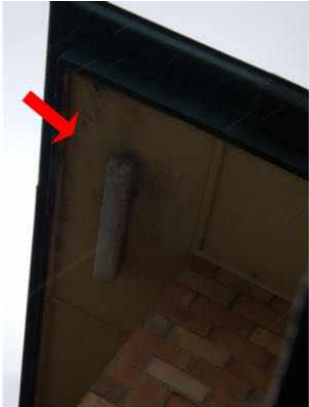
Defects 3.05

Building:	Building 1
Location:	All External Areas
Finding:	Eaves - Damaged
Information:	The few sections of eaves around the external property were found to be in a visibly poor condition. The damage may have been sustained as a result of a number of possible causes, including poor roof drainage, leaking roof plumbing or minor impact damage.

The damage to the eave sheeting in this area detracts from the appearance of the structure, as well as potentially compromising the structural integrity of the roofing area.

Where eaves show moderate to severe damage, remedial works may be required. Where water damage is suspected as being the underlying cause, appointment of a licensed plumber is advised as a matter of urgency to identify the source of the water leak.

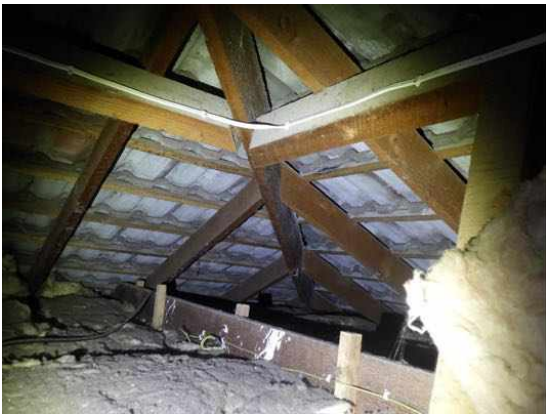
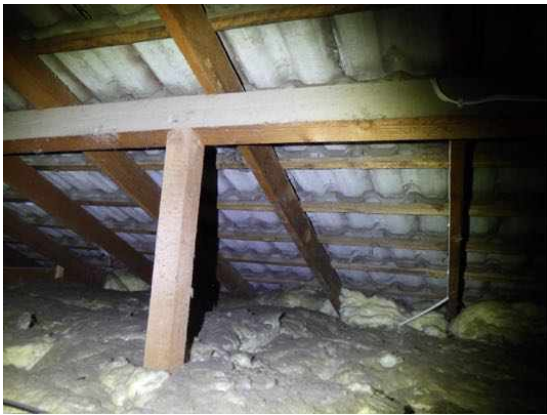
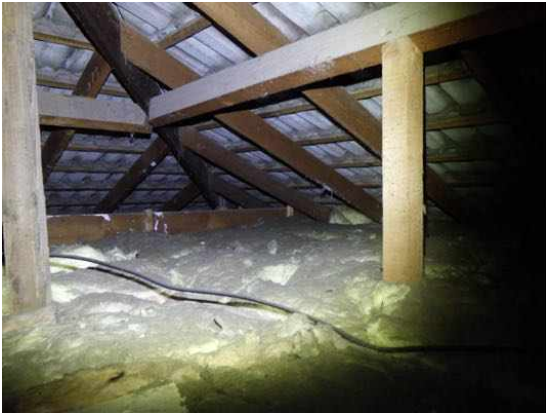
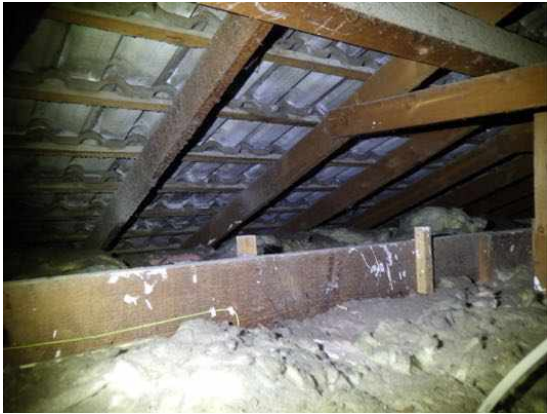
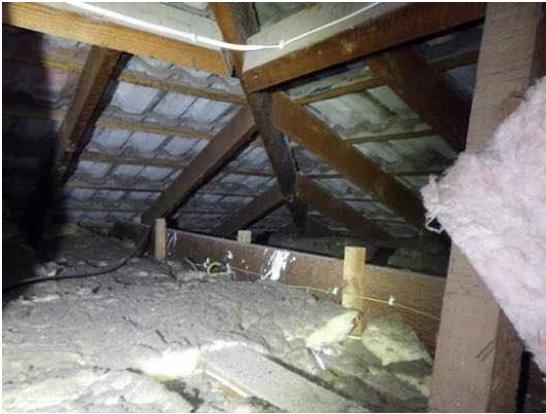
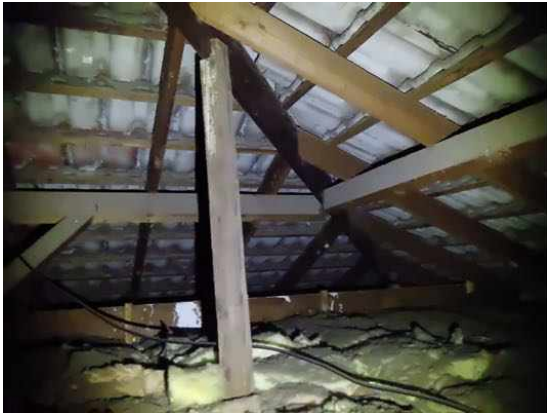
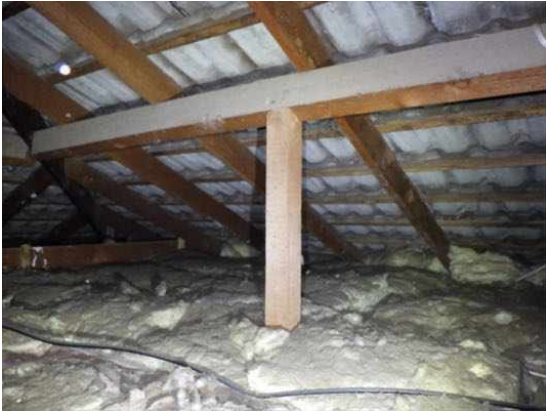
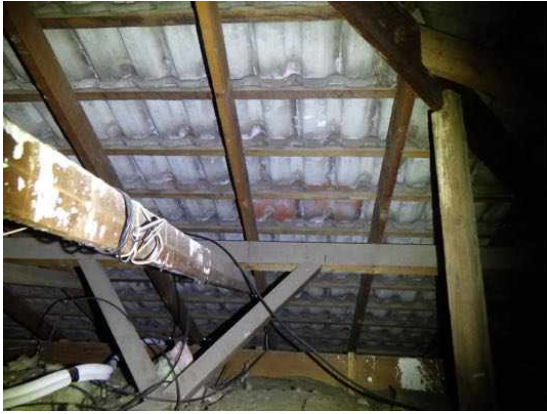
Building: Building 1
Location: All Areas
Finding: Additional Photos - Obstructions and Limitations
Information: These photographs are an indication of the obstructions and limitations which impeded full inspection of the property at the time of inspection. These obstructions can hide an array of defects and should be removed to allow full inspection to be carried out. A re-inspection is recommended once the areas are made accessible.
