Building and Timber Pest Inspection Report

Inspection Date: Wed, 11 Feb 2026

Property Address: 30 Shirley Cres, Matraville NSW 2036,
Australia

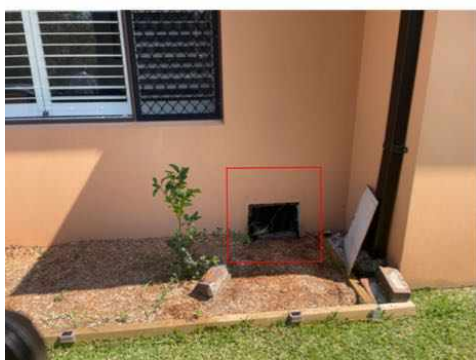
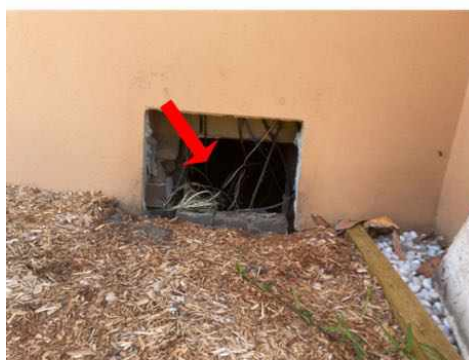
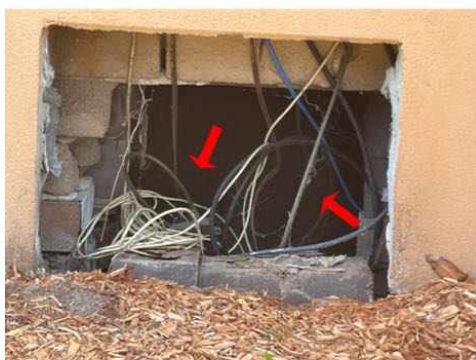
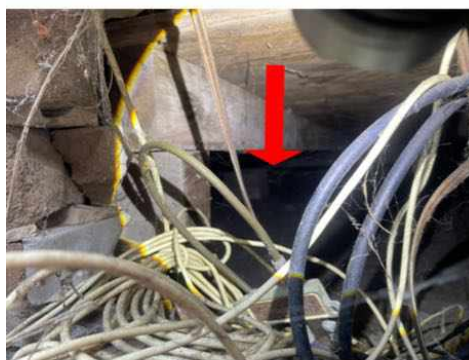
Finding 1.01

Building:	Main Building
Location:	Subfloor entrance
Finding:	Electrical wires exposed
Information:	Exposed electrical wiring was identified. Exposed electrical wiring represents a potential safety hazard including for fire and personal contact. Contact a licensed electrician urgently for further inspection investigation and rectification.

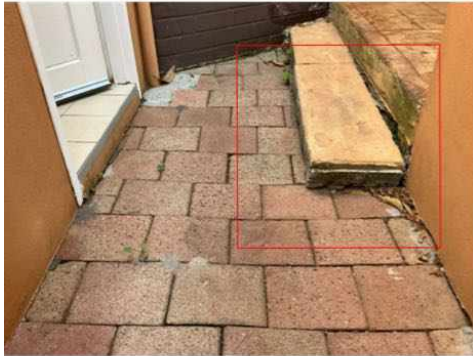
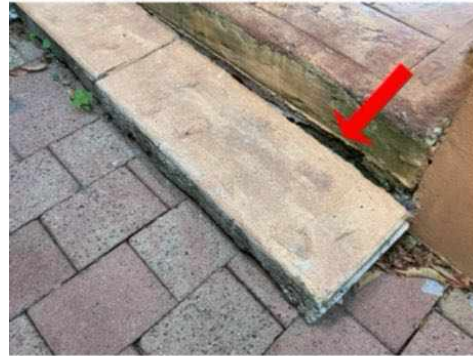
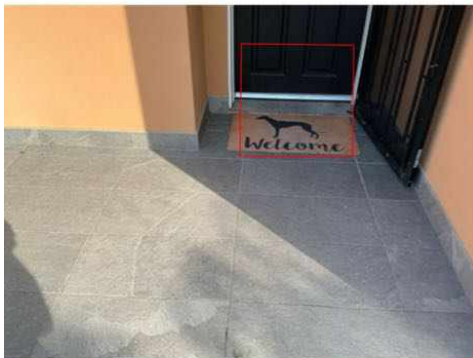
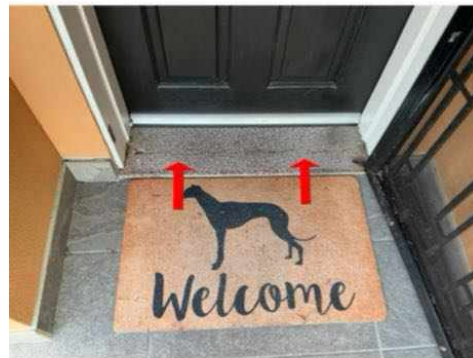
Finding 1.02

Building:	Main Building
Location:	Side rear entrance, front door
Finding:	Building element - Damaged- rear entry side passage step, front door step
Information:	Breakage occurs generally when the building materials have either aged and decayed, or as a result of damage (accidental or deliberate).

consequence. Such works are necessary, as all building elements play a key role in the operation and function of the overall structure and its performance.

A builder should be appointed to repair or replace the affected building element prior to any subsequent damage being caused.

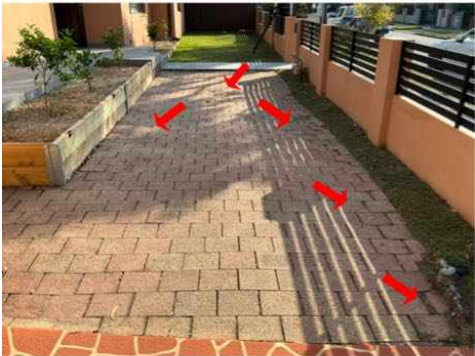
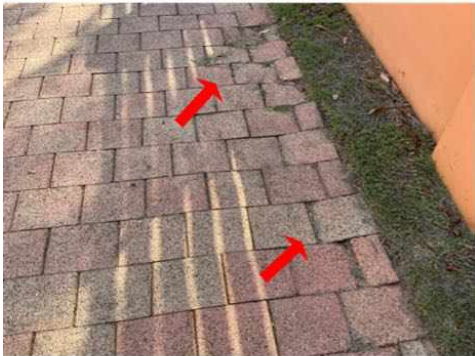
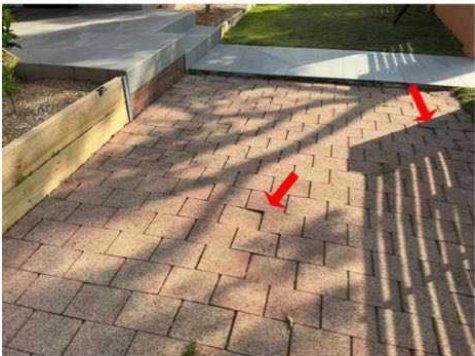
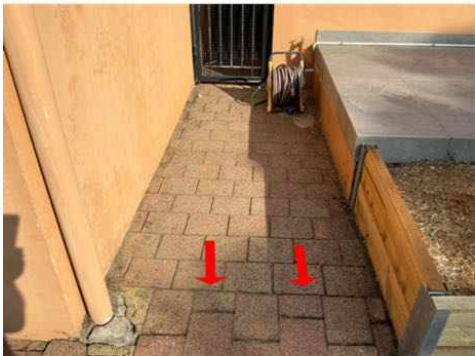
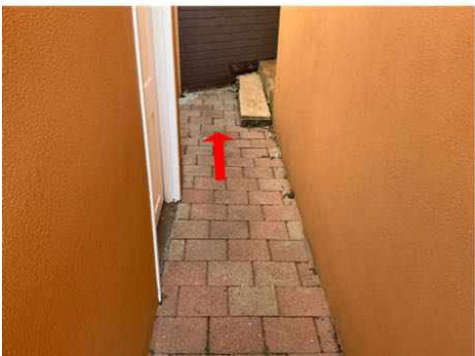
Finding 1.03

Building:	Main Building
Location:	Front yard and side passage
Finding:	Paving uneven
Information:	Sections of the external paved area are uneven, creating a potential trip hazard. It appears as though the area has been subject to rough installation, or that paving sections have lifted due to movements in the foundation of the property.

Where paving creates a trip hazard, personal injury may ensue if due caution is not taken by all persons within this area.

Re-paving of the area is required as soon as possible to remedy this situation. Further consultation with a specialist concreter is advised.

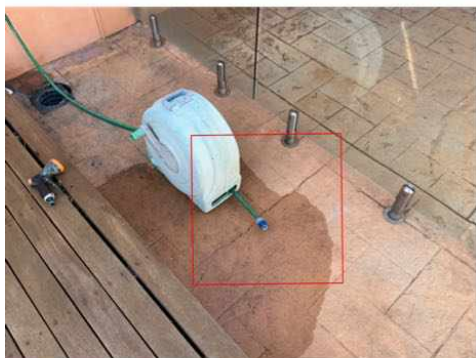
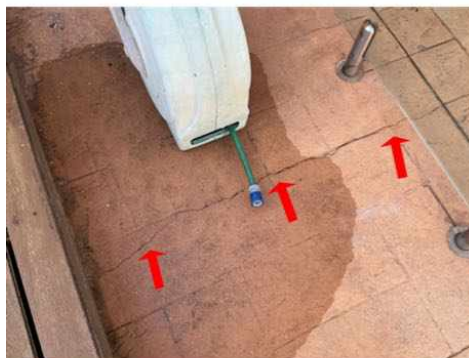
To be considered Category 2, the approximate width of the crack is less than 2.0mm, or a change in offset of less than 15mm when a 3m straight edge is placed over the defect.

Category 2 cracks to slabs should be monitored for a period of 12 months. At the end of the monitoring period, cracks rated greater than Category 2 are considered defects that require rectification.

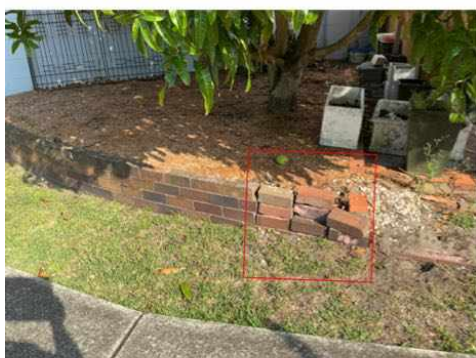
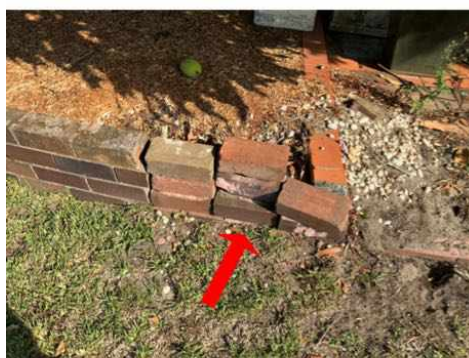
Finding 3.02

Building: Main Building
 Location: Southern end garden
 Finding: Retaining wall - Defective
 Information:

If left unmanaged, the retaining wall may become a safety hazard if it continues to destabilise. Where retaining walls further rot and decay, an environment is created that is conducive to termite and pest infestation.

Significant repair and replacement should be expected. Where retaining walls are considered structural walls, a structural engineer / surveyor should be consulted regarding required remedial works. Otherwise, a landscaper or retaining wall installer may be appointed to repair or replace the wall, at the discretion of the client.

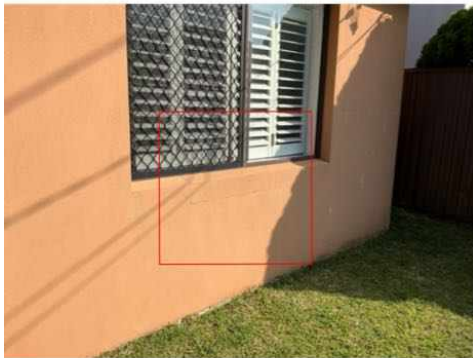
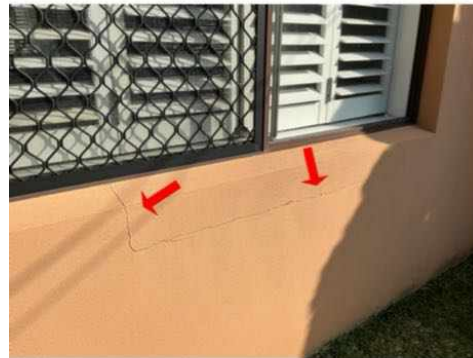
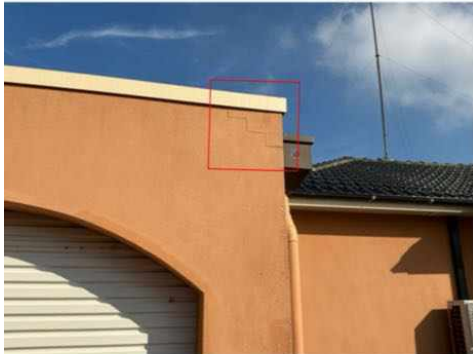
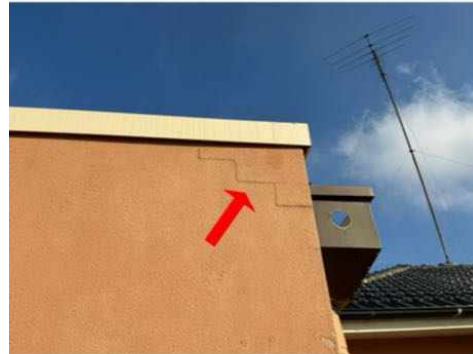
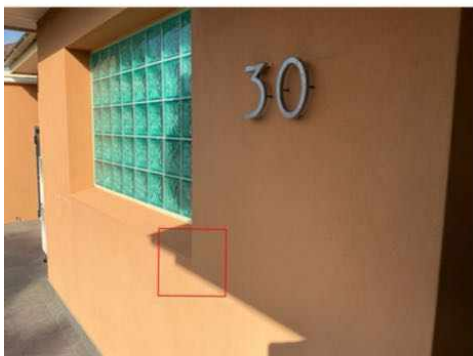
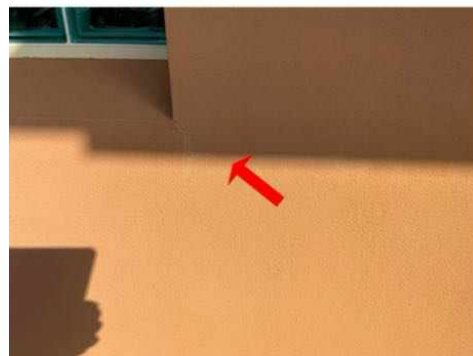
Finding 3.03

Building: Main Building
 Location: Front wall, garage, side passage

Category 2 damage is required to be monitored for a period of 12 months. After the monitoring period, a crack rated at Category 2 or above is considered a defect requiring rectification.

Always contact your building inspector should cracks widen, lengthen, or become more numerous.

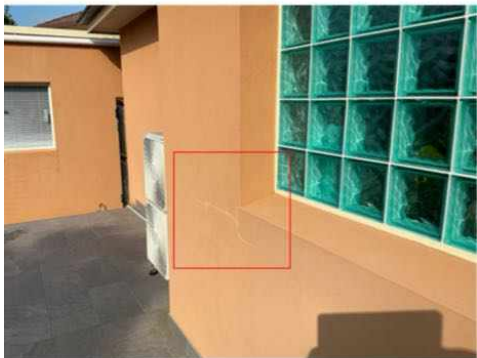
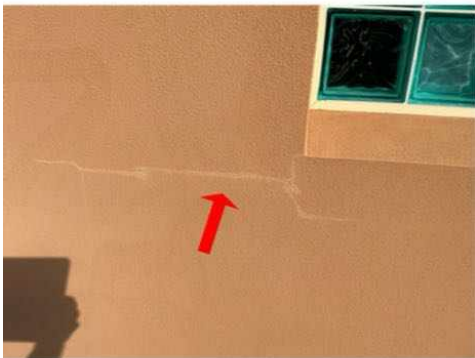
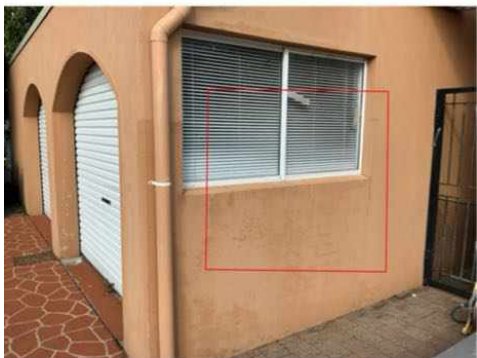
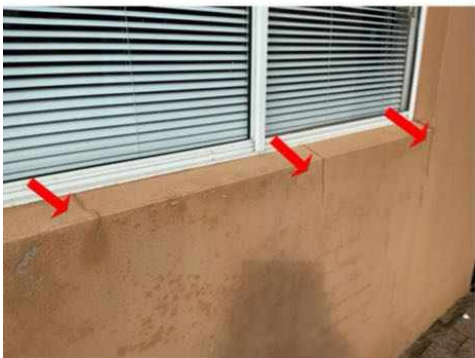
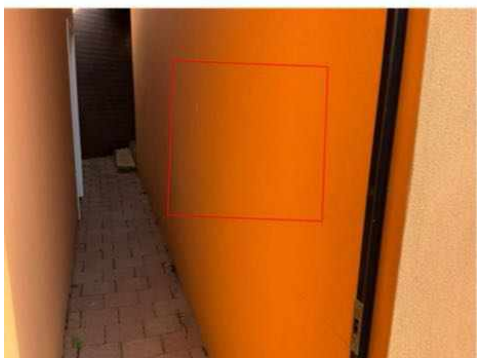
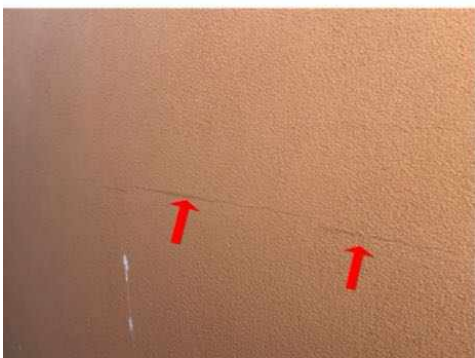
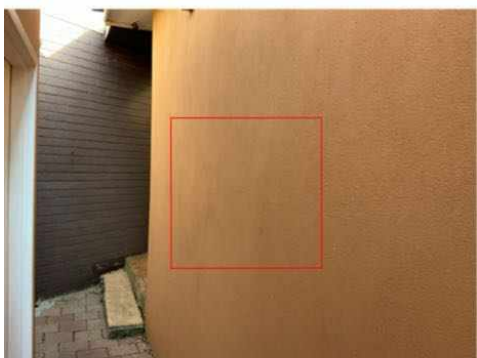
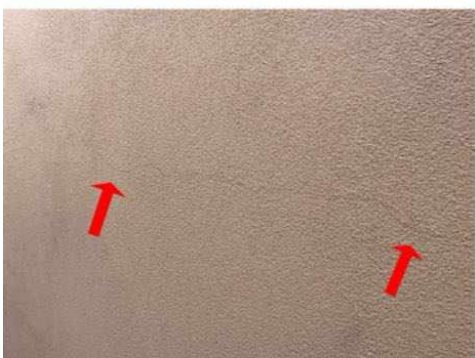
Finding: Cracks to external render - Category 2

Information: It has been observed that cracking to internal rendered surfaces has occurred. The degree of damage falls within Category 2, described as noticeable cracks which are easily filled. Cracking of this size are generally less than 5mm in width.

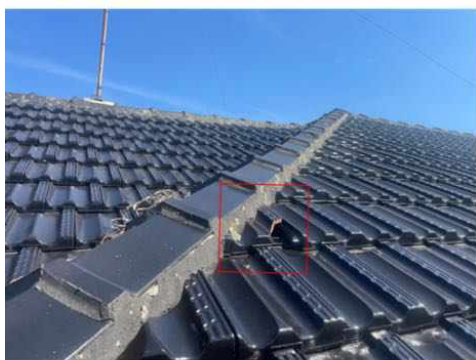
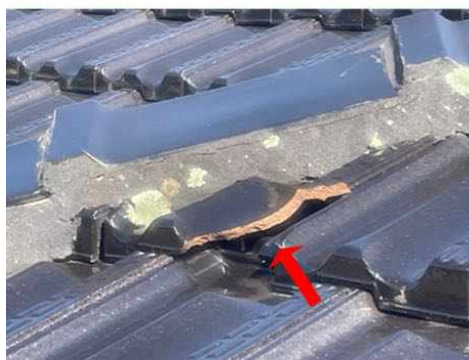
Finding 3.04

Building:	Main Building
Location:	Roof Exterior- eastern side
Finding:	Roof tiles - Broken
Information:	Upon inspection of the exterior roof covering, broken roofing tiles were identified. Broken and friable roof tiles are generally the result of ageing and weathering of what is essentially a porous material.

If left to further deteriorate, broken and brittle roof tiles are likely to lead to water penetration via the roof into the ceiling space, causing secondary damage to ceiling linings, insulation and roof structures. Broken roof tiles are also likely to detract from the effectiveness of the roof drainage system, creating potential for secondary damage to the exterior roof covering and roof plumbing.

Replacement of broken tiles is required and should be performed by a roofing contractor as soon as possible.

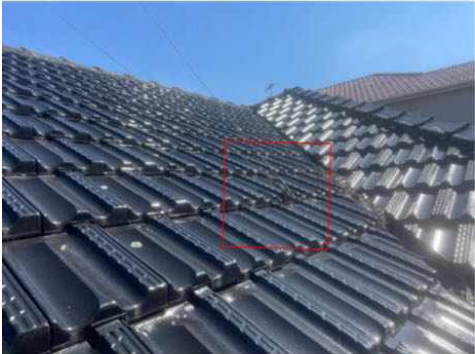
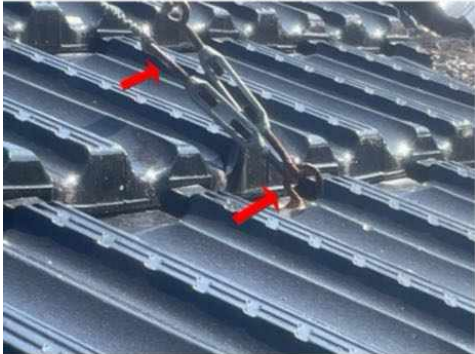
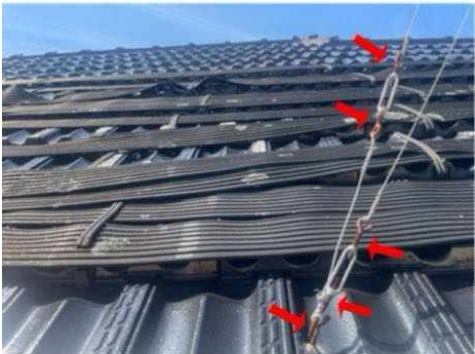
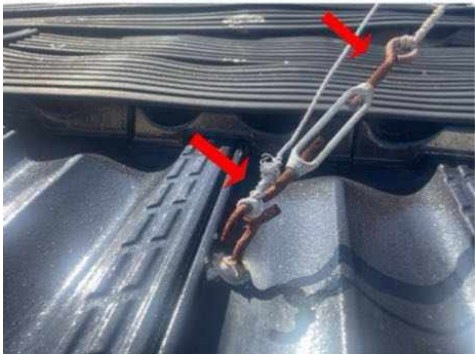
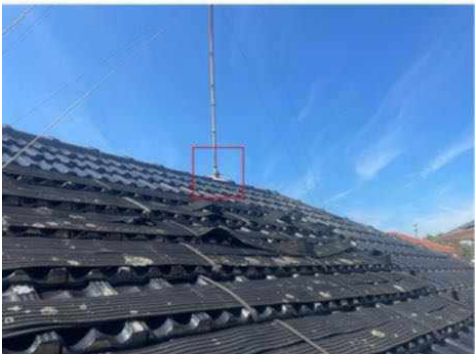
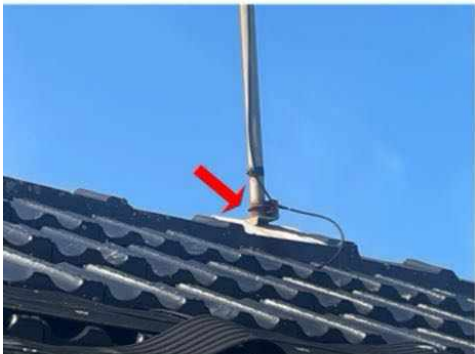
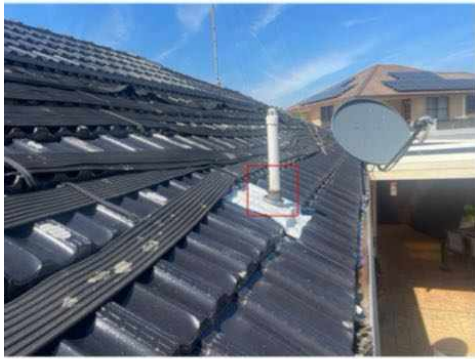
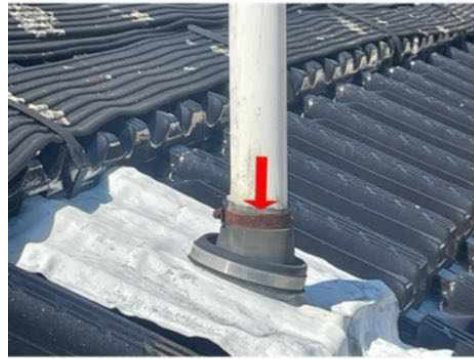
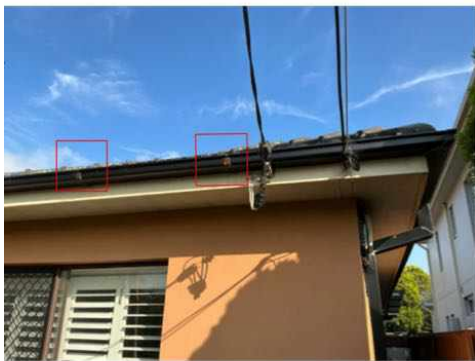
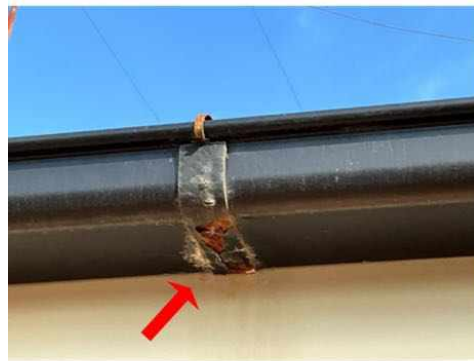
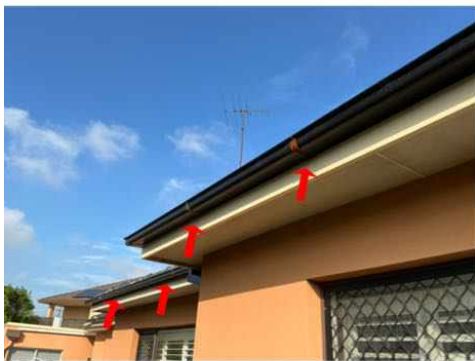
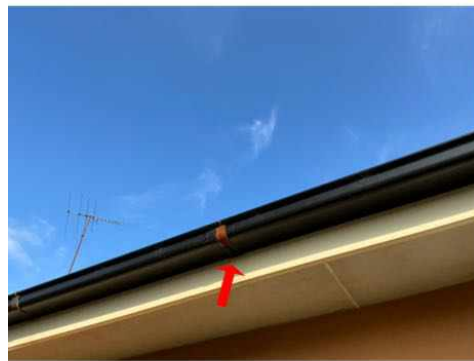
Finding 3.05

Building:	Main Building
Location:	Roof Exterior
Finding:	Building element - Rusted or corroded- aerial anchoring supports, aerial base and poll, exhaust pipe hose clamp bracket, guttering brackets
Information:	These building elements shows evidence of rusting and corrosion, which is likely to have developed as a result of excessive exposure to moisture and or inadequate coatings.

As surface rust provides no protection to the underlying iron, the deteriorating condition is likely to worsen if not addressed in the short-term future.

Where possible, the use of galvanized (treated) metals or aluminium coated metals aid in rust prevention, as does regular general maintenance. Rust formation can be controlled with coatings, such as paint, that isolate the iron from the environment.

Rusting and corrosion should be managed by ideally removing or limiting the affected surface from exposure to moisture. A registered builder may be appointed to replace

any building elements that have been severely affected by rust or water damage.

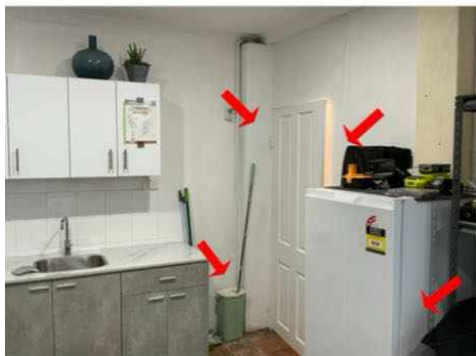
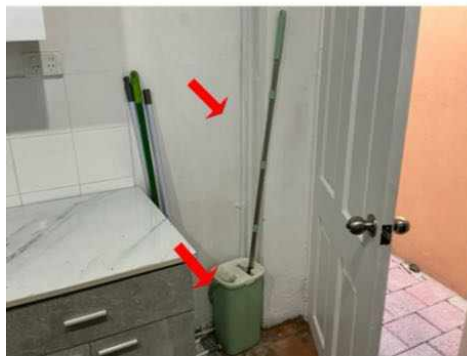
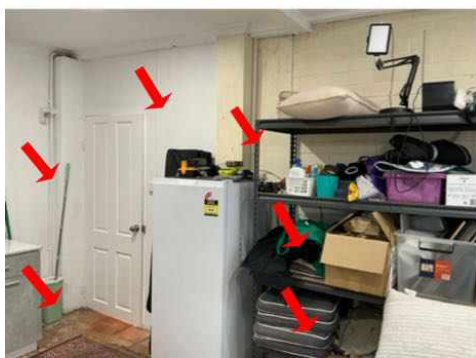
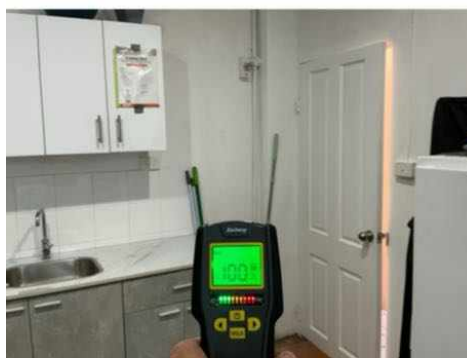
Finding 3.06

Building:	Garage
Location:	Garage
Finding:	Excessive Moisture Identified.
Information:	Excessive moisture can attract termites and produce conditions that promote fungal growth and wood decay.

Excessive moisture is generally caused by deteriorated, inadequate or missing roof drainage, leaking plumbing pipes or fixtures, poorly plumbed HWS overflows or condenser units and poor site drainage.

If mould growth has been found there may be environmental biological or health

issues involved. In these cases an appropriately qualified inspector should also be contacted.

Prior to any remedial works being performed a qualified plumber should be appointed to further inspect the property and to identify the cause of the excessive moisture. Works to remove affected building elements may then be necessary and should be performed by an appropriate tradesperson.

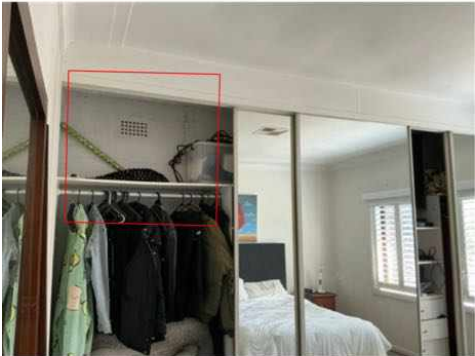
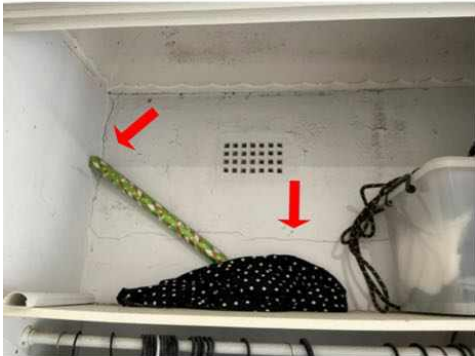
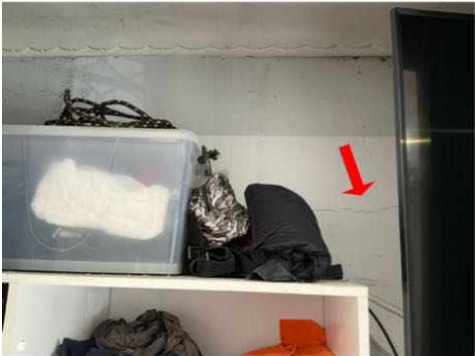
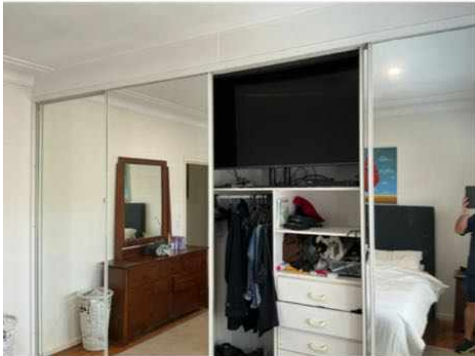
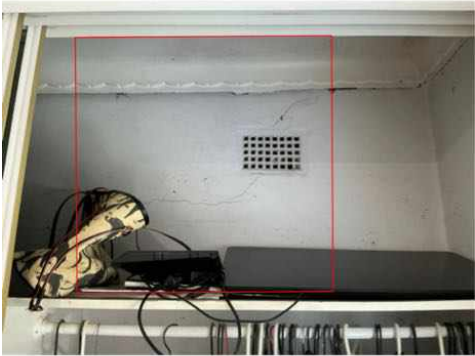
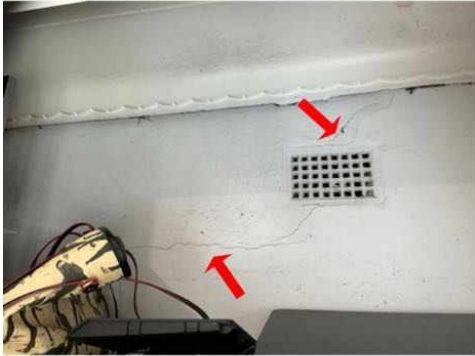
Finding 3.07

Building:	Main Building
Location:	Main bedroom, behind built-in wardrobe
Finding:	Cracks to internal render - Category 2
Information:	It has been observed that cracking to internal rendered surfaces has occurred. The degree of damage falls within Category 2, described as noticeable cracks which are easily filled. Cracking of this size are generally less than 5mm in width.

Category 2 damage is required to be monitored for a period of 12 months. After the monitoring period, a crack rated at Category 2 or above is considered a defect requiring rectification.

Always contact your building inspector should cracks widen, lengthen, or become more numerous.

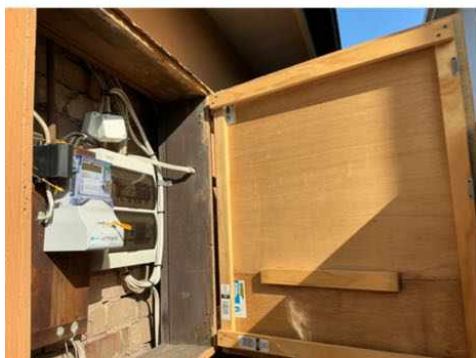
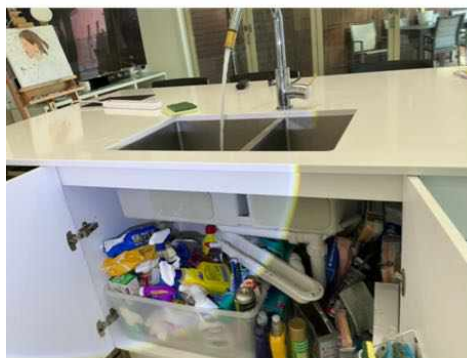
Building:	Main Building
Location:	Meter box, under kitchen sink
Finding:	Termite Management System - no evidence of a chemical installation
Information:	The application of a post-construction chemical termite barrier is highly recommended for all properties, particularly if live termite activity has been found on the site previously. Such barriers are highly effective in preventing termite attack on any timber building elements throughout the property.

A durable notice should be placed in the switchboard unit to indicate current termite barriers. At the time of inspection, it appeared as though no termite management system has been installed, with no evidence to suggest preventative works taking place.

The client may consider gaining further advice from a pest controller as to the costs and procedures involved with this application. It is recommended that obtaining such advice be a short-term priority.

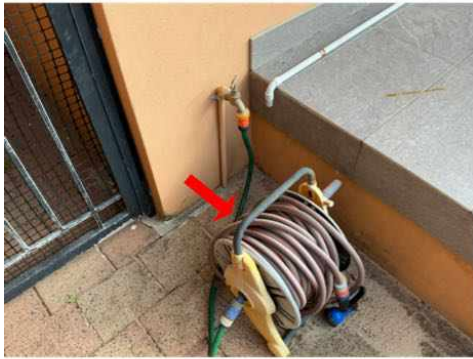
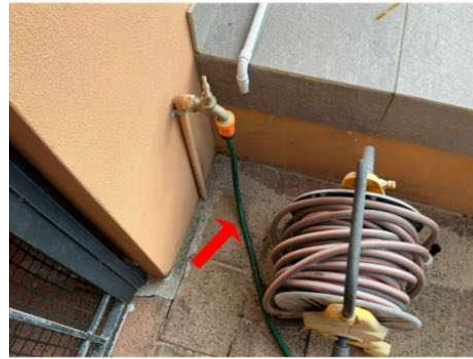
Finding 6.02

Building:	Main Building
Location:	All Areas
Finding:	Overflow - Not plumbed for drainage (Excessive Moisture)
Information:	The overflow is not plumbed or connected to suitable drainage, which has resulted in the surrounding area becoming excessively damp. These damp conditions can lead to secondary defects such as rot, rust or corrosion of associated building elements, the formation of fungal decay, or even the creation of potential slip hazards.

When coupled with poor site drainage, pooling of water may also attract termite activity to this area. It is highly recommended that a qualified plumber be appointed to install adequate drainage to the overflow. These works will ensure that the area remains dry and free of any secondary defects.

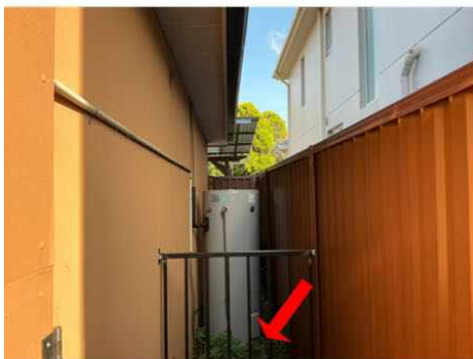
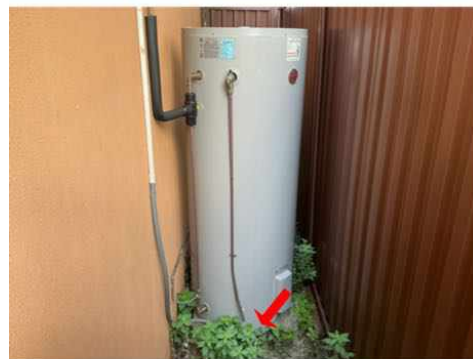
Finding 6.03

Building: Main Building
 Location: Side passage- north
 Finding: HWS Overflow - Not Connected
 Information: The Hot Water System (HWS) overflow was found to be disconnected from storm water drainage and is creating excessive moisture in the surrounding area.

These damp conditions can lead to secondary defects such as rot, rust or corrosion of associated building elements, the formation of fungal decay, or even the creation of potential slip hazards. When coupled with poor site drainage, pooling of water may also attract termite activity to this area.

It is highly recommended that a licensed plumber be appointed to connect the HWS overflow in order to prevent such an environment from being created. These minor works should be carried out as soon as possible.

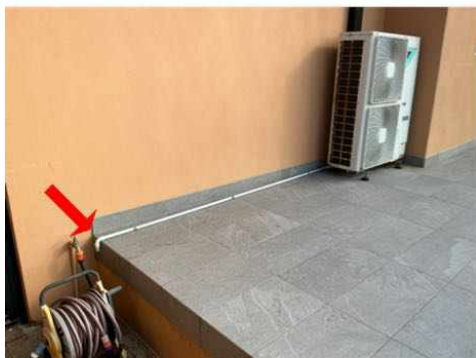
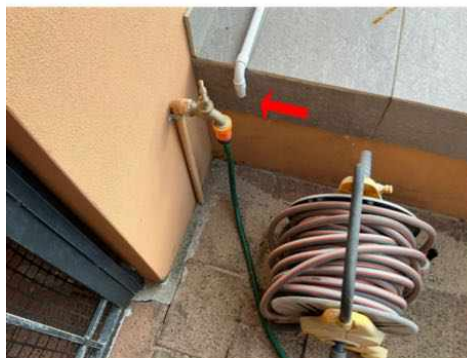
Finding 6.04

Building: Main Building
 Location: All Areas
 Finding: Air conditioner - Disconnected overflow
 Information: The Air Conditioner (A/C) overflow was found to be disconnected from storm water

drainage and is creating excessive moisture in the surrounding area.

Such leaking creates an environment which is conducive to an array of defects, including water damage to associated building elements and the attraction of termite or timber pest infestation.

It is highly recommended that a licensed plumber be appointed to connect the A/C overflow in order to prevent such an environment from being created. These minor works should be carried out as soon as possible.

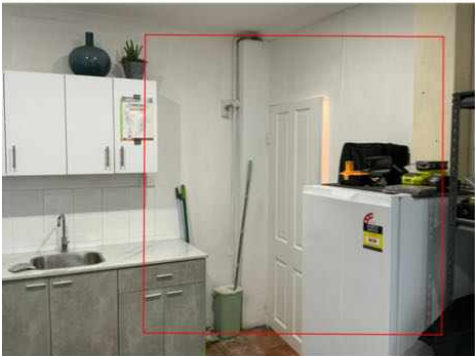
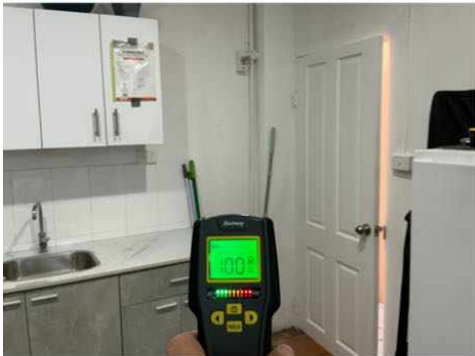
Excessive moisture is generally caused by deteriorated, inadequate or missing roof drainage, leaking plumbing pipes or fixtures, poorly plumbed HWS overflows or condenser units and poor site drainage.

Prior to any remedial works being performed a qualified plumber should be appointed to further inspect the property and to identify the cause of the excessive moisture. Works to remove affected building elements may then be necessary and should be performed by an appropriate tradesperson.

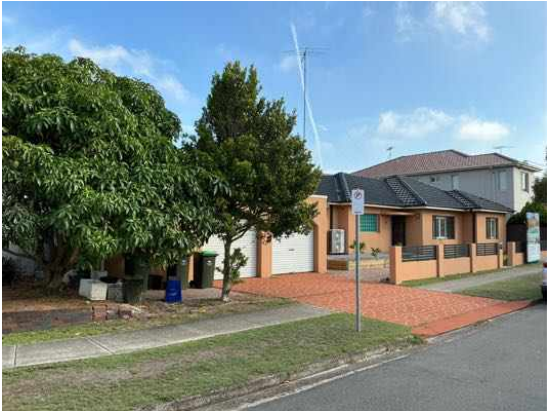
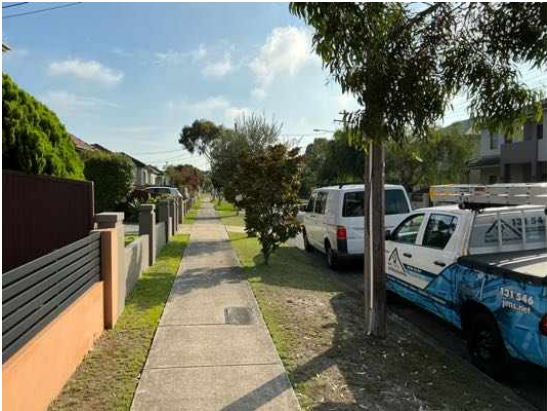
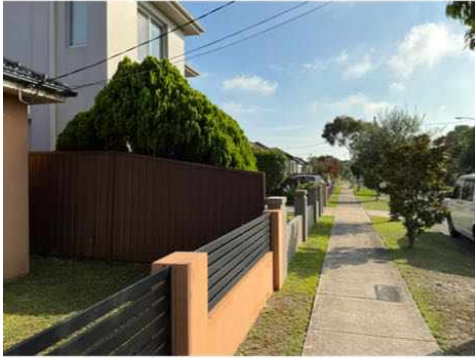
Finding 6.06

Building: Main Building
Location: All Areas
Finding: Trees to be inspected within the property.
Information: Trees can be conducive to termite activity and nesting. Trees over 100mm on the property, should be drilled and tested for termite activity.

Regular inspections every 6-12 months- or advised by the termite management system installer.

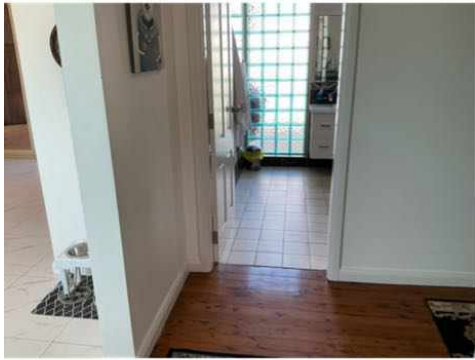
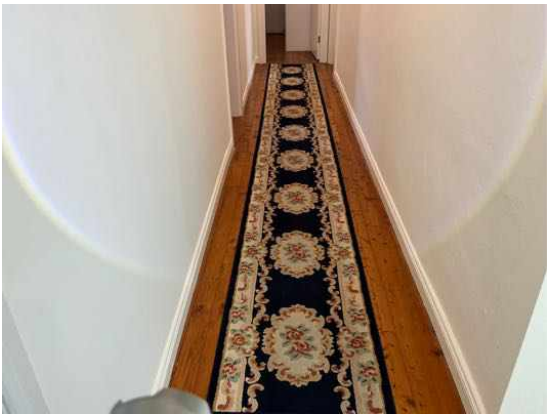
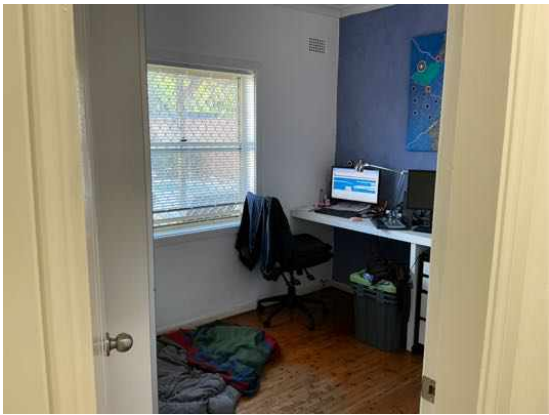
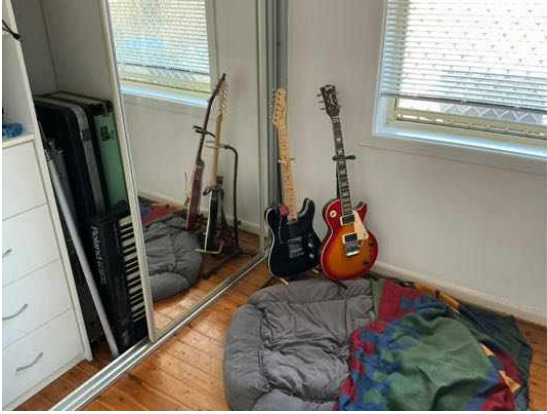
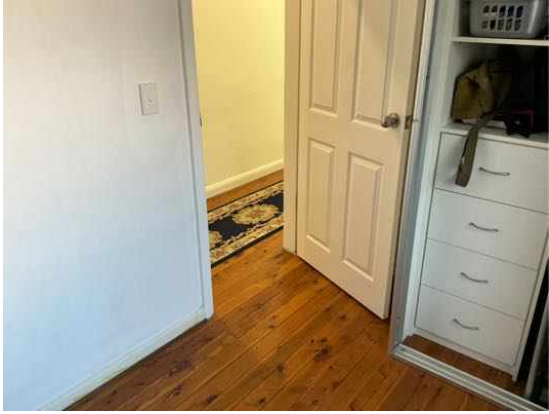
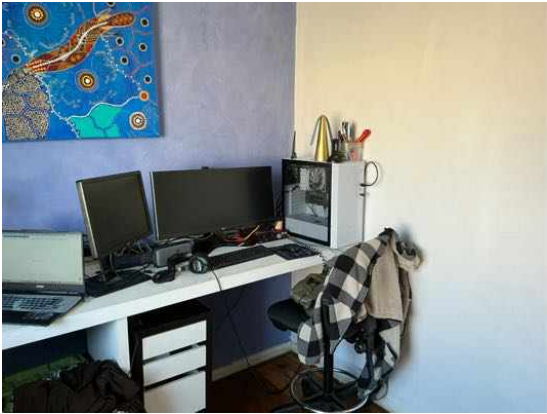
Noted Item

Building: Main Building
Location: All Areas- internal
Finding: Additional Photos - Obstructions and Limitations
Information: These photographs are an indication of the obstructions and limitations which impeded full inspection of the property at the time of inspection. These obstructions can hide an array of defects and should be removed to allow full inspection to be carried out. A re-inspection is recommended once the areas are made accessible.

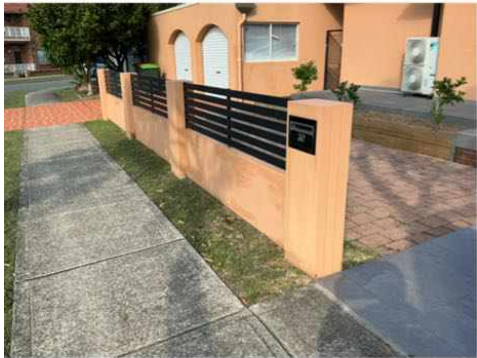
Noted Item

Building: Main Building
Location: All Areas- external
Finding: Additional Photos - Obstructions and Limitations
Information: These photographs are an indication of the obstructions and limitations which impeded full inspection of the property at the time of inspection. These obstructions can hide an array of defects and should be removed to allow full inspection to be carried out. A re-inspection is recommended once the areas are made accessible.

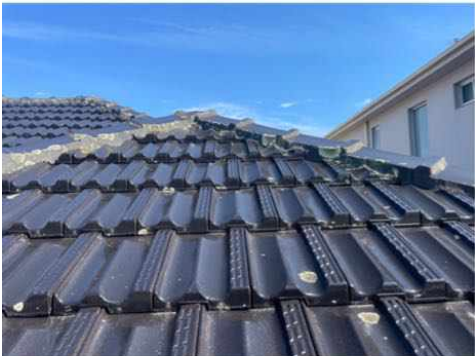
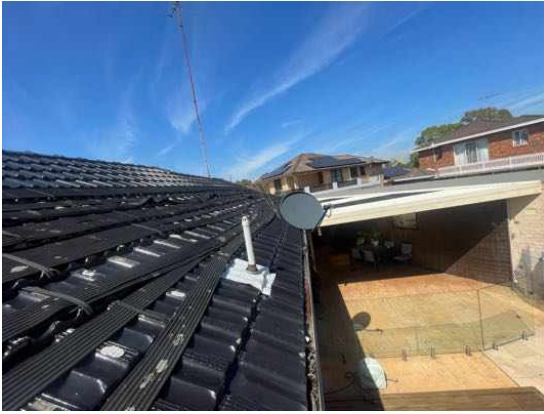
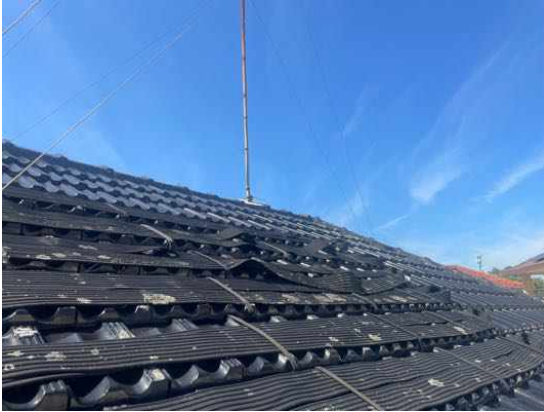
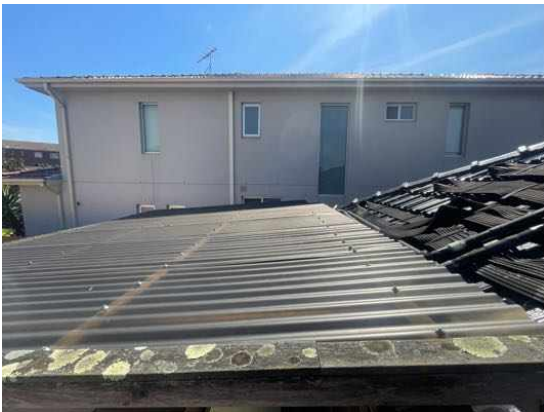
Noted Item

Building: Main Building
Location: Roof Exterior
Finding: Additional Photos - Obstructions and Limitations
Information: These photographs are an indication of the obstructions and limitations which impeded full inspection of the property at the time of inspection. These obstructions can hide an array of defects and should be removed to allow full inspection to be carried out. A re-inspection is recommended once the areas are made accessible.

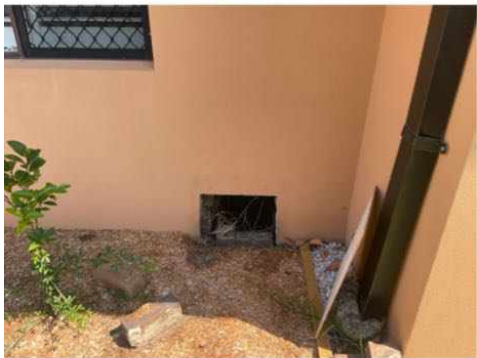
Noted Item

Building:	Main Building
Location:	Subfloor
Finding:	Additional Photos - Obstructions and Limitations
Information:	These photographs are an indication of the obstructions and limitations which impeded full inspection of the property at the time of inspection. These obstructions can hide an array of defects and should be removed to allow full inspection to be carried out. A re-inspection is recommended once the areas are made accessible.

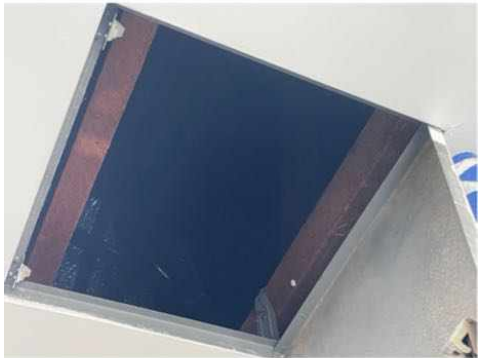
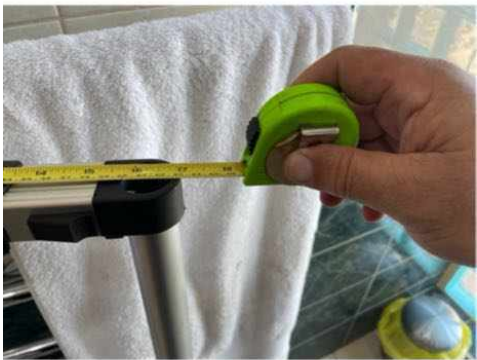
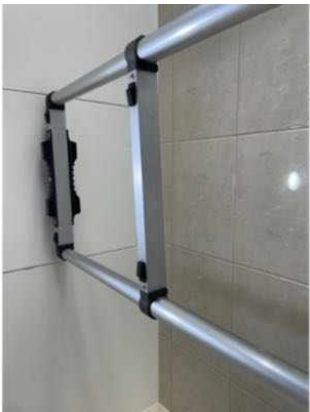
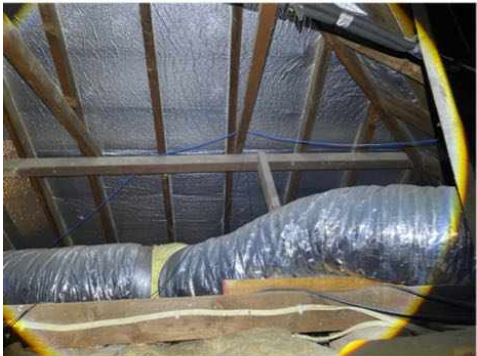
Noted Item

Building: Main Building
Location: Roof Void
Finding: Additional Photos - Obstructions and Limitations
Information: These photographs are an indication of the obstructions and limitations which impeded full inspection of the property at the time of inspection. These obstructions can hide an array of defects and should be removed to allow full inspection to be carried out. A re-inspection is recommended once the areas are made accessible.
