Building Inspection Report

Inspection Date: Mon, 23 Mar 2026

Property Address: 1/16 First St, Black Rock VIC 3193, Australia

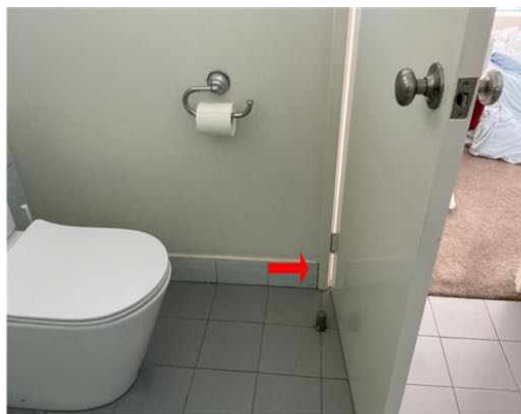
Defects 3.07

Building:	Main Building
Location:	Ensuite - Master
Finding:	Tiles - Cracked or damaged
Information:	Cracking was evident to the tiling in this area at the time of inspection. While the cracking appears to be minor, this area is frequently exposed to water, allowing potential for water penetration into adjoining sections of walls or flooring.

If left unmanaged, water penetration to these areas may lead to subsequent water damage, which is likely necessitate repair work to affected building elements.

A tiling contractor should be appointed to ensure that no further water damage occurs. The re-application of silicone and grouting throughout remaining tile work is also advised, to further protect the area against water penetration.

Where water penetration has led to water damage, appointment of a relevant tradesperson may be required to repair damaged building elements.

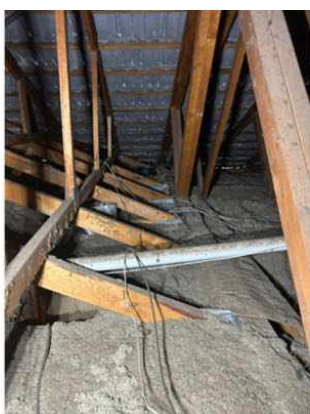
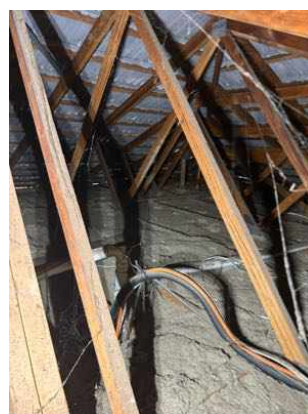
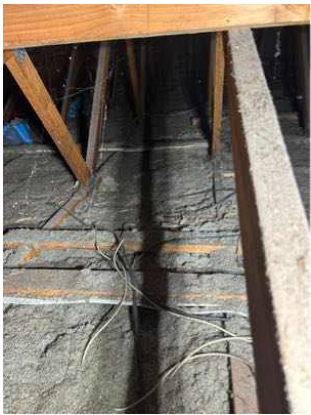
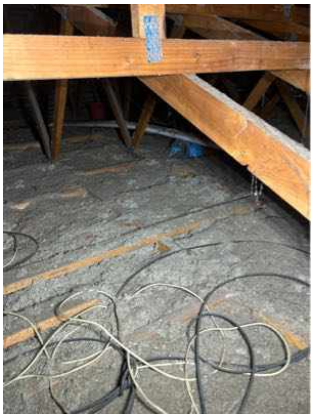
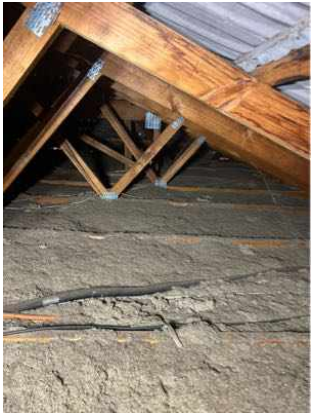
Defects 3.19

Building: Garage
Location: Roof Void
Finding: Evidence of Vermin
Information: Evidence of pests or rodents were present in the roof space at time of inspection including animal pings and odor. Rodents can cause issues ranging from smells and stains through to physical damage to wiring and other elements in the roof void. A licensed pest controller should be appointed to free the roof void of any pests and to install deterrents or seal access points to ensure that rodents can not enter the roof space as easily.

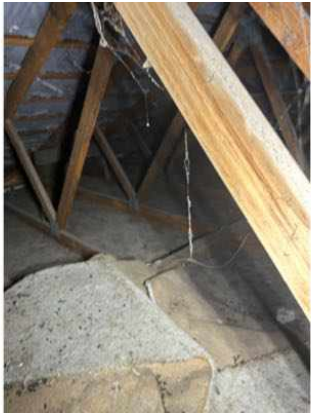
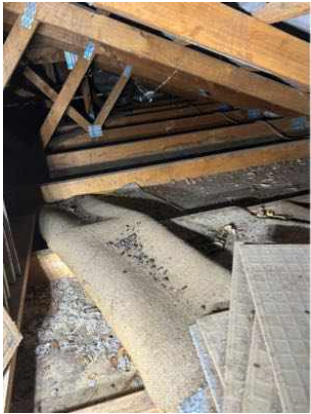
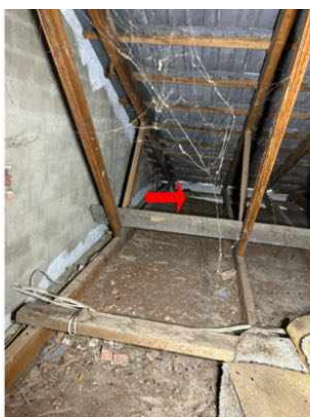
Defects 3.20

Building:	Garage
Location:	Roof Void
Finding:	Ceiling sagging -
Information:	Sections of the ceiling were found to be sagging at the time of inspection. Sagging to the fixed ceiling structure generally indicates that the building materials have swollen, due to contact with water, or that fixings (e.g. nails or glue) have become loose and require reattachment. This is a very common defect in carports due to their lack of insulation and or their susceptibility to moisture. Condensation builds up in the roof and rests on the plasterboard softening it somewhat which makes it more likely to sag and release from its fixing points.

In some cases, sagging ceiling linings may also indicate that there are structural issues, causing surfaces to warp, twist or sag. Where sagging appears to be major, appointment of a structural engineer is advised to further inspect the property and identify the source and rectification works required.

Where minor sagging is evident, comparatively minor works, such as re-gluing of ceiling sheets, may be required. Such works may be performed by relevant tradespeople, such as plasterers and painters. Where excessive moisture has caused the roofing structure to swell and sag, the source of the water leak should primarily be identified prior to any remedial works being performed.

While damage is minimal at this stage a licensed plasterboard contractor should be appointed to repair the ceiling. Insulating the area could be a considered by the client once repaired.

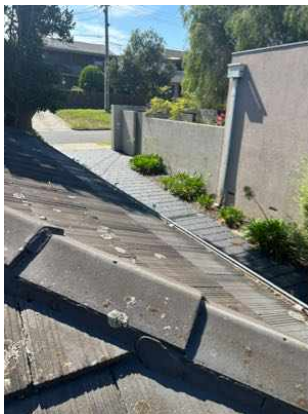
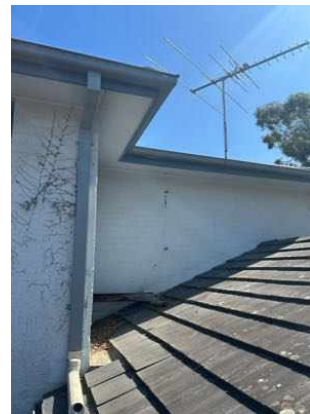
Noted Item

Where left unmanaged, deteriorating roof tiles are likely to lead to a number of secondary defects, including minor water leaks and weather exposure to internal roofing structures.

Consultation with a roofing contractor is highly advised to gain advice on cost of remedial works that may be required in the short to medium term. Remedial works are likely to increase the longevity of the exterior roofing structure.
