Building and Timber Pest Inspection Report

Inspection Date: Wed, 04 Mar 2026

Property Address: 10 Cadogan Cres, Woongarra NSW 2259,
Australia

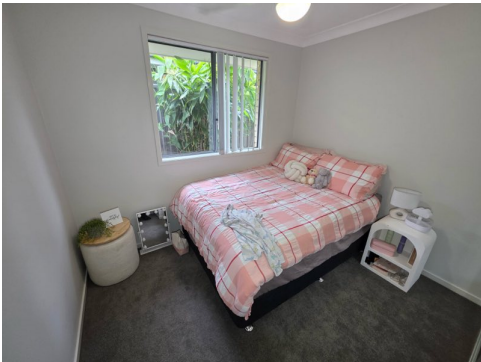
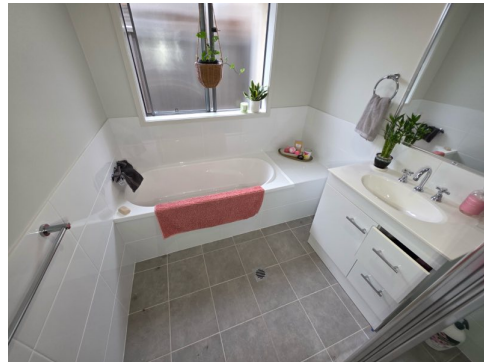
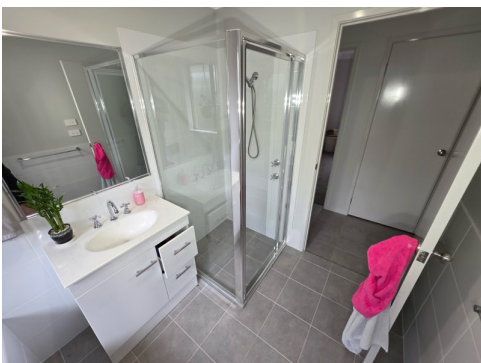
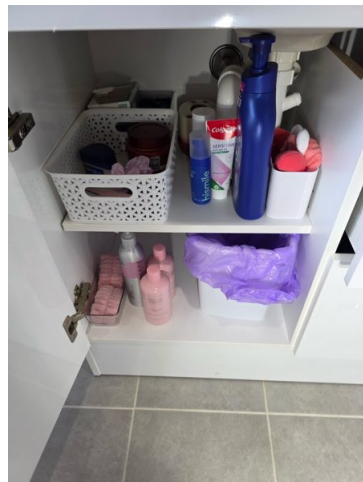
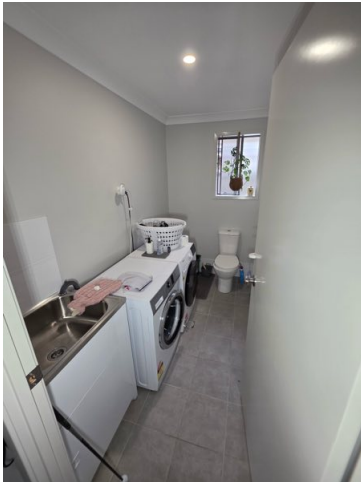
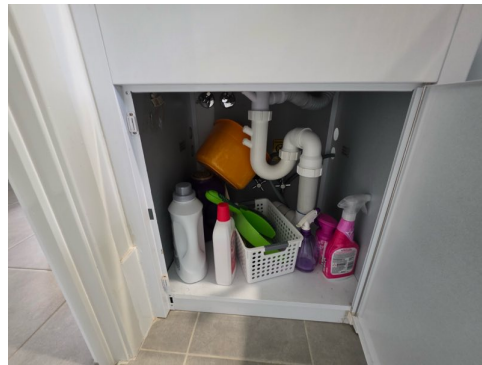
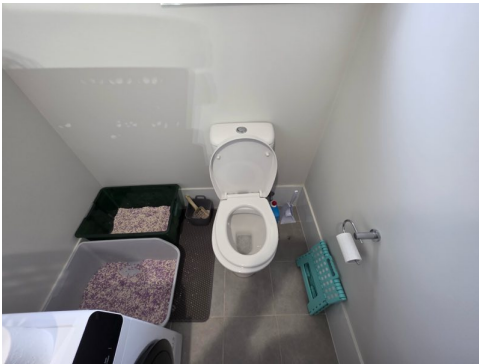
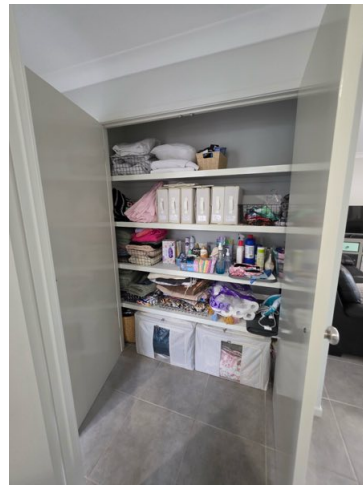
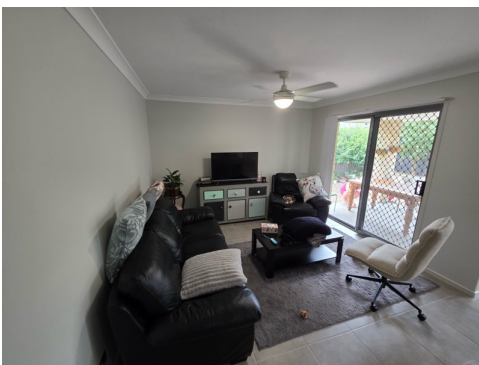
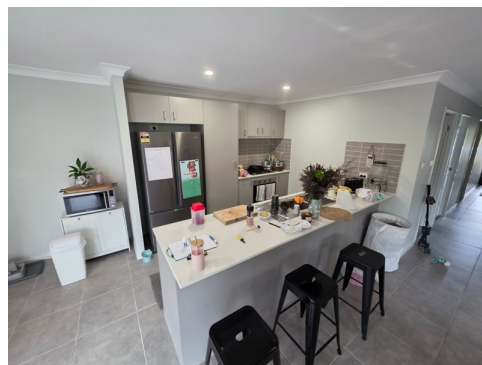
Information: These photographs are an indication of the obstructions and limitations which impeded full inspection of the property at the time of inspection. These obstructions can hide an array of defects and should be removed to allow full inspection to be carried out. A re-inspection is recommended once the areas are made accessible.

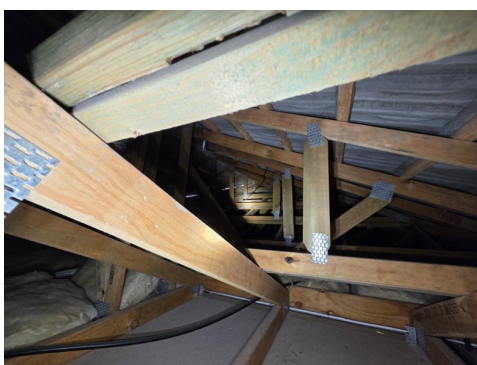
No immediate action is required; however, purchasers should be aware that areas of the roof space were not accessible for inspection due to framing configuration and access limitations.
