# Building and Timber Pest Inspection Report

Inspection Date: Thu, 12 Feb 2026

Property Address: 165 Beauchamp Rd, Matraville NSW 2036,  
Australia

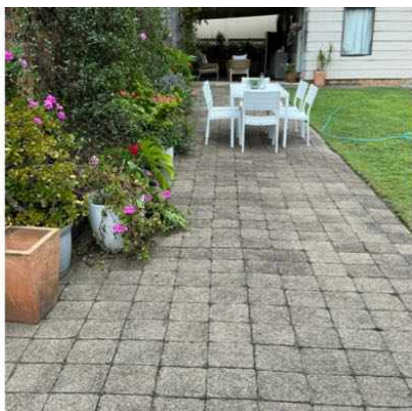
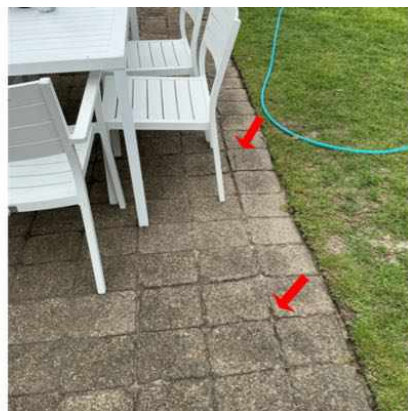
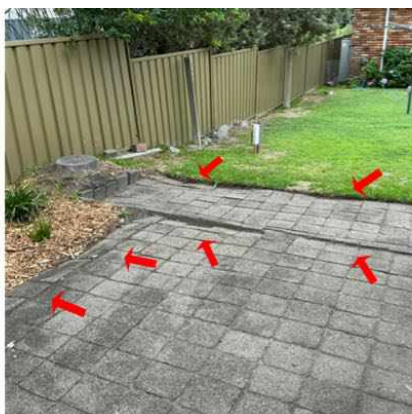
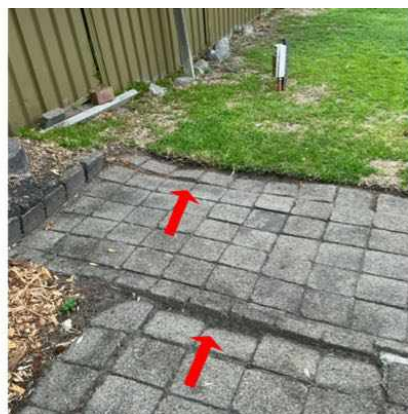
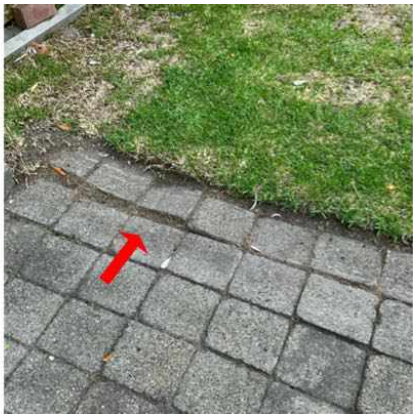
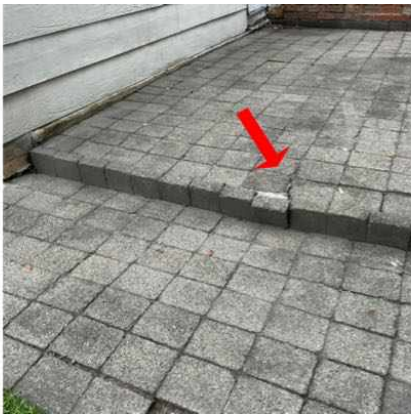
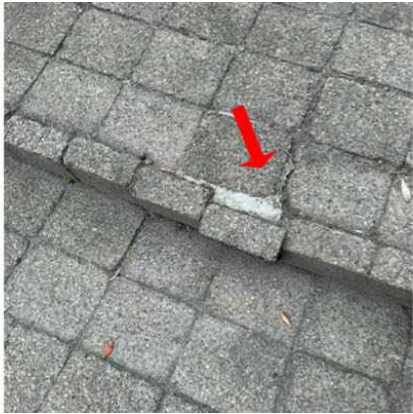
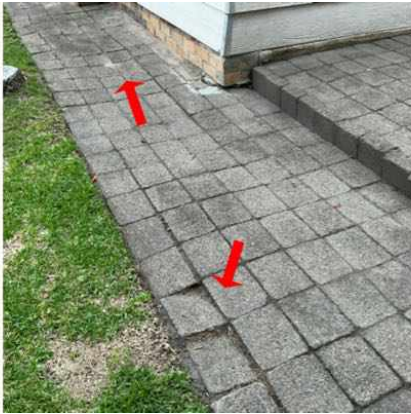
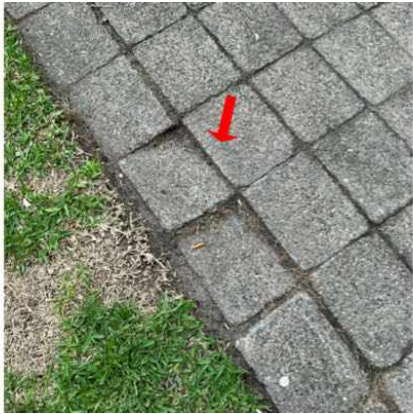
Building: Yard  
Location: Side and rear external paved areas  
Finding: Paving uneven  
Information: Sections of the external paved area are uneven, creating a potential trip hazard. It appears as though the area has been subject to rough installation, or that paving sections have lifted due to movements in the foundation of the property.

Where paving creates a trip hazard, personal injury may ensue if due caution is not taken by all persons within this area.

Re-paving of the area is required as soon as possible to remedy this situation. Further consultation with a specialist concreter is advised.

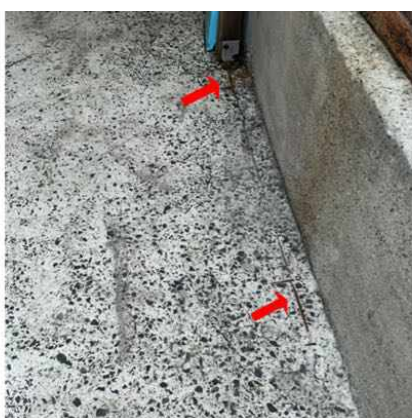
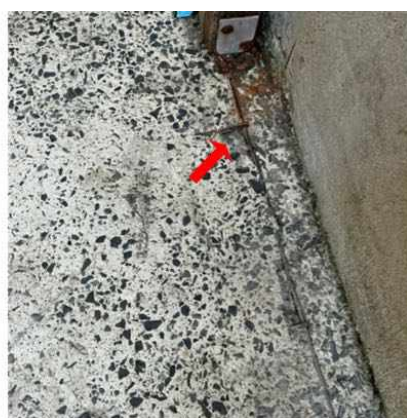
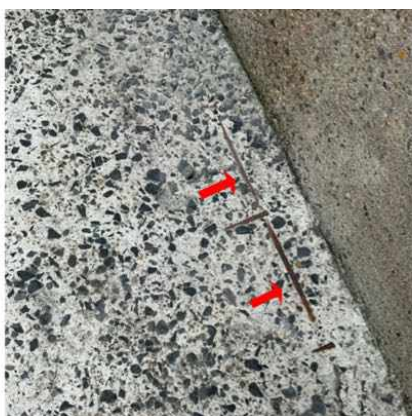
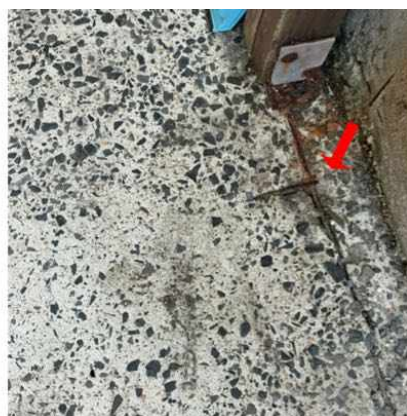
### Finding 3.02

Building: Main Building  
 Location: Driveway  
 Finding: Building element - Rusted or corroded

Where possible, the use of galvanized (treated) metals or aluminium coated metals aid in rust prevention, as does regular general maintenance. Rust formation can be controlled with coatings, such as paint, that isolate the iron from the environment.

Rusting and corrosion should be managed by ideally removing or limiting the affected surface from exposure to moisture. A registered builder may be appointed to replace any building elements that have been severely affected by rust or water damage.

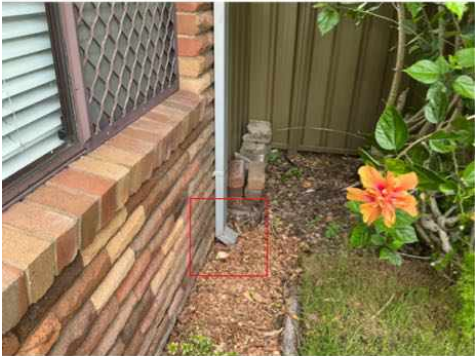
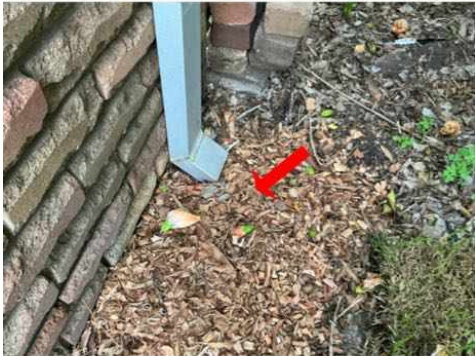
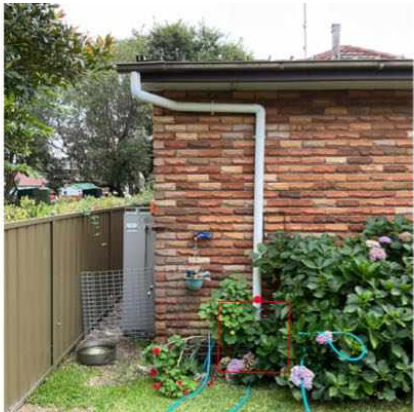
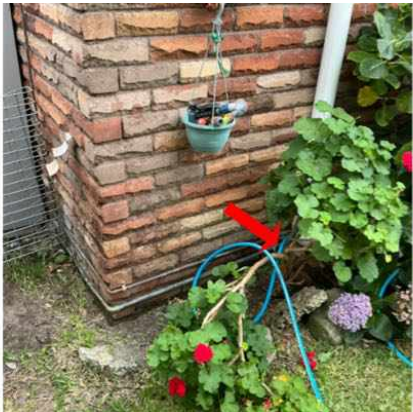
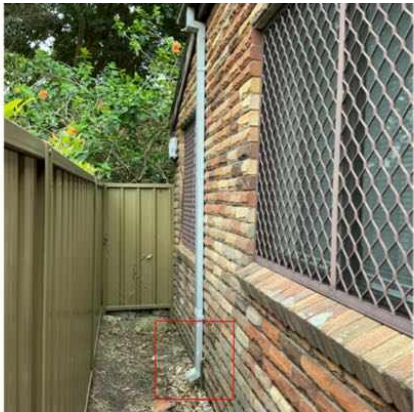
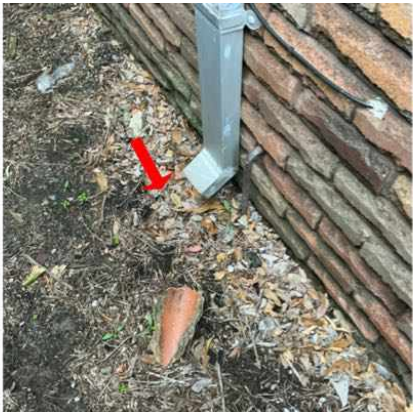
### Finding 3.03

Building: Main Building  
 Location: Roof Exterior  
 Finding: Guttering and/or Downpipes - Not plumbed for drainage  
 Information: The guttering or downpipes are not plumbed or connected to suitable drainage, which has resulted in the surrounding area becoming excessively damp. These damp conditions can lead to secondary defects such as rot, rust or corrosion of associated building elements, the formation of fungal decay, or even the creation of potential slip

hazards.

When coupled with poor site drainage, pooling of water may also attract termite activity to this area.

It is highly recommended that a qualified plumber be appointed to install adequate drainage to the overflow. These works will ensure that the area remains dry and free of any secondary defects.

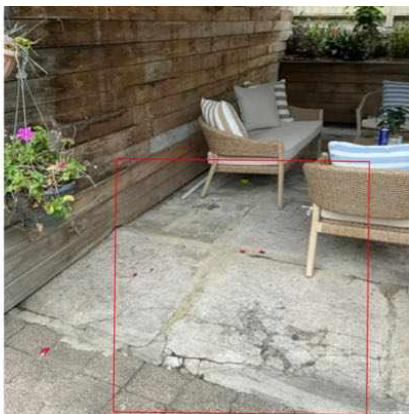
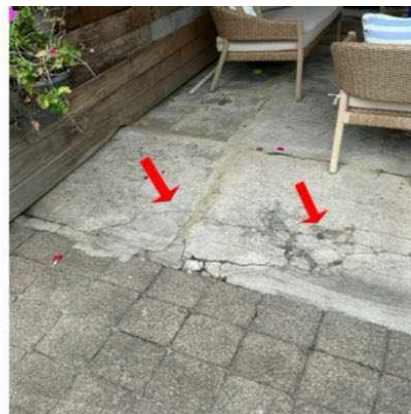
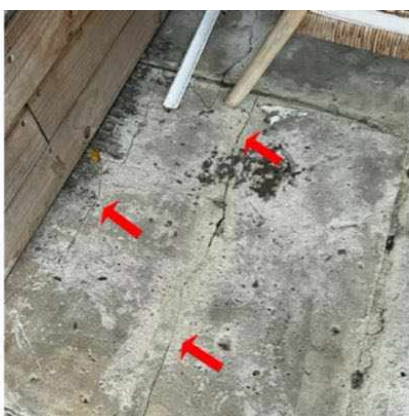
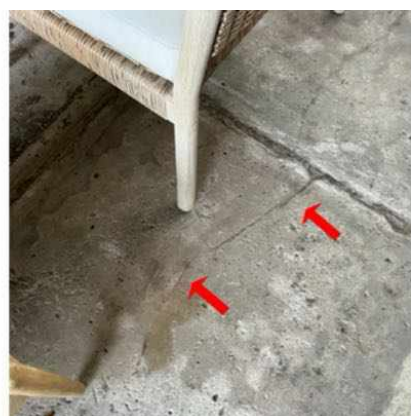
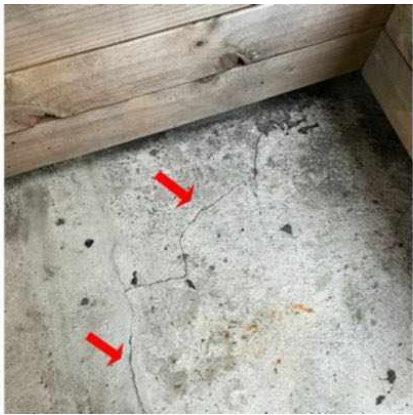
**Finding 3.04**

Building: Yard  
Location: Back patio

Monitoring of all cracking should be conducted frequently. Always contact a building inspector should cracks widen, lengthen, or become more numerous. Additionally, your building inspector should also be contacted if associated building elements such as doors and windows become more difficult to operate over time.

Relevant tradespeople, such as carpenters, painters and plasterers, should be appointed to perform remedial works, as deemed necessary.

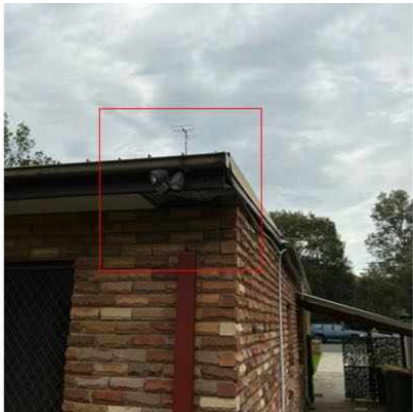
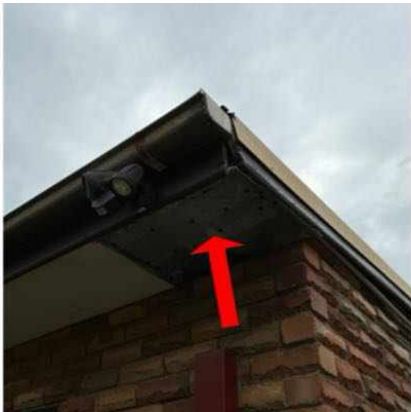
**Finding 3.05**

Building: Main Building  
Location: Back yard and side passage  
Finding: Incomplete or substandard works- Eaves & Fascia boards separated or missing.  
Information: The works to this area appear to be incomplete or have been completed to a substandard level.

Works that have not been completed to a satisfactory level create potential for the development of building defects and may impede on the safety and integrity of the overall structure.

It is highly recommended that the relevant trades be appointed to complete these works and ensure the safety of the area and the longevity of all associated building elements.

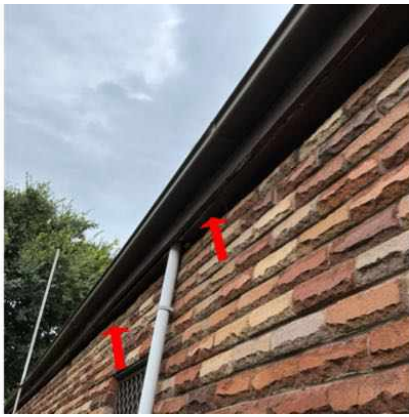
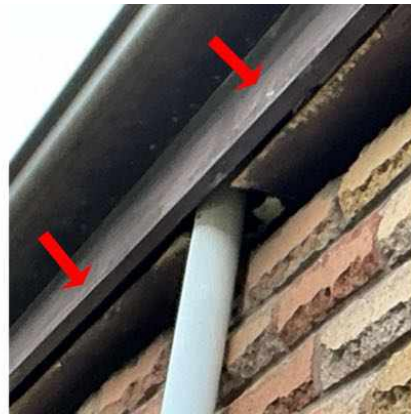
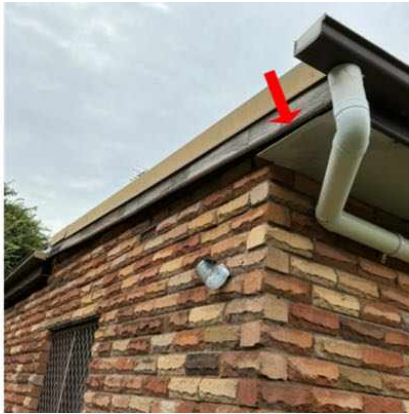
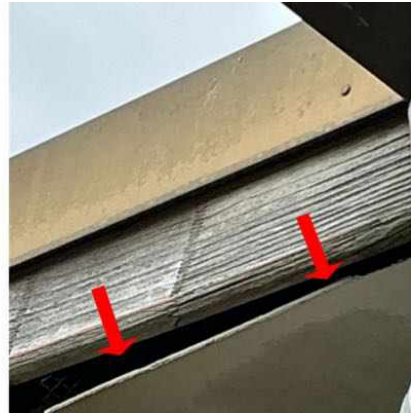
### Finding 3.06

Building:	Building 2
Location:	Back Storage shed
Finding:	Incomplete or substandard works- storeroom external fascia's, eaves, capping-sealants.
Information:	The works to this area appear to be incomplete or have been completed to a substandard level.

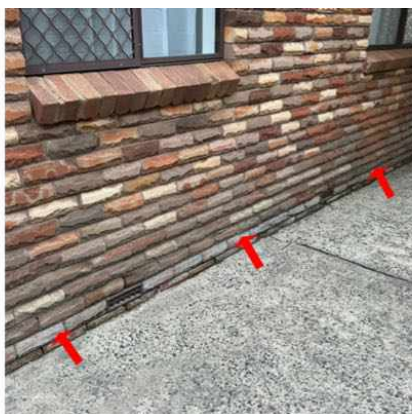
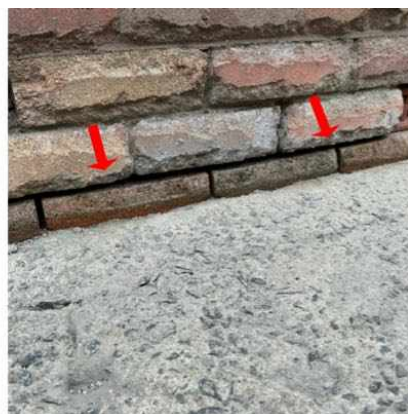
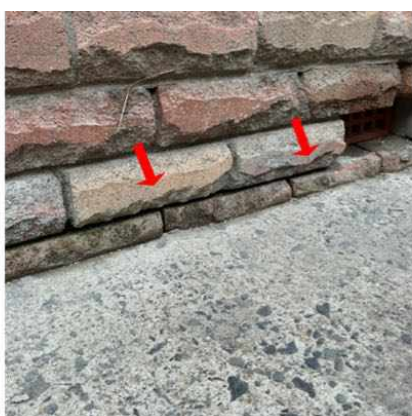
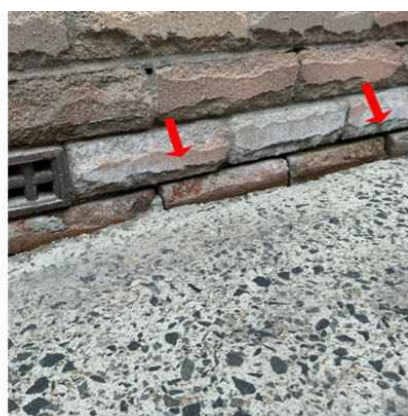
### Finding 3.07

Building:	Main Building
Location:	Side passage-north side
Finding:	Brickwork - Deteriorated mortar
Information:	Mortar, or 'bedding', is the material which fills joints and intersections between bricks in masonry walls and structures. Sections of mortar in this brickwork were identified as having deteriorated, which is generally expected for a property of this age and condition.

Mortar may deteriorate as a result of age of building materials, minor movement of bricks, or frequent exposure to weathering. Mortar should be replaced to ensure that bricks remain in their intended location and to prevent gaps, which would allow water

or moisture ingress and secondary damage as a result.

Mortar deterioration can be addressed by a bricklayer where areas of deterioration are localised and easily accessible. Alternatively, appointment of a registered builder is advised, to repoint large areas of decaying mortar. Where secondary structural defects have become evident, consultation with a structural engineer may be required.

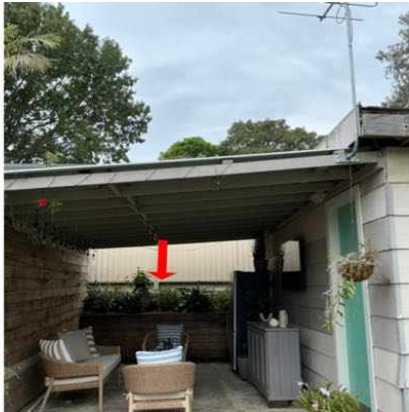
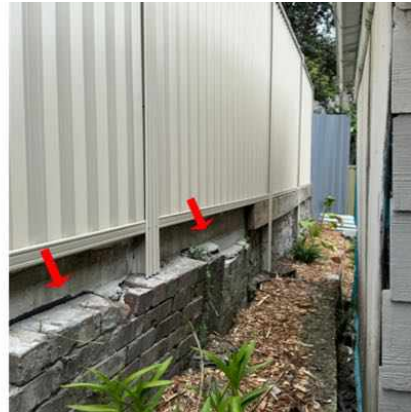
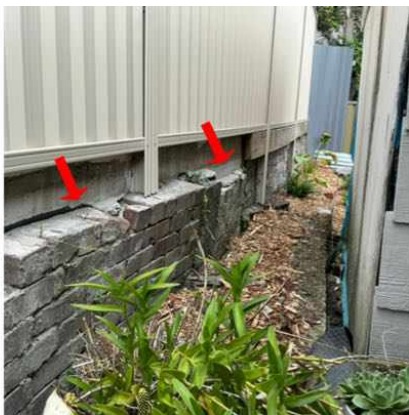
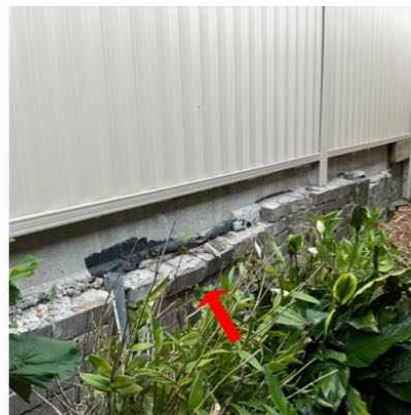
### Finding 3.08

Building:	Yard
Location:	Rear back fence
Finding:	Retaining wall - Defective
Information:	The retaining wall in this area was found to be defective at the time of inspection. Generally, defective retaining walls are caused by poor original design or material use. However, deteriorated retaining walls may also be a result of substandard construction, poor site drainage or unmanaged stormwater flows.

If left unmanaged, the retaining wall may become a safety hazard if it continues to destabilise. Where retaining walls further rot and decay, an environment is created that is conducive to termite and pest infestation.

Significant repair and replacement should be expected. Where retaining walls are considered structural walls, a structural engineer / surveyor should be consulted

regarding required remedial works. Otherwise, a landscaper or retaining wall installer may be appointed to repair or replace the wall, at the discretion of the client.

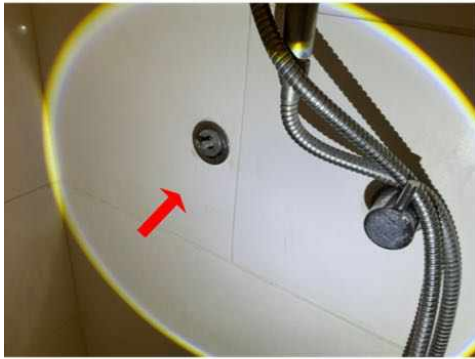
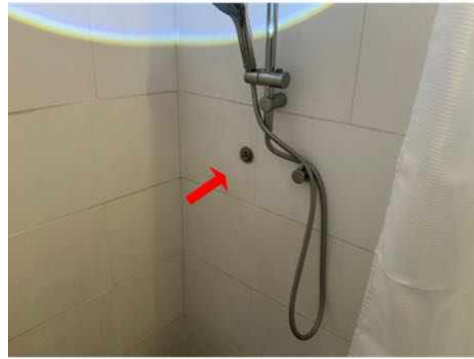
### Finding 3.09

Building:	Main Building
Location:	Second bathroom adjoining Laundry
Finding:	Building element - Broken or Damaged- tap fitting missing
Information:	Breakage occurs generally when the building materials have either aged and decayed, or as a result of damage (accidental or deliberate).

Repair and/or replacement of broken elements is advised to ensure that additional secondary defects do not arise as a consequence. Such works are necessary, as all building elements play a key role in the operation and function of the overall structure and its performance.

A relevant tradesperson should be appointed to repair or replace the affected building element prior to any subsequent damage being caused.

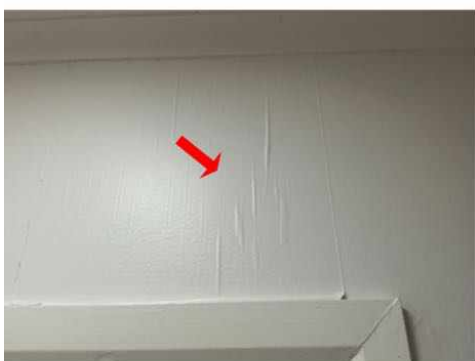
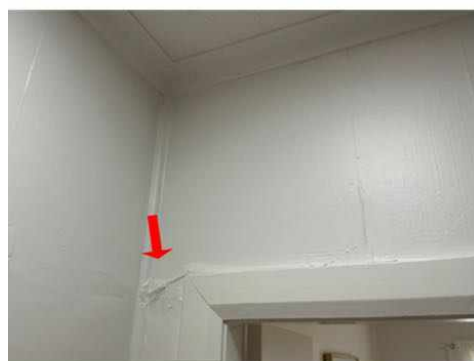
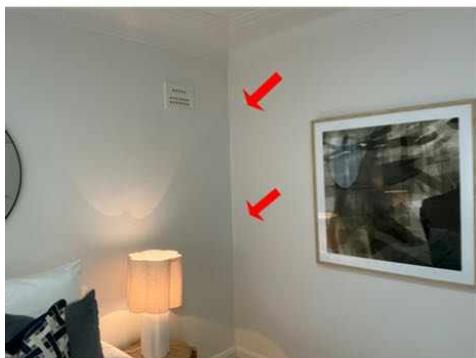
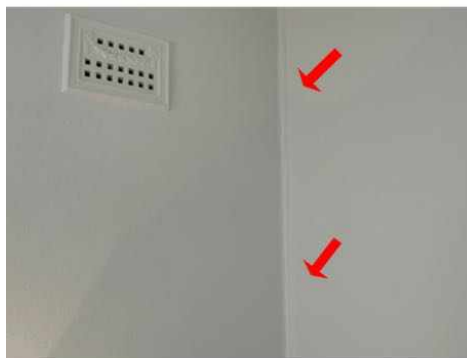
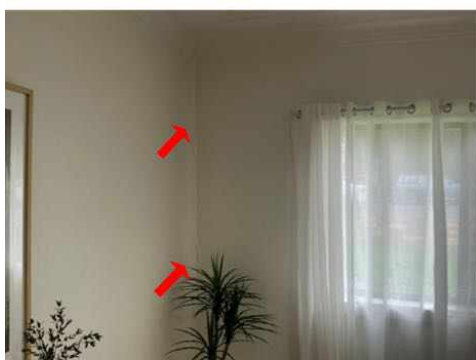
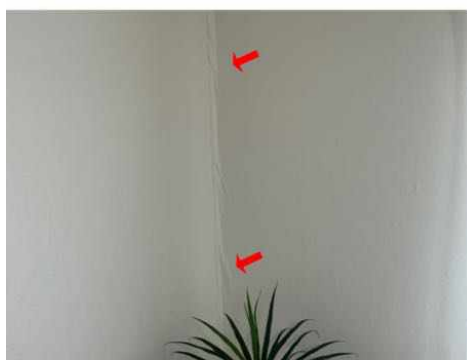
### Finding 3.10

Building:	Main Building
Location:	Hallway entrance, bedrooms
Finding:	Painted surface - Bubbling
Information:	Sections of paint in this area was found to have bubbled and deteriorated. Paint bubbling is generally an indication of excessive moisture in the area, that is currently hidden by the painted surface.

The presence of excessive moisture can have major implications on associated building elements if left unattended. While only seemingly minor at this stage, the damage cannot be determined due to the paint obstructing any further inspection of the damage.

It is highly advised that the affected paint be cleaned to allow a further, more invasive inspection by a licensed plumber. Failure to act on this defect may necessitate major works in the future.

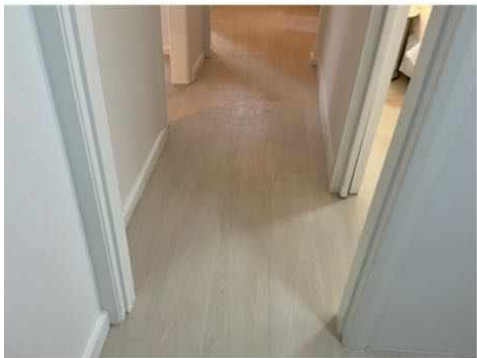
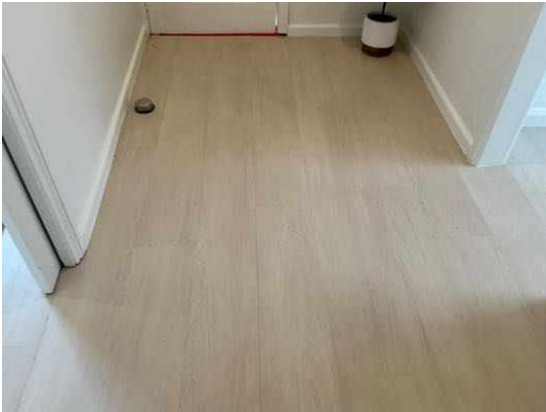
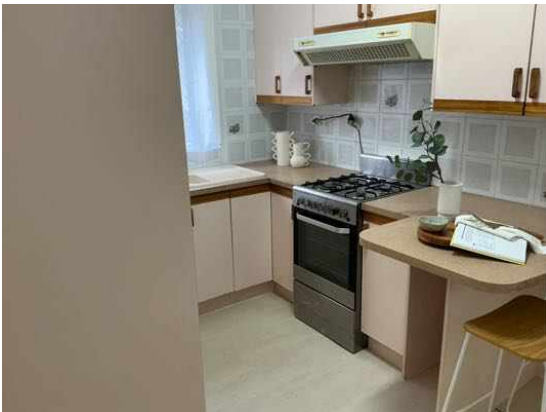
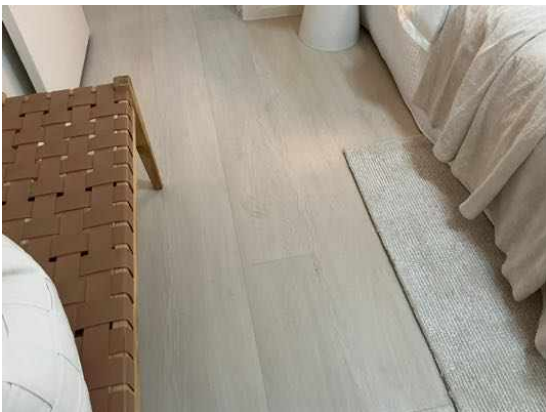
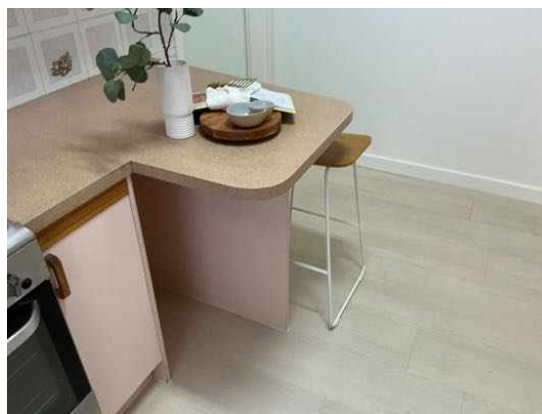
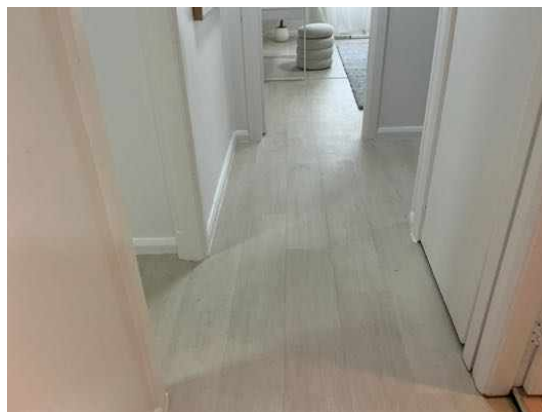
### Finding 3.11

Building:	Main Building
Location:	All internal flooring throughout house
Finding:	Flooring - Uneven
Information:	The internal flooring in this area is out of level and uneven. Uneven flooring is likely to indicate minor defects such as expected movement of the foundations of the property, but may also indicate subsidence of the associated subfloor stumps.

It is advised that the flooring be closely monitored to identify any further movement. Where flooring remains relatively unchanged for an extended period of time (i.e. several months), it is likely that this defect has been caused by expected movement of the foundations of the property.

However, where flooring is uneven further, potentially invasive inspection of the subfloor structures and stumps in this area is required. In this case, works to repair are likely to be required, and would be carried out by a registered builder specialising in re-stumping.

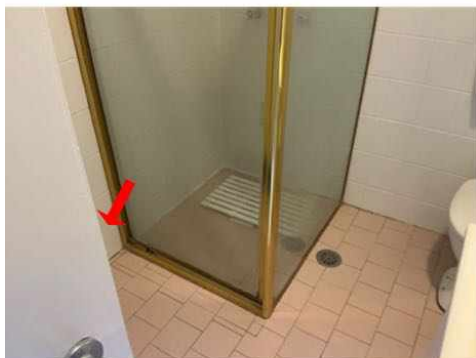
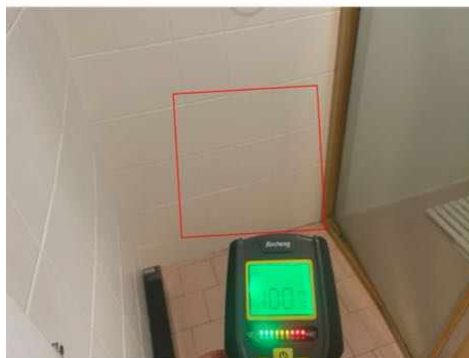
### Finding 3.12

Building:	Main Building
Location:	Bathroom
Finding:	Excessive Moisture Identified.
Information:	Excessive moisture can attract termites and produce conditions that promote fungal growth and wood decay.

Excessive moisture is generally caused by deteriorated, inadequate or missing roof drainage, leaking plumbing pipes or fixtures, poorly plumbed HWS overflows or condenser units and poor site drainage.

If mould growth has been found there may be environmental biological or health issues involved. In these cases an appropriately qualified inspector should also be contacted.

Prior to any remedial works being performed a qualified plumber should be appointed to further inspect the property and to identify the cause of the excessive moisture. Works to remove affected building elements may then be necessary and should be performed by an appropriate tradesperson.

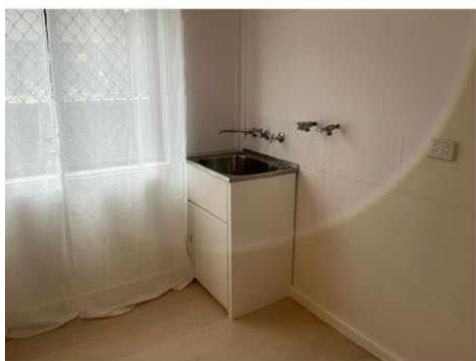
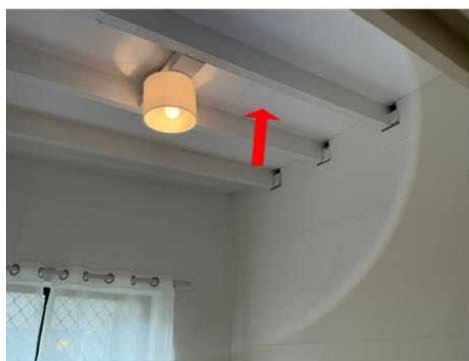
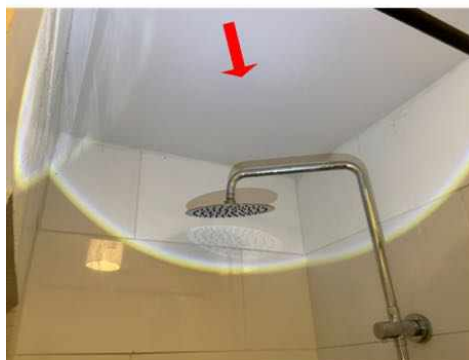
**Finding 3.13**

Building: Main Building  
 Location: Laundry & second bathroom  
 Finding: Exhaust fan - Missing  
 Information: An exhaust fan has not been installed in this area. Missing exhaust fans may lead to the development of more significant defects such as moisture damage to surrounding building materials from inadequate ventilation. Inadequate ventilation in internal areas creates an environment that is conducive to the formation and development of mould and other respiratory hazards. It is highly advised that a licensed electrician be appointed to retrospectively install an exhaust fan. Failure to perform works to aid the ventilation of the area may lead to the development of these secondary defects.

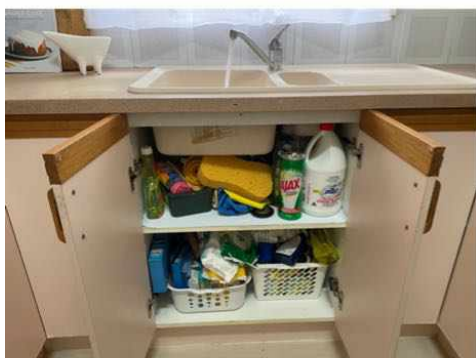
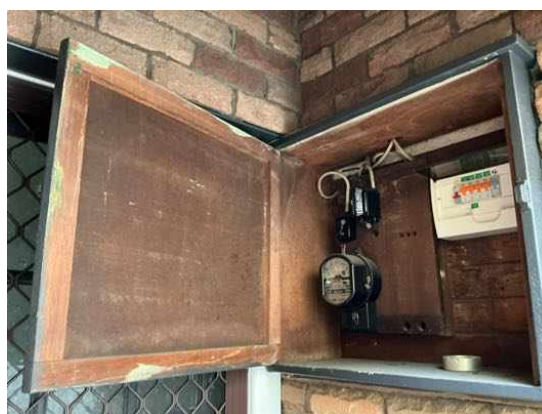
Building:	Main Building
Location:	Meter box and under kitchen sink
Finding:	Termite Management System - no evidence of a chemical installation
Information:	The application of a post-construction chemical termite barrier is highly recommended for all properties, particularly if live termite activity has been found on the site previously. Such barriers are highly effective in preventing termite attack on any timber building elements throughout the property.

A durable notice should be placed in the switchboard unit to indicate current termite barriers. At the time of inspection, it appeared as though no termite management system has been installed, with no evidence to suggest preventative works taking place.

The client may consider gaining further advice from a pest controller as to the costs and procedures involved with this application. It is recommended that obtaining such advice be a short-term priority.

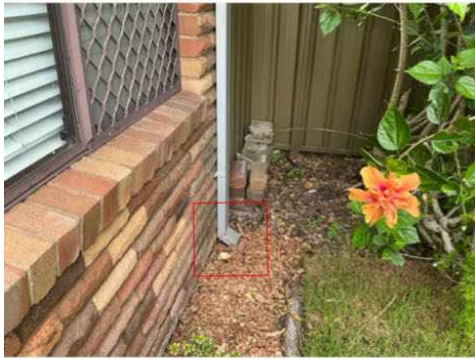
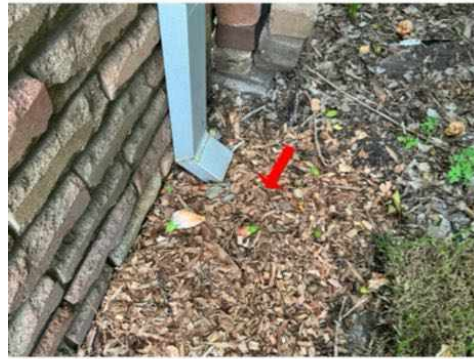
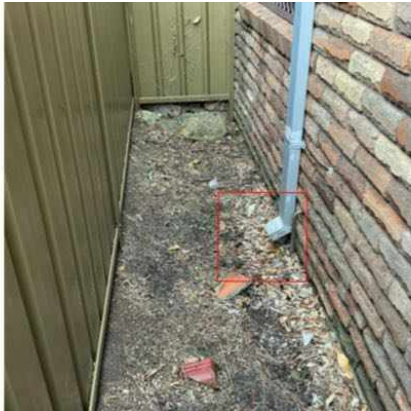
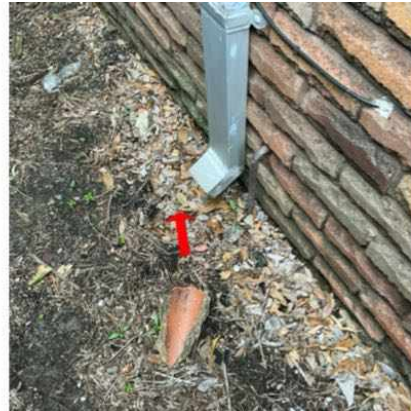
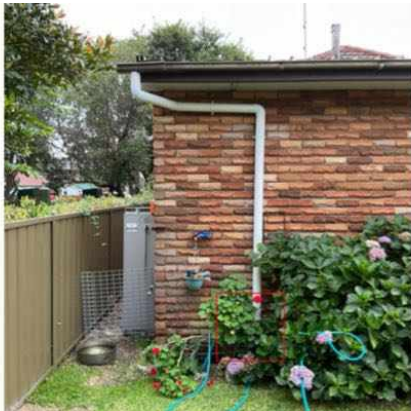
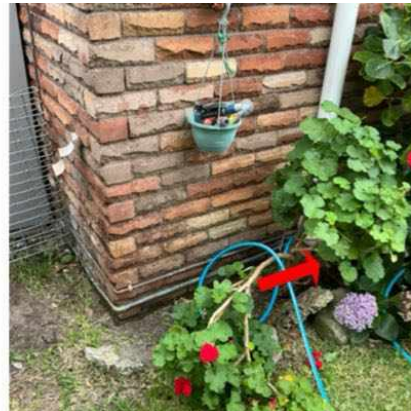
### Finding 6.02

Building:	Main Building
Location:	External drain pipes around all of building

Finding: Overflow - Not plumbed for drainage (Excessive Moisture)  
 Information: The overflow is not plumbed or connected to suitable drainage, which has resulted in the surrounding area becoming excessively damp. These damp conditions can lead to secondary defects such as rot, rust or corrosion of associated building elements, the formation of fungal decay, or even the creation of potential slip hazards.

When coupled with poor site drainage, pooling of water may also attract termite activity to this area. It is highly recommended that a qualified plumber be appointed to install adequate drainage to the overflow. These works will ensure that the area remains dry and free of any secondary defects.

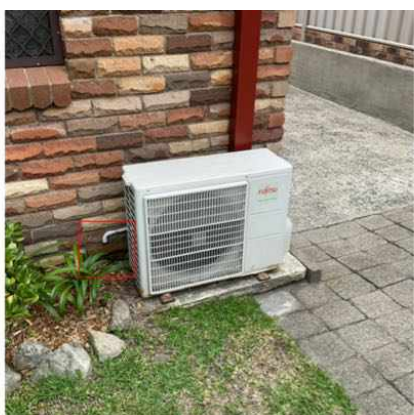
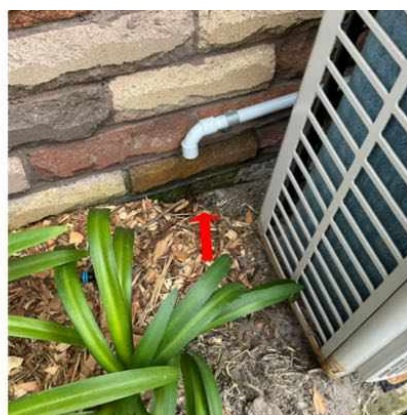
### Finding 6.03

Building:	Main Building
Location:	Back yard
Finding:	Air conditioner - Disconnected overflow
Information:	The Air Conditioner (A/C) overflow was found to be disconnected from storm water drainage and is creating excessive moisture in the surrounding area.

Such leaking creates an environment which is conducive to an array of defects, including water damage to associated building elements and the attraction of termite or timber pest infestation.

It is highly recommended that a licensed plumber be appointed to connect the A/C overflow in order to prevent such an environment from being created. These minor works should be carried out as soon as possible.

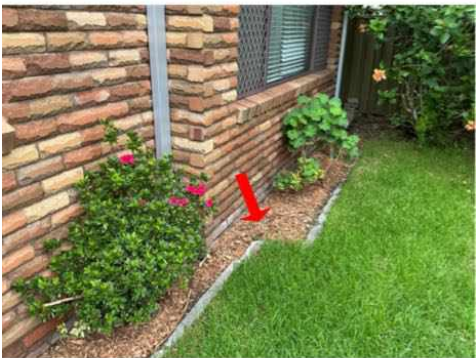
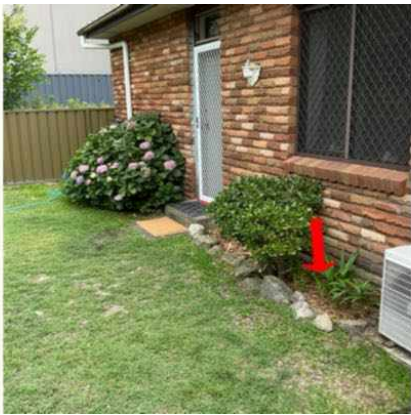
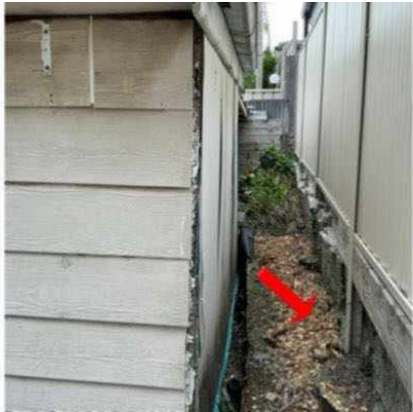
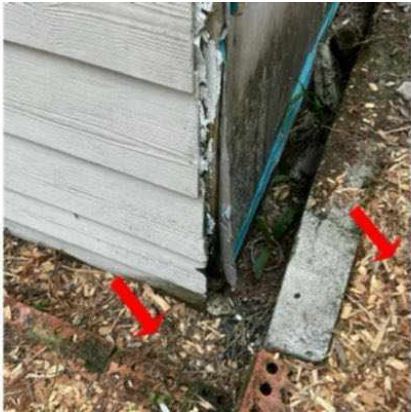
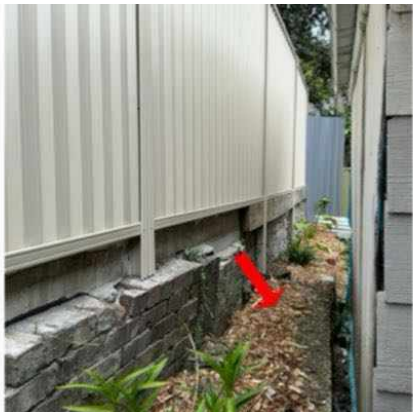
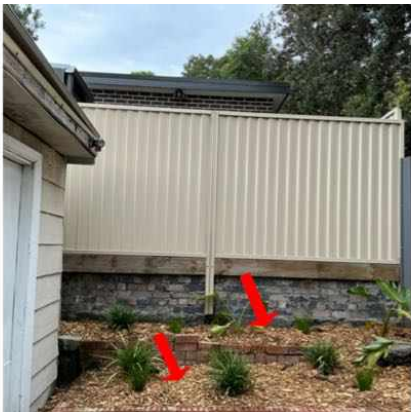
### Finding 6.04

Building:	Main Building
Location:	Front and rear garden beds, behind storage shed
Finding:	Untreated or non-durable timbers in a hazardous environment (Timbers in ground contact)
Information:	To reduce the risk of timber pest attack it is essential that timber used in a hazardous environment (e.g. in direct contact with the ground or frequently exposed to damp conditions) is of sufficient durability and/or is adequately preservative treated.

Untreated timbers in direct contact with the ground are likely to develop severe wood rot and/or fungal decay if left unattended creating attraction for subterranean termites to infest the timbers from surrounding areas.

If untreated or non-durable timbers are found to be in a hazardous environment it is highly advised that replacement of these building elements be performed as soon as possible to aid the protection of the property against termite / timber pest attack.

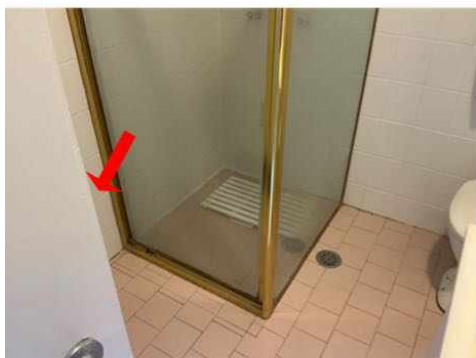
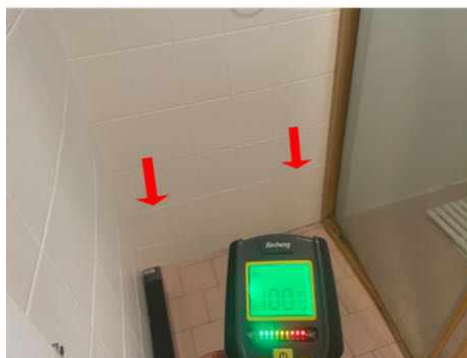
**Finding 6.05**

Building: Main Building  
 Location: Main bathroom  
 Finding: Excessive moisture - identified  
 Information: Excessive moisture can attract termites and produce conditions that promote fungal growth and wood decay.

Excessive moisture is generally caused by deteriorated, inadequate or missing roof drainage, leaking plumbing pipes or fixtures, poorly plumbed HWS overflows or condenser units and poor site drainage.

Excessive moisture was only found adjacent to the main bathroom shower recess. A plumber should be sought urgently in identifying and eliminating moisture. There is no subfloor to access. Whilst the floors throughout are uneven in all rooms, the floors appear solid. Access to the subfloor would be advantageous, in being able to evaluate the structures, as this was not possible. The outer fascia's and eaves require preventative maintenance. Similarly, the back storage shed requires preventative maintenance to many areas of its exterior.

Prior to any remedial works being performed a qualified plumber should be appointed to further inspect the property and to identify the cause of the excessive moisture. Works to remove affected building elements may then be necessary and should be performed by an appropriate tradesperson.

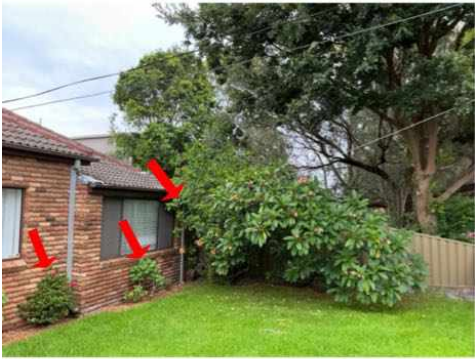
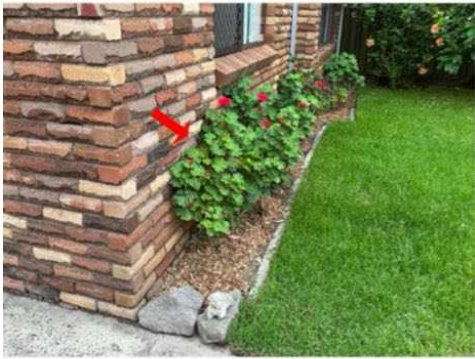
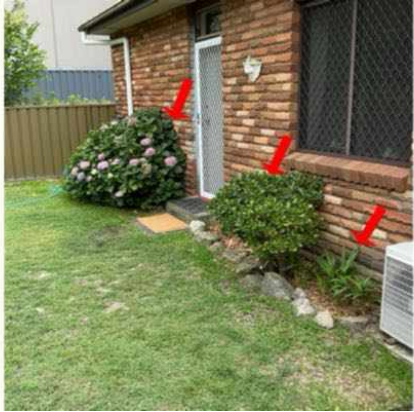
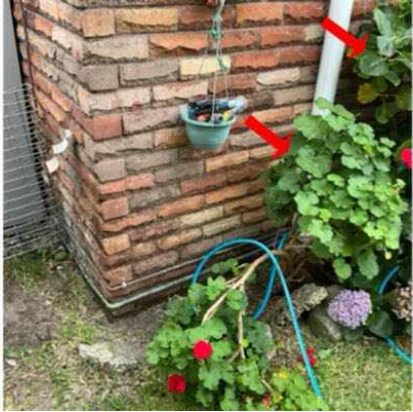
### Finding 6.06

Building:	Main Building
Location:	Front and rear garden beds
Finding:	Bridging - Vegetation
Information:	Where vegetation obstructs inspection of building elements, also known as bridging as it provides a bridging point for the access of termites, full inspection can not be achieved. Consequently moisture or dampness may be present and the areas becomes conducive to termite activity. Plants against or very close to buildings provide cover, shade and can provide an environment that is attractive to termite infestation.

The removal and replanting of species that do not provide "cover" or cutting back of existing vegetation will assist greatly in preventing Bridging from occurring.

The removal of any such materials that may be conducive to termite activity should be carried out as soon as possible and arrange re inspection to minimize the risk of termite attack.

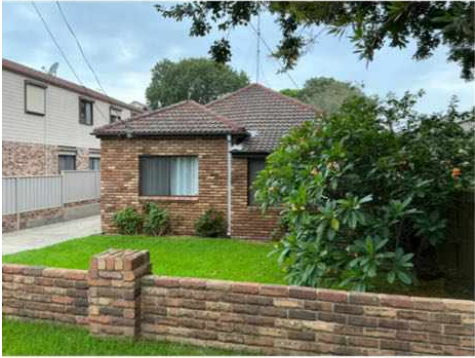
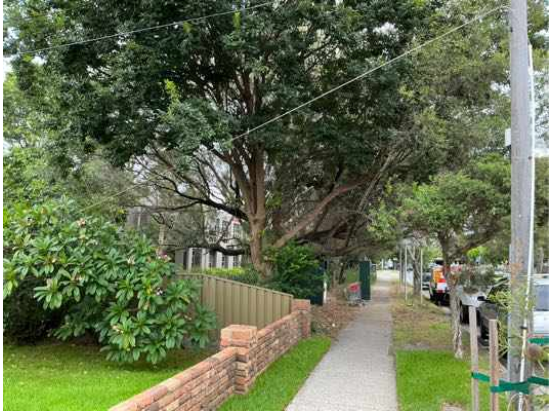
**Finding 6.07**

Building: Main Building  
 Location: All Areas  
 Finding: Trees to be inspected within the property.  
 Information: Trees can be conducive to termite activity and nesting. Trees over 100mm on the property, should be drilled and tested for termite activity.

Regular inspections every 6-12 months- or advised by the termite management system installer.

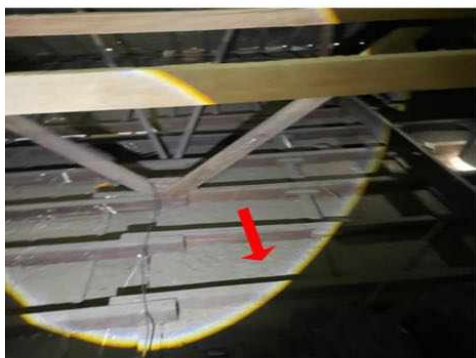
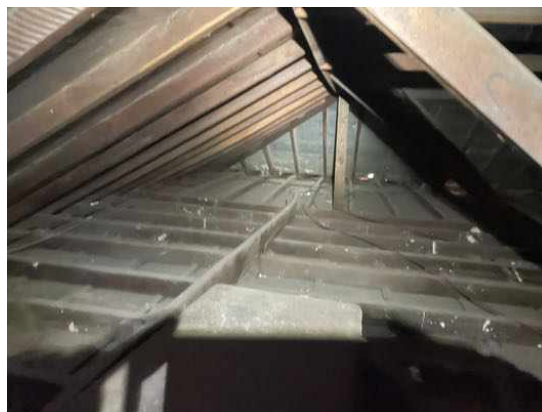
Building: Main Building  
Location: Roof Void  
Finding: Insulation - Missing  
Information: Upon inspection of the roof void it was noted that insulation is not present.

Insufficient insulation will result in a comparatively higher cost to heat and cool a property as there is a lack of Insulation (or uneven coverage of insulation) which works as a barrier to heat transfer. This helps to keep out unwanted heat in summer and preserves warmth inside your home in winter. It can also help soundproof your home from unwanted airborne noise transfer.

Where insulation is absent, the area does not meet current Australian Standards. Installation of adequate insulation is required and should be conducted as soon as possible.

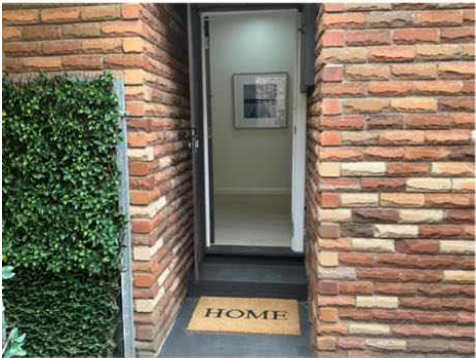
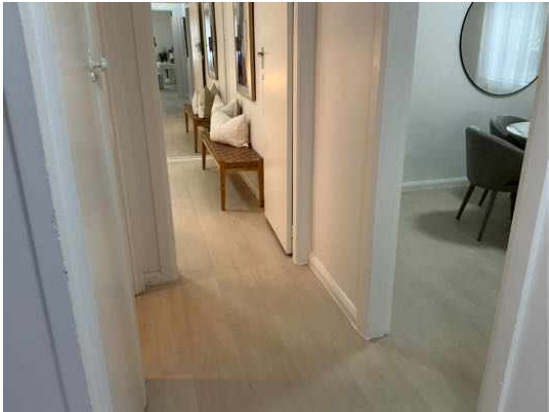
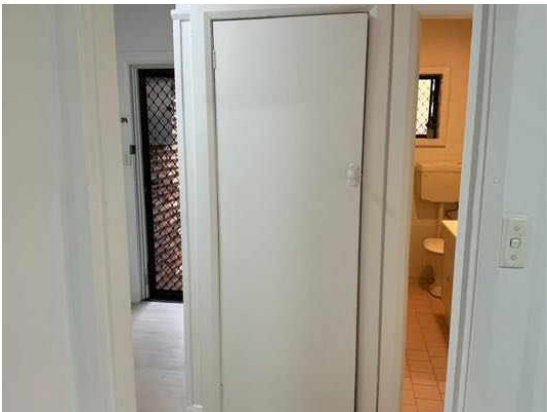
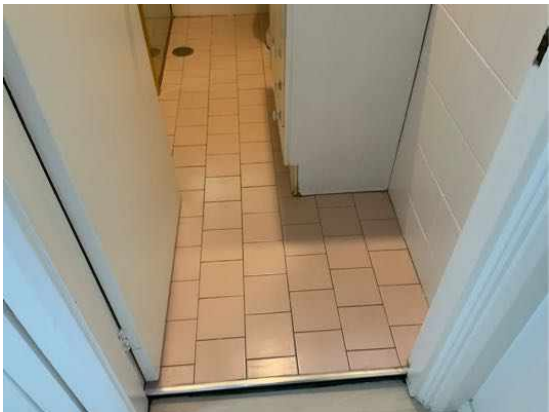
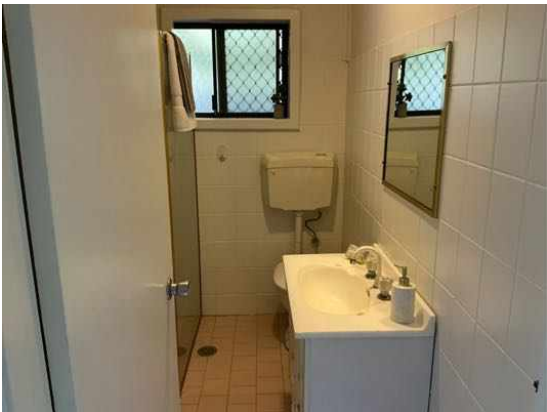
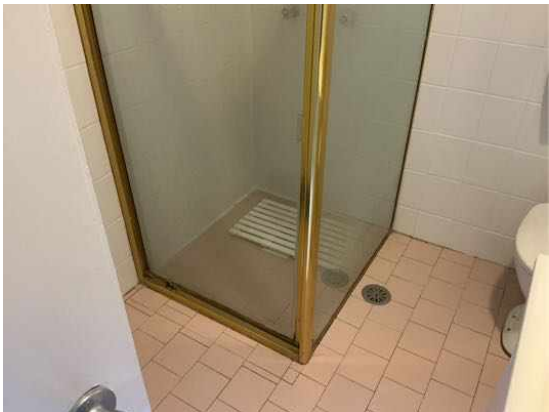
Building: Main Building  
Location: All Areas-internal  
Finding: Additional Photos - Obstructions and Limitations  
Information: These photographs are an indication of the obstructions and limitations which impeded full inspection of the property at the time of inspection. These obstructions can hide an array of defects and should be removed to allow full inspection to be carried out. A re-inspection is recommended once the areas are made accessible.

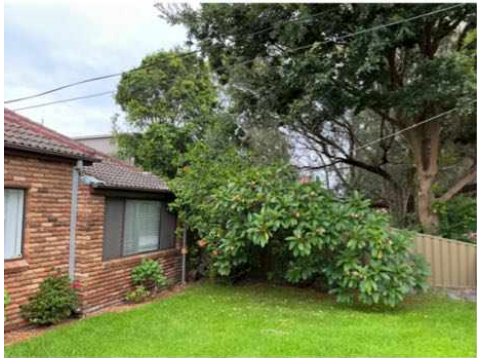
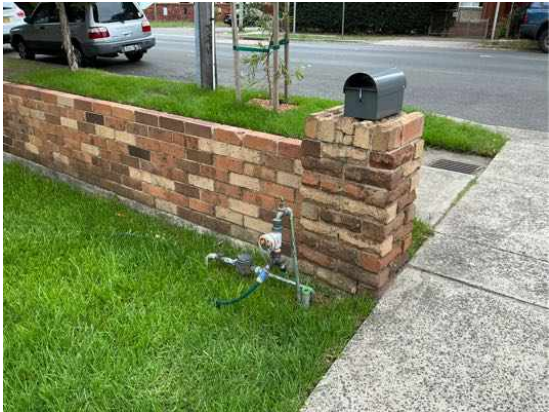
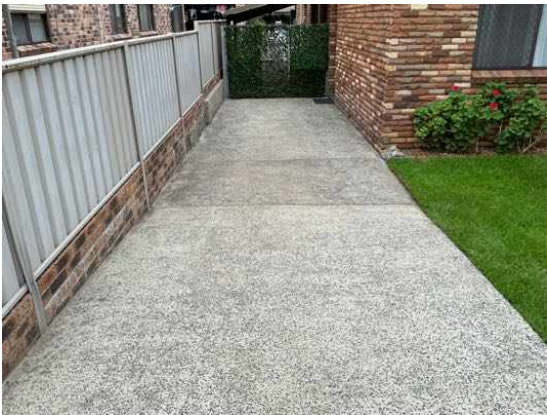
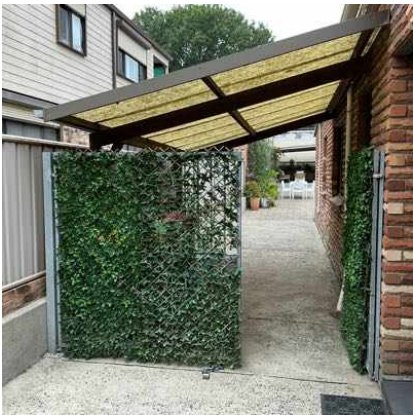
Building: Main Building  
Location: All Areas- external- (including rear storage area)  
Finding: Additional Photos - Obstructions and Limitations  
Information: These photographs are an indication of the obstructions and limitations which impeded full inspection of the property at the time of inspection. These obstructions can hide an array of defects and should be removed to allow full inspection to be carried out. A re-inspection is recommended once the areas are made accessible.
