# Building and Timber Pest Inspection Report

Inspection Date: Thu, 12 Feb 2026

Property Address: 165 Beauchamp Rd, Matraville NSW 2036,  
Australia

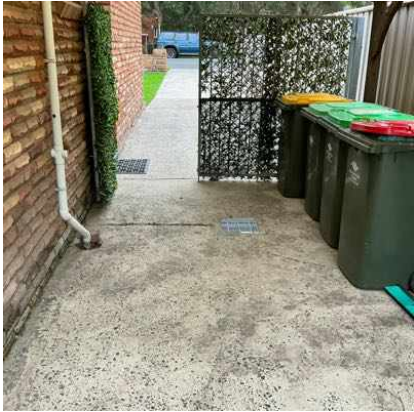
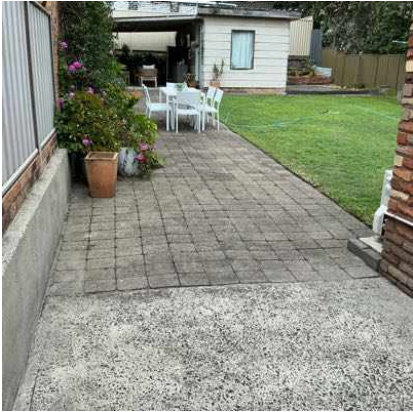
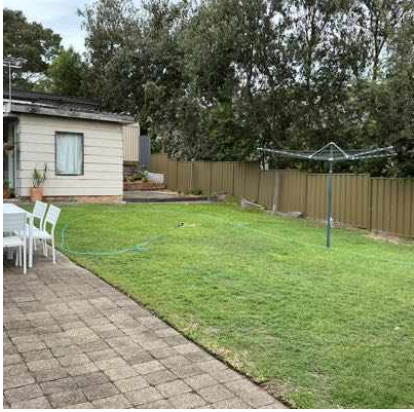
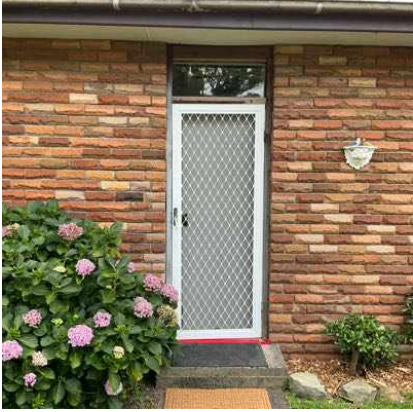
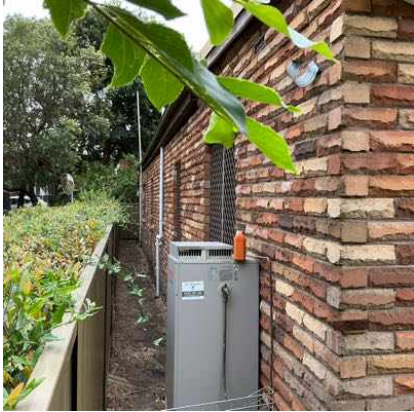
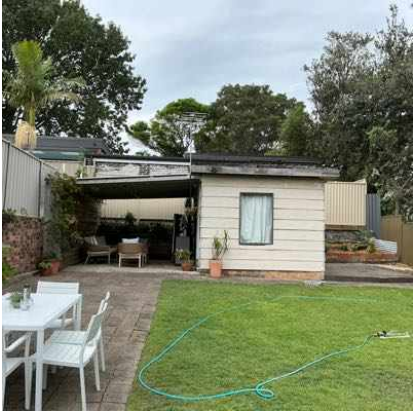
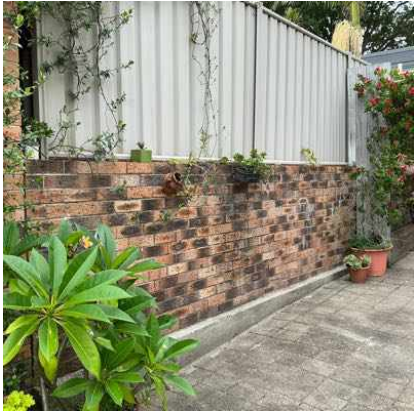
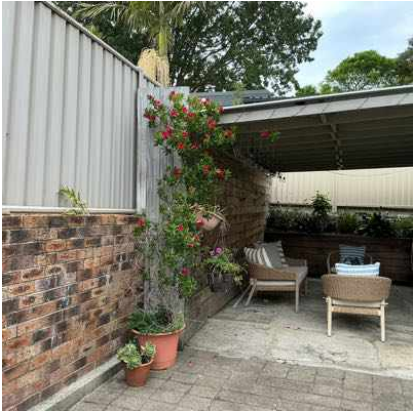
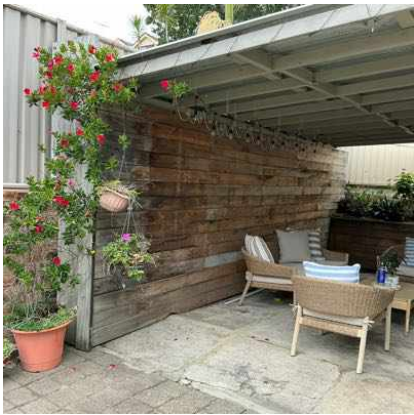
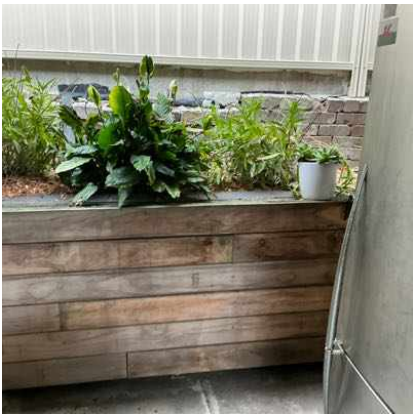
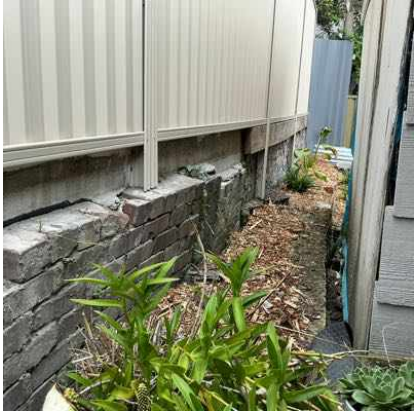
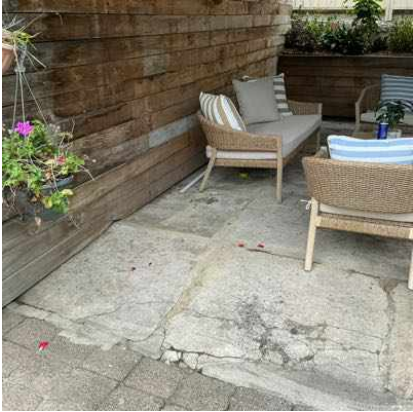
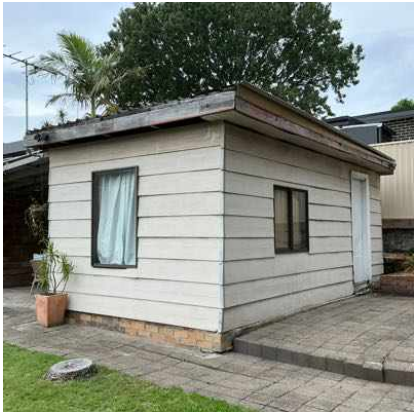
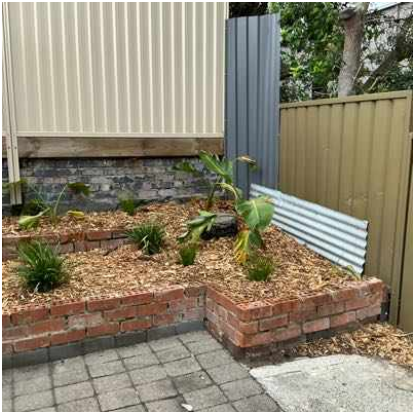
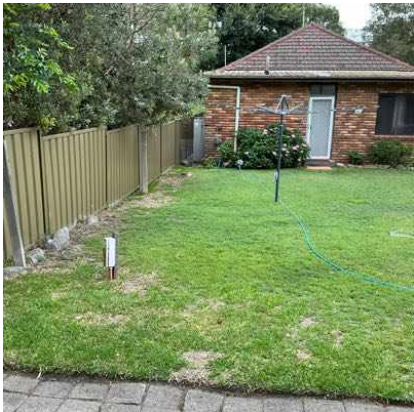
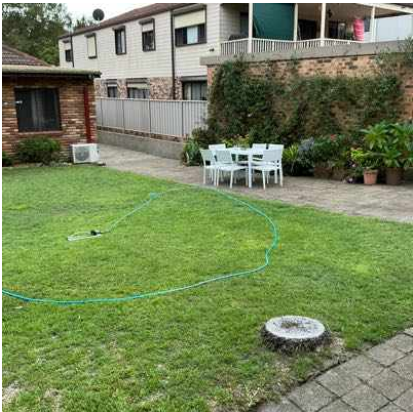
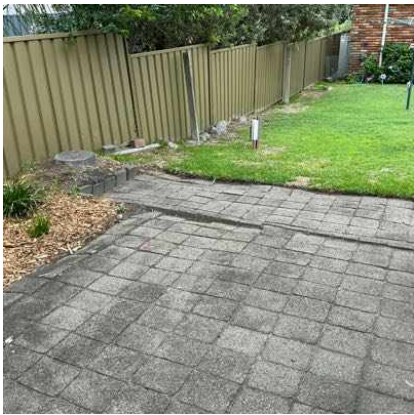
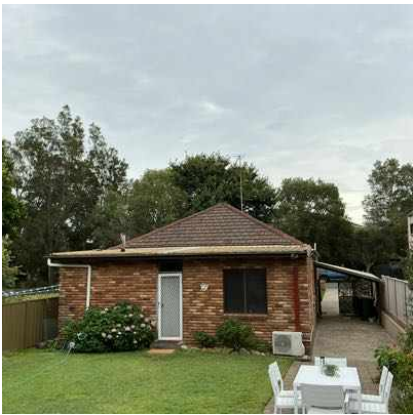
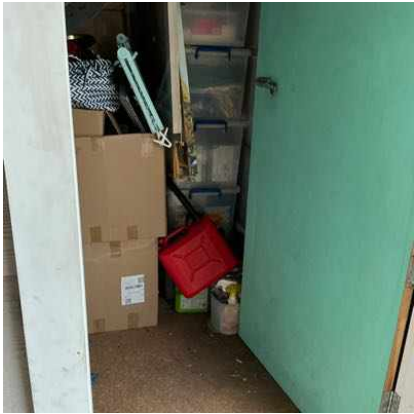
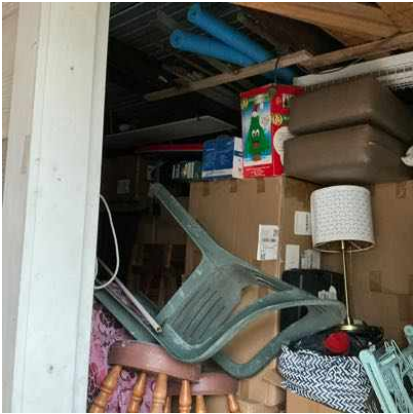
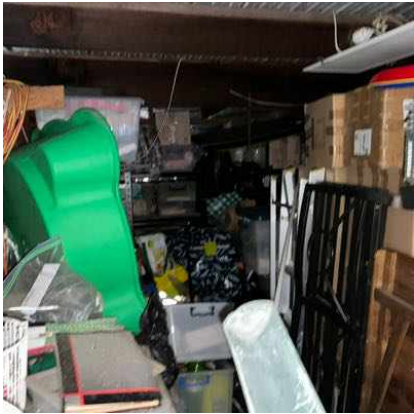
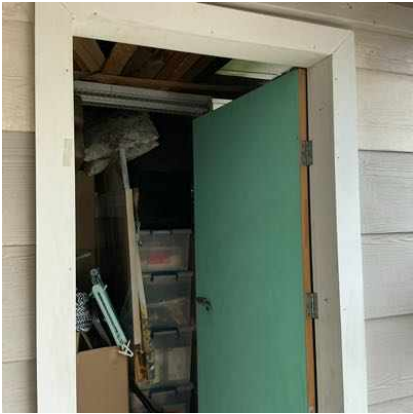
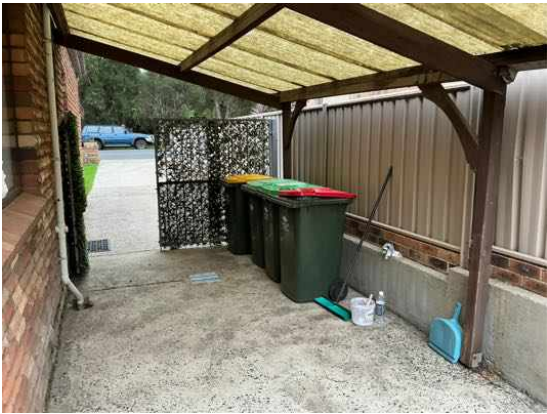
Building: Main Building  
Location: All Areas- external- (including rear storage area)  
Finding: Additional Photos - Obstructions and Limitations  
Information: These photographs are an indication of the obstructions and limitations which impeded full inspection of the property at the time of inspection. These obstructions can hide an array of defects and should be removed to allow full inspection to be carried out. A re-inspection is recommended once the areas are made accessible.

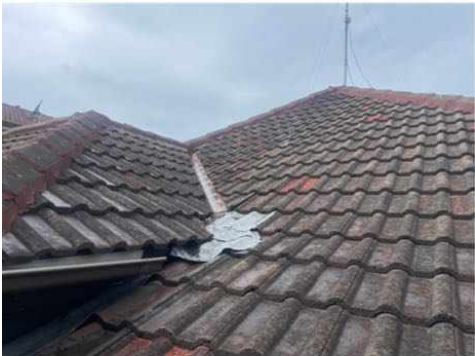
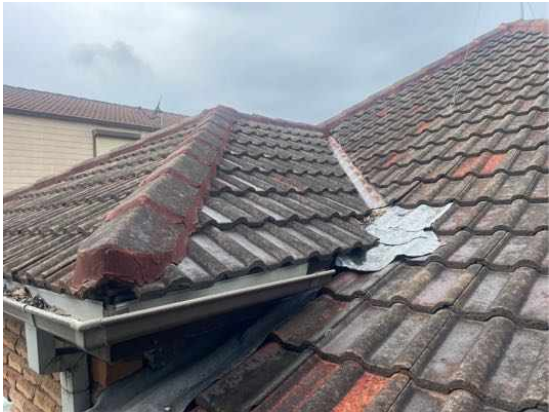
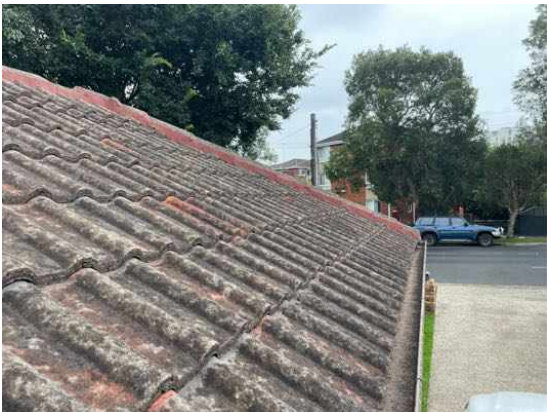
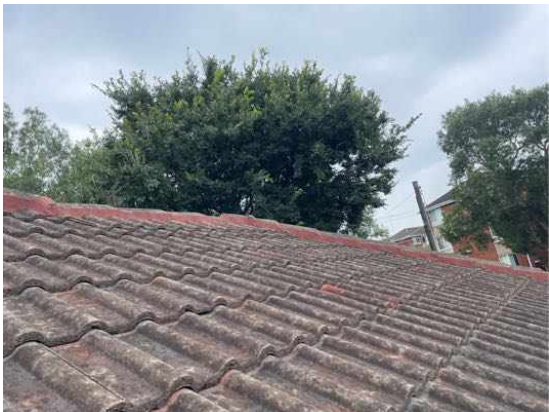
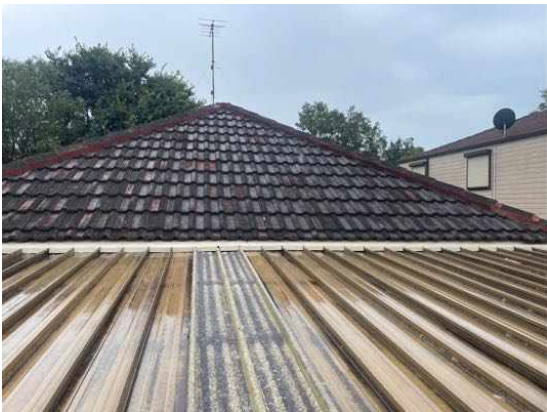
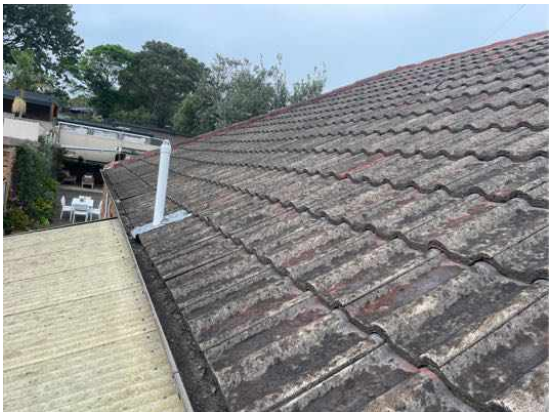
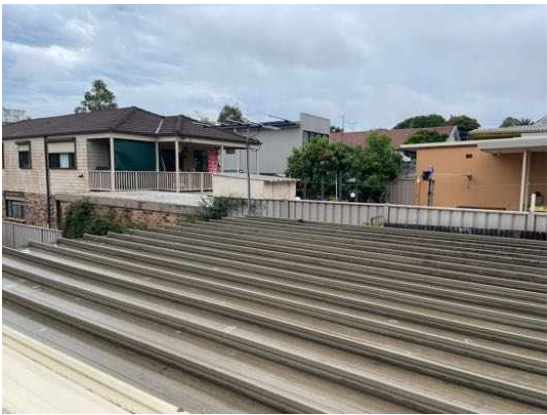
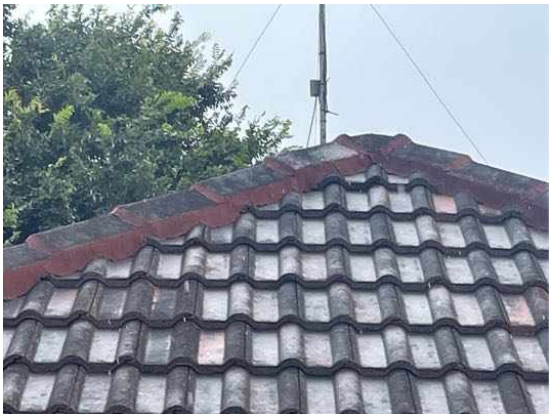
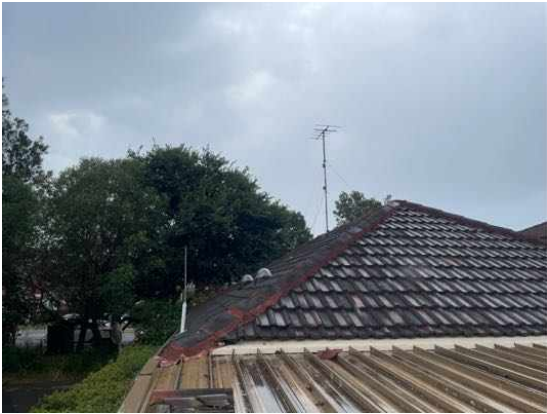
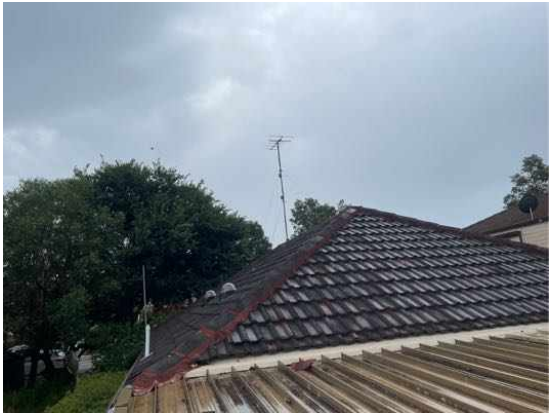
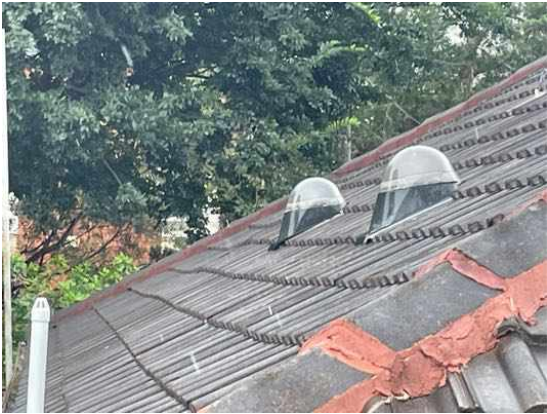
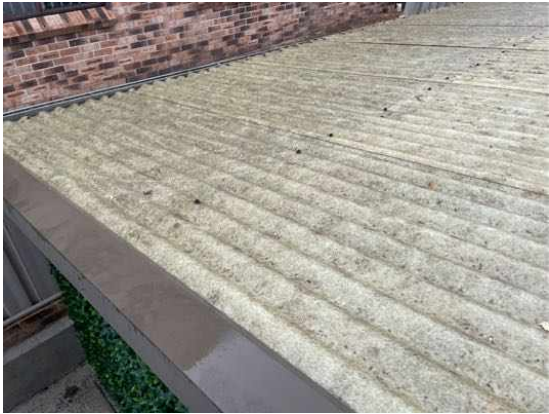
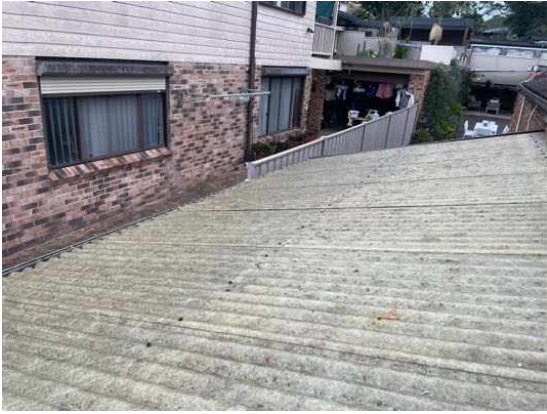
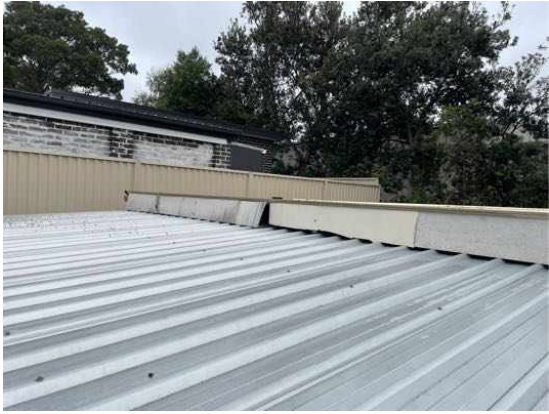
Building: Main Building  
Location: Roof Exterior  
Finding: Additional Photos - Obstructions and Limitations  
Information: These photographs are an indication of the obstructions and limitations which impeded full inspection of the property at the time of inspection. These obstructions can hide an array of defects and should be removed to allow full inspection to be carried out. A re-inspection is recommended once the areas are made accessible.

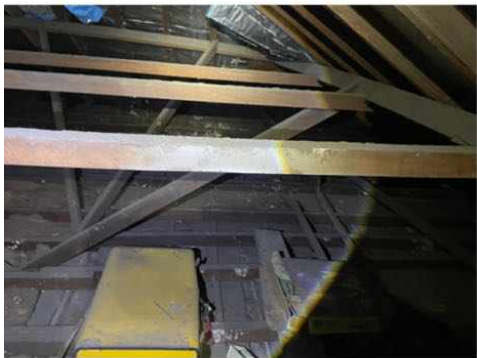
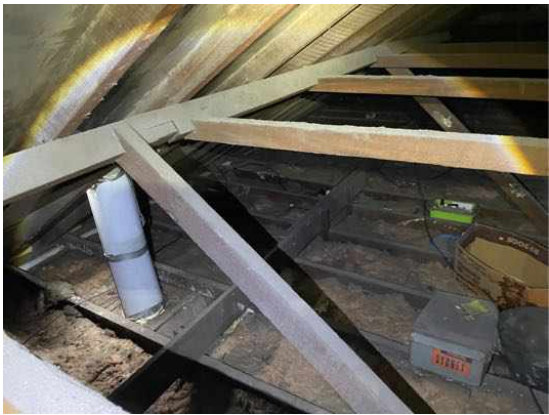
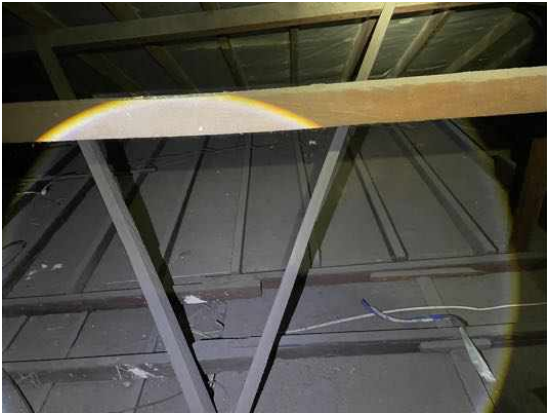
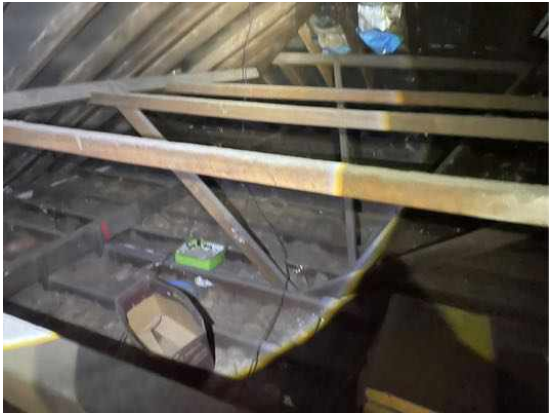
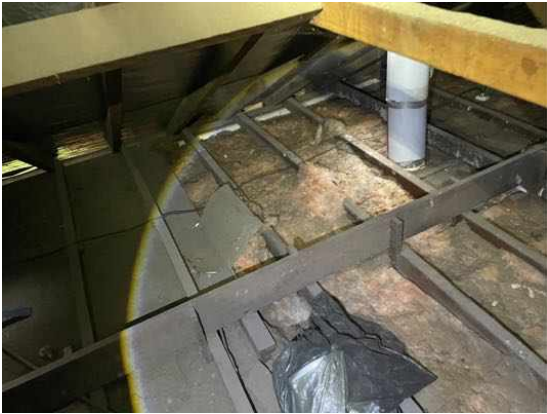
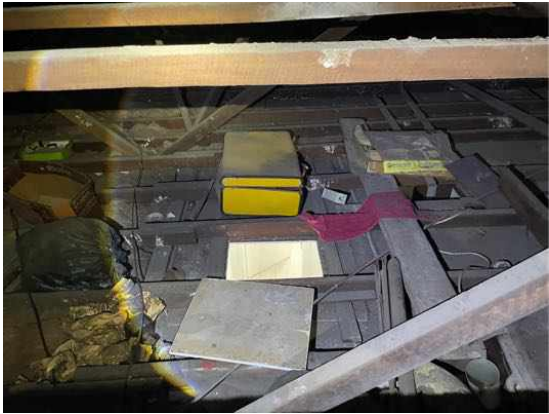
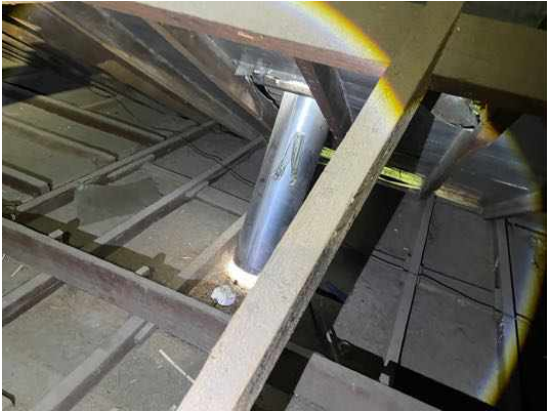
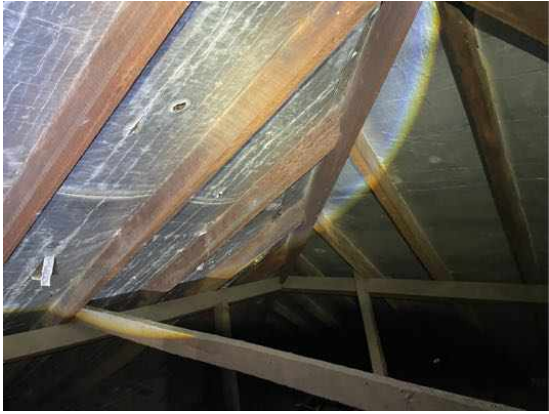
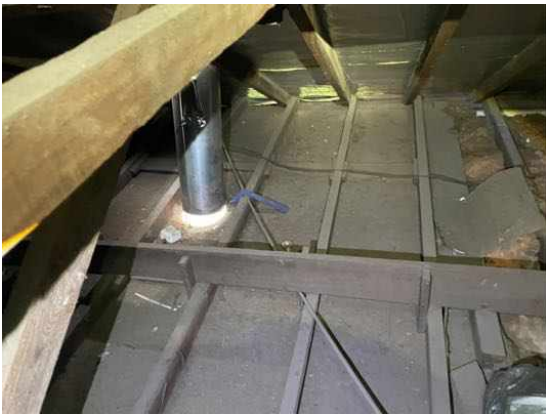
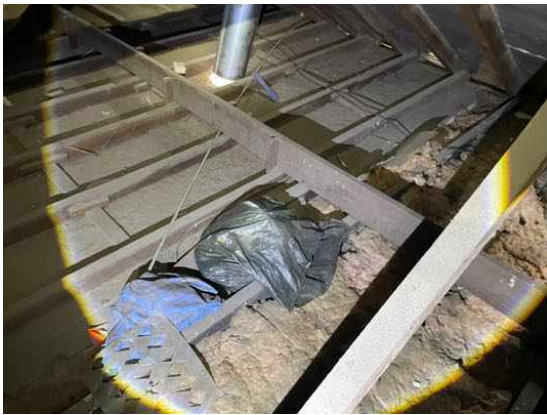
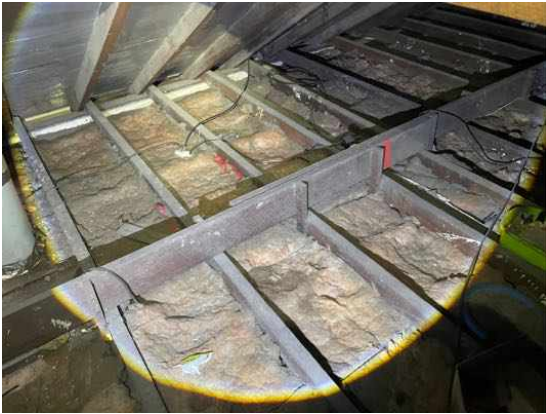
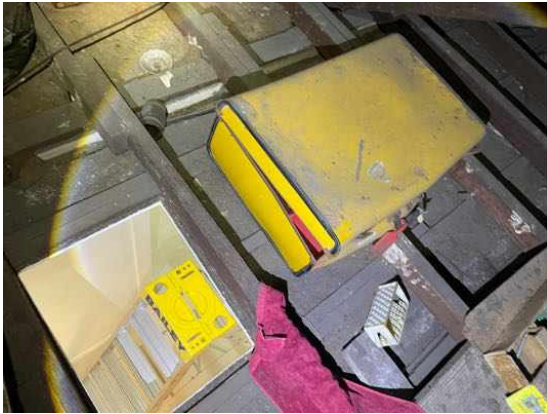
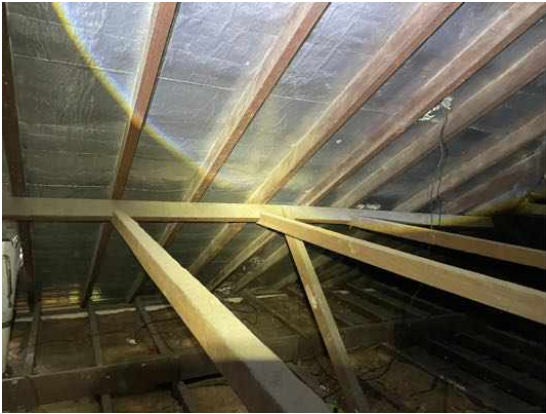
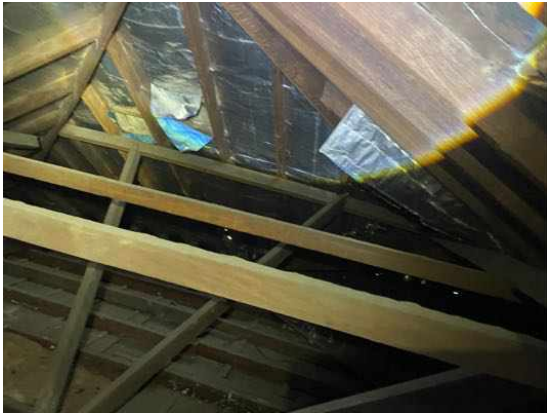
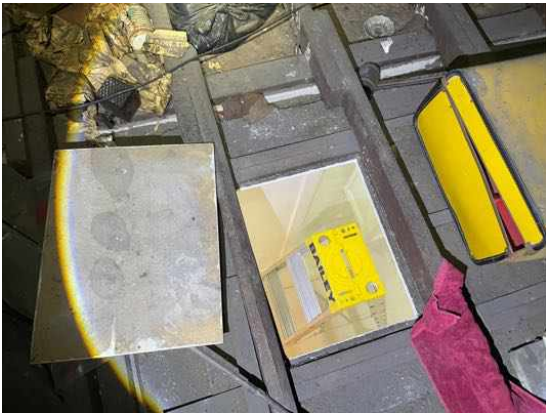
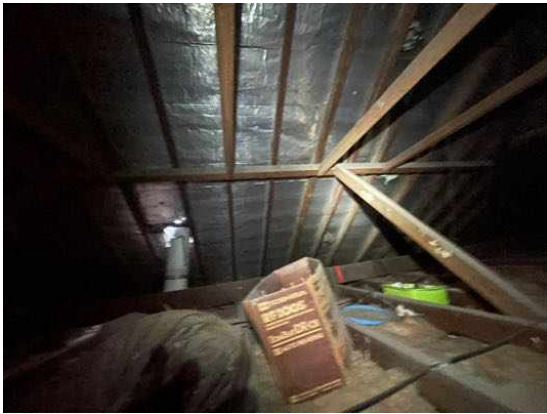
Building:	Main Building
Location:	Roof Void
Finding:	Additional Photos - Obstructions and Limitations
Information:	These photographs are an indication of the obstructions and limitations which impeded full inspection of the property at the time of inspection. These obstructions can hide an array of defects and should be removed to allow full inspection to be carried out. A re-inspection is recommended once the areas are made accessible.
