# Building and Timber Pest Inspection Report

Inspection Date: Mon, 9 Mar 2026

Property Address: 21 Falcon Cct, West Wodonga VIC 3690,  
Australia

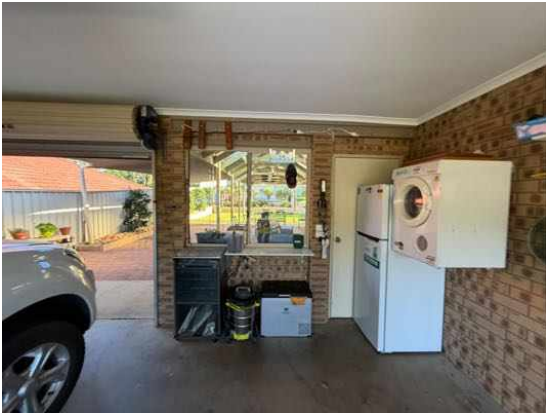
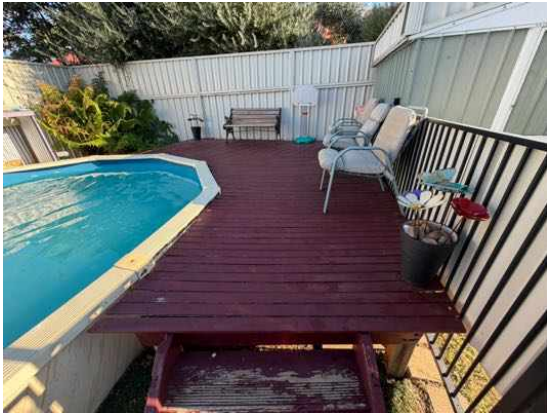
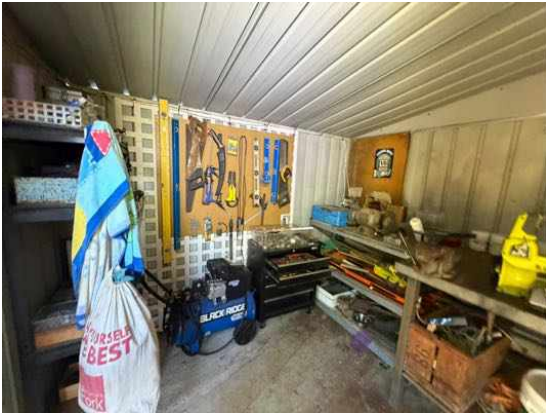
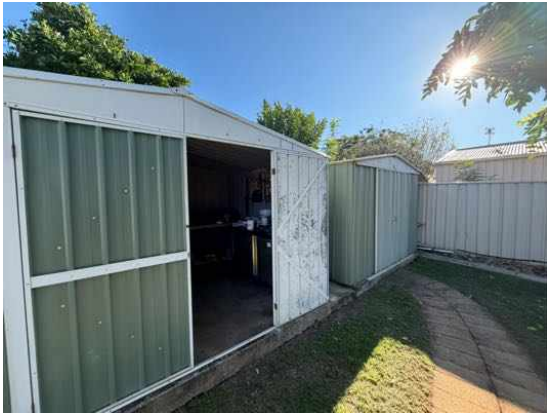
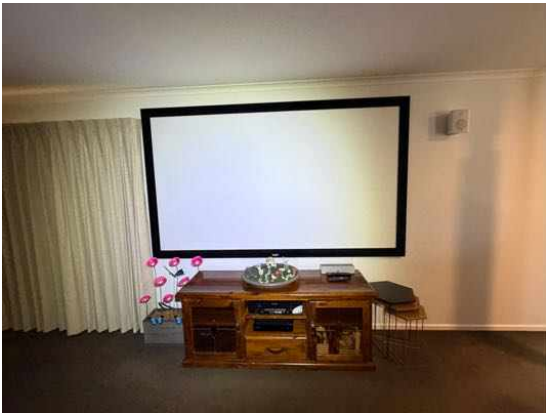
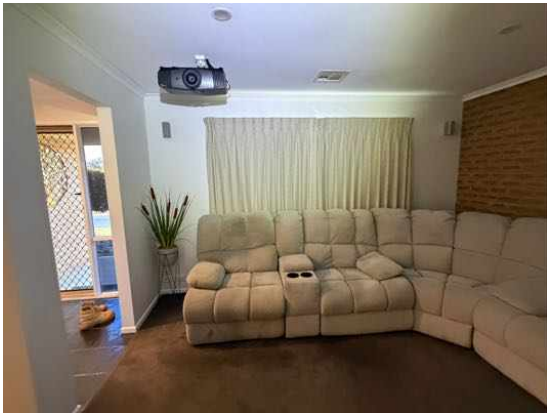
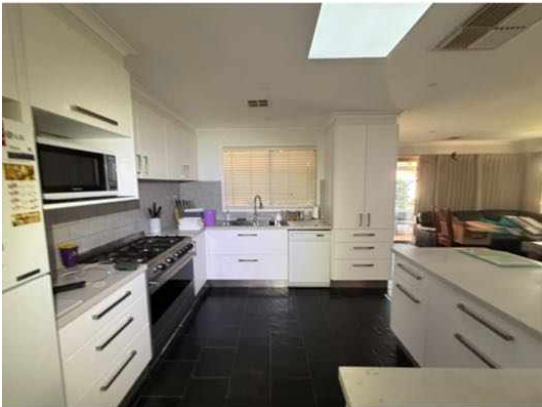
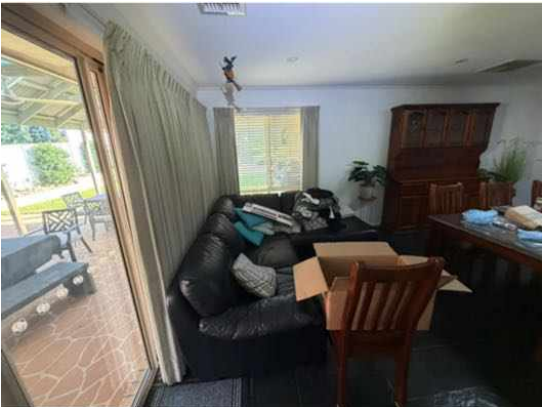
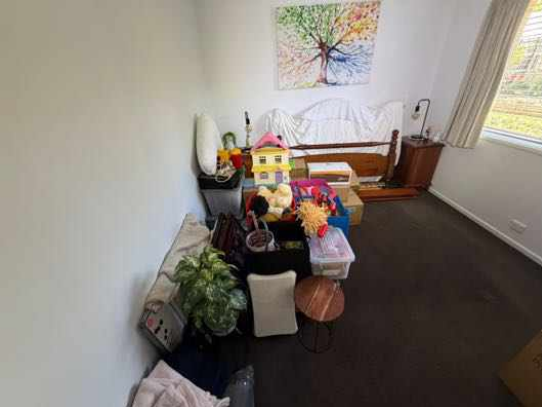
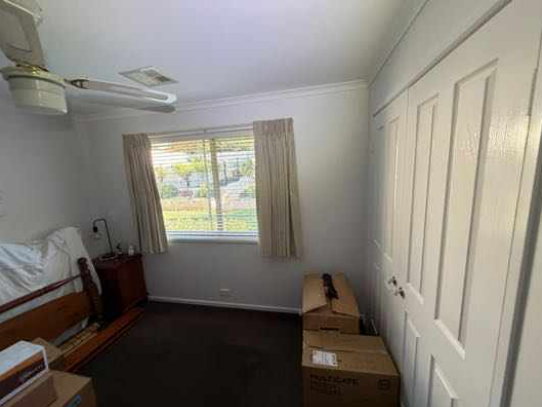
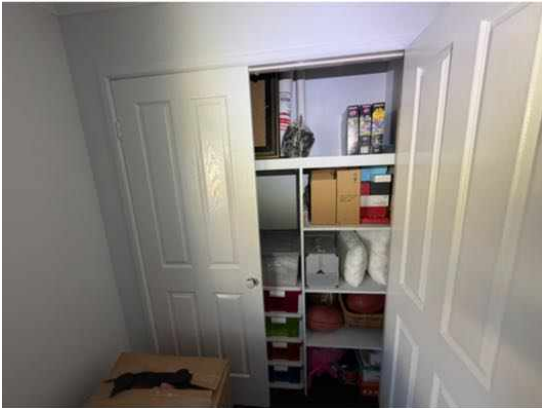
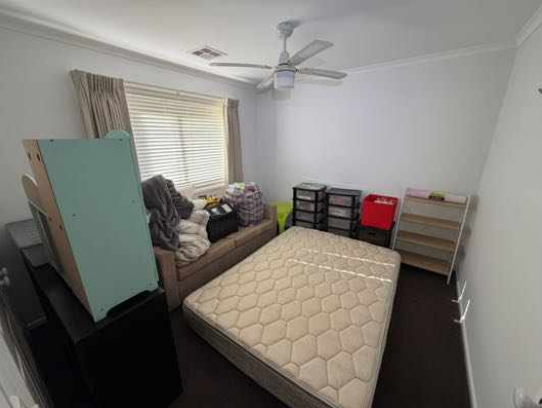
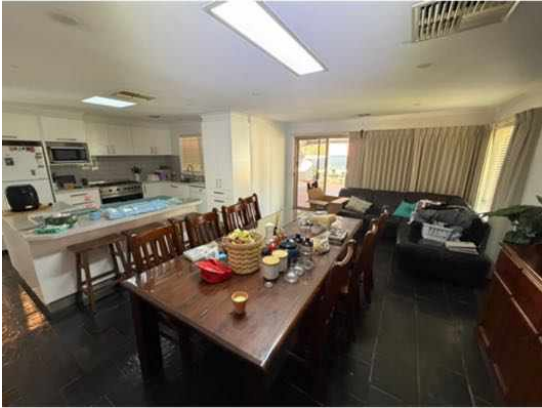
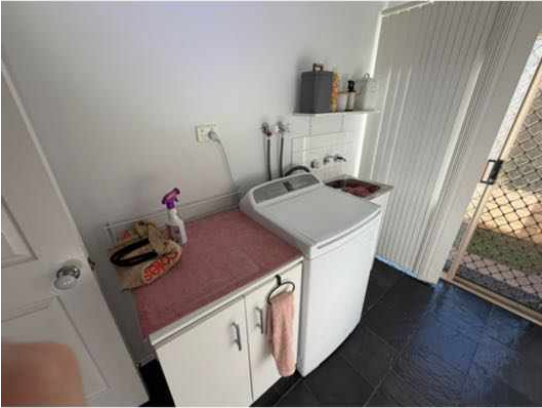
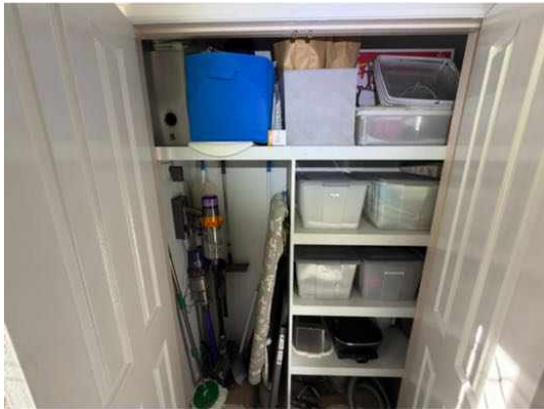
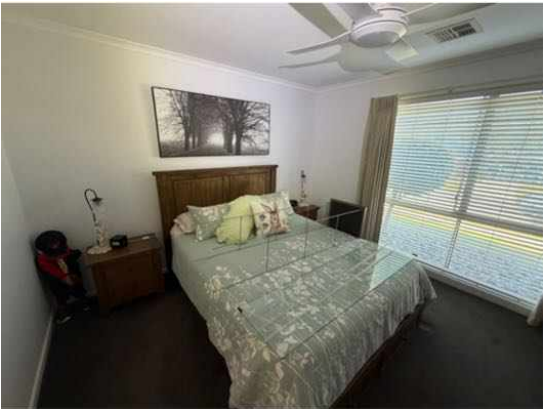
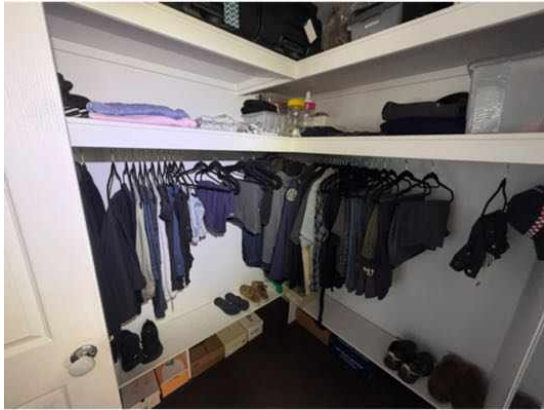
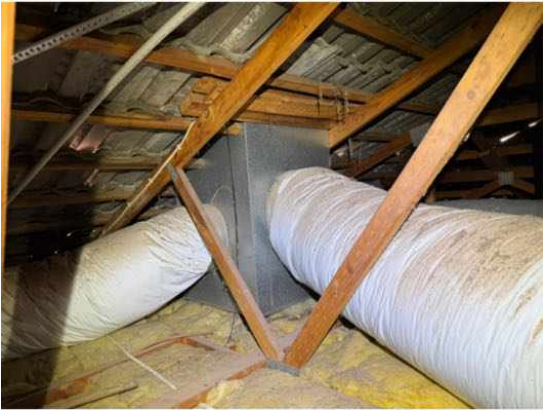
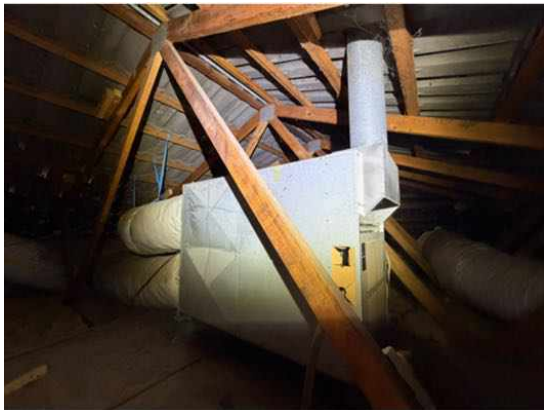
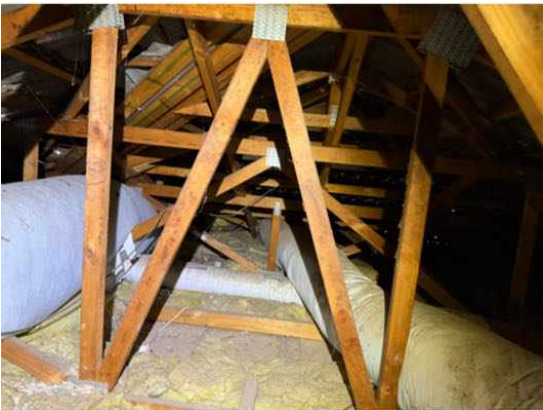
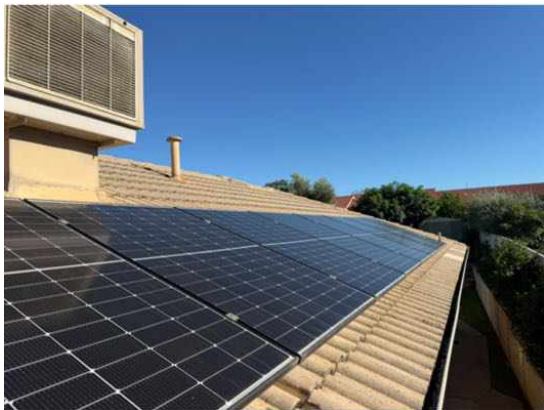
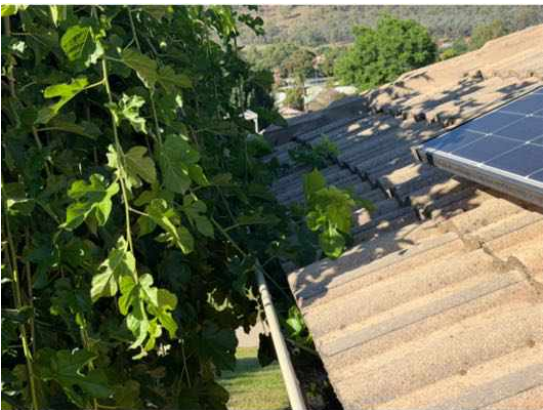
Building: Main Building  
Location: All Areas  
Finding: Additional Photos - Obstructions and Limitations  
Information: These photographs are an indication of the obstructions and limitations which impeded full inspection of the property at the time of inspection. These obstructions can hide an array of defects and should be removed to allow full inspection to be carried out. A re-inspection is recommended once the areas are made accessible.
