# Building and Timber Pest Inspection Report

Inspection Date: Thu, 5 Feb 2026

Property Address: 41 Symonds Rd, Dean Park NSW 2761,  
Australia

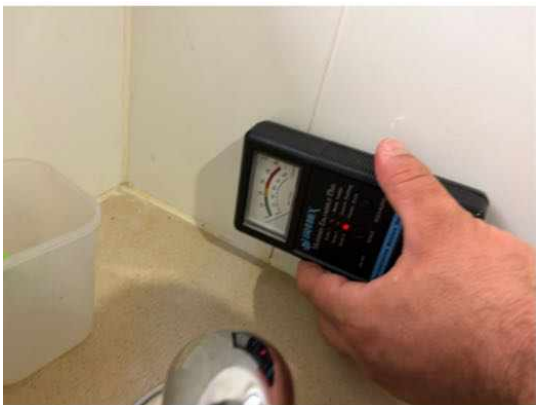
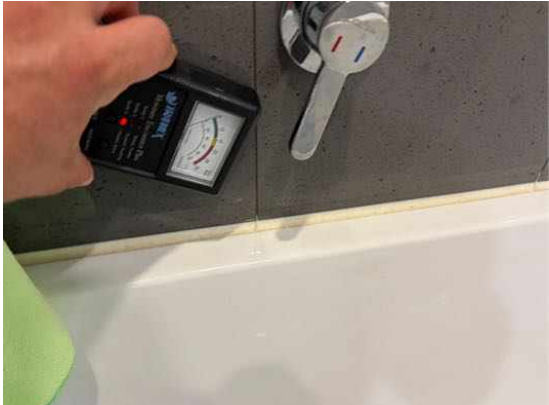
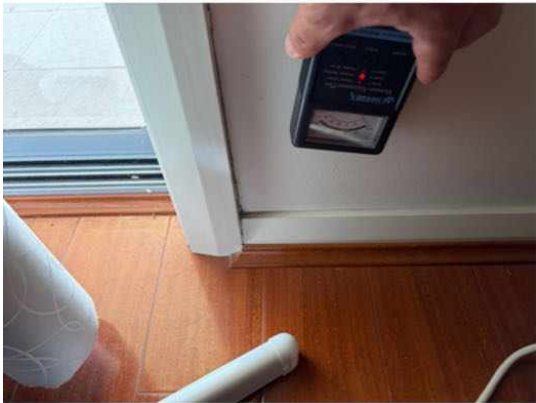
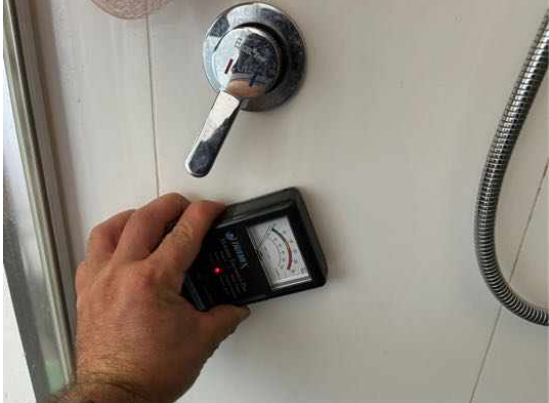
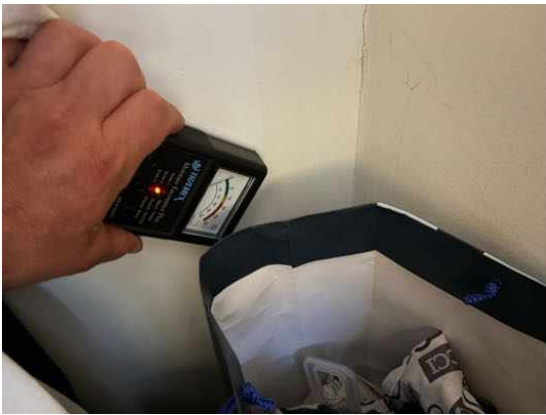
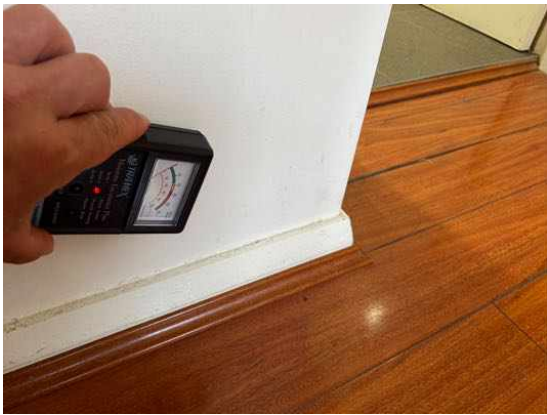
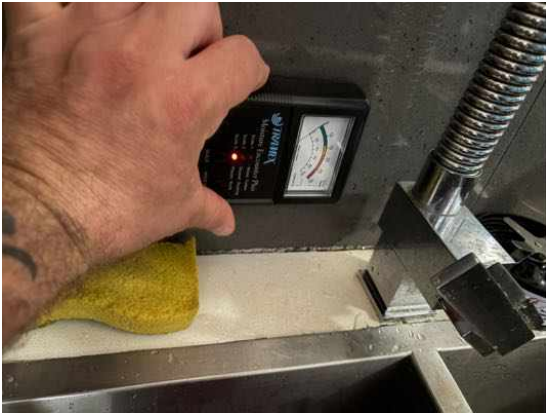
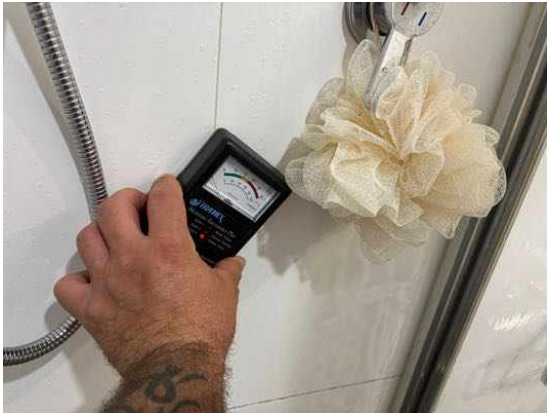
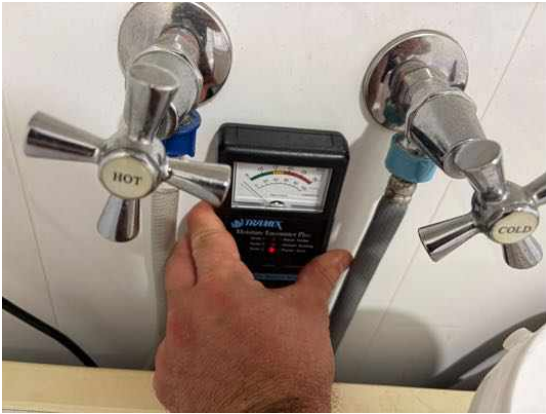
Building: Main Building  
Location: All Areas  
Finding: Moisture metre  
Information: During the inspection the property was checked for moisture using a moisture metre.

This is for information only.

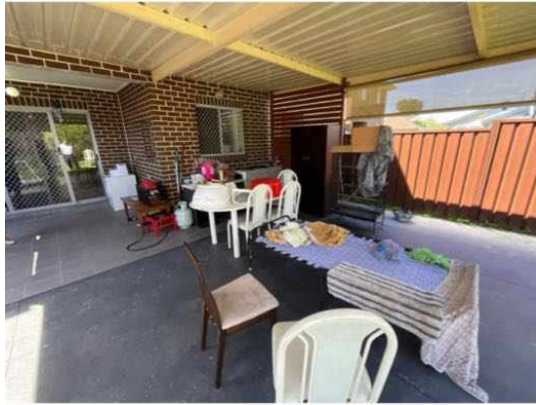
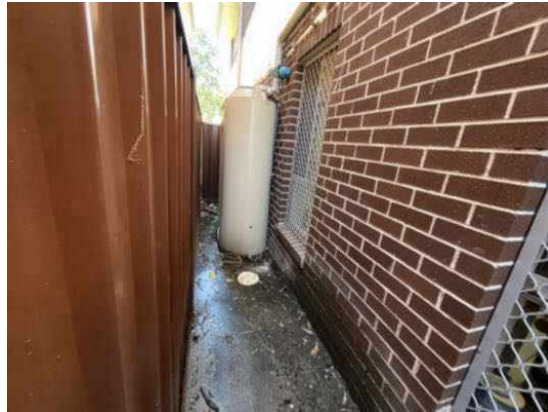
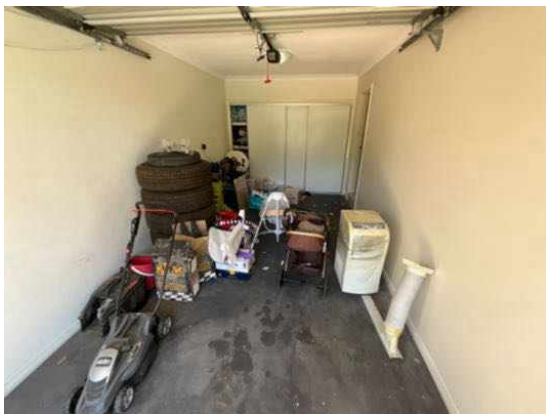
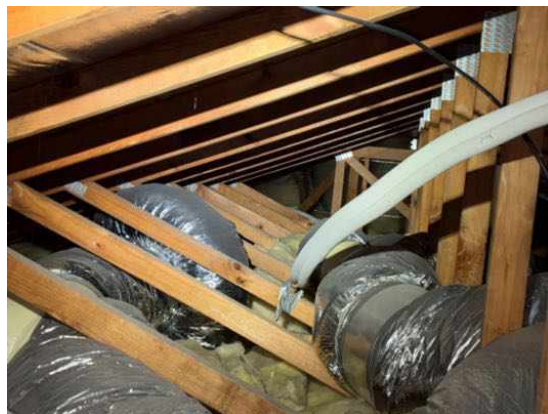
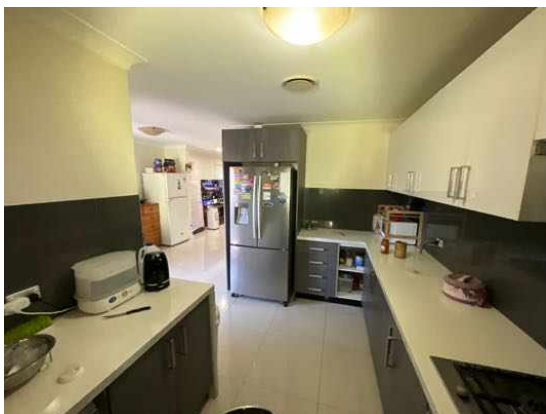
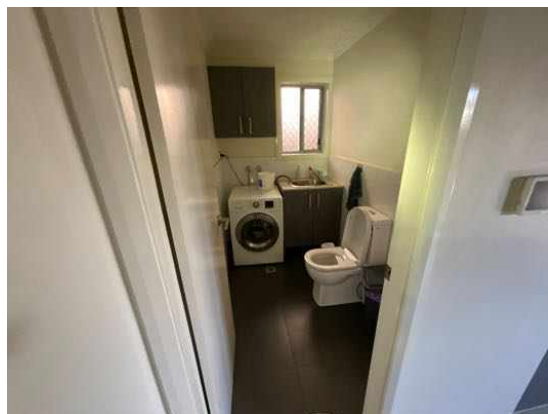
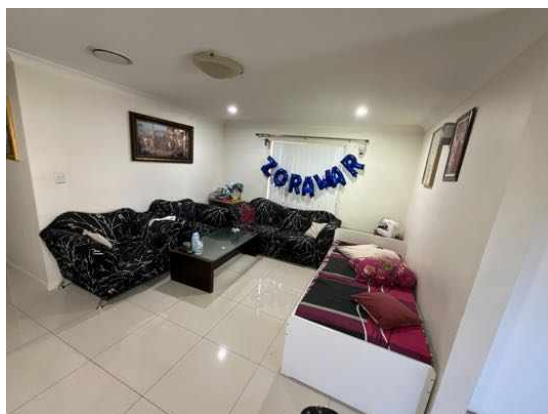
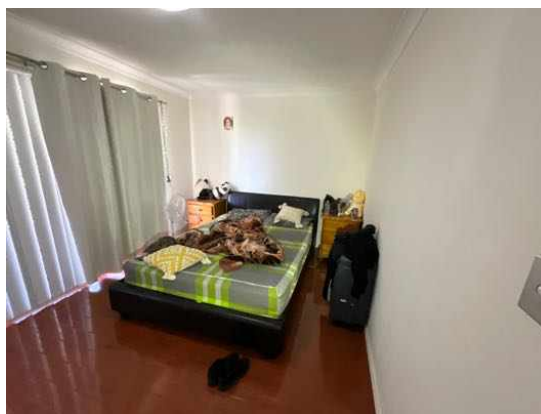
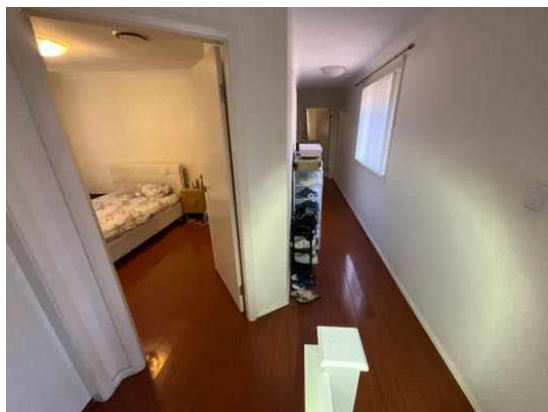
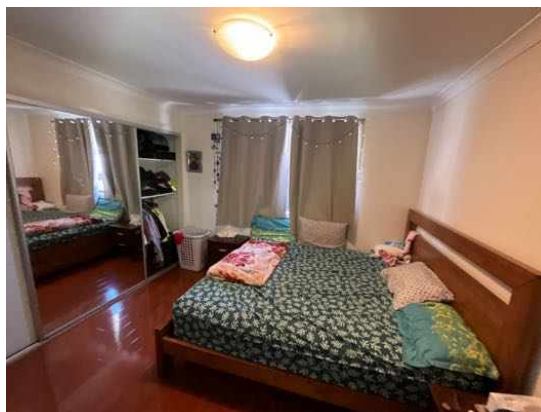
Building: Main Building  
Location: All Areas  
Finding: Additional Photos - Obstructions and Limitations  
Information:

These photographs are an indication of the obstructions and limitations which impeded full inspection of the property at the time of inspection. These obstructions can hide an array of defects and should be removed to allow full inspection to be carried out. A re-inspection is recommended once the areas are made accessible.

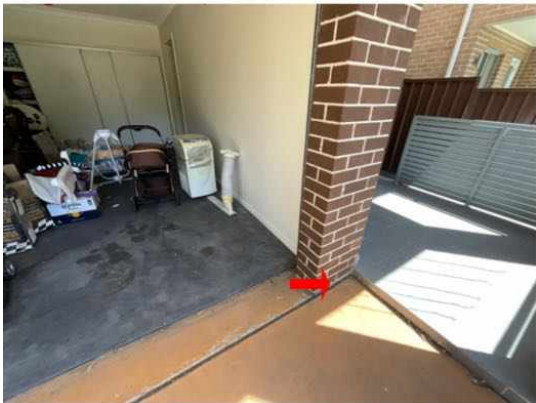
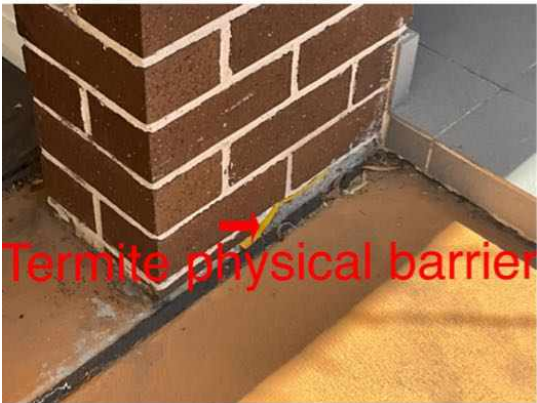
## The following items were noted as - Evidence of a previous termite management program

Where a Termite Management System has been identified you should refer to the type of barrier date of installation warranty conditions and any documentation provided by a builder or past owner. Consult the company who installed the barrier to confirm whether the system is still under warranty.

Most chemical termite management systems expire and require replenishment and all physical systems are primarily designed to prevent concealed entry.
