# Building and Timber Pest Inspection Report

Inspection Date: Thu, 5 Mar 2026

Property Address: 2-18 Shepreth Ave, Noble Park VIC 3174,  
Australia

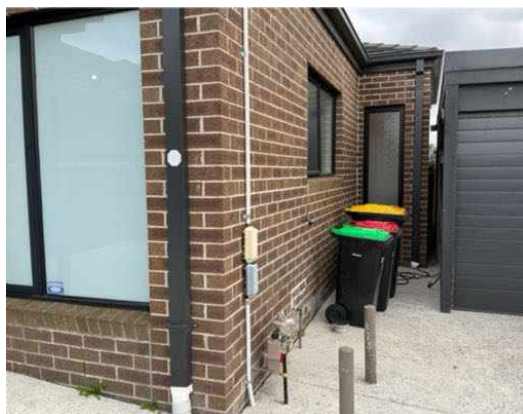
Where any part of an attachment to a building is not isolated and is not provided with a clear gap of not less than 25mm from building, bridging occurs. Attachments to buildings such as hot water services, downpipes, verandahs, decks, steps, fences, service conduits and the like provide the opportunity for concealed entry.

Building attachments of this nature need to be frequently inspected for termite activity by a qualified inspector.

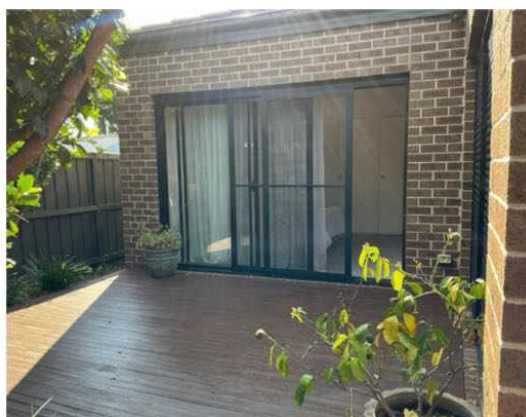
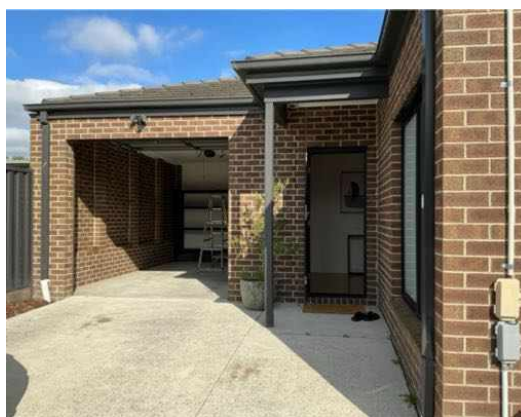
Building: Main Building  
Location: All External Areas  
Finding: Additional Photos - Obstructions and Limitations  
Information: These photographs are an indication of the obstructions and limitations which impeded full inspection of the property at the time of inspection. These obstructions can hide an array of defects and should be removed to allow full inspection to be carried out. A re-inspection is recommended once the areas are made accessible.

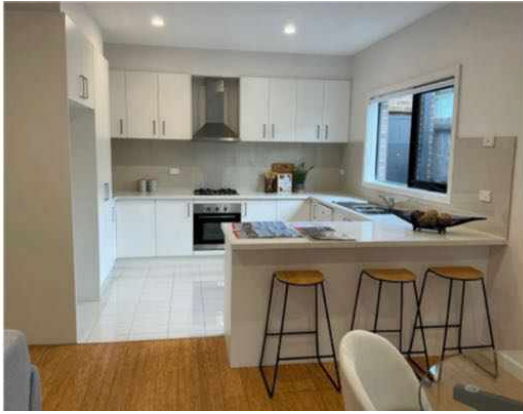
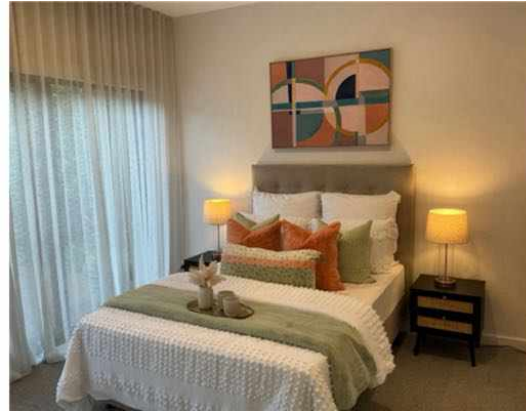
Building: Main Building  
Location: All Internal Areas  
Finding: Additional Photos - Obstructions and Limitations  
Information: These photographs are an indication of the obstructions and limitations which impeded full inspection of the property at the time of inspection. These obstructions can hide an array of defects and should be removed to allow full inspection to be carried out. A re-inspection is recommended once the areas are made accessible.

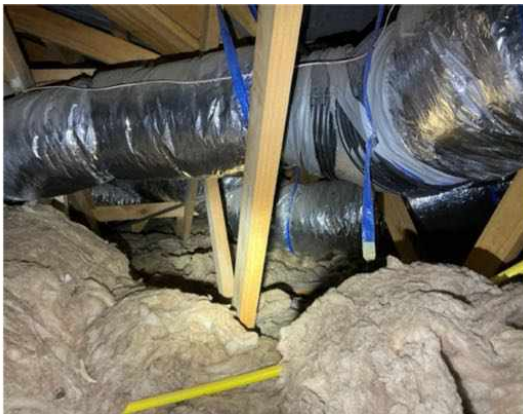
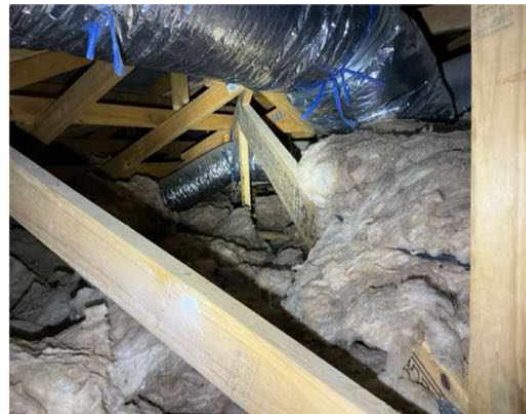
Building: Main Building  
 Location: Roof Void  
 Finding: Obstructions and Limitations -roof cavity  
 Information: These photographs are an indication of the obstructions and limitations which impeded full inspection of the roof cavity at the time of inspection. These obstructions can hide an array of defects and should be removed to allow full inspection to be carried out. A re-inspection is recommended once the areas are made accessible.

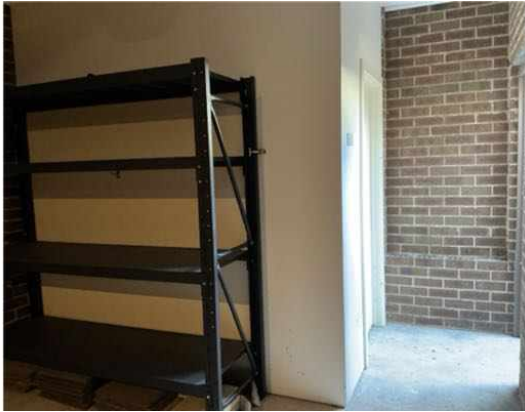
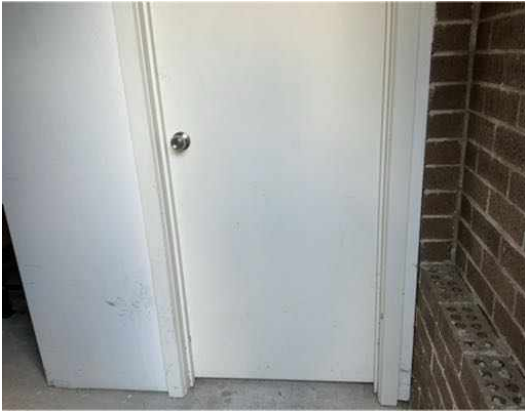
Building: Main Building  
Location: Garage  
Finding: Room inside garage locked  
Information: The room inside the garage was locked during inspection and could not be inspected.
