Building and Timber Pest Inspection Report

Inspection Date: Tue, 10 Mar 2026

Property Address: 63 Martins Rd, Cooroy QLD 4563, Australia

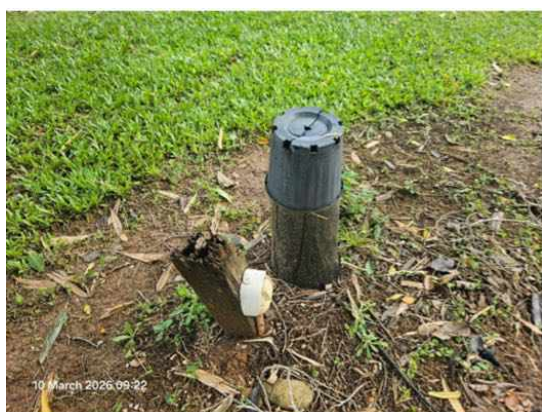
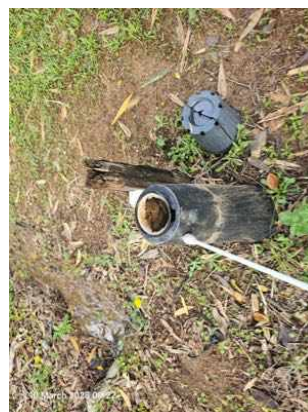
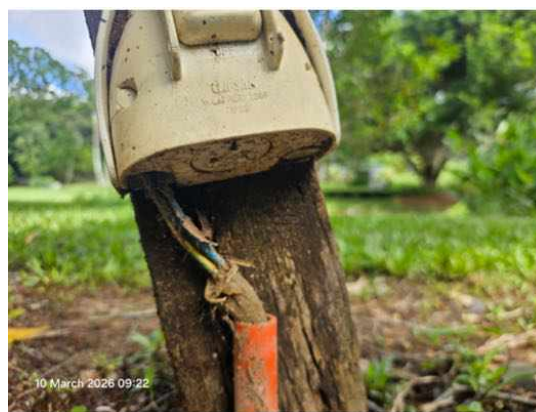
Building: Yard
 Location: Rear yard area
 Finding: Suspected electrical safety - GPO exposed cables
 Information: On the day of inspection the external power point in the rear yard has exposed wires between the conduit and the GPO.

It is advised that the connection be assessed by a licensed electrical contractor for compliance.

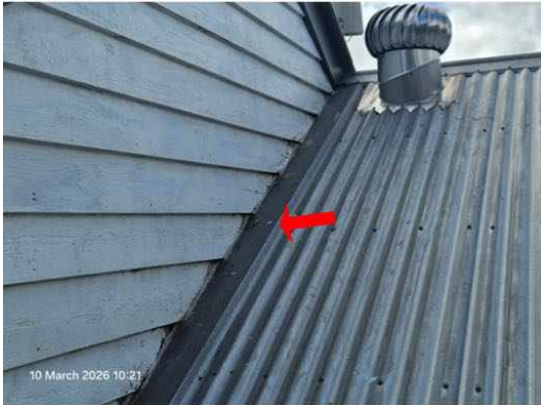
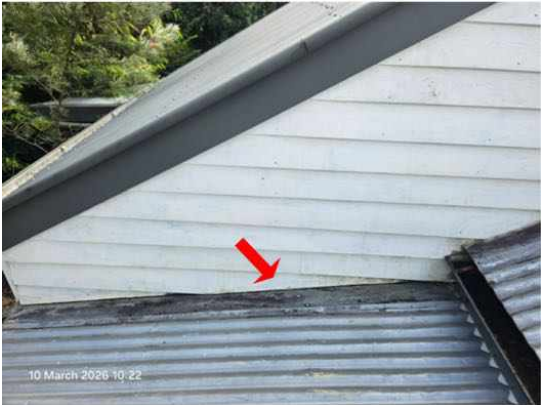
Finding 3.02

Building: Main Building
 Location: As shown
 Finding: External cladding defective installation
 Information: These images show the external cladding of the roof gable. The cladding is positioned onto the surface of the roof flashing. This can have an effect on the integrity of the cladding over the long term. As previously identified, the ends of the cladding have developed wood rot. This is caused by moisture entering the end grain of the timber boards.

Cladding installed over flashings should have a clearance of approximately 20mm + to allow all roof water to freely drain to the gutter. It is advisable to have this cladding cut back to create a clearance gap.

The services of a licensed carpenter could be sought to carry out the work.

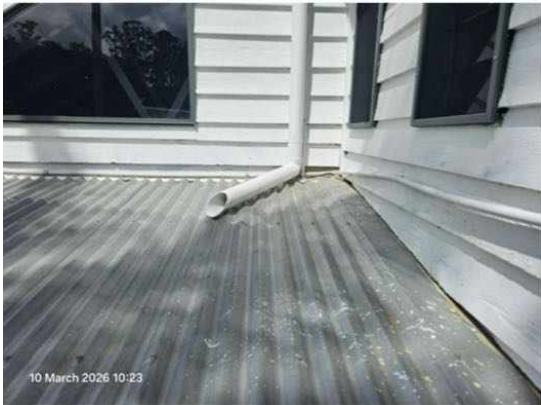
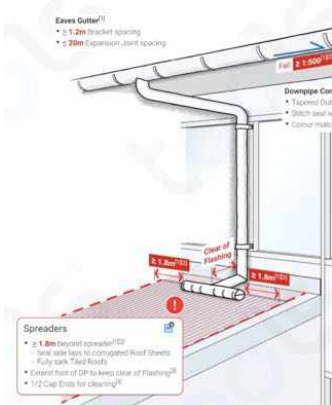
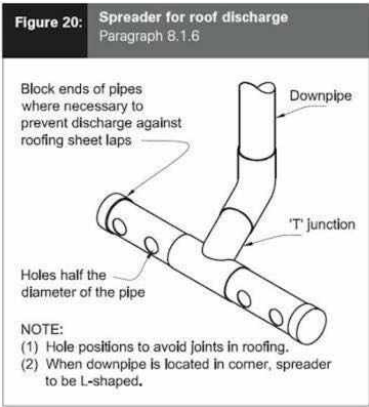
Finding 3.03

Building: Main Building
 Location: Kitchen
 Finding: Downpipe spitter / spreader - incorrect installation
 Information: On the day of inspection it was noted that the downpipe spitter / spreader was not installed correctly to the main roof. These are required to distribute water on to the lower roof surface over an increased area and to direct water way from flashings, cladding and wall surfaces by spreading the flow and decreasing discharge pressure.

A licensed plumber could be engaged to carry out this work.

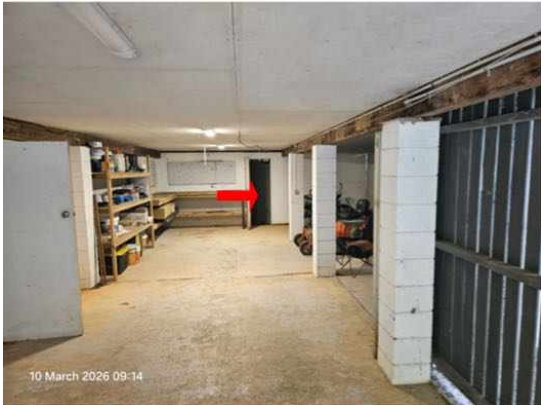
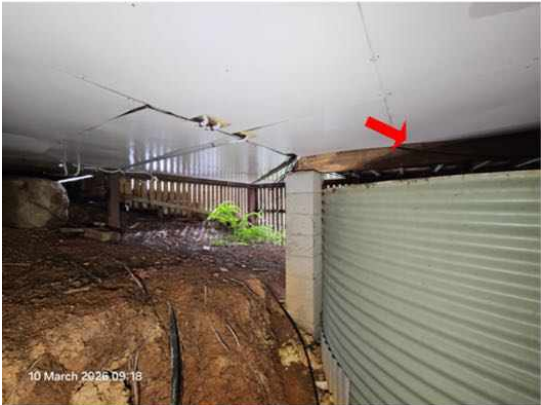
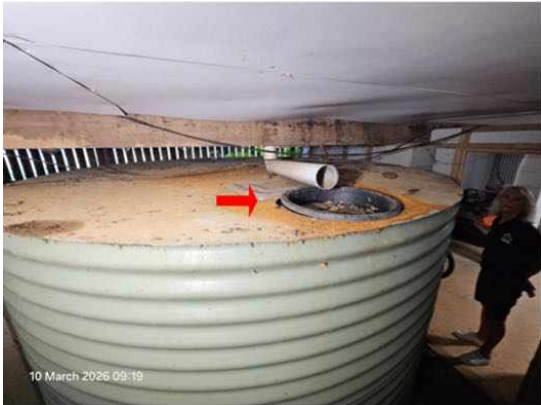
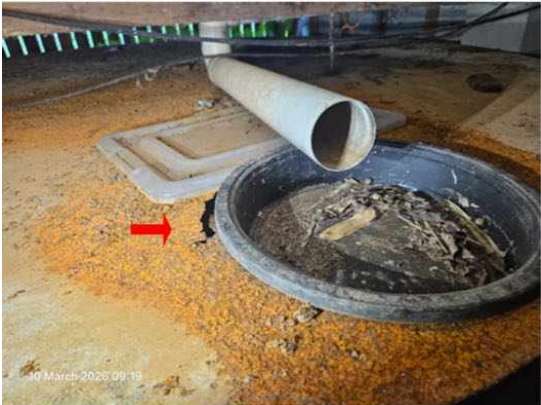
Finding 3.04

Building: Main Building
 Location: Garage
 Finding: Rust - rain water tank
 Information: The top of the rain water around the inlet strainer is rusted and the metal of the is holed. This should be repaired with some urgency to prevent debris and vermin from falling into the tank.

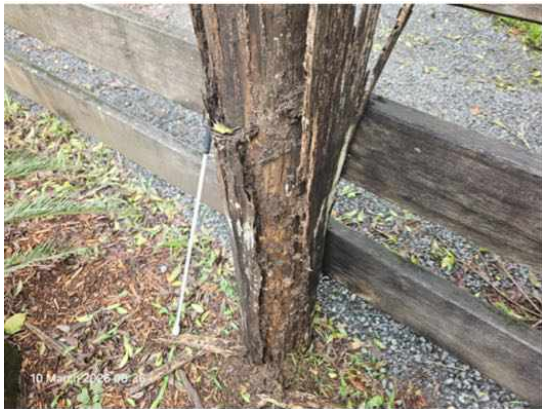
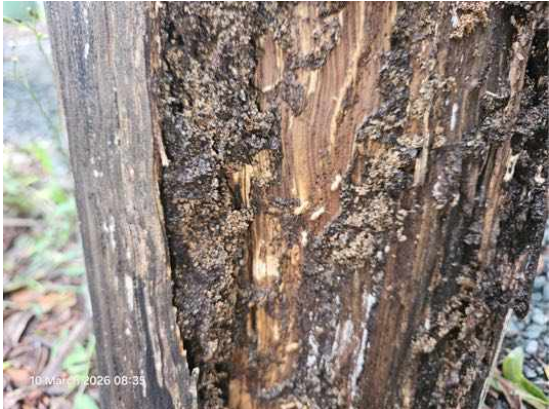
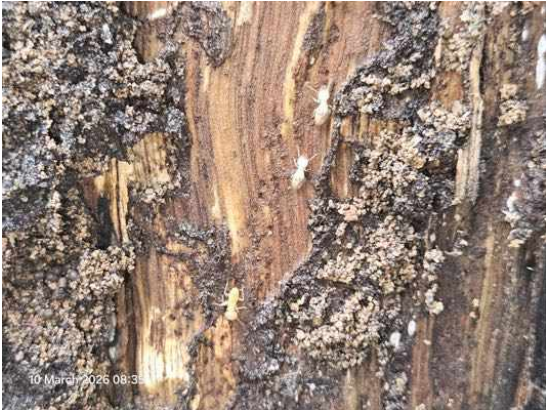
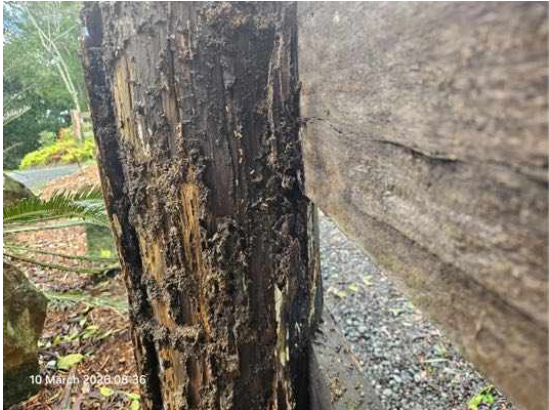
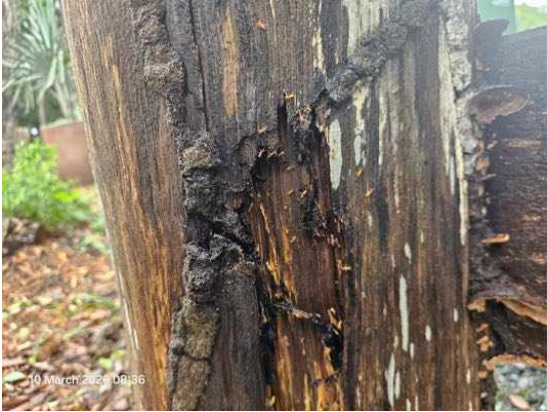
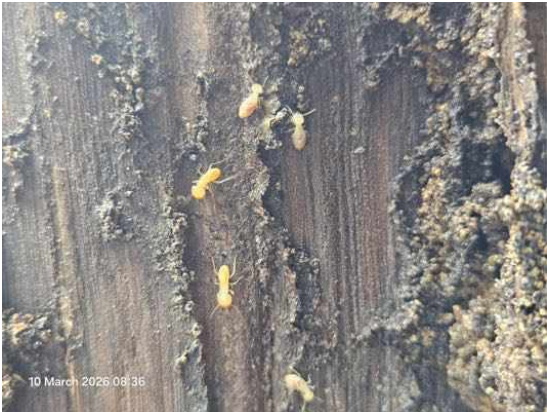
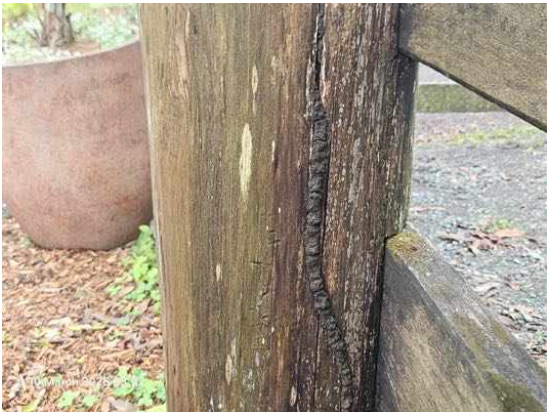
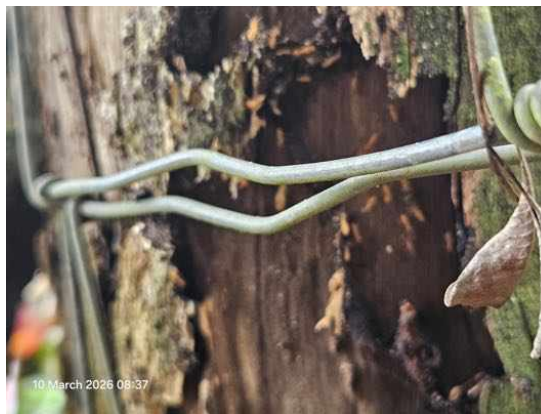
Finding 4.01

Building: Yard
Location: Front fence
Finding: Termite damage - active presence
Information: During the inspection of the property grounds termite activity was found in the fence posts at the front entry to the property. As shown in the photographs, active termites are seen. The species appear to be Coptotermes, a more destructive member of the species.

It is highly recommended that a pest controller be engaged to carry out the required inspection of the area and the property to provide a proposal for a barrier and the treatment of the active pests.

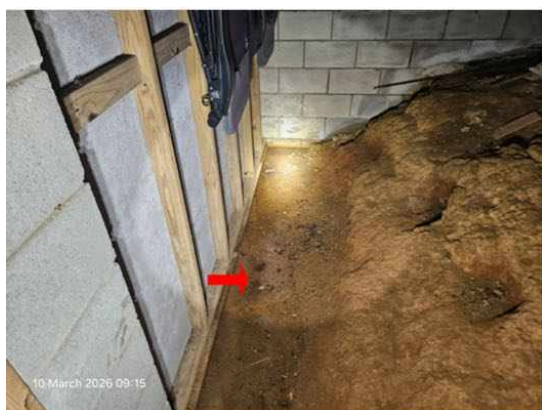
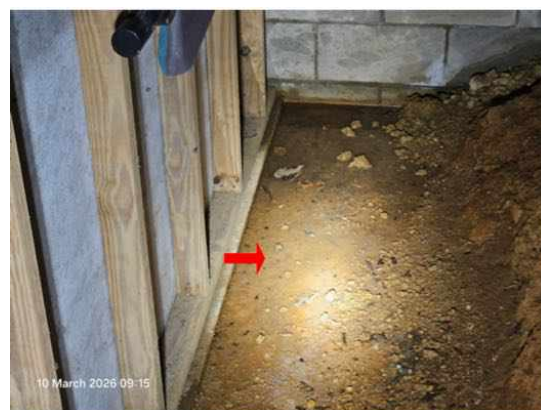
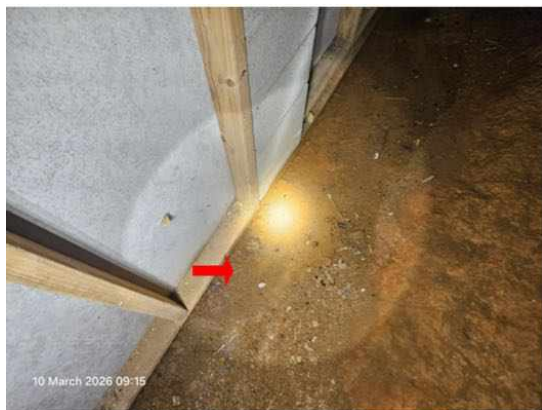
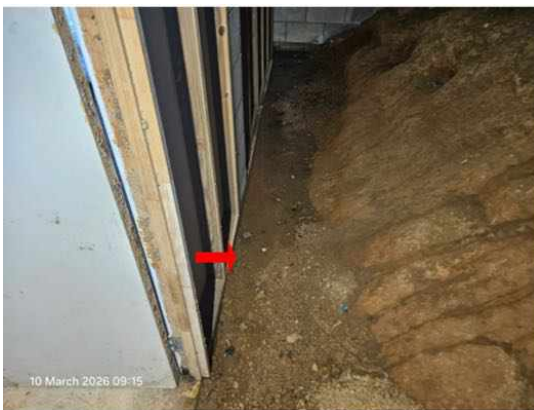
Building: Main Building
 Location: Garage
 Finding: Subfloor drainage
 Information: Noted during the inspection of the subfloor area was the lack of satisfactory drainage. Water was seen lying against the garage floor slab at a height just below the wall frame.

Poor drainage can lead to a number of issues ranging from moisture related mould growth, timber framing damage, foundation defects, or increased timber pest risk.

Where possible, efforts should be made to facilitate the areas ability to freely drain. This can be done by creating a drainage aperture through the subfloor wall to the outside. Increasing ventilation in this area of the subfloor will assist with ongoing moisture reduction.

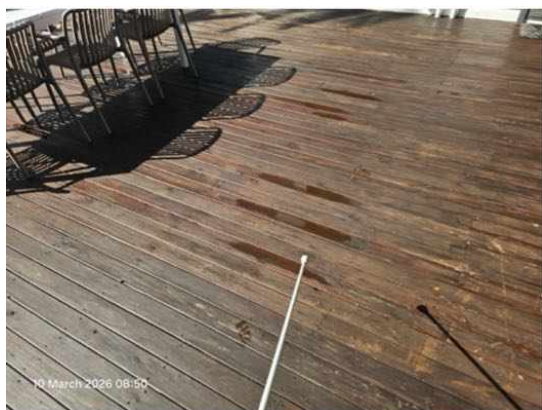
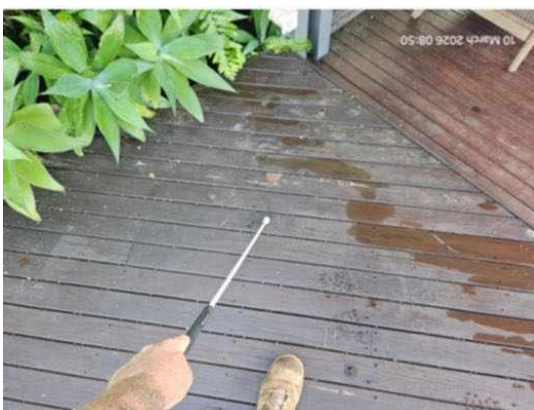
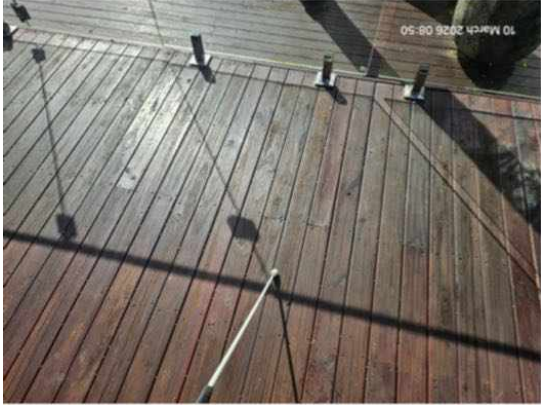
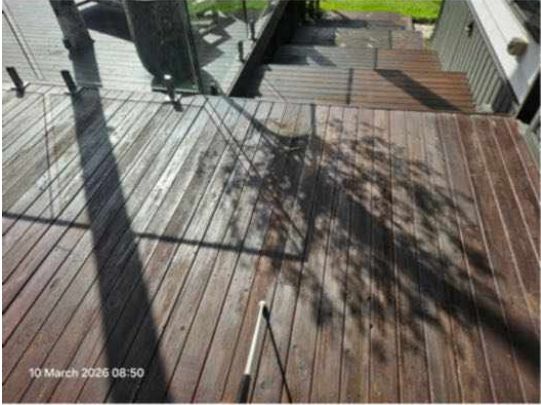
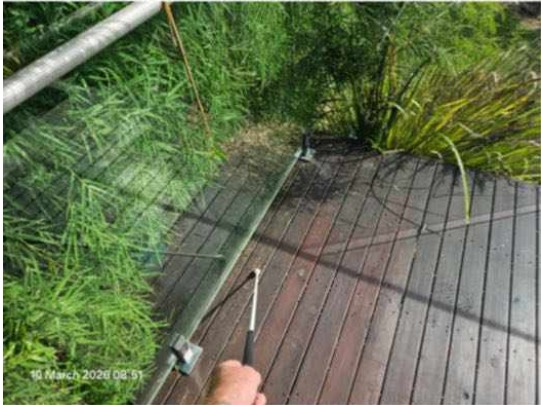
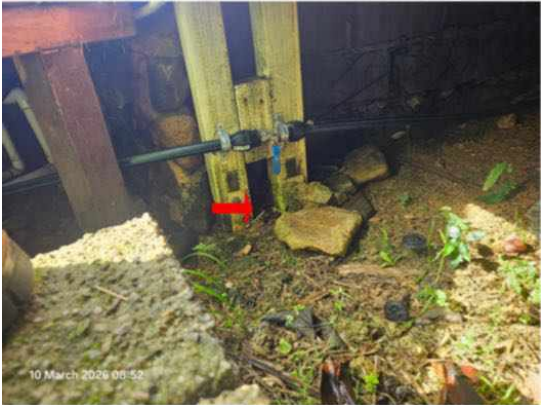
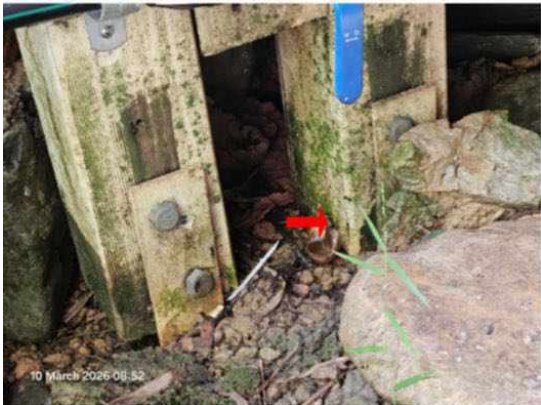
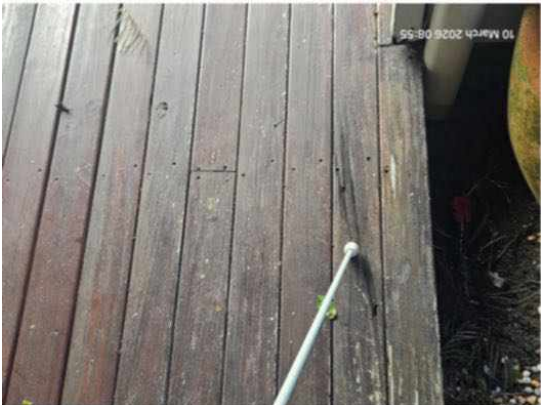
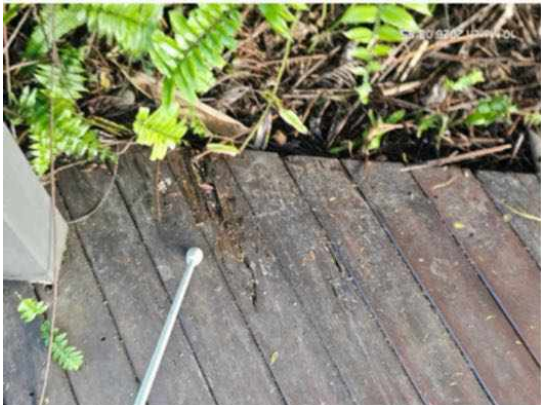
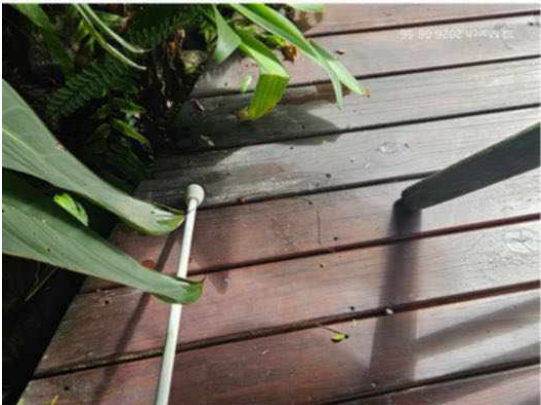
Finding 6.02

Building: Main Building
Location: As shown
Finding: Wood rot / fungal decay
Information: The timber building components shown have evidence of wood rot in various sections of the timber. Different areas are at differing stages of degradation ranging from pre-stage to established; however, it would be prudent to have all areas existing and pre-stage wood rot rectified.

Wood rot, also known as Fungal Decay, occurs when timbers and other cellulose building materials are exposed to damp conditions on an ongoing basis. This could be the result of exposure to weathering over a prolonged period of time, or the attraction of excessive moisture from other abutting building materials.

Early intervention and regular maintenance, particularly of exterior timbers, will prolong the useful life of these building elements. Prior to any works being performed, the cause of the moisture that has created the visible wood rot should be identified and addressed in a suitable manner. Replacement of affected timbers may then be a necessary step in protecting surrounding building elements from such deterioration.

A licensed carpenter or licensed builder should be consulted to advise on a solution for the affected building materials.

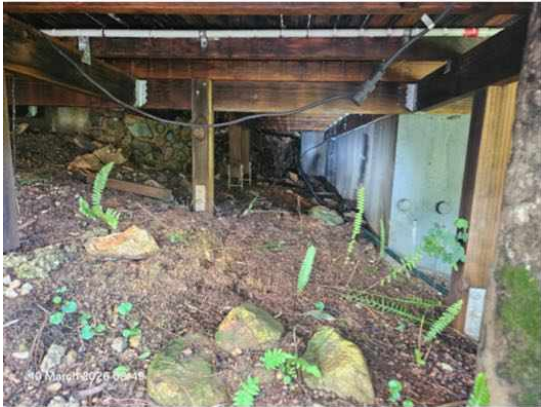
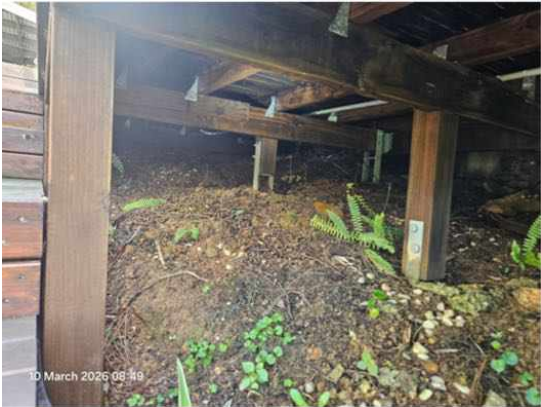
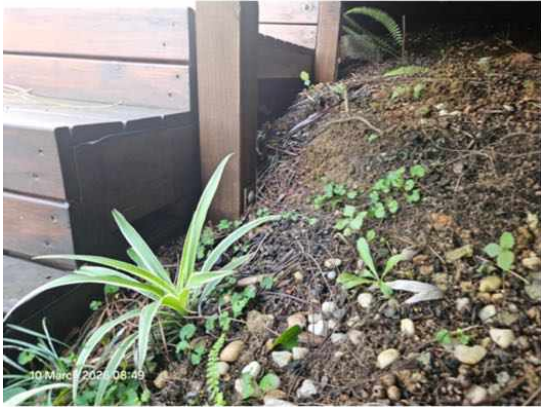
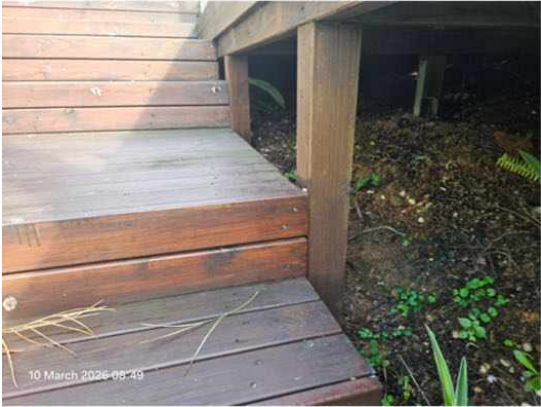
Finding 6.03

Building: Main Building
Location: Decks
Finding: Timber contact with ground - posts
Information: It was noted during inspection, that many of the timber post of the deck are in contact with the ground and do not have sufficient clearance to provide and adequate inspection zone. These could be a possible entry point for timber pests. The posts of the deck / verandah are concealed and cannot be inspected. These will be considered in the same way when assessing risk.

The soil and debris should be cleared away from the base of all timber structural members to provide clear visible access to view the post bases. Where this cannot be done, advice from the timber pest controller maintaining the inspection programme should be sought.

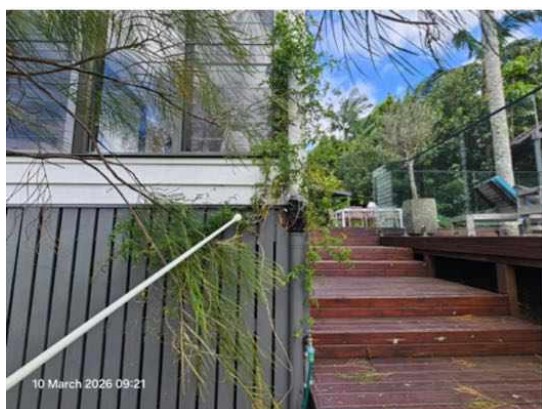
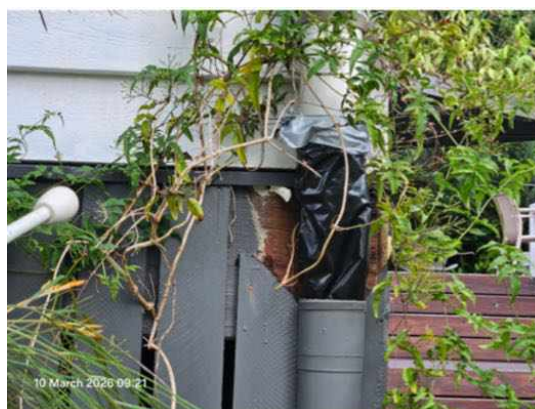
Finding 6.04

Building: Main Building
 Location: As shown
 Finding: Downpipe - Connection broken
 Information: The downpipes of the house show evidence of breakage or disconnection and are not connected to the stormwater system adequately or directed away from the property.

This leads to excessive moisture in the areas around the pipes and against the foundations of the house. This can lead to conducive conditions for timber pests and vermin infestation and have adverse effects on the foundations.

A licensed plumber may be appointed to repair the downpipe connections and provide adequate extensions to the pipes..

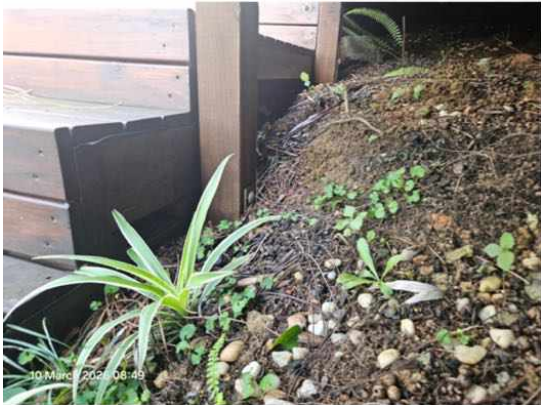
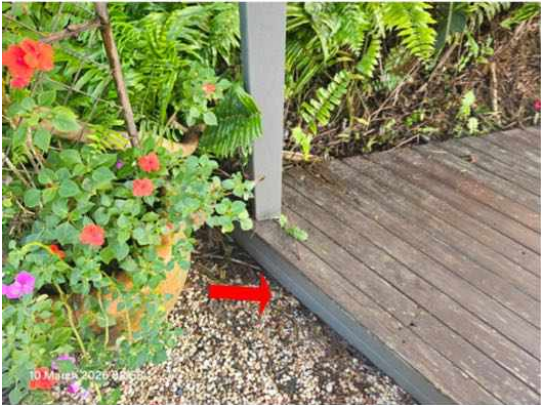
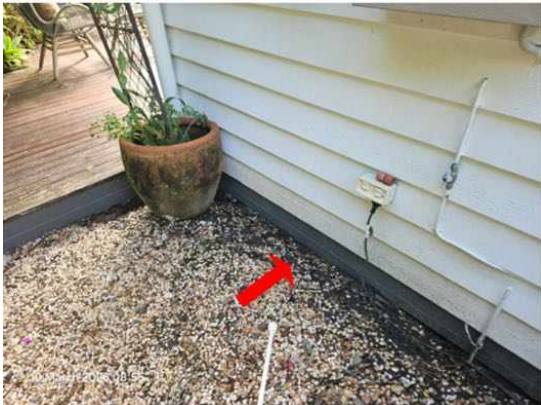
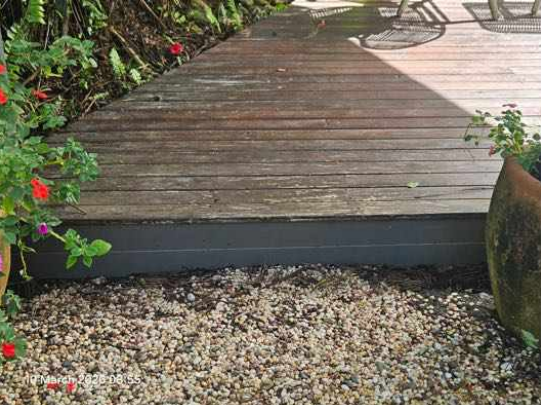
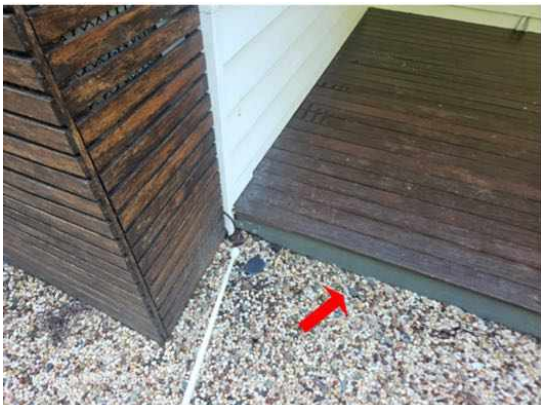
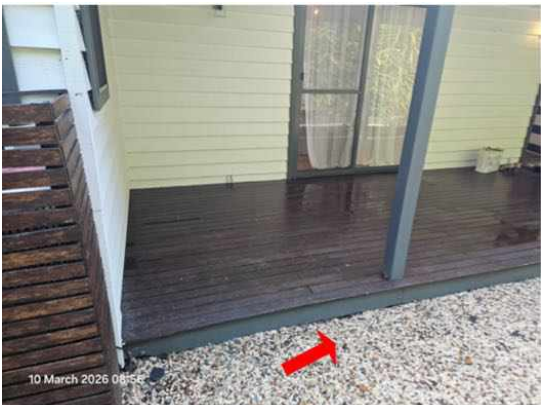
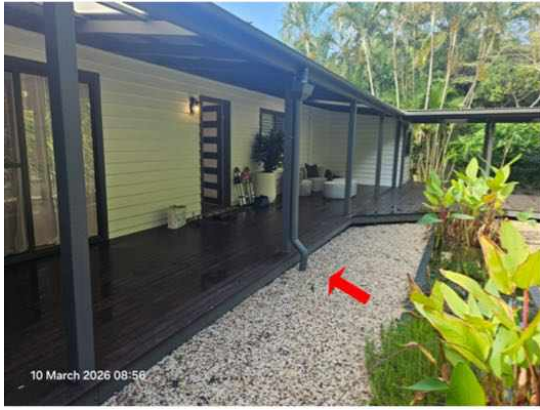
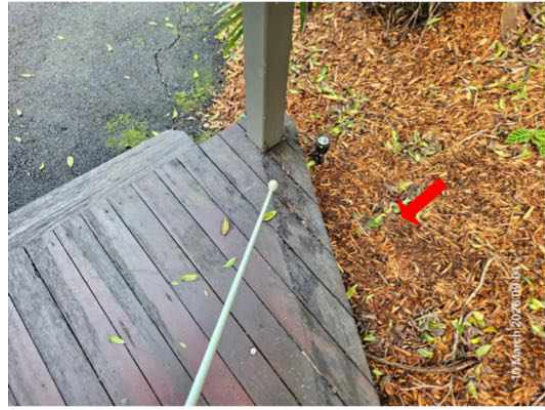
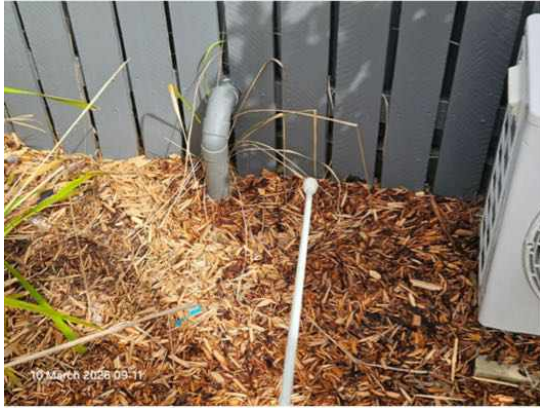
Finding 6.05

Building: Main Building
 Location: As shown
 Finding: Areas conducive to timber pest activity.
 Information: During the inspection of the exterior of the building many areas were identified that will, or do, create conducive conditions for increased timber pest activity. Where timber building elements are close to or touching the ground surface, the ability to satisfactorily inspect these locations is dramatically reduced.

If timber building elements are close to, or touching, the ground timber pest can gain access without detection and measures should be taken to provide an inspectable clearance zone.

The attached photo set is indicative and the advice of a licensed timber pest controller should be sought.

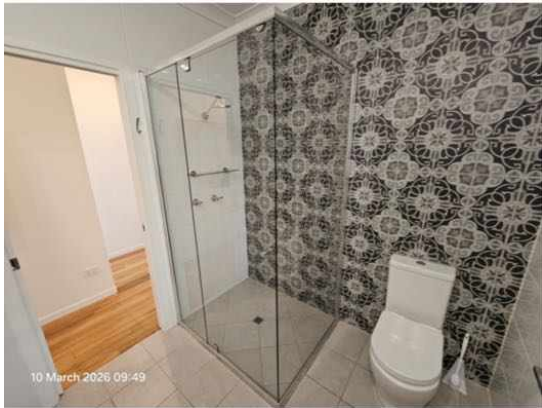
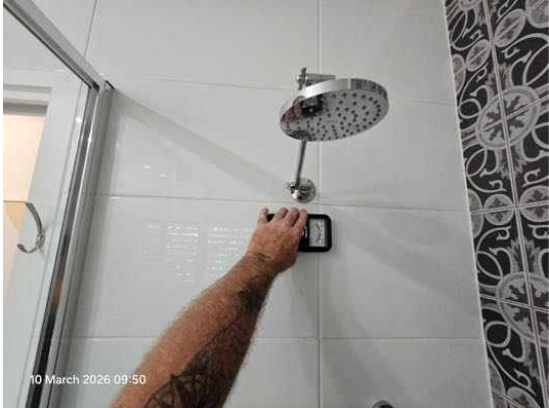
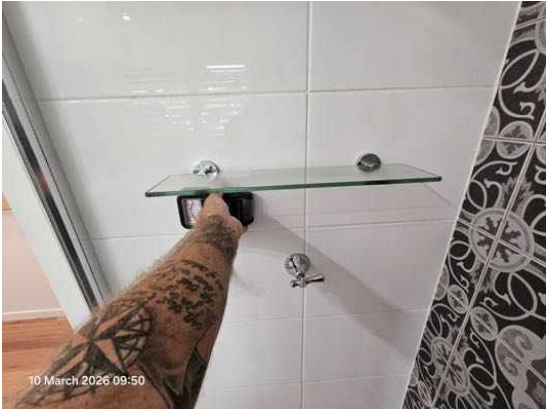
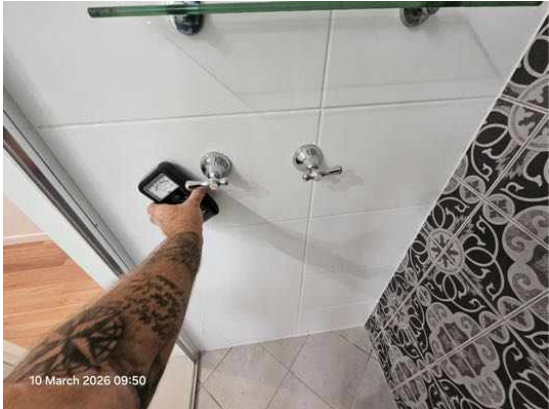
Building: Main Building
Location: Bathroom, ensuite
Finding: No moisture detected in bathroom / ensuite
Information: On the day of inspection the showers in the bathroom/s and ensuite are measure for moisture using a "Tramex" moisture meter. During this inspection no moisture was detected in these areas and the tiled / sheeted surfaces appear to be in good order.

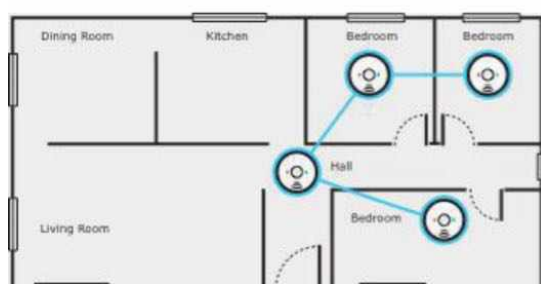
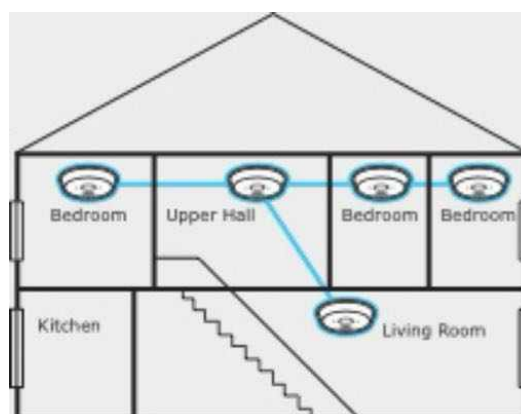
Building: Main Building
 Location: All Internal Areas
 Finding: Smoke Detectors and Alarms. AS 3786:2014
 Information: Reporting on Smoke Detectors or Alarms, including hard wired smoke detection systems and their legislative requirements, is outside the Scope of this Report.

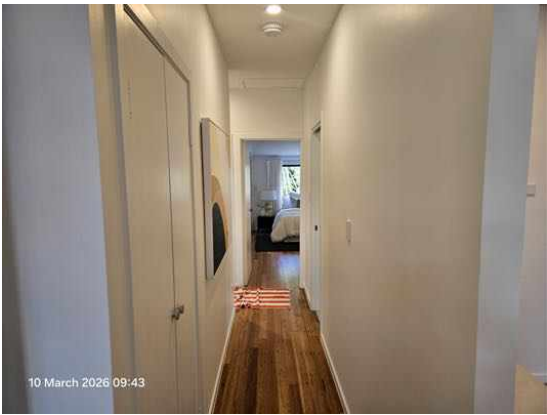
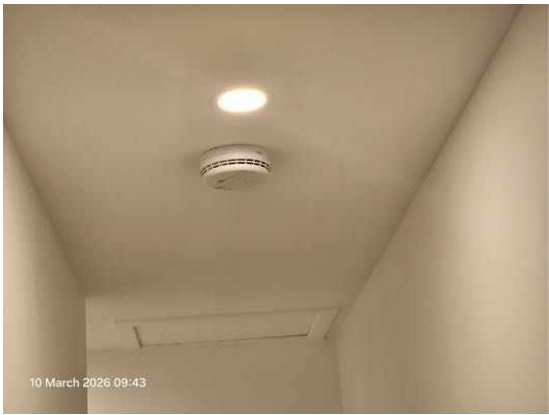
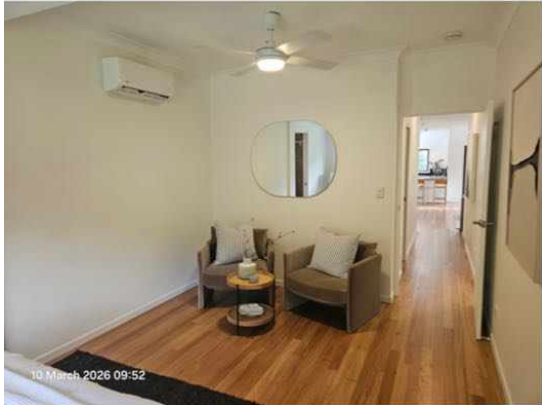
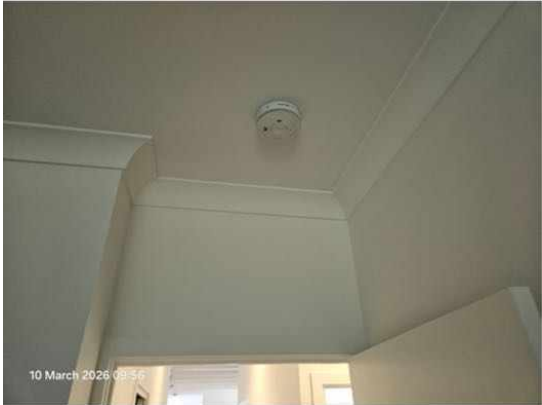
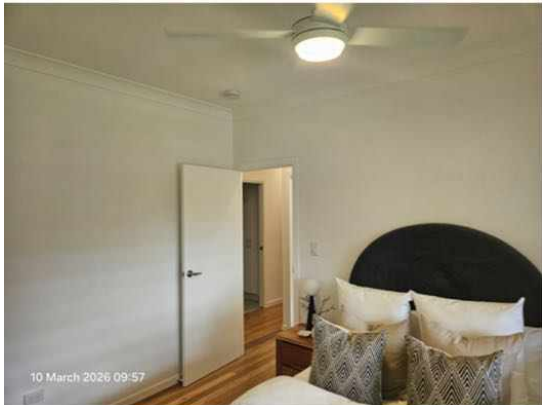
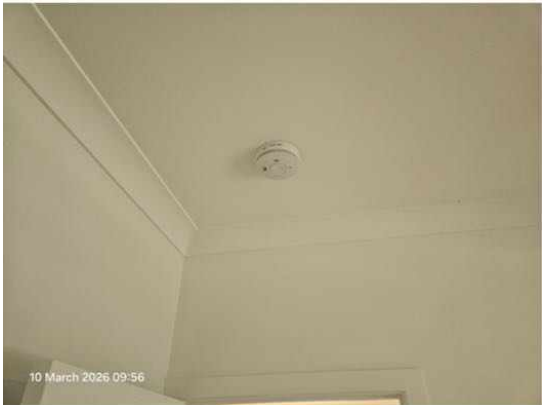
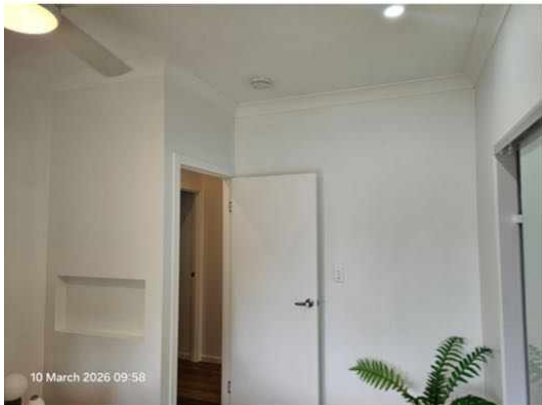
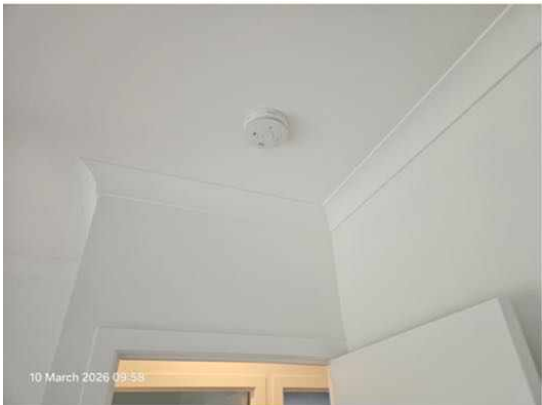
Avoid installing smoke alarms in dead air space. This is an area in which trapped hot air will prevent smoke from reaching the alarm. The space generally occurs at the apex of cathedral ceilings, the corner junction of walls and ceiling, and between exposed floor joists.

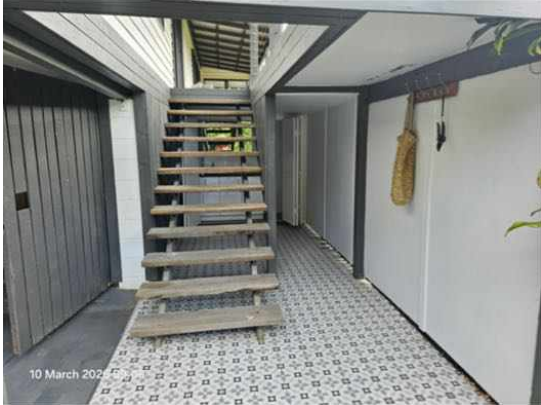
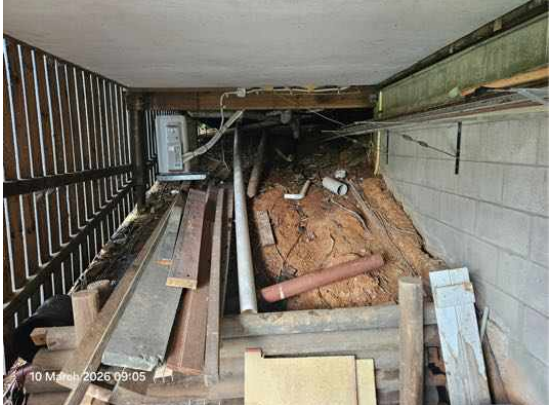
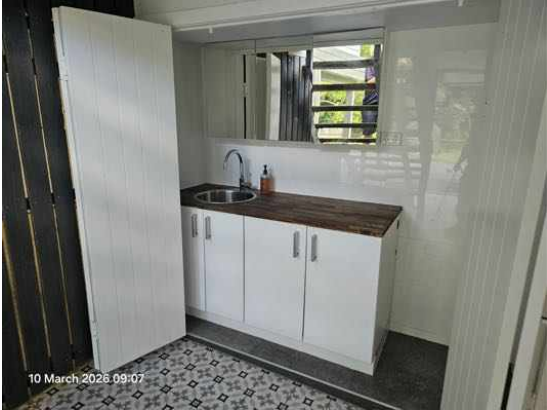
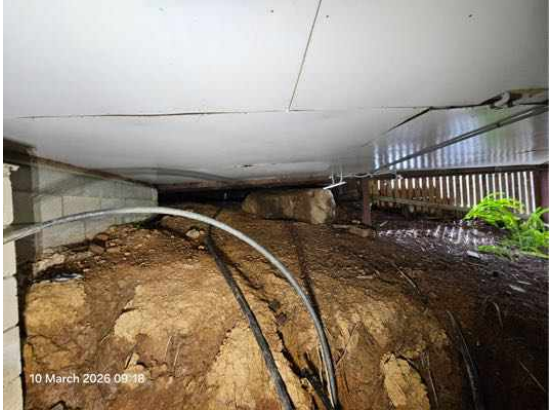
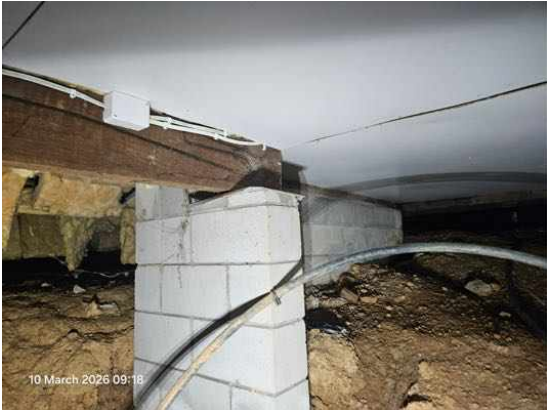
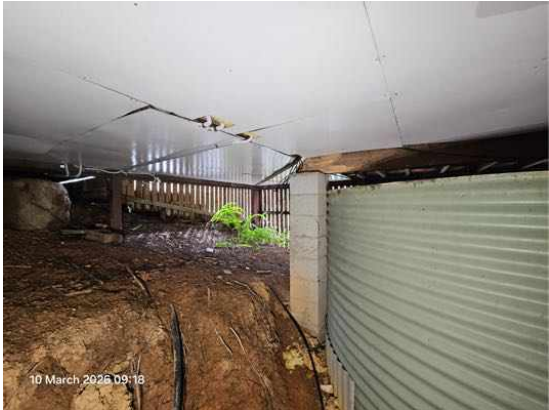
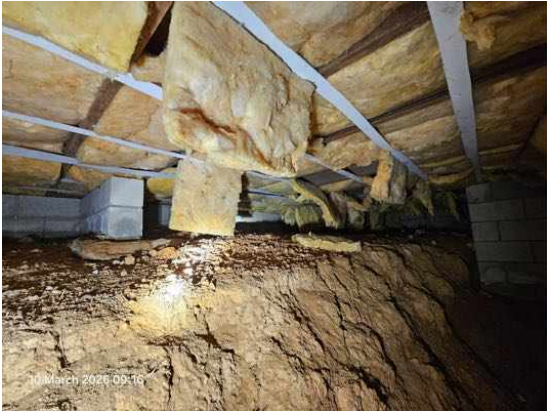
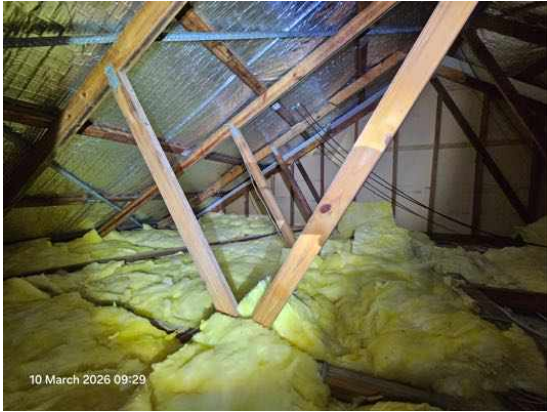
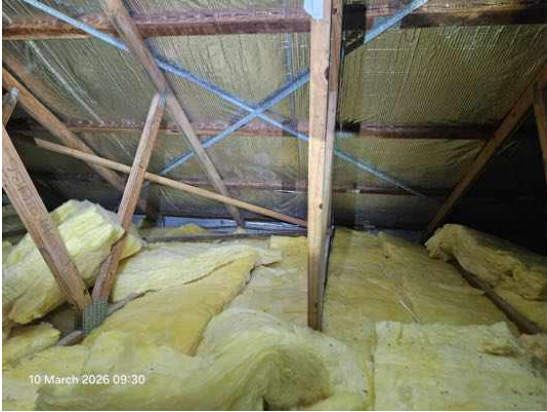
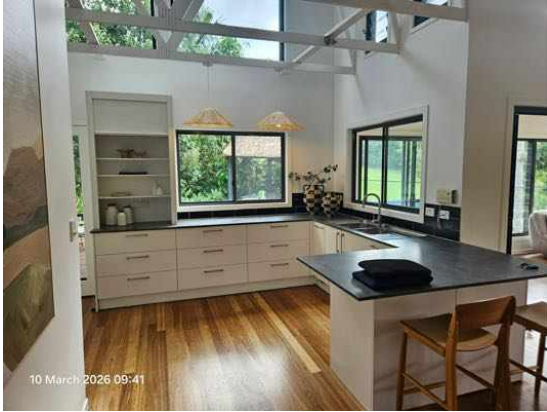
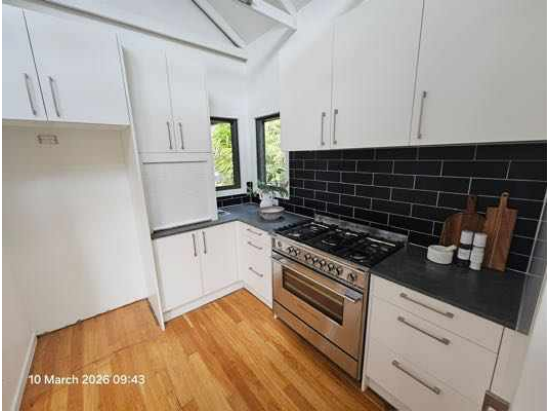
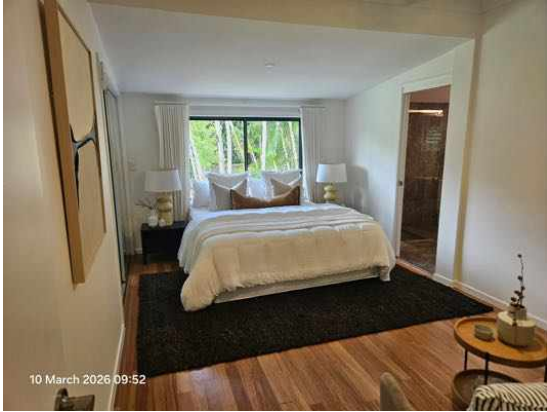
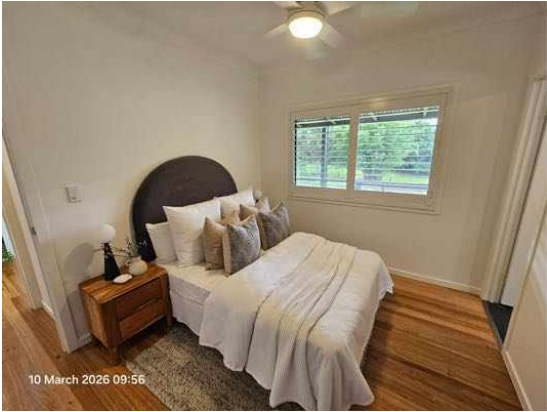
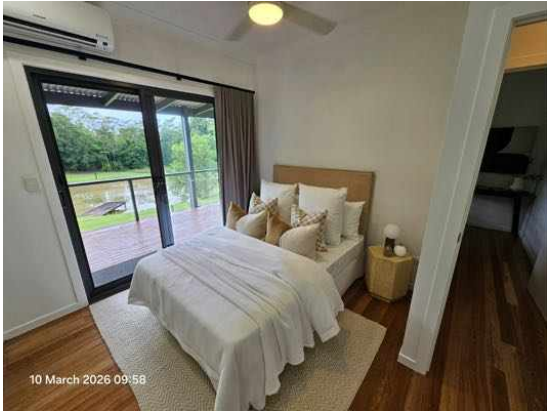
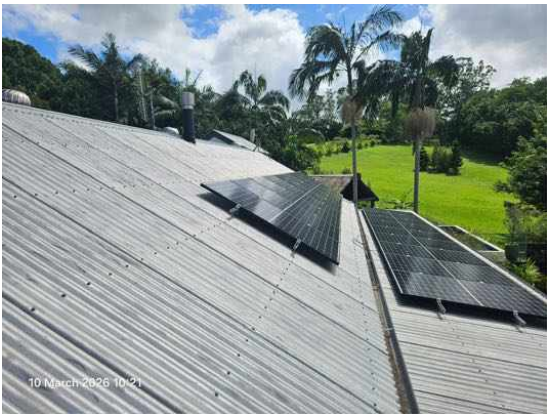
Building: Main Building
Location: All Areas
Finding: Additional Photos - Obstructions and Limitations
Information: These photographs are an indication of the obstructions and limitations which impeded full inspection of the property at the time of inspection. These obstructions can prevent full inspections of the areas shown.

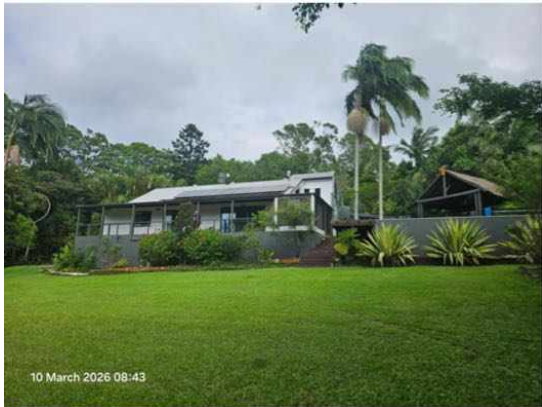
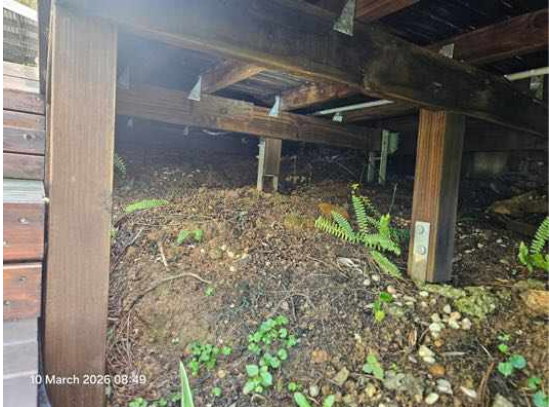
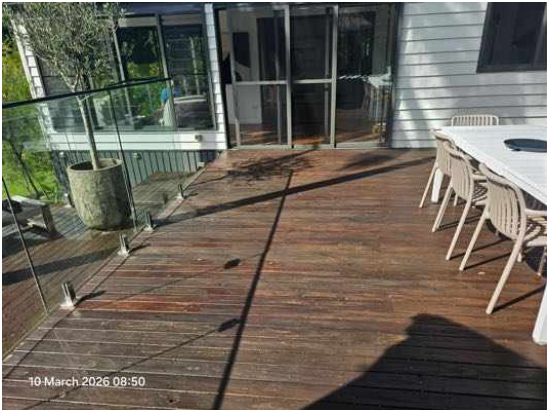
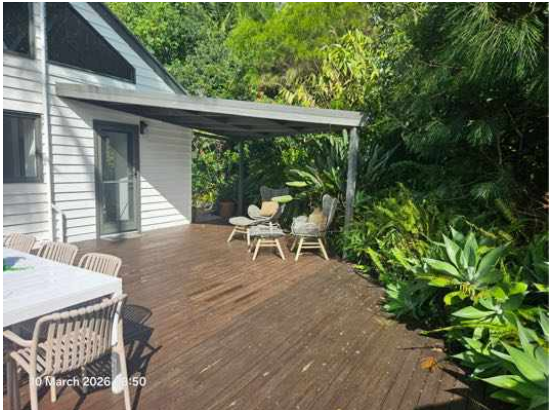
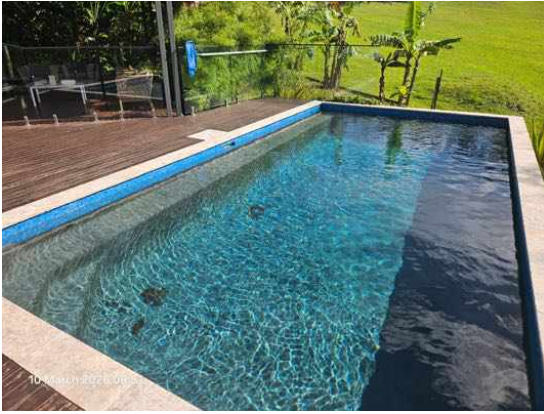
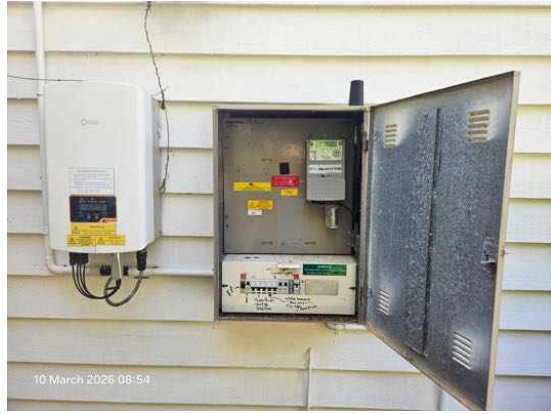
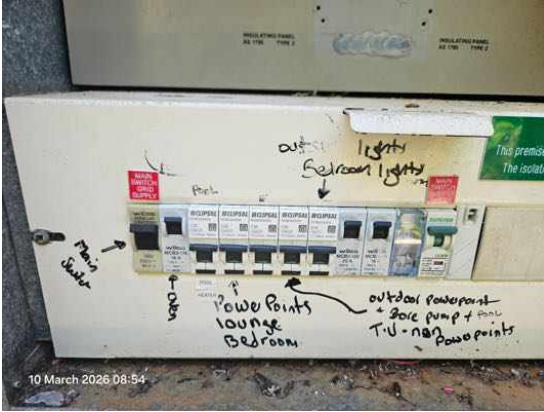
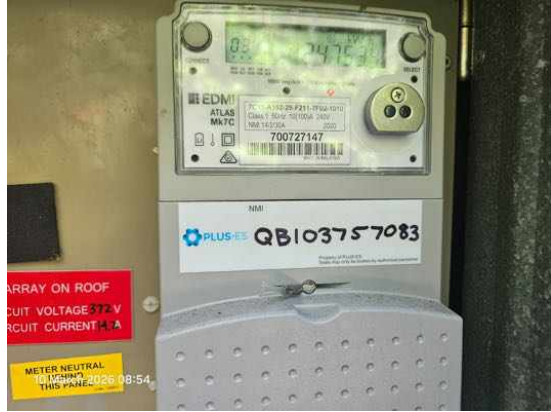
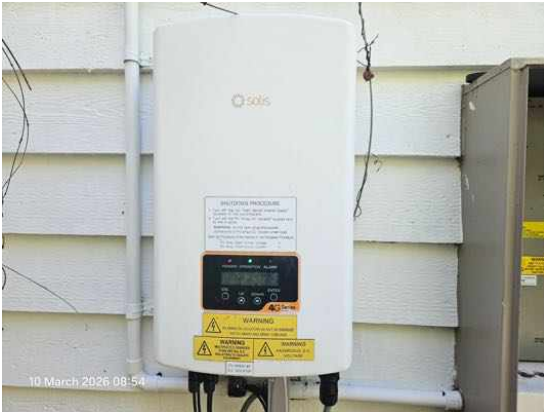
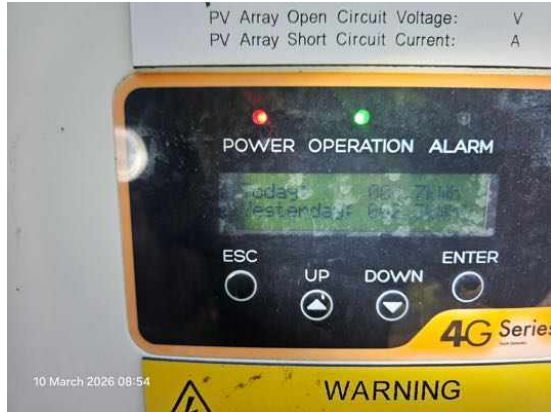
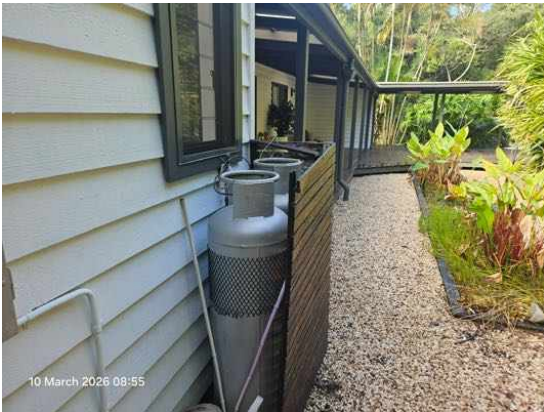
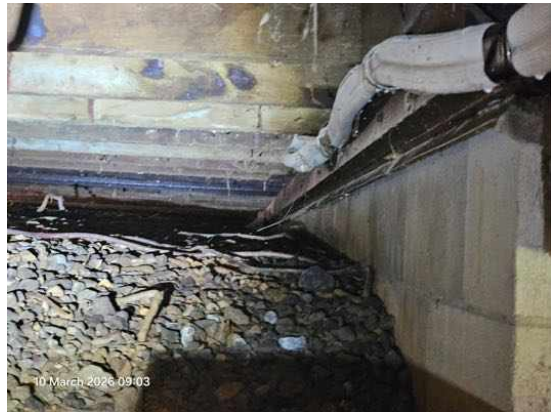
Building: Main Building
Location: All Areas
Finding: Additional Photos for client reference
Information: Additional photos are provided for your general reference.

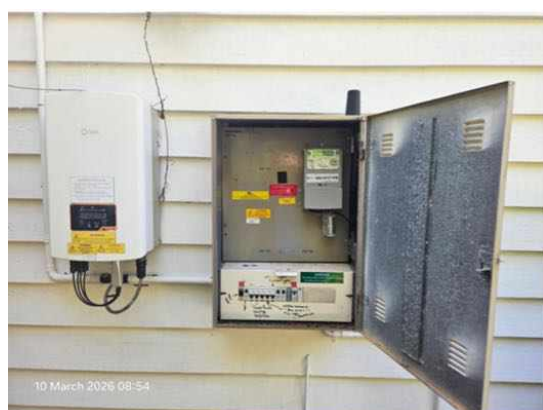
The building employs a physical barrier system to the subfloor in the form of ant-caps. In 2002 a partial chemical barrier was applied to a portion of the perimeter. Given the high risk nature of the property, it is strongly advised that a licensed timber pest controller be engaged to assess the properties needs.

In order for a barrier system to be effective, the property must have regular inspections at intervals of not greater than 12 months. Depending on the risk profile attributed to the property, these inspections may be recommended at lesser time periods.
