# Building and Timber Pest Inspection Report

Inspection Date: Fri, 20 Feb 2026

Property Address: 5/18a-22 Wyatt Avenue, Burwood NSW  
2134

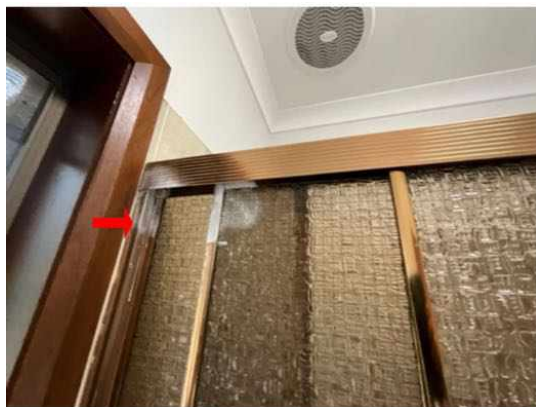
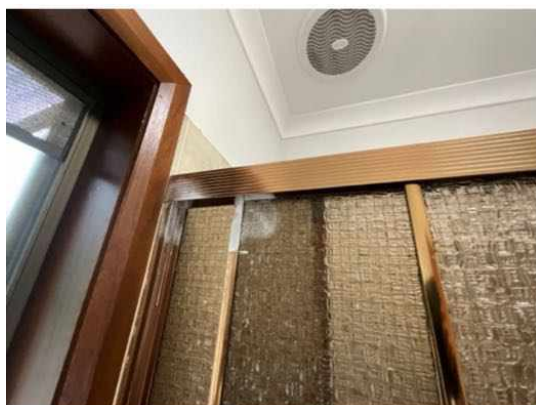
Information: The shower screen door was jamming and not closing smoothly at the time of inspection. This is likely due to worn or loose hinges, screws, or rollers causing the door to drop out of alignment.

Continued use may result in further misalignment or possible glass failure, presenting a safety risk. Prompt assessment and repair by a qualified glazier is recommended.

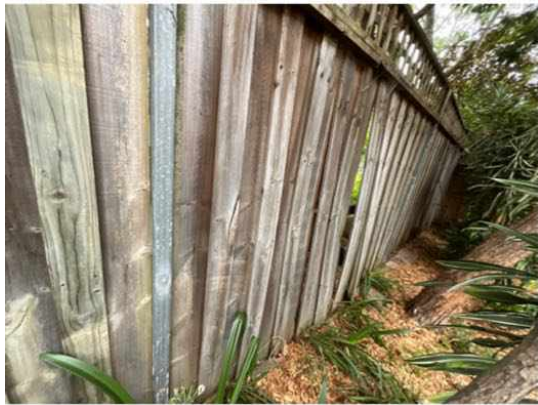
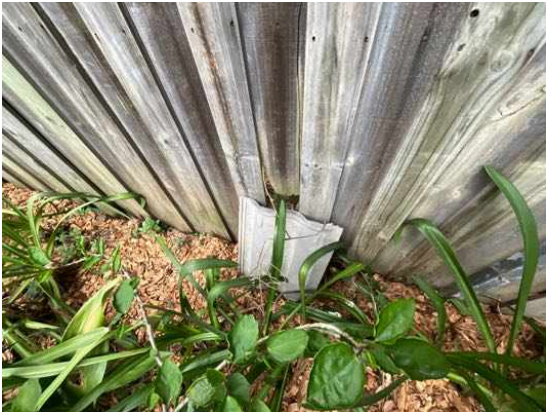
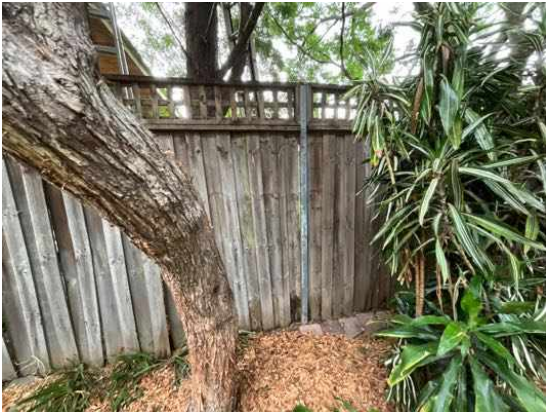
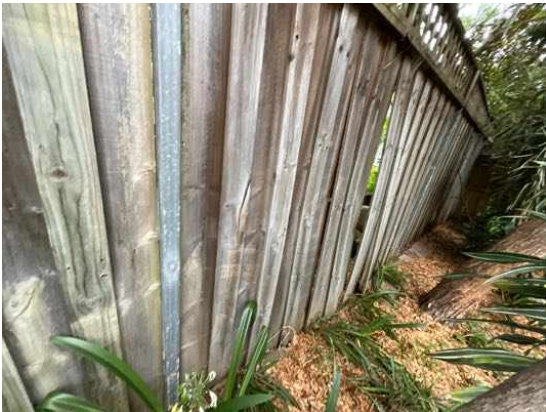
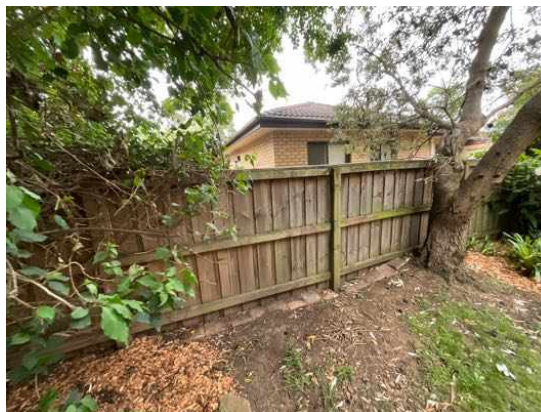
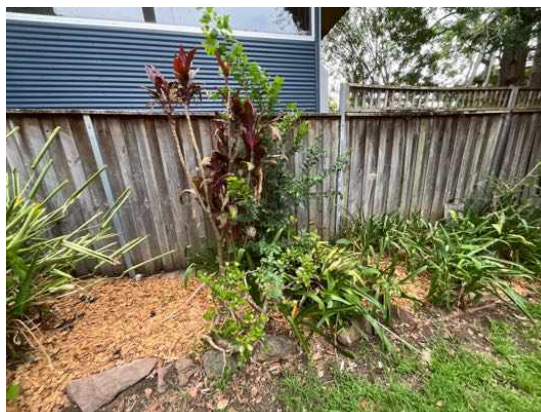
Building:	Main Building
Location:	All Areas
Finding:	Deteriorated fence
Information:	The fence along the property boundary has deteriorated significantly, showing signs of rot, rust, and structural weakness. Several sections are leaning or have become detached, compromising the integrity of the fence and its ability to perform its intended function.

The deteriorated fence poses multiple risks:

1. **Safety Hazard:** The unstable fence may collapse, posing a risk of injury to residents, visitors, and passersby.
2. **Security Concern:** The compromised fence may allow unauthorized access to the property, increasing the risk of theft, vandalism, or trespassing.
3. **Property Damage:** Falling sections of the fence could damage nearby structures, plants, or other property features.

- **Licensed Fencing Contractor:** A professional fencing contractor should be hired to assess the extent of the damage and either repair or replace the deteriorated sections.
- **Handyman Services:** For minor repairs, a qualified handyman could be engaged to reinforce or repair specific sections of the fence.
- **Landscaper (if the fence is part of a larger garden feature):** If the fence is integrated into the landscape design, a landscaper with experience in fencing could be involved in the repair or replacement process.

It's important to ensure that whoever is hired is experienced and qualified to ensure the fence is restored to a safe and functional condition, compliant with local regulations.

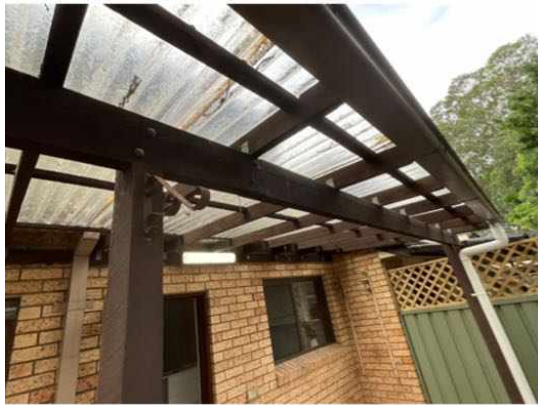
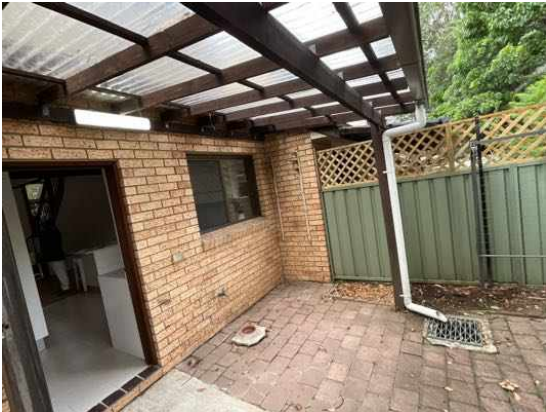
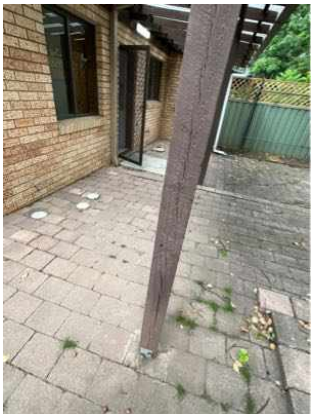
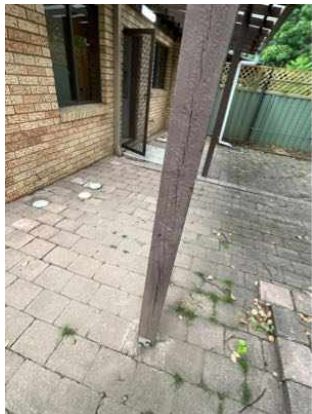
### Finding 3.02

Building:	Main Building
Location:	All Areas
Finding:	Timber - exposed to weather
Information:	External timbers that are frequently exposed to harsh weather conditions require adequate protection in order to maintain their condition. Where timbers have not been painted or treated adequately, general deterioration is likely to occur at an accelerated rate.

If left unattended, replacement of these timbers is likely to be necessary in the short-term future. Adequate treatment of these timbers is required as soon as possible by a painting contractor or general handyman.

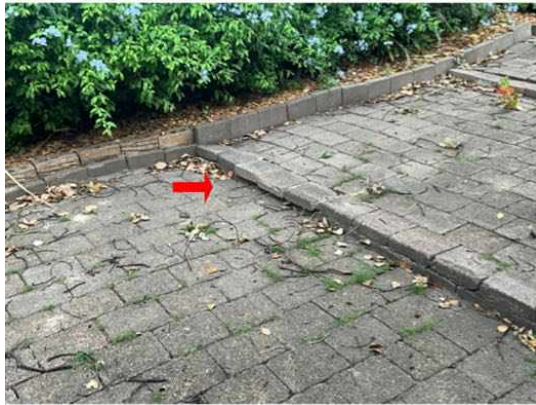
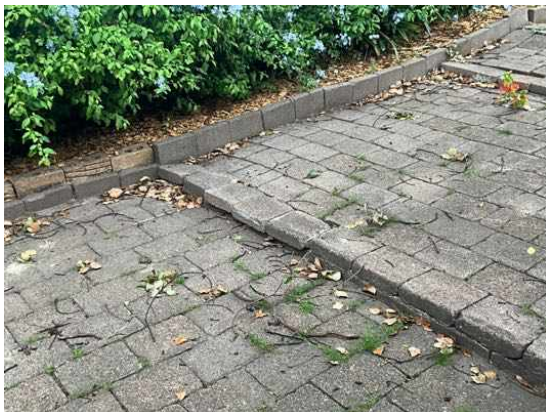
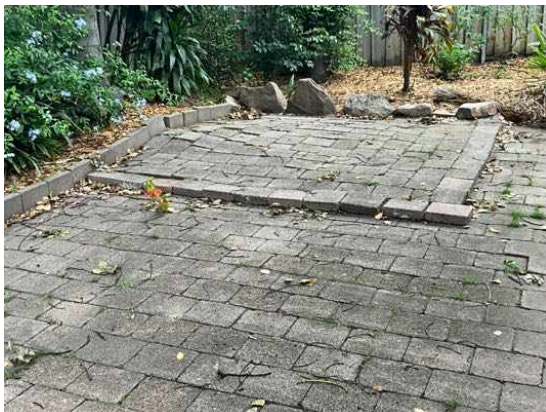
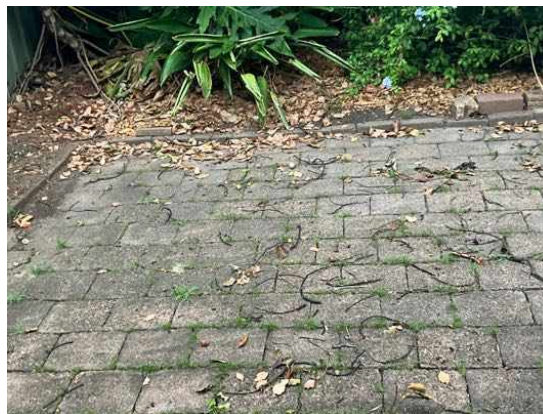
**Finding 3.03**

Building: Main Building  
Location: All Areas  
Finding: Bricks / Pavers uneven and displaced....  
Information: Cracked, uneven, and displaced pavers were observed. Several pavers appear loose, misaligned, or deteriorated.  
Risk:  
The uneven surface poses a significant trip hazard for pedestrians and may impact the usability of the driveway. Displacement and cracking can worsen over time due to vehicle traffic, poor subbase compaction, or water ingress. Wall cracking may lead to

moisture entry or structural wear if left untreated.

- A qualified paving contractor should be engaged to lift, relevel, and relay the affected pavers with proper bedding and compaction.
- A licensed builder or bricklayer should repair and seal the masonry wall crack around the pipe to prevent further water ingress and deterioration.
- Drainage should also be checked to ensure water is not contributing to the issue.

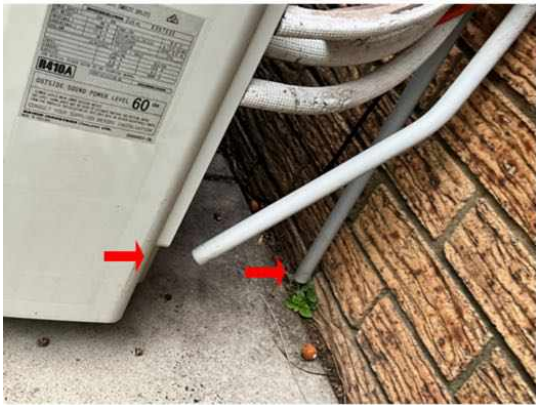
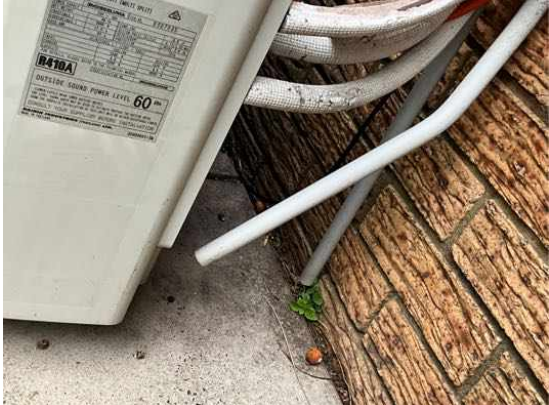
### Finding 3.04

Building:	Main Building
Location:	Exterior walls - right side
Finding:	Air conditioner - Disconnected overflow
Information:	The Air Conditioner (A/C) overflow was found to be disconnected from storm water drainage and is creating excessive moisture in the surrounding area.

Such leaking creates an environment which is conducive to an array of defects, including water damage to associated building elements and the attraction of termite or timber pest infestation.

It is highly recommended that a licensed plumber be appointed to connect the A/C overflow in order to prevent such an environment from being created. These minor works should be carried out as soon as possible.

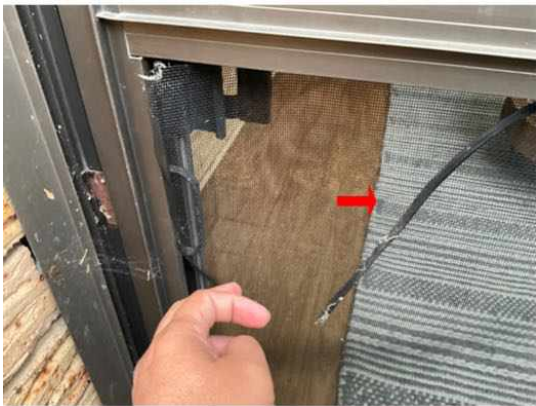
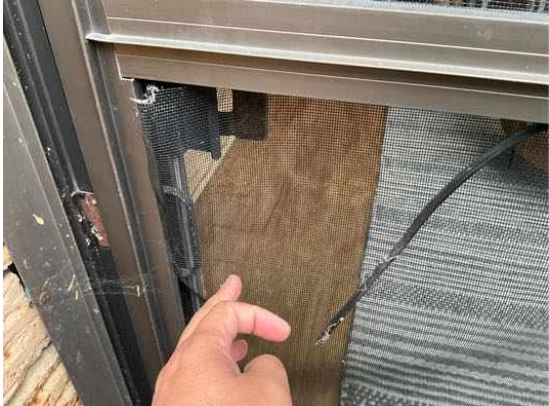
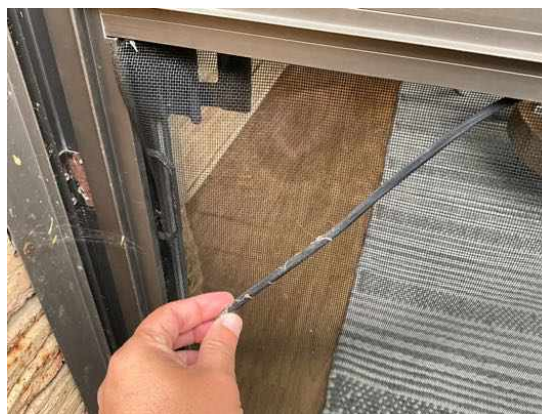
**Finding 3.05**

Building: Main Building  
Location: Front Elevation  
Finding: Beadings - damaged or deteriorated.  
Information: Damaged or deteriorated beadings pose several risks. They compromise the integrity , allowing drafts, moisture, and even pests to enter the building. This can lead to energy loss, water damage, and decreased indoor air quality.

A qualified repair technician should be contacted to assess and repair the damaged or deteriorated beadings. They can replace worn-out beadings, and ensure it is properly installed and function to maintain energy efficiency and structural integrity.

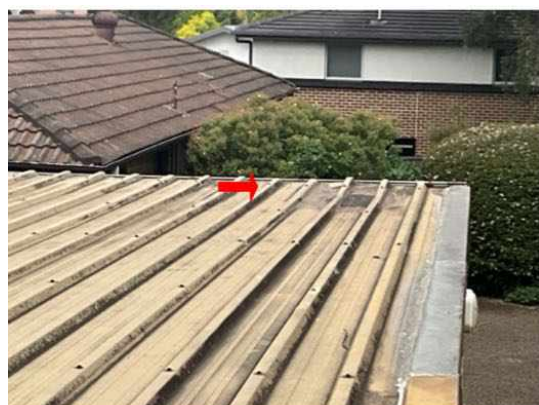
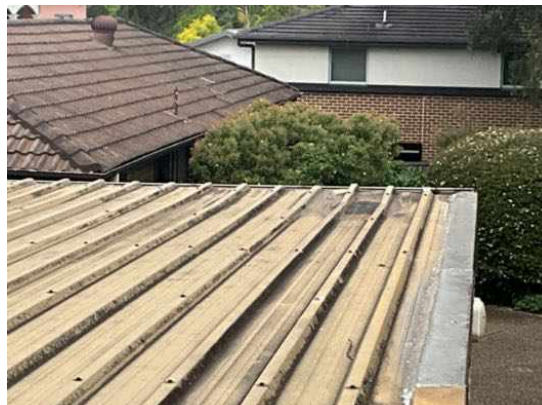
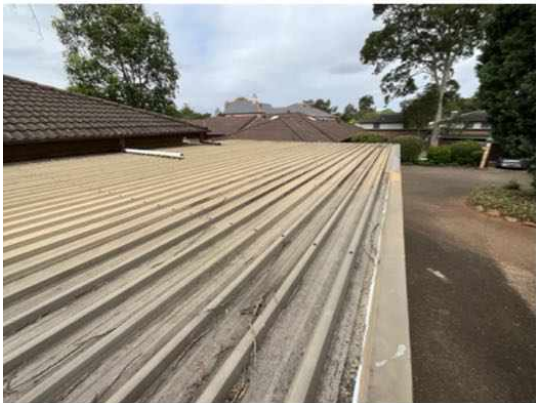
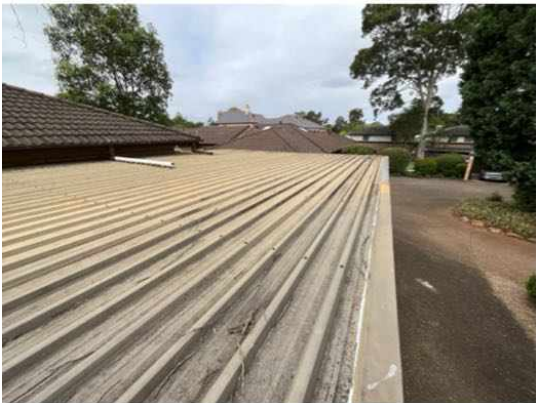
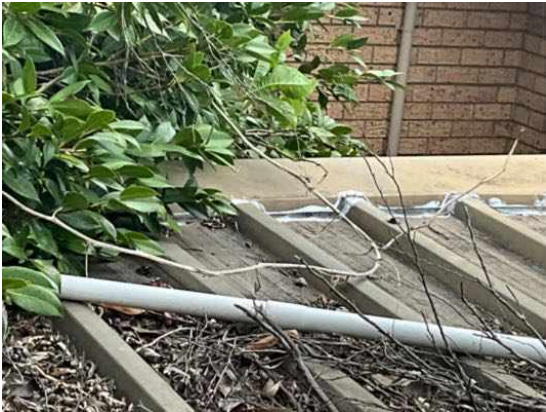
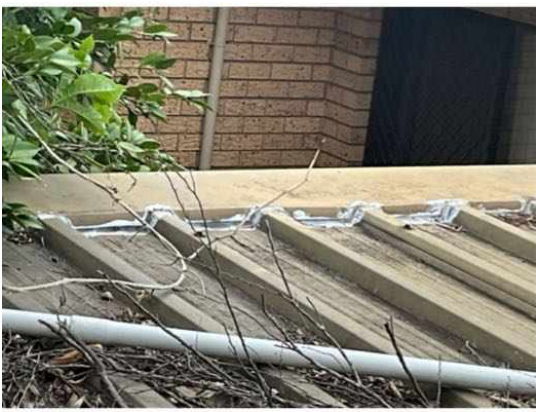
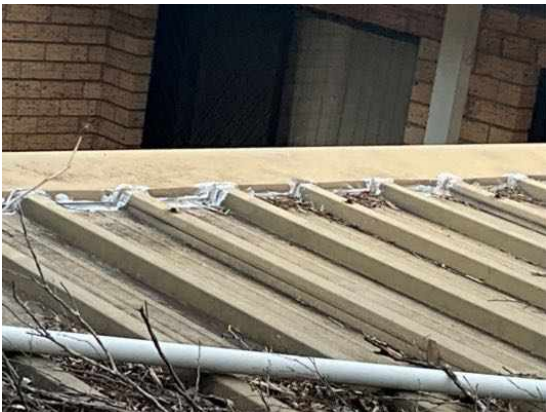
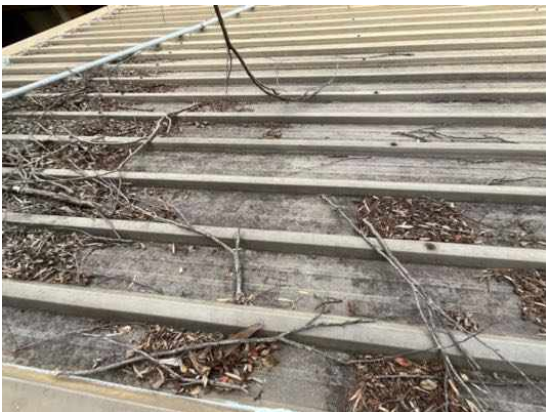
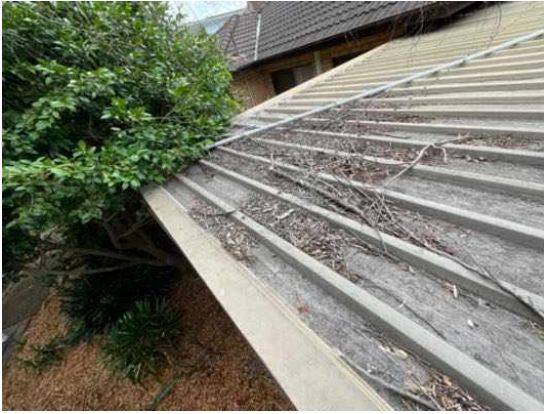
### Finding 3.06

Information: The roof sheeting shows visible weathering, surface oxidation, and deterioration of fastener washers. Some sheet overlaps appear uneven and may not provide adequate weatherproofing at joints near the dormer. The sealant and flashing junctions also show signs of age and deterioration.

Prolonged weather exposure and rusting can lead to corrosion, potential roof leaks, and reduced lifespan of the sheeting. Deteriorated fasteners may allow water ingress, particularly around joints and penetrations.

Engage a licensed roofing contractor to inspect and maintain the affected areas. Replace rusted screws and washers, resecure loose or uneven sheets, and apply protective roof coating or repainting as required. Check flashings and sealants to ensure watertightness.

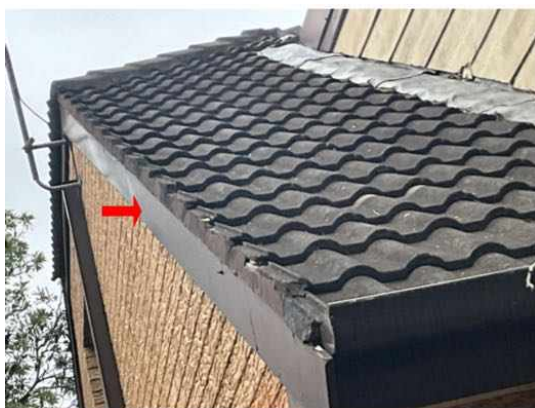
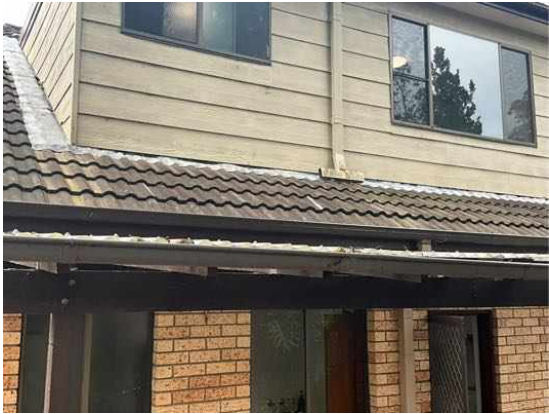
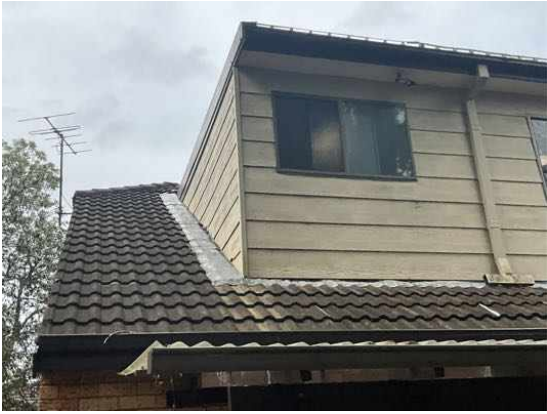
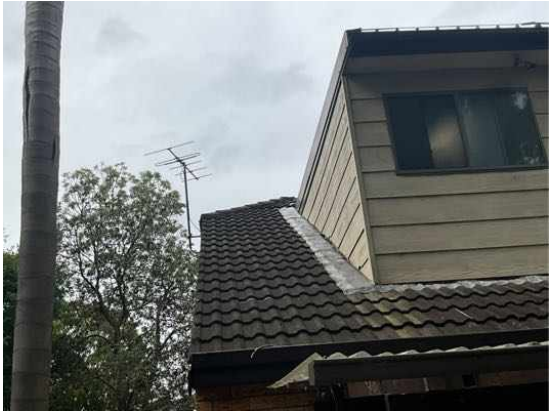
### Finding 3.07

Building:	Main Building
Location:	All Areas
Finding:	Roof Weathered
Information:	Upon inspection of the exterior roofing, the majority of roof was not in a fair condition. While weathering of the roof is consistent with the age of the property, maintenance works are required.

Isolated areas of mortar have come loose in the valleys and minor cracking is also present. Re-pointing and re-sealing the may be considered as an interim solution by the client to help preserve and extend the life span of the tiles.

Where left unmanaged, deteriorating roof are likely to lead to a number of secondary defects, including minor water leaks and weather exposure to internal roofing structures.

Consultation with a roofing contractor is highly advised to gain advice on cost of remedial works that may be required in the short to medium term. Remedial works are likely to increase the longevity of the exterior roofing structure.

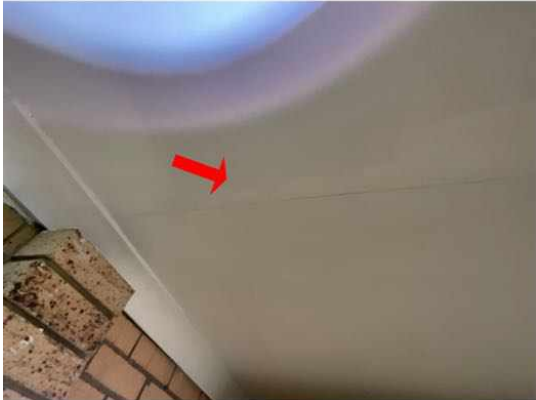
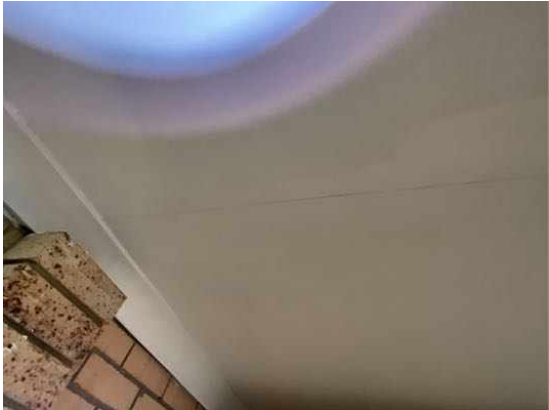
Finding 3.08

Building: Main Building  
Location: Garage  
Finding: Gyprock - Crack ( Fine )  
Information: Fine cracks have appeared in the gyprock of the ceiling, suggesting potential issues with settling or structural movement.

The fine cracks in the gyprock ceiling pose a risk of further widening, compromising the aesthetic appeal of the space, and potentially indicating underlying structural problems.

A skilled plasterer or a contractor specializing in drywall repairs should assess the extent of the cracks and address them promptly. Identifying and fixing the root cause of the issue, whether related to settling or structural concerns, is essential to prevent further damage and maintain the integrity of the ceiling.

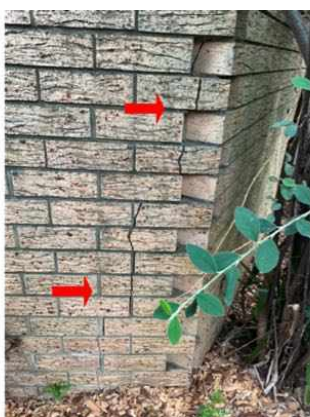
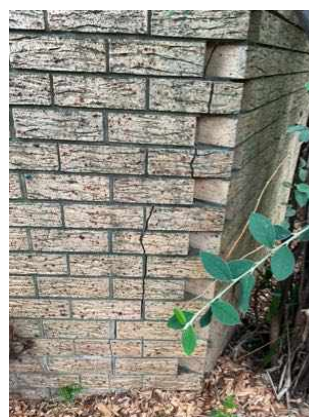
### Finding 3.09

Building:	Main Building
Location:	Yard - Front
Finding:	Brickwork - Cracking noticeable
Information:	There were several cracks and or crack repairs evident to external brickwork.

Noticeable cracks are a common occurrence in external brickwork and are a likely result of age expected building movement, general expansion, and/or contraction of building materials in different weather conditions. Noticeable cracks in brickwork may develop if left unattended, with potential for necessitating major remedial works or replacement of the brickwork.

It is highly advised that a qualified bricklayer be appointed to provide necessary works to cracked brickwork to prevent any further damage. Such works should be conducted as soon as possible.

Always monitor these cracks and contact a building inspector should cracks widen, lengthen, or become more numerous.

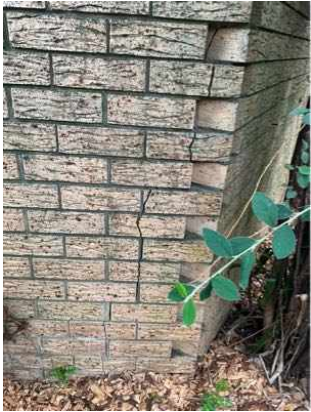
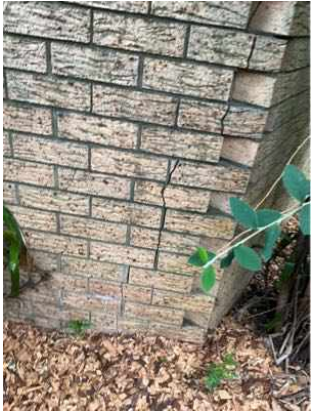
**Finding 3.10**

Building: Main Building  
Location: All Areas  
Finding: Poor workmanship  
Information: The structure exhibits signs of poor workmanship, evident in various aspects of construction and finishing.

Risk: Poor workmanship poses a range of risks, including compromised structural integrity, potential safety hazards, and a decreased lifespan of the structure. It may also lead to aesthetic and functional issues.

Resolution: A qualified contractor or construction professional should be consulted to assess and address the poor workmanship. They can implement corrective measures to ensure structural soundness, safety, and overall quality of the construction.

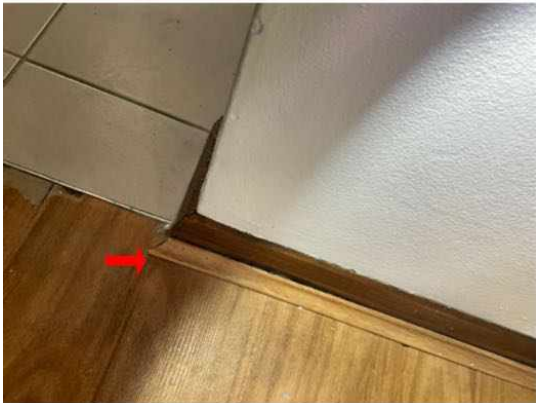
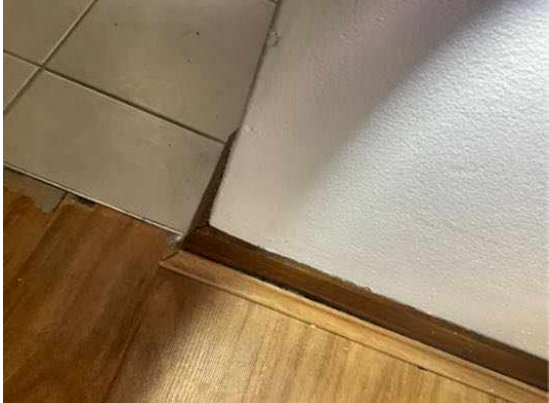
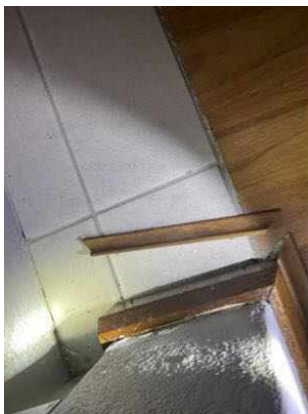
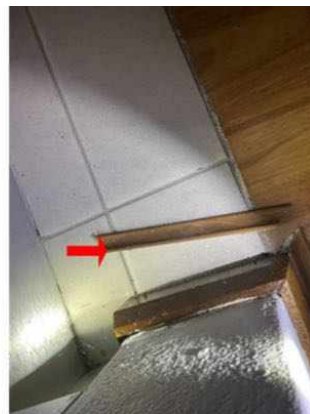
### Finding 3.11

Finding: Grouting - Missing or damaged

Information: It was noted on inspection that sealant or grout is Missing or damaged. A flexible sealant is required to allow for expected expansion and contraction, while keeping the joint water tight and protective of all associated building materials.

Flexible and mould resistant materials should be applied to affected areas to prevent any subsequent water damage that is likely to occur. Regular maintenance and replacement of damage or missing or damaged sealant and grout is highly recommended , as this is a regular wear and tear defect.

A sealant specialist or tiling contractor should be appointed to complete these works as soon as possible

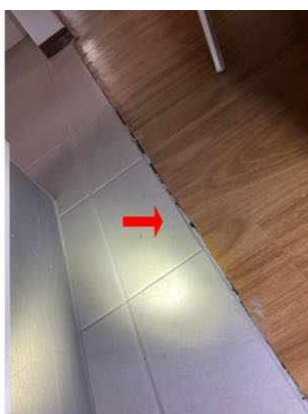
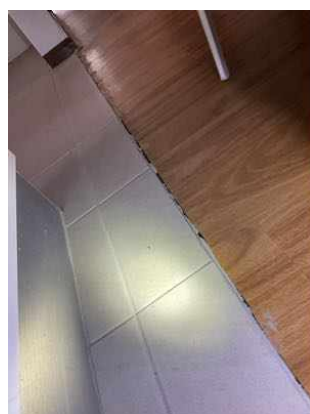
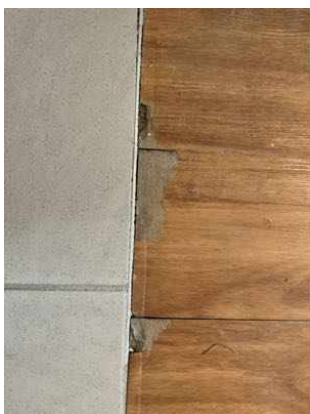
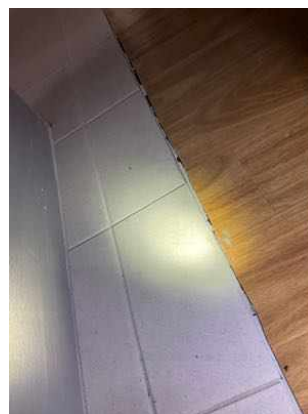
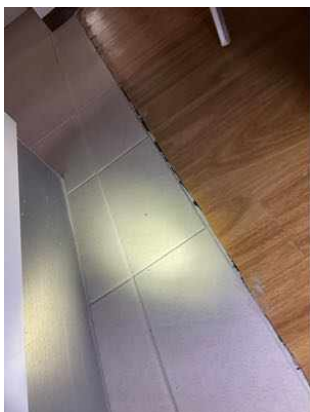
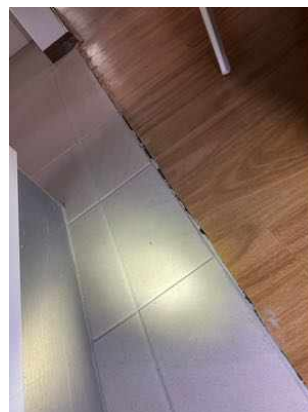
### Finding 3.12

Finding: Water damage

Information: The area has sustained water damage resulting in potential structural issues. This damage compromises both the aesthetic and functional aspects.

1 **Plumber:** If the water damage is due to plumbing issues, a plumber can fix leaks and ensure there are no further water-related problems.

2 **General Contractor:** If the damage is extensive and affects the surrounding area, a general contractor can coordinate the repair work, including any related structural or cosmetic repairs.

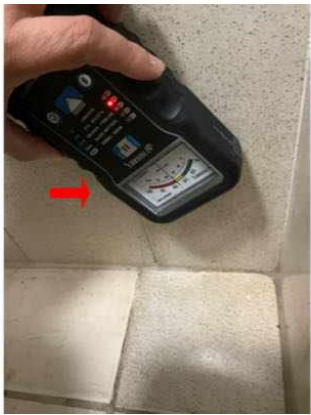
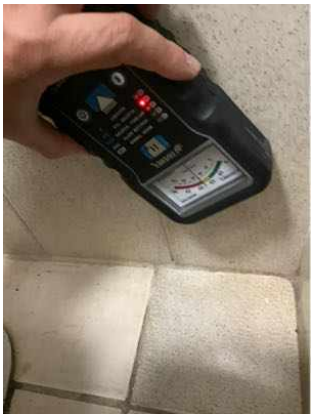
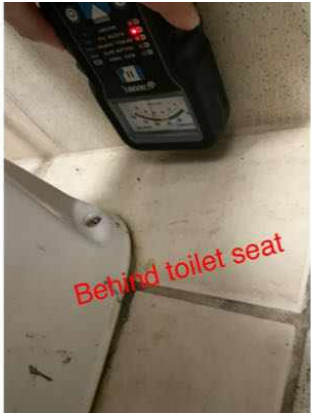
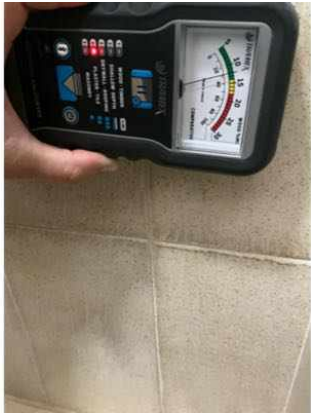
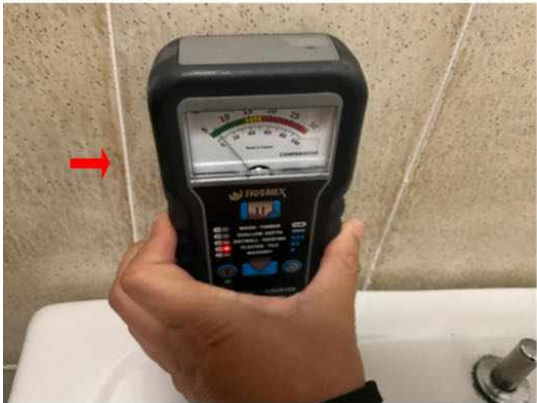
**Finding 3.18**

Building: Main Building  
Location: Ensuite  
Finding: Shower - Damp

Information: Damp is evident to the lower 300mm of wall to the shower alcove. This defect is quite common, and is suspected to have been caused by moisture permeating through the grouting in this area, which shows evidence of deterioration. Leaking pipes within the adjoining wall is also a possible cause.

Unmanaged damp in the shower recess is likely to facilitate the formation and development of mould and fungi growth, decaying associated building materials and compromising their structural integrity. It is important to address damp conditions, as the World Health Organisation notes that excess moisture leads - on almost all indoor materials - to growth of microbes such as moulds, fungi and bacteria, which subsequently emit spores and other matter into the indoor air. Exposure to these contaminants is associated with a wide range of respiratory and other health-related problems.

Consultation with a qualified plumber or bathroom specialist is advised immediately to identify the cause of damp and to perform remedial works as required. Where excessive mould growth is present, further inspection by a specialist environmental health inspector should also be considered.

Always ensure that sealant and grout is in good condition to prevent any moisture issues occurring in the future.

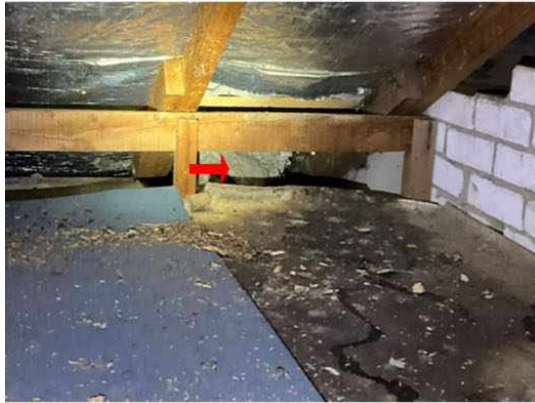
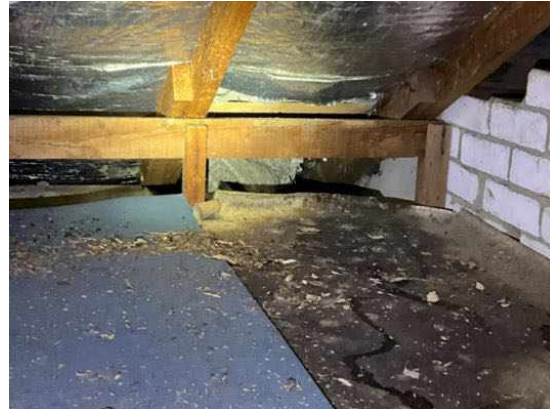
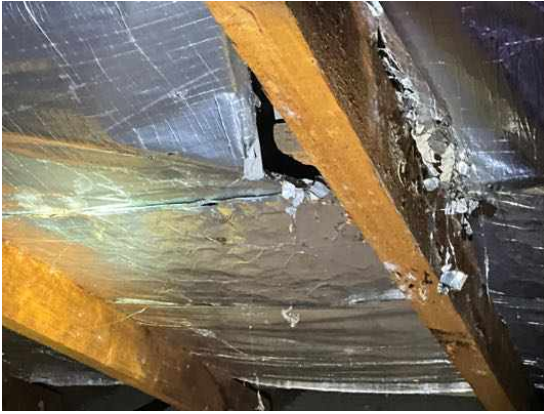
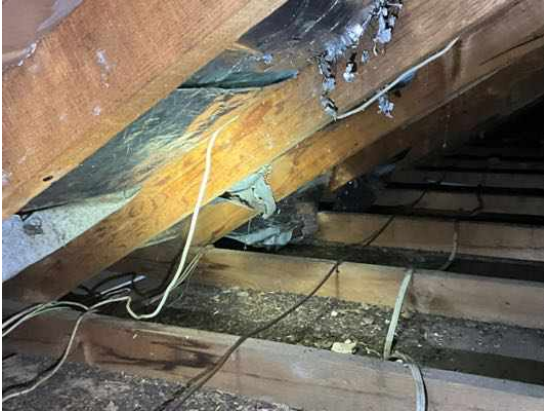
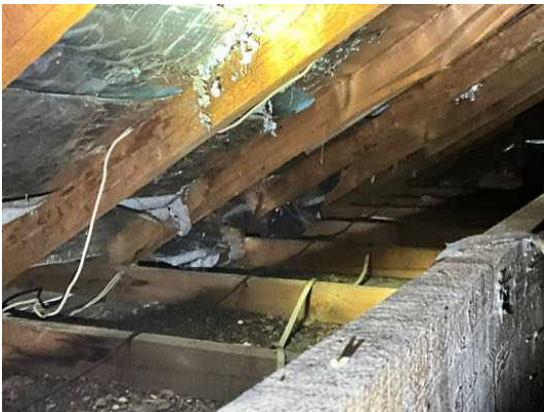
### Finding 3.21

Building:	Main Building
Location:	Roof Void
Finding:	Insulation - Missing
Information:	Upon inspection of the roof void it was noted that insulation is not present.

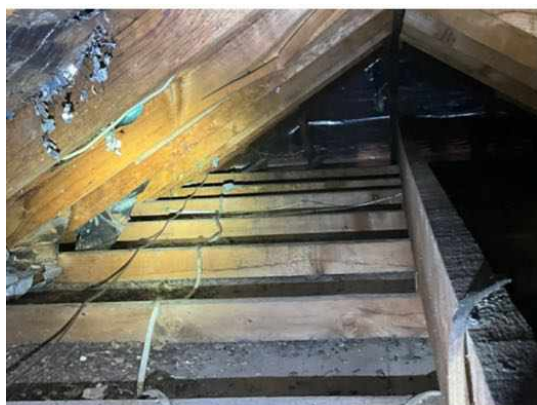
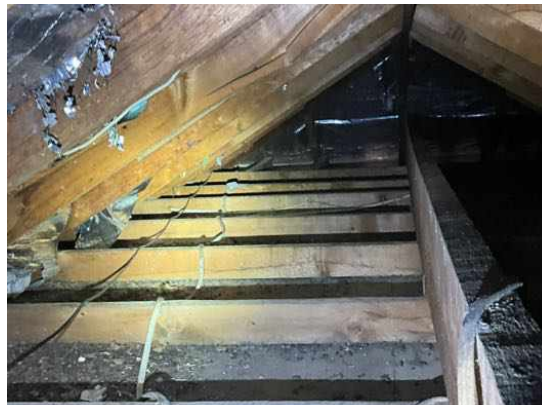
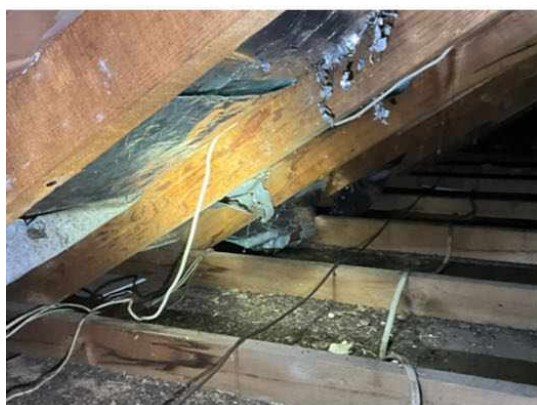
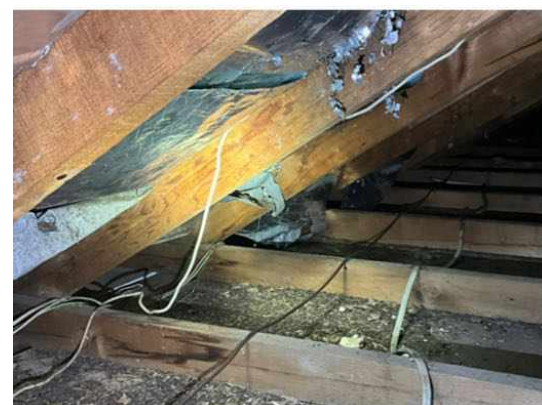
Insufficient insulation will result in a comparatively higher cost to heat and cool a property as there is a lack of Insulation (or uneven coverage of insulation) which works as a barrier to heat transfer. This helps to keep out unwanted heat in summer and preserves warmth inside your home in winter. It can also help soundproof your home from unwanted airborne noise transfer.

Where insulation is absent, the area does not meet current Australian Standards. Installation of adequate insulation is required and should be conducted as soon as possible.

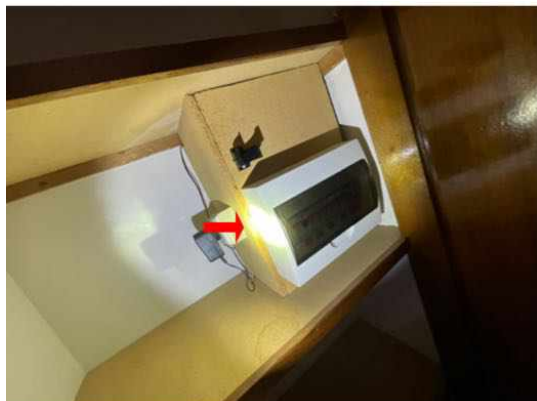
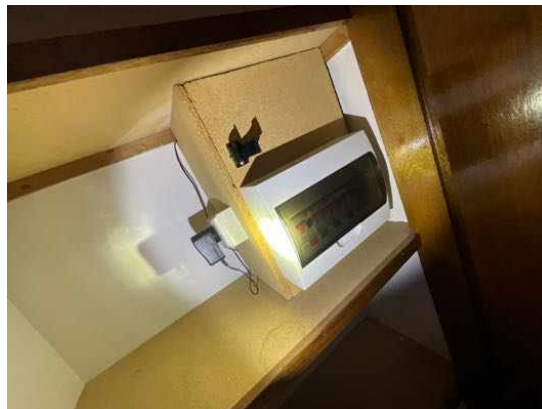
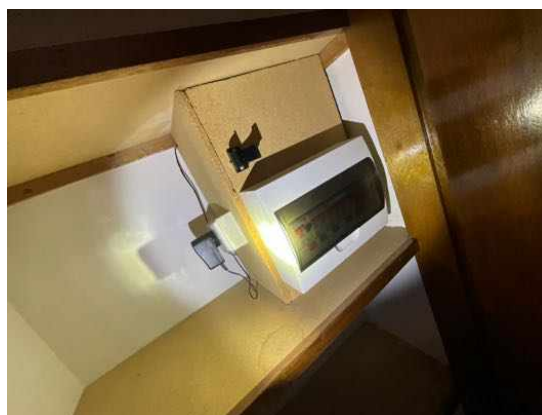
Building:	Main Building
Location:	Cabinetry upstairs
Finding:	No Evidence of Termite Management System - Durable notice / Legible Sticker
Information:	The application of a pre & post-construction chemical termite barrier is highly recommended for all properties. Such barriers are highly effective in preventing termite attack on any timber building elements throughout the property.

A durable notice was not placed in the switchboard unit to indicate current termite barriers is legible at the time of inspection.

Client must seek further information from the vendor or real estate agent if the conditions of termite management systems were maintained.

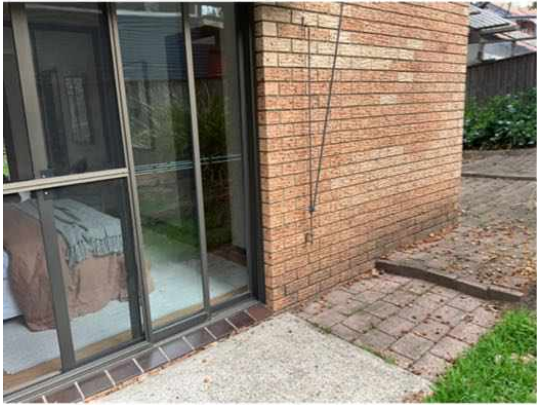
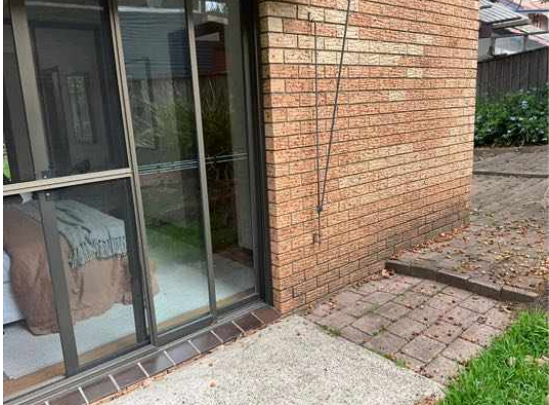
### Finding 6.02

Building:	Main Building
Location:	All Areas
Finding:	Slab Edge - Exposure
Information:	An inspection zone of at least 75mm in relation to the exposed slab edge, between the bottom brick and the perimeter pavement, is required. This inspection zone should be maintained in order to force termites into the open where they can be detected more readily during regular inspections. The slab edge should not be concealed by anything that may prevent inspection of the area, including render, landscaping, soil, turf, paving, concrete cladding or other structures.

Where the slab edge cannot be properly inspected, it is highly recommended that

termite or timber pest inspections be carried out every 6-12 months to aid protection of the property against infestation.

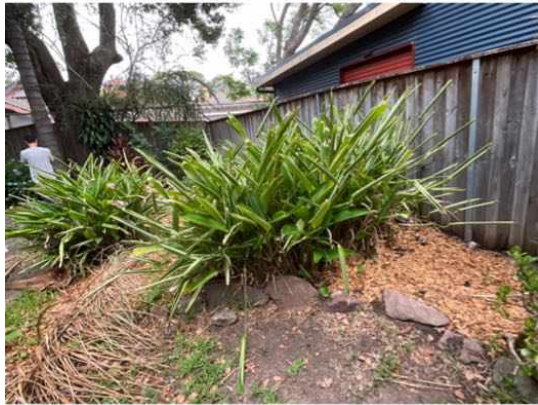
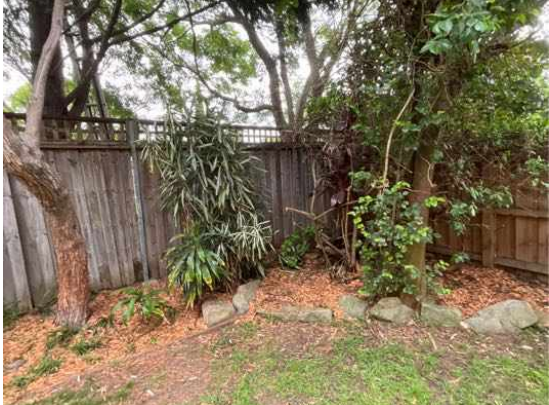
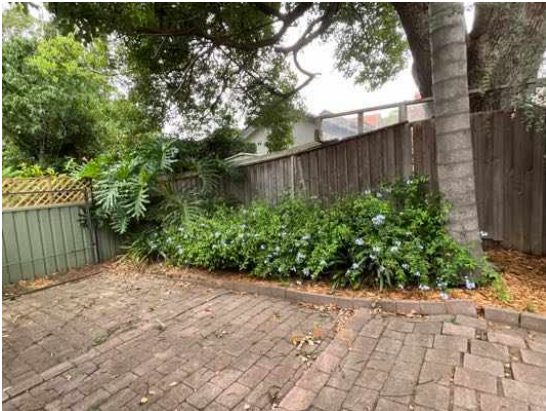
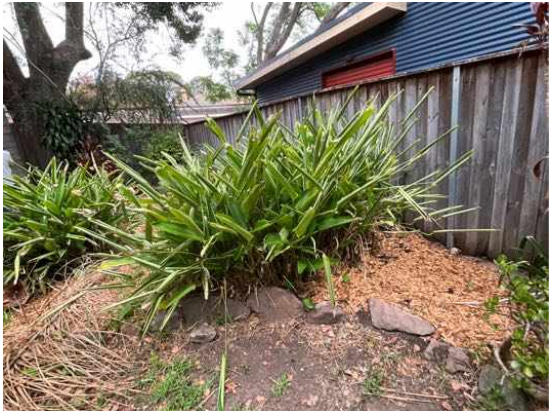
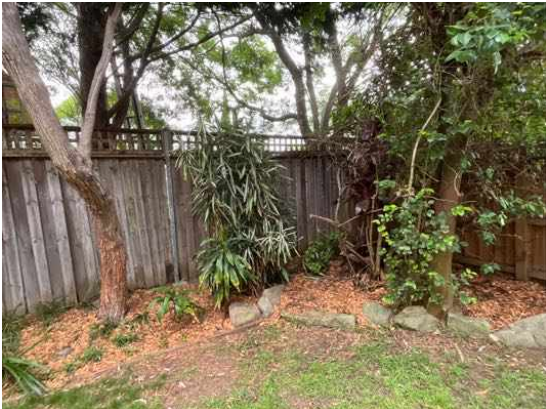
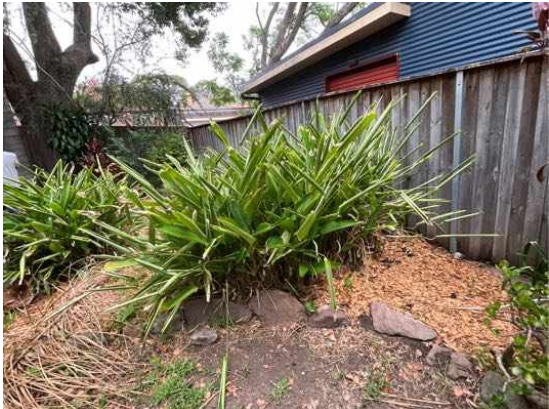
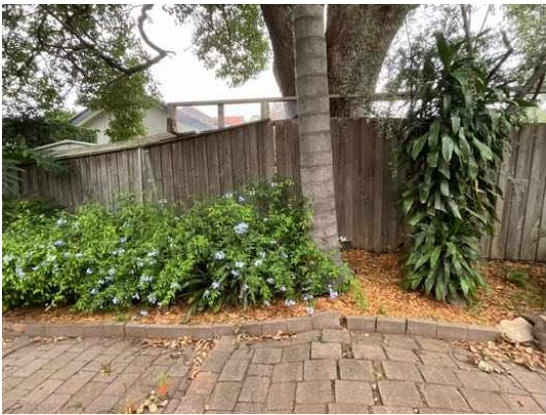
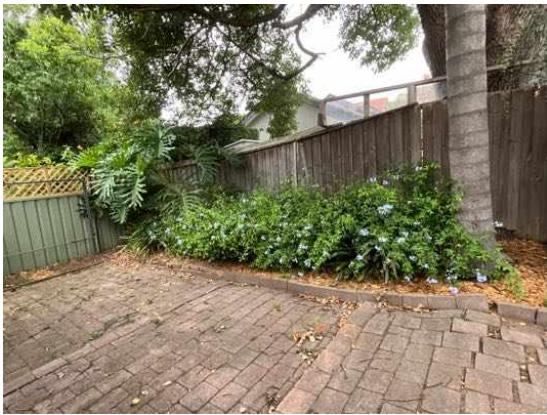
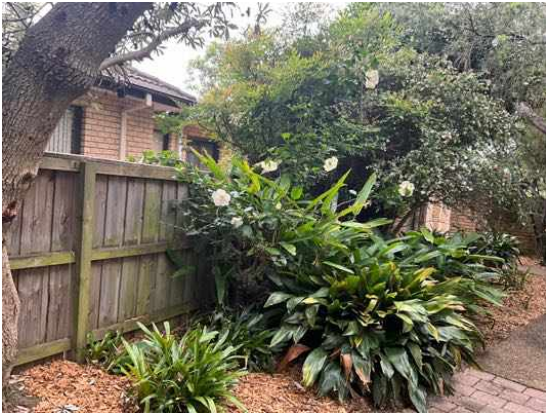
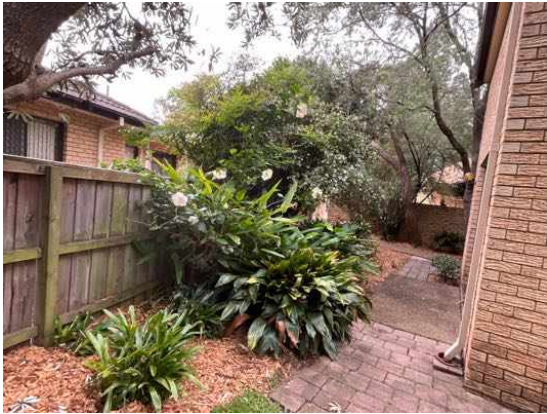
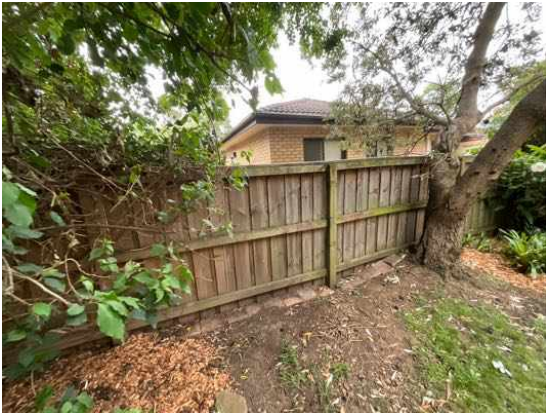
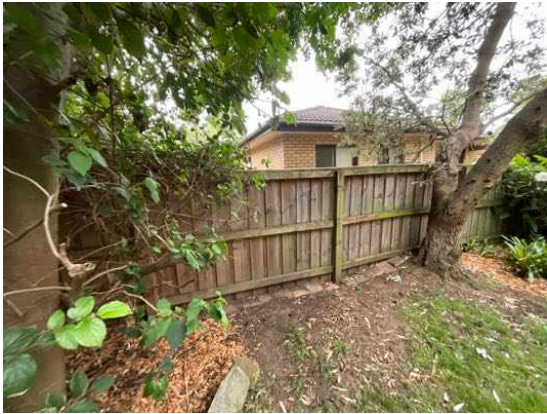
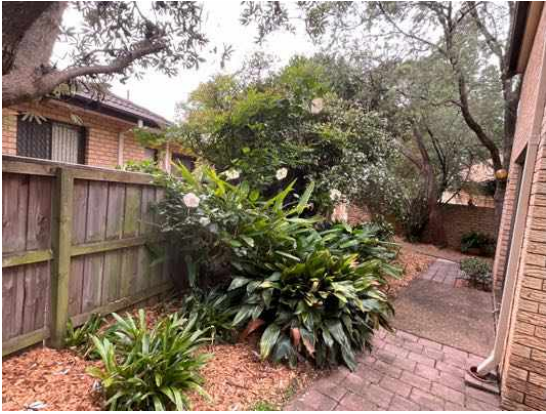
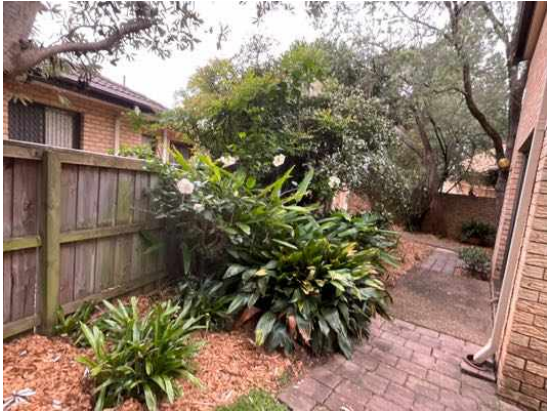
Finding 6.03

Building: Main Building  
Location: All Areas  
Finding: Dense vegetation around a property can increase the risk of termite infestation  
Information: The presence of dense vegetation around a property can increase the risk of termite infestation, as it provides a conducive environment for them. To address this, consider maintaining a clear space between the vegetation and your home. If you suspect a termite issue, it's advisable to consult with a licensed pest control professional for inspection and treatment.

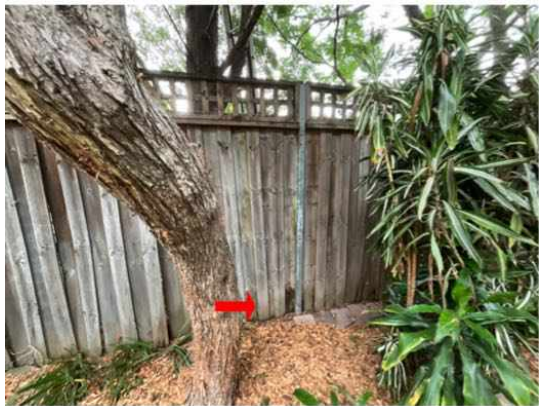
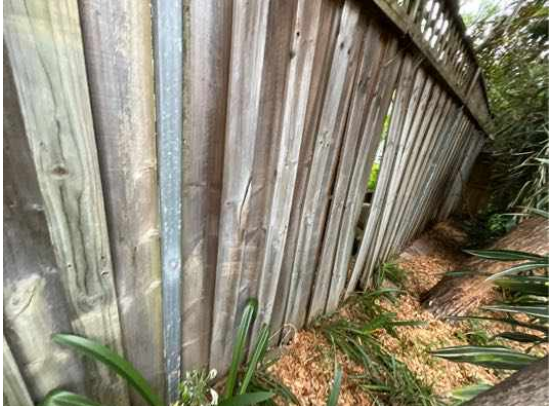
**Finding 6.04**

Building: Main Building  
 Location: All Areas  
 Finding: Timber on ground / conducive conditions to termite damage  
 Information: Timber on the ground is indeed conducive to termite damage. Termites are known to thrive in moist environments, and wood in contact with soil or moisture is more susceptible to infestation.

To prevent this, it's important to keep timber elevated and away from direct ground contact. Regular inspections and proper termite control measures are also essential to protect your wooden structures from termite damage.

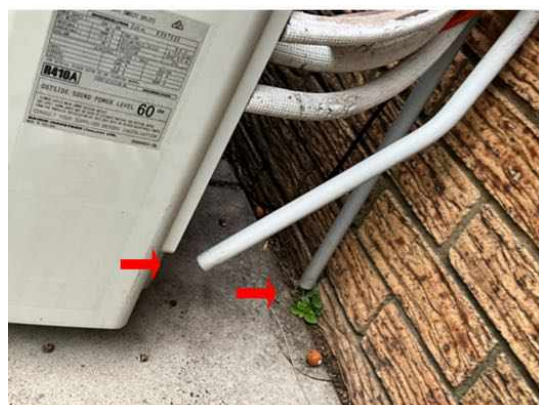
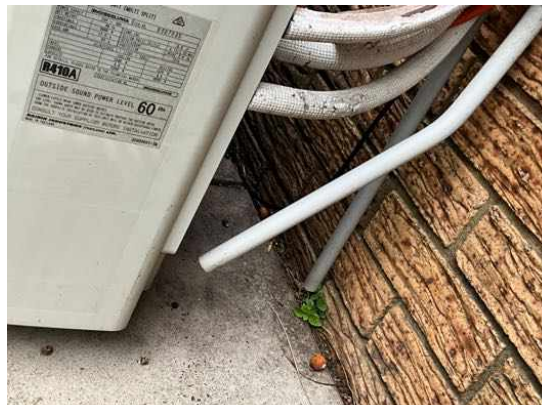
### Finding 6.05

Building:	Main Building
Location:	Exterior walls - right side
Finding:	Aircon - Excessive moisture conducive condition near Air-conditioner
Information:	<p>Excessive moisture near an air conditioner can indeed create conducive conditions for termites. Termites are attracted to damp and decaying wood, which can be found in areas with high moisture levels. To fix this issue:</p> <ol style="list-style-type: none"> <li>1. Fix Leaks: Check for any leaks or condensation around your air conditioning unit. Repair any damaged pipes, drains, or insulation that may be causing moisture buildup.</li> <li>2. Proper Drainage: Ensure that your air conditioner has proper drainage. Make sure the condensate drain line is clear and directed away from your home's foundation.</li> <li>3. Ventilation: Improve ventilation around the unit. Ensure that the area is well-ventilated to reduce humidity levels.</li> <li>4. Regular Maintenance: Schedule regular maintenance for your air conditioning system. This can help prevent leaks and ensure</li> </ol>

5. Please consult a HVAC Technician: HVAC (Heating, Ventilation, and Air Conditioning) technicians are trained to diagnose and

repair a wide range of air conditioning problems. They can handle issues with the cooling system, refrigerant, electrical components, and more.

6. Consult an appropriate and Qualified Professional: For severe moisture issues or persistent termite problems, consult with a

pest control professional who can provide targeted solutions.

By addressing these issues, you can reduce the moisture levels around your air conditioner and minimize the attractiveness of the area to termites.
