# Building and Timber Pest Inspection Report

Inspection Date: Fri, 20 Feb 2026

Property Address: 5/18a-22 Wyatt Avenue, Burwood NSW  
2134

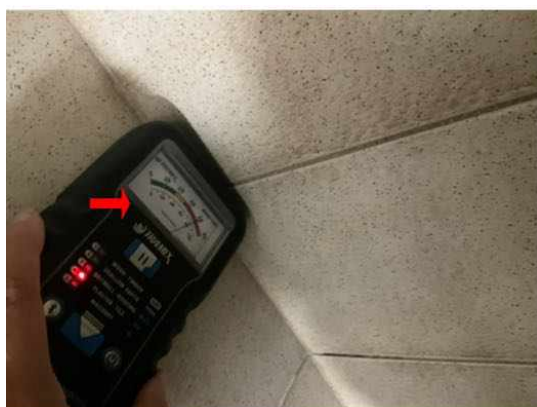
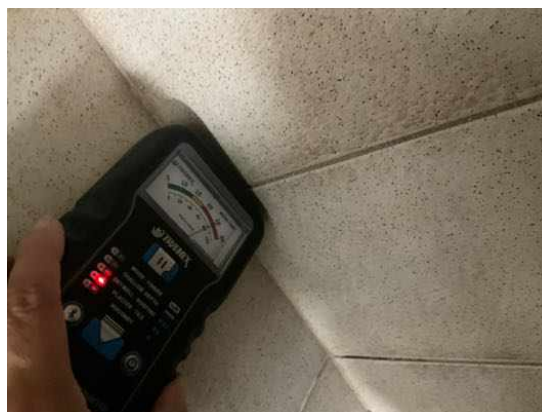
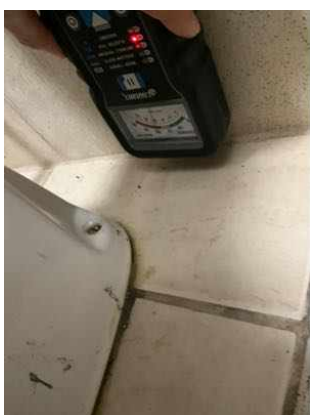
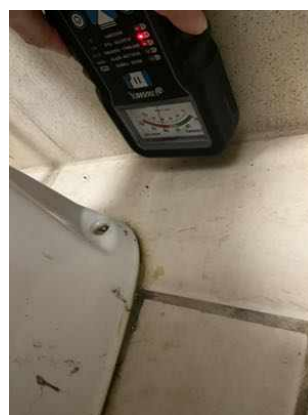
Building:	Main Building
Location:	Ensuite
Finding:	Excessive moisture - Conducive to Timber pest
Information:	Excessive moisture can attract termites and produce conditions that promote fungal growth and wood decay.

Excessive moisture is generally caused by deteriorated inadequate or missing roof drainage leaking plumbing pipes or fixtures poorly plumbed HWS overflows or condenser units and poor site drainage.

Prior to any remedial works being performed a qualified plumber should be appointed to further inspect the property and to identify the cause of the excessive moisture. Works to remove affected building elements may then be necessary and should be

performed by an appropriate tradesperson.

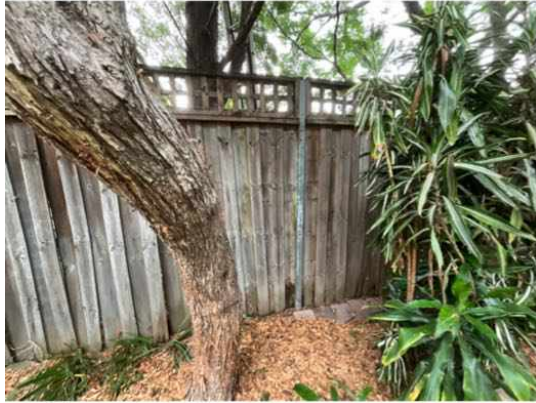
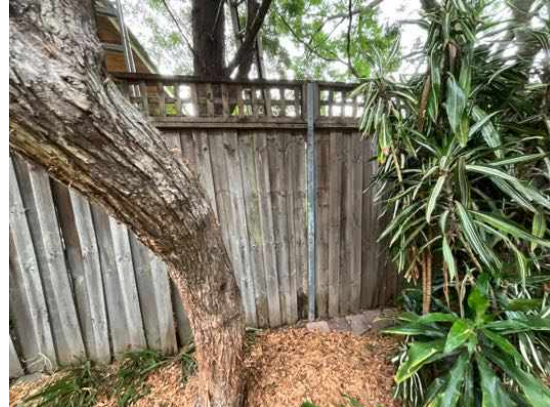
### Finding 7.01

Building:	Main Building
Location:	All Areas
Finding:	Wood rot
Information:	This building element shows evidence of wood rot. Wood rot, also known as Fungal Decay, occurs when timbers and other cellulose building materials are exposed to damp conditions on an ongoing basis. This could be the result of exposure to weathering over a prolonged period of time, or the attraction of excessive moisture from other abutting building materials. Contributing factors also include poor air ventilation in the area.

Wood rot is often associated with general damp problems and is evidenced by a 'musty' smell or mould and mildew occurring on surfaces. If left unmanaged, damp conditions can lead to further health problems and the decay of timbers will continue.

cause of the moisture that has created the visible wood rot should be identified and addressed in a suitable manner. Replacement of affected timbers may then be a necessary step in protecting surrounding building elements from such deterioration.

A qualified plumber may be appointed to assess the cause of excessive moisture and to provide advice on any remedial works as required. A qualified carpenter or registered builder may also be required to replace affected building materials.

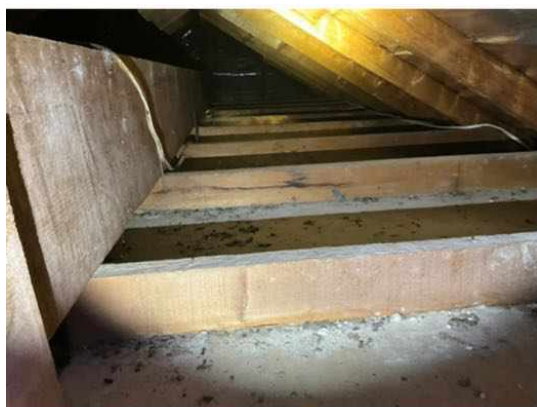
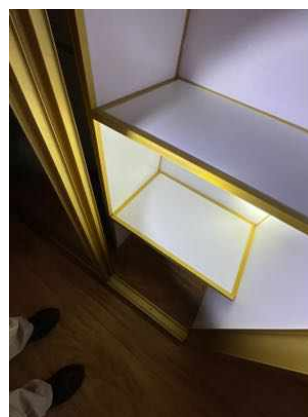
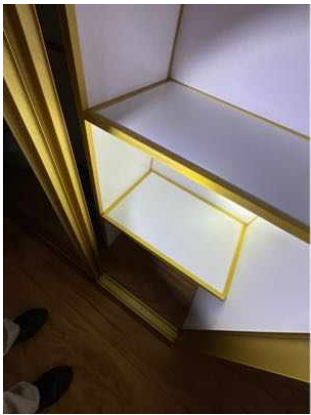
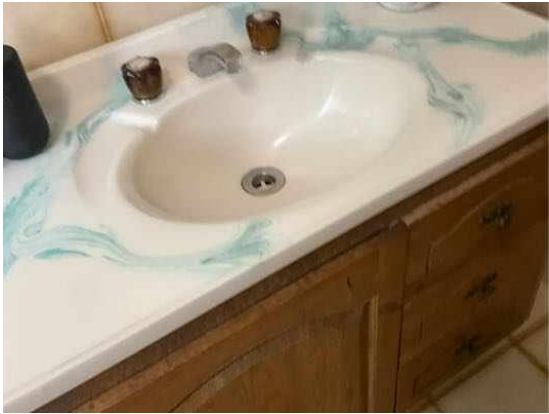
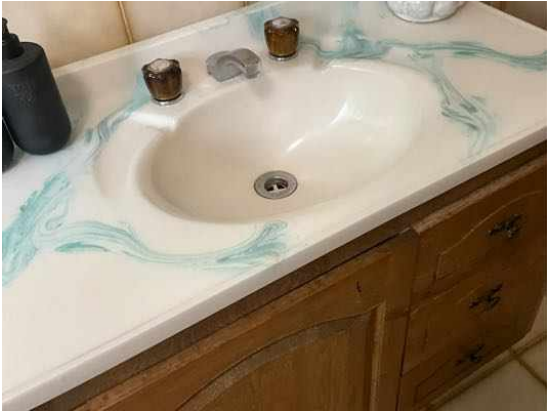
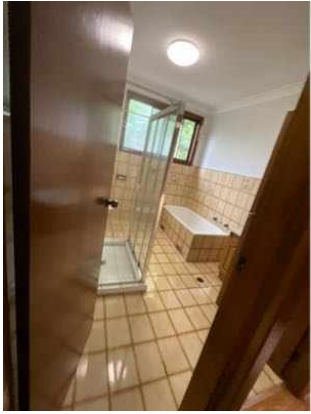
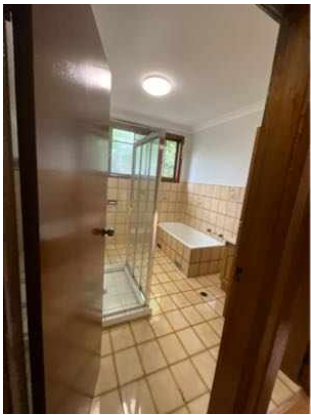
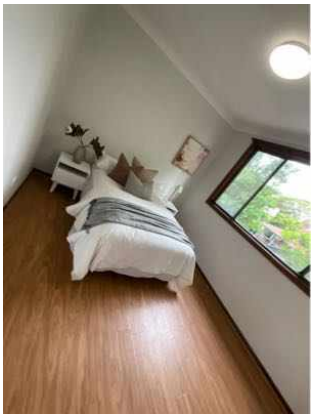
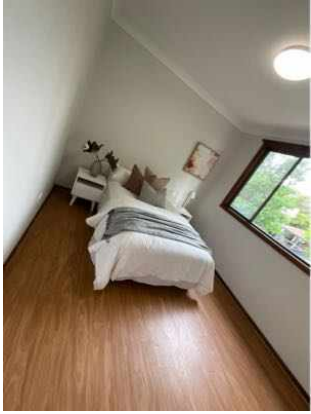
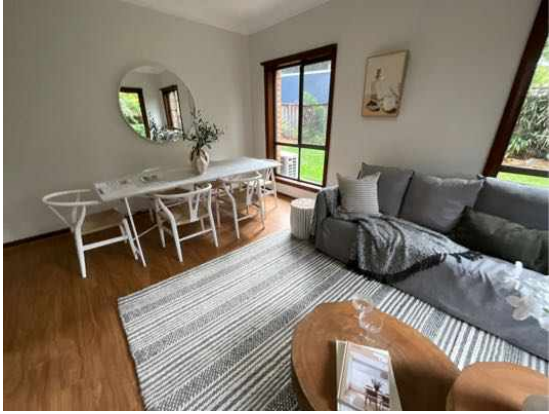
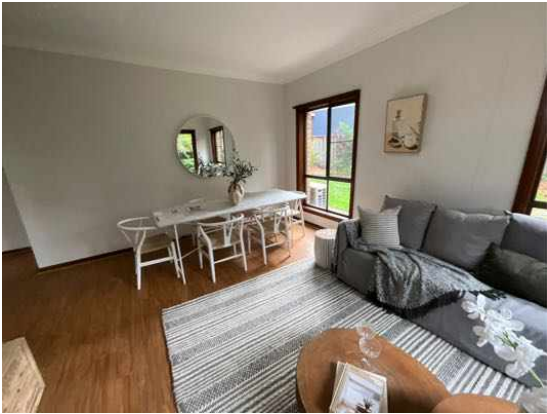
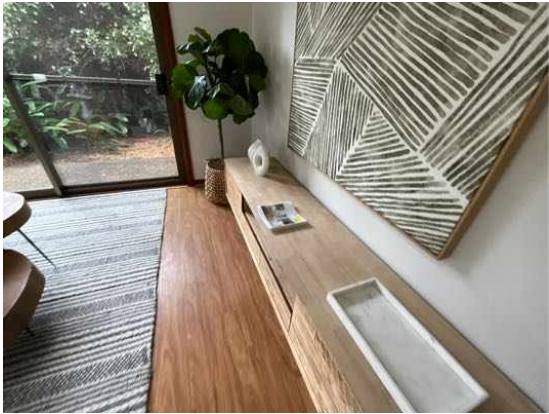
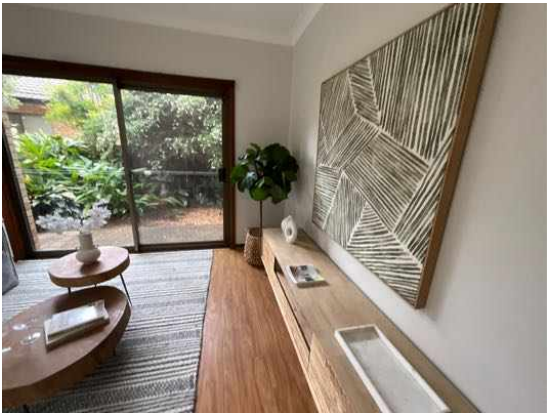
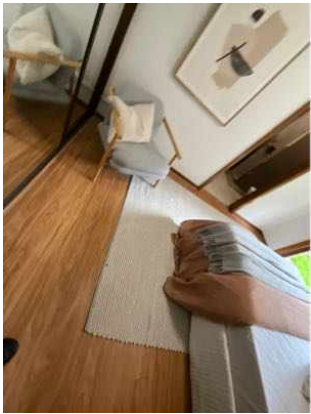
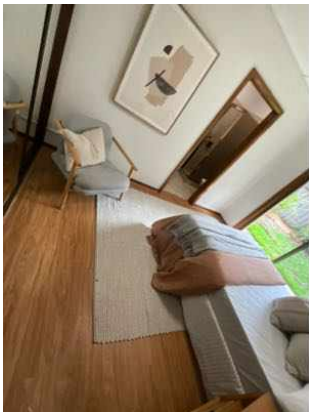
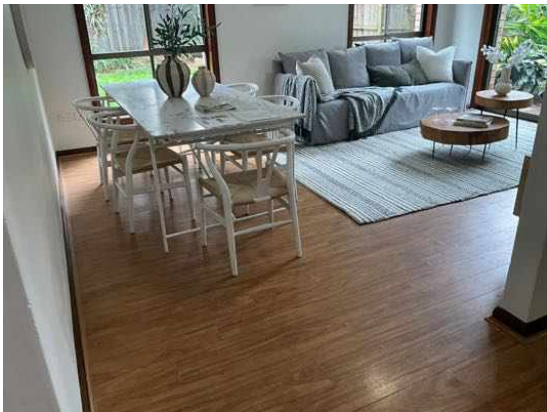
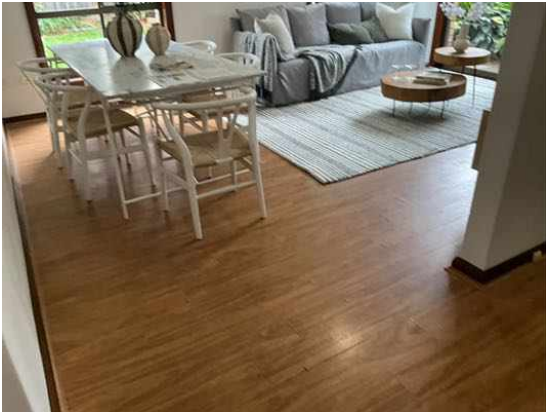
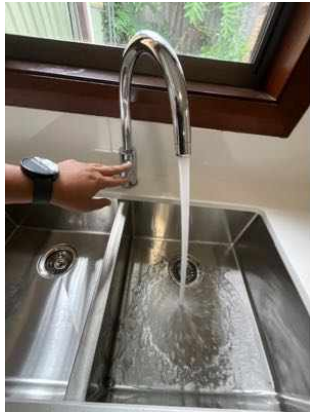
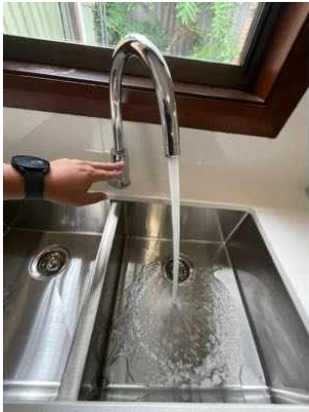
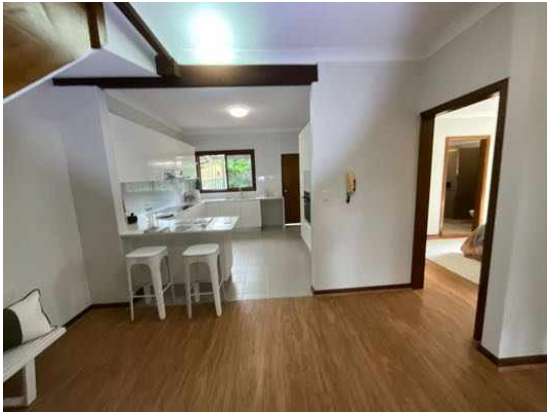
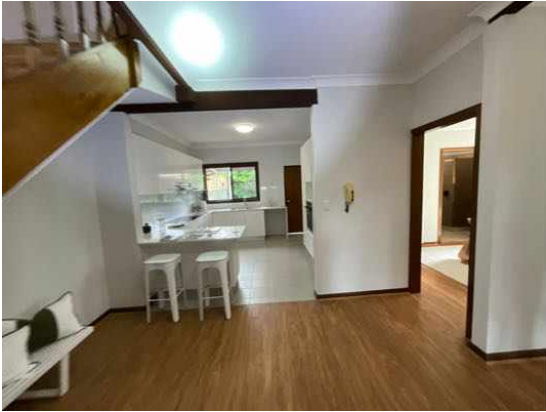
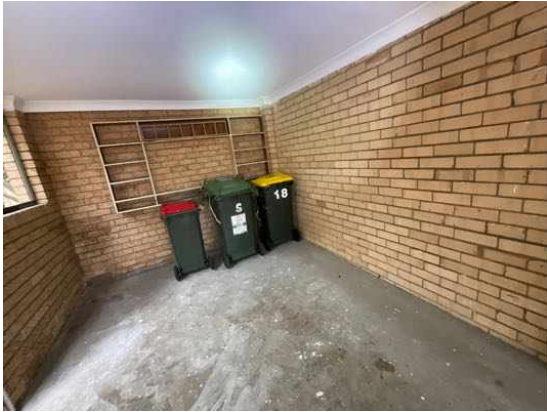
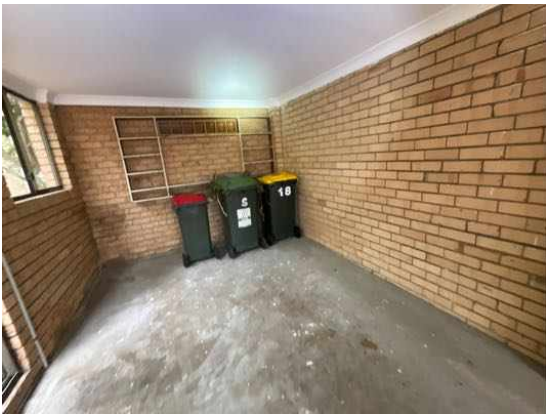
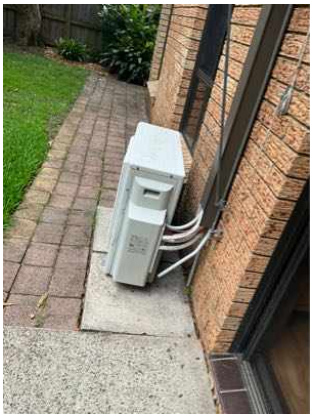
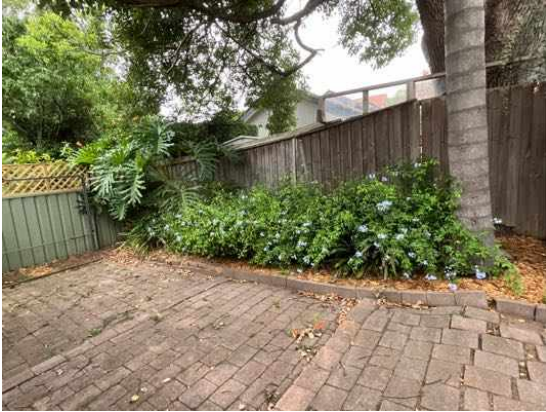
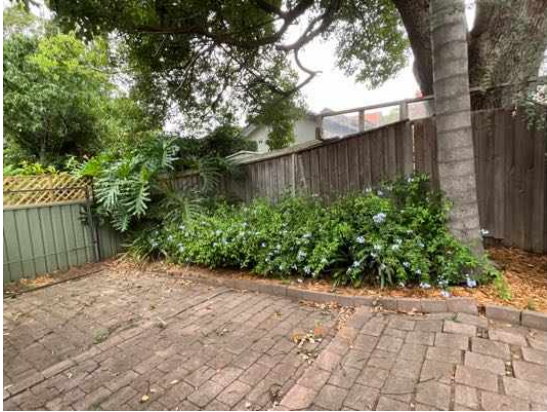
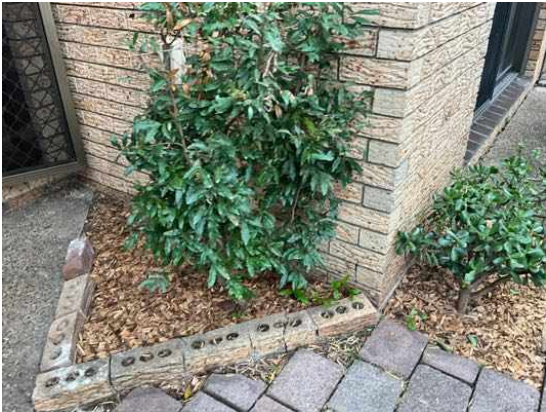
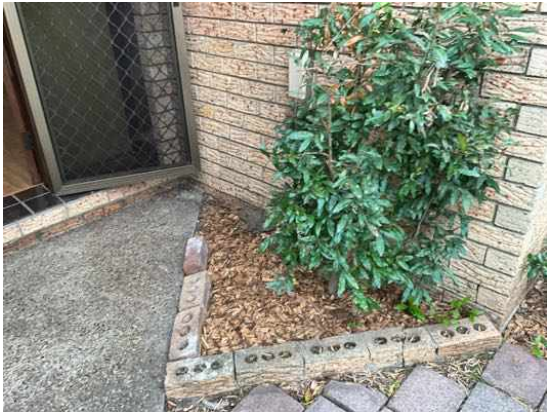
Building: Main Building  
Location: All Areas  
Finding: Additional Photos - Obstructions and Limitations  
Information: These photographs are an indication of the obstructions and limitations which impeded full inspection of the property at the time of inspection. These obstructions can hide an array of defects and should be removed to allow full inspection to be carried out. A re-inspection is recommended once the areas are made accessible.

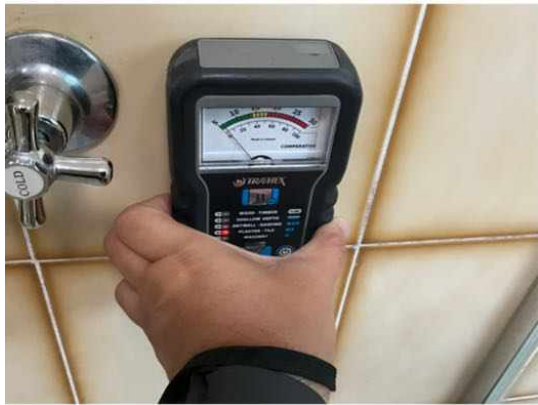
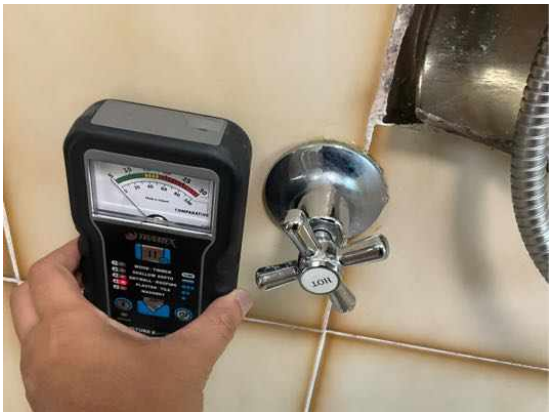
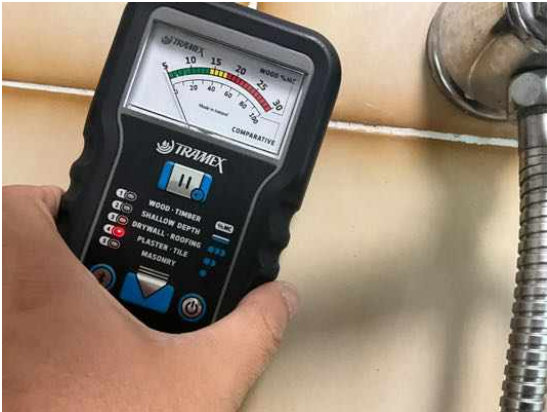
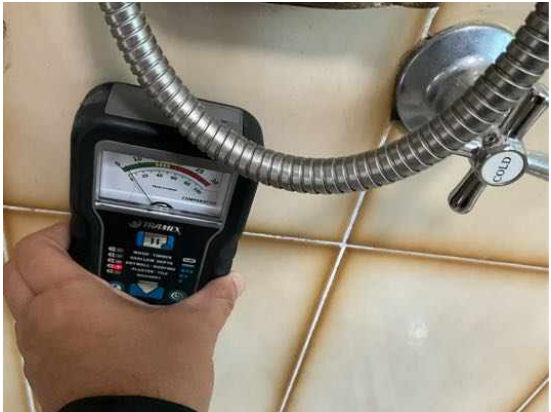
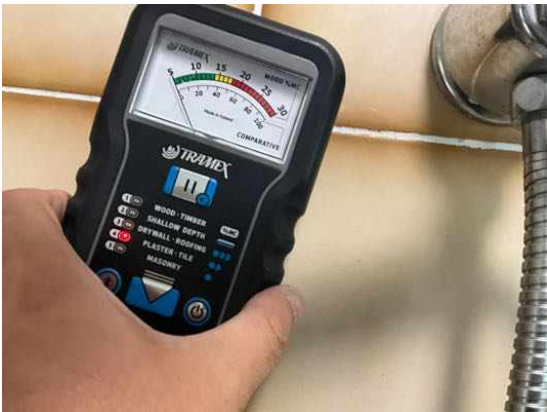
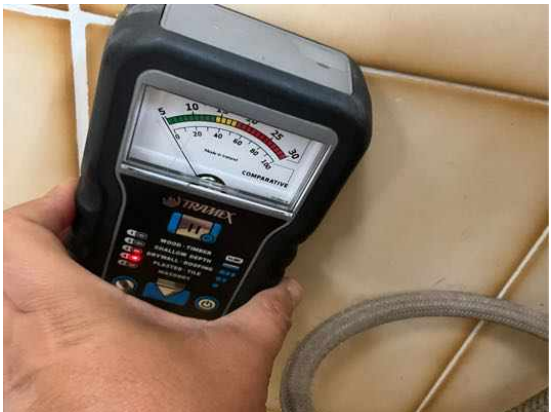
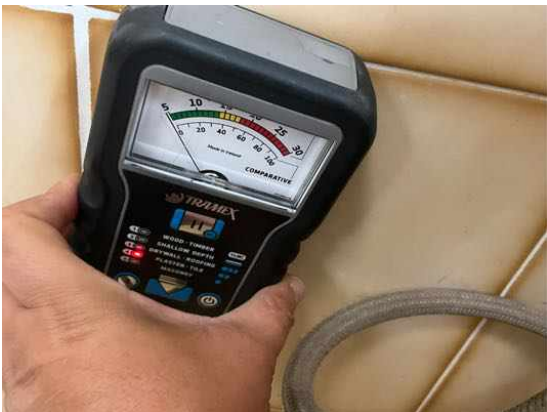
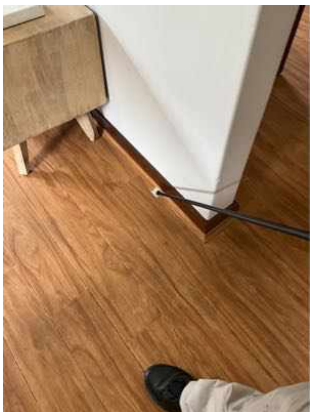
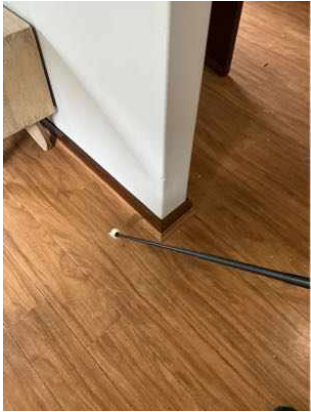
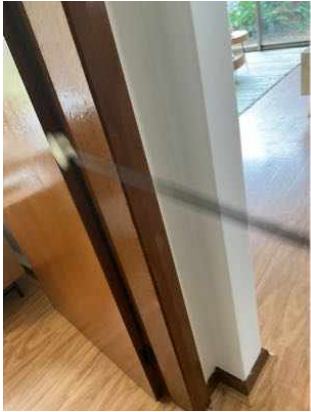
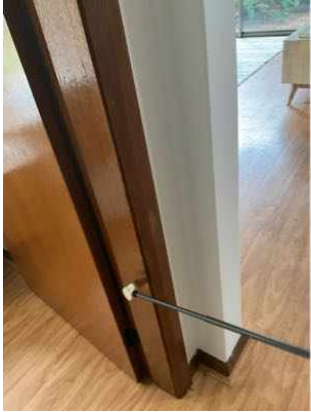
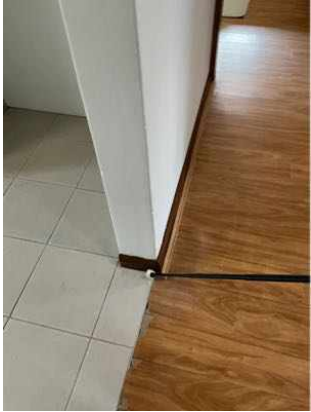
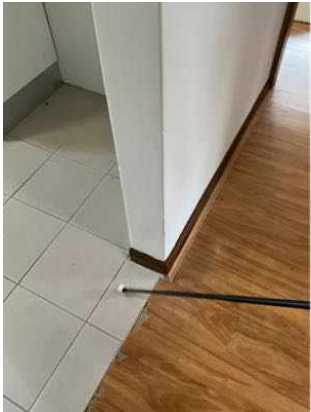
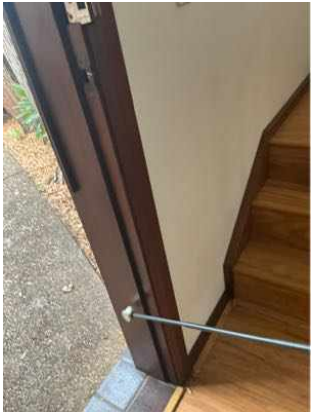
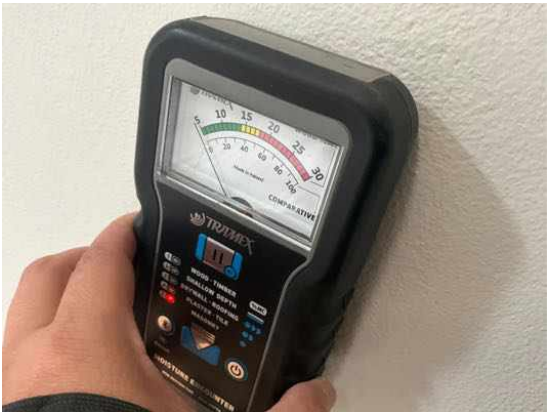
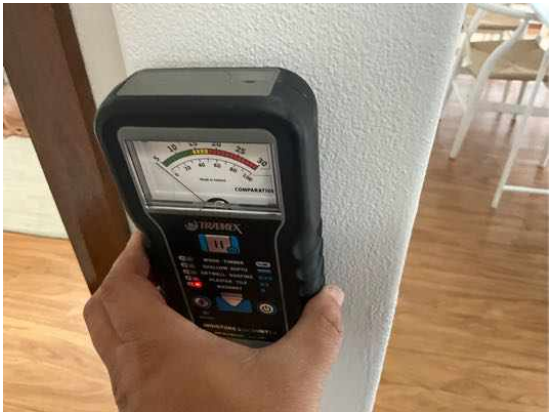
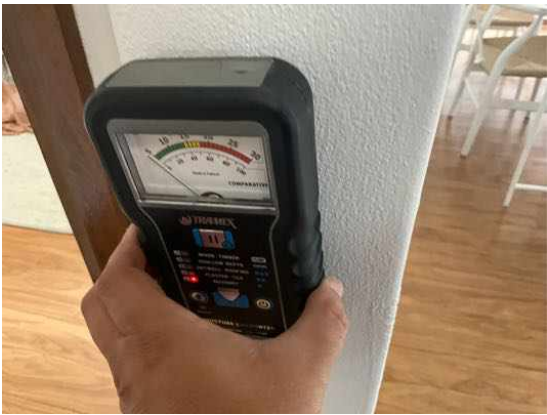
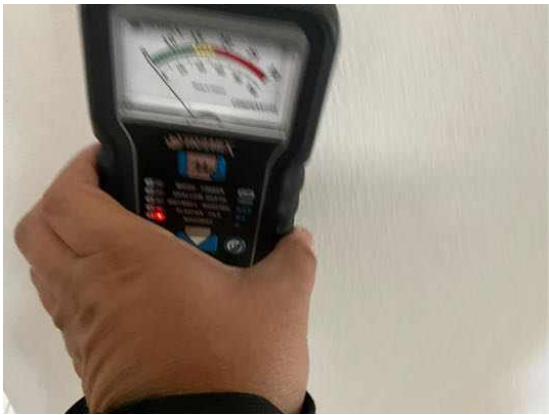
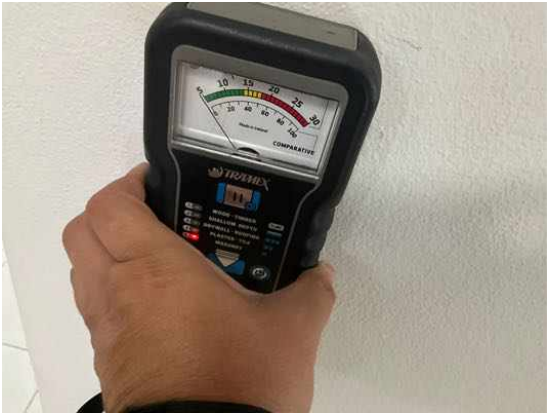
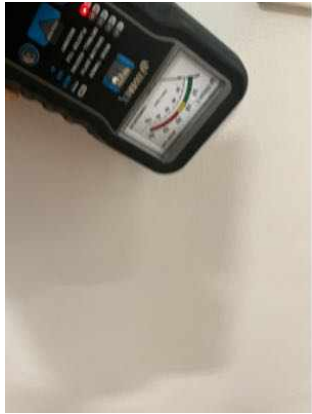
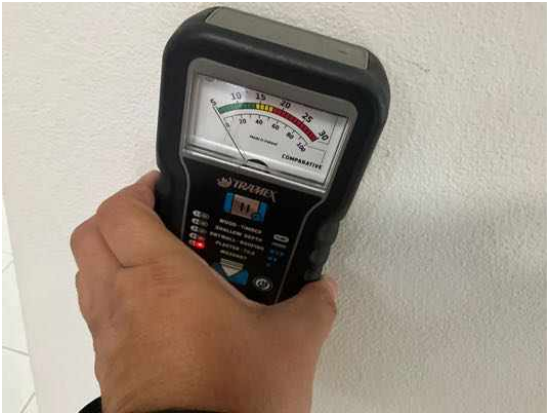
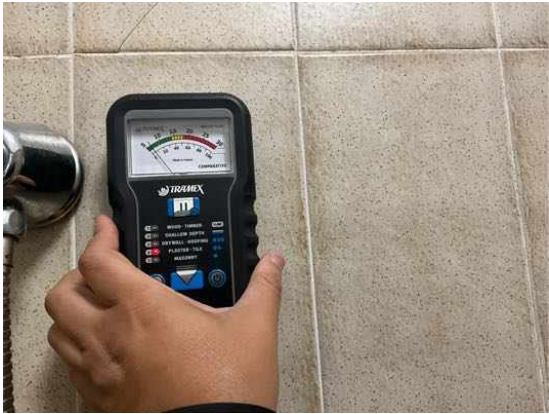
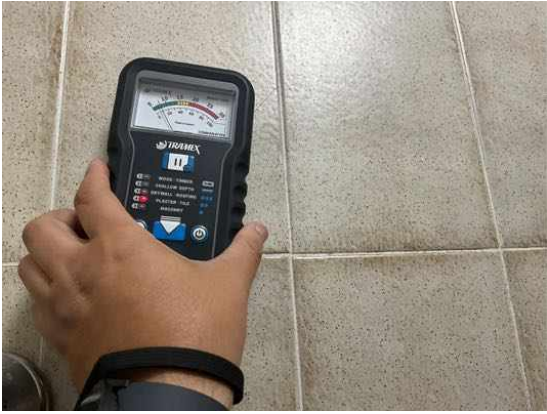
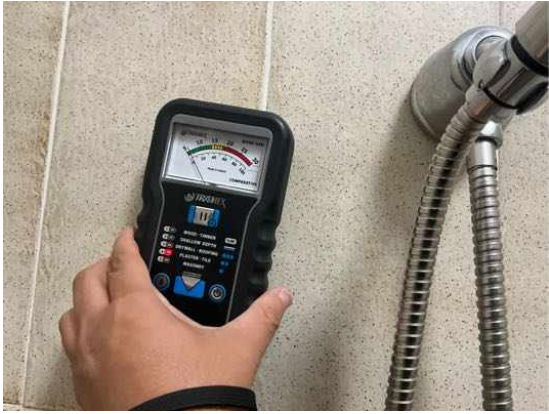
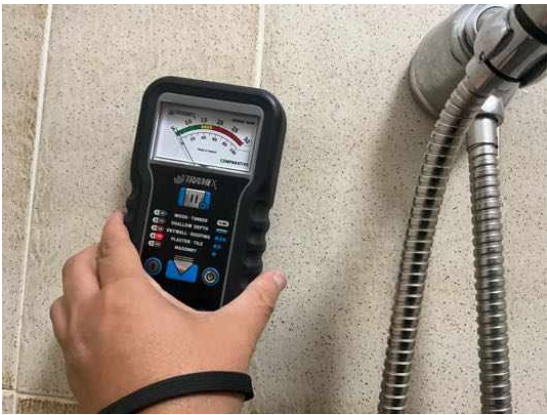
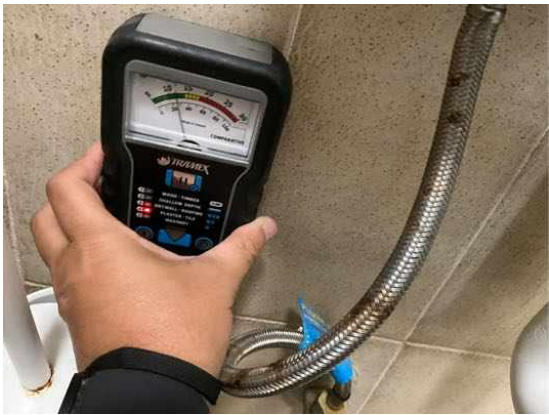
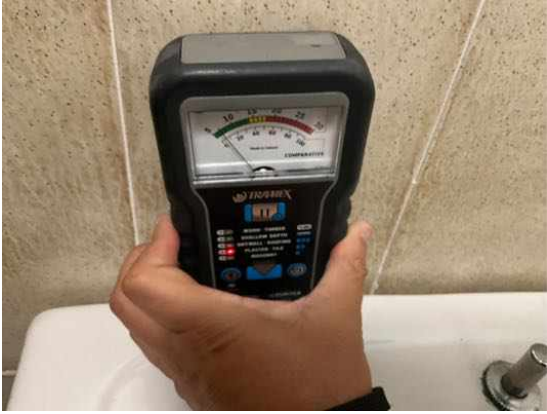
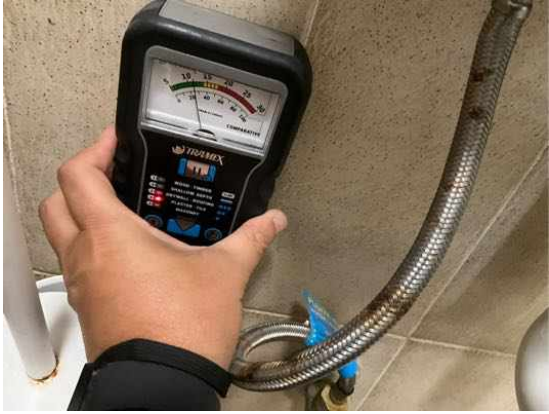
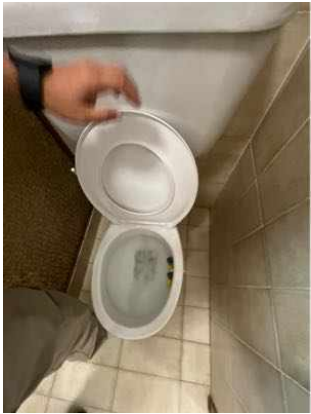
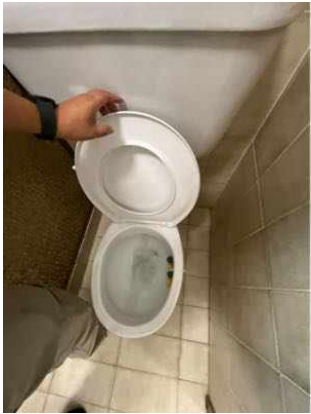
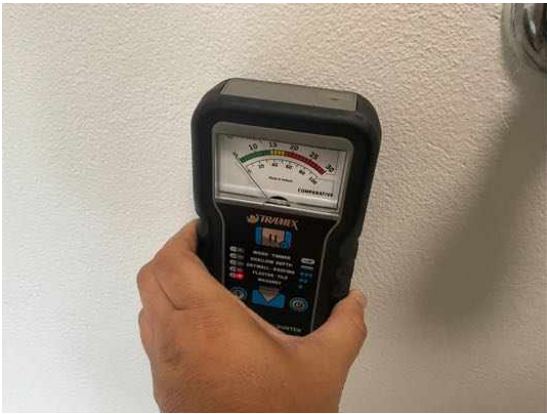
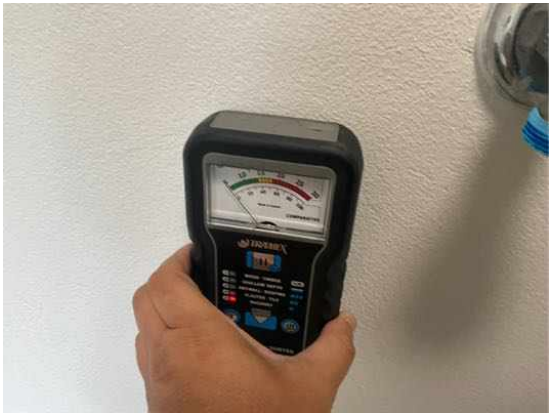
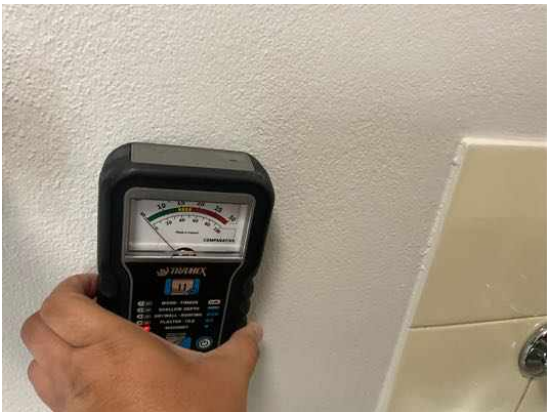
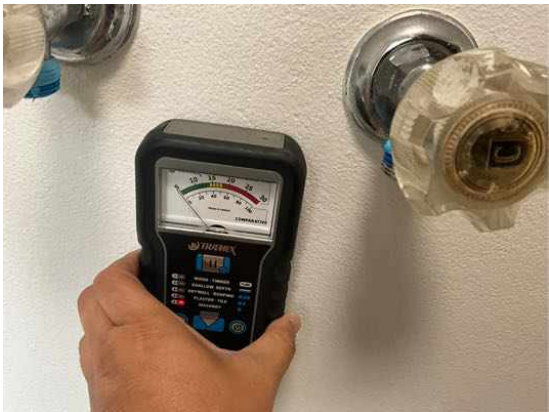
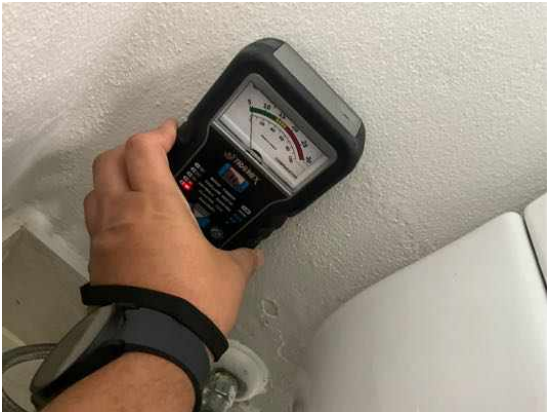
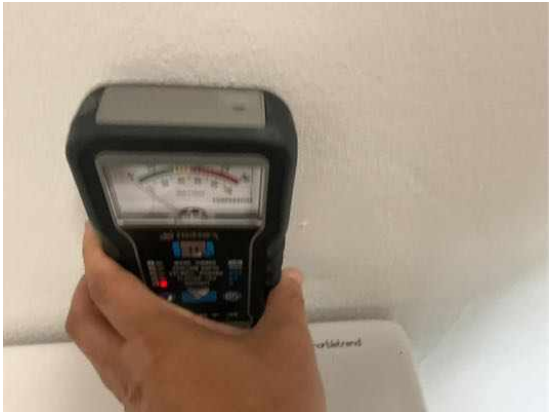
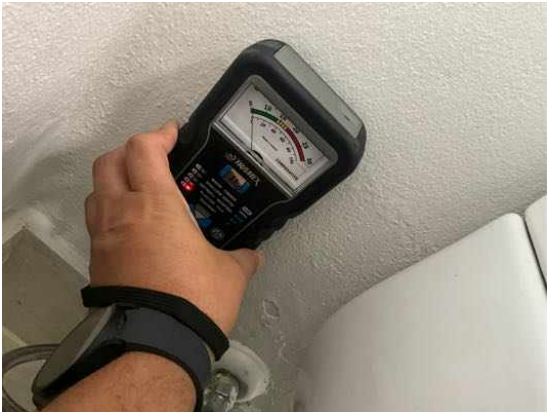
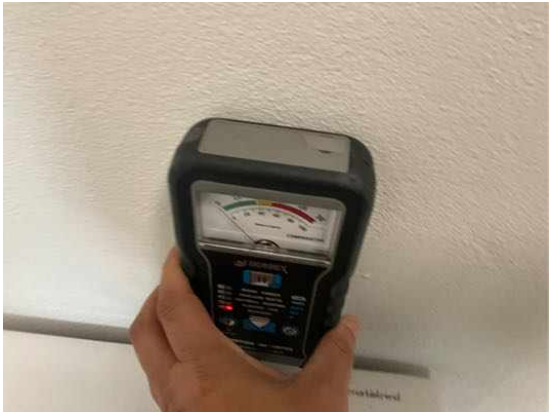
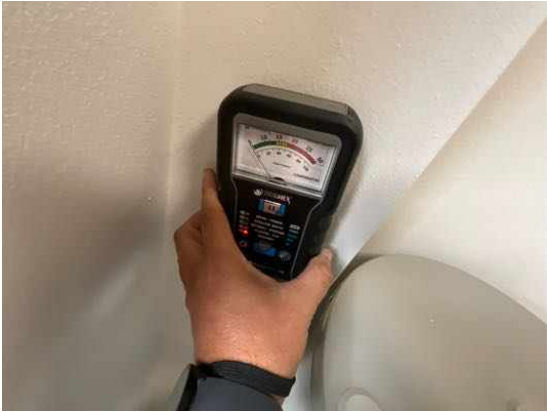
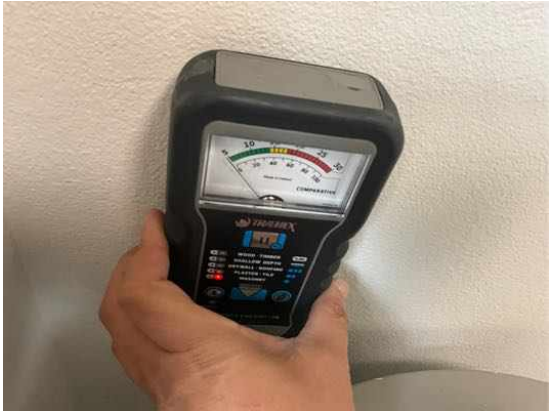
Building: Main Building  
Location: All Areas  
Finding: Additional Photos  
Information: Additional photos are provided for your general reference
