Building and Timber Pest Inspection Report

Inspection Date: Fri, 16 Jan 2026

Property Address: 2/105 Lowanna Dr, Buddina QLD 4575,
Australia

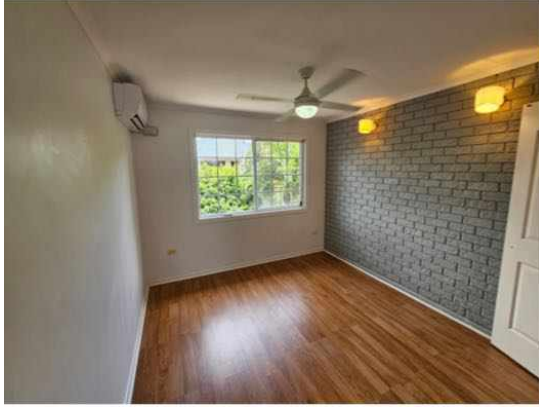
Windows to be protected Windows are defective if they do not comply with provision 3.9.2.6 of Volume 2 of the BCA that requires that a window opening must have protection if the floor below the window in a bedroom is 2m or more above the ground surface beneath.

Type of protection Windows requiring protection are defective if they are not fitted with a device to restrict the window opening or a screen, with secure fittings. The device or screen, where required, is defective if it permits a 125mm sphere to pass through the window or screen or is unable to resist an outward horizontal action of 250 N.

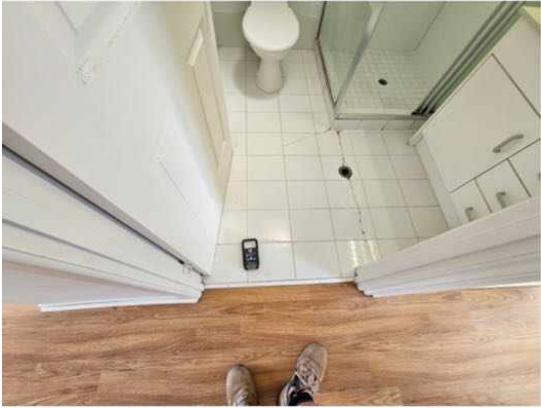
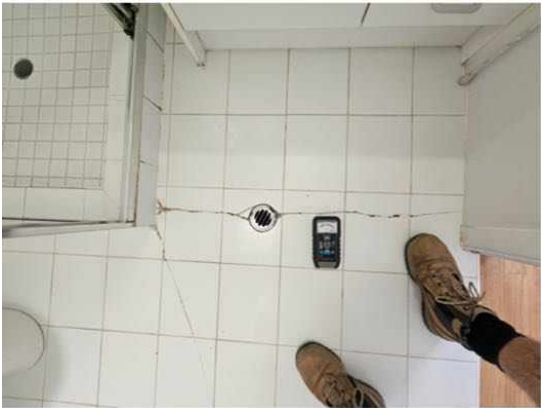
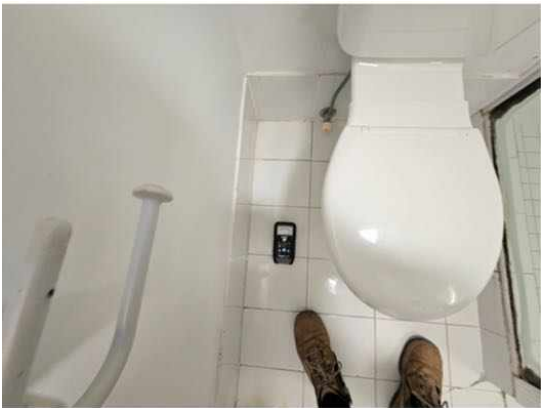
Finding 2.01

Finding: Elevated moisture in ensuite - floor

Information: Elevated moisture was noted in the tiled floor of the ensuite and is reflected in the ceiling of the garage directly below the toilet. The moisture levels were elevated throughout the floor. This could possibly be due to excess water from showering and regular bathing activities within the room entering via the large cracking in the floor.

The moisture reflected below may be entering via the plumbing services penetrating the floor, or through a failure in the floor / shower membrane, or from the plumbing service housed in the floor cavity. A definitive cause will most probably only be found through testing of the plumbing service and / or by conducting an invasive inspection of the floor cavity from the garage ceiling below.

Elevated moisture can attract timber pests and vermin, and produce conditions that promote timber pest attack, fungal growth and wood decay.

It is recommended that this be investigated further. Flood testing the shower may provide more insight; however, invasive inspections may be required via the ground floor ceiling. Engaging a leak testing specialist may also be prudent.

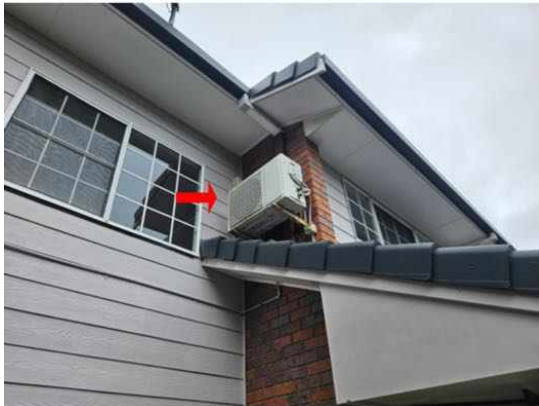
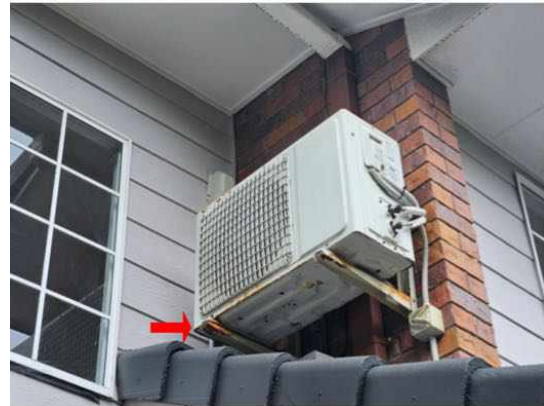
Finding 3.02

Building:	Main Building
Location:	As shown
Finding:	Air conditioner mounts rusting
Information:	On the day of inspection it was noted that the mounting brackets of the air conditioner outdoor unit on the roof surface are rusting and may require treatment or replacement. Consulting with an air conditioning contractor would be of benefit.

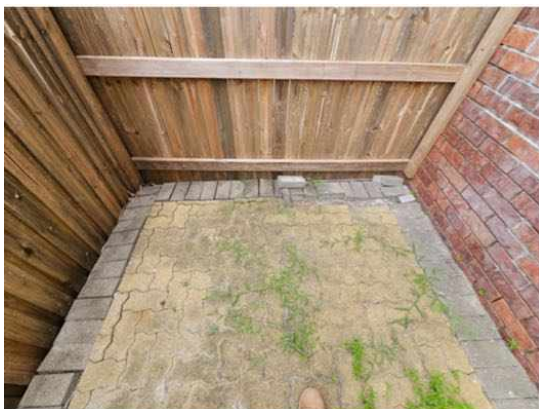
Finding 3.03

Building:	Yard
Location:	Rear
Finding:	Paving - Uneven
Information:	The external paved area is uneven, creating a potential trip hazard. It appears as though the area has been subject to poor installation, or that paving sections have lifted due to movements in the foundation of the property.

Where paving creates a trip hazard, personal injury may ensue if due caution is not taken by all persons within this area. Further consultation with a paving contractor or concreter is advised.

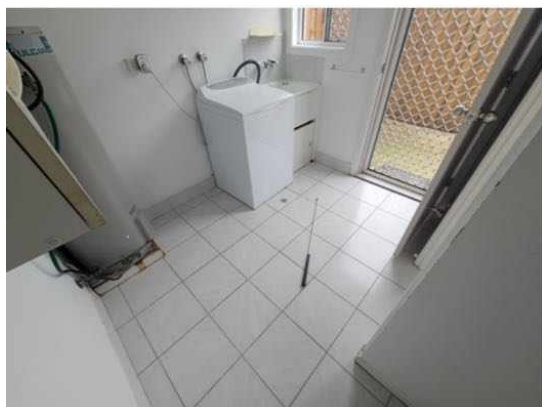
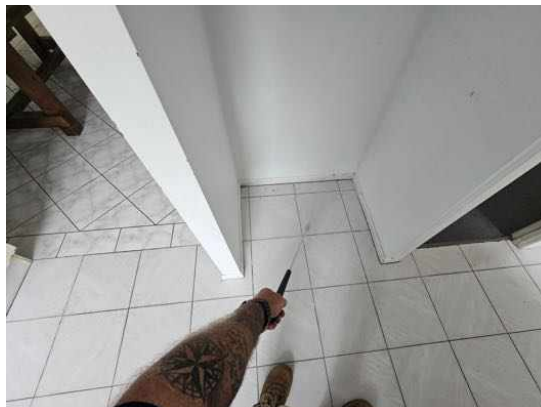
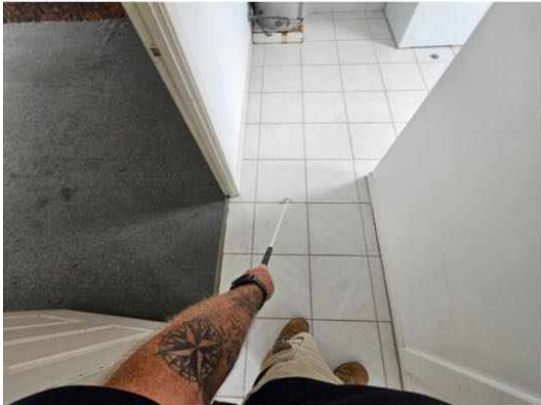
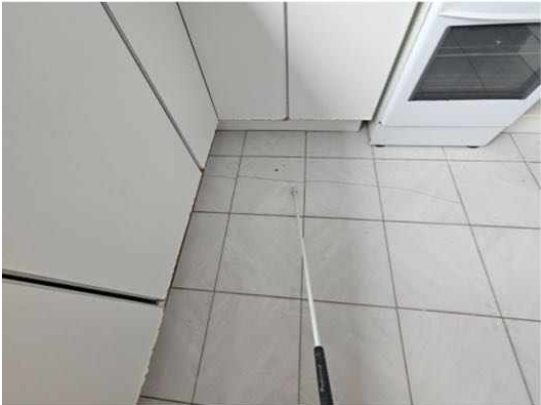
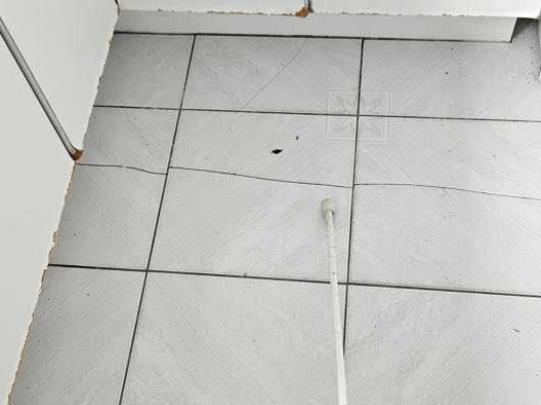
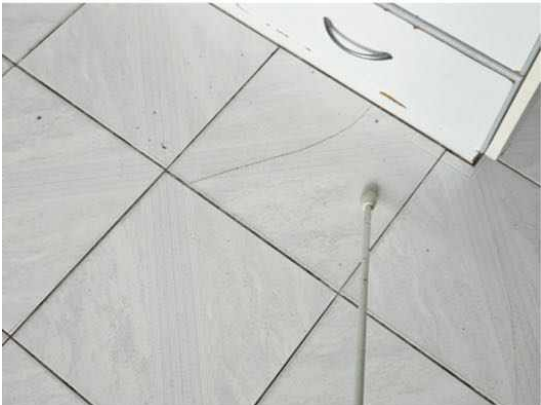
Finding 3.04

Building:	Main Building
Location:	As shown
Finding:	Tiles - Drummy and / or cracked
Information:	Drummy and / or cracked tiled areas were identified at the time of inspection.

The term 'drummy' refers to tiles that have become detached from their fixing, despite otherwise being in relatively good condition. Such defects are generally caused by physical or moisture damage to the area. Drummy tiled areas may also be a direct result of poor workmanship during the construction process.

Tiled areas may swell and shrink with changes in air humidity if the area has sustained moisture damage. Any exposure to moisture is capable of causing tiled areas to become drummy and/or cracked over a prolonged period of time. Drummy tiled areas generally require removal and replacement of affected tiles.

Specialist trades are available for these types of services. A licensed builder may be required to undertake works if damage is extensive or if secondary building defects have resulted. Otherwise, it is advised that a tiling contractor be appointed to perform works as necessary.

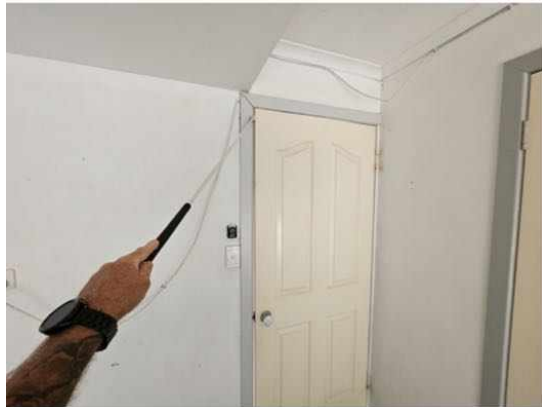
Finding 3.05

Building: Main Building
 Location: As shown
 Finding: Doors - Binding/Jamming
 Information: The doors to the rooms shown are binding / jamming in the openings.

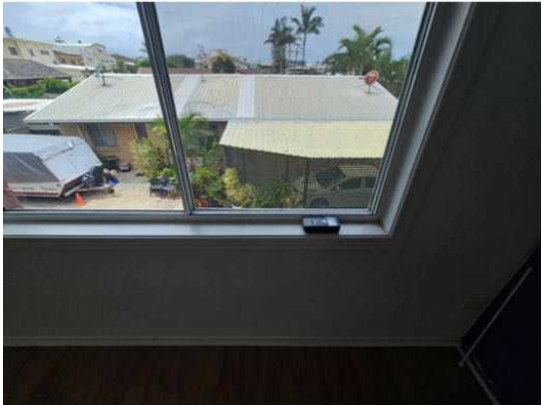
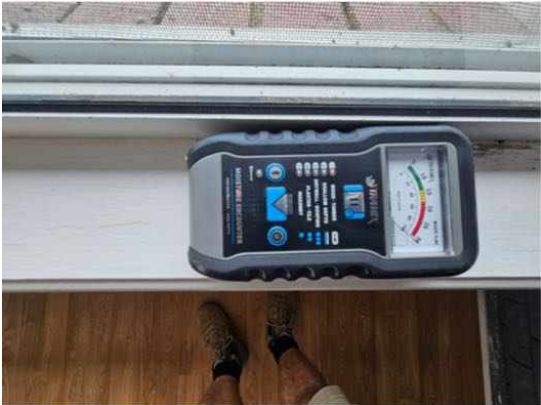
Finding 3.06

Building: Main Building
 Location: As shown
 Finding: Timber window sill / reveal moisture
 Information: During the inspection elevated moisture readings were noted in the timber reveals of the windows shown. This may indicate that minor moisture may be entering through

the joint between the bottom aluminium profile and the brick sill or the lower side of the window opening. There does not appear to be any damage or physical moisture effects present.

This should be monitored and if there is a change in the reveal appearance, a licensed painter should be engaged to carry out the necessary repairs.

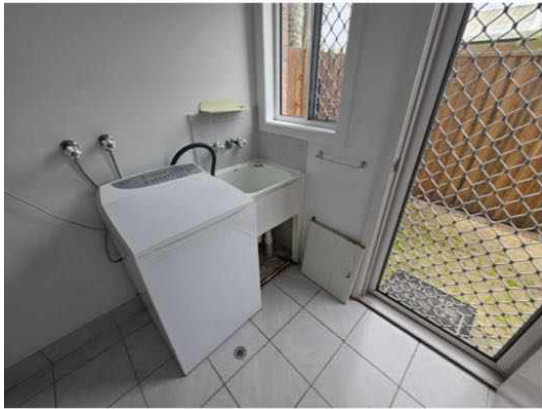
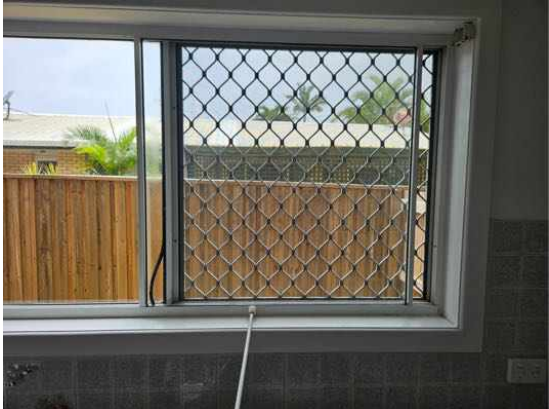
Finding 3.07

Building: Main Building
Location: All Internal Areas
Finding: Windows - operation
Information: During the inspection the windows are checked for functionality. Most of the aluminium windows are either stiff to slide, unable to be opened easily or jammed shut. Most do not have functioning latches.

A suitably qualified trade person should be engaged to service the windows.

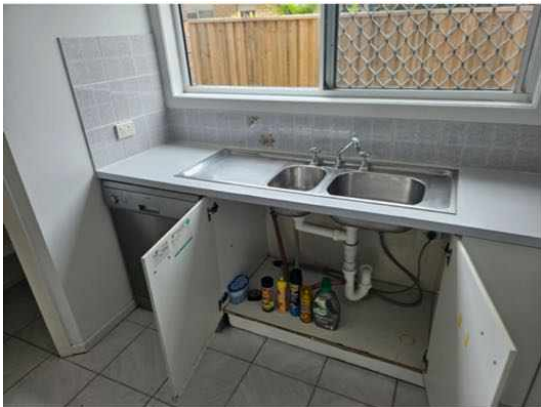
Finding 3.08

Building:	Main Building
Location:	Kitchen
Finding:	Moisture damage to cabinets - kitchen
Information:	During the inspection moisture damage was observed in the cabinet floor and cabinet surface edges in the kitchen. It is a consistent defect that is possible due to water spilling over the edge of benches and can also be an effect of poor materials used in construction and high humidity.

It would be of advantage to have the cabinetry assessed by a licensed cabinet maker.

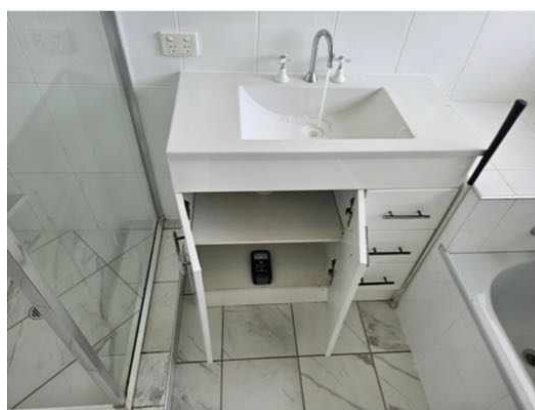
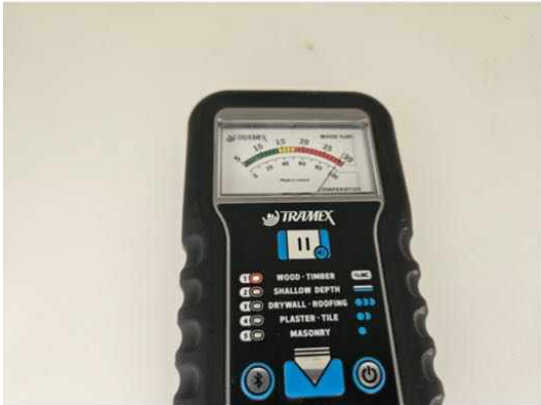
Finding 3.09

Building:	Main Building
Location:	Bathroom
Finding:	Evidence of elevated moisture - bathroom and ensuite vanity
Information:	Evidence of elevated moisture was detected during the inspection in the shelf and floor if the vanity cupboard of the bathroom and ensuite.

Excessive moisture can attract timber pests and produce conditions that promote timber pest attack, fungal growth and wood decay.

Excessive moisture in this areas is generally caused by deteriorated, inadequate or missing waterproofing membrane to the adjacent wet area, or leaking plumbing pipes, or penetration through external walls.

It is highly recommended that all plumbing and drainage fixtures and fittings be maintained regularly in order to prevent excessive moisture being present in the internal areas of the property.

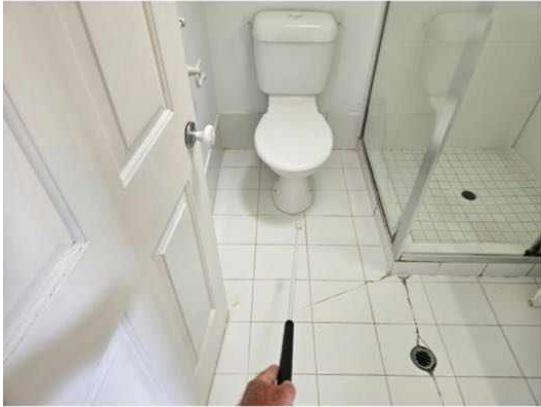
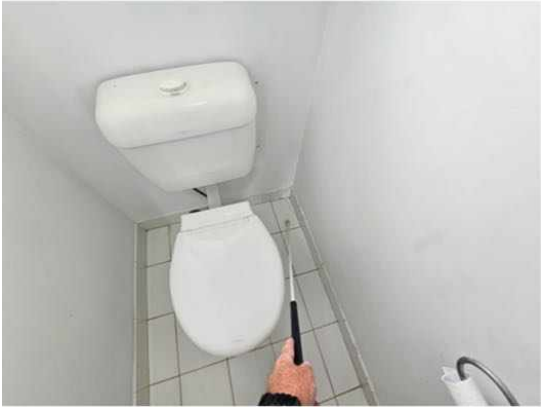
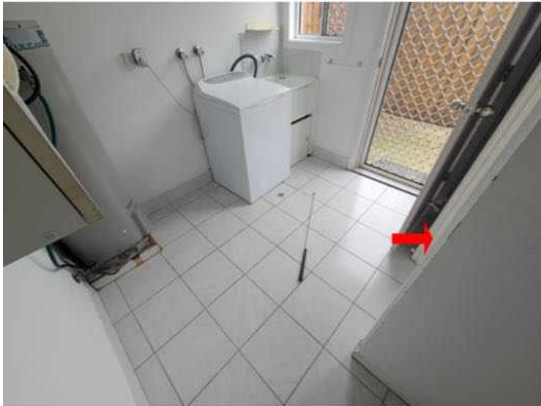
Finding 3.10

Building: Main Building
Location: Toilet (WC), all
Finding: Toilet Pan - all pans
Information: During the inspection it was noted that the pan seals at the rear of all toilet are worn. The pan seal is a rubber component that provides an air tight seal between the toilet pan and the floor pipe.

In the short term it may be prudent to consult with a licensed plumber for a repair solution.

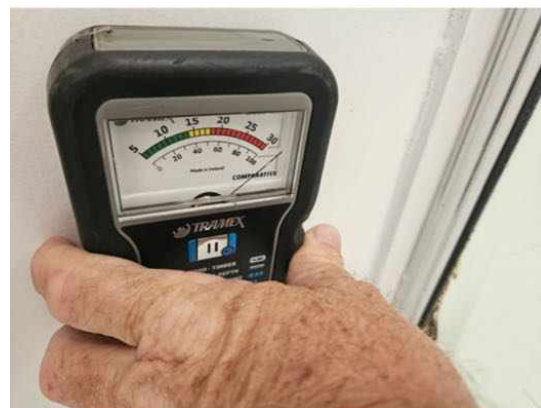
Finding 6.03

Building:	Main Building
Location:	Ensuite - Master
Finding:	Elevated moisture present at the time of inspection - ensuite
Information:	Elevated moisture was noted in the wall surface beside the shower screen of the ensuite shower.

This could possibly be due to deteriorated grout and silicone sealants. These can break down over time and become porous, allowing moisture to enter the wall sheet surface behind the tiles. It is difficult to assess this shower due to the laminated panels affixed to the original tiled wall. The sheets are loose the surface does not provide an adequate substrate to gain a definitive reading.

Elevated moisture can attract timber pests and vermin, and produce conditions that promote timber pest attack, fungal growth and wood decay.

It is recommended that the laminate sheet be re-fixed into position or removed and the shower surface remediated.

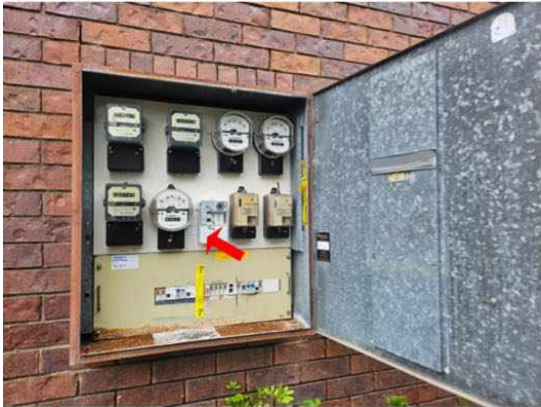
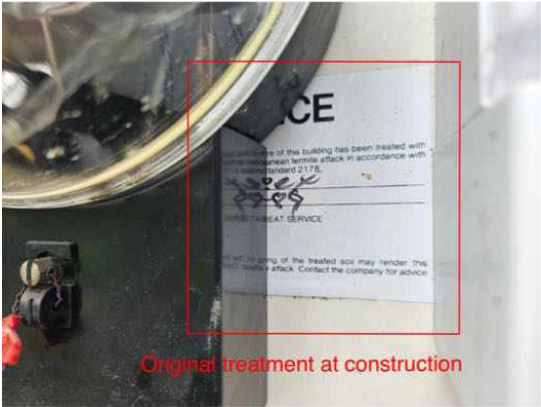
Noted Item

Where a Termite Management System has been identified you should refer to the type of barrier date of installation warranty conditions and any documentation provided by a builder or past owner. Consult the company who installed the barrier to confirm whether the system is still under warranty.

It is recommended that a licensed pest controller be consulted and a system proposal sought.
