# Building and Timber Pest Inspection Report

Inspection Date: Thu, 29 Jan 2026

Property Address: 85 Iola Ave, Farmborough Heights NSW  
2526, Australia

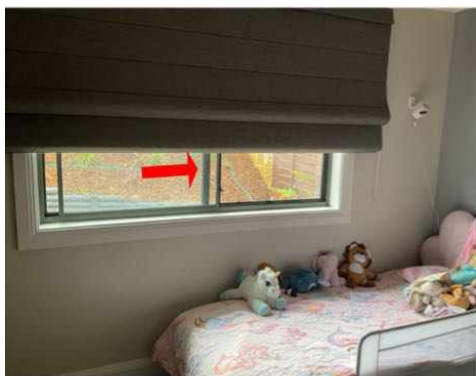
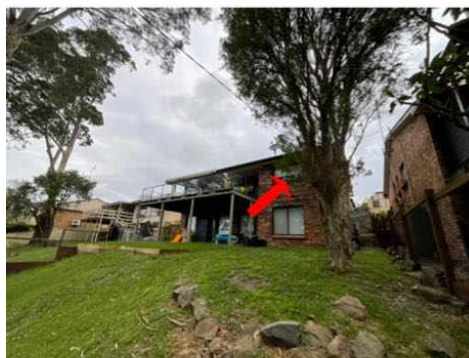
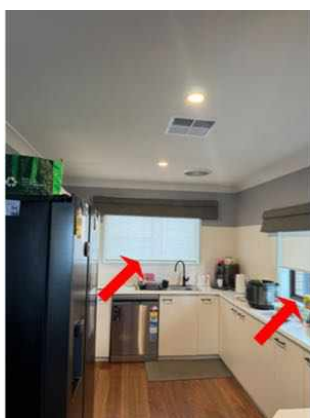
| Finding: | Window opening restrictors missing. |

Window restrictors are required where people who are vulnerable to the risk of falling have access to windows. This means all windows above ground level which do not have another fall prevention safety measure in place, such as a balcony or balustrade should have a restrictor.

These need to be added urgently for the safety of all persons.

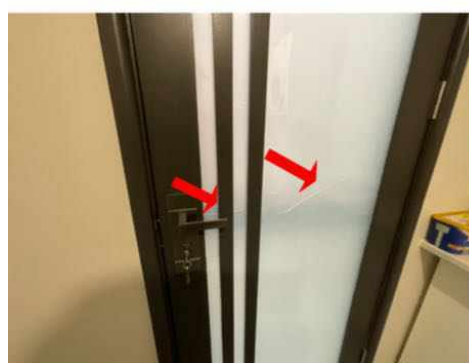
#### Finding 1.02

| Finding: | Door and balcony glass - Cracked |
| Information: | Cracks were identified in the laundry door glass and verandah railing glass window. Cracks in glass is generally the result of impact damage, and is likely to develop further when left unmanaged. |

The likelihood of this glass further cracking and shattering is increased exponentially, providing a safety hazard in the area. The cracked glass also impairs the weather tightness of the laundry, creating potential for minor water leaks.

A qualified glazier is required to repair these areas as soon as possible. Depending on the extent of the cracking, replacement may be required. Please be advised that any persons coming into contact with the cracked glass should do so with due caution to avoid any personal injury that may ensue.

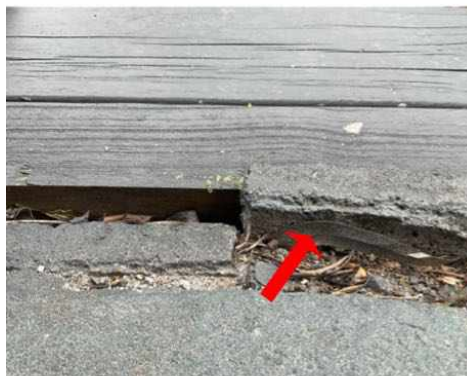
### Finding 1.03

| Finding: | Trip safety hazard |
| Information: | A raised section of concrete has created a trip hazard on the pedestrian footpath. The uneven surface poses a risk to pedestrians, particularly the elderly, children, and |

individuals with mobility impairments. This requires urgent repair by a concreting contractor.

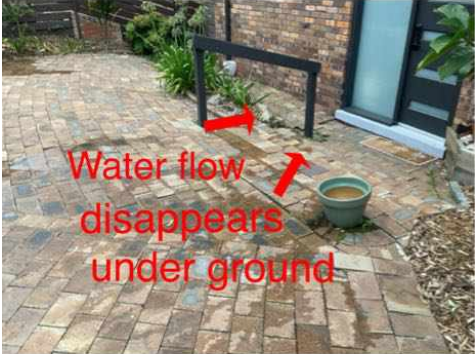
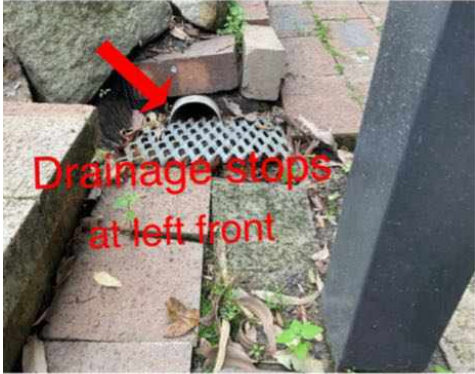
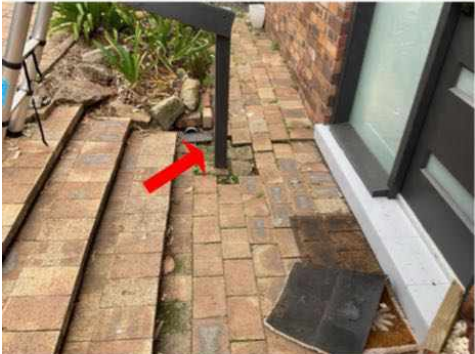
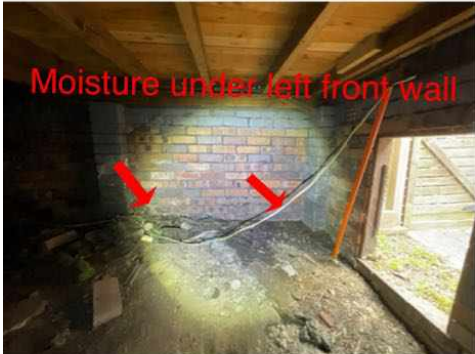
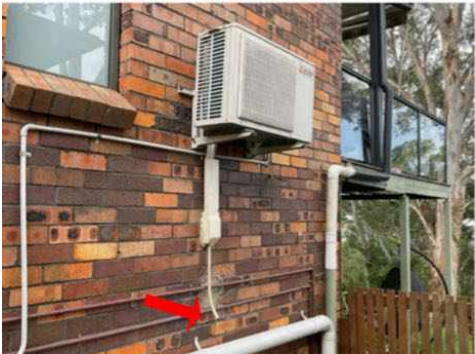
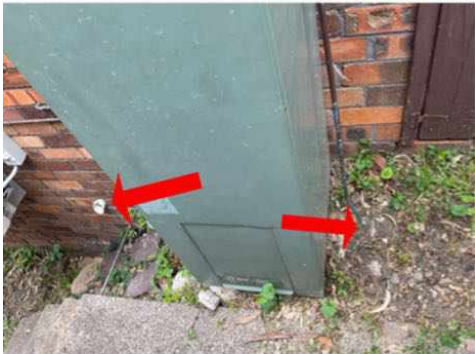
### Finding 2.01

| Finding: | Site drainage - Inadequate |
| Information: | The site drainage in this front middle area was found to be inadequate at the time of inspection, creating potential for subsequent water damage to associated building elements. While Ag drains have been installed on the right front wall. A drain finishes in the middle and appears to go underground. Damp conditions were found in the left front subfloor. The air conditioner and hot water system overflows also discharge water against the left side house walls. |

It is important that water does not lie against the base of walls; surrounding paths and ground levels should be sloped to drain water away from walls. Downpipes should not discharge stormwater onto lower walls or plinths. Stormwater should be carried away by large, regularly cleaned drains. Ground levels may need to be lowered to expose a buried DPC.

Where site drainage is inadequate, installation of an Agricultural (Aggie) Drain may be required. A qualified plumber should be appointed to further inspect the property and perform any remedial works as necessary. Secondary defects are likely to occur if left unmanaged.

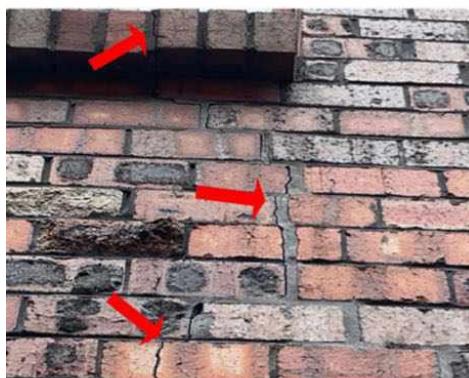
**Finding 2.02**

| Finding: | Step cracking to brickwork major |
| Information: | Step cracking was identified to the brickwork in the left and rear external wall areas at the time of inspection. The rear wall showed 7mm of cracking (pictured 1-3) which is a |

major defect. The NSW Standards and Tolerances 2017 states cracks over 5mm in width are a major defect requiring rectification work.

The following photos show minor cracking which should be monitored annually. Note- some areas have been repaired and have cracked again.

Step cracking, which is similar to other forms of cracking, has a variety of possible causes. However, the most common is the subsidence of adjacent footings.

Where step cracking is extensive or severe in the rear wall, the client is advised to consult a structural engineer. Minor step cracking can be used as a warning sign to address factors causing stress to the wall, which can include the effect of surrounding trees, water leaks, soil erosion, or even the presence of reactive soils in the surrounding area.

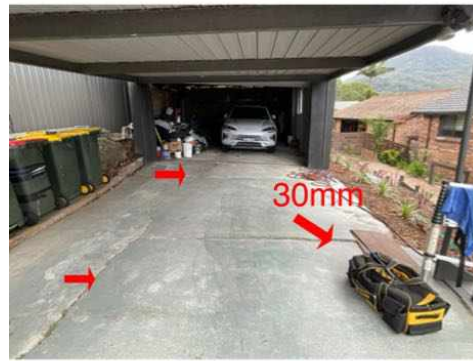
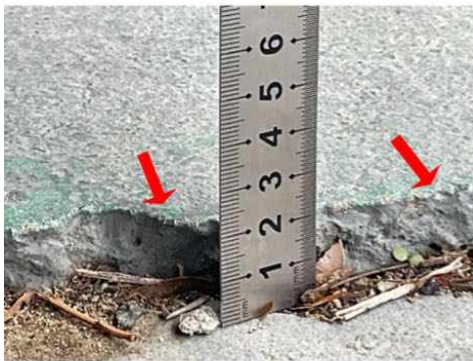
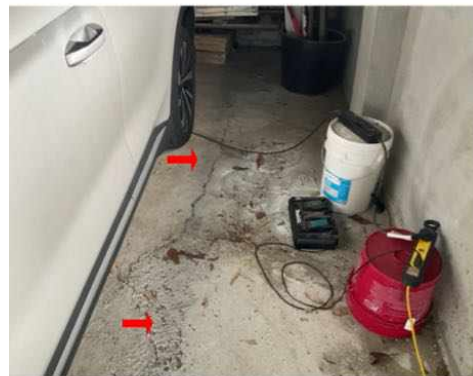
### Finding 2.03

| Finding: | Crack in concrete slab - Category 4 |
| Information: | Cracks coded as Category 4 was identified in the driveway slab of up to 30mm. A Category 4 crack is described as a crack that appears as a gap in the slab, with disturbing curvature or change in level affecting the slab. |

The approximate width of these cracks or gap is over 4mm or a change in offset of greater than 25mm when a 3m straight edge is placed over the defect.

Category 4 cracking to slabs exceeds allowable Standards and Tolerances, and are therefore considered as major defects that require rectification.

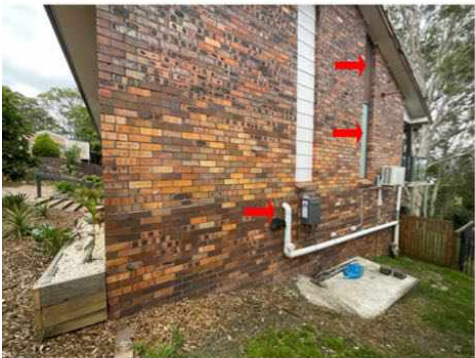
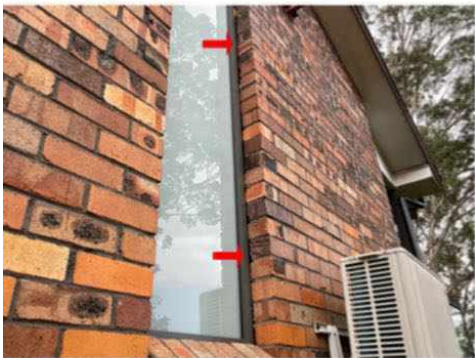
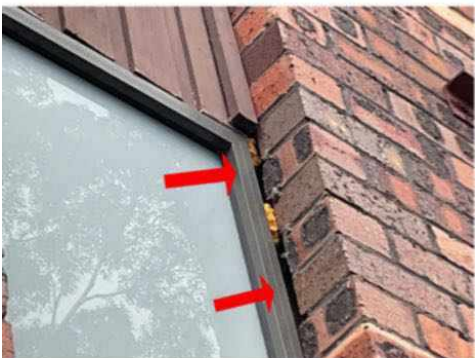
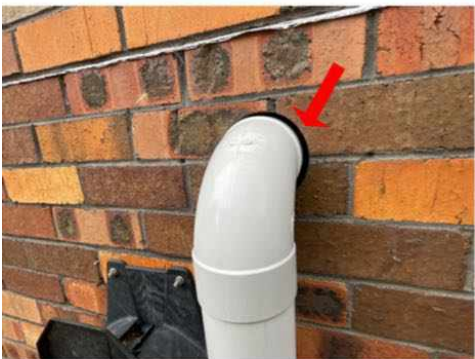
### Finding 2.04

| Finding: | Sealant (external) - Missing. |
| Information: | It was noted on inspection that many areas of external sealant was missing the external walls. Large gaps in the cladding were also evident. |

Flexible sealants should be applied to these affected areas to prevent any subsequent water damage that is likely to occur.

A sealant specialist or carpenter should be appointed to complete these works as soon as possible

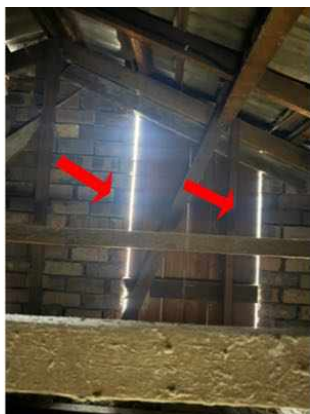
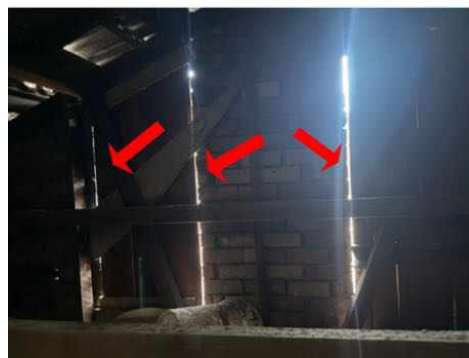
Finding 2.05

Building: Building 1  
 Location: Pictured Areas  
 Finding: Sealant (external) - Missing to left and right walls  
 Information:

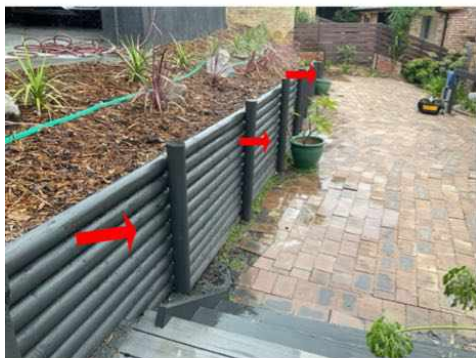
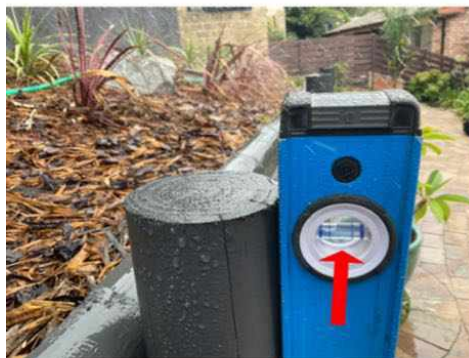
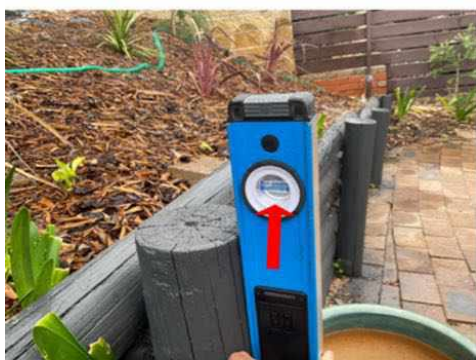
### Finding 2.06

Building: Building 1  
 Location: Yard - Front  
 Finding: Retaining wall - Defective  
 Information: The retaining wall in this front area was found to be defective at the time of inspection. Generally, defective retaining walls are caused by poor original design or material use. However, deteriorated retaining walls may also be a result of substandard construction, poor site drainage or unmanaged stormwater flows.

If left unmanaged, the retaining wall may become a safety hazard if it continues to destabilise. Where retaining walls further rot and decay, an environment is created that is conducive to termite and pest infestation.

Significant repair and replacement should be expected. Where retaining walls are considered structural walls, a structural engineer / surveyor should be consulted regarding required remedial works. Otherwise, a landscaper or retaining wall installer may be appointed to repair or replace the wall, at the discretion of the client.

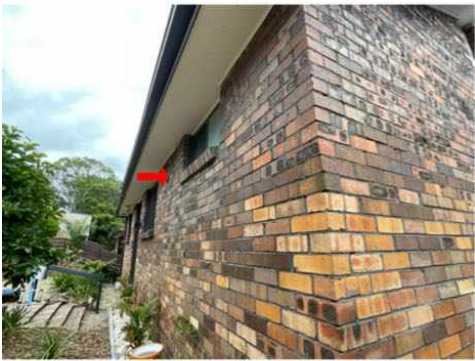
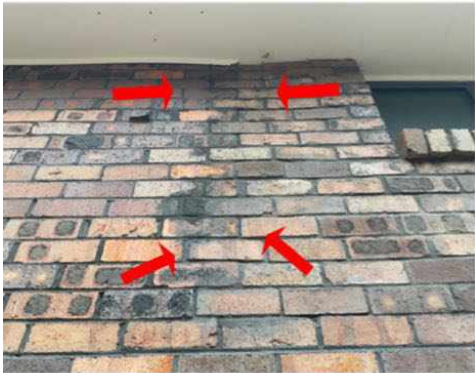
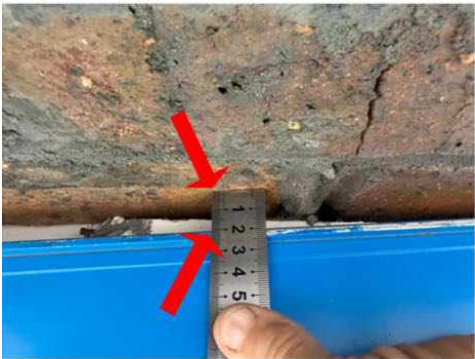
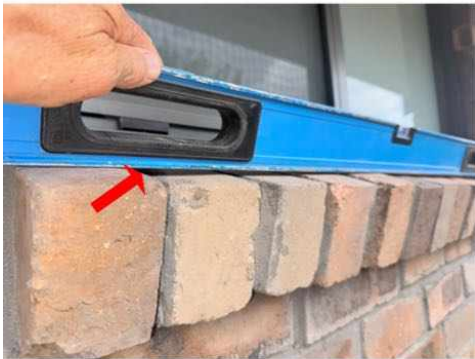
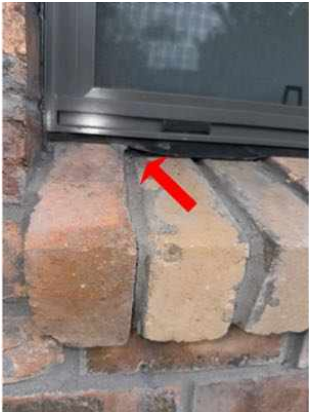
### Finding 3.01

The top of the wall is bowing inward 20mm. Minor cracking is evident to some bricks. Part of the eave trim is missing. The right small window ledge bricks are also not aligned leaving gaps for moisture and pest access. No reason for this repair was obvious.

Works that have not been completed to a satisfactory level create potential for the development of building defects and may impede on the safety and integrity of the overall structure.

It is highly recommended that the relevant trades be appointed to complete these works and ensure the safety of the area and the longevity of all associated building elements.

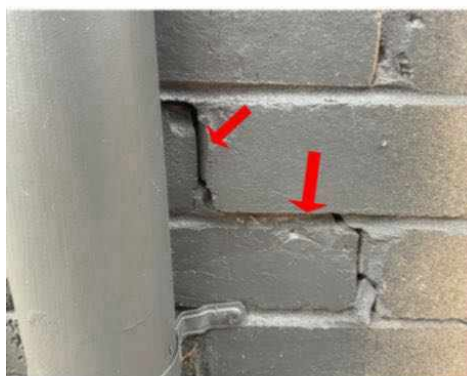
**Finding 3.02**

Building: Building 2  
Location: Exterior garage walls  
Finding: Step cracking to brickwork  
Information: Step cracking in the garage was identified to the brickwork at the time of inspection. See step cracking defect description previously in this report.

This minor step cracking can be used as a warning sign to address factors causing stress to the wall, which can include the effect of surrounding trees, water leaks, soil erosion, or even the presence of reactive soils in the surrounding area.

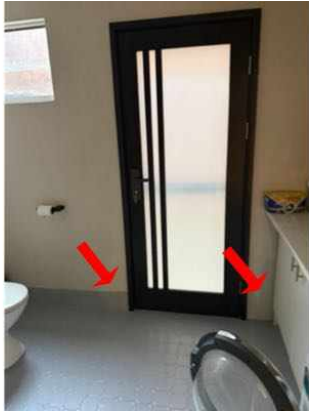
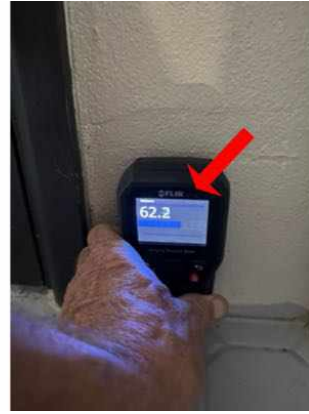
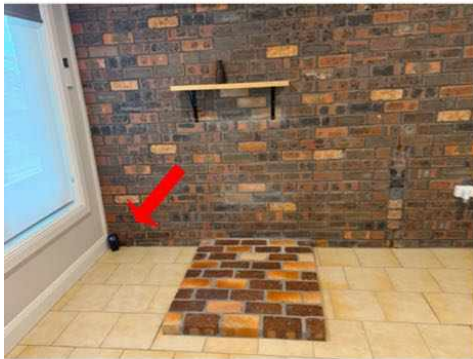
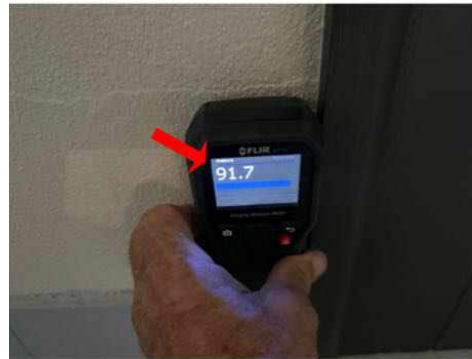
### Finding 3.03

| Finding: | Evidence of excessive moisture was present at the time of inspection |
| Information: | Excessive moisture was found in each internal side walls. The laundry wall showed a reading of 62.2 and the rumpus room a reading of 91.7. |

Nearby readings produced a very low or Nil result in these areas for reference.

Excessive moisture can attract termites and produce conditions that promote termite attack, fungal growth and wood decay. Excessive moisture is generally caused by deteriorated, inadequate or missing roof drainage, rising damp, leaking plumbing pipes or fixtures, poorly plumbed HWS overflows or condenser units and poor site drainage. It is highly recommended that all plumbing and drainage fixtures and fittings be maintained regularly in order to prevent excessive moisture being present in the internal property.

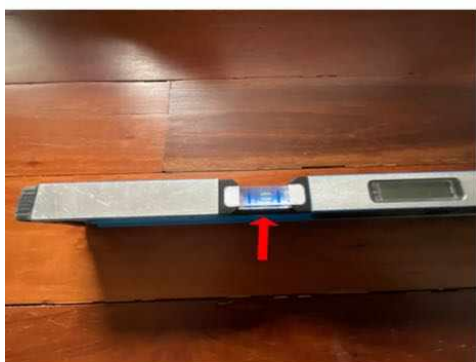
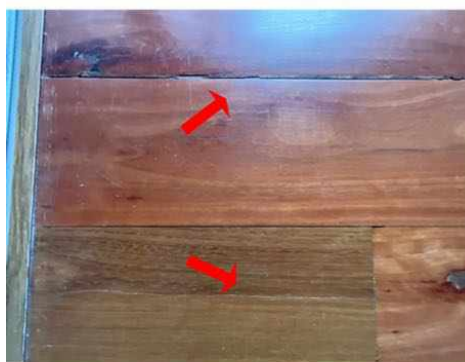
Information: The internal flooring in some areas is out of level and uneven. Uneven flooring is likely to indicate minor defects such as expected movement of the foundations of the property.

It is advised that the flooring be closely monitored to identify any further movement. Where flooring remains relatively unchanged for an extended period of time (i.e. several months), it is likely that this defect has been caused by movement of the foundations of the property.

However, where flooring is uneven further, a structural engineer should be consulted.

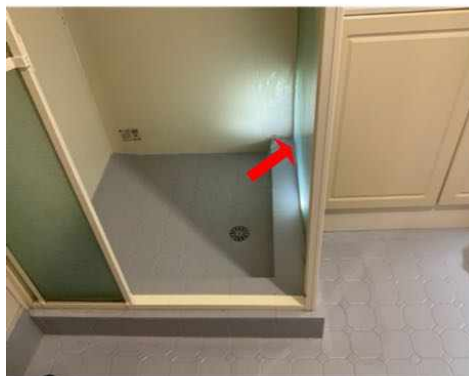
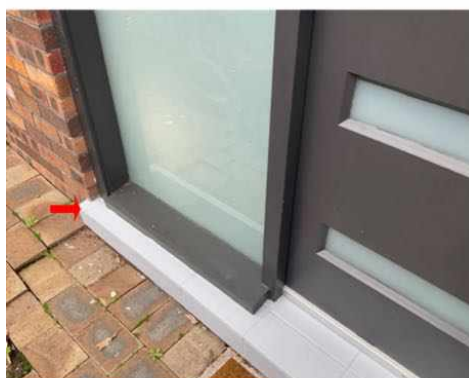
### Finding 3.06

| Finding: | Tiles cracked |

Cracked tiles throughout the household detract from the overall appearance of the affected areas. In wet areas of kitchens and bathrooms, it can lead to water damage of adjoining walls and floors.

Replacement of cracked tiles is recommended as soon as possible. A tiling contractor may be appointed to perform these works. Where cracks become more numerous, contact a licensed building inspector for further investigation.

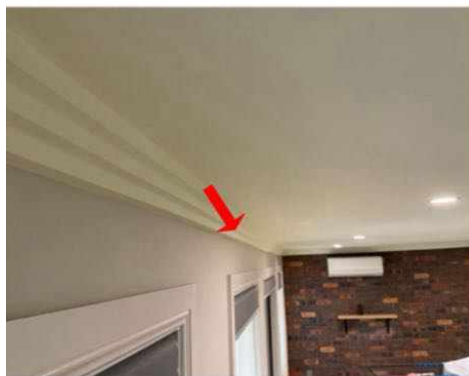
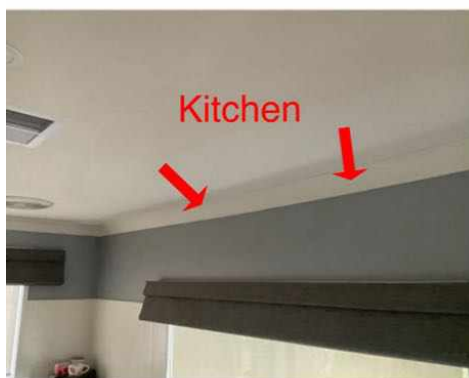
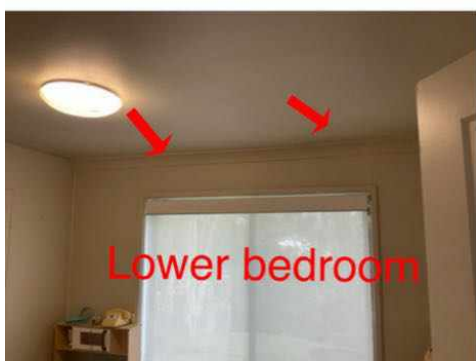
| Information: | The ceilings/cornice in the kitchen, loungeroom and lower bedroom were found to be sagging/ wavy at the time of the inspection. Sagging to the fixed ceiling structure generally indicates that the building materials have swollen, due to contact with water, or that fixings (e.g. nails or glue) have become loose and require reattachment. |

In some cases, sagging ceiling linings may also indicate that there are structural issues, causing surfaces to warp, twist or sag, or that structural timber elements have been weakened from termite activity. Where sagging appears to be major, appointment of a structural engineer is advised to further inspect the property and identify the cause of the damage and determine the rectification works required.

An invasive inspection is required to remove timber and/or plaster in these areas to check this area for the cause.

Where minor sagging is evident, comparatively minor works, such as re-gluing of ceiling sheets, may be required. Such works may be performed by relevant tradespeople, such as plasterers and painters. Where excessive moisture has caused the roofing structure to swell and sag, the source of the water leak should primarily be identified prior to any remedial works being performed.

The appropriate action should be taken by the client as soon as possible to ensure that any potential further damage is limited.

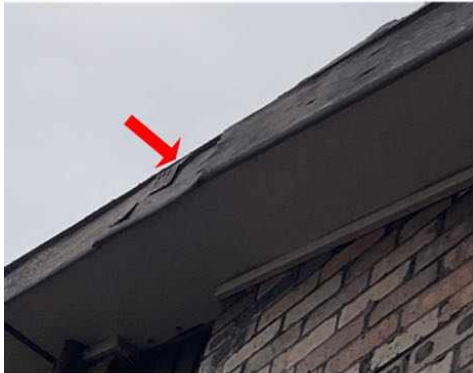
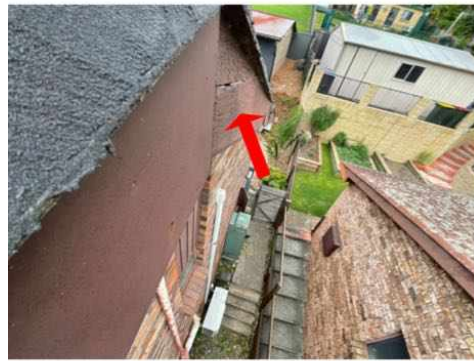
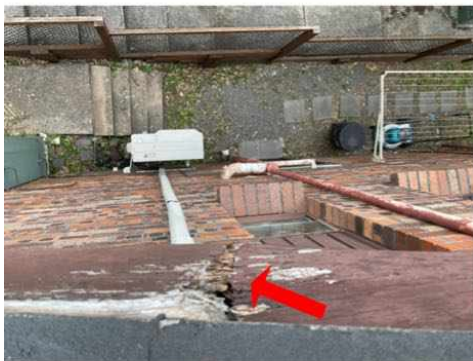
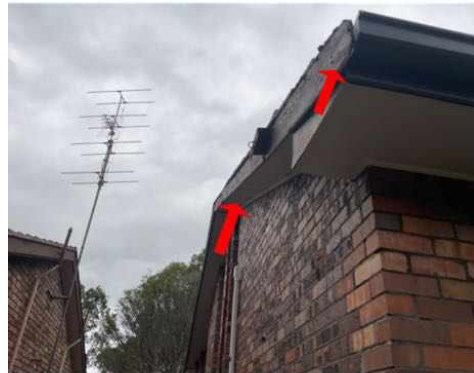
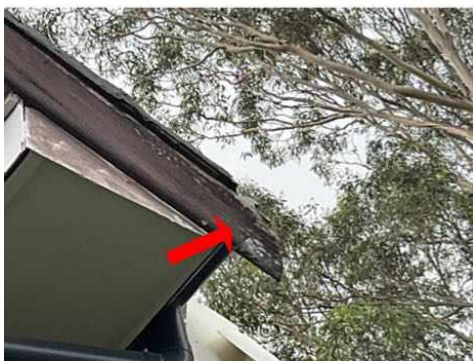
### Finding 3.08

| Information: | Upon inspection of the exterior roofing, the majority of the roof tiles areas were considered to be in a good condition. However the timber barges showed wood rot and splitting on both side wall areas. Here, maintenance works and some timber replacement is required. Where left unmanaged, deteriorating timber materials are |

likely to lead to a number of secondary defects, including minor water leaks and weather exposure to internal roofing structures.

Consultation with a roofing contractor or carpenter is highly advised to gain advice on cost of remedial works that are required.

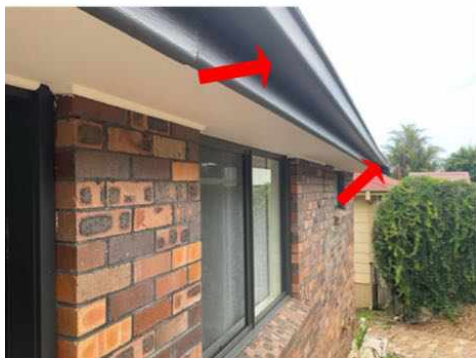
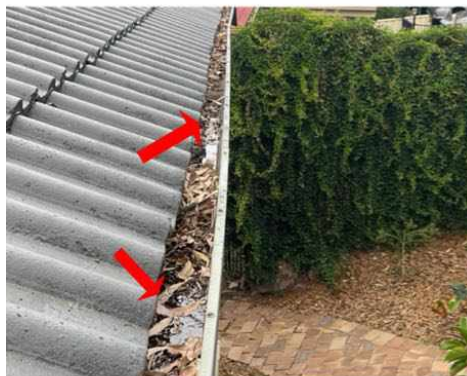
### Finding 3.09

| Information: | There is an insufficient fall in the front right house gutter, which means that the angle of |

this gutter is inadequate for rainwater to drain away. This is resulting in pooling of water in the area, creating the potential for water damage to nearby areas. This is likely to lead to further defects if not repaired. Adjustment by a roofing contractor is required as soon as possible to prevent any damage to this area.

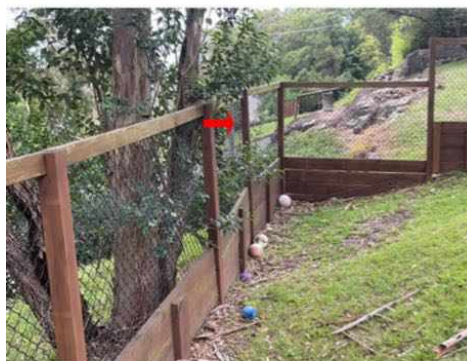
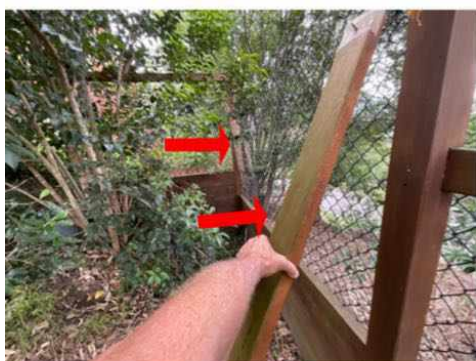
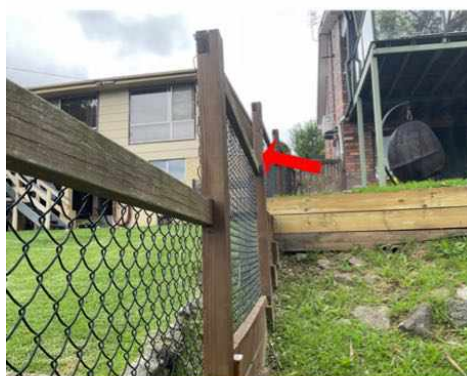
| Finding: | Fences damaged - leaning and loose |
| Information: | Evidence of damage to the many fences was identified at the time of the inspection. The likely cause of these fences leaning is not enough concrete used in the post footings. The left rear fence top plate has snapped in half. The right rear fence post is loose. If left unmanaged this fence may deteriorate further. It is suggest a fencing contractor be engaged for rectification when convenient. |

The cost of repairing some fences is often shared between neighbours.

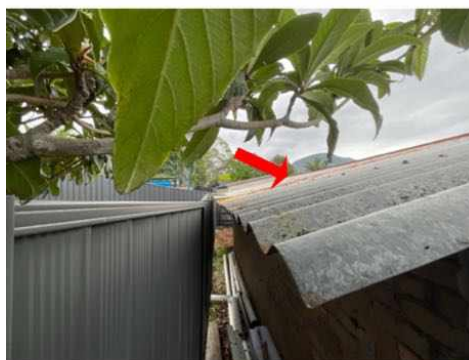
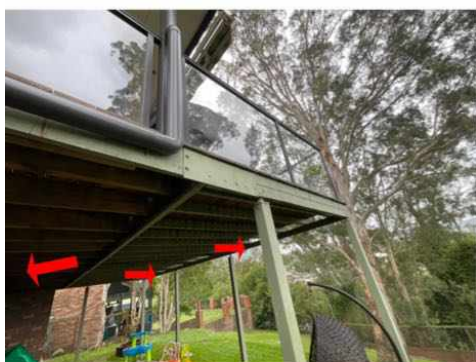
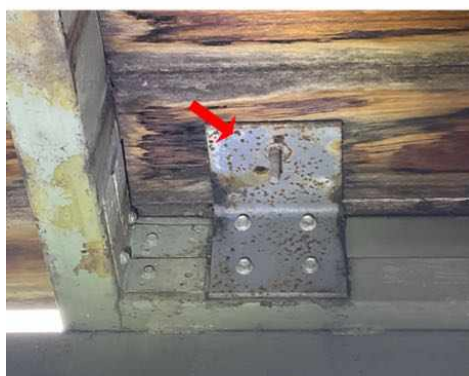
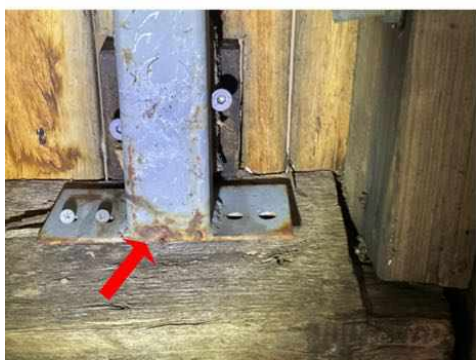
### Finding 3.13

| Finding: | Building element - Rusted or corroded |
| Information: | This building element shows evidence of rusting and corrosion, which is likely to have developed as a result of excessive exposure to moisture and or inadequate coatings. |

As surface rust provides no protection to the underlying iron, the deteriorating condition is likely to worsen if not addressed in the short-term future.

Where possible, the use of galvanized (treated) metals or aluminium coated metals aid in rust prevention, as does regular general maintenance. Rust formation can be controlled with coatings, such as paint, that isolate the iron from the environment.

Rusting and corrosion should be managed by ideally removing or limiting the affected surface from exposure to moisture. A registered builder may be appointed to replace any building elements that have been severely affected by rust or water damage.

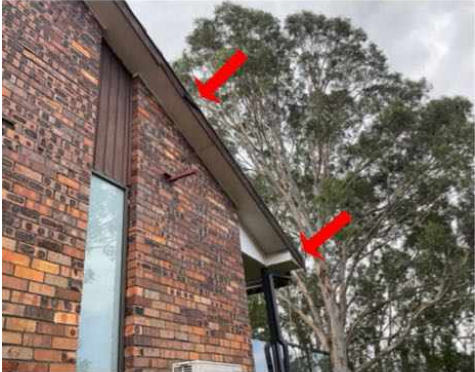
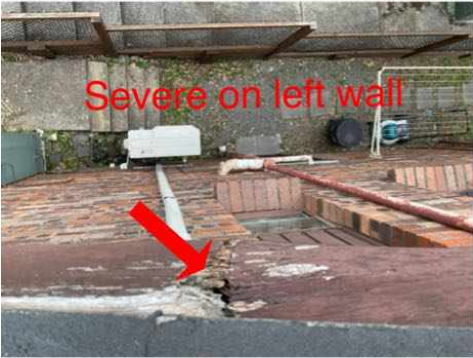
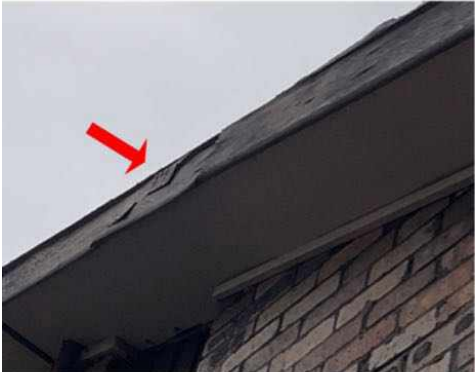
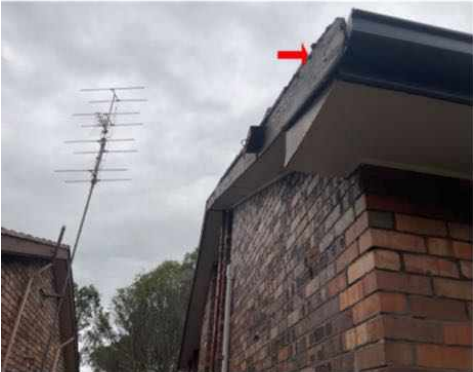
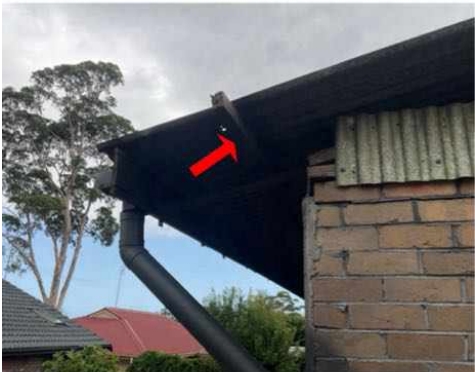
### Finding 3.14

| Finding: | Wood rot |
| Information: | The building shows evidence of wood rot. Wood rot, also known as Fungal Decay, occurs when timbers and other cellulose building materials are exposed to damp conditions on an ongoing basis. This could be the result of exposure to weathering over a prolonged period of time, or the attraction of excessive moisture from other abutting building materials. |

cause of the moisture that has created the visible wood rot should be identified and addressed in a suitable manner. Replacement of affected timbers may then be a necessary step in protecting surrounding building elements from such deterioration.

A qualified carpenter or registered builder may also be required to replace affected building materials.

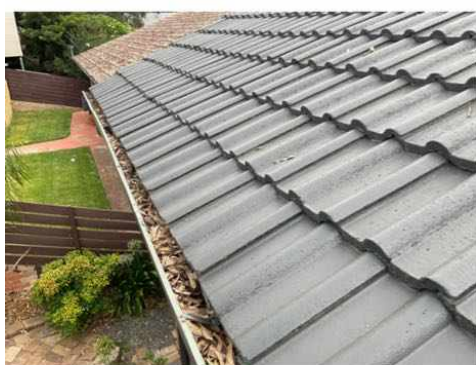
**Finding 3.15**

Building: Building 1  
Location: Roof exterior  
Finding: Gutters - Full and blocked

Information: The guttering on around the roof was found to be blocked at the time of the inspection. Roof plumbing structures, such as guttering and downpipes, should be free of all debris to prevent blockages. Blockages of the guttering and downpipes will lead to pooling and accumulated water overflows, which is likely to subsequently flood eaves and exterior walls.

Blocked gutters are likely to lead to high levels of moisture in the affected areas which can cause rust and decay of the gutters and downpipes and wood rot to adjoining timber areas. Blockages in gutters should therefore be removed immediately to ensure dry conditions are maintained.

It is highly advised that gutters be cleaned by the homeowner or a general handyperson as a matter of urgency.

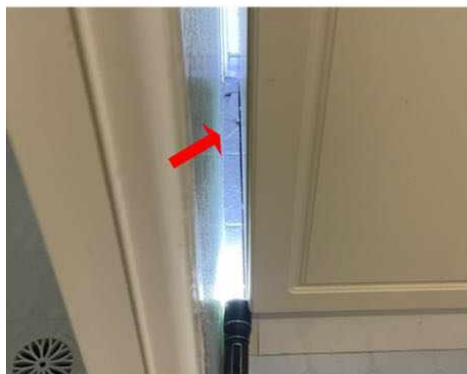
### Finding 3.16

Building: Building 1  
 Location: Laundry  
 Finding: Shower screen - Leaking  
 Information: Leaking and cracked tiles was evident to the lower shower at the time of inspection. It is suspected that the leaking has occurred as a result missing sealant. Leaking from the shower , where left unattended, is likely to lead to water damage to adjoining flooring and walls. Such damage can lead to water damage and necessitate extensive remedial works being required. Active water leaks may also create an environment that is susceptible to the formation and development of mould.

Appointment of a sealant expert is required to repair or replace this missing sealant. Such works should be performed as soon as possible to ensure that no further damage occurs.

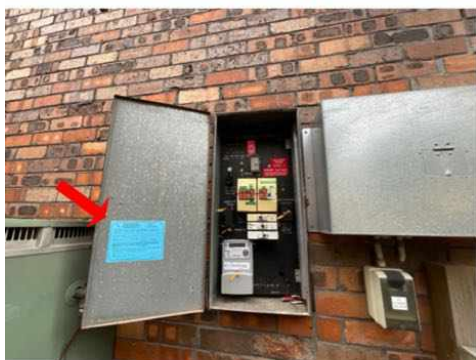
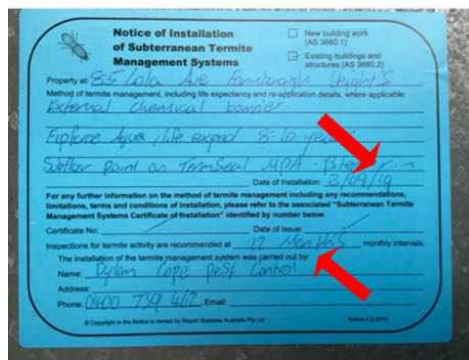
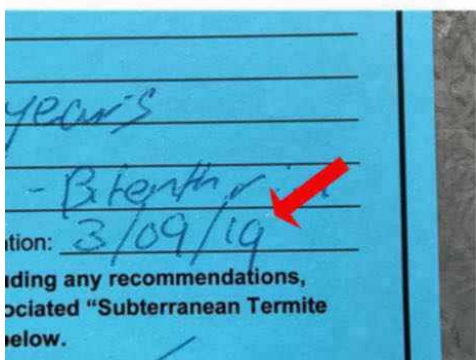
| Information: | The application of a post-construction chemical termite barrier is highly recommended for all properties. Such barriers are highly effective in preventing termite attack on any timber building elements throughout the property. |

A durable notice should be placed in the switchboard unit to indicate current termite barriers. At the time of inspection, the durable notice was evident and it appeared as though a termite management system has been installed in 2019, with no evidence to suggest preventative works taking place since 2019 as per the barrier warranty.

It is recommended to get annual termite inspections as per this barrier warranty and the conducive conditions found during this inspection and listed in this report.

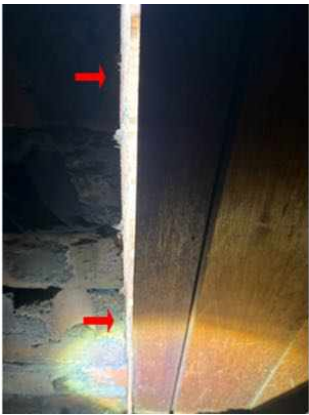
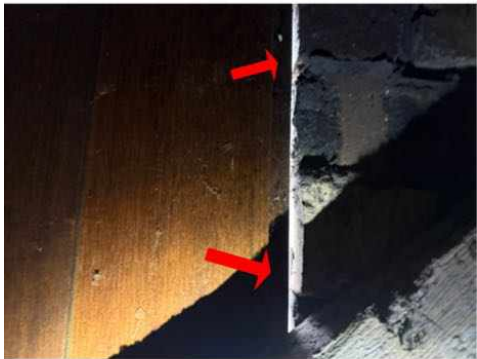
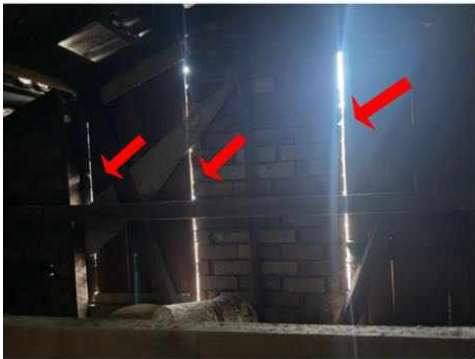
**Finding 6.02**

Building: Building 1  
 Location: Exterior walls  
 Finding: Sealant (external) - missing and attractive to termites  
 Information: It was noted on inspection that areas of external sealant was missing to small areas of the external walls. A flexible sealant or flashing is required to protect the associated building materials from rainwater ingress. Any moisture ingress into the property is very attractive to termites. Flexible sealants or flashing should be applied to these affected areas to prevent termite activity.

A sealant specialist or skilled handy person should be appointed to complete these works as soon as possible.

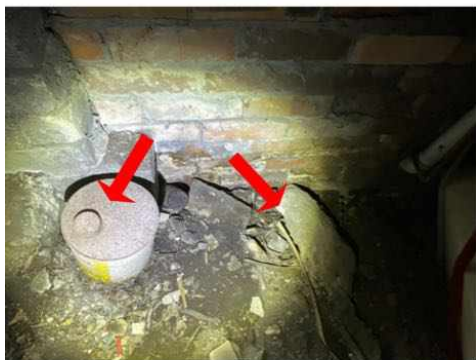
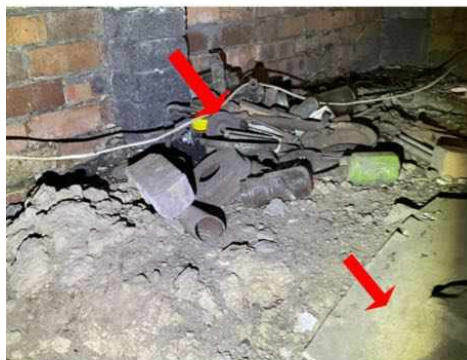
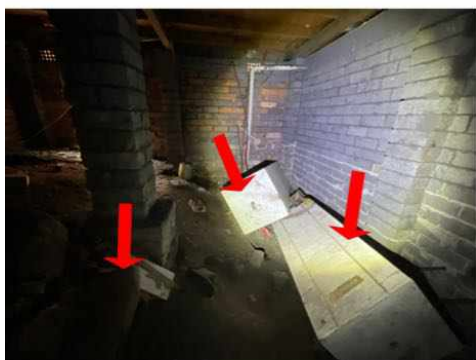
An array of debris was found in the subfloor area at the time of inspection. Debris in this area restricts subfloor ventilation and creates potential for concealed pest entry. Stored timbers and other materials may also make the area susceptible to termite activity and wood rot.

A clear and empty subfloor will be better ventilated and easier to maintain in a dry condition. The removal of any timber debris is vital in minimising the risk of termite or wood borer activity.

Debris in the subfloor should be removed as soon as possible. Depending on the location and amount of debris and stored items, the homeowner may elect to undertake this task. Alternatively there are a large number of rubbish removal subcontractors that could undertake these works.

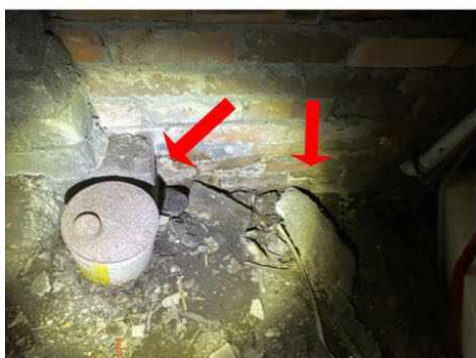
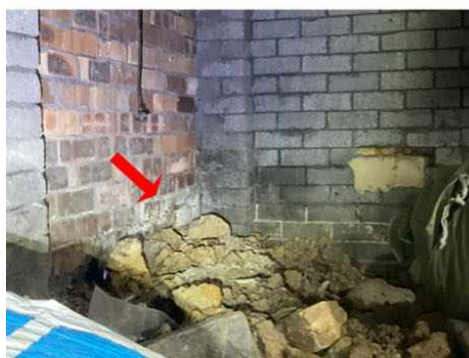
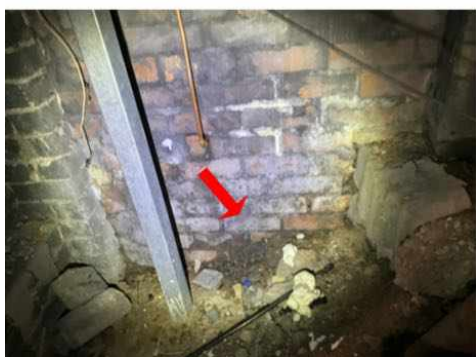
### Finding 6.05

Building: Building 1  
 Location: Subfloor  
 Finding: Damp - Rising  
 Information:

Rising damp is generally managed by the installation of a damp proof course during construction. A Damp Proof Course (DPC) is an impermeable barrier at the base of the wall above ground level. However, many 19th Century buildings have no damp course installed, or the materials have failed. The DPC may have been omitted as a consequence of poor workmanship, or it may have been bridged where materials built up against the side of the house allow moisture ingress above the DPC level.

The first step in addressing rising damp is to diagnose the cause. The identified cause should be addressed first before addressing the appearance and other defects which have resulted from the rising damp. If the original cause is not resolved, further cases of damp are likely to ensue, resulting in secondary defects.

Consultation with a qualified plumber is advised immediately to identify the cause of the damp and perform remedial works as required.

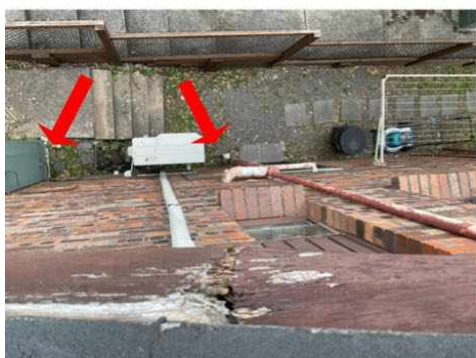
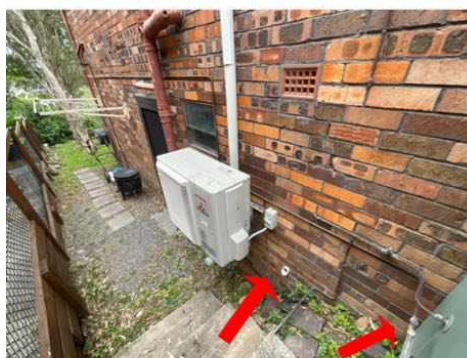
### Finding 6.06

| Information: | The pictured overflow pipes are not plumbed or connected to suitable drainage, which has resulted in the surrounding area becoming excessively damp. |

These damp conditions can lead to secondary defects such as rot, rust or corrosion of associated building elements, the formation of fungal decay, or even the creation of potential slip hazards. When coupled with poor site drainage, pooling of water may also attract termite activity to this area. It is highly recommended that a qualified plumber be appointed to install adequate drainage to these areas. These works will ensure that the area remains dry and free of any secondary defects.

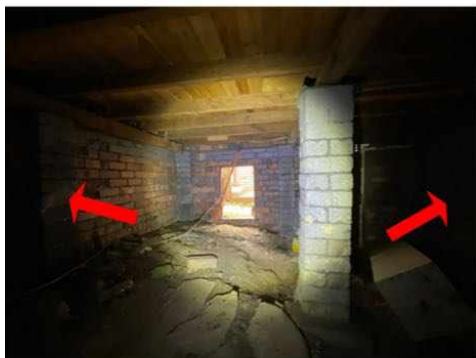
### Finding 6.07

| Finding: | Subfloor ventilation - Inadequate |
| Information: | Adequate subfloor ventilation aids in preventing excessive moisture wood rot and termite activity by ensuring a dry subfloor environment. |

Where ventilation is substandard or blocked, it is usually caused by factors such as failure to install adequate vents during construction or earth and vegetation covering vents. Low subfloor clearance and stored items or debris in the subfloor also restricting airflow.

Subfloor ventilation can be improved in most cases by addressing the causes such as exposing subfloor vents, installing additional vents, installing mechanical ventilation and removing debris from the subfloor.

A registered builder should be appointed as soon as possible to perform these works as necessary.

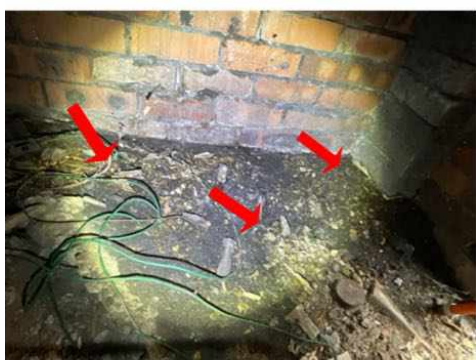
### Finding 6.08

| Information: | Where evidence of mould growth was noted, there may be environmental, biological or health issues associated with the report. A specialist inspection by a suitably qualified environmental health inspector is warranted, where mould is extensive or where any queries regarding air quality spores or other related issues apply. |

Subfloor mould is generally caused by moisture ingress, lack of external drainage, lack of adequate ventilation and subfloor debris present. These issues need rectification

Generally, the client is advised to ensure that the general environment is free of moisture and humidity to aid in the prevention of mould formation and development.

to stop mould development. Any mould found during the inspection should be cleaned immediately by a cleaning contractor or the homeowner as applicable.

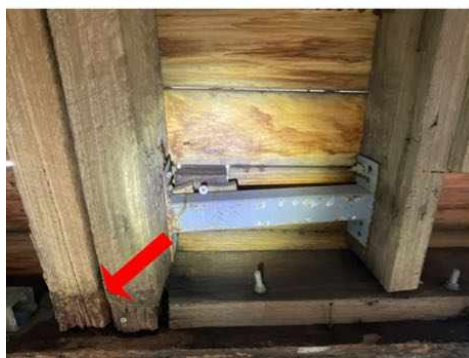
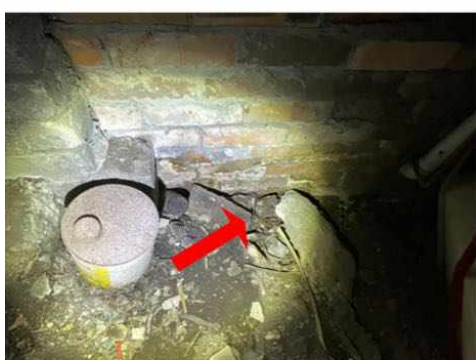
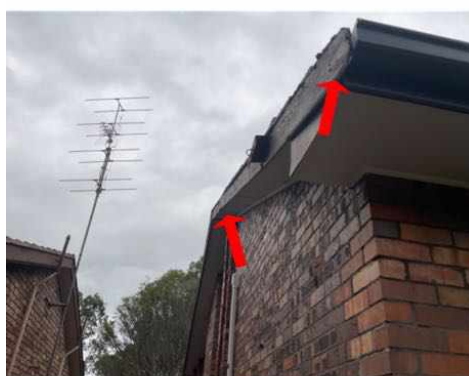
### Finding 7.01

**Building:** Building 1  
**Location:** Verandah  
**Finding:** Fungal decay - present (localised)  
**Information:** Fungal decay also known as wood decay or wood rot generally refers to the deterioration of timber elements when in contact with excessive levels of moisture for a prolonged period of time.

The development of fungal decay is accelerated by temperatures from 5degreeC to 40degreeC as well as the presence of oxygen. Generally fungal decay develops on timber elements that are in use in an external environment which are exposed to rain penetration.

Note - See ALL wood rot photos, all these show fungal decay.

In this case, some of the affected timber elements are in a decaying state and will need replacement by a carpenter or licensed builder.

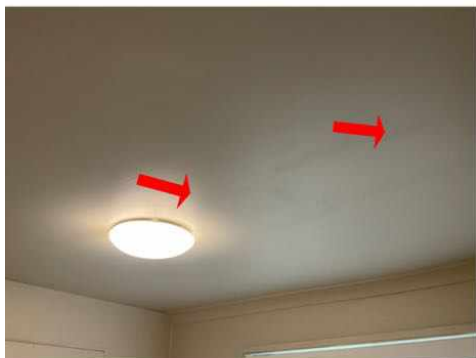
Building: Building 1  
Location: Lower bedroom  
Finding: Ceiling repairs for your information  
Information:

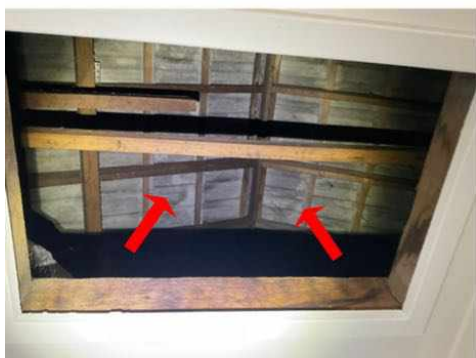
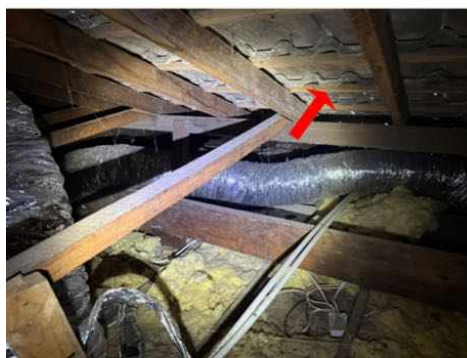
| Finding: | Sarking - Missing |
| Information: | Sarking is missing under the roof sheeting. Sarking acts as an insulator that helps with noise reduction and protects against water penetration. Sarking plays a key role in the operation and function of the overall roofing structure and its performance. |

Although not a requirement at the time of construction, replacement of any missing building element is advisable (although this can be quite expensive to do after the time of construction). Where sarking is missing, regular inspections of the roof tiles for cracking and potential moisture penetration is required.

Sarking may be retrospectively fitted by a registered builder at the discretion of the client.

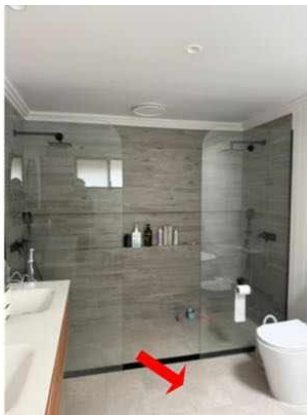
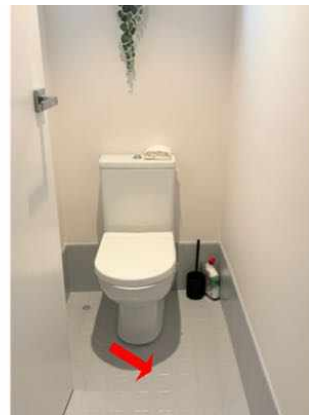
- Membrane used and Manufacturers Specifications. - The Installer and Installation Certification.

With older property's where this information is unavailable all wet areas should be monitored. If any leaks, water staining, peeling or bubbling of the paint become evident to any adjacent walls or ceilings below a licensed builder or waterproofing specialist is recommended to investigate further.
