Building and Timber Pest Inspection Report

Inspection Date: Thu, 26 Feb 2026

Property Address: g6/6A Atkinson St, Liverpool NSW 2170,
Australia

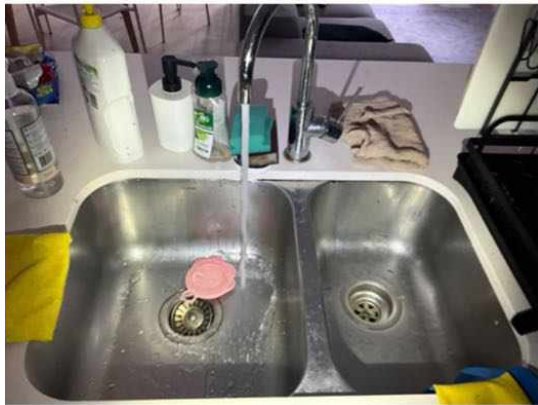
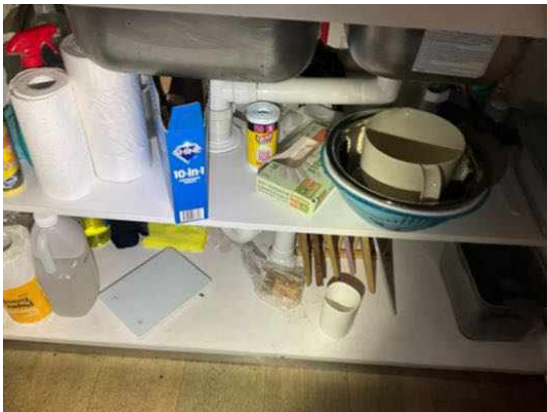
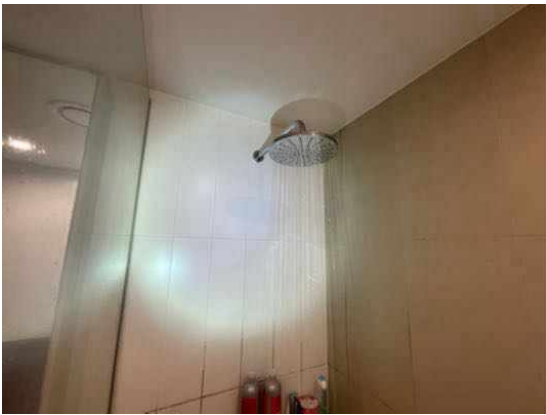
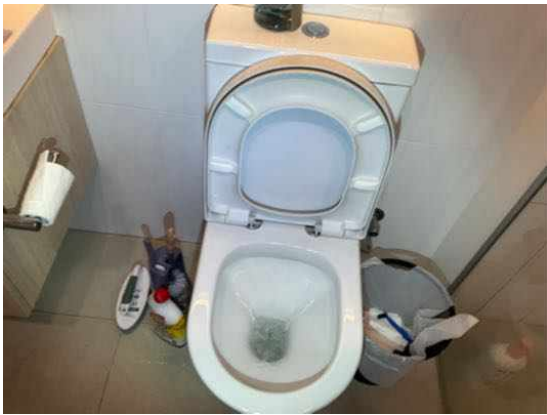
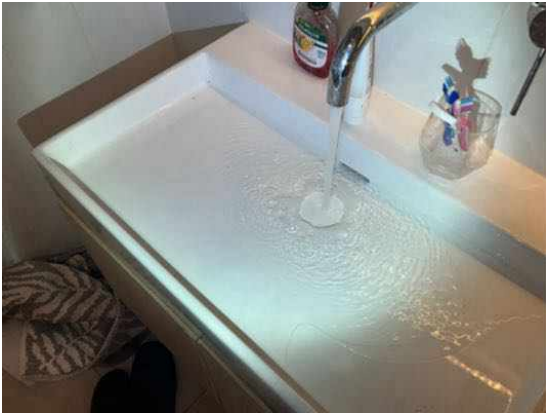
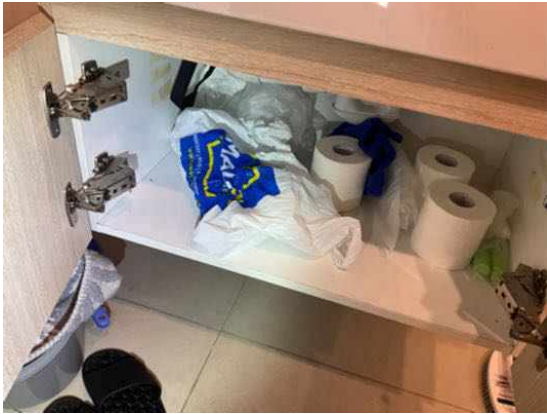
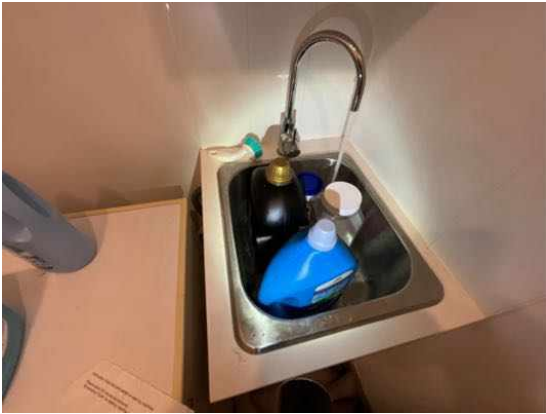
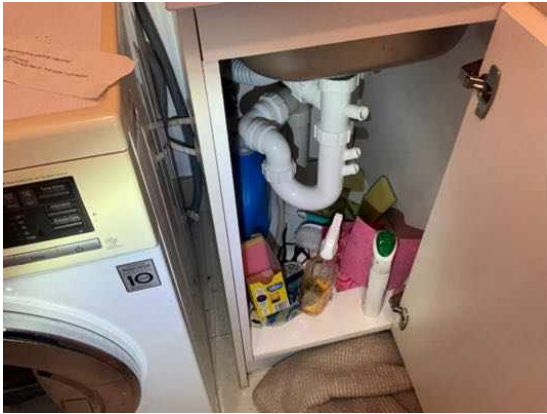
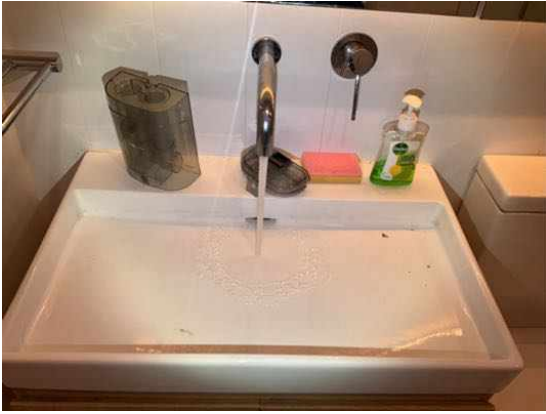
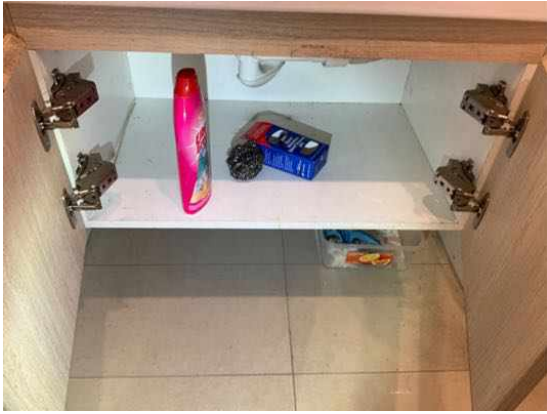
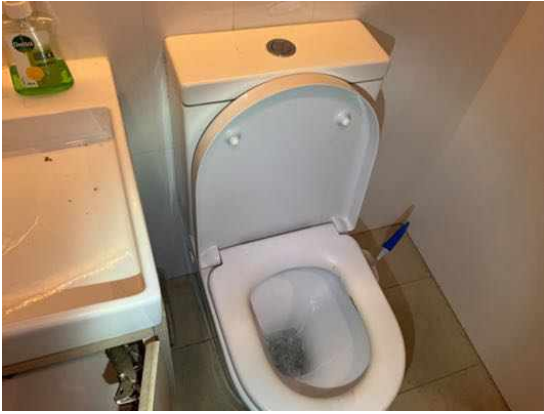
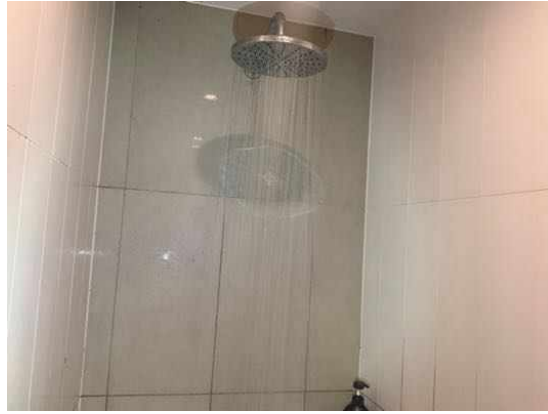
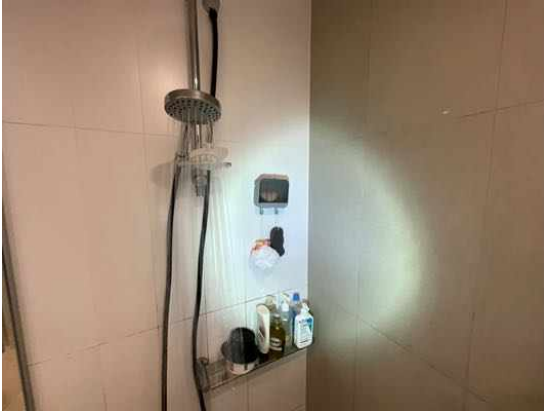
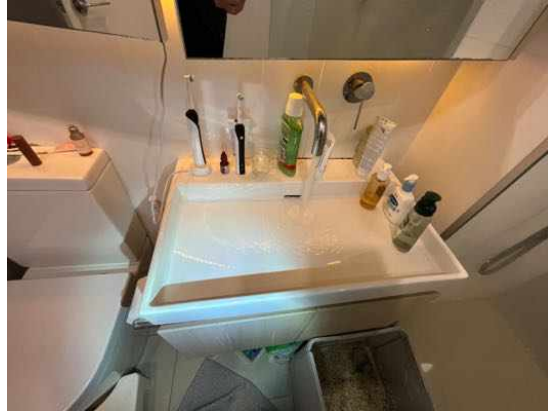
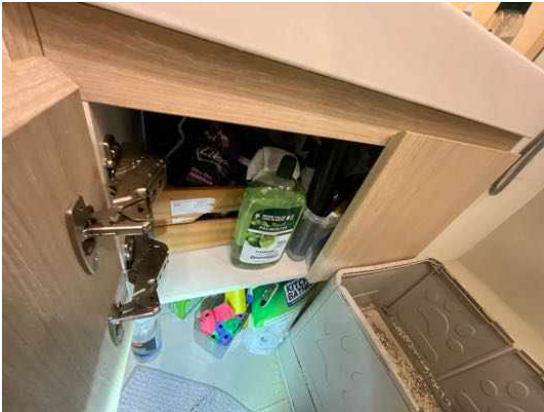
Building: Main Building
Location: All Wet Areas
Finding: Additional Photos
Information:

Additional photos are provided for your general reference.

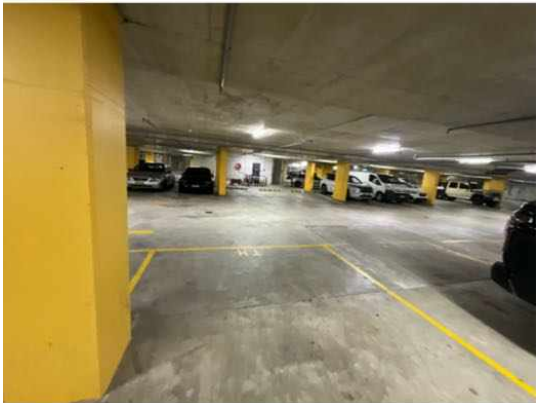
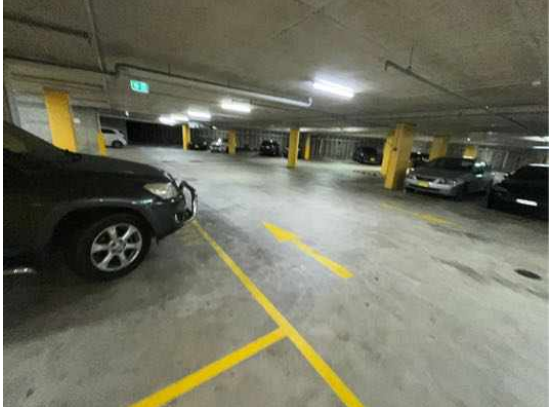
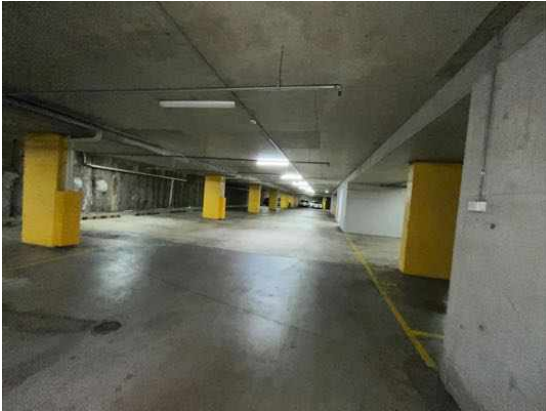
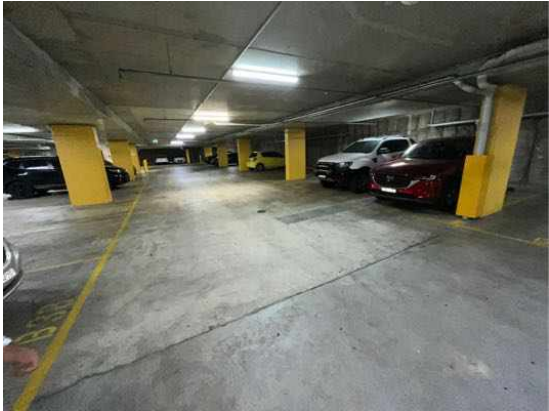
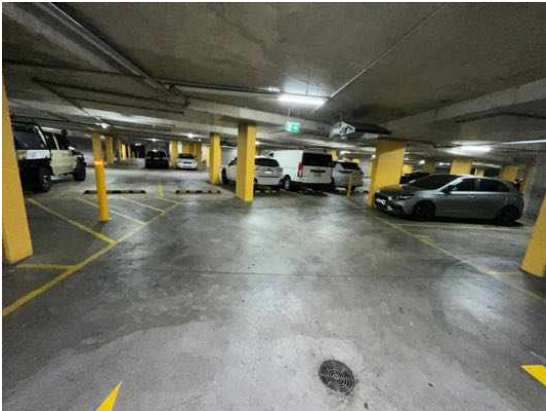
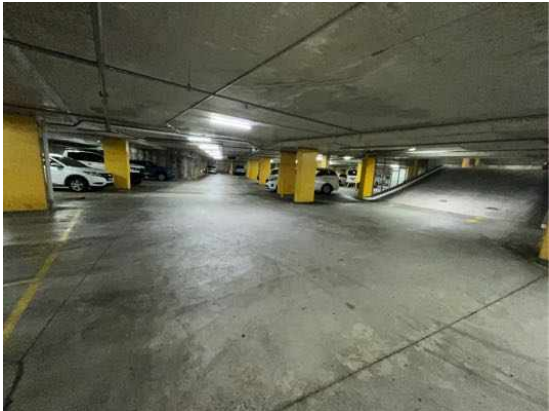
Building: Main Building
Location: Garage
Finding: Additional Photos- Garage
Information: Additional photos are provided for your general reference. Arrows may have been included to highlight areas of importance. Please discuss these photos with your building consultant for clarification.
