Building and Timber Pest Inspection Report

Inspection Date: Mon, 19 Jan 2026

Property Address: Unit 9/300 Jersey Rd, PLUMPTON, NSW,
2761, Australia

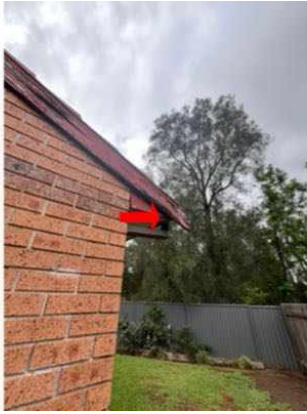
Building: Main Building
Location: All Areas
Finding: Deterioration caused by Fair and Wear and Tear

Information: Certain forms of deterioration commonly associated with fair wear and tear may not be specifically identified or itemised within this report. The external areas of the property display several age-related conditions typical for a dwelling of this era, including cracking and breakage to pathway tiles, displacement of pavers, general deterioration to timber boundary fencing, ageing and weathering to timber gates, and surface deterioration to fascia boards. These forms of degradation commonly occur over time due to ongoing weather exposure, ground movement, moisture cycles, and general usage, and they do not necessarily indicate defective workmanship or structural failure.

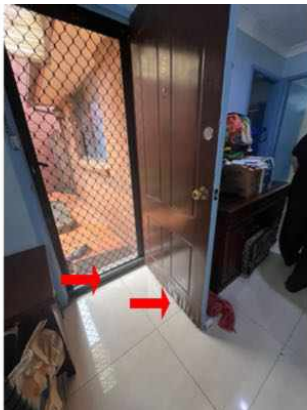
Finding 3.02

Information: The bottom section of the entry door shows visible swelling and distortion. This type of deterioration is typically caused by moisture absorption into the door substrate, resulting in expansion, delamination, or softening of the lower panel. The affected area displays warping and deformation, consistent with prolonged contact with moisture, poor weather protection, inadequate sealing, or past water ingress near the threshold. If left unmanaged, the condition may worsen over time, potentially affecting door operation, security, and overall durability.

Repair or replacement of the door, along with ensuring adequate weatherproofing around the doorway, is recommended to prevent further moisture-related deterioration.

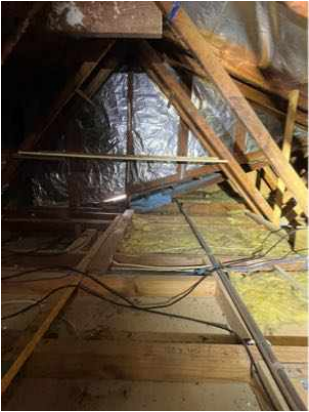
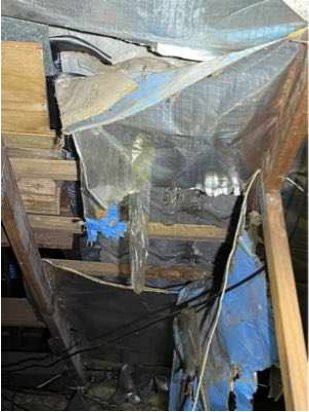
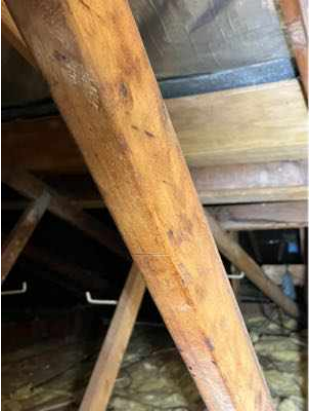
Overall, the roof void displayed a combination of aged materials, inadequate maintenance, moisture impact, and substandard service installation, and further assessment by appropriate licensed trades is recommended to identify required repairs and reinstate safe and compliant conditions within the space.

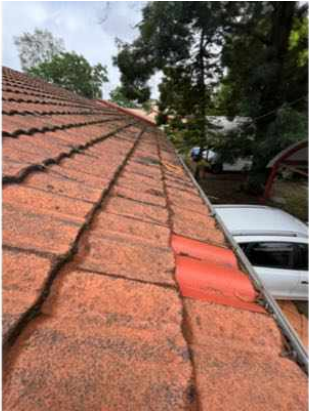
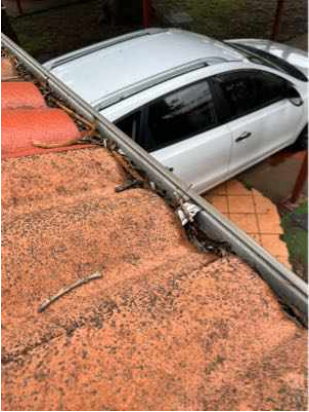
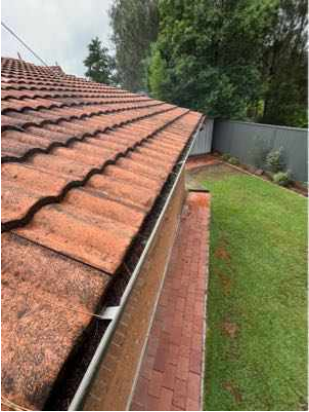
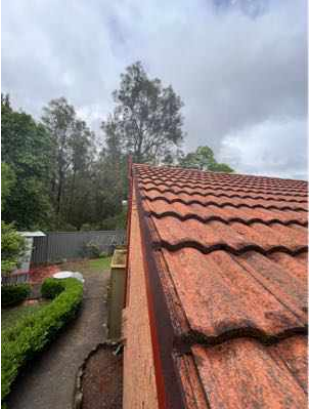
Noted Item

Gutters in several sections were obstructed with leaf litter and debris, preventing effective drainage and increasing the risk of overflow into eaves and wall cavities if left unmaintained. Flashings around roof junctions and penetrations showed signs of previous patching and weathering and may not be providing optimal moisture protection.

While no active leaks were noted at the time of inspection, the overall condition indicates that routine maintenance is necessary, including cleaning of gutters, reinstating displaced tiles, and sealing or upgrading junction flashings to ensure the roof continues to perform as intended. Periodic monitoring is recommended, and a roofing contractor should be engaged to address these maintenance items.
