# Building and Timber Pest Inspection Report VR

Inspection Date: Tue, 3 Mar 2026

Property Address: 11 Woodford St, Brushgrove NSW 2460,  
Australia

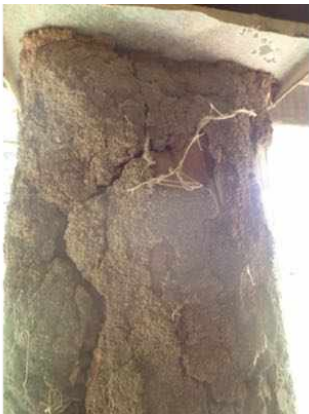
### Finding 4.01

Building: Main Building  
Location: Subfloor  
Finding: Termite Activity Identified to Loose Timbers and Timber Stumps in Subfloor  
Information: Termites were identified to several loose timbers located on the ground within the subfloor area and to all three timber stumps. Active termite presence indicates a risk of damage to structural timber elements within the building if left untreated. Further invasive inspection of concealed areas of the building is recommended to gain a better understanding of the extent of termite activity and any associated damage that may not be visible at the time of inspection. Treatment and further assessment should be carried out by a licensed timber pest specialist, with repairs to any damaged structural elements undertaken by a licensed builder or suitably qualified tradesperson.
