Building and Timber Pest Inspection Report

Inspection Date: Sat, 31 Jan 2026

Property Address: Unit 7/59 Essington St,
WENTWORTHVILLE, NSW, 2145, Australia

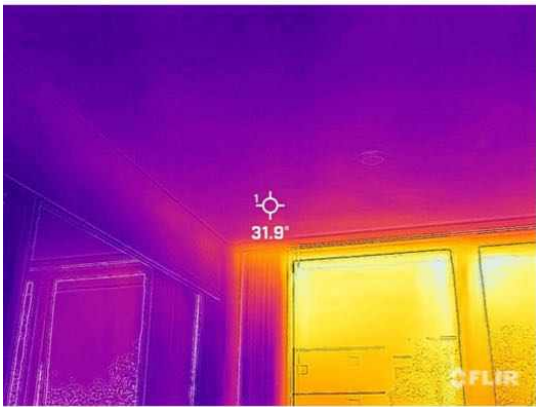
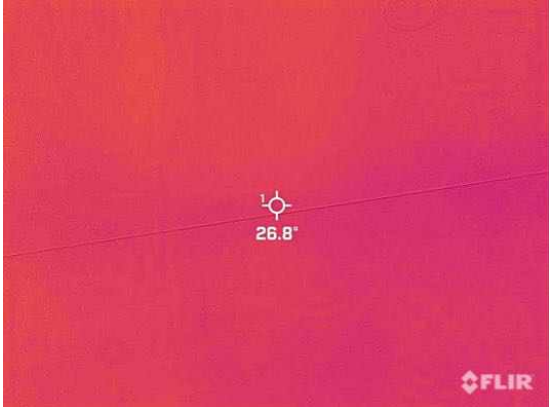
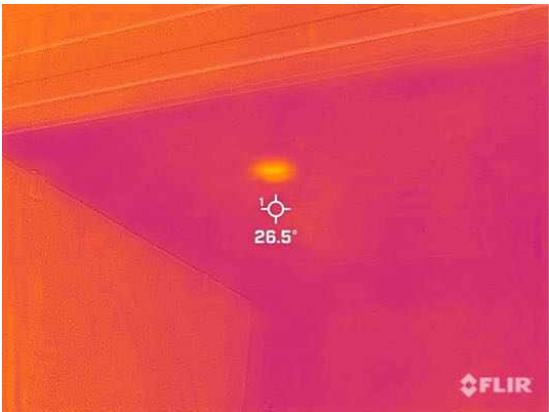
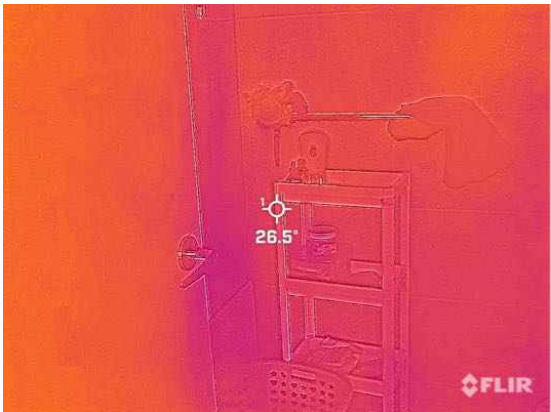
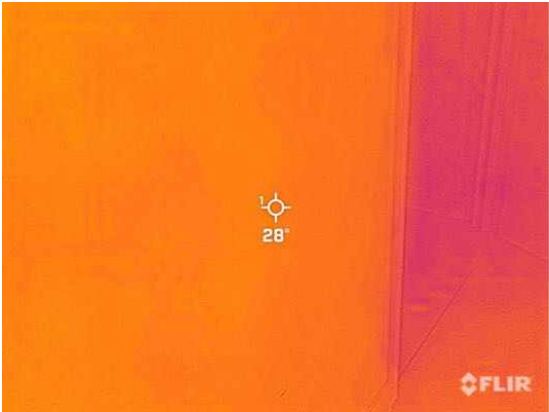
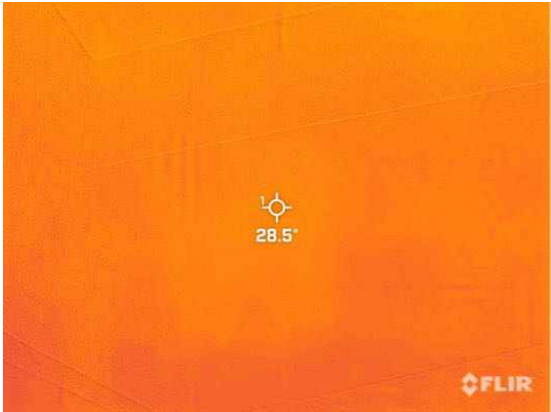
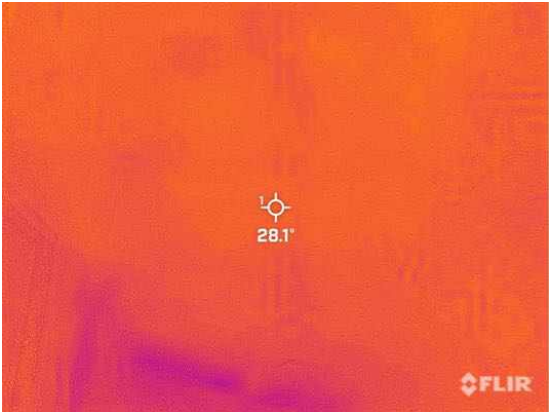
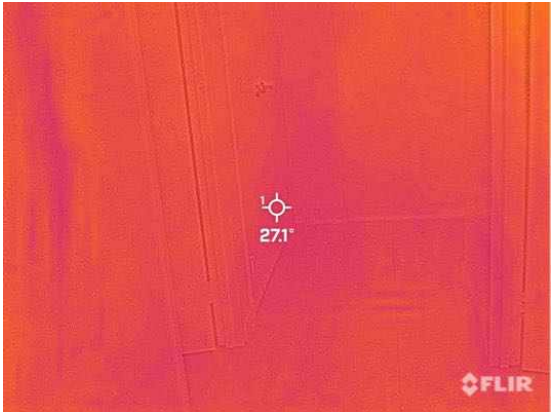
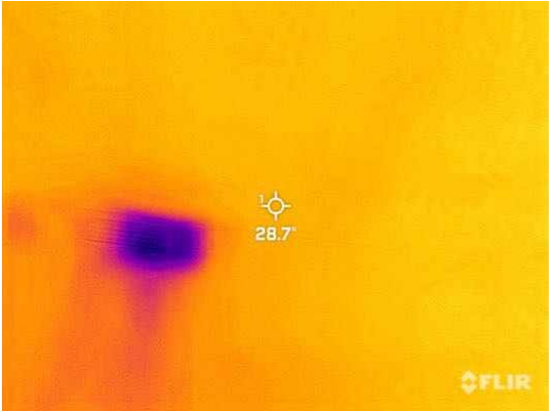
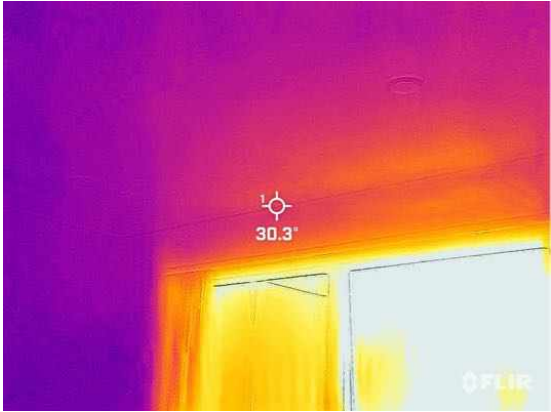
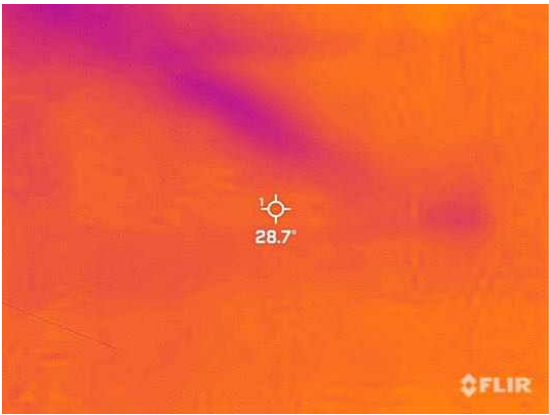
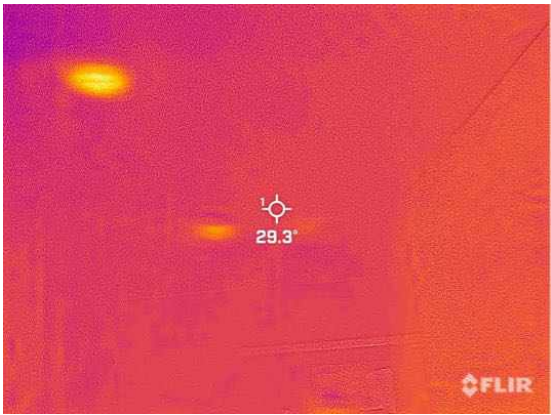
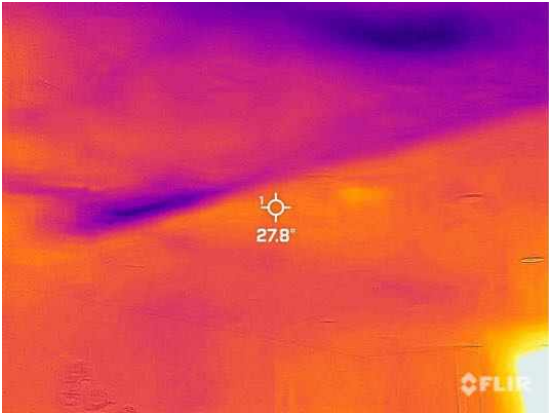
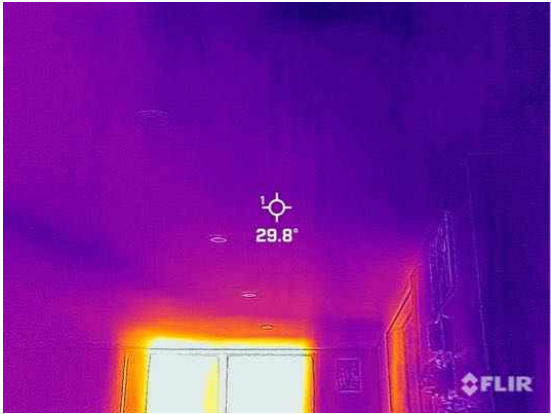
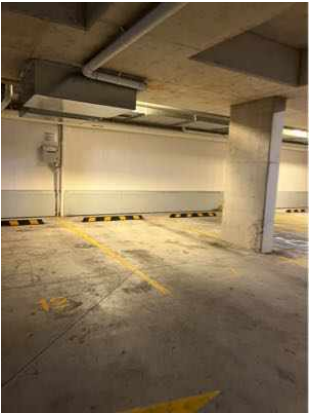
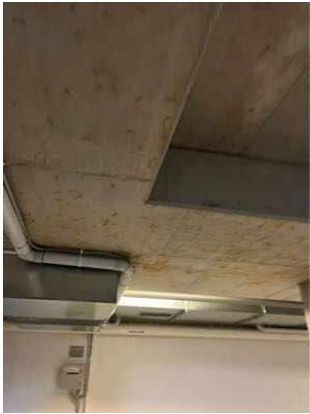
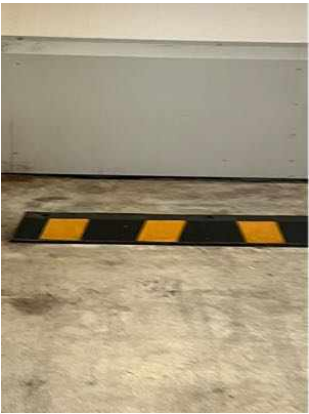
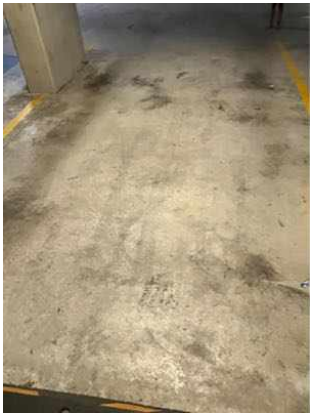
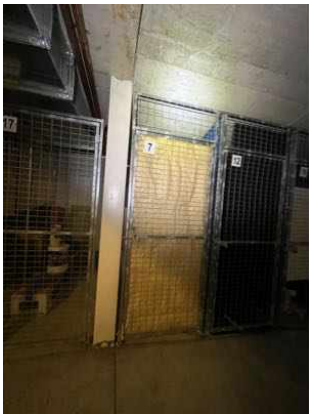
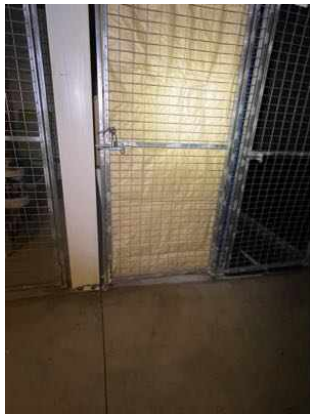
Building: Main Building
Location: All Areas
Finding: Additional Photos
Information: Thermal imaging camera was used to detect any active water leaks or/ and termite activities in the property. No water leaks or termite activities were found from inspection by thermal imaging camera. Additional photos are attached for general reference.
