## Building Inspection Report

Inspection Date: Mon, 23 Feb 2026

Property Address: a104/38 B Manchester Dr, Schofields NSW  
2762, Australia

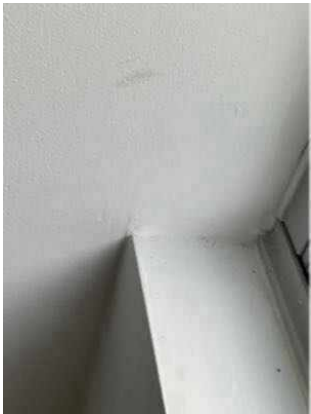
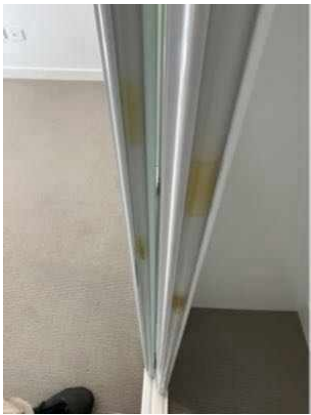
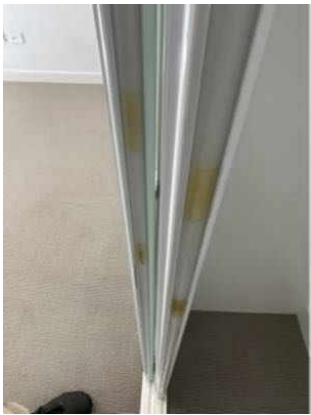
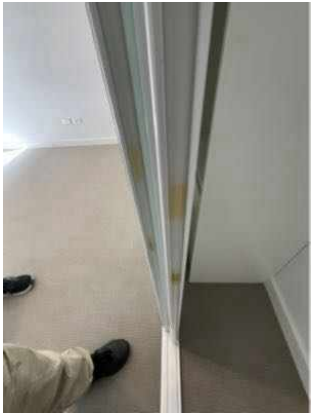
### Defects 3.03

Building:	Main Building
Location:	All Areas
Finding:	Cleaning required
Information:	It was observed that the house requires cleaning.

Works are defective where windows are not clean, floors are not swept, mopped or vacuumed as appropriate, tiles, sinks, basins, baths, windows or any other area throughout the property are not cleaned, and shelving, drawers and cupboards are not ready for use not cleaned and ready for use at handover.

Building sites are defective if they are not clear of building debris.

Please note: Not all cleaning defects were documented with photographs. However, it is the responsibility of the builder to attend to all cleaning issues, regardless of whether they were captured in the provided images. It is important for the builder to thoroughly inspect the property and address any and all cleaning deficiencies to ensure the

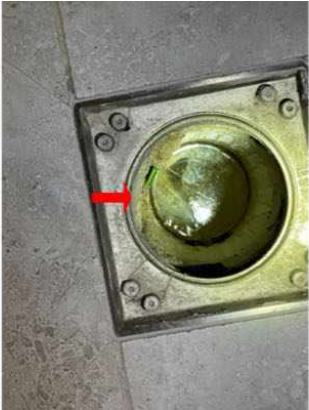
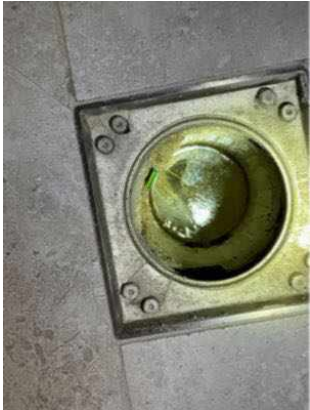
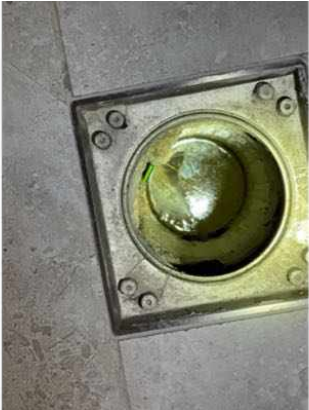
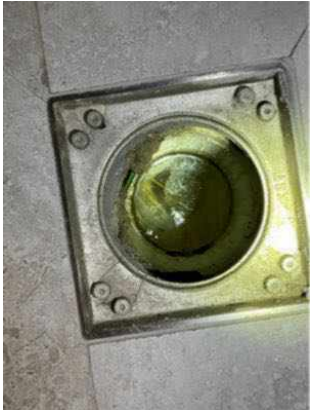
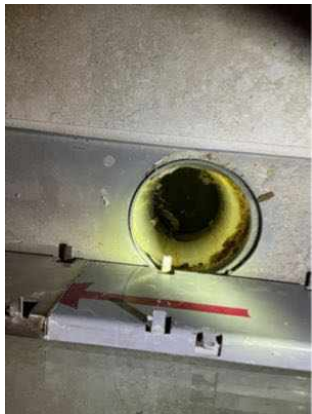
Defects 3.04

Building: Main Building  
Location: All Areas  
Finding: Floor waste Debris  
Information: It was noted that there is builder debris in the floor waste drainage. Debris in the plumbing system may lead to blockages in the future.

This is referenced against the Australian Standards and Tolerances clause 19.8 Cleaning - Owners are entitled to expect that the building site and works are clean and tidy on completion.

Building sites are defective if they are not clear of building debris. All floor wastes need to be checked and cleared prior to handover.

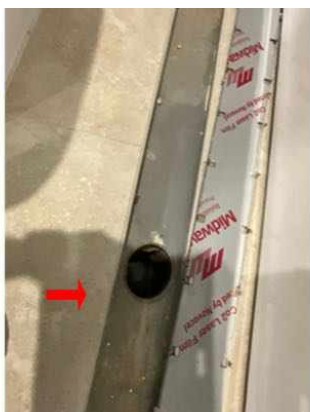
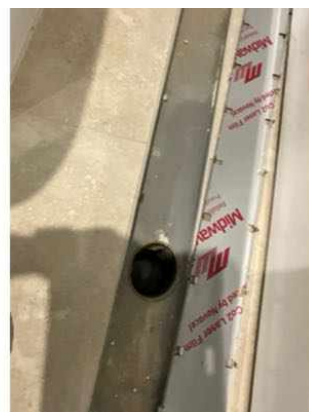
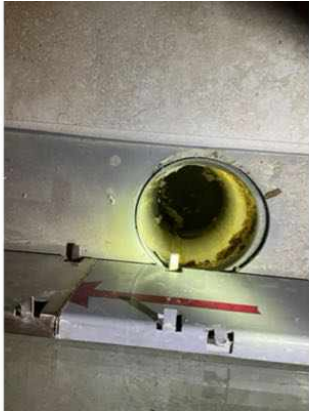
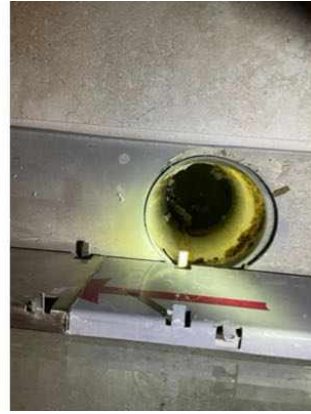
### Defects 3.05

Building:	Main Building
Location:	All Areas
Finding:	Floor waste- missing internal grill component (strainer or insert)
Information:	The drain cover in the tiled floor area is missing its internal grill component (strainer or insert), exposing a direct opening into the drain pipe. This is considered a non-compliant installation as the drain cover is incomplete.

- AS/NZS 3500.2:2021 – Plumbing and Drainage – Sanitary plumbing and drainage requires that all plumbing fittings and fixtures must be installed in a manner that prevents debris from entering the drainage system and ensures the safe operation of the drain.
- The Guide to Standards and Tolerances 2017, Section 13 (Plumbing and Drainage), notes that drainage systems should be installed in accordance with relevant standards, including correct fitting of drain covers and grates to ensure hygiene, safety, and protection from blockages.

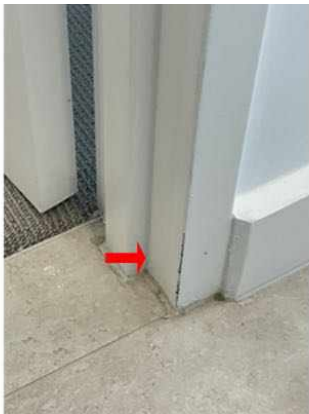
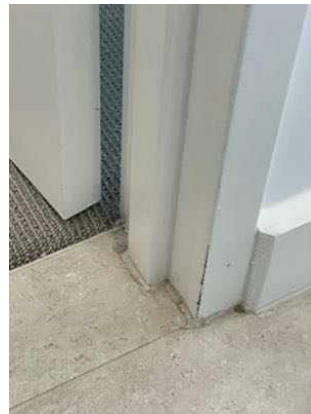
### Defects 3.06

Building: Main Building  
 Location: Bedroom - Master  
 Finding: Paint - Substandard  
 Information: Areas were identified where the surface finish of the painting is substandard and this is considered a defect.

Any irregularity in the surface which is visible from a normal viewing position is considered a defect. Marks may also be a result of fault by other tradespeople throughout the construction process.

Defective surface finish of paintwork is marked with an arrow to the below photos in the following locations.

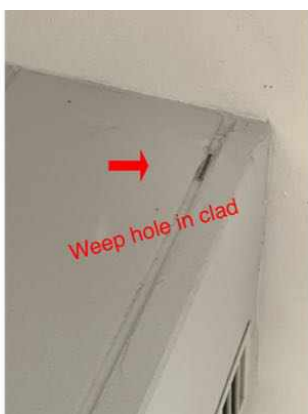
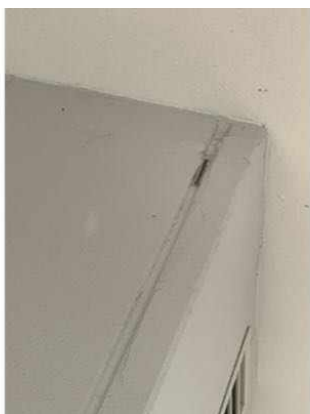
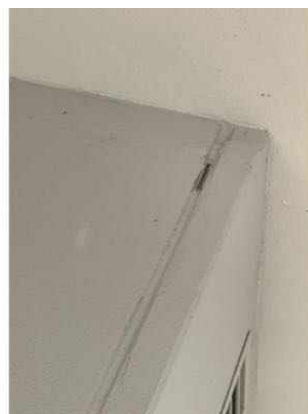
### Defects 3.07

Building:	Main Building
Location:	Yard
Finding:	Weep Hole to External Cladding- suspected non compliance
Information:	A weep hole has been observed to the external wall cladding system. The installation appears inconsistent and may not comply with the manufacturer's installation requirements.

Incorrectly installed or non-compliant weep provisions may allow moisture ingress behind the cladding system or restrict adequate drainage and ventilation, potentially leading to concealed moisture damage over time.

It is recommended that the cladding manufacturer's installation manual and system specifications be reviewed to confirm compliance. A suitably qualified builder or façade specialist should assess and rectify as required.

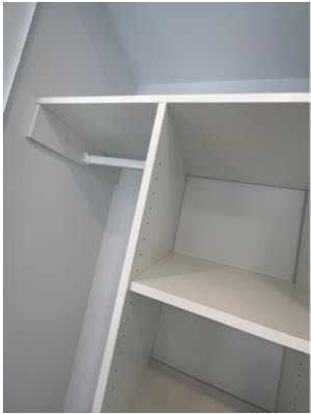
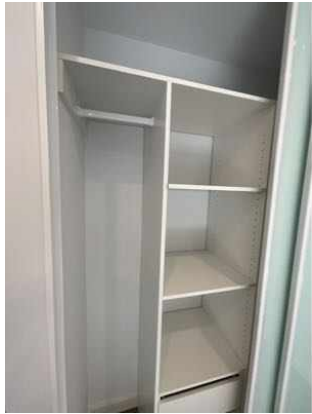
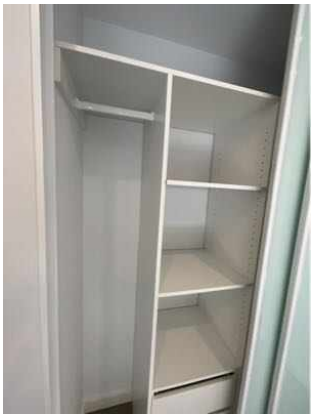
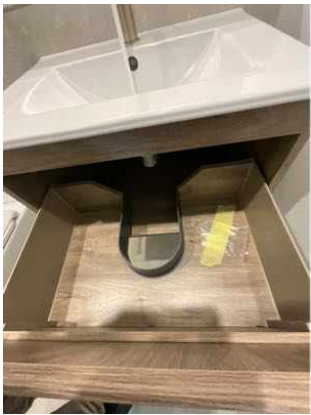
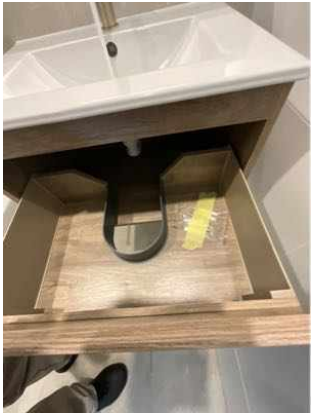
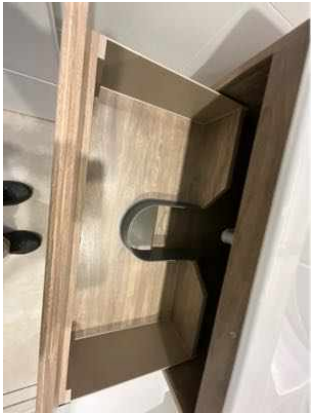
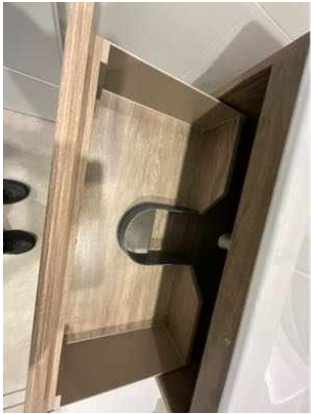
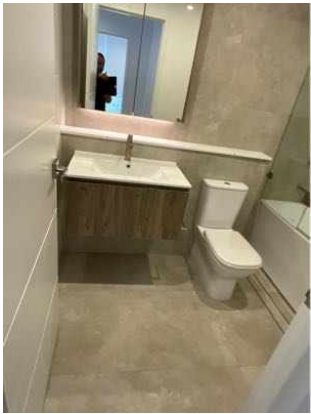
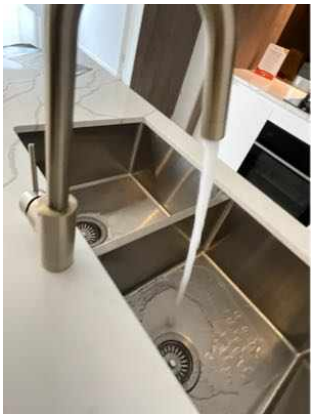
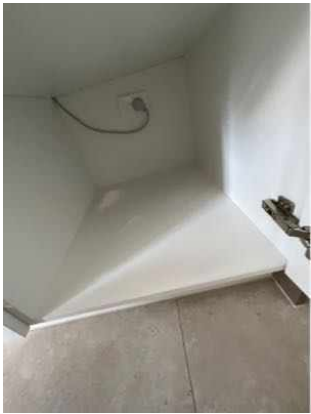
#### Noted Item

Building: Main Building  
Location: All Areas  
Finding: Additional Photos - Obstructions and Limitations  
Information: These photographs are an indication of the obstructions and limitations which impeded full inspection of the property at the time of inspection. These obstructions can hide an array of defects and should be removed to allow full inspection to be carried out. A re-inspection is recommended once the areas are made accessible.

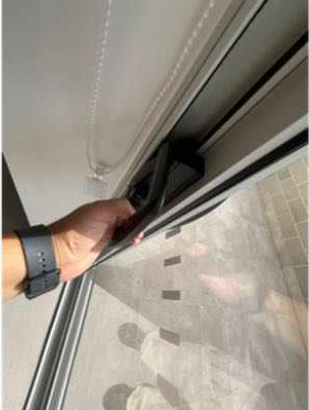
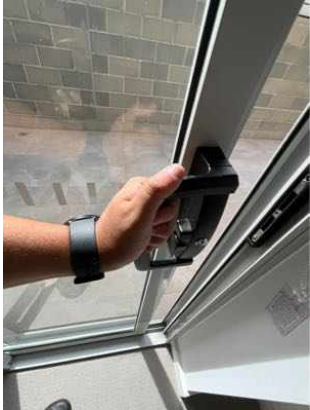
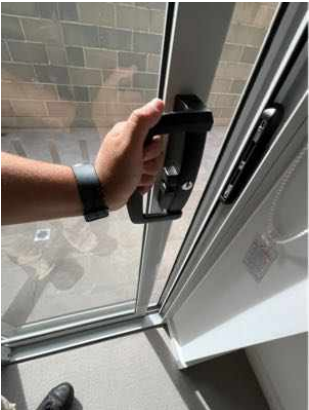
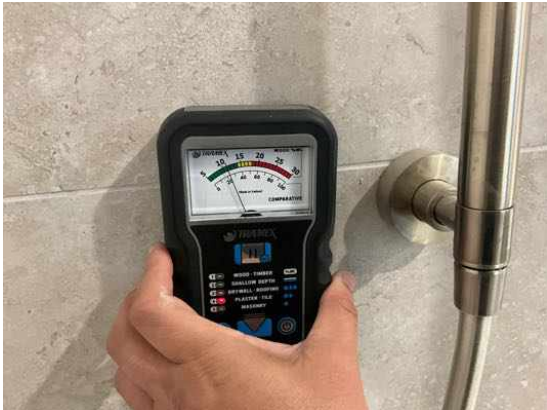
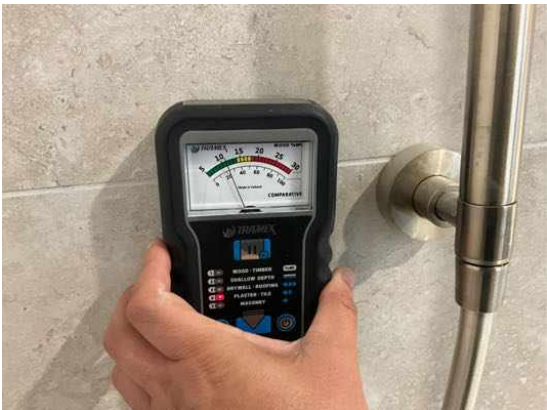
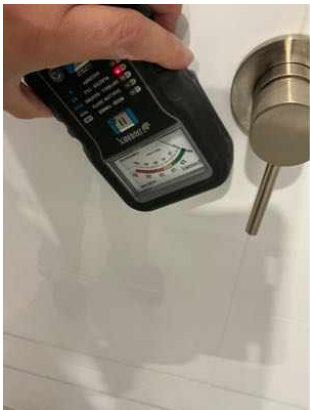
Noted Item

Building: Main Building  
Location: All Areas  
Finding: Additional Photos  
Information: Additional photos are provided for your general reference
