Building and Timber Pest Inspection Report

Inspection Date: Tue, 3 Mar 2026

Property Address: 2 Cloud Cl, Redan VIC 3350, Australia

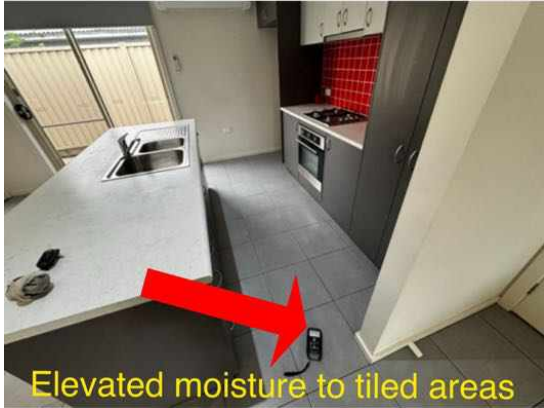
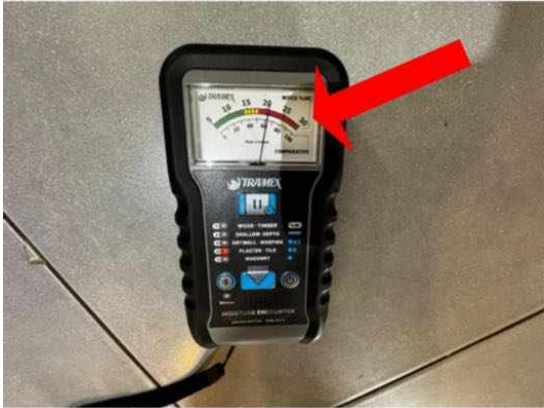
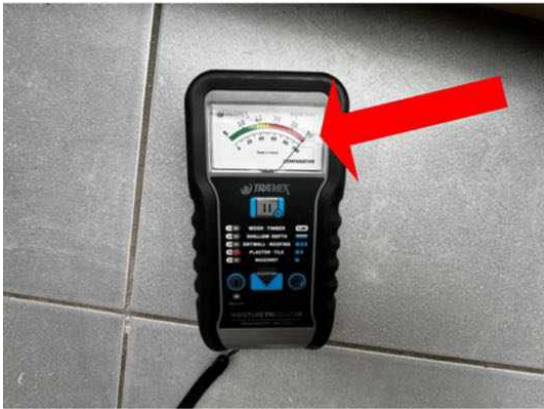
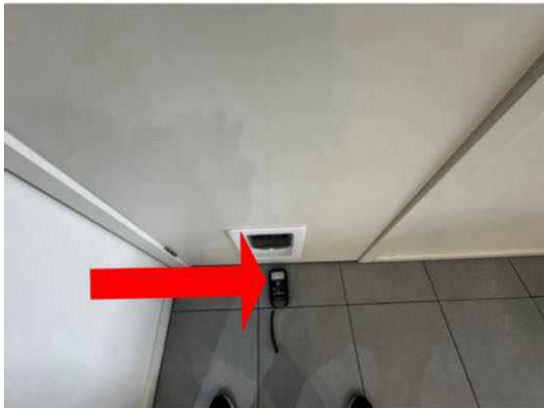
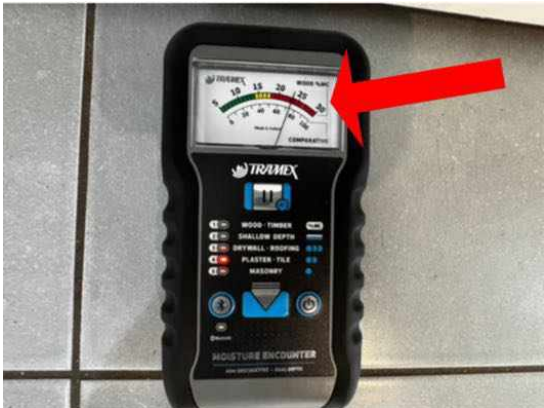
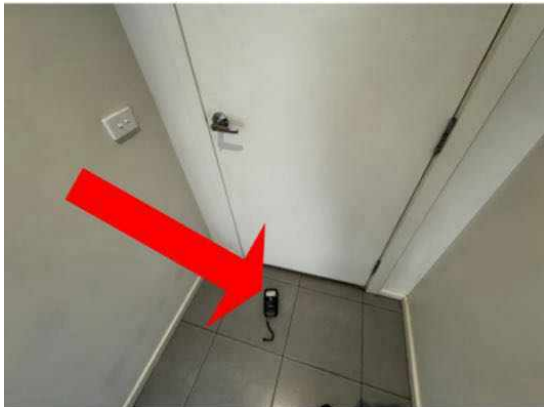
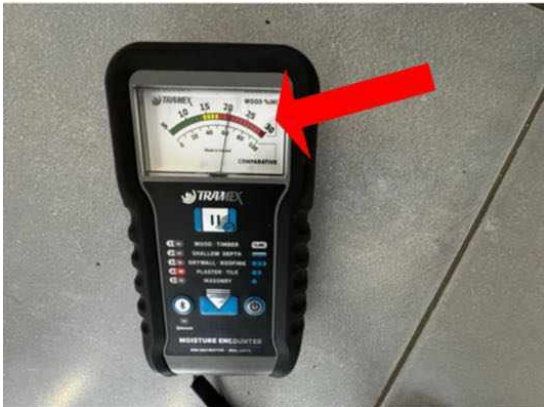
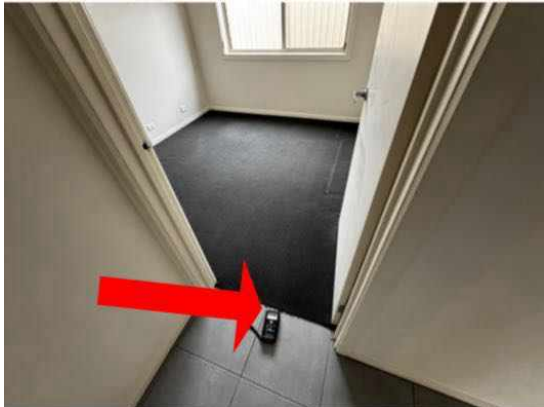
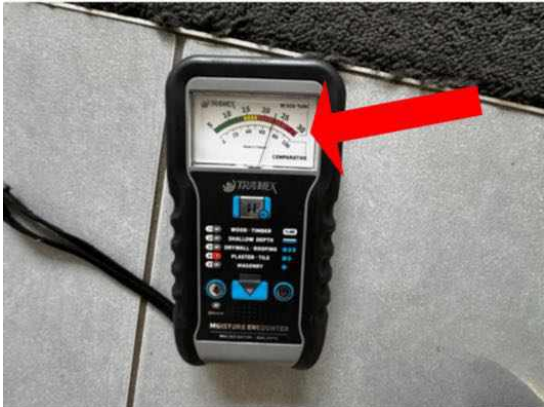
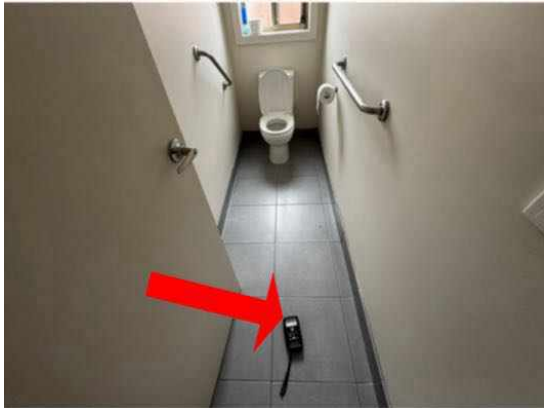
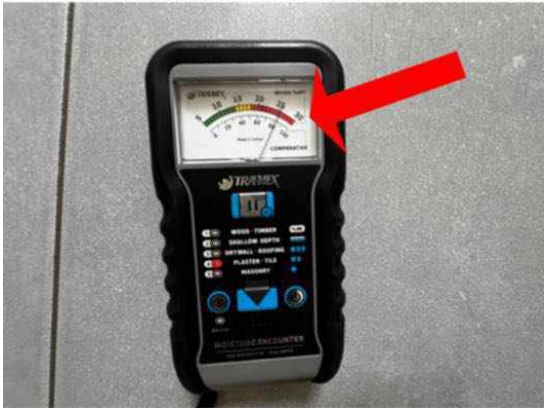
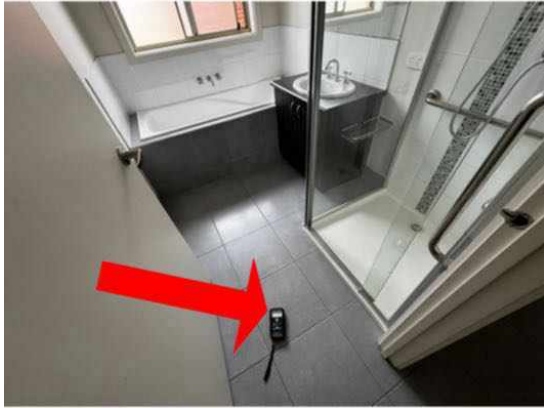
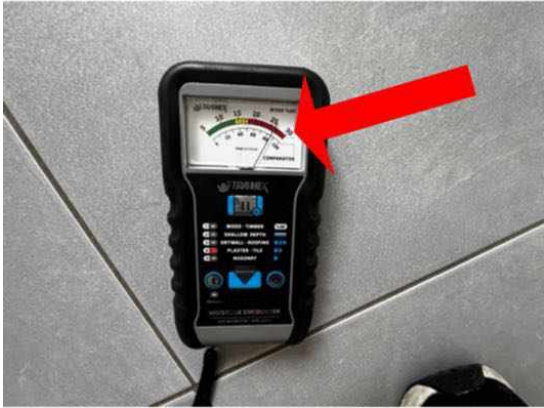
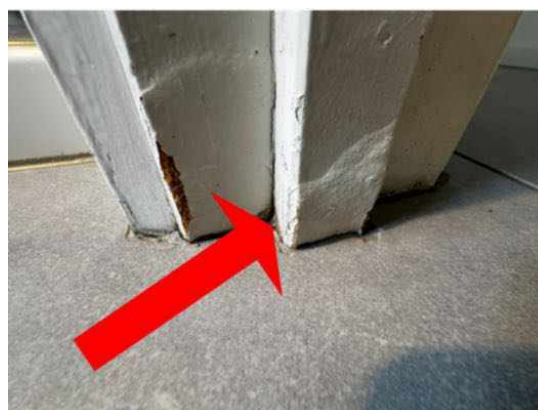
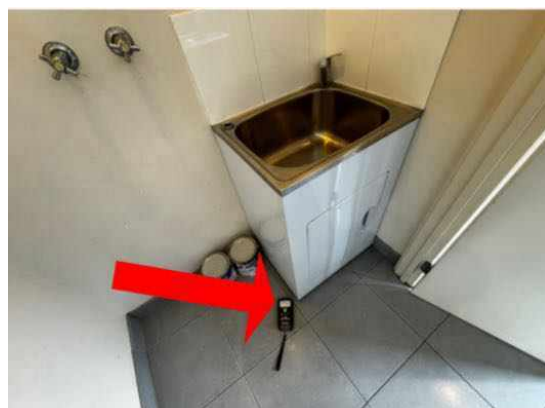
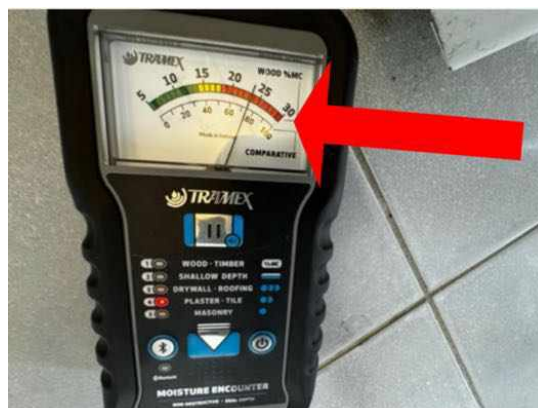
Building: Main Building
Location: All Tiled Areas > All Areas
Finding: Elevated Moisture Levels – Floor Tiled Areas (Major Defect)
Information: Elevated moisture readings ranging from approximately 60% to 100% were detected using a moisture meter to all floor tiled areas within the dwelling. The elevated readings were consistent across the tiled areas. Minor moisture-related swelling was observed to the bathroom door jamb, which is consistent with prolonged exposure to moisture.

No active water leaks were identified during the inspection. It should be noted that running water was not available at the time of inspection, which limited the ability to fully test plumbing fixtures and wet areas. Moisture testing of adjoining carpeted areas did not reveal elevated readings, suggesting that the moisture appears to be largely confined to the tiled areas.

The source of the elevated moisture readings could not be determined at the time of inspection. Possible causes may include historical water leaks, a concealed plumbing leak beneath the slab or within wall cavities, failure of waterproofing in wet areas, or excessive wet mopping practices. Regardless of the cause, the presence of widespread elevated moisture readings indicates a potential underlying issue.

Further investigation recommended in the short term due to the extent of elevated moisture readings and potential risk of concealed damage.

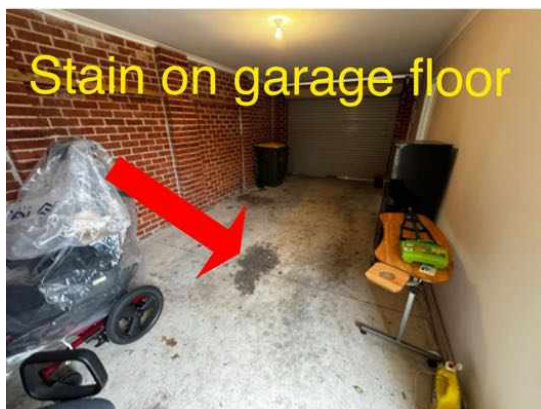
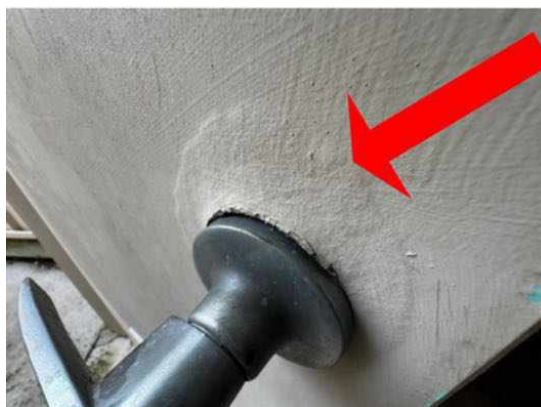
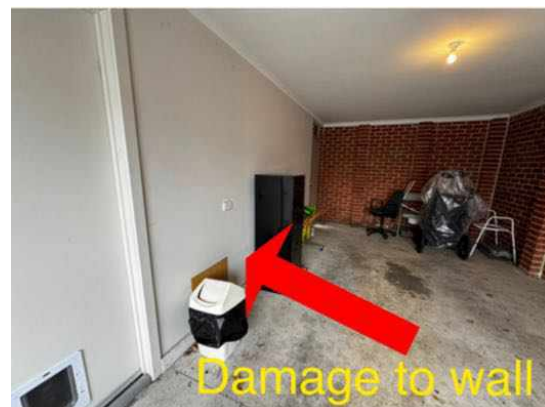
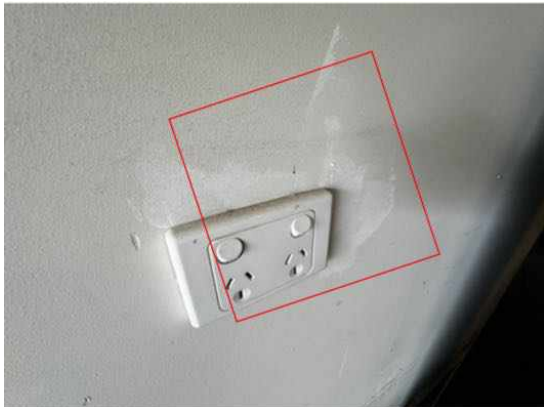
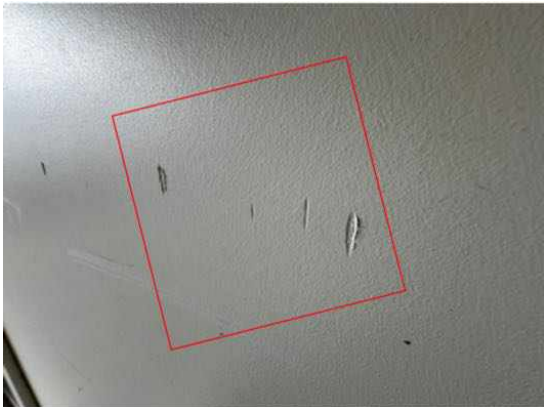
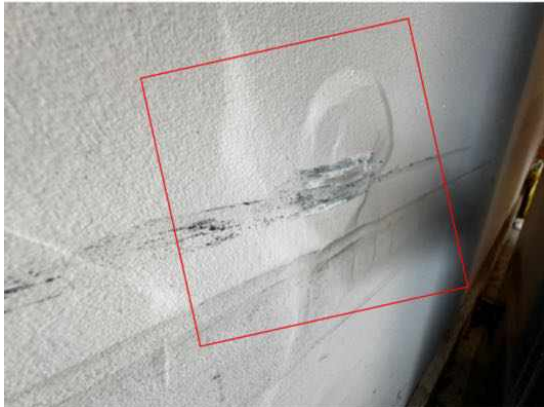
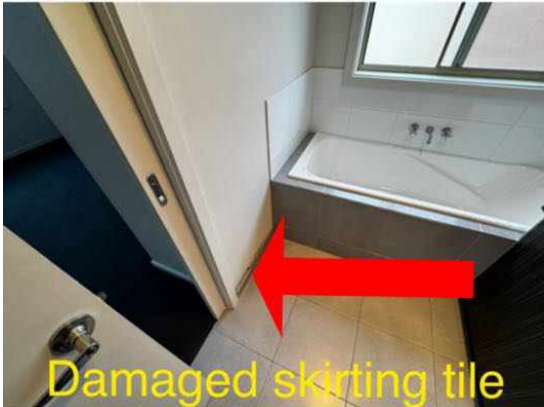
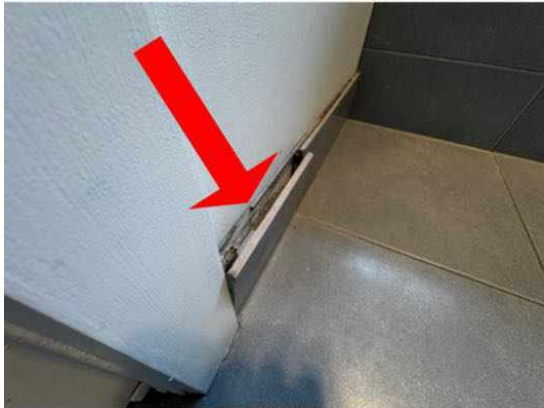
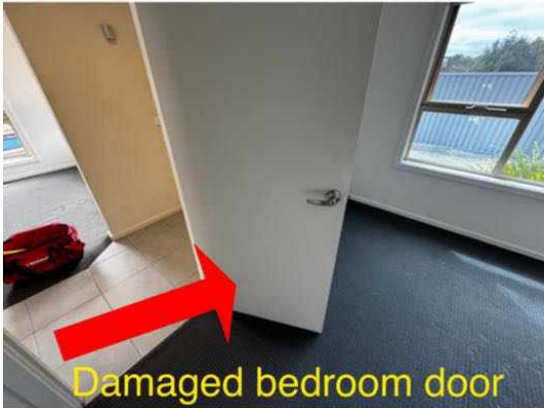
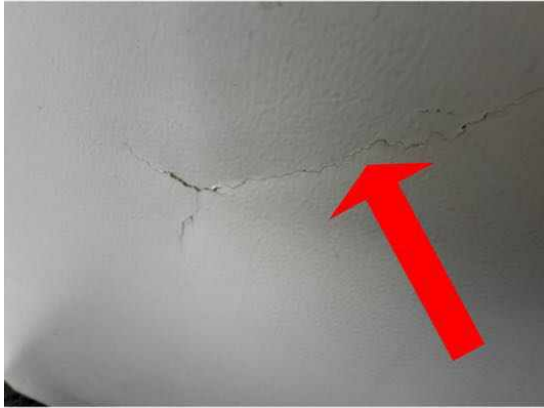
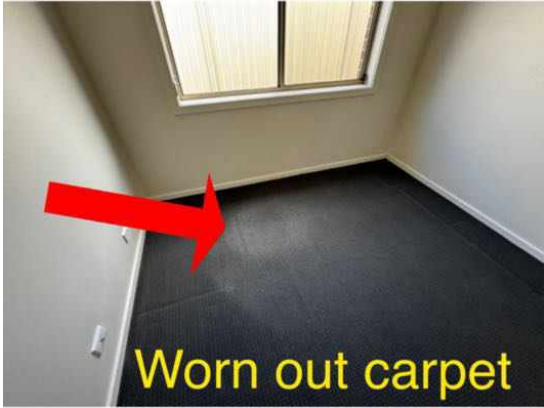
Finding 3.02

Building:	Main Building
Location:	All Areas > All Areas
Finding:	Minor Internal Defects – Garage, Doors, Flooring and Joinery
Information:	The following minor internal defects were observed during the inspection:

In the main bathroom, the tile skirting was observed to be partially separating from the

Maintenance recommended in the short to medium term.

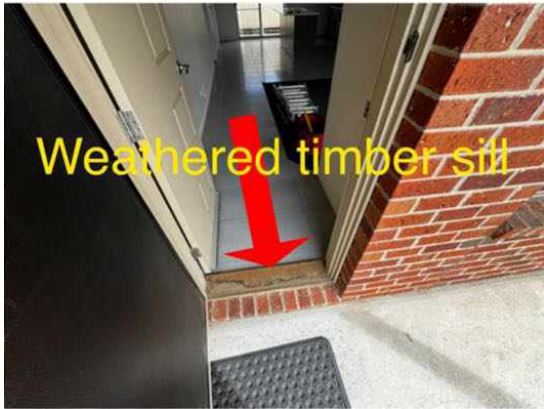
Weathered timber sill

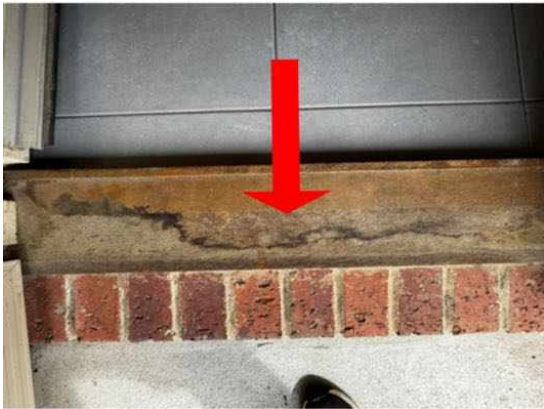
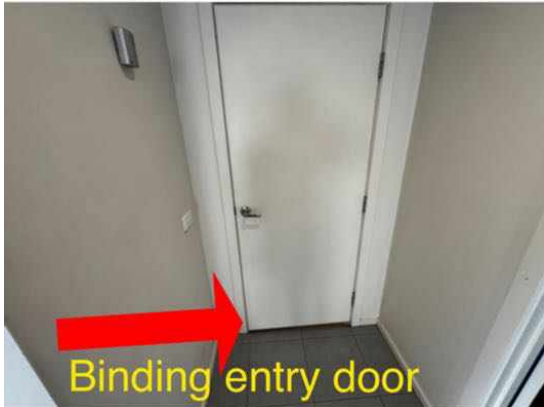
Binding entry door

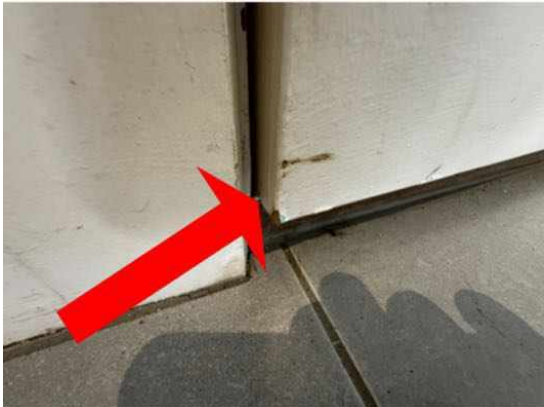
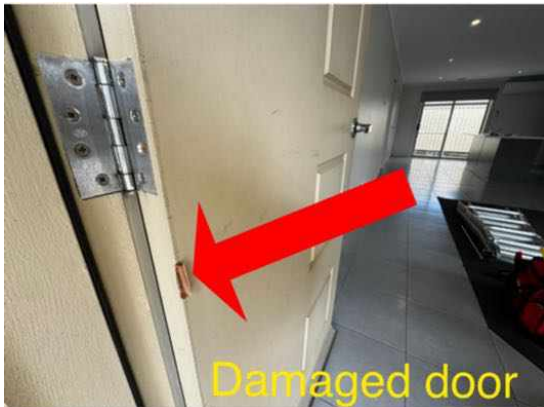
Damaged door

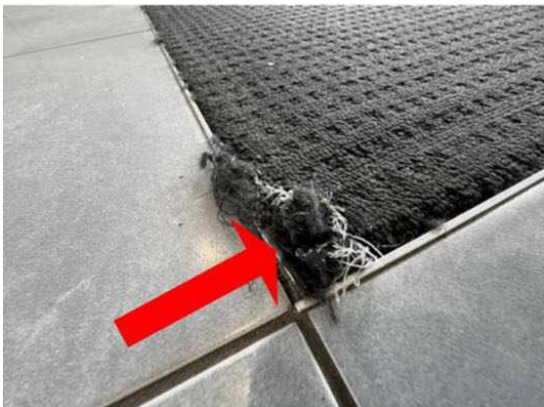
Damaged carpet

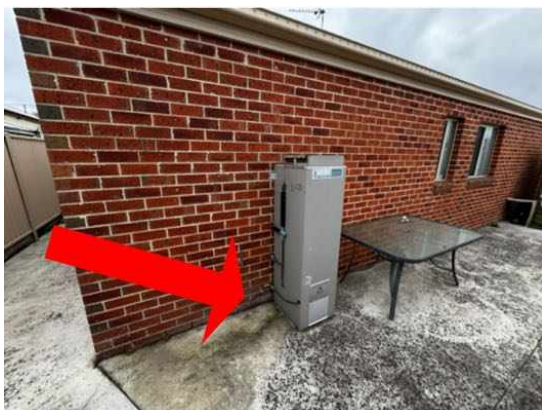
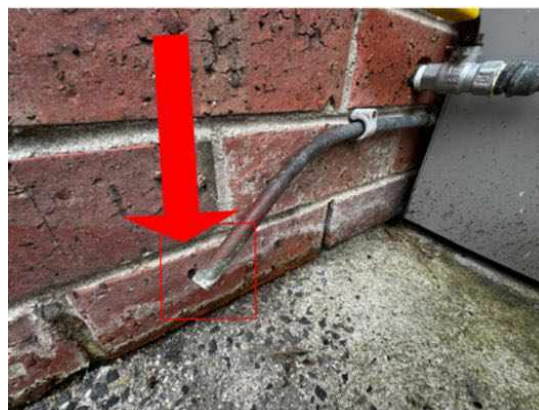
Building:	Main Building
Location:	Walls > Rear Left
Finding:	Uncontrolled discharge from hot water unit (TP)
Information:	At the time of inspection, the hot water unit located to the rear of the building was observed to have an overflow pipe discharging directly onto the ground, rather than being connected to a suitable drainage system. This condition allows ongoing moisture to accumulate at the base of the building and surrounding soil.

Conditions that promote persistent dampness or poor drainage around a building are recognised as conducive to termite activity, as elevated moisture levels can attract subterranean termites and support concealed foraging activity. Uncontrolled discharge from hot water system overflows may therefore increase moisture-related deterioration and termite risk.

As a result, the discharge from the air conditioner unit overflow is considered to contribute to conditions conducive to termite activity. It is recommended that a licensed plumber be engaged to connect the overflow pipe to an appropriate drainage point, ensuring that water is not discharged directly onto the ground adjacent to the

building, with further advice from a licensed termite management or pest control contractor where elevated termite risk is identified.

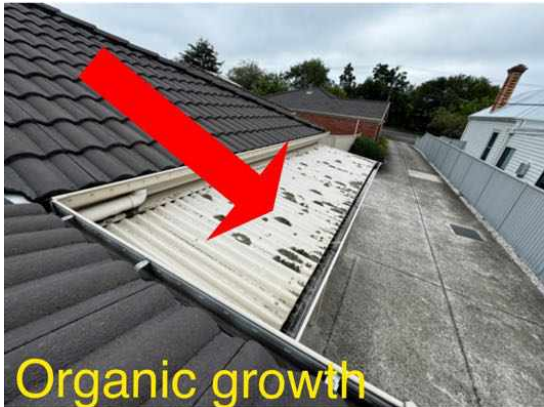
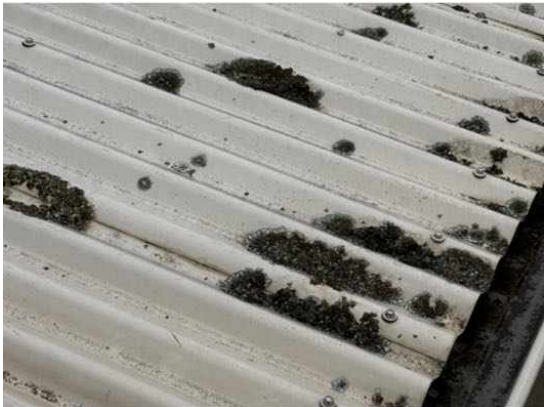
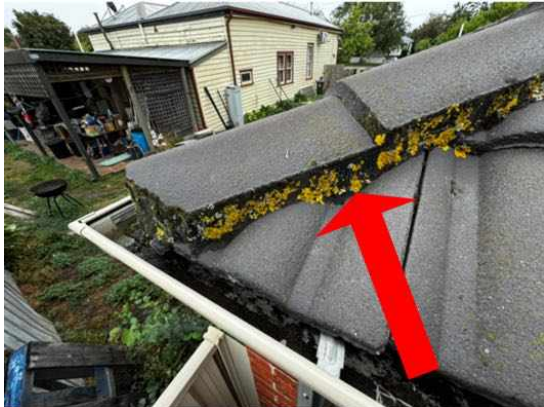
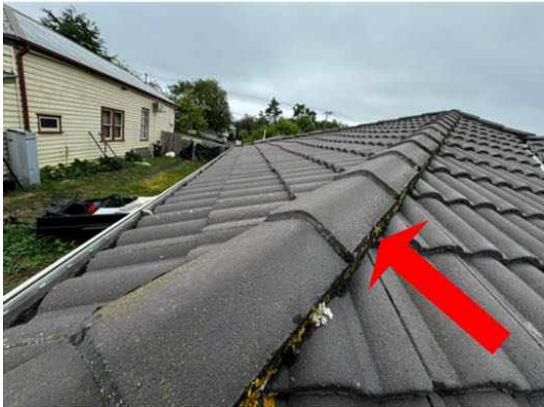
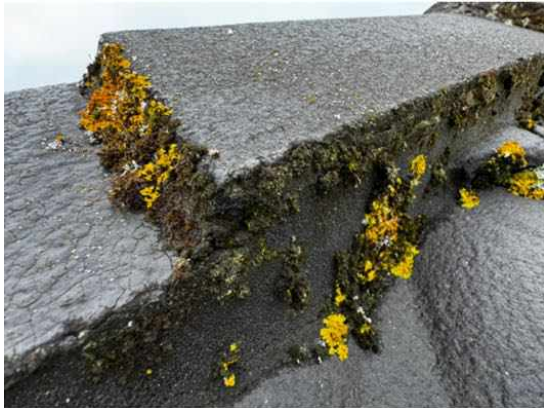
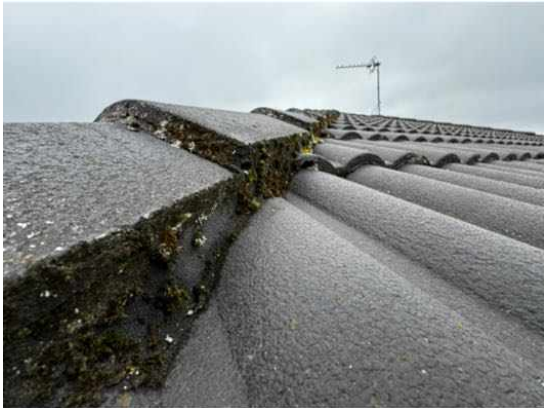
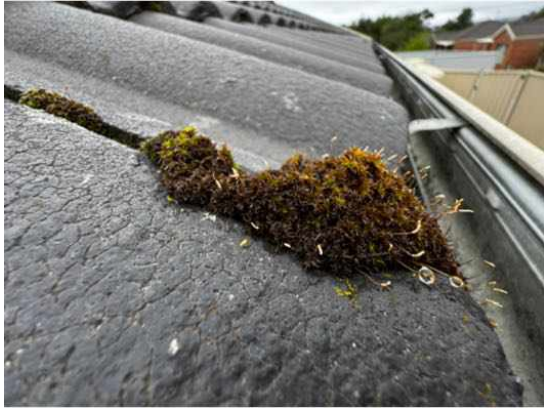
Finding 6.05

Building:	Main Building
Location:	Roof Exterior > All Areas
Finding:	Organic growth on roof (TP)
Information:	At the time of inspection, organic growth was observed to the roof areas. These conditions promote prolonged moisture retention and the potential for blockage of roof drainage, the issue is suspected to be associated with a lack of routine maintenance.

In accordance with AS 3660.2, conditions that promote ongoing dampness and moisture accumulation are recognised as increasing termite risk to existing buildings, as elevated moisture levels can create environments conducive to termite foraging and concealed activity. The potential for blocked gutters and downpipes may allow water to overflow or discharge against building elements, increasing moisture exposure to adjacent materials and reducing the effectiveness of termite risk management through visual inspection.

As a result, the observed organic growth are considered to increase moisture-related deterioration and elevate the overall risk of termite activity. It is recommended that an appropriately qualified roof plumber be engaged to clean and service the gutters and downpipes and that roof surfaces be maintained to reduce moisture retention, with ongoing monitoring and advice from a licensed termite management or pest control contractor where elevated termite risk is identified.

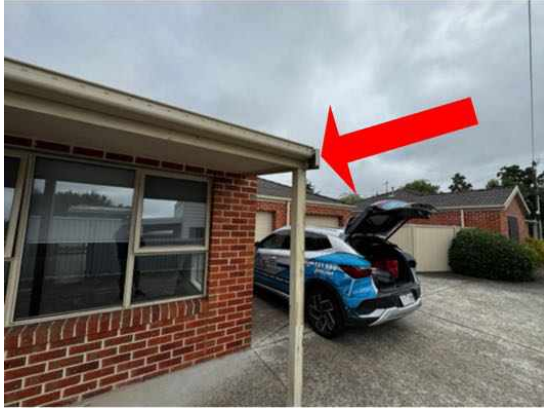
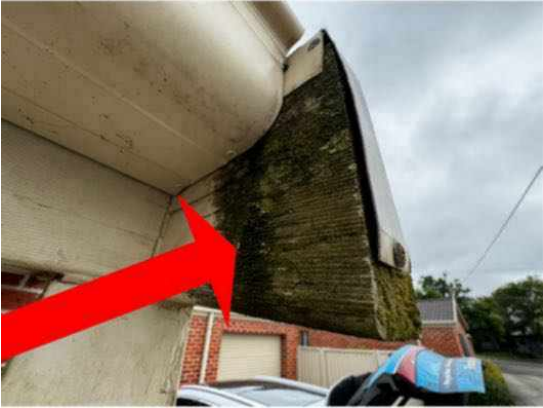
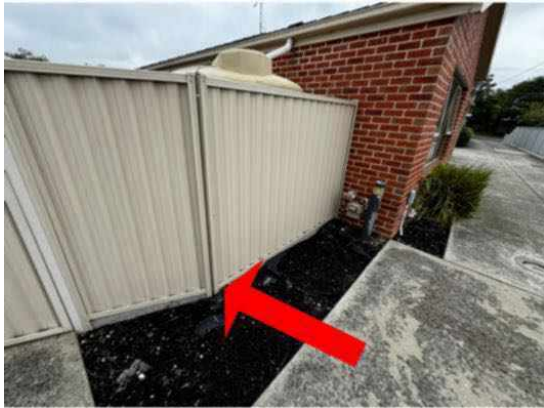
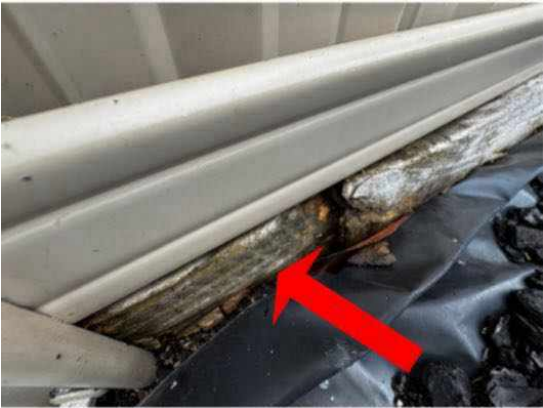
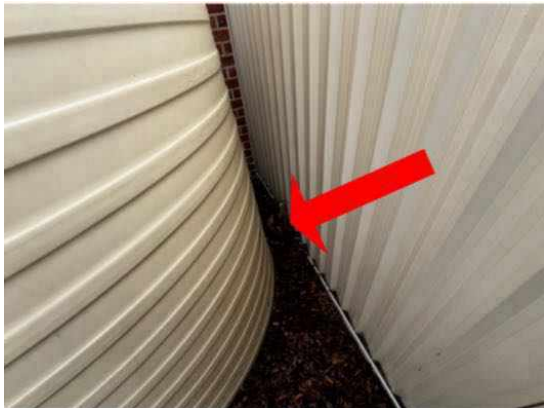
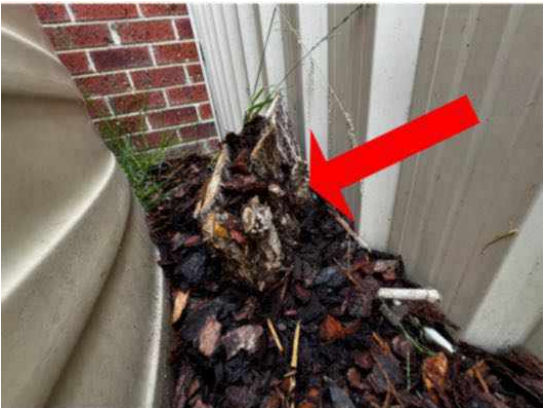
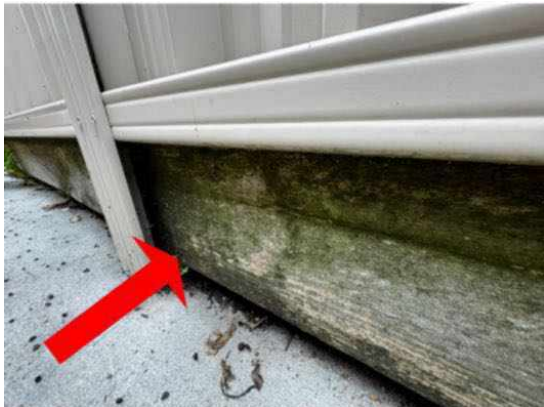
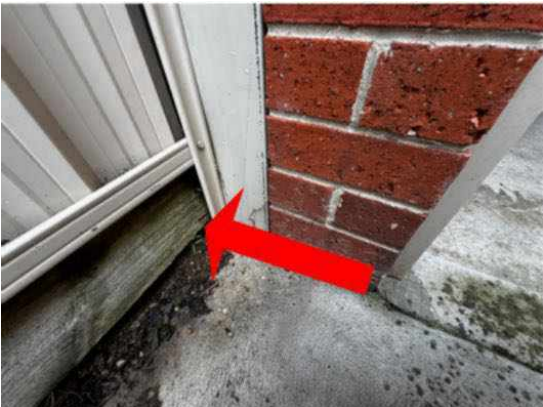
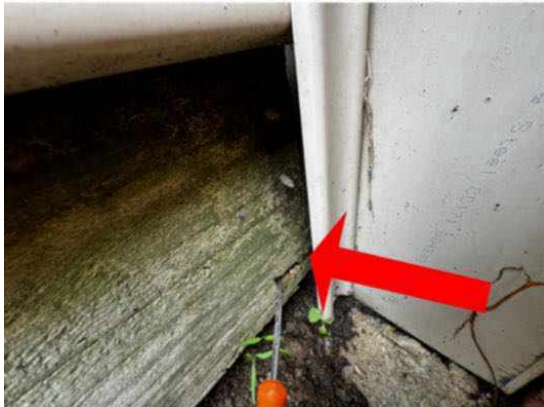
Building:	Main Building
Location:	All Areas > All Areas
Finding:	Timber decay & rot - Conducive conditions (TP)
Information:	At the time of inspection, evidence of timber decay at varying stages was observed to the timbers under fence panels, fascia board on front porch, and dead tree stump next to water tank.

These conditions are suspected to have developed over time due to prolonged moisture exposure and a lack of appropriate timber maintenance, allowing moisture ingress and decay to progress within the timber elements. In accordance with AS 3660.2, deteriorated and moisture-affected timber is recognised as increasing the risk of termite activity, as decayed timber can attract termites and may provide concealed access or harbourage, particularly where defects are obscured by finishes such as paint.

As a result, these condition are considered to present an elevated risk of ongoing

deterioration and potential termite susceptibility. It is recommended that an appropriately qualified builder or carpenter be engaged to further assess the extent of timber decay, remove any concealed deteriorated material, and undertake suitable repairs or replacement, with consideration also given to advice from a licensed termite management or pest control contractor where termite risk is identified.

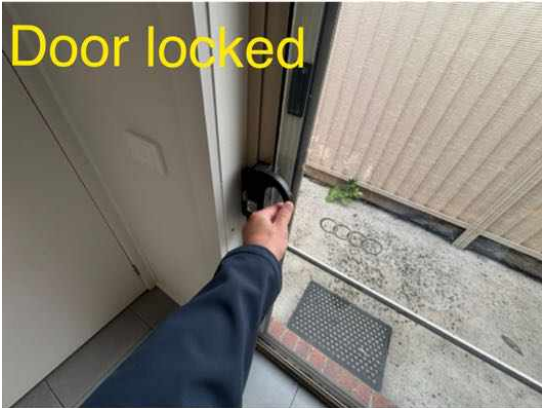
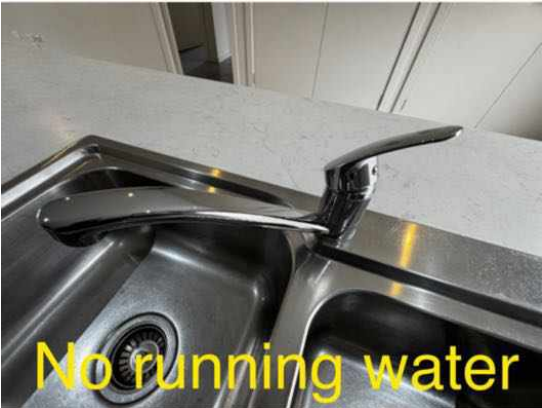
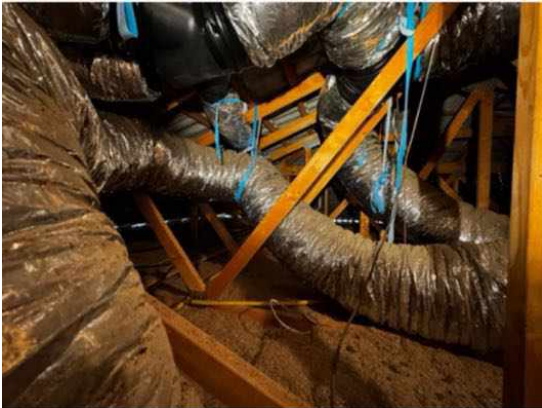
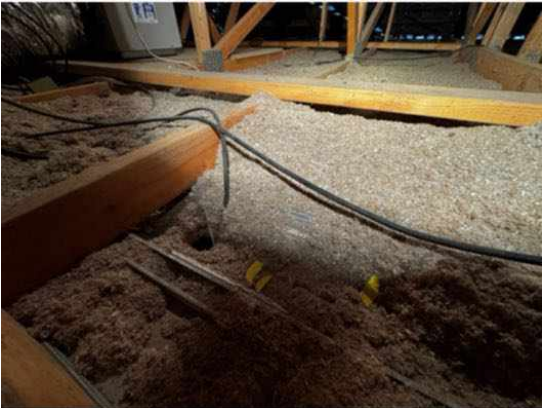
Building: Main Building
Location: All Areas > All Areas
Finding: Additional Photos - Obstructions and Limitations
Information: These photographs are an indication of the obstructions and limitations which impeded full inspection of the property at the time of inspection. These obstructions can hide an array of defects and should be removed to allow full inspection to be carried out. A re-inspection is recommended once the areas are made accessible.

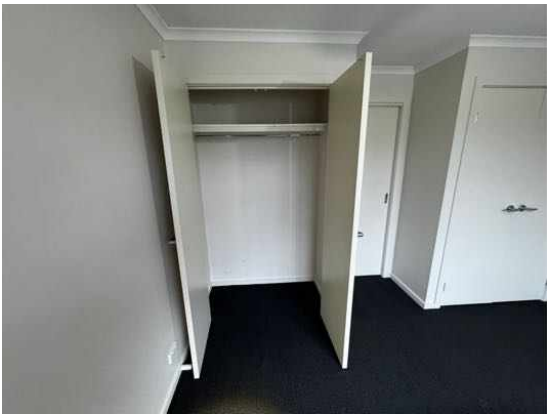
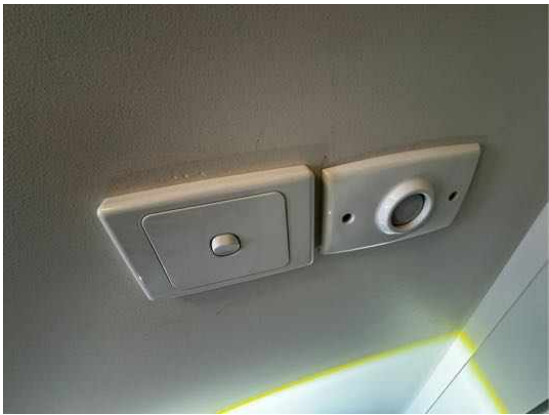
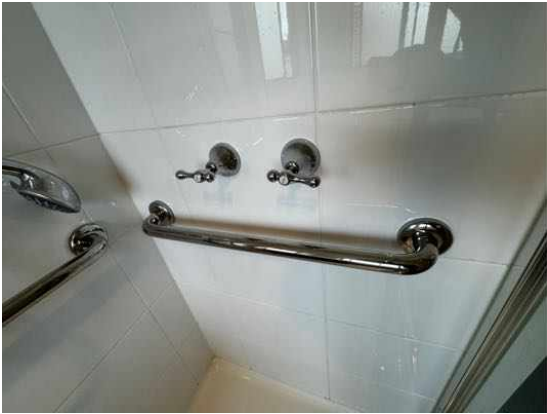
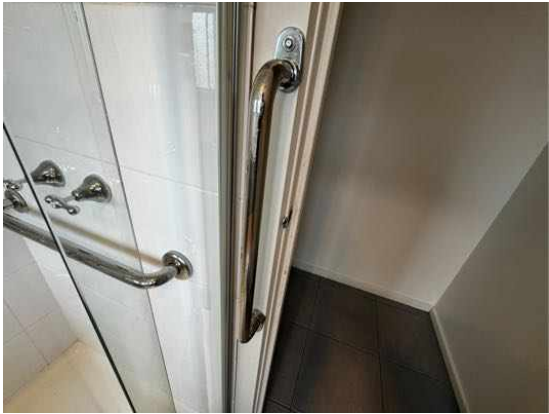
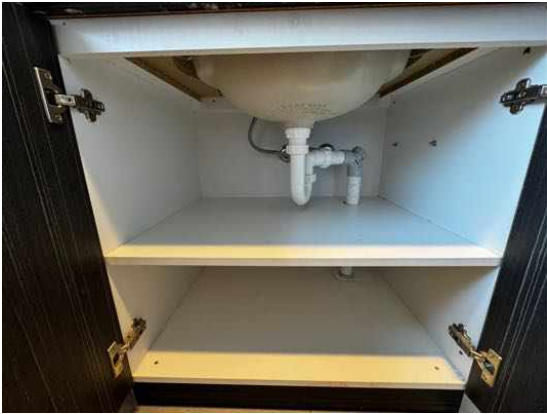
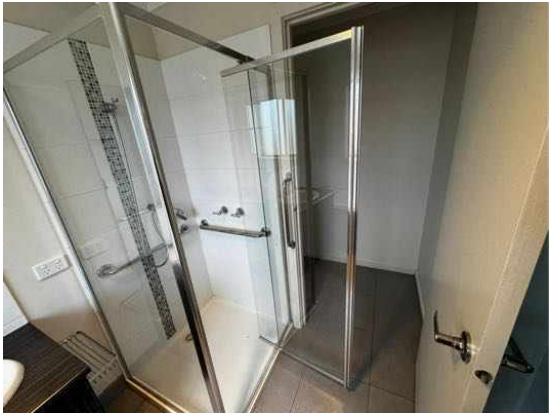
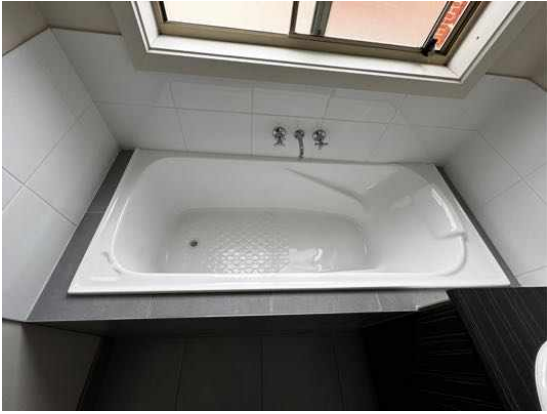
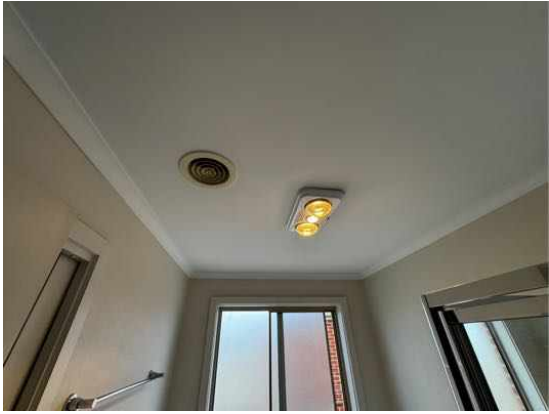
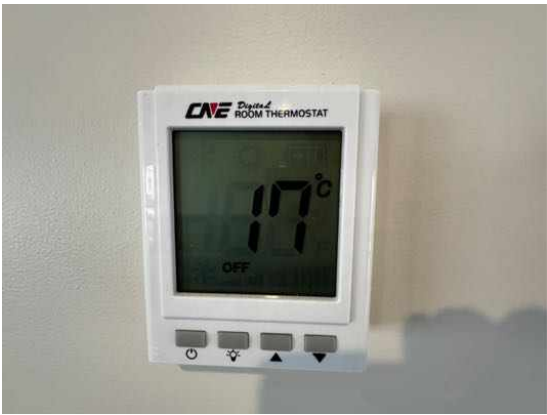
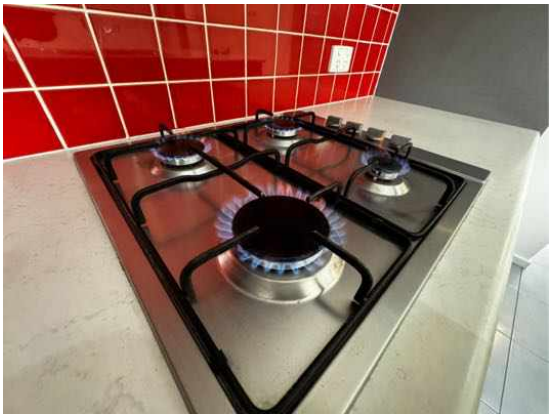
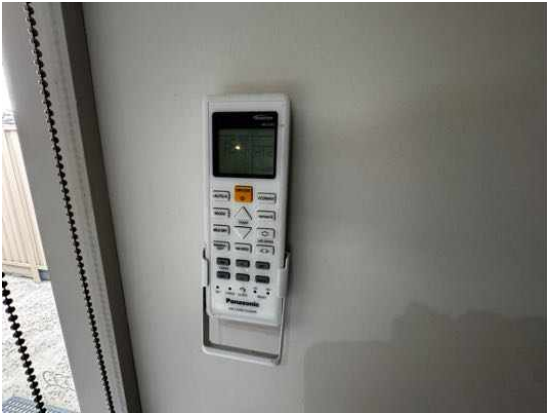
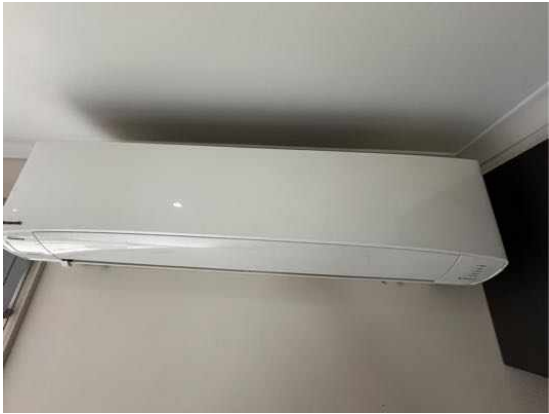
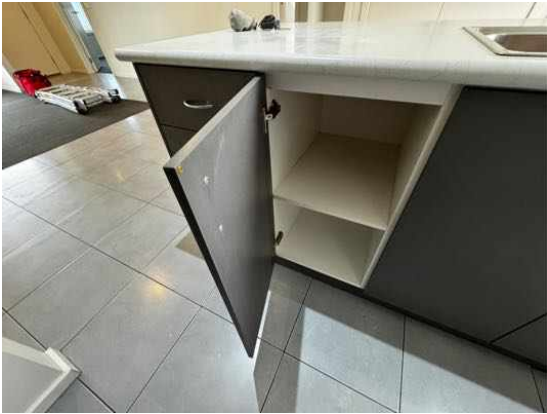
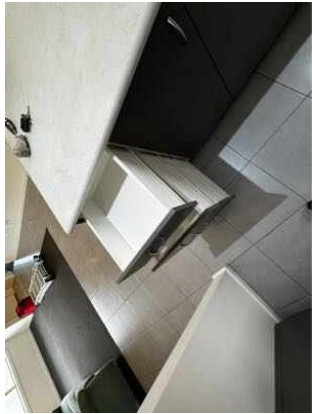
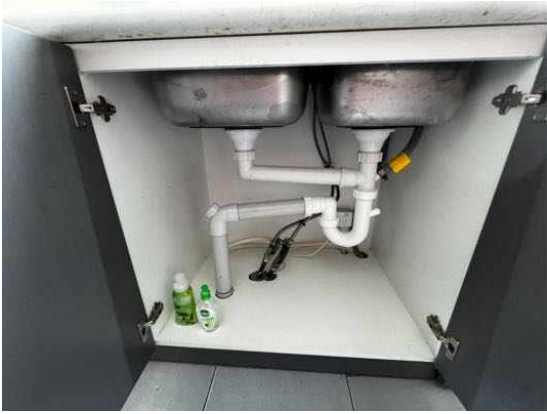
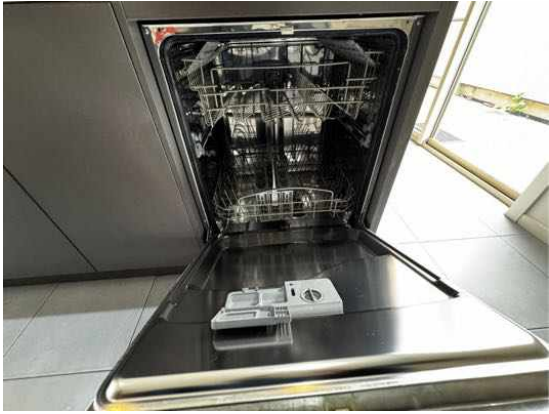
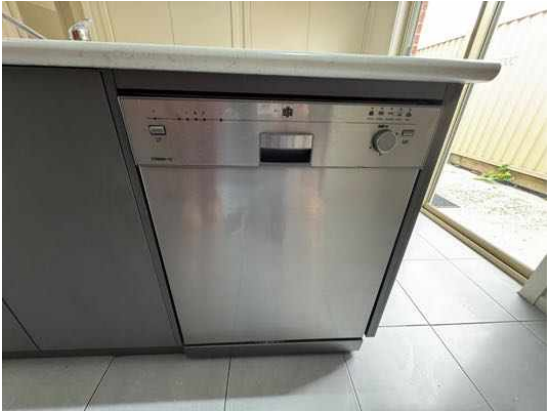
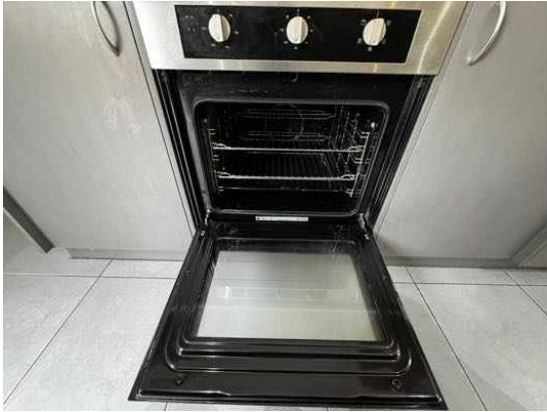
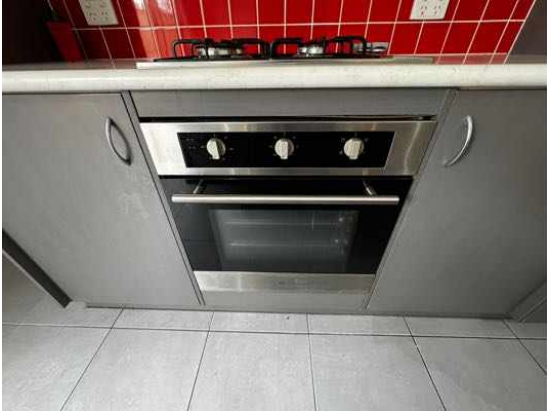
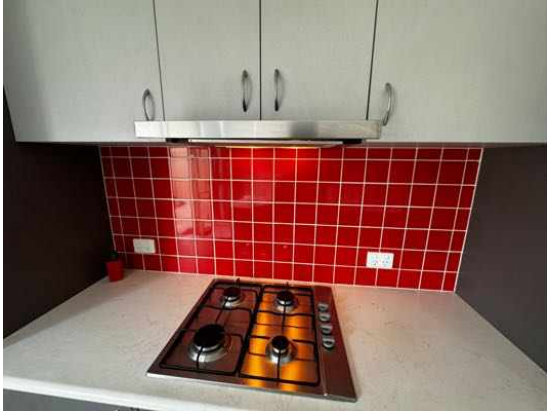
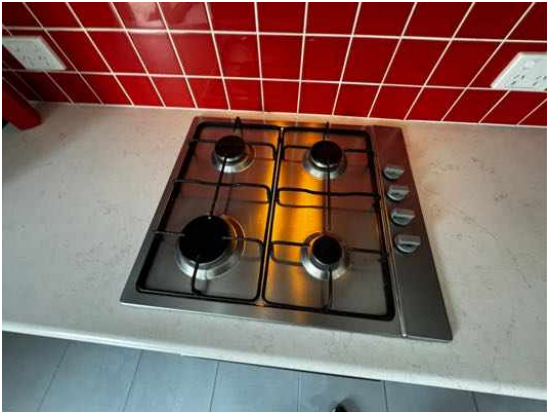
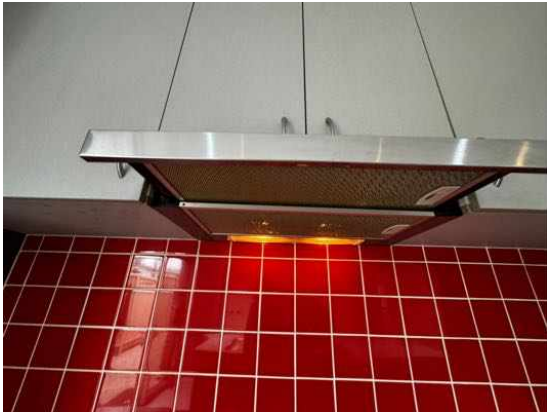
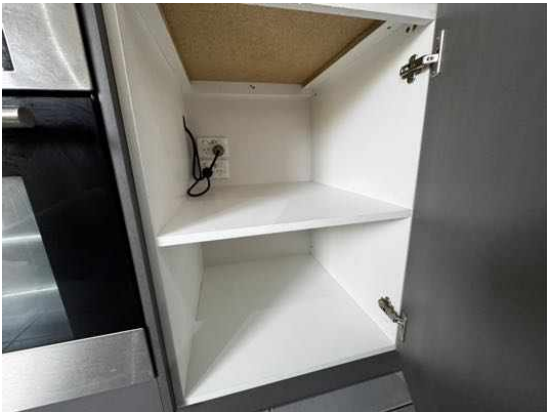
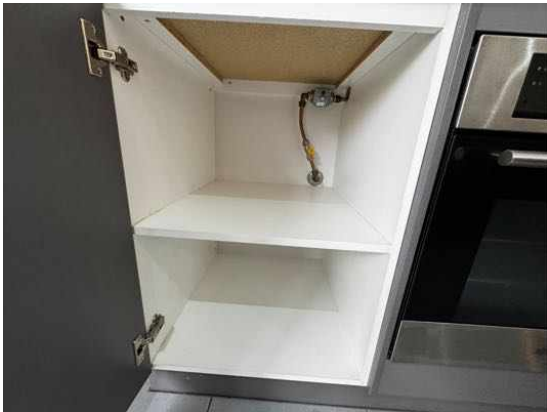
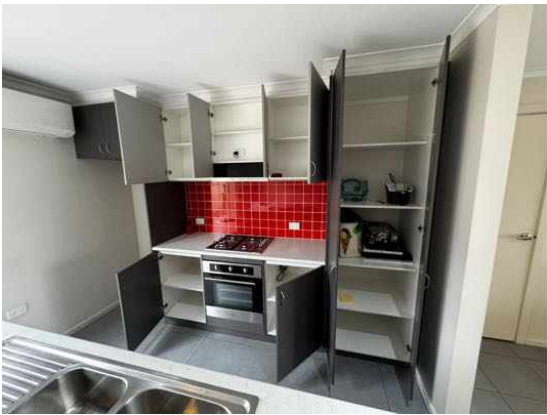
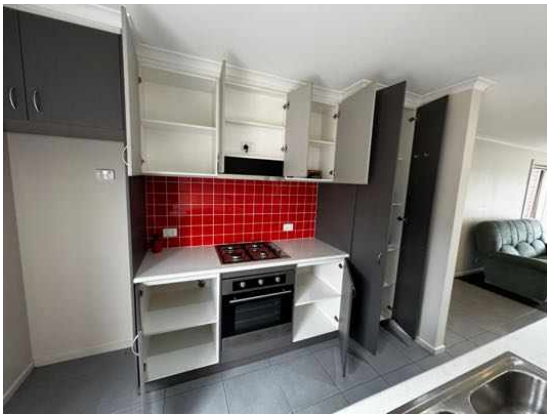
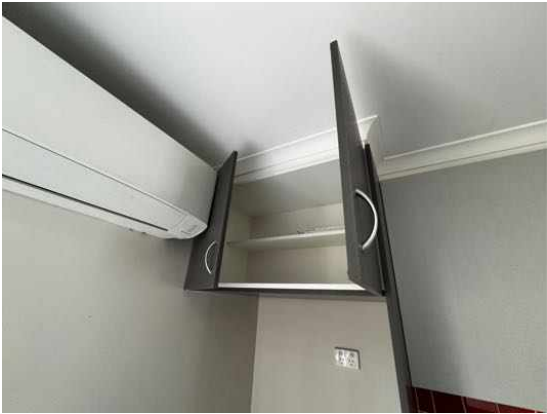
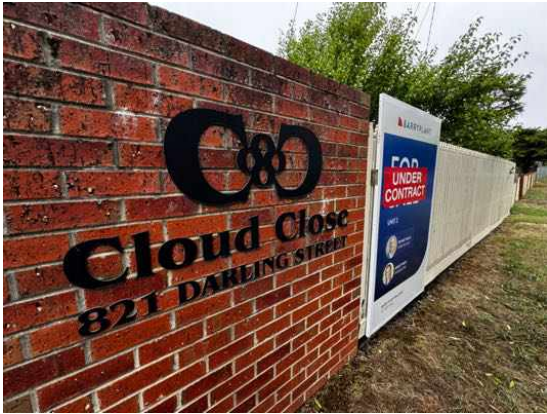
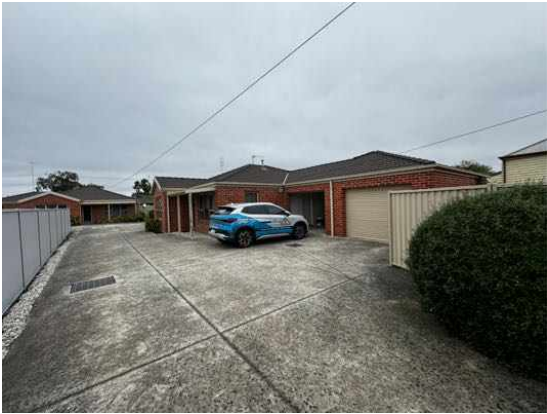
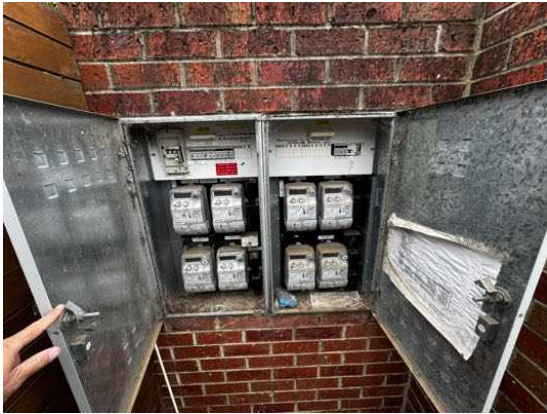
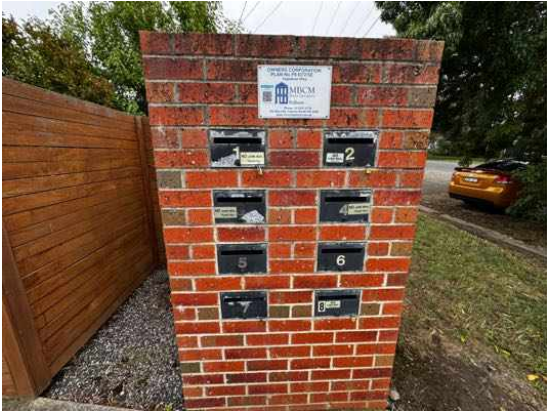
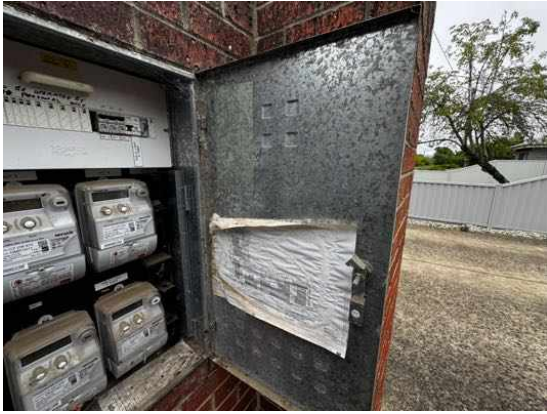
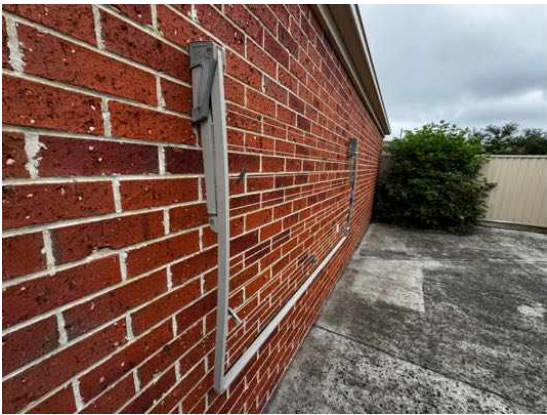
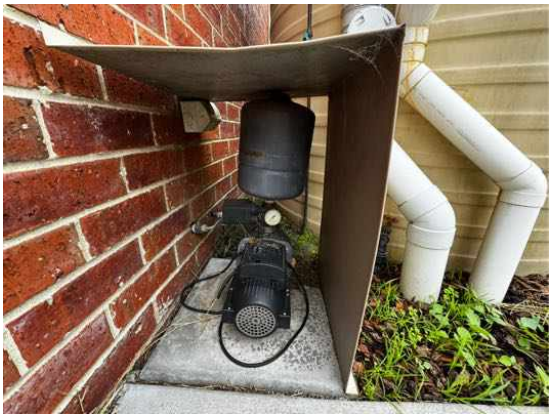
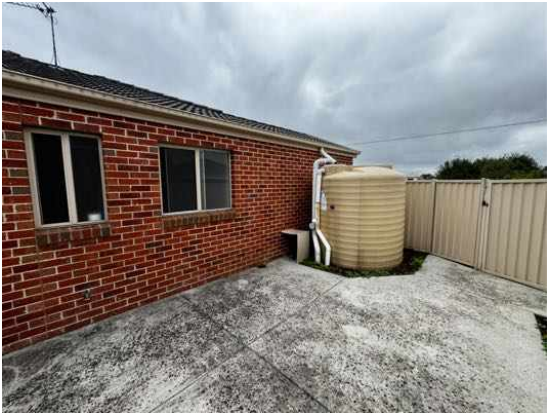
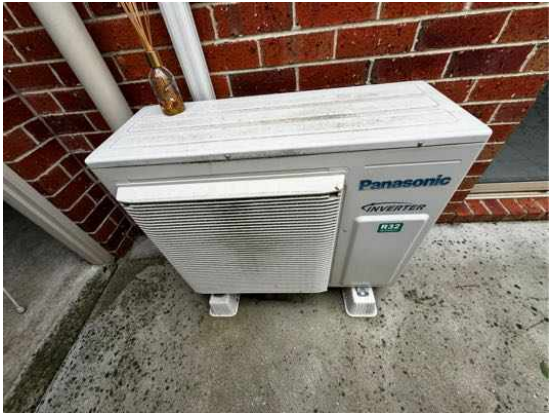
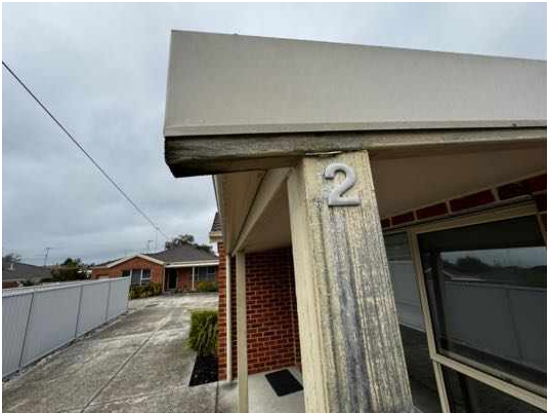
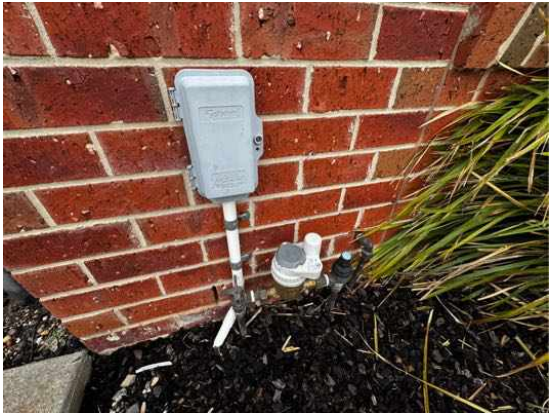
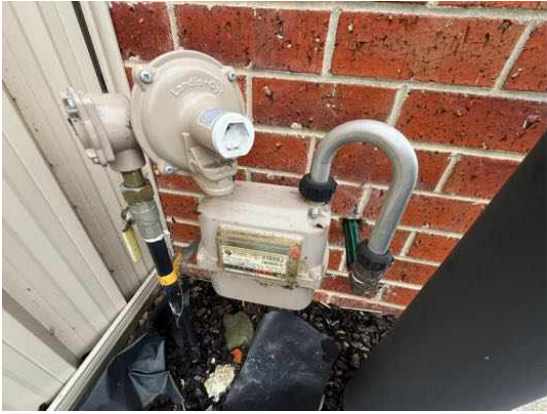
Building: Main Building
Location: All Areas > All Areas
Finding: Termite investigation techniques (TP)
Information: All accessible areas of the dwelling were inspected, with particular attention paid to wet areas, which were closely assessed for elevated moisture levels and temperature anomalies that may indicate conditions conducive to termite activity.

In an attempt to identify concealed or hidden timber pest activity, a range of inspection techniques were adopted. These included the use of a moisture meter to assess susceptible areas, sounding of timber elements using a handheld probing device, and visual assessment of materials for signs commonly associated with termite activity. These signs include moisture-related deterioration, deformation of timber, termite mud leads or bridging, and irregular or regular shaped holes within timber elements that may indicate pest-related damage.

It is noted that termite activity can generate increased moisture and localized temperature variations, and where such irregularities are detected, further investigation may be warranted. However, it is also acknowledged that certain obstructions, including floor coverings, wall linings, wall tiles, and fixed cabinetry such as bathroom fit-offs, can conceal termite activity and limit the effectiveness of visual inspection. As a result, the absence of visible evidence at the time of inspection does not eliminate the possibility of concealed termite activity within inaccessible or obstructed areas of the building.
