Building and Timber Pest Inspection Report

Inspection Date: Thu, 26 Mar 2026

Property Address: 4 Alwyn Avenue, Wallacia NSW 2745

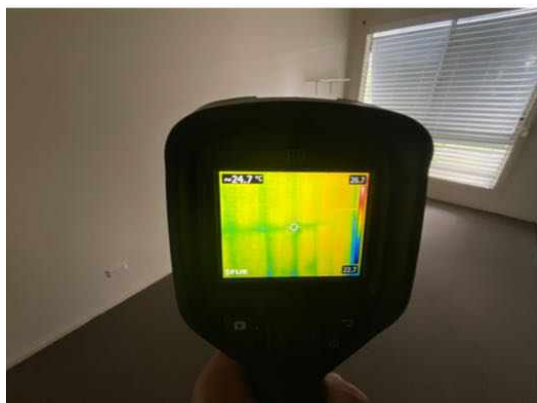
Termites release heat in the form of carbon dioxide and build mud tubes with high moisture content, which can create irregular heat patterns on surfaces such as walls, ceilings, and floors.

At the time of the inspection, no abnormalities indicating live termite activity were observed. However, it's important to note that various factors—such as obstructions, ambient temperature, and wall material/thickness—can impact the accuracy of thermal readings. In cases where surfaces are visually restricted or obstructed, a comprehensive thermal scan may not always be feasible.

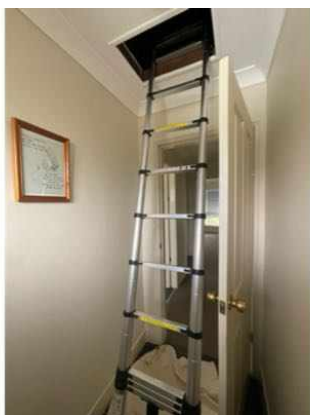
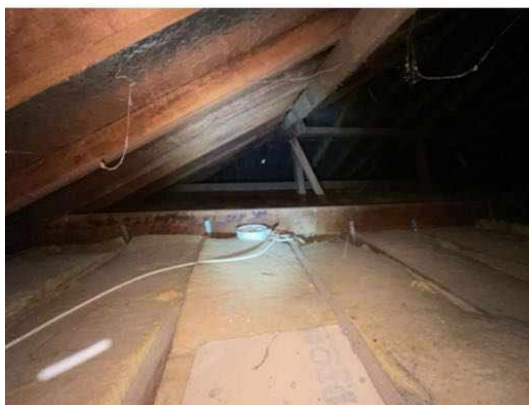
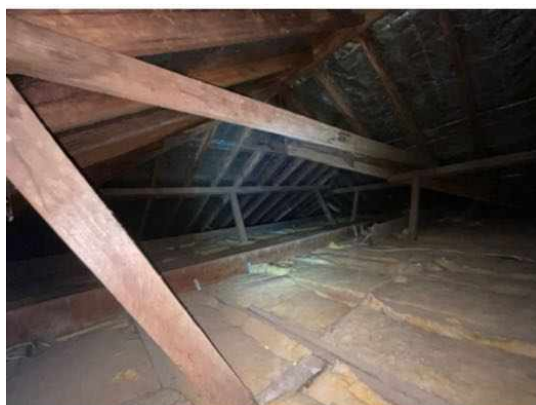
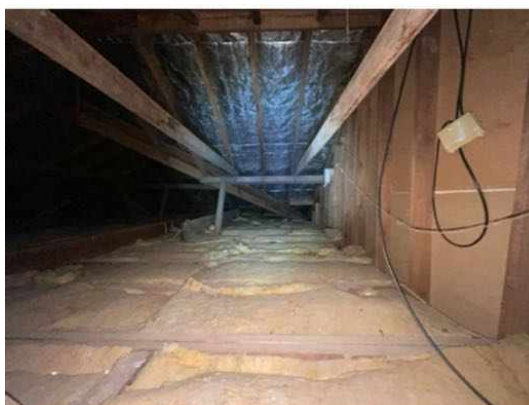
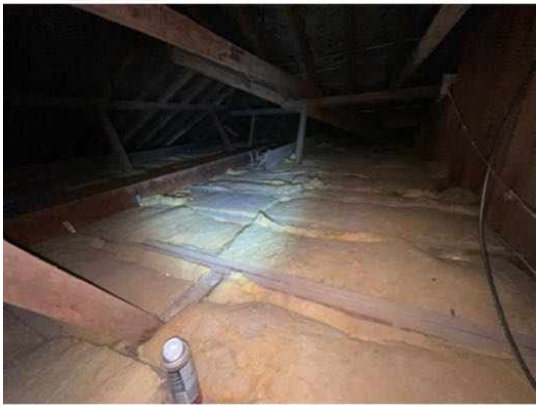
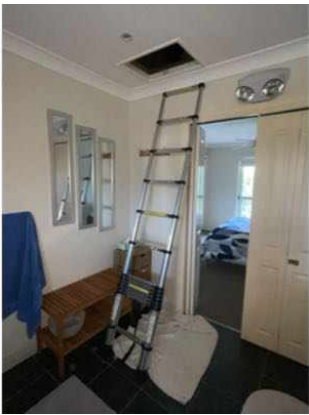
The inspection of the roof void was limited by restricted access and obstructions. While no significant issues were identified in the areas inspected, it is possible that defects may exist in concealed or inaccessible sections. Ongoing monitoring and maintenance are recommended as part of standard property care.

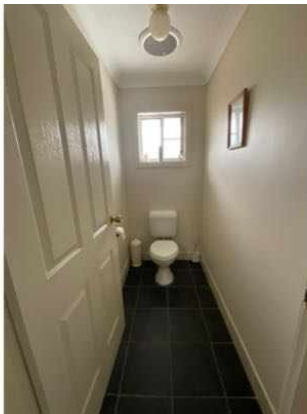
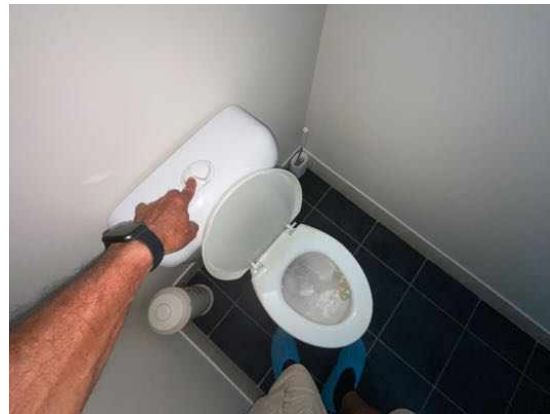
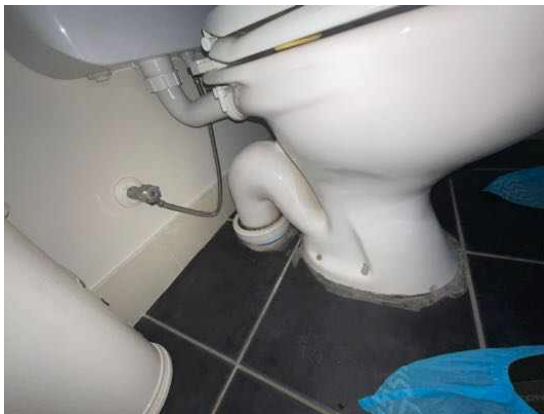
- No leaks were observed during the flushing process.
- The toilet operated normally with no signs of malfunction or abnormal water flow.
- The toilet pan was securely fixed to the floor at the time of inspection.

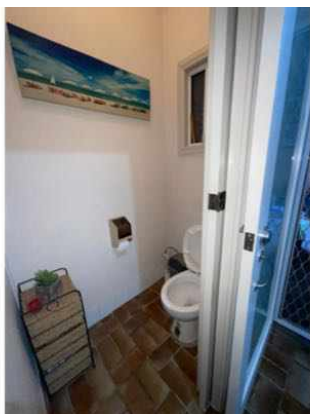
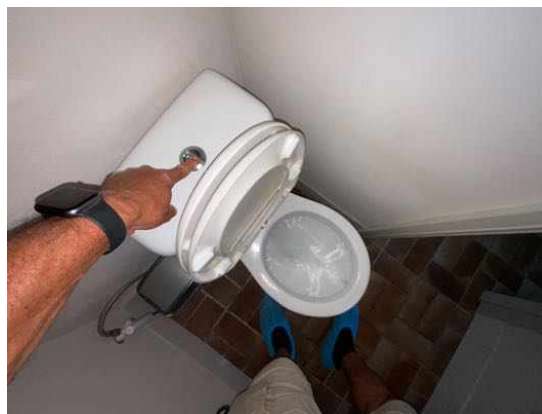
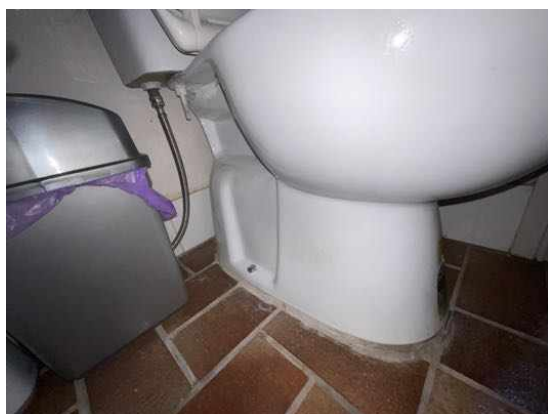
Building: Main Building
 Location: Toilet (WC)
 Finding: Overall Condition: Toilet.
 Information: TOILET ASSESSMENT

- Toilet:
- No leaks were observed during the flushing process.
 - The toilet operated normally with no signs of malfunction or abnormal water flow.

- The toilet pan was securely fixed to the floor at the time of inspection.

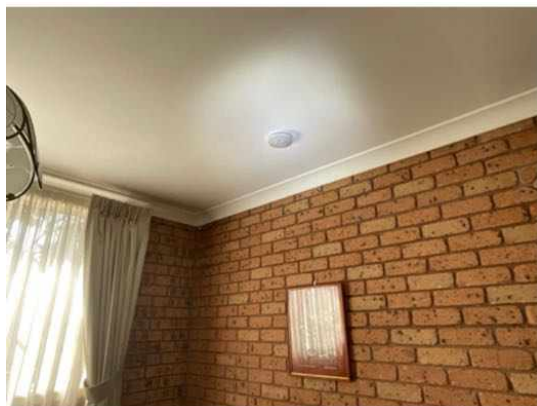
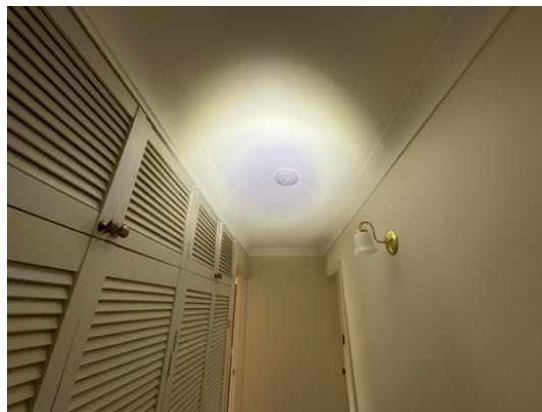
Failure to comply with these requirements may pose a serious risk to occupant safety.

- All smoke detectors be tested monthly by the homeowner.
- All systems comply with the requirements of AS 3786 and any applicable state-based legislation.
