Building and Timber Pest Inspection Report

Inspection Date: Mon, 09 Mar 2026

Property Address: 601 Pacific Hwy, Wyoming NSW 2250,
Australia

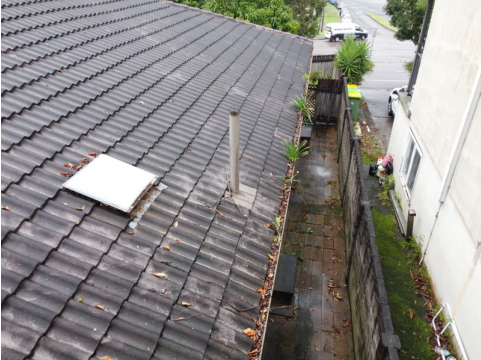
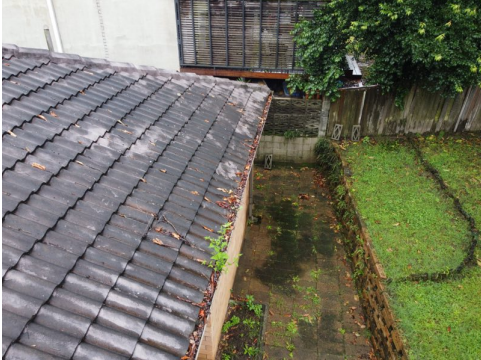
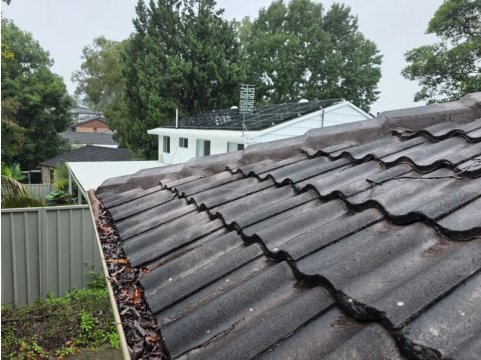
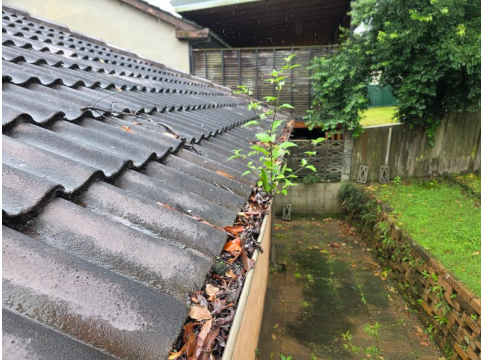
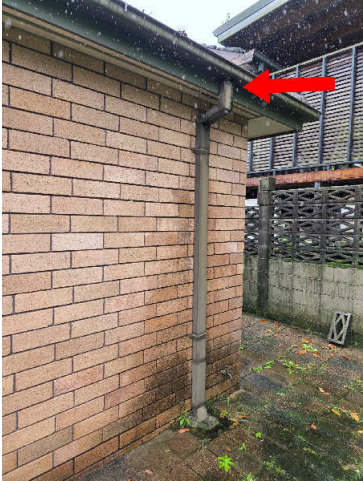
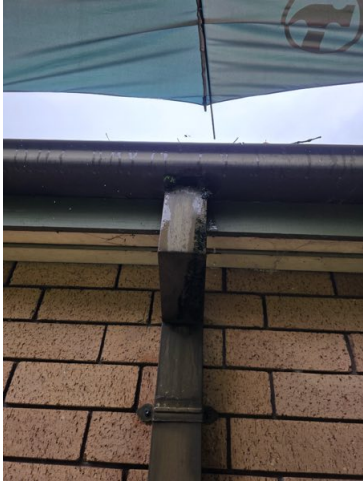
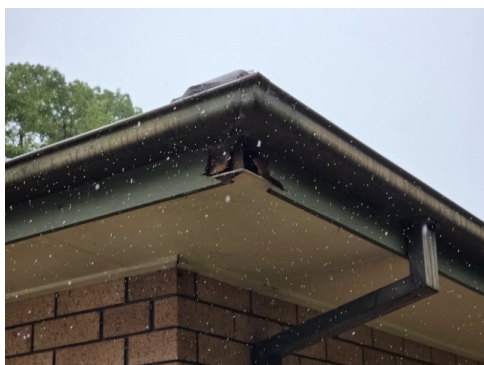
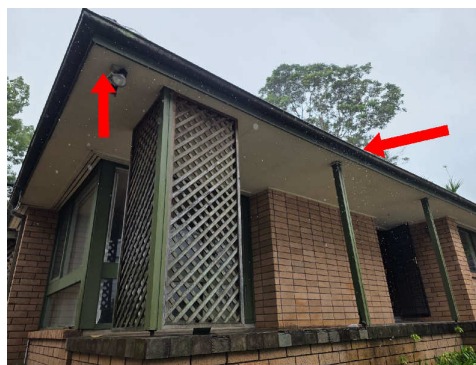
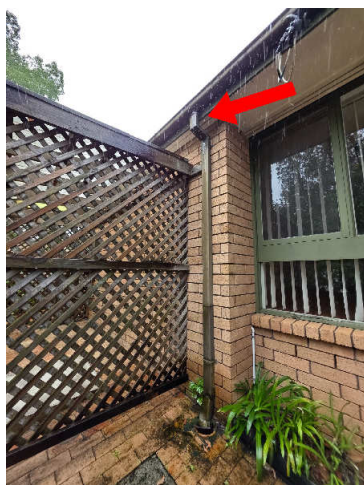
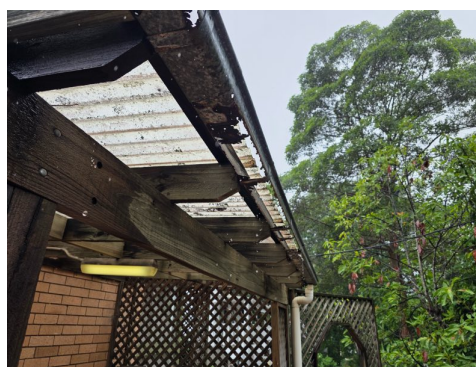
Finding: Roof Drainage System Defects – Gutters, Downpipes and Associated Deterioration

Information: Multiple defects were observed to the roof drainage system. Several downpipes were disconnected or improperly connected, allowing roof water to discharge directly onto the ground adjacent to the building. Gutters were heavily filled with debris and appeared blocked, and a section along the driveway side had sagged, allowing water to accumulate and overflow during rainfall. The gutter attached to the front pergola was also heavily corroded with sections rusted through. Deterioration to fascia boards was noted at external corners, which may be associated with prolonged moisture exposure.

Where roof drainage systems do not function correctly, uncontrolled roof water discharge can occur and ongoing moisture exposure to surrounding building elements may result. A roofing plumber should be engaged to assess and rectify the guttering and downpipe system as required, and a builder should address any associated building deterioration. This should be done as a matter of urgency to prevent further moisture exposure and deterioration.

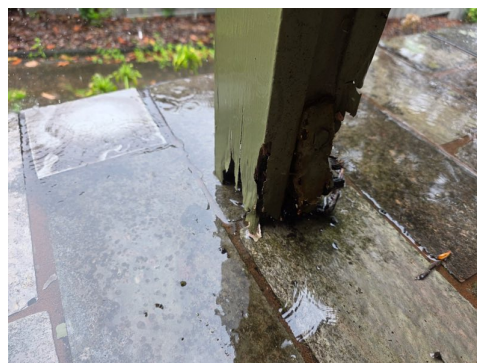
Finding 2.02

Finding: Severely Decayed Veranda Post – Driveway Side

Information: A veranda support post located below the affected gutter section on the driveway side was observed to be severely decayed at its base due to fungal decay. The lower portion of the post has deteriorated and the post has dropped, meaning it no longer appears to be providing effective support to the veranda structure. Continued deterioration may affect the stability of the supported structure.

A builder should be engaged to assess and rectify as required. This should be done as a matter of urgency.

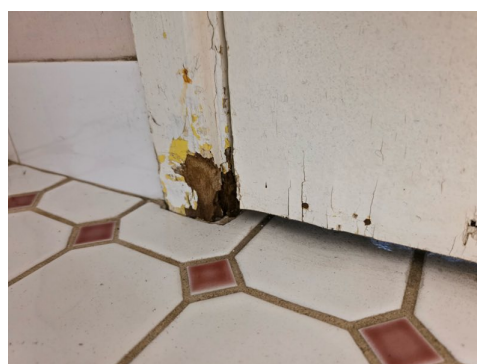
Finding 2.03

Finding: Severe Timber Decay – Laundry External Door Frame and Door

Information: The lower sections of the external laundry door jamb and architrave were observed to be heavily deteriorated due to fungal decay. The bottom of the laundry door is also delaminating and shows clear signs of prolonged moisture exposure and moisture damage. Continued deterioration may affect the function of the door and allow ongoing moisture exposure to surrounding building elements. Concealed damage could not be ruled out during a non-invasive inspection.

A builder should be engaged to assess, carry out a further investigation to determine the extent of any concealed damage, if any, and to rectify as required. This should be done without delay.

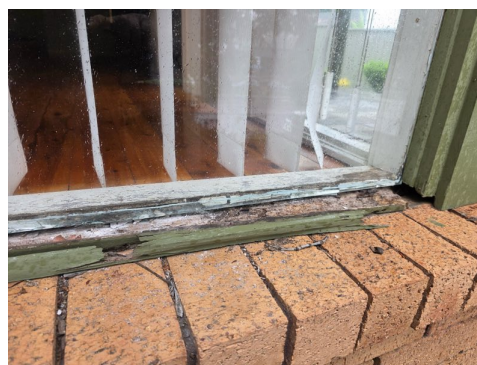
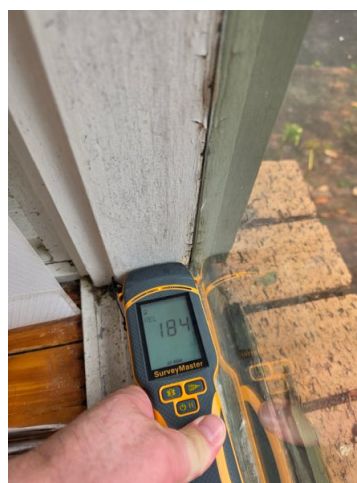
Finding: Timber Decay to Window Bottom Rail – Living Room Corner Window

Information: The external bottom rail of the corner window in the living room was observed to be deteriorated due to fungal decay. The timber shows clear signs of moisture-related breakdown and no longer appears to be providing full weather protection to the window assembly. Slightly elevated moisture readings were also recorded to the internal window framing and concealed deterioration within the surrounding wall structure cannot be ruled out.

A builder should be engaged to assess and repair or replace the affected timber components as required. This should be carried out as soon as practicable to prevent further deterioration.

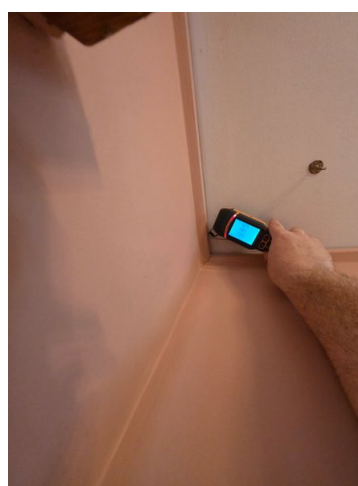
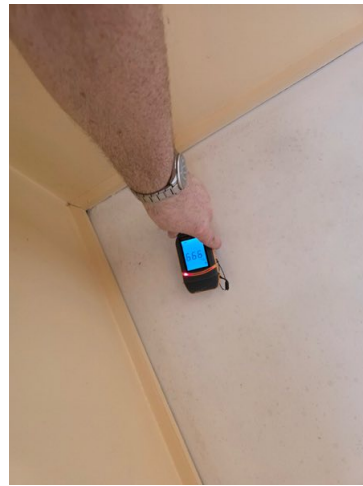
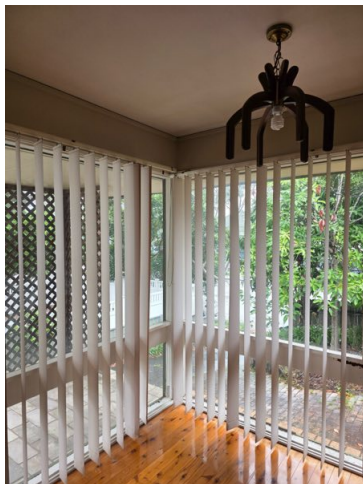
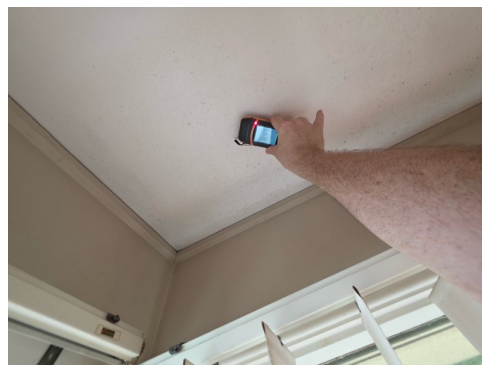
Finding 3.02

Finding: Ceiling Staining and Suspected Mould Growth

Information: Yellow spot-like staining was observed to sections of the ceiling linings in Bedrooms 1 and 2. In addition, small spot-like marks consistent with suspected mould growth were noted to the ceiling corners, particularly to the external wall corner of Bedroom 2 where elevated moisture readings were recorded. A similar condition was observed in the living room corner above the window as well. These conditions indicate ongoing moisture presence and may be associated with condensation, humidity, or possible moisture ingress.

Concealed deterioration within ceiling materials cannot be ruled out during a visual inspection. A licensed builder should investigate the source of moisture and carry out rectification as required. This should be addressed without delay to prevent further deterioration.

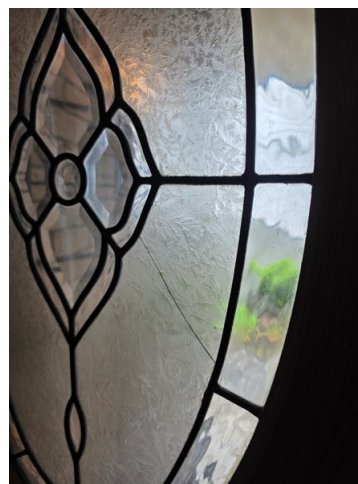
Finding 3.03

Finding: Cracked Leadlight Glass – Front Entry Door

Information: Cracking was observed in the leadlight glass panel in the front entry door. Cracked glass may deteriorate further over time and can present a breakage hazard if the panel becomes unstable.

A glazier should be engaged to assess and rectify as required. This should be done at the owner's discretion.

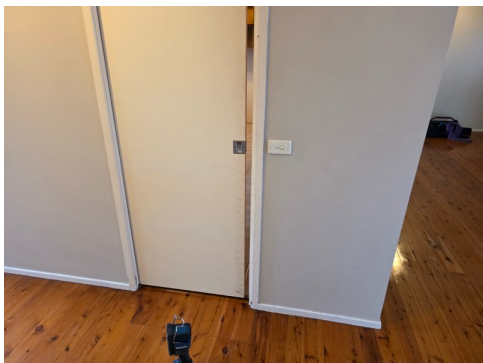
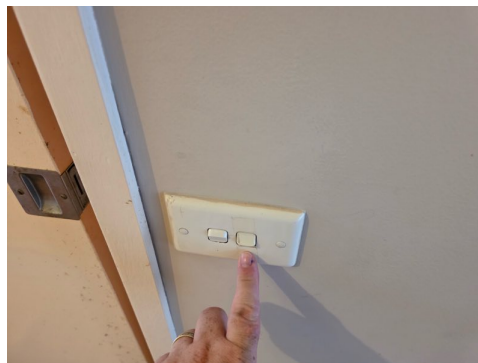
Finding 3.04

Information: A light switch in the dining room was tested and did not operate. Non-operational electrical fittings may indicate a fault in the switch or associated wiring.

A licensed electrician should be engaged to assess and rectify as required. This should be done as soon as practicable.

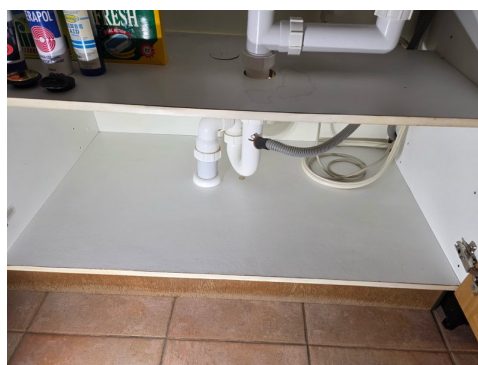
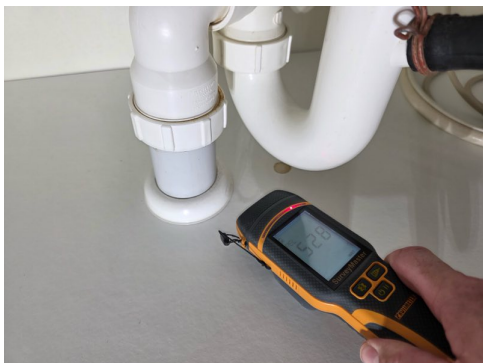
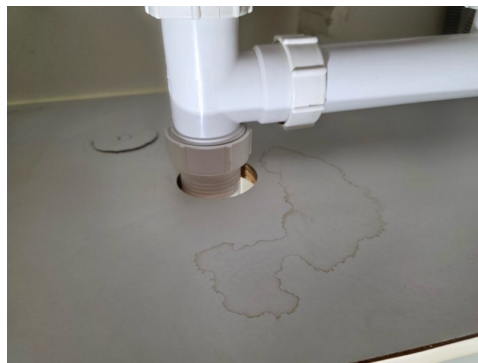
Finding 3.05

Finding: Elevated Moisture and Minor Water Damage – Kitchen Sink Cabinet

Information: Elevated moisture readings were recorded to the cabinet carcass beneath the kitchen sink. Minor deterioration was observed to the cabinet base along with water staining to the shelf above. This indicates ongoing or previous moisture exposure in the cabinet area and concealed deterioration in surrounding cabinetry cannot be ruled out.

A licensed plumber should be engaged to carry out further investigation and rectify as required. This should be done as soon as practicable.

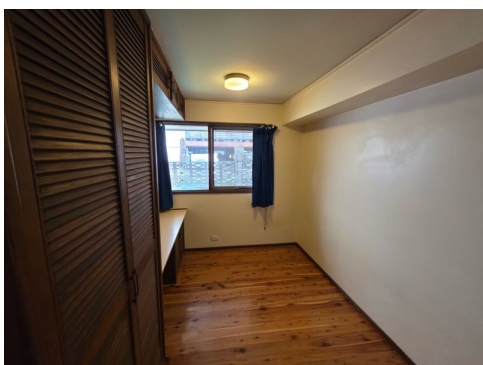
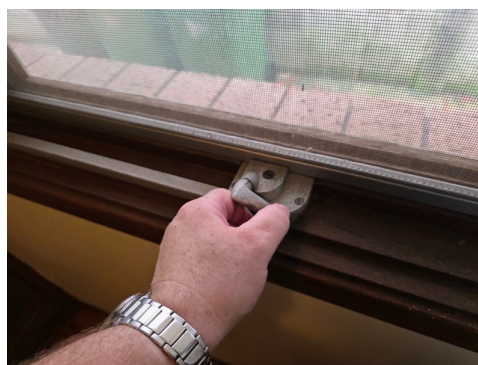
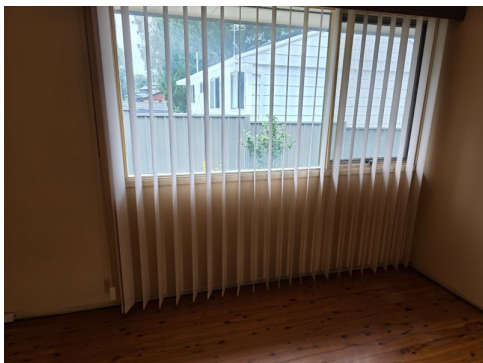
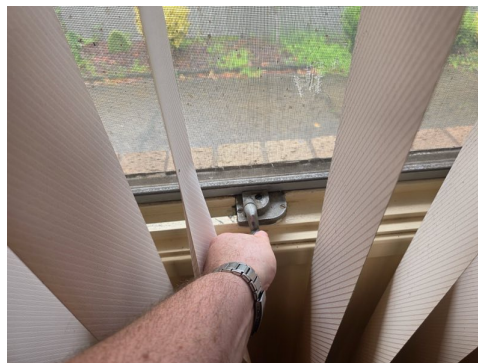
Finding 3.06

Information: Several window winders were tested and did not operate. Non-operational winding mechanisms can prevent windows from opening or closing correctly and may affect ventilation and security.

A builder should be engaged to assess and rectify as required. This should be done at the owner's discretion.

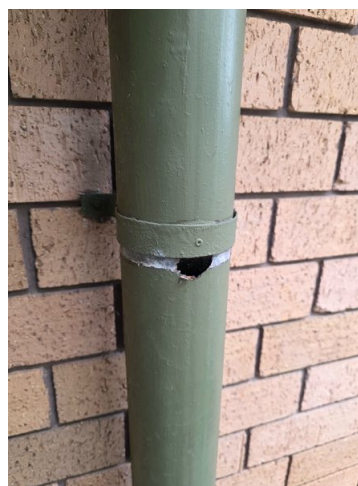
Finding 3.07

Finding: Corroded Sewer Vent Pipe

Information: The metal sewer vent pipe was observed to have a rusted hole through its face approximately halfway up its height. Corrosion holes can allow sewer gases to escape and may allow continued deterioration of the pipe.

A licensed plumber should be engaged to assess and rectify as required. This should be done as soon as practicable.

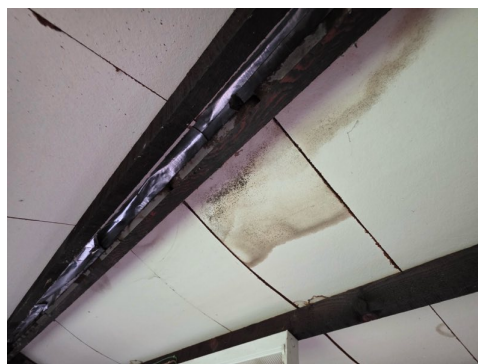
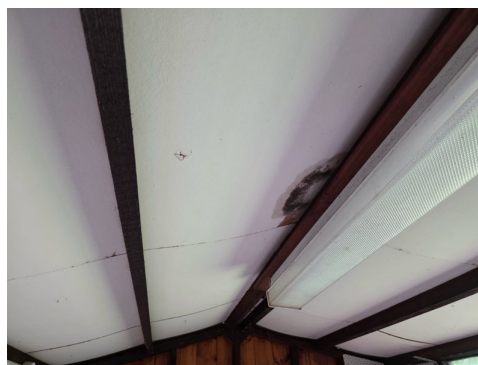
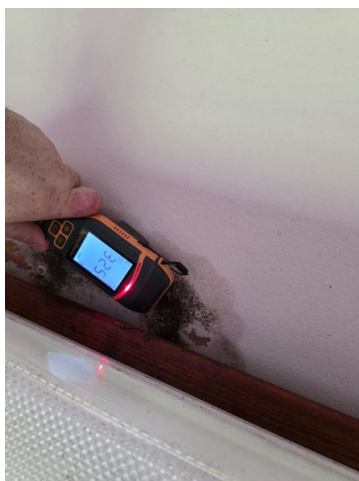
Finding 3.08

Finding: Water Staining and Elevated Moisture – Shed Ceiling Linings

Information: The shed ceiling linings appear to be a chipboard-type material and multiple sheets displayed visible water staining. Elevated moisture readings were also recorded in several areas, indicating ongoing or recent moisture exposure. Continued moisture exposure may lead to progressive deterioration of these sheet materials.

A builder should be engaged to carry out further investigation and rectify as required. This should be done as soon as practicable.

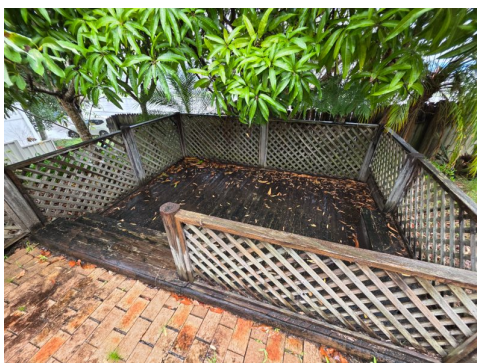
Information: The substructure of the decking in the front yard was not accessible for inspection due to low clearance, ground contact, or cladding. Inaccessible areas such as this prevent a full visual inspection and create conditions conducive to concealed termite entry or timber decay, as any damage or activity may remain undetected until it becomes extensive.

Where practical, the deck should be modified to allow adequate clearance and access for future inspection. Where modification is not possible, the risk of concealed attack remains. In such cases, it is essential that a licensed pest controller establish an ongoing termite management plan and carry out regular timber pest inspections every 6–12 months.

This matter should be addressed without delay to ensure concealed areas are monitored and managed effectively.

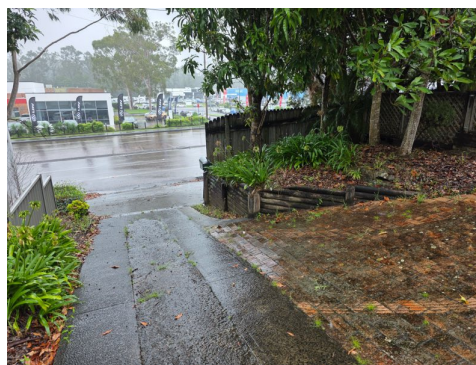
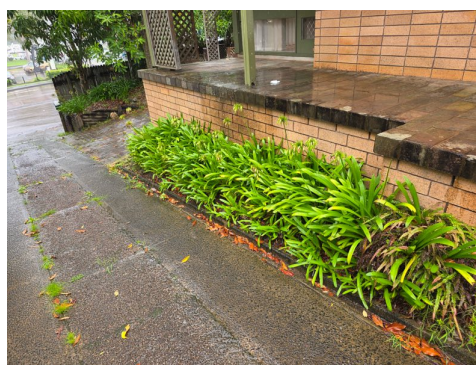
Finding 6.02

Finding: Garden Beds - Conditions Conducive to Termites

Information: Garden beds, particularly those constructed from untreated timber, were noted adjacent to the dwelling. These create a highly conducive environment for termite activity due to the combination of retained soil moisture from watering, direct soil contact, and the organic material in the soil and timber edging. Such conditions increase the risk of concealed termite ingress into the property, as termites can travel through the garden beds and enter the structure undetected.

Where practical, garden beds should be removed, relocated, or modified so that they do not abut the dwelling. Where this is impractical or undesirable, the risk of concealed termite activity remains. In these cases, a licensed pest controller should establish an ongoing termite management plan, and regular timber pest inspections should be carried out every 6–12 months to assist in protecting the property against infestation.

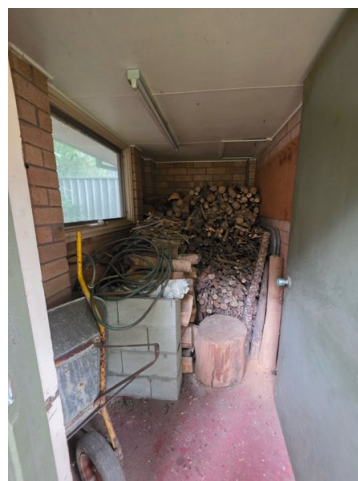
Finding 6.03

Finding: Stored Timber – Termite Conducive Condition

Information: Stored timber was observed in the storage room at the rear of the carport. Timber stored against or close to structures can create conditions conducive to termite activity and may attract termites to the vicinity of the building.

A licensed pest controller should be engaged to assess and advise as required. Ongoing termite management is recommended, including timber pest inspections every 6–12 months. This should be done at the owner's discretion.

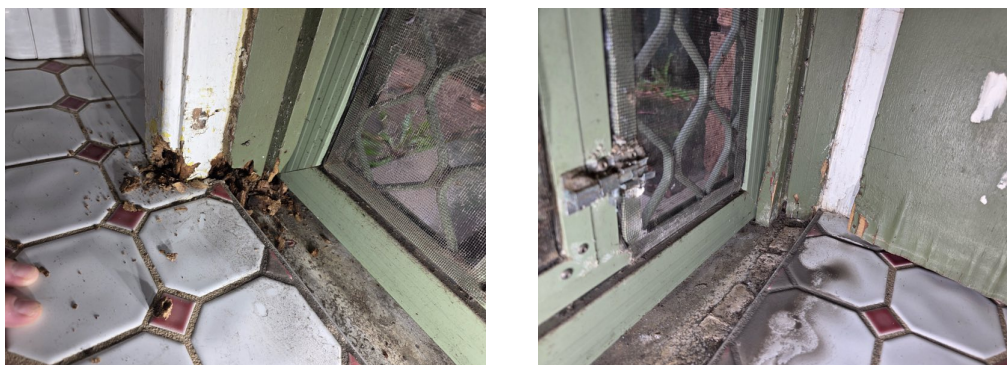
Finding 7.01

Finding: Fungal - Fungal decay observed in timber elements

Information: Fungal decay was observed in timber elements in the fascia boards, window frame, verandah post, laundry door jamb and shed fly screen frame. Fungal decay (commonly referred to as wood rot) occurs when timber remains damp for extended periods, allowing fungal spores to colonise and break down the wood fibres. This process reduces the strength, durability, and integrity of the timber.

Decay is typically caused by poor drainage, regular wetting, or direct contact with soil or saturated surfaces.

Recommend a licensed builder or pest manager assess the extent of deterioration and replace or treat affected timbers as necessary. Regular timber pest inspections should be carried out every 6–12 months. Rectify without delay.

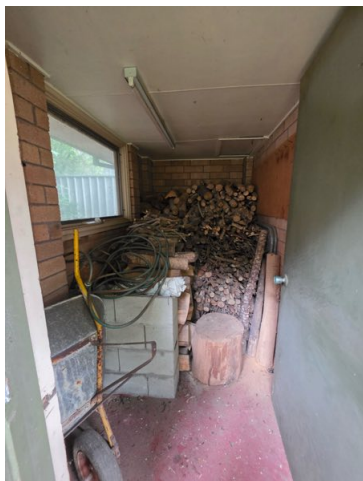
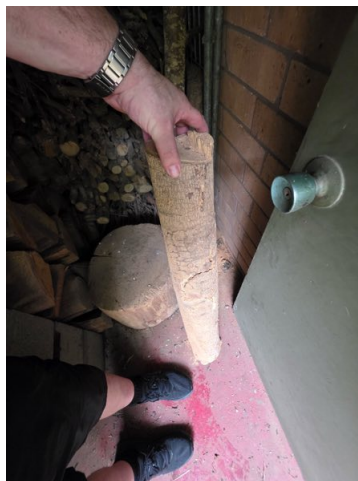
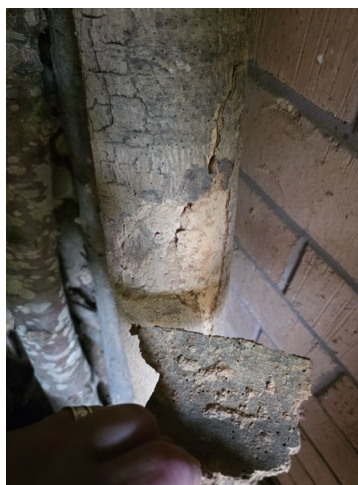
Information: Evidence consistent with wood borer activity was observed in a piece of stored firewood in the shed area. Numerous small round exit holes were visible in the timber, which is typical of wood borer infestation. The affected timber does not form part of the building structure.

Infested firewood can act as a harbourage for timber pests and may introduce or sustain pest activity on the property if stored close to the dwelling. The affected timber should be removed from the site or stored well away from the building. Regular timber pest inspections should continue at intervals of approximately 6–12 months to monitor conditions.

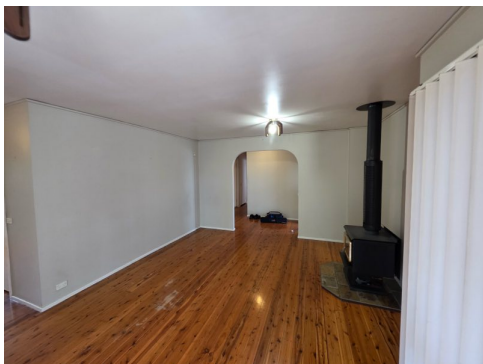
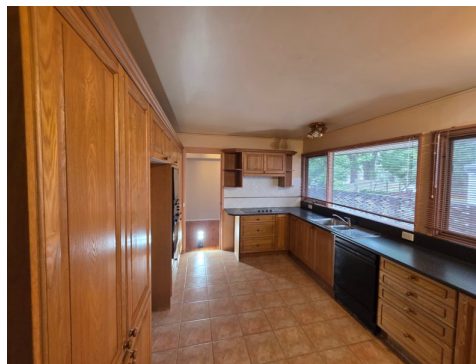
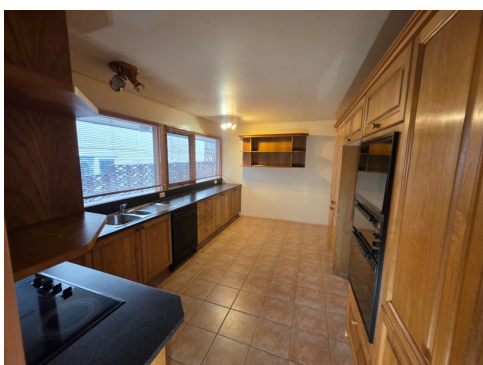
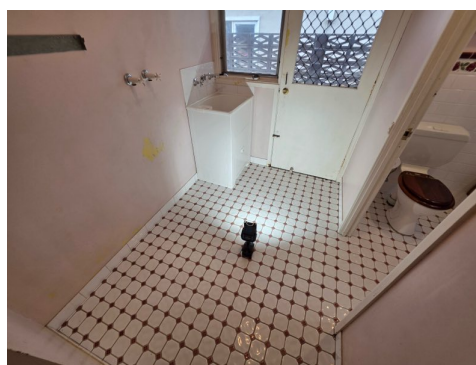
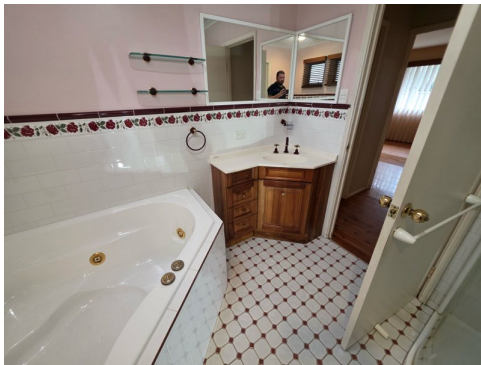
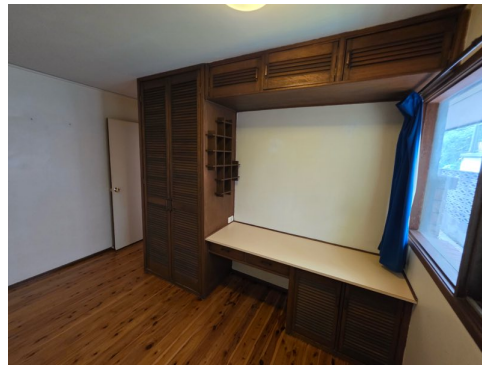
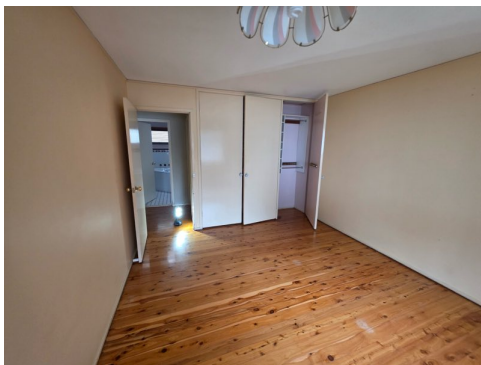
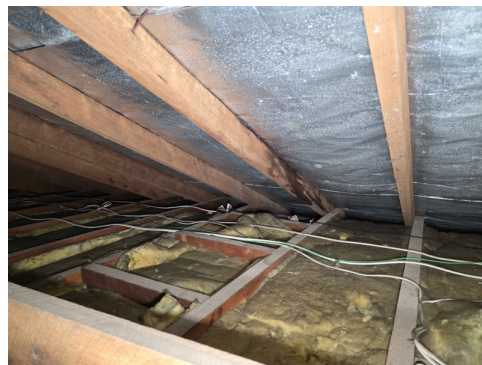
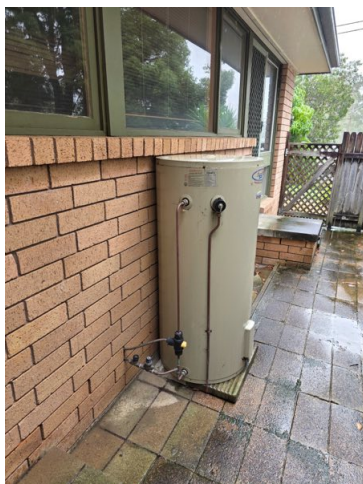
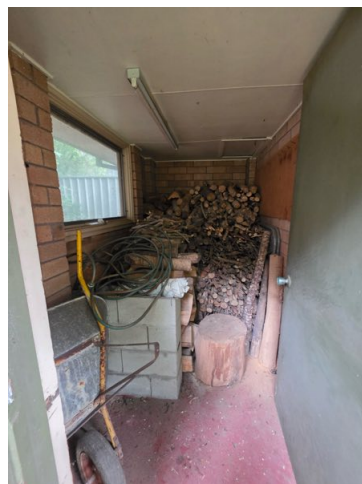
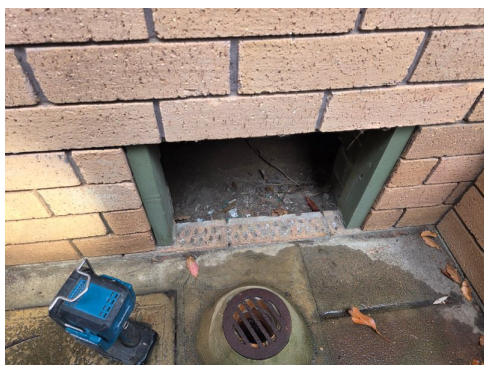
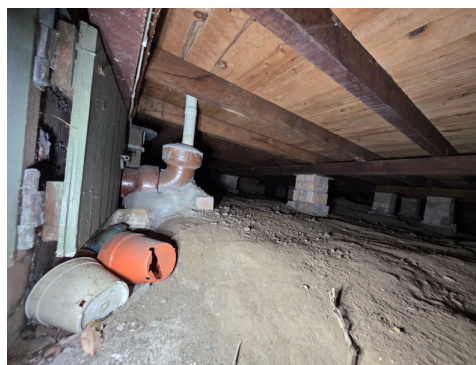
Finding: Additional Photos - Obstructions and Limitations

Information: These photographs are an indication of the obstructions and limitations which impeded full inspection of the property at the time of inspection. These obstructions can hide an array of defects and should be removed to allow full inspection to be carried out. A re-inspection is recommended once the areas are made accessible.

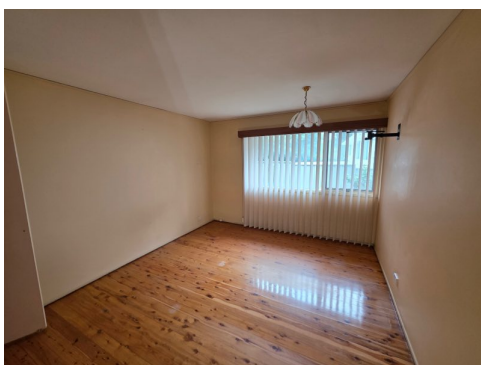
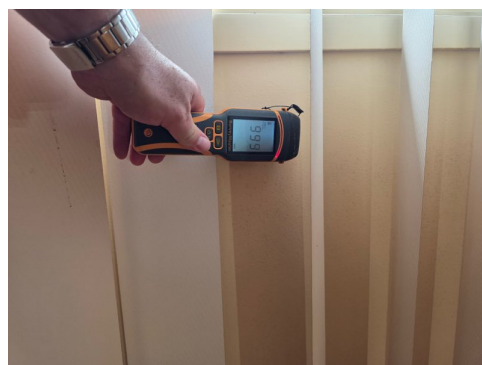
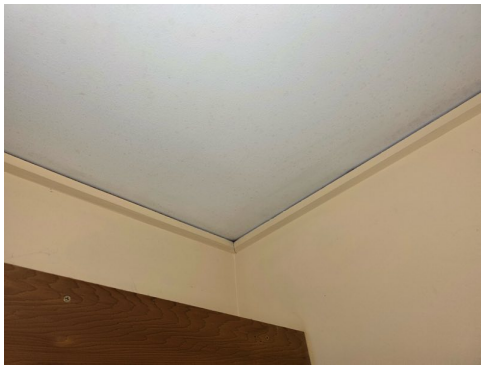
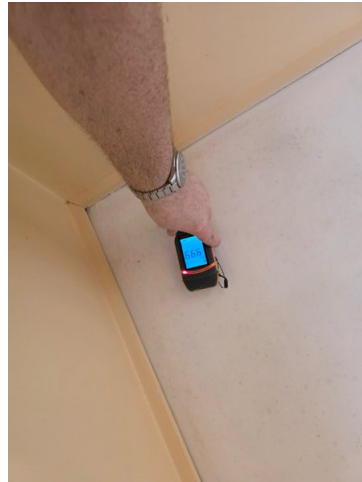
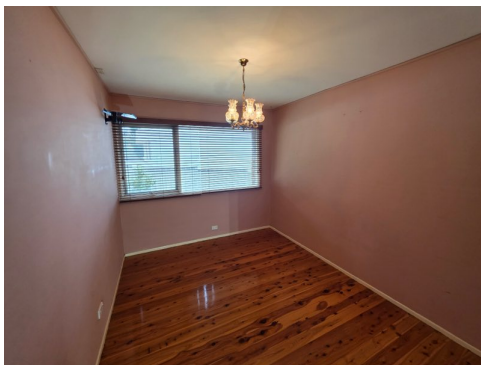
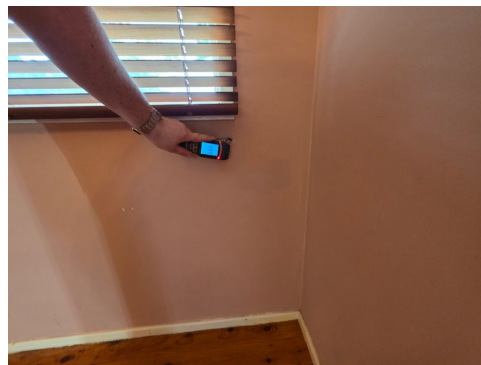
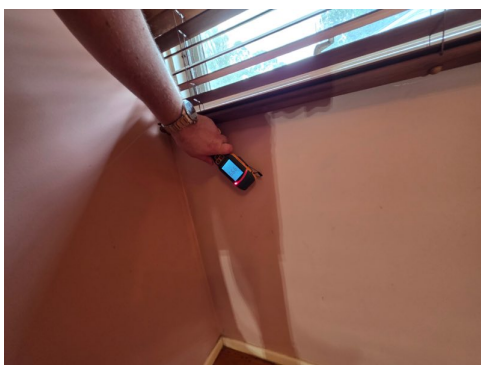
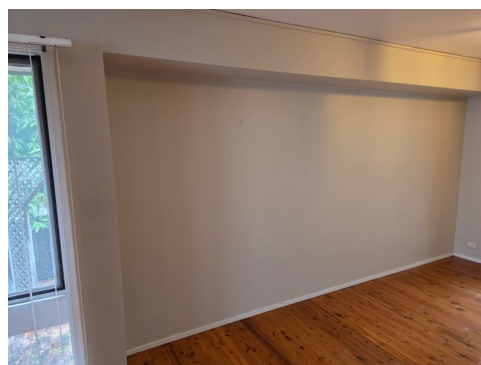
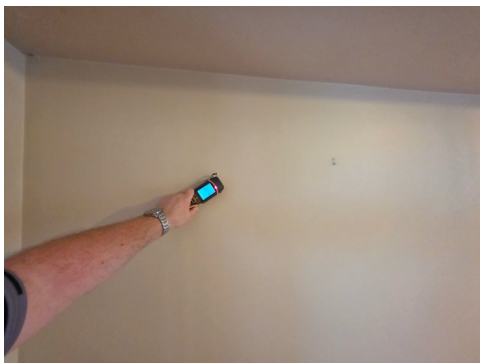
Finding: Elevated Moisture Readings – Multiple Internal Walls

Information: Elevated moisture readings were recorded along several internal perimeter walls, including beneath windows in Bedrooms 1, 2 and 3 and along the rear wall of Bedroom 3. No visible deterioration, swelling, or material breakdown was observed in these areas at the time of inspection. The inspection occurred during wet and humid conditions following recent rainfall, which may influence moisture meter readings in wall linings.

Although no damage was evident, concealed moisture sources or deterioration cannot be ruled out in a visual, non-invasive inspection. It is recommended that the affected areas be monitored and, if moisture levels persist or deterioration becomes evident, a licensed builder should investigate and rectify as required.

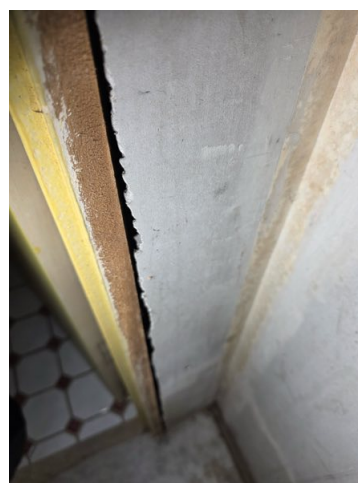
Information: Reporting on asbestos is outside the scope of this inspection. Suspected asbestos-containing material (ACM) was observed in the bathroom, laundry, eave and meter box. Based on our experience in the building industry, there is a higher risk that the identified building elements contain asbestos, particularly given that any home constructed prior to 1990 may contain asbestos in various forms.

No sample testing has been undertaken to confirm the presence of asbestos. We strongly recommend a separate Asbestos Inspection and Condition Audit be carried out by a licensed assessor, which may include laboratory testing for definitive confirmation.

In the meantime, the client is advised to act with caution, especially when considering any disturbance of the material through wear and tear, renovations, extensions, demolition, or maintenance activities.

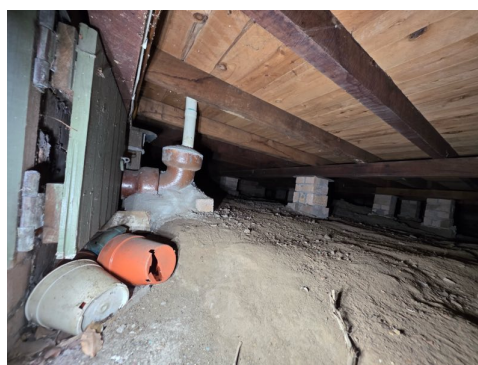
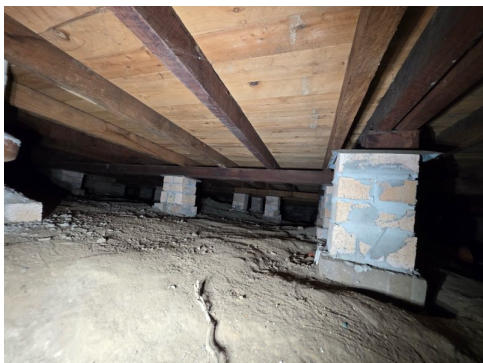
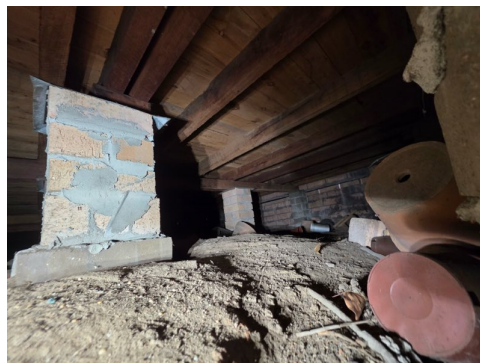
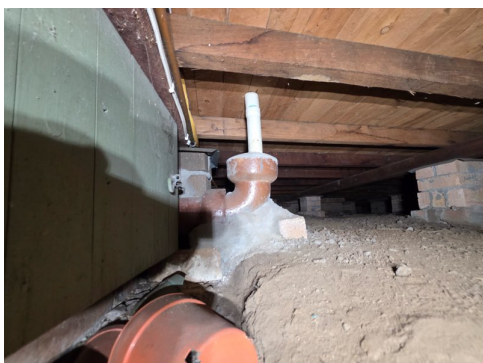
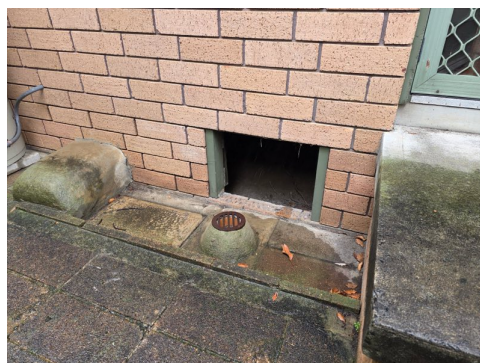
Information: The subfloor area could not be accessed due to restricted opening size, preventing inspection of the subfloor structure and conditions. A visual inspection was conducted from the opening to the subfloor area. Defects or timber pest activity may exist in areas that were not accessible for inspection.

A builder should be engaged to carry out further investigation as required. This should be done at the owner's discretion.

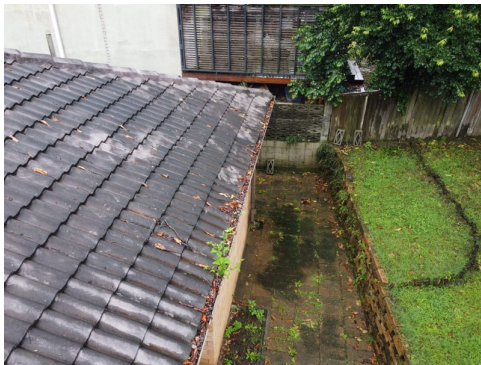
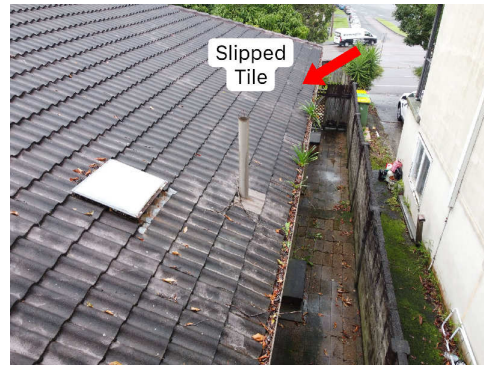
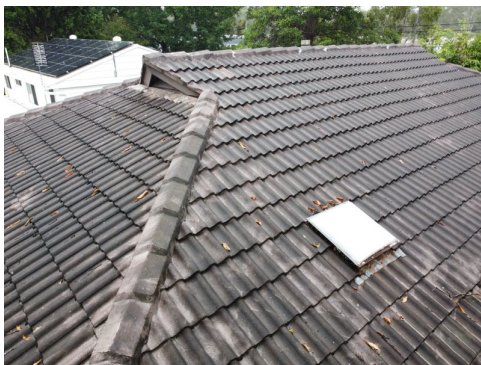
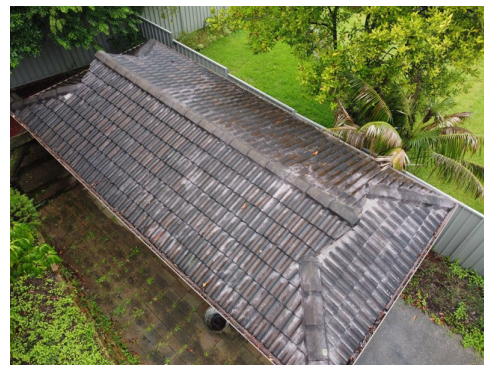
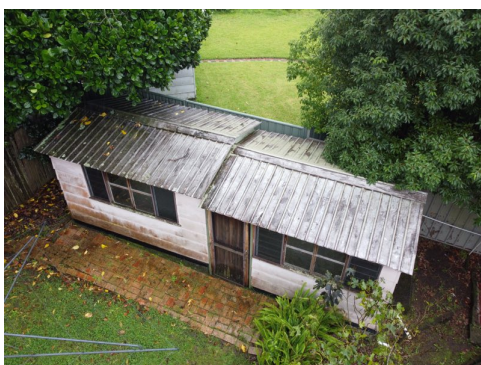
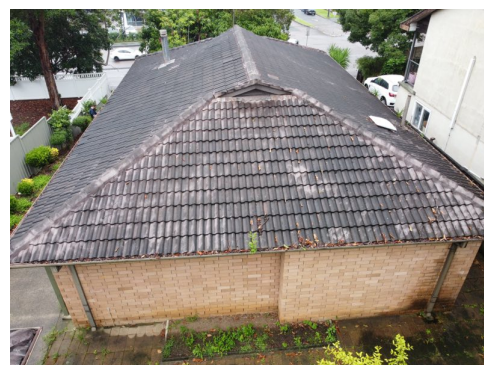
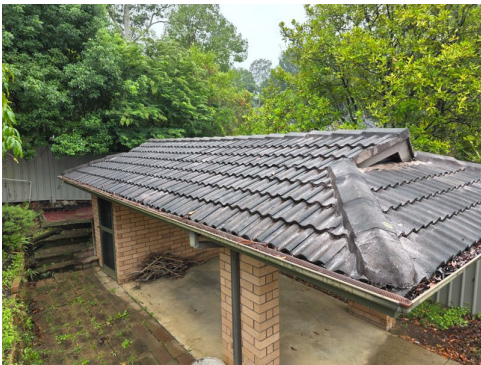
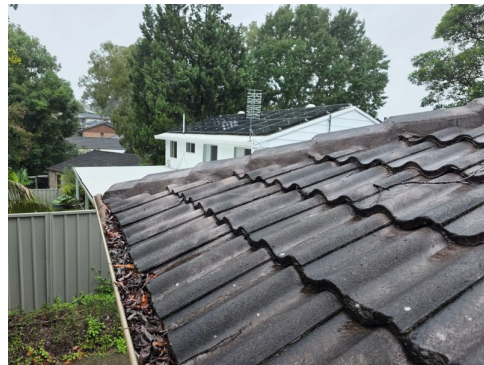
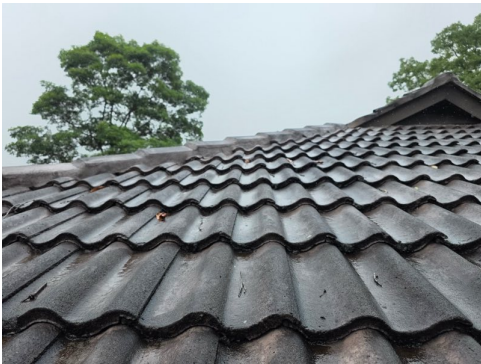
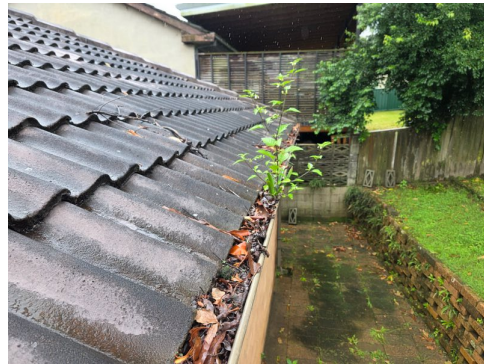
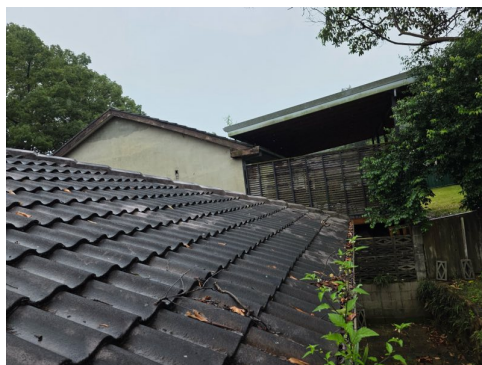
Information: Additional photos are provided for your general reference
