# Building and Timber Pest Inspection Report

Inspection Date: Fri, 6 Feb 2026

Property Address: 75 Read St, Bronte NSW 2024, Australia

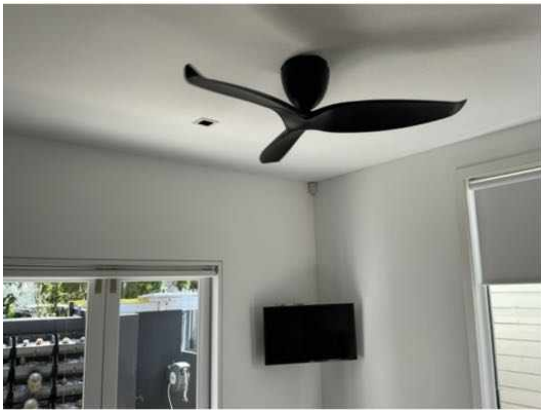
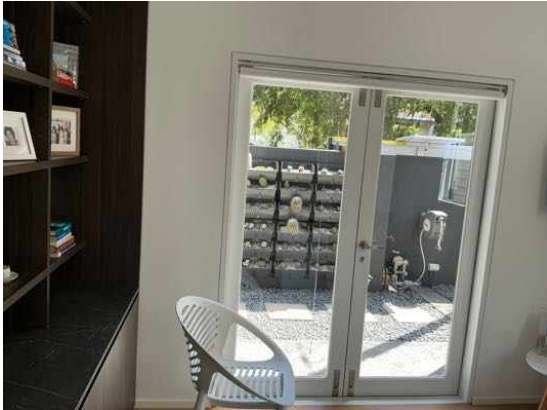
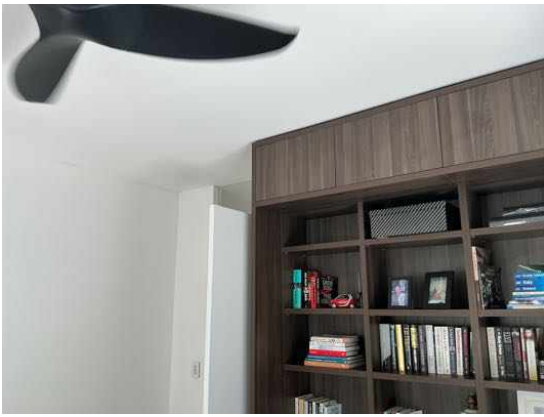
Building: Main Building  
Location: Study  
Finding: No Visible Building Defects Observed  
Information: During the inspection, no visible building defects were noted in this area at the time of assessment. Everything appeared to be in satisfactory condition based on a visual inspection.

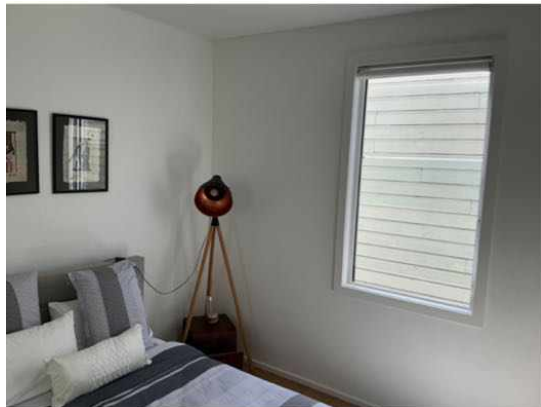
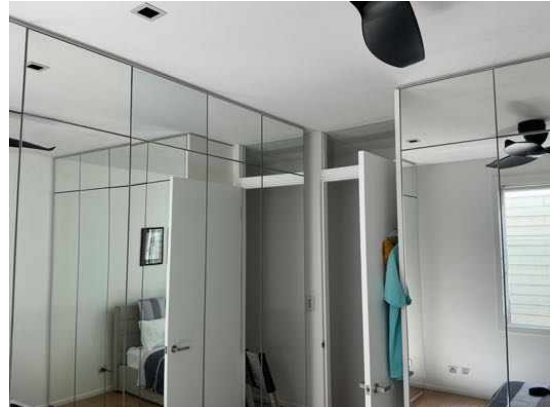
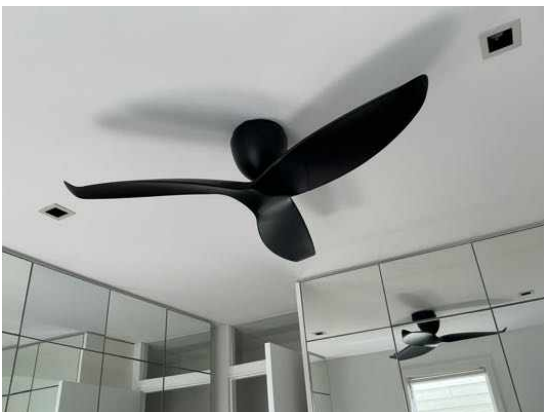
Building: Main Building  
Location: Bedroom  
Finding: No Visible Building Defects Observed  
Information: During the inspection, no visible building defects were noted in this area at the time of assessment. Everything appeared to be in satisfactory condition based on a visual inspection.

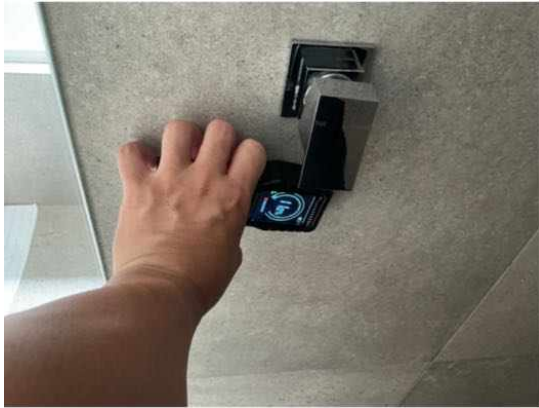
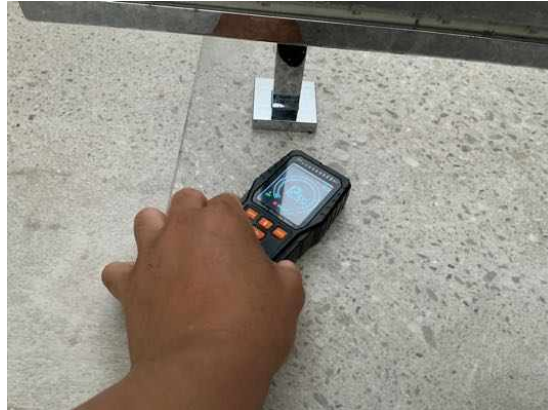
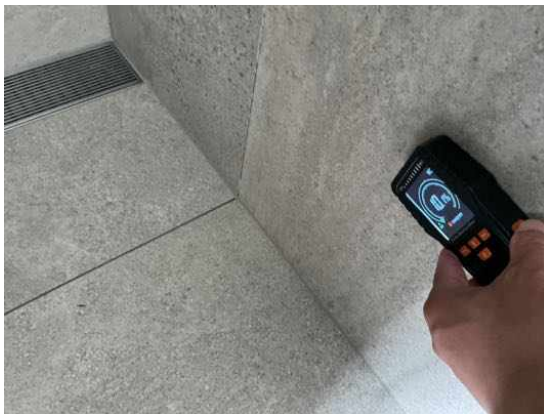
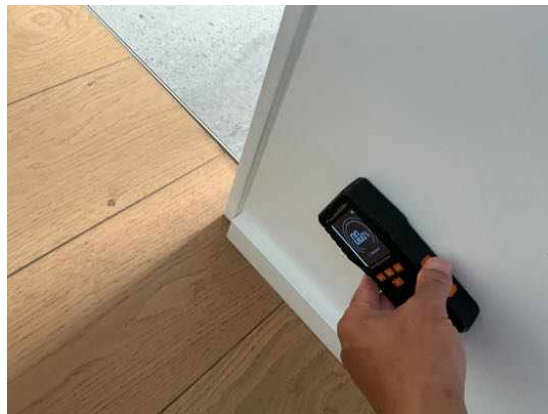
Location: Bathroom  
Finding: No high moisture reading found  
Information: During the home inspection, These areas were checked using a moisture meter, and no high moisture readings were detected.

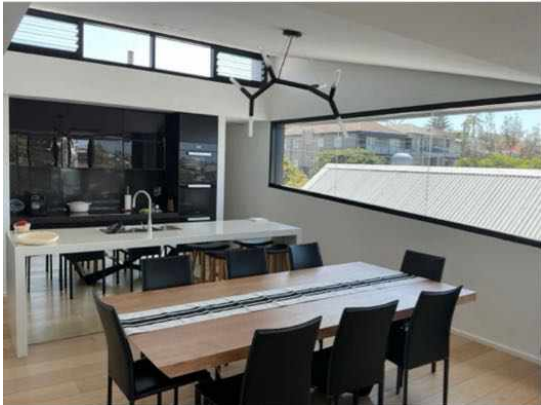
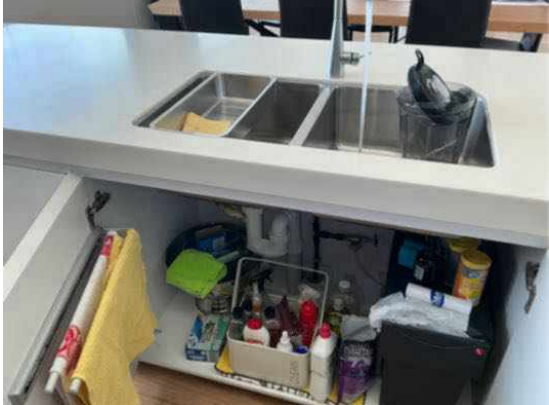
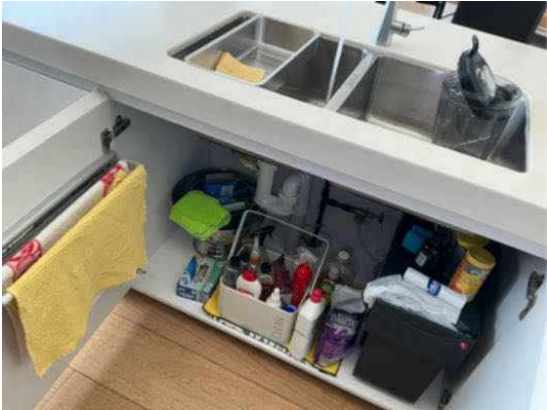
Building: Main Building  
 Location: Kitchen  
 Finding: No Visible Building Defects Observed  
 Information: During the inspection, no visible building defects were noted in this area at the time of assessment. Everything appeared to be in satisfactory condition based on a visual inspection.

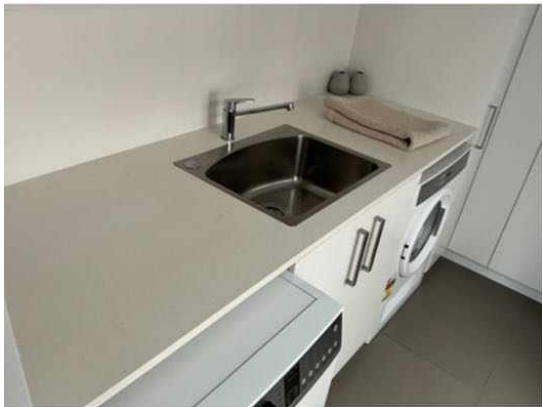
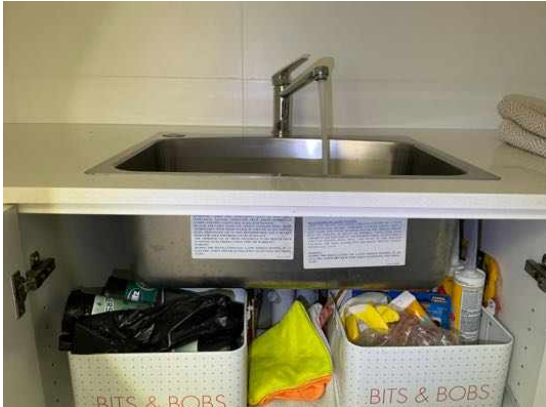
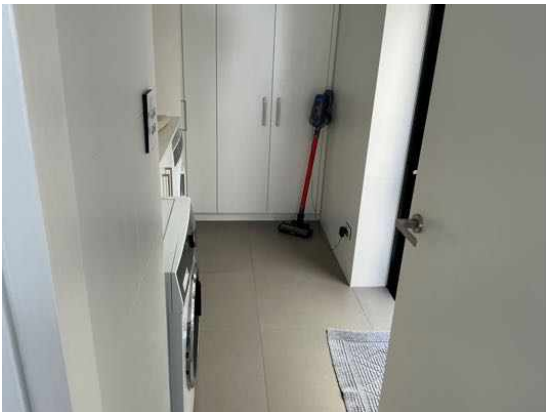
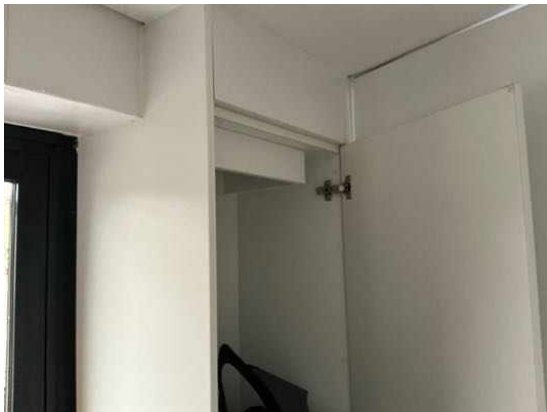
Building: Main Building  
Location: Laundry  
Finding: No Visible Building Defects Observed  
Information: During the inspection, no visible building defects were noted in this area at the time of assessment. Everything appeared to be in satisfactory condition based on a visual inspection.

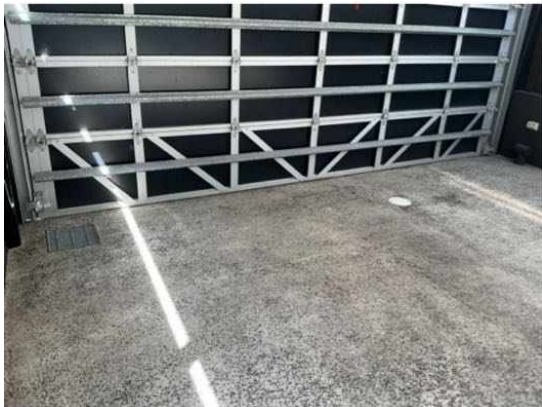
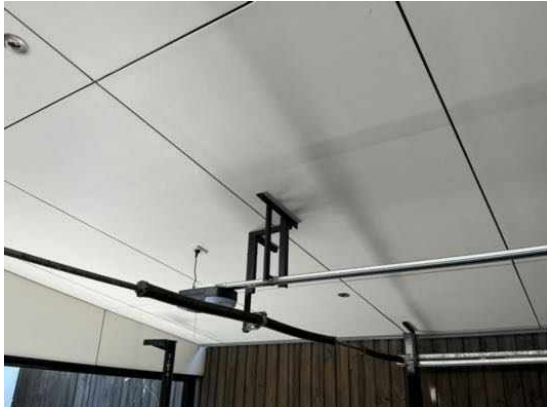
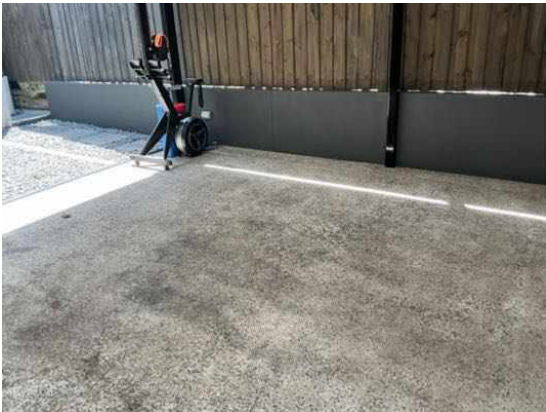
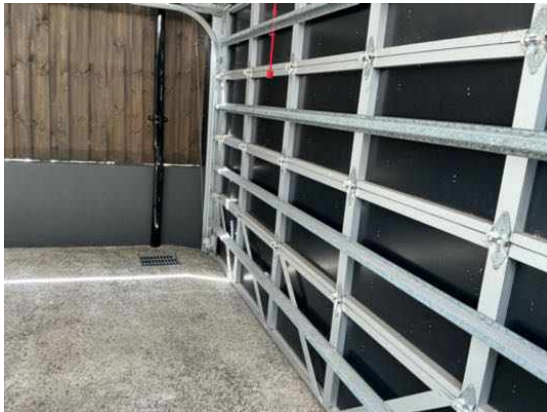
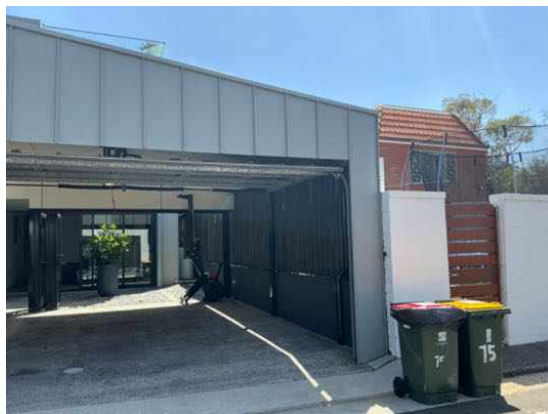
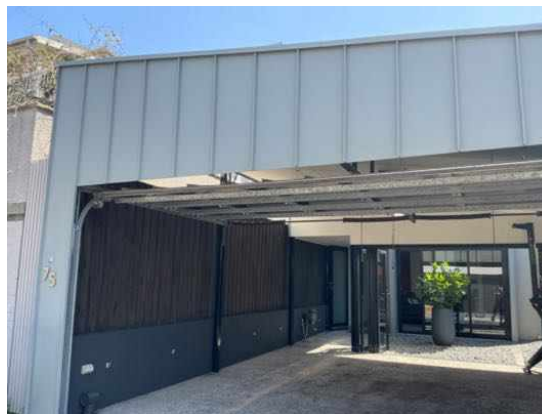
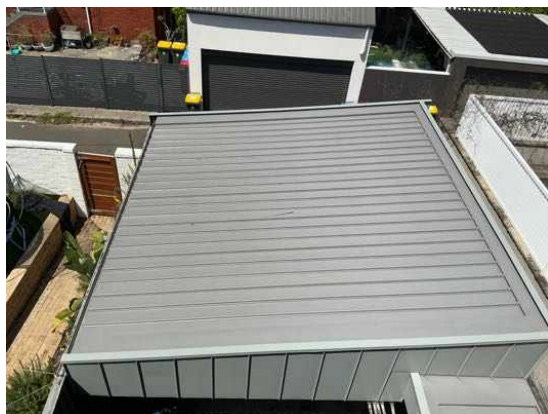
Building: Main Building  
Location: Garage  
Finding: No Visible Building Defects Observed  
Information: During the inspection, no visible building defects were noted in this area at the time of assessment. Everything appeared to be in satisfactory condition based on a visual inspection.
