BEFORE YOU BUY
BEFORE YOU BUILD

Building and Timber Pest Inspection Report

Inspection Date: Wed, 18 Mar 2026

Property Address: 25 Kaylaur Cres, Albion Park Rail NSW
2527, Australia

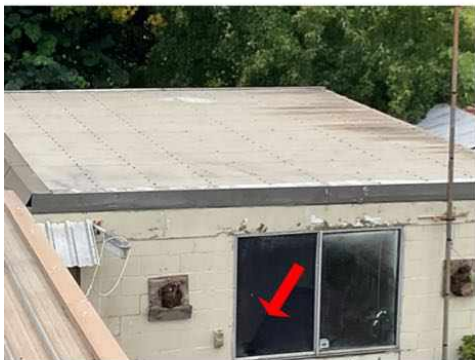
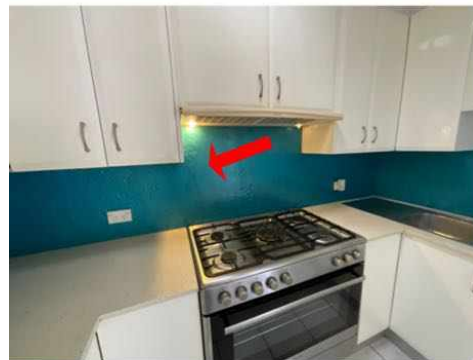
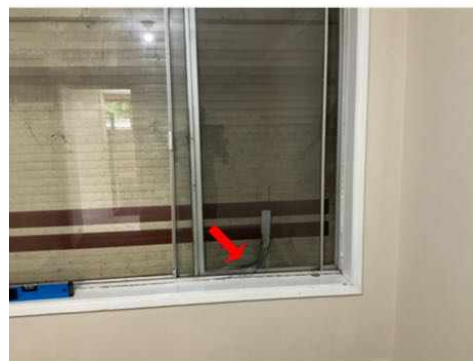
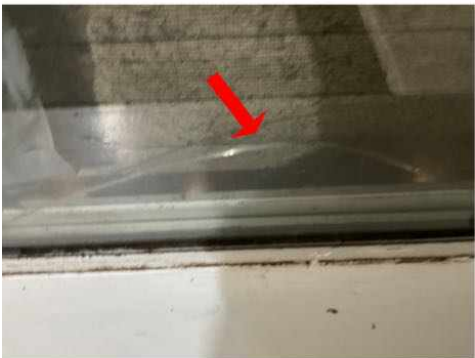
Building:	Building 1
Location:	Windows
Finding:	Windows and splashback - Cracked
Information:	Cracks were identified in these areas. Cracking in windows is generally the result of impact damage, and is likely to develop further when left unmanaged.

The likelihood of this windowpanes further cracking and shattering is increased exponentially, providing a safety hazard in the area. The cracked windows also impairs the weather tightness of the building, creating potential for minor water leaks.

Most of the shutters around the house walls did not work, all,requiring repair.

A qualified glazier is required to repair the window as soon as possible. Depending on the extent of the cracking, replacement of the window may be required. Please be advised that any persons coming into contact with the cracked window should do so with due caution to avoid any personal injury that may ensue.

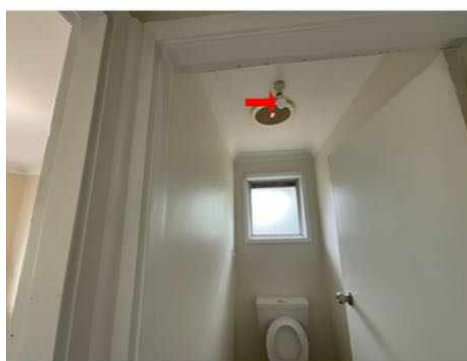
Building: Building 1
Location: Pictured areas
Finding: Electrical fittings - Broken or missing
Information: Many lights did not work or were missing bulbs. The rear fuse box was unprotected. Breakage occurs generally when the building materials have aged and decayed, but may also be indicative of impact damage to the building element (accidental or deliberate).

Left unmanaged, these fittings may cause further damage to surrounding building elements. Some broken fitting does expose electrical works, and may create a safety hazard if there is potential contact with persons in the area.

Repair and/or replacement of all lighting is advised. A Licensed electrician should be appointed to check all electrical wiring in the property. All fuses were turned off by the inspector on leaving to prevent any further damage.

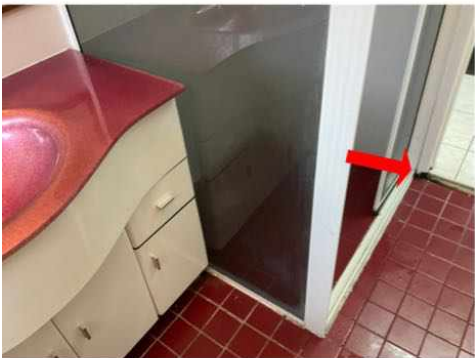
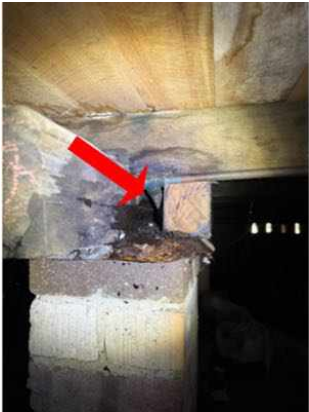
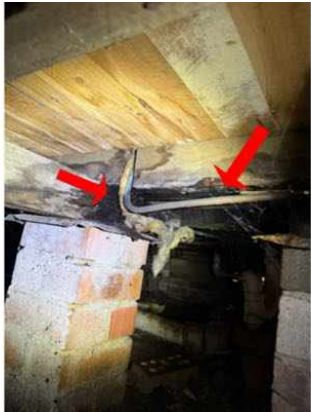
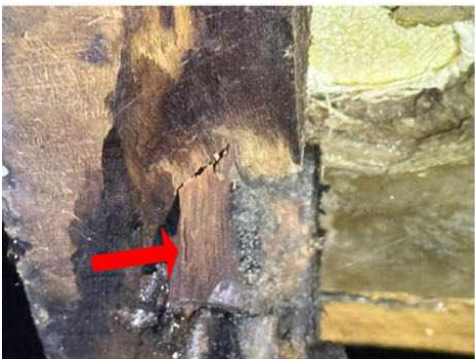
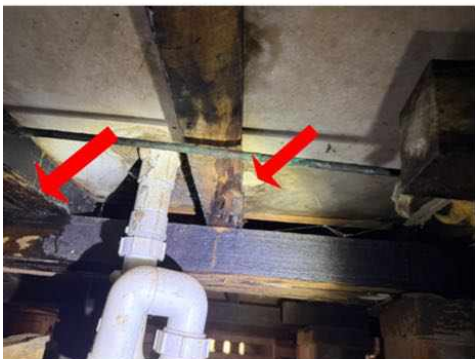
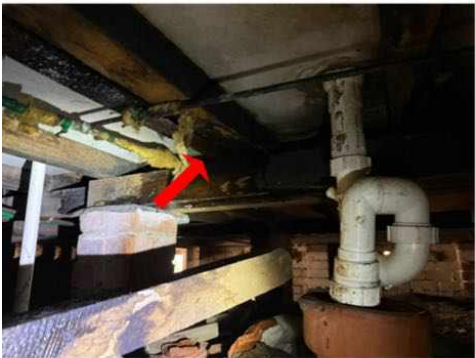
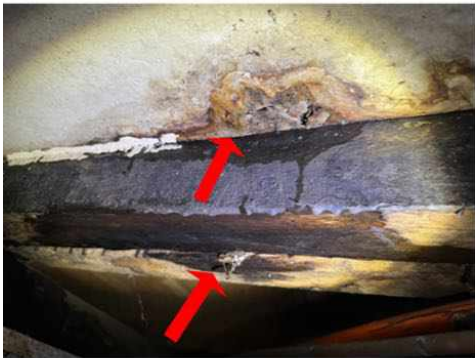
Building:	Building 1
Location:	Pictured areas
Finding:	Subfloor structure - Wood rot
Information:	The subfloor structures are showing signs of deterioration and wood rot (fungal decay) of the timbers. It is suspected that this defect has developed as a result of damp conditions from many bathroom leaks. Here the flooring and some supportive timbers have suffered water damage.

The presence of wood rot to the subfloor structure is also conducive to termite infestation. As timber stumps are in direct contact with the ground, concealed termite is made possible. Such entry is made easier if the timbers become non-durable due to even slight wood rot.

Where wood rot is present to any structural timber, rectification or replacement of the affected timber building element is required. The adequate timeframe for such works are dependent on the severity of the rot. Where rot has developed to become widespread, replacement of sections of the subfloor structure may be required. Consultation with a registered builder specialising in re-stumping is highly advised as soon as possible.

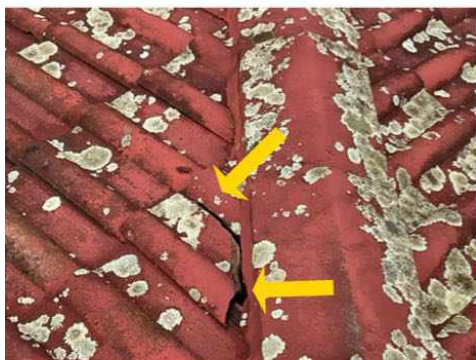
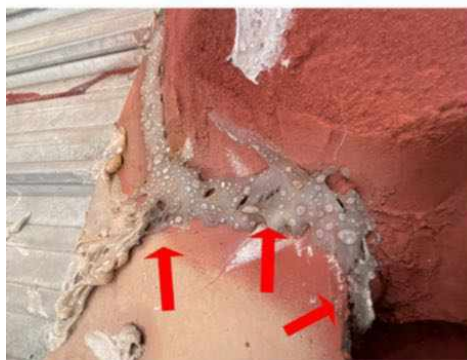
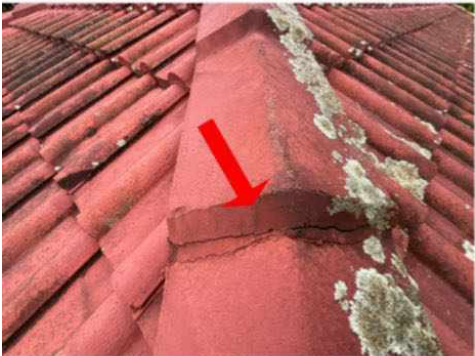
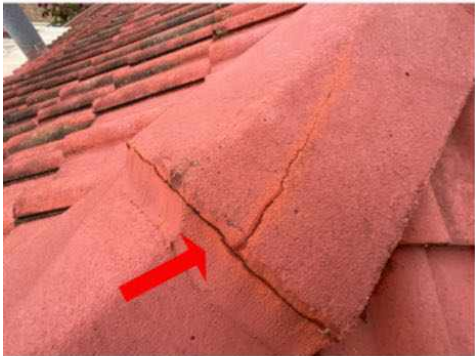
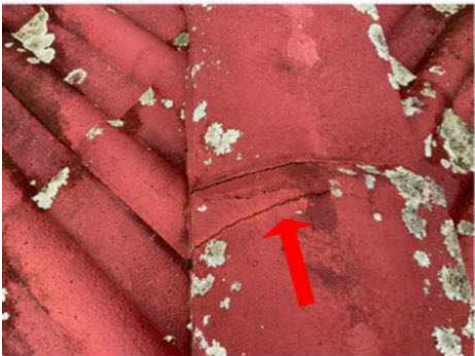
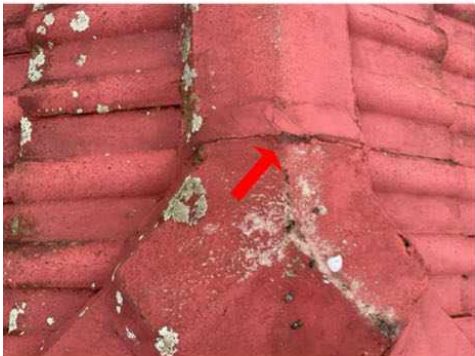
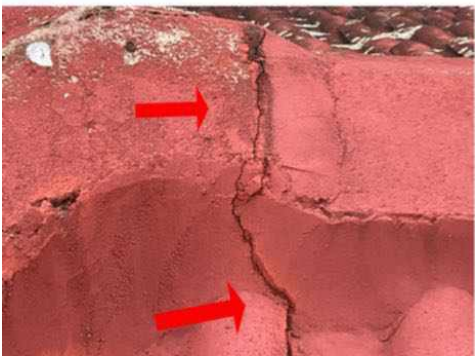
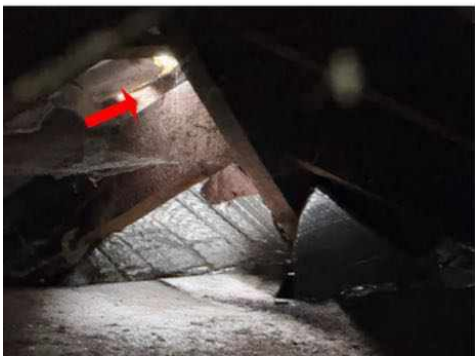
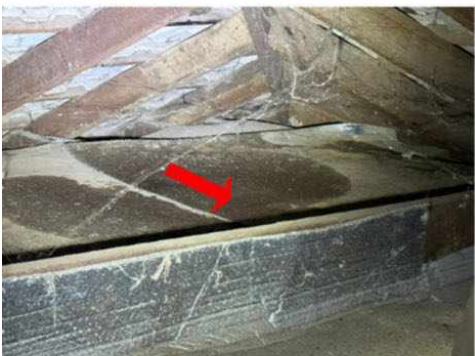
Finding 3.01

Building: Building 1
Location: Roof Exterior
Finding: Roof tiles - Weathered
Information: Upon inspection of the exterior roofing, the majority of roof tiles were considered to be in a fair condition. Two areas in the front Roth and rear left roof void corners appear wet from roof leaks. While weathering of the tiles is consistent with the age of the property, maintenance works are immediately required. The roof tile on picture one is allowing water ingress in the front right roof. The damaged sealant also appears to be allowing water into the left rear roof.

Isolated areas of mortar also show minor cracking present. Re-pointing and re-sealing the may be considered as an interim solution by the client to help preserve and extend the life span of the tiles.

Where left unmanaged, deteriorating roof tiles are likely to lead to a number of secondary defects, including minor water leaks and weather exposure to internal roofing structures.

Consultation with a roofing contractor is urgently advised to gain advice on cost of remedial works to stop further damage. Remedial works are likely to increase the longevity of the exterior roofing structure.

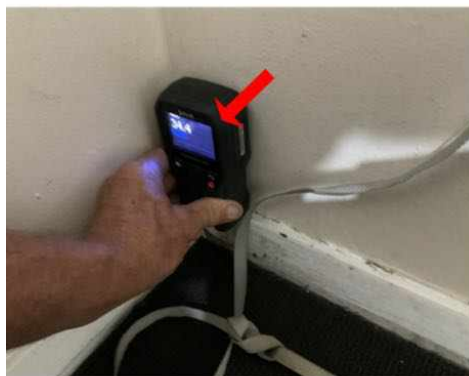
Building:	Building 1
Location:	Walls surrounding bathroom and front bedroom walls
Finding:	Evidence of excessive moisture was present at the time of inspection
Information:	Excessive moisture was found in the hall and rear bedroom walls from bathroom leaks. High moisture was also found in the front bedroom walls.

Excessive moisture can attract termites and produce conditions that promote termite attack, fungal growth and wood decay.

Excessive moisture is generally caused by deteriorated, inadequate or missing roof drainage, damaged waterproofing membranes and sealant, leaking plumbing pipes or fixtures, poorly plumbed HWS overflows or condenser units and poor site drainage.

It is highly recommended that all plumbing and drainage fixtures and fittings be maintained regularly in order to prevent excessive moisture being present in the internal property.

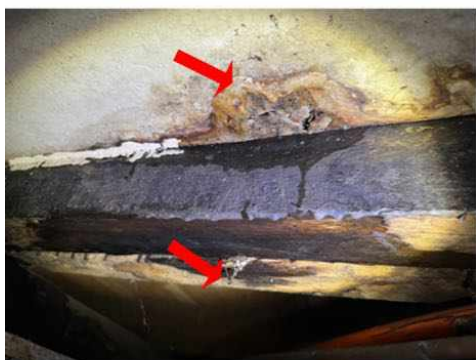
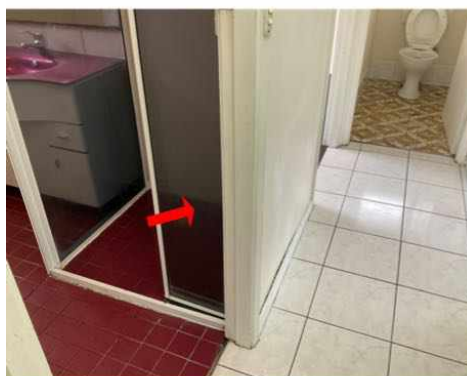
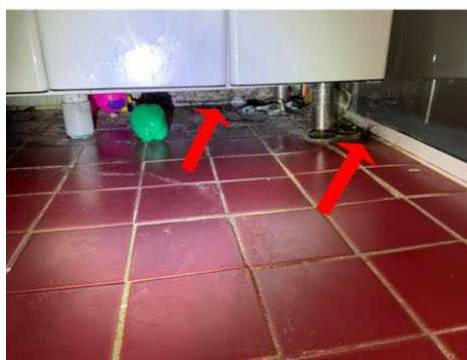
Finding 3.04

Building:	Building 1
Location:	Bathroom & laundry
Finding:	Sealant and grouting - Missing or damaged
Information:	It was noted on inspection that sealant or grout is degraded to these pictured areas.

Different materials and floor areas move at different rates, generally causing cracking to grout or sealant at this point. A flexible sealant is required to allow for expected expansion and contraction, while keeping the joint water tight and protective of all associated building materials.

Flexible and mould resistant materials should be applied to affected areas to prevent any subsequent water damage that is likely to occur. Regular maintenance and replacement of damage or missing or damaged sealant and grout is highly recommended to the wet areas, as this is a regular wear and tear defect. Sealant and grouting in areas that come into regular contact with water should be maintained for the long term care of your property.

A sealant specialist or tiling contractor should be appointed to complete these works as soon as possible

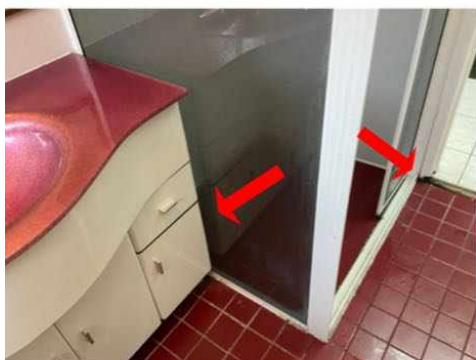
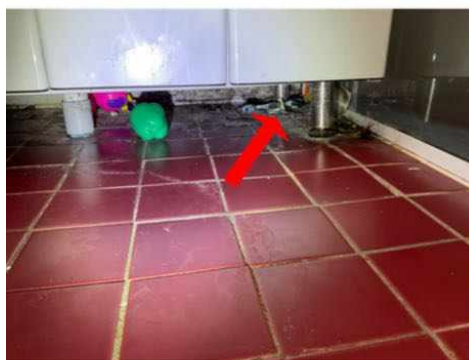
Finding 3.05

Building:	Building 1
Location:	Bathroom
Finding:	Shower screen - Leaking
Information:	Leaking was evident to the shower screening in two corners at the time of inspection. It is suspected that the leaking has occurred as a result missing sealant. Leaking from the shower , where left unattended, is likely to lead to water damage to adjoining flooring and walls. Such damage can lead to water damage and necessitate extensive remedial works being required. Active water leaks may also create an environment that is susceptible to the formation and development of mould.

Appointment of a sealant expert is required to repair or replace this missing sealant. Such works should be performed as soon as possible to ensure that no further damage occurs.

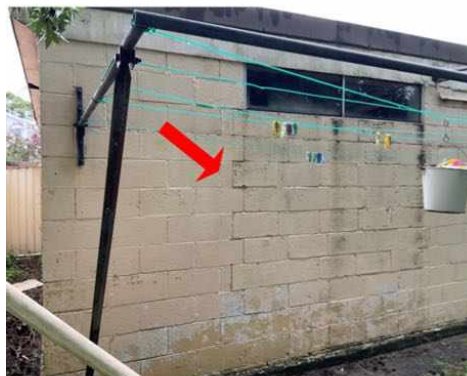
Finding 3.06

Building:	Building 2
Location:	Exterior front and rear walls of rear building
Finding:	Step cracking to brickwork (minor)
Information:	Step cracking was identified to the brickwork in this area at the time of inspection. Step cracking, which is similar to other forms of cracking, has a variety of possible causes. However, the most common is the subsidence of adjacent footings.

Step cracking is a relatively common defect, and is most likely to occur adjacent to windows, doors and other openings. Mortar failure in the gaps between affected bricks indicates the stresses and tensions affecting the wall.

Where step cracking is extensive or severe, the client is advised to consult a structural engineer. This minor step cracking can be used as a warning sign to address factors causing stress to the wall, which can include the effect of surrounding trees, water leaks, soil erosion, or even the presence of reactive soils in the surrounding area.

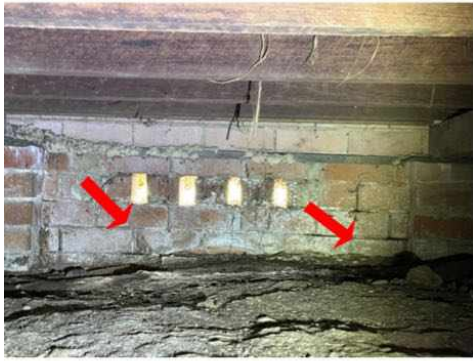
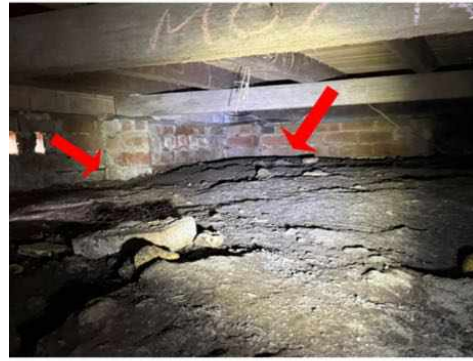
Finding 3.07

Building:	Building 1
Location:	All Subfloor Areas
Finding:	Damp - Rising
Information:	Rising damp describes the upward movement of water in low sections of building elements (e.g. walls) by capillary action - the movement of water through porous materials such as bricks, sandstone or mortar.

The first step in addressing rising damp is to diagnose the cause. The identified cause should be addressed first before addressing the appearance and other defects which have resulted from the rising damp. If the original cause is not resolved, further cases of damp are likely to ensue, resulting in secondary defects.

Consultation with a qualified plumber is advised immediately to identify the cause of the damp and perform remedial works as required.

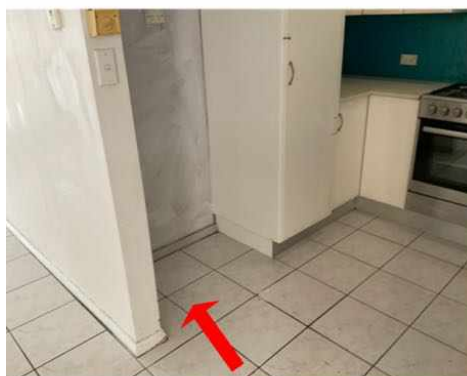
Cracked tiles throughout the household detract from the overall appearance of the affected areas however it is unlikely to create or lead to any secondary defects.

While not considered a matter of urgency, replacement of cracked floor tiles is recommended at the clients discretion. A tiling contractor may be appointed to perform these works. Where cracks become more numerous, contact a licensed building inspector for further investigation.

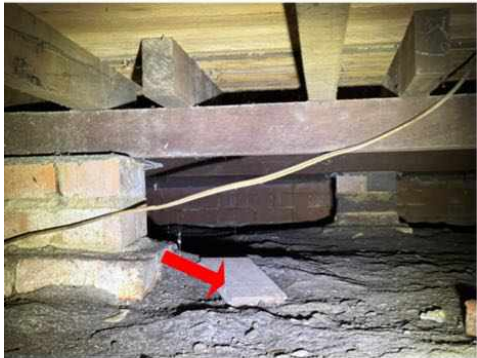
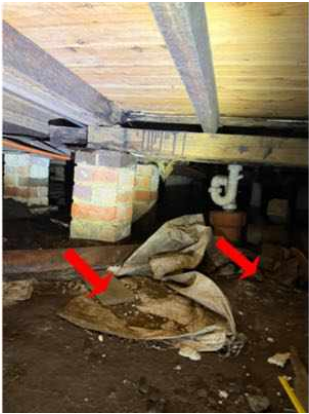
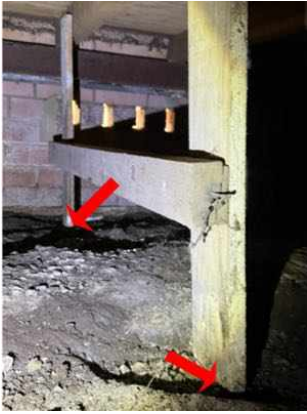
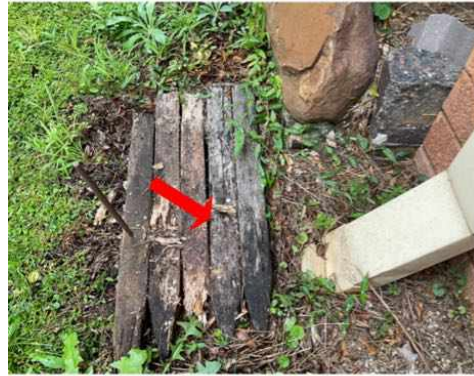
Finding 6.03

Removal of all waste timber that is in direct contact with ground is highly advised. This timber is promoting mould and wood rot and is very attractive to termites.

Frequent pest inspections are advised to readily identify any termite activity in these areas.

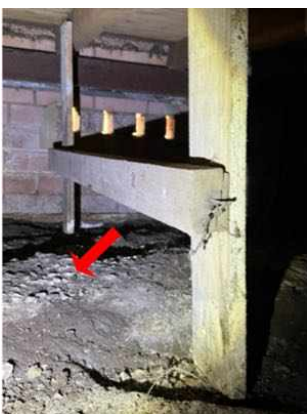
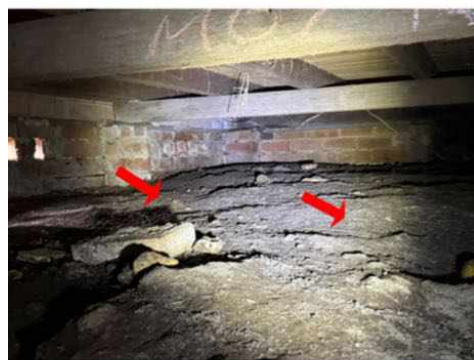
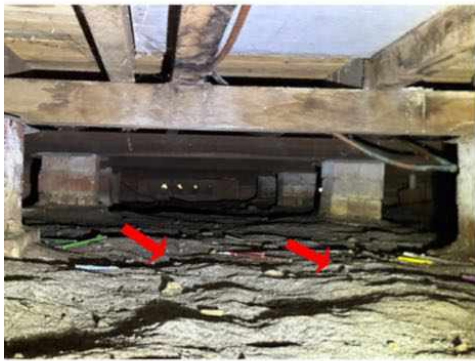
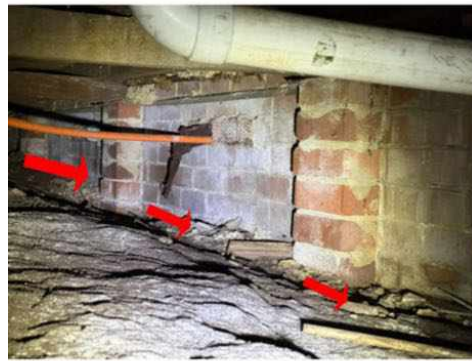
Subfloor mould is generally caused by moisture ingress, lack of external drainage, lack of adequate ventilation and subfloor debris present. These issues need rectification

to stop mould development. Any mould found during the inspection should be cleaned immediately by a cleaning contractor or the homeowner as applicable.

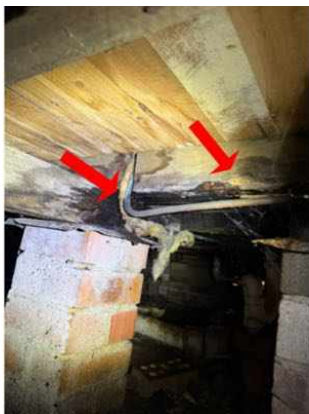
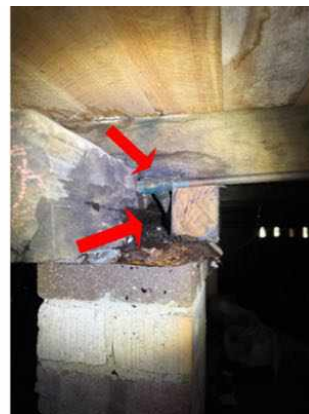
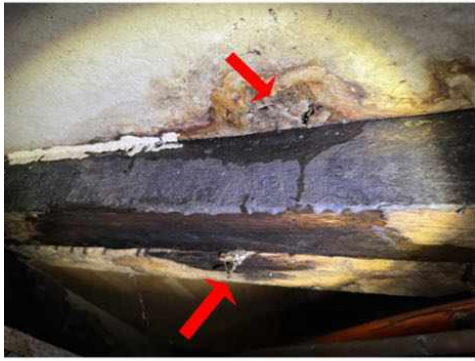
Finding 7.01

Evidence of fungal decay activity and/or damage

Building:	Building 1
Location:	Pictured areas
Finding:	Fungal decay - present (localised)
Information:	Fungal decay also known as wood decay or wood rot generally refers to the deterioration of timber elements when in contact with excessive levels of moisture for a prolonged period of time.

The development of fungal decay is accelerated by temperatures from 5degreeC to 40degreeC as well as the presence of oxygen. Generally fungal decay develops on timber elements that are in use in an external environment which are exposed to rain penetration.

In this case, the affected timber element is in a decaying state and will need replacement by a carpenter or licensed builder.

Note - See ALL wood rot photos in building defects above, all these show fungal decay.

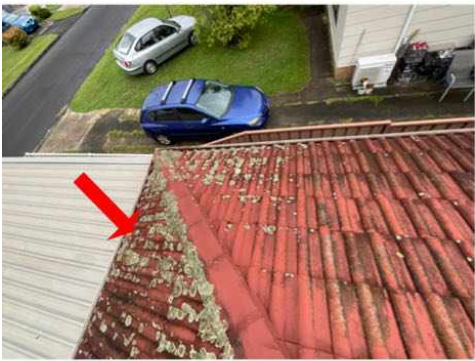
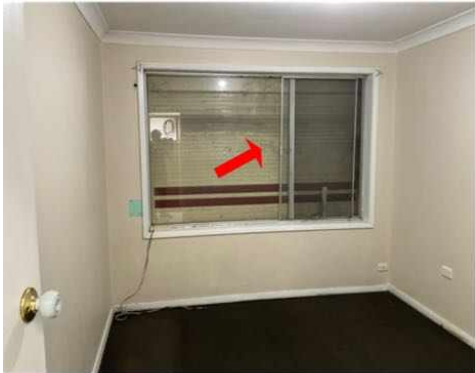
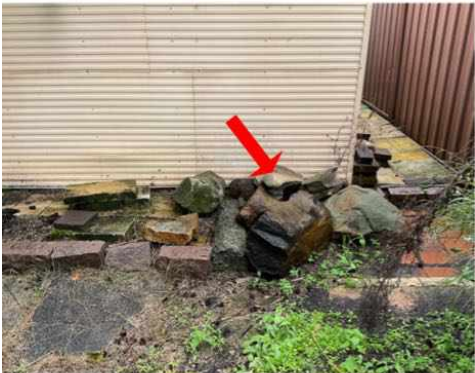
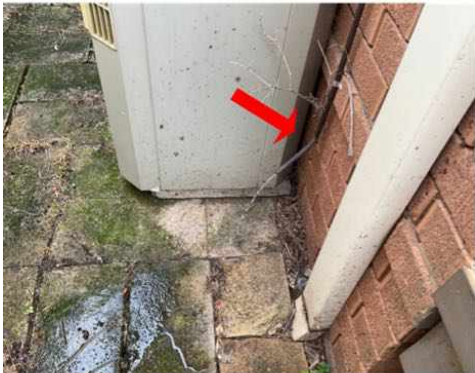
Building:	Building 1
Location:	All External Areas
Finding:	Additional Photos - Obstructions and Limitations of EXTERNAL AREAS
Information:	These photographs are an indication of the obstructions and limitations which impeded full inspection of external areas at the time of inspection. These obstructions can hide an array of defects and should be removed to allow full inspection to be carried out. A re-inspection is recommended once the areas are made accessible.

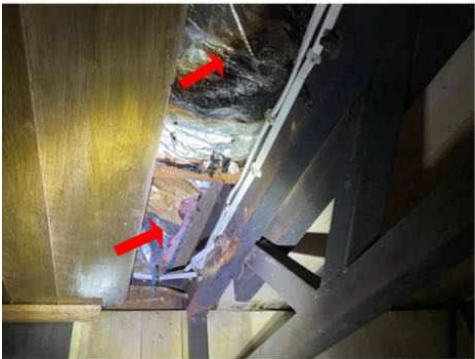
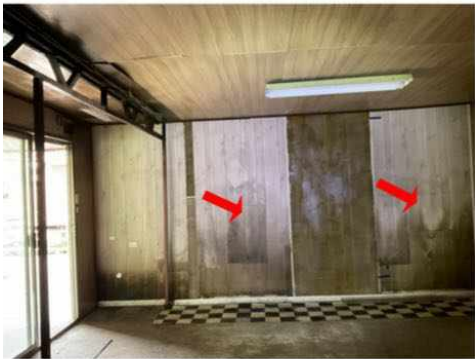
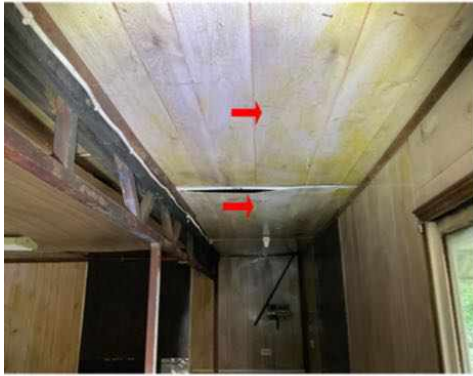
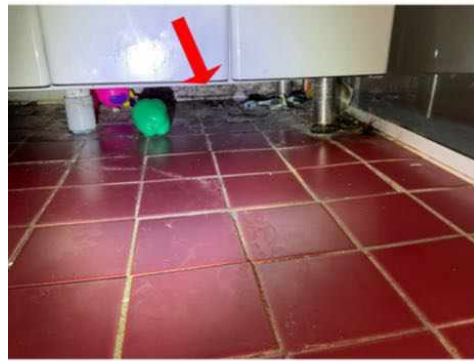
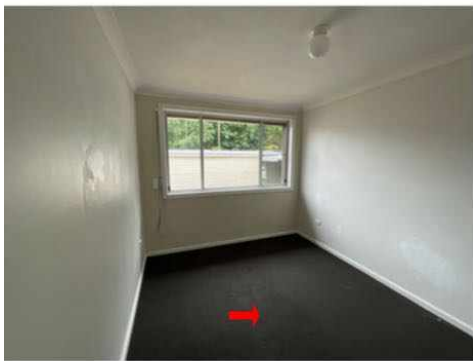
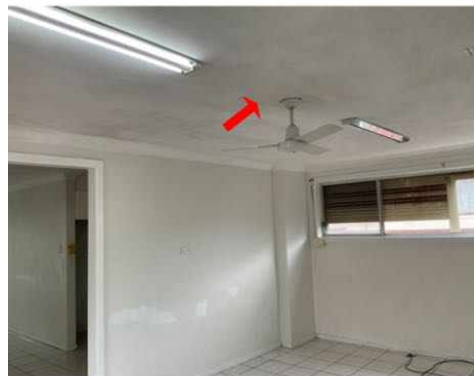
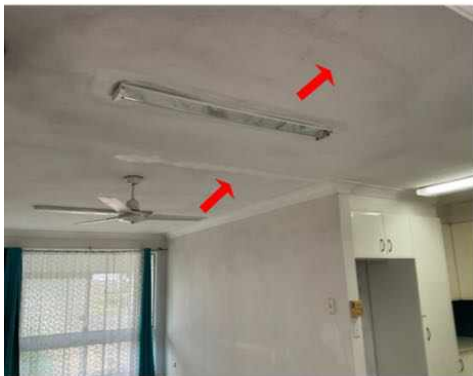
Building: Building 1
Location: All Internal Areas
Finding: Additional Photos - Obstructions and Limitations of INTERNAL AREAS
Information: These photographs are an indication of the obstructions and limitations which impeded full inspection of Internal areas at the time of inspection. These obstructions can hide an array of defects and should be removed to allow full inspection to be carried out. A re-inspection is recommended once the areas are made accessible.

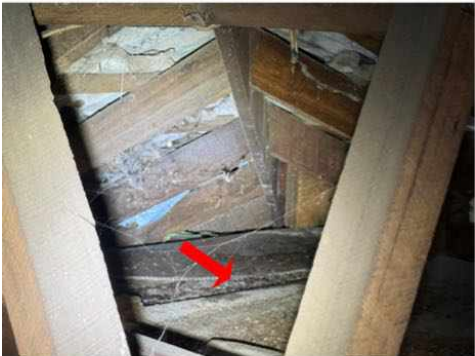
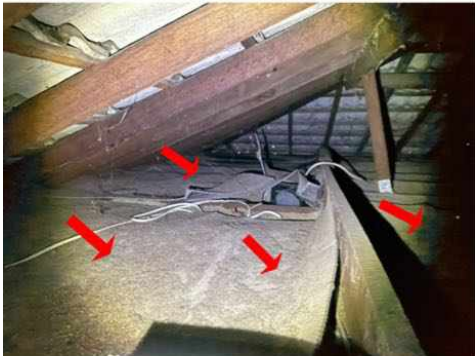
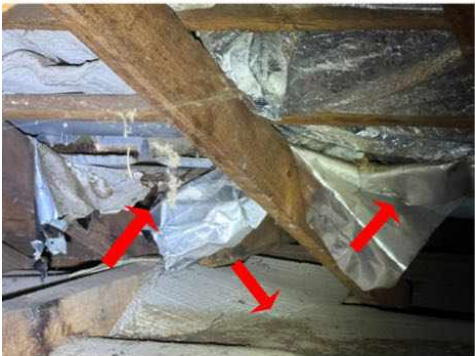
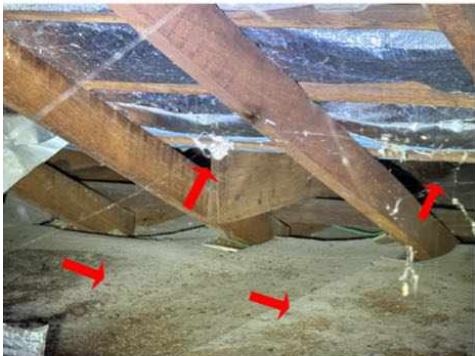
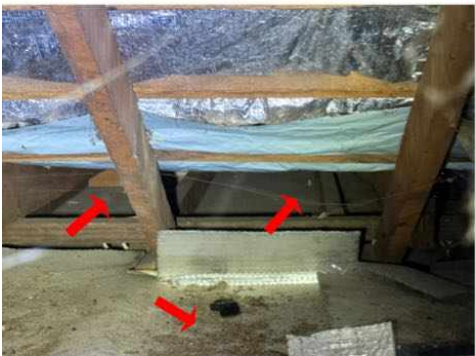
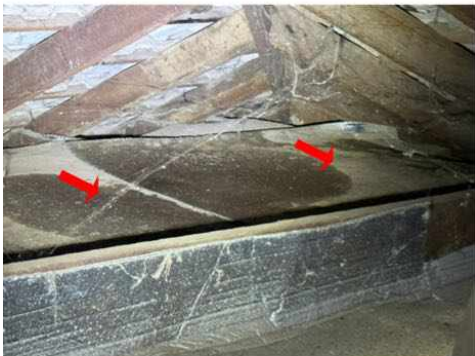
Building: Building 1
 Location: All Roof cavity areas
 Finding: Additional Photos - Obstructions and Limitations of the ROOF CAVITY
 Information: These photographs are an indication of the obstructions and limitations which impeded full inspection of roof cavity areas at the time of inspection. These obstructions can hide an array of defects and should be removed to allow full inspection to be carried out if applicable. No ceiling joists were visible as they were all covered in sarking.

The inspection was also limited to areas with an allowable crawl space of 600mm x 600mm, in particular towards the external walls where the roof line diminishes, these areas were not accessible.

A re-inspection is recommended once the areas are made accessible.

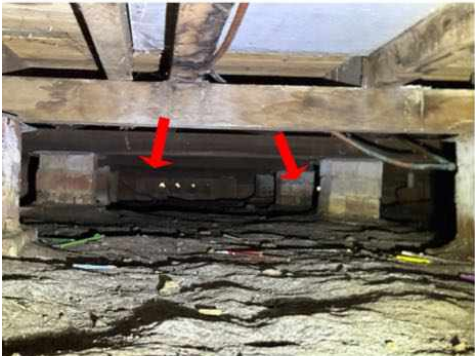
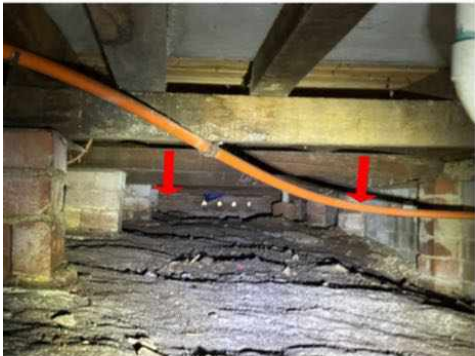
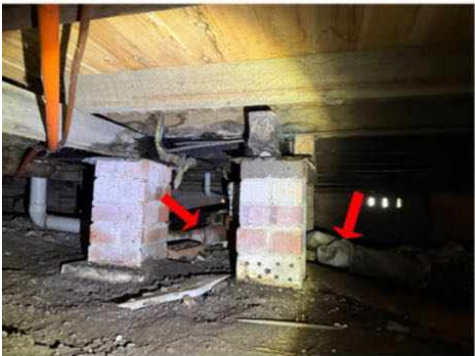
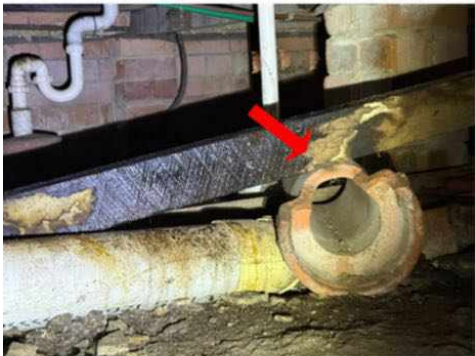
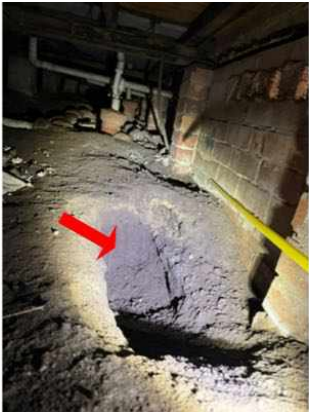
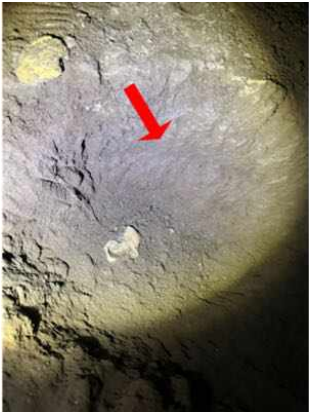
Building: Building 1
Location: All Subfloor Areas
Finding: Additional Photos - Obstructions and Limitations of SUBFLOOR AREAS
Information: These photographs are an indication of the obstructions and limitations which impeded full inspection of subfloor areas at the time of inspection. These obstructions can hide an array of defects and should be removed to allow full inspection to be

carried out. Only the right third of the subfloor was accessible as the entire left side had very low clearance. Large holes were also found in some areas for no known reason.

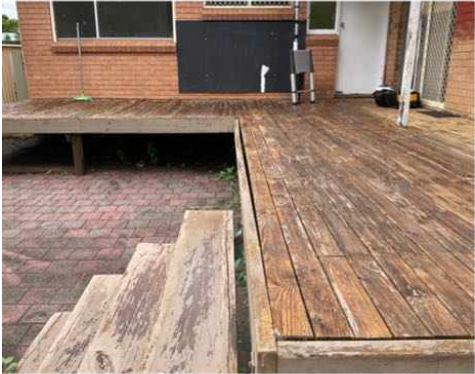
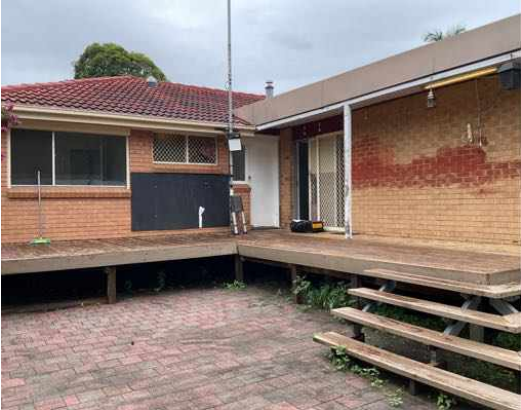
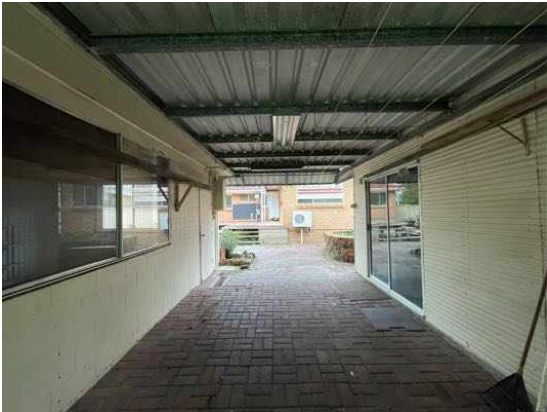
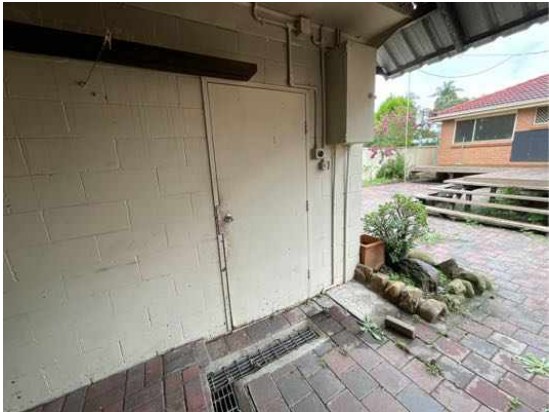
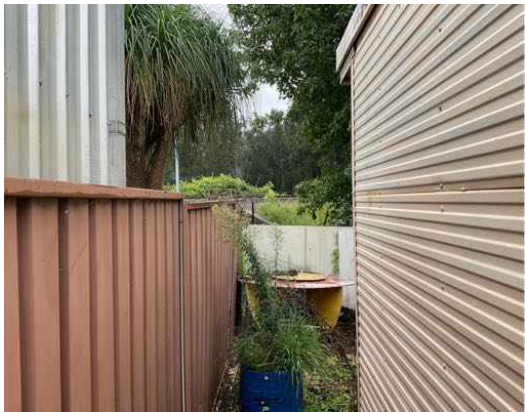
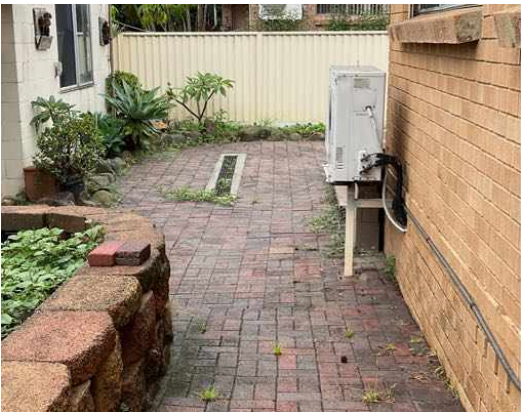
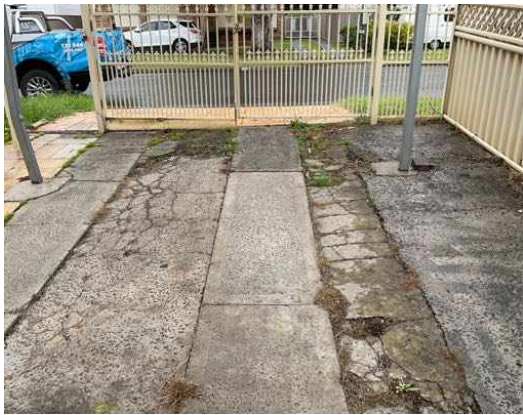
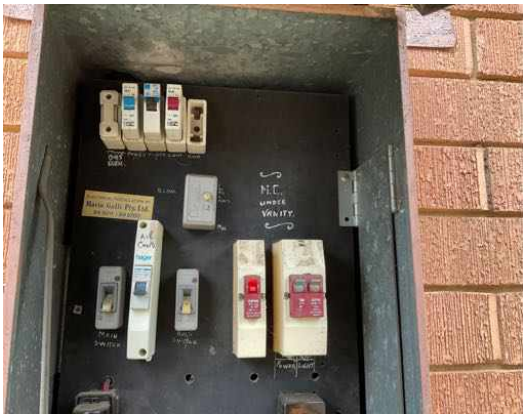
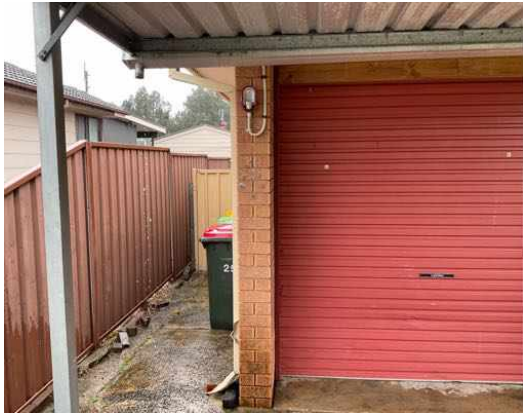
Building: Building 1
Location: All External Areas
Finding: Additional Photos
Information: Additional photos are provided for your general reference

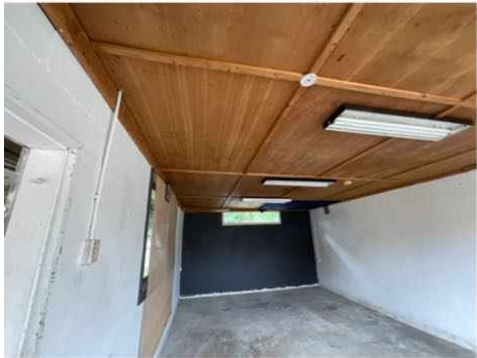
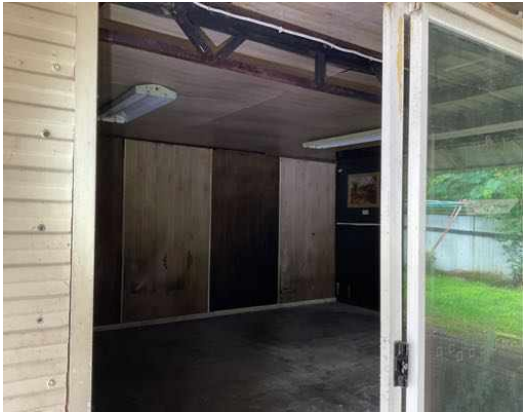
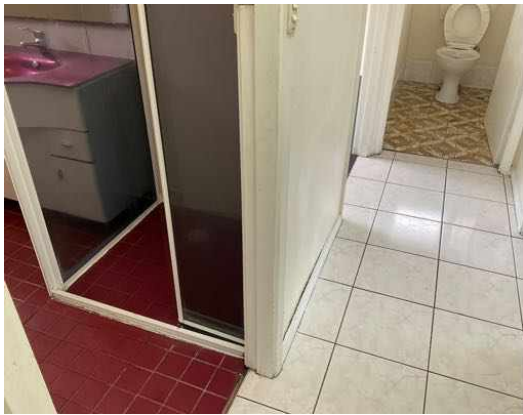
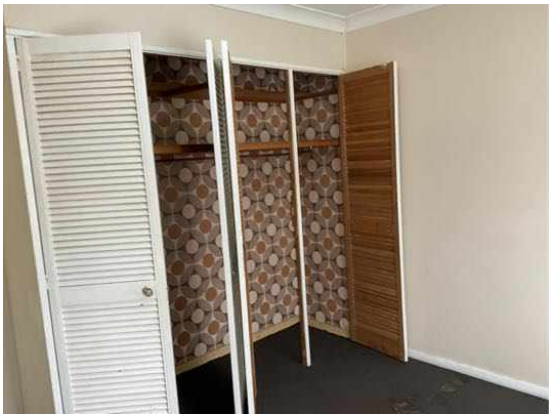
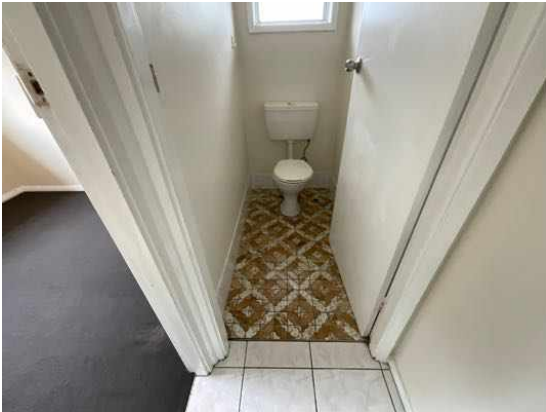
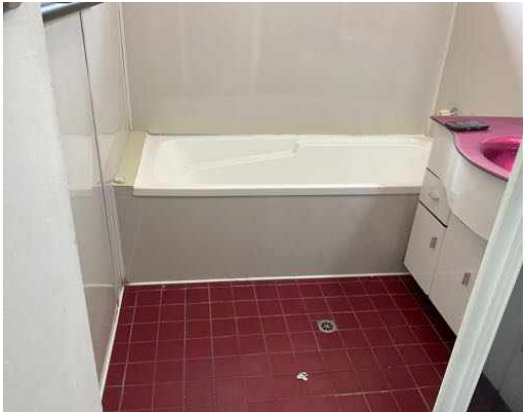
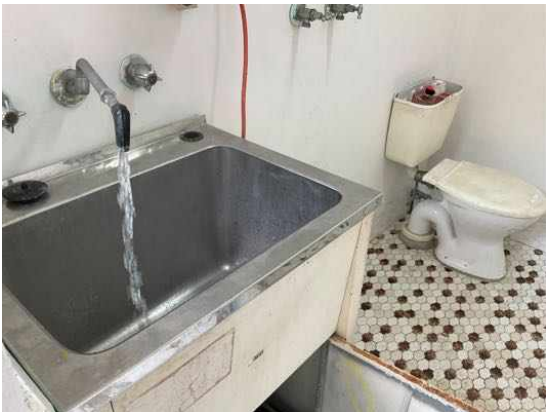
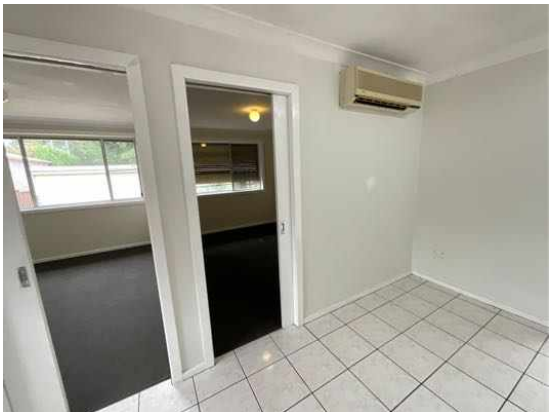
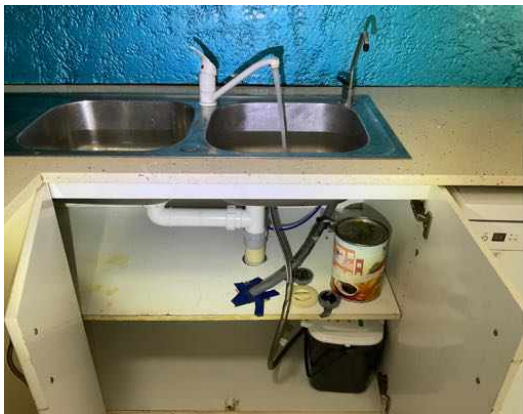
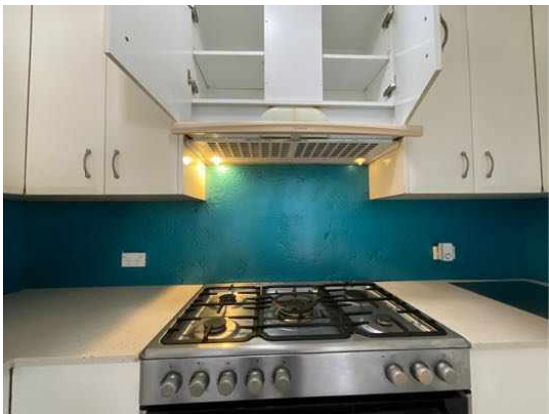
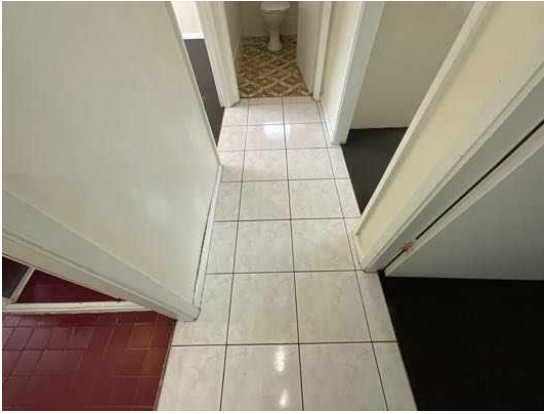
Building: Building 1
Location: All Internal Areas
Finding: Additional Photos
Information: Additional photos are provided for your general reference

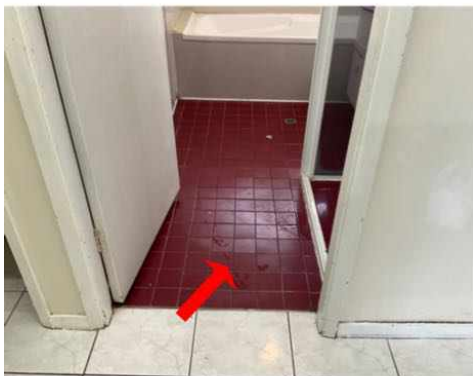
Building: Building 1
 Location: Bathrooms and laundry
 Finding: Waterproofing membranes - Information Only
 Information: Internal Water Proofing Membranes, are crucial in preventing water ingress into the property is important to know that the Membrane System used is to Australian Standards and has been installed correctly.

With older property's where this information is unavailable all wet areas should be monitored. If any leaks, water staining, peeling or bubbling of the paint become evident to any adjacent walls or ceilings below a licensed builder or waterproofing specialist is recommended to investigate further.
