# Building and Timber Pest Inspection Report

Inspection Date: Wed, 14 Jan 2026

Property Address: 27 Hamilton Ave, Earlwood NSW 2206,  
Australia

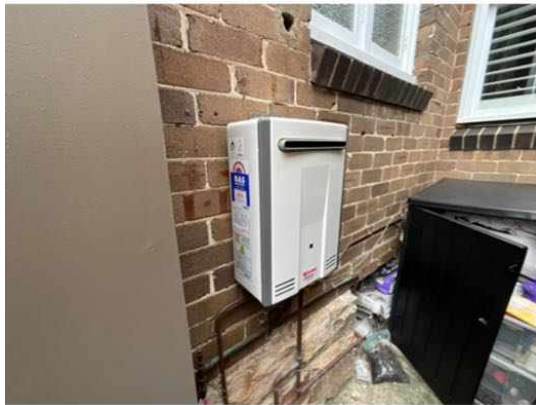
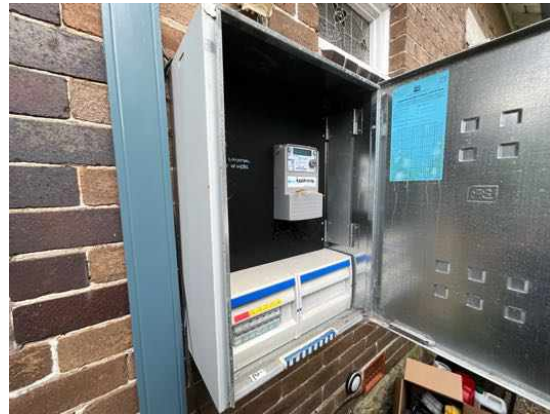
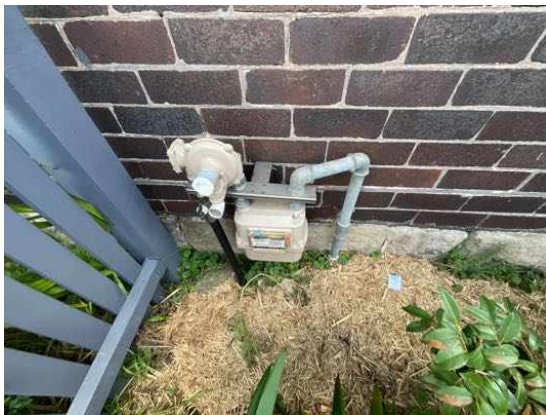
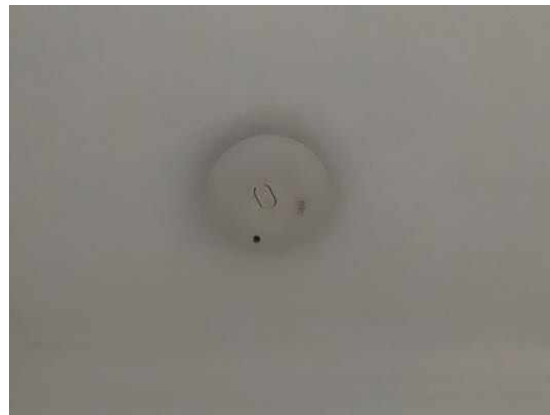
Building: Main Building  
Location: All Areas  
Finding: Photos Added  
Information: Additional photos are provided for your general reference.

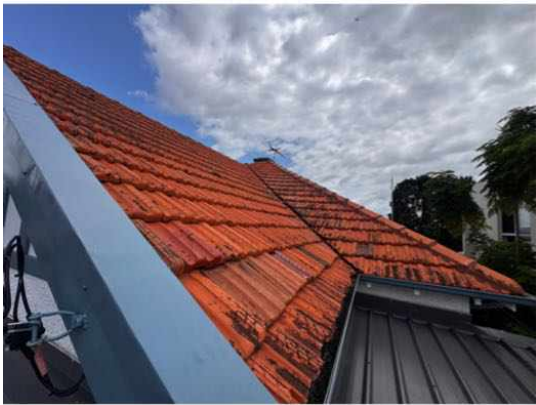
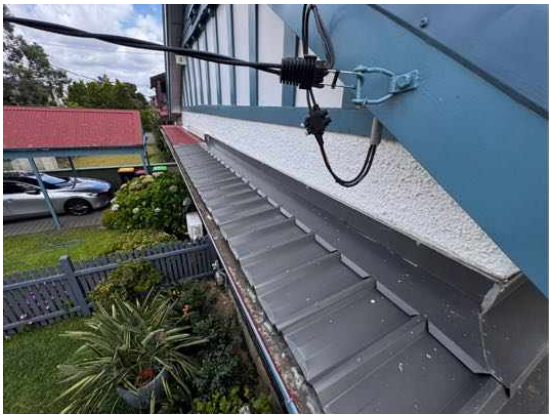
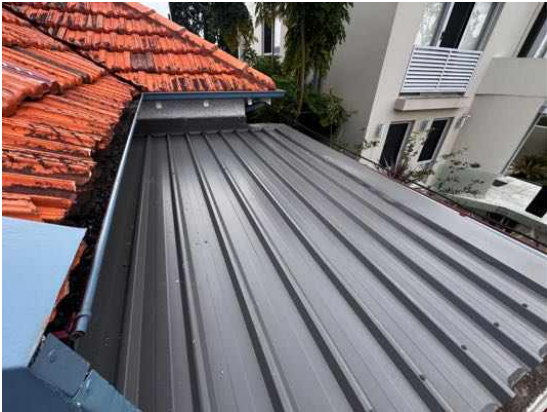
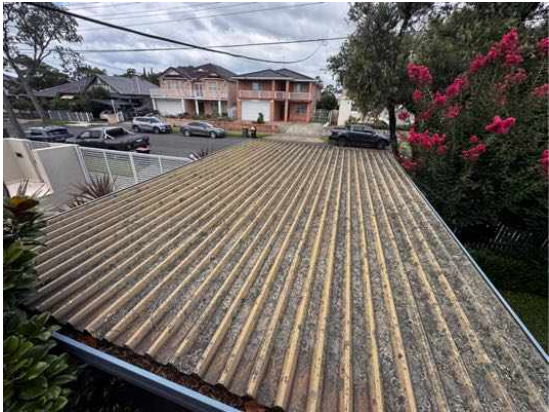
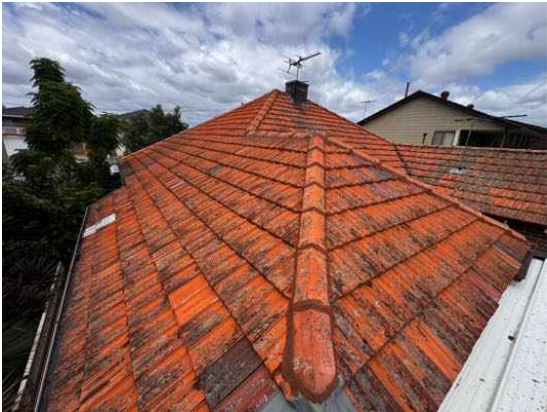
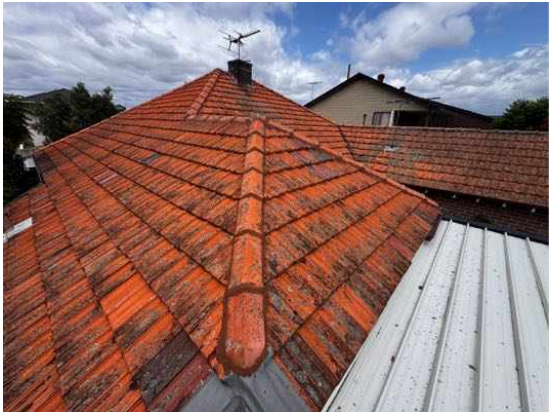
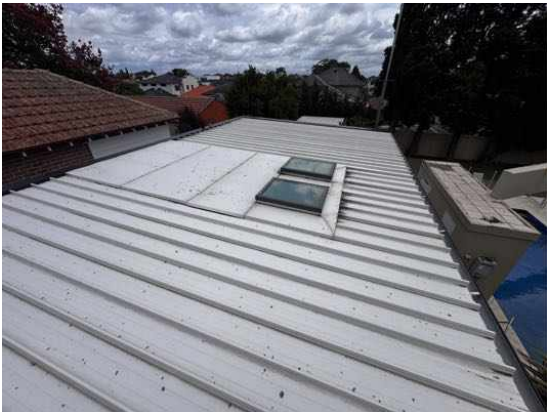
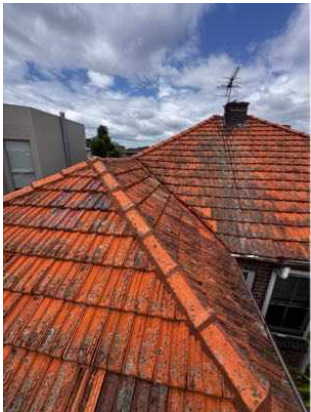
Building: Main Building  
Location: Roof Exterior  
Finding: Photos Added  
Information: Additional photos are provided for your general reference.

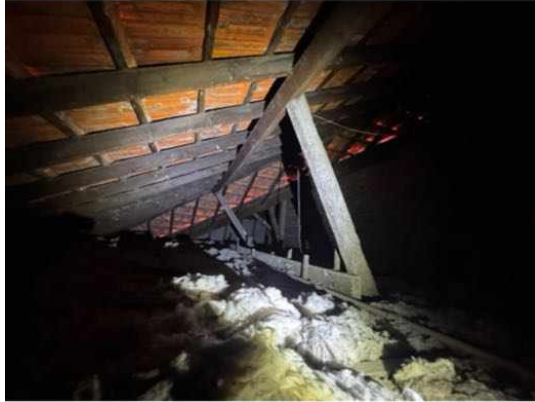
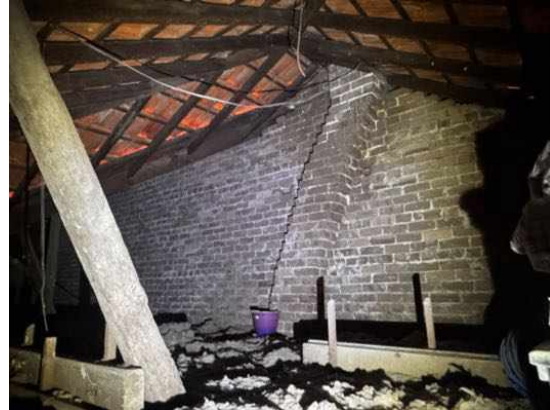
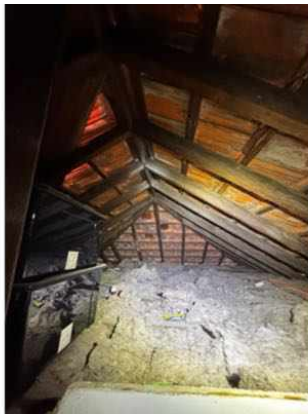
Building: Main Building  
Location: Roof Void  
Finding: Photos Added  
Information: Additional photos are provided for your general reference.
