Building Inspection Report

Inspection Date: Thu, 29 Jan 2026

Property Address: 4 Edwin Pl, Austins Ferry TAS 7011,
Australia

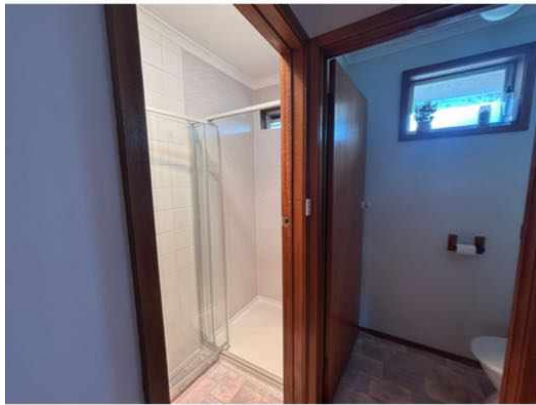
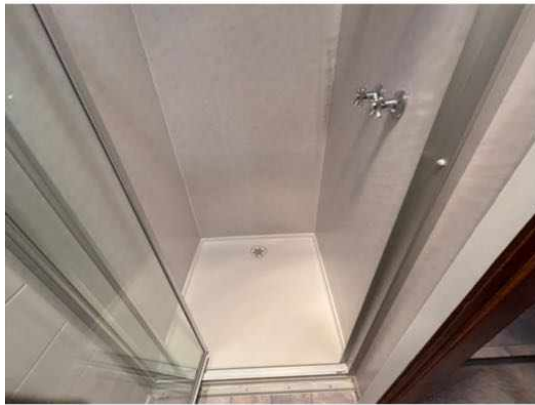
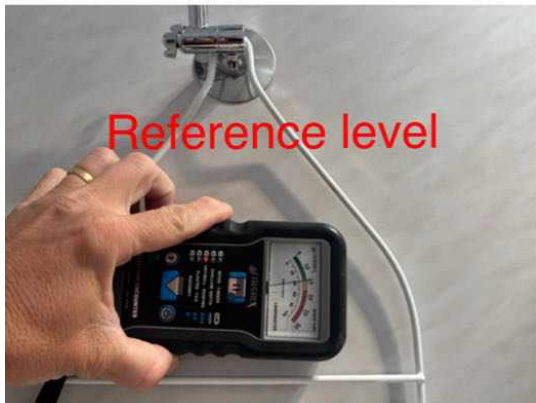
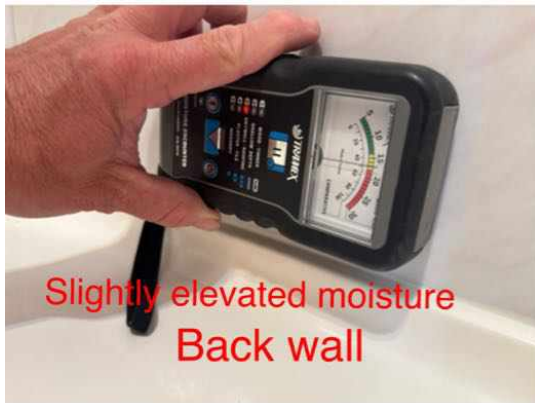
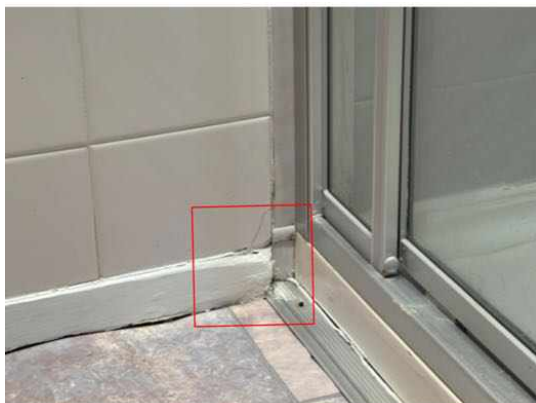
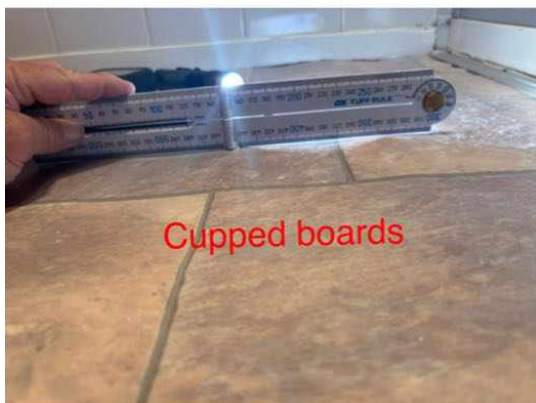
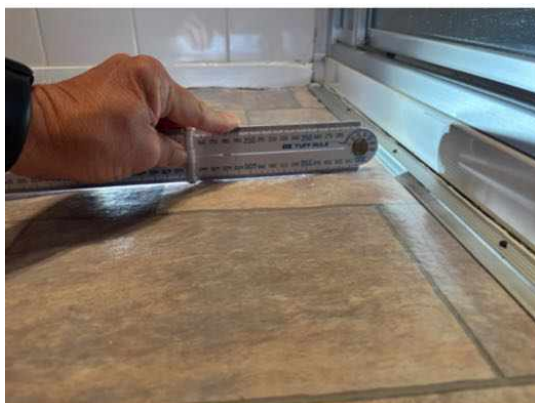
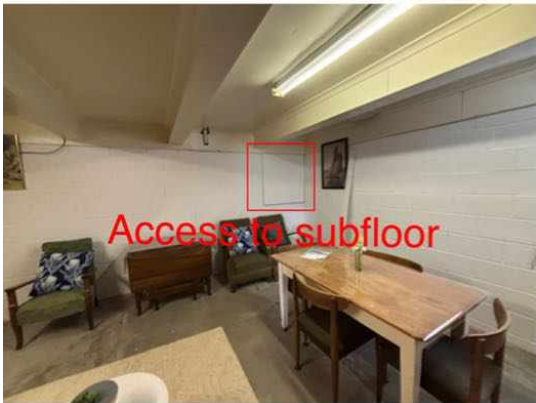
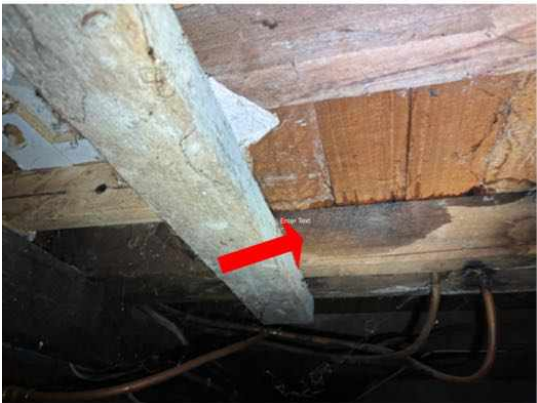
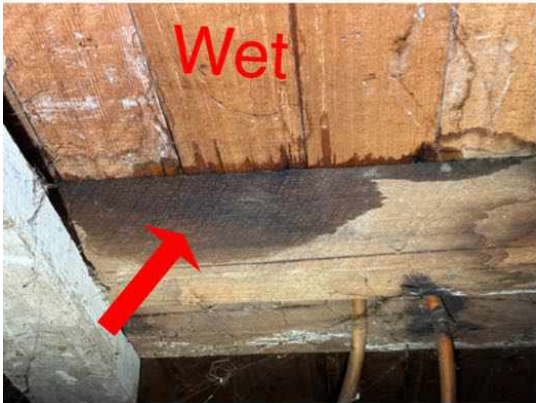
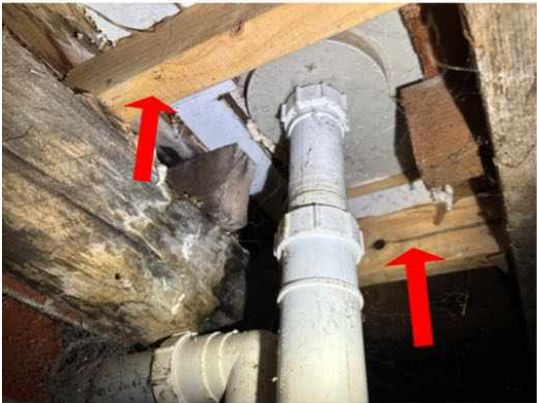
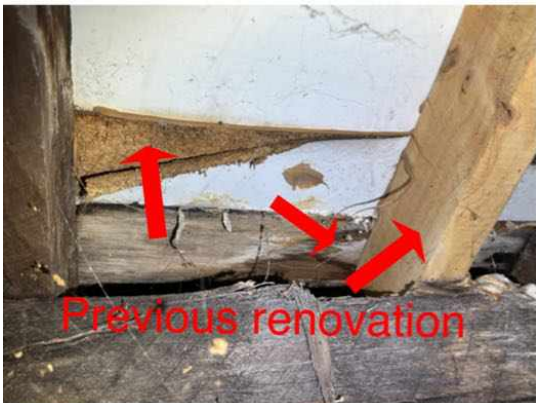
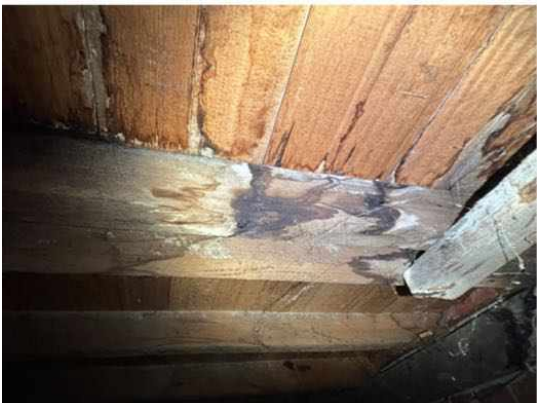
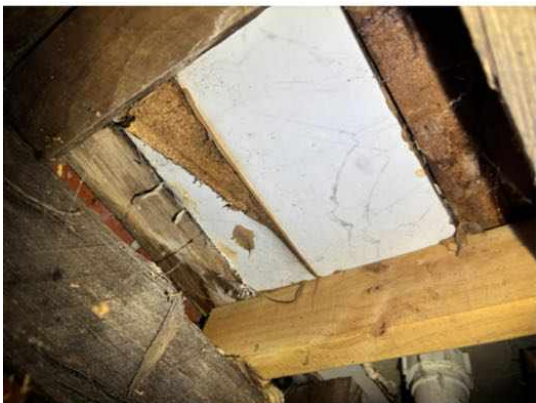
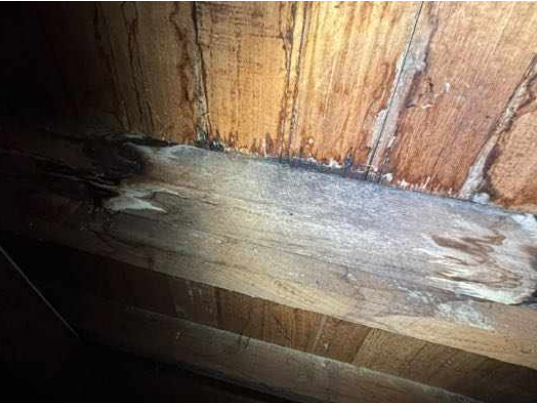
Defects 2.01

Building: Main Building
 Location: Shower room
 Finding: Shower active water leak
 Information: In the subfloor there is active water underneath the shower taps area. It was wet after running the shower just a couple of minutes. The subfloor timbers are wet and are water stained. There is also some damaged chipboard and pine framing, that looks to have been a previous renovation/repair, however these have also become water damaged.

In the shower room, there were elevated moisture readings low down on the shower wall panelling. This usually indicates water is behind this area, which is not uncommon.

On the wall next to the shower, there is some previous water damage visible. There is also a cracked tile. Additionally the floor boards are cupped from water damage.

It is most likely that this shower will need to be demolished and reconstructed. Only once the door, panelling, tray and flooring is removed will the full extent of the damage be visible.

If not rectified, water will continue to ingress and may lead to water damage and deterioration of the surrounding building elements if the water proofing membrane is not intact or absent. However our non invasive inspections is unable to determine the adequacy of the water proofing membrane.

Recommend client engage a Lic Plumber to inspect and rectify the leak, as soon as possible.

Recommend client engage a Lic Builder who specialises in bathroom renovation, to carry out a more invasive inspection, advise and rectify as soon as possible.

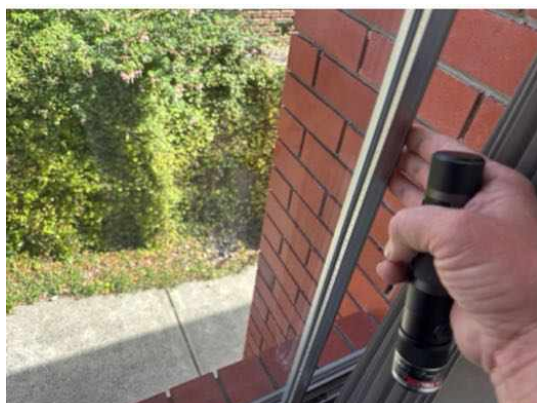
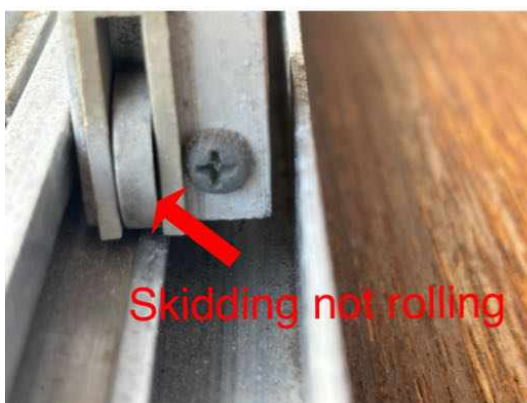
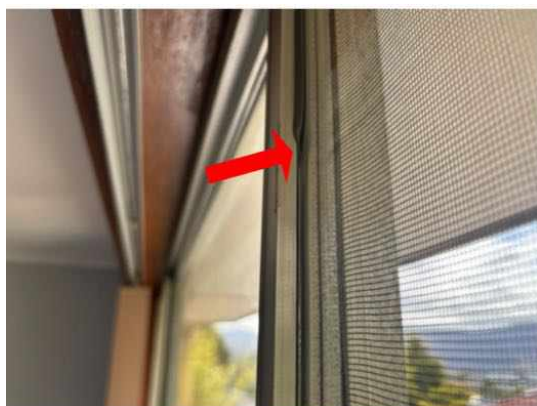
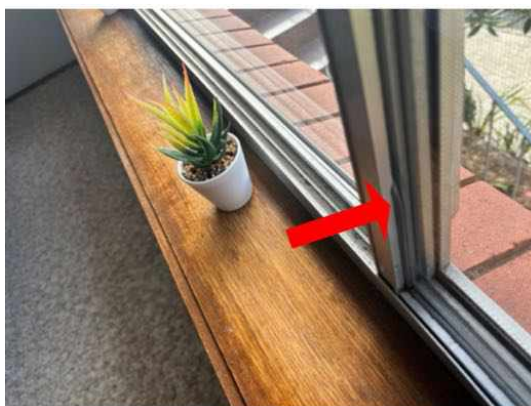
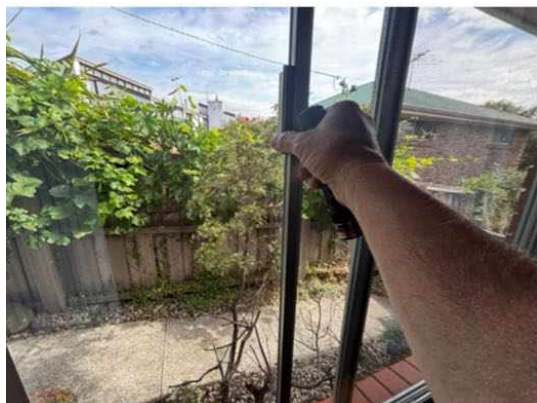
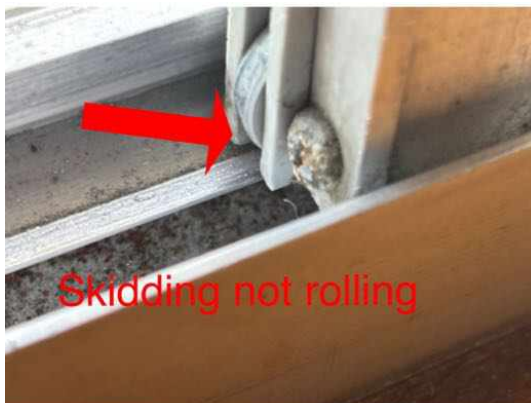
Defects 3.01

Building:	Main Building
Location:	Multiple locations
Finding:	Windows - cleaning and maintenance required
Information:	In multiple locations throughout the property, the windows would benefit from cleaning and maintenance. One window would not open and was missing some rubber and other windows had wheels dragging on the tracks instead of spinning.

Generally, factors such as general age of the building element and a lack of maintenance are the usual causes for this type of defect.

Windows provide ventilation to the adjoining area and should be at a fully operational level to ensure user comfort. Restricted function of the window may also pose as a potential safety hazard if required for emergency egress from the building.

Recommend client engage a Handy Person to rectify as soon as practicable.

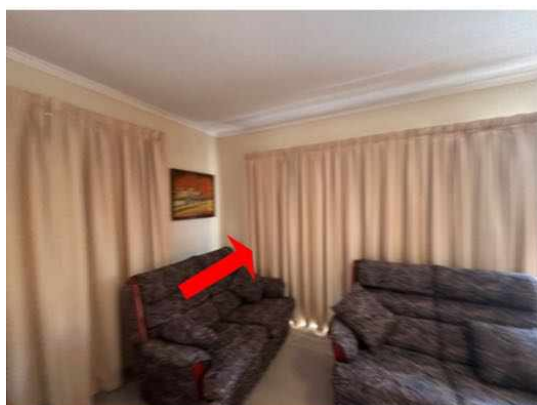
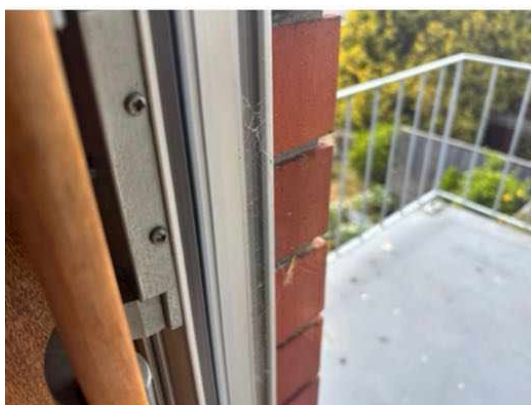
Defects 3.02

Building: Main Building
Location: Multiple locations
Finding: Door latch broken
Information: One (of two) sliding door to the living room has a broken latch. This impedes the function of the door.

Generally, factors such as general age of the building element and a lack of maintenance are the usual causes for this type of defect.

Recommend client engage Handy Person to rectify as soon as practicable.

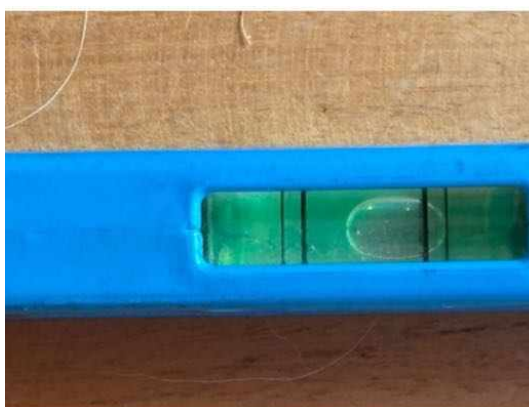
Defects 3.03

Building:	Main Building
Location:	Dining room
Finding:	Floor out of level (minor)
Information:	The dining room floor was out of level a minor amount near the kitchen. I couldn't see underneath as there are batts and foil fitted under the floor. This is a non invasive inspection. The floor felt firm. It may have had some movement in the past.

Recommend client monitor.

If movement increases, recommend client engage a Lic Builder to inspect and rectify (if required) as soon as possible.

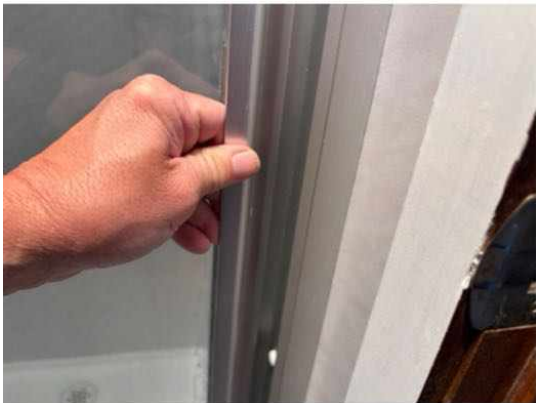
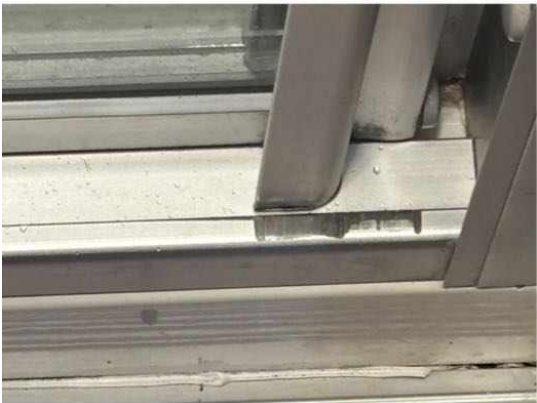
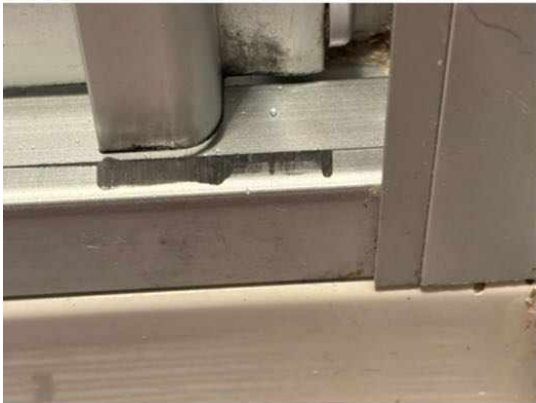
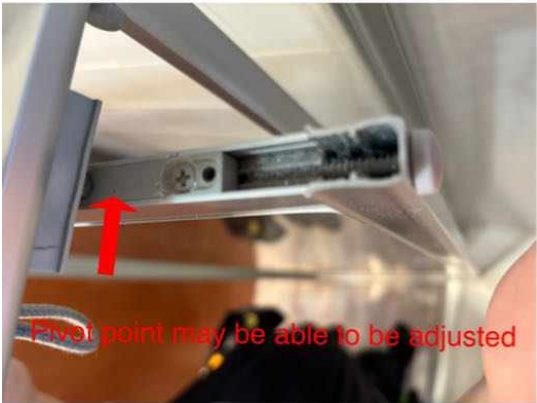
Defects 3.04

Building:	Main Building
Location:	Shower room
Finding:	Shower door binding
Information:	The bathroom shower door is binding on the bottom/ of the door. This defect inhibits the functionality of the affected door.

Failure to rectify will lead to further deterioration to the building elements.

Pivot point may be able to be adjusted

Recommend client engage a Handy Person to rectify as soon as practicable. However there is a leak to the shower and if the bathroom is to be renovated then fix or replace screen at that time.

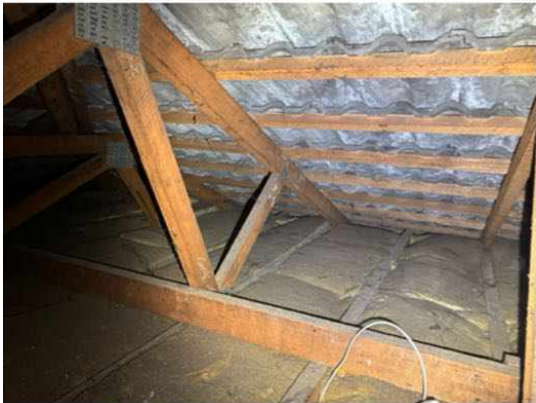
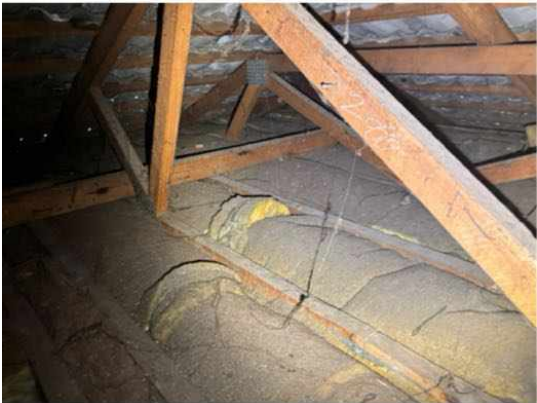
Defects 3.05

Building: Main Building
 Location: Roof void
 Finding: Insulation batts
 Information: For your information. The insulation in the roof are batts.

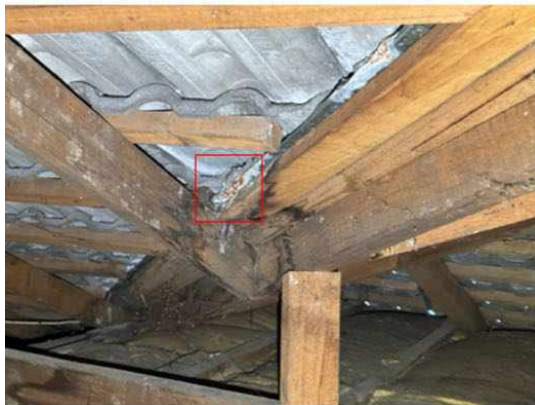
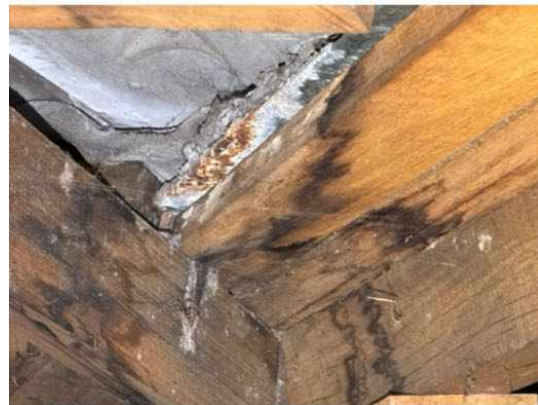
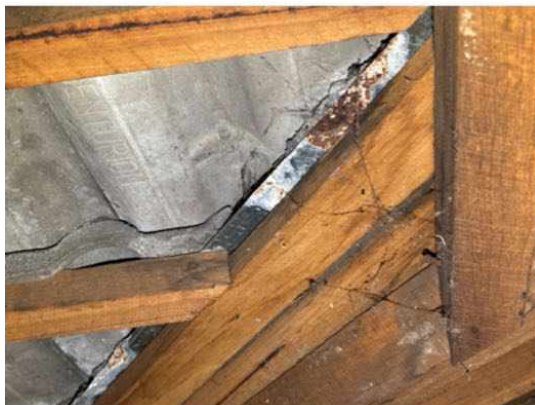
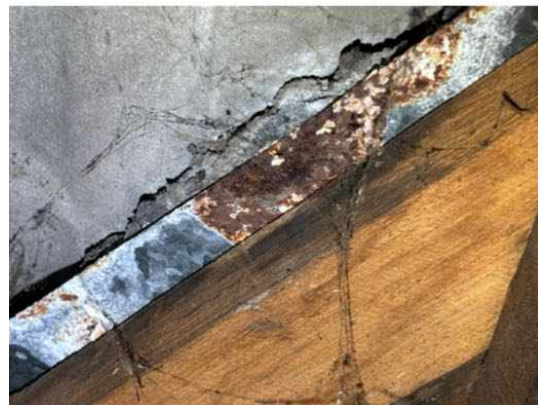
Defects 3.06

Building: Main Building
 Location: Roof void
 Finding: Corrosion to valley metal

In the roof void there is some corrosion to the roof valley metal, at the front of the house. This pointing has deteriorated to this valley. This is most likely allow water in and causing the corrosion.

Rusting and corrosion, which is likely to have developed as a result of excessive exposure to moisture and or inadequate coatings.

As surface rust provides no protection to the underlying iron, the deteriorating condition is likely to worsen if not addressed in the short-term future.

Recommend client engage a Tiled Roof Contractor to rectify as soon as possible, to prevent further deterioration.

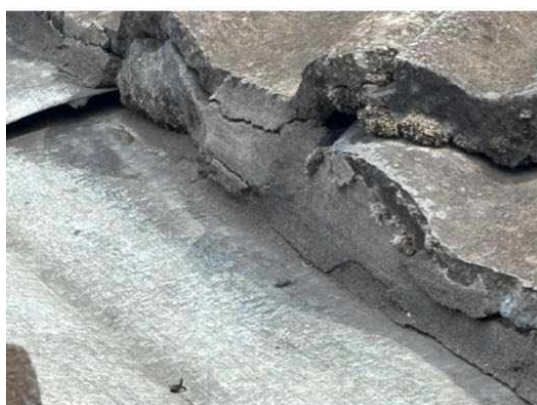
Defects 3.07

Building:	Main Building
Location:	Roof
Finding:	Tiled roof - maintenance required
Information:	The roof is in fair condition for its age. Concrete tiles such as these get brittle with age and cracks can occur. It is good that there has been some repointing and repairs done and most of that is looking good from the ladder. It is unusual that the slipped tiles were not put back in place prior to repointing. But some of that pointing has cracked again and there are a few cracked tiles and some silicone repairs. As these roof age they do need regular inspections and maintenance.

Broken and friable roof tiles are generally the result of ageing and weathering of what is essentially a porous material.

If left to further deteriorate, broken and brittle roof tiles are likely to lead to water penetration via the roof into the ceiling space, causing secondary damage to ceiling linings, insulation and roof structures. Broken roof tiles are also likely to detract from the effectiveness of the roof drainage system, creating potential for secondary damage to the exterior roof covering and roof plumbing.

Recommend client engage a Tiled Roof Contractor to rectify as soon as possible.

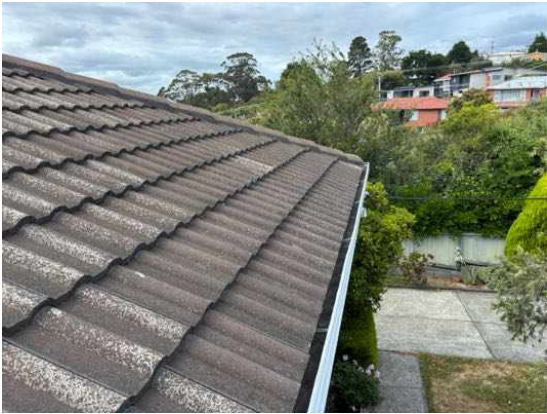
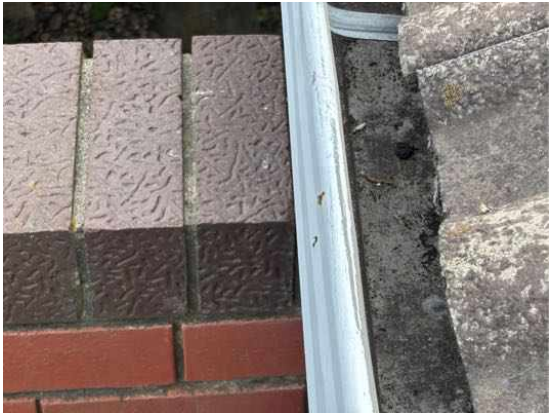
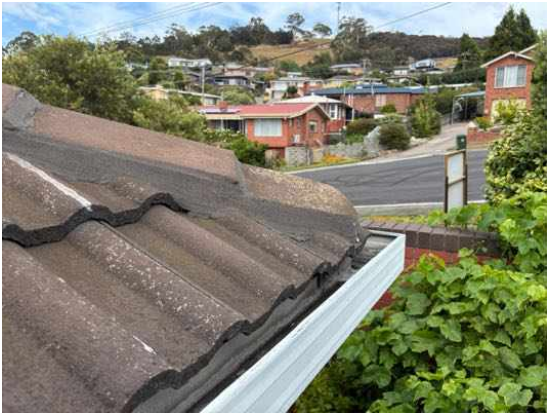
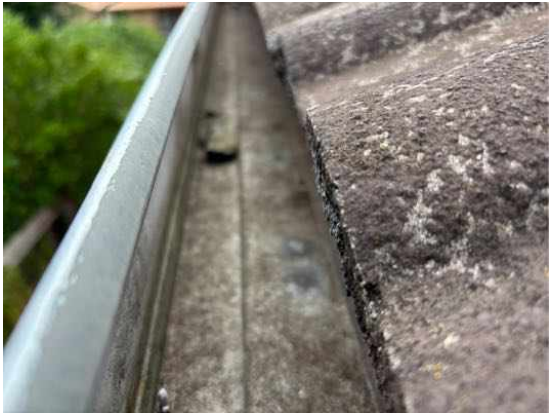
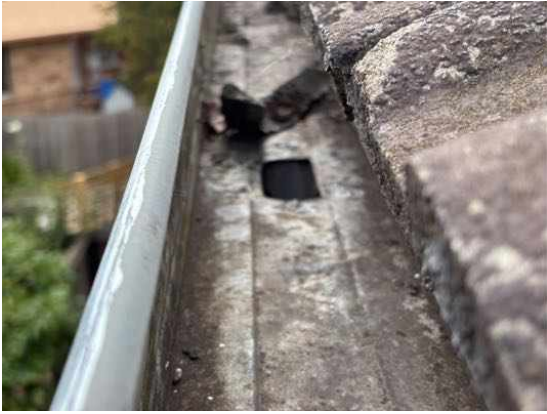
Defects 3.08

Building: Main Building
Location: Roof
Finding: Gutters - debris
Information: There is some debris in the gutters.

Blocked gutters are likely to lead to high levels of moisture in the affected areas. Such moisture can cause rust and decay of the associated building materials. Blockages in gutters should therefore be removed immediately to ensure dry conditions are maintained.

Recommend client engage a Handy Person to clean the gutters as soon as possible.

Recommend client ensure that all gutters be maintained on a frequent basis to ensure the condition of roof plumbing.

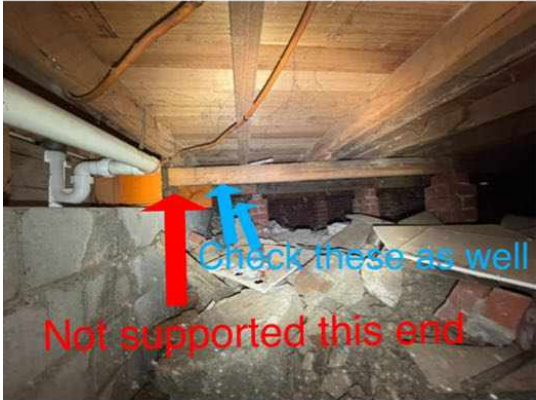
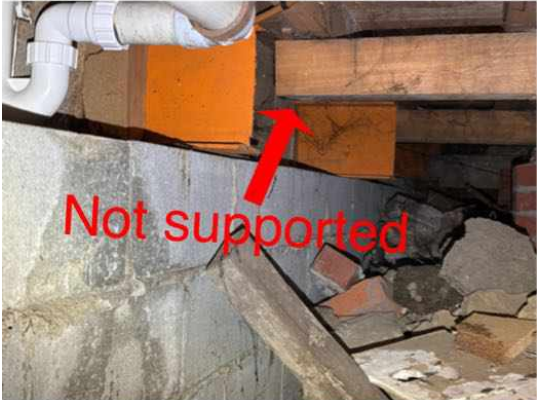
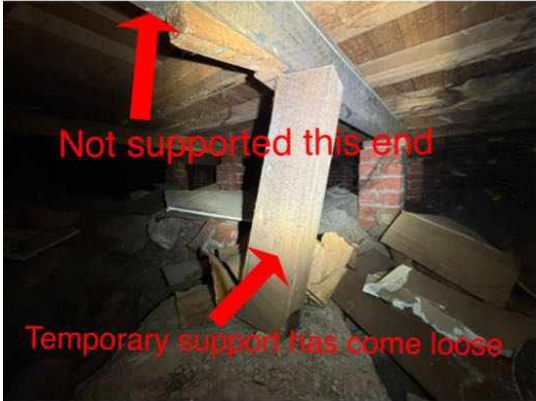
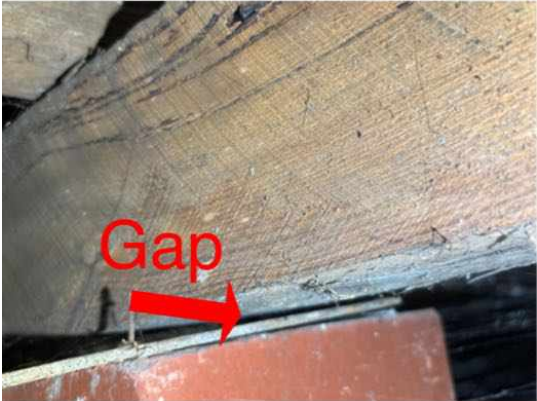
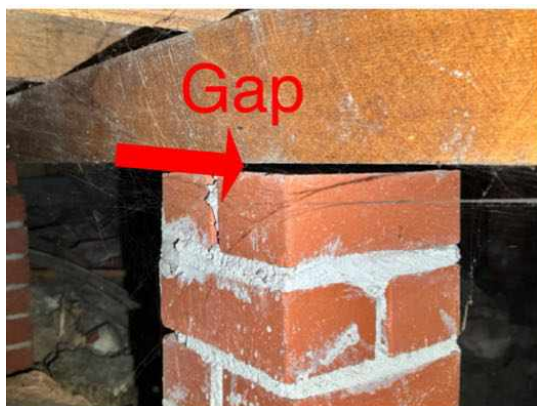
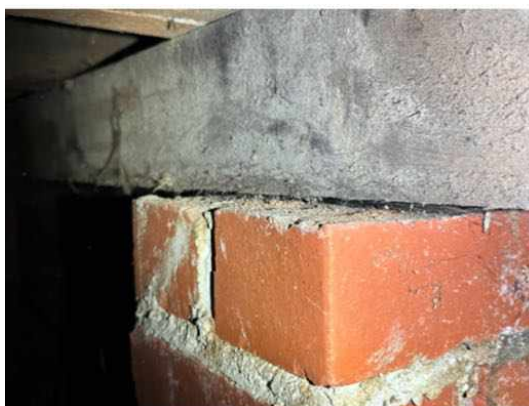
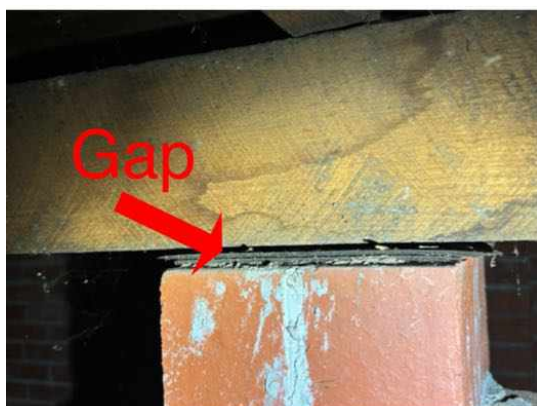
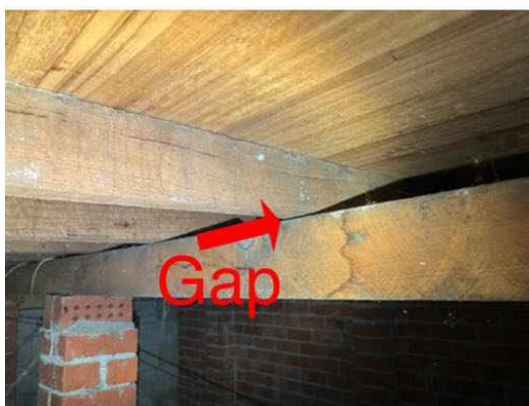
Defects 3.09

Building: Main Building
Location: Subfloor
Finding: Joists compromised
Information: In the subfloor several joists have been compromised. There is one in particular which is underneath the bath that needs to be reinforced/ supported.

Joists and bearers are structural timbers that support the flooring structure. A bath full of water is a heavy load, need to ensure the structure is sound.

Recommend client engage a Carpenter to rectify as soon as possible.

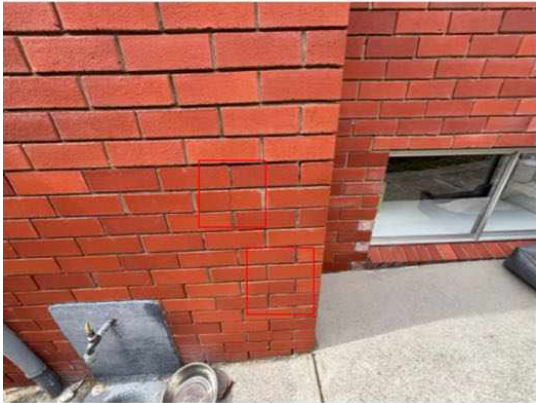
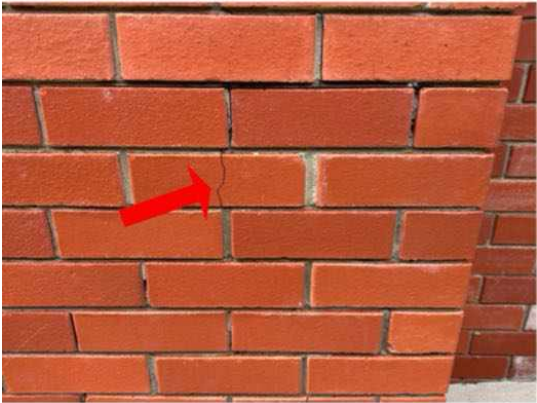
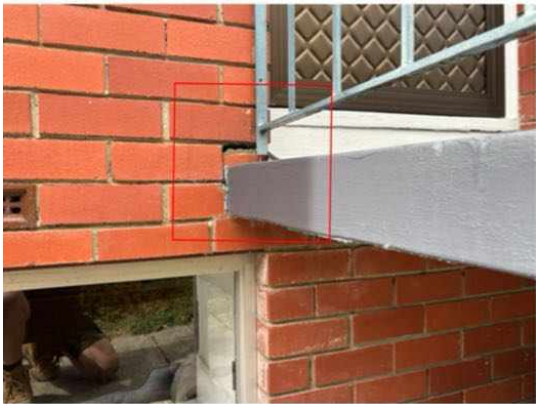
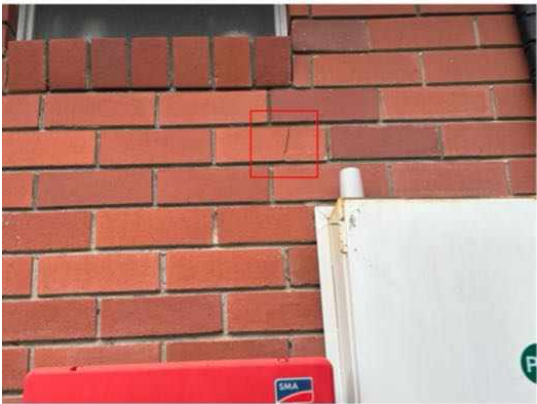
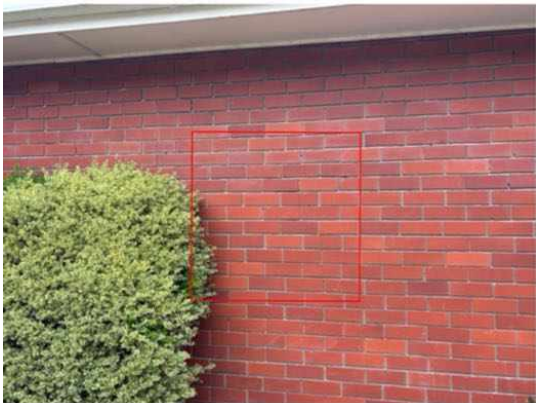
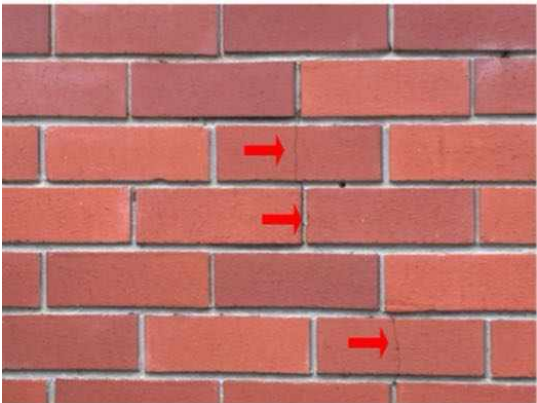
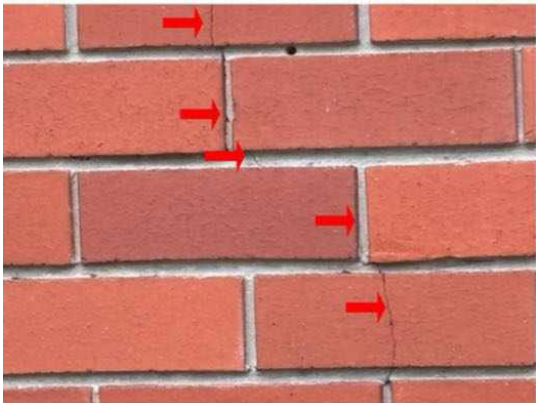
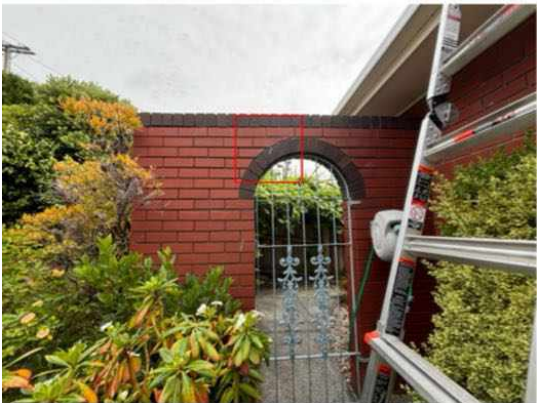
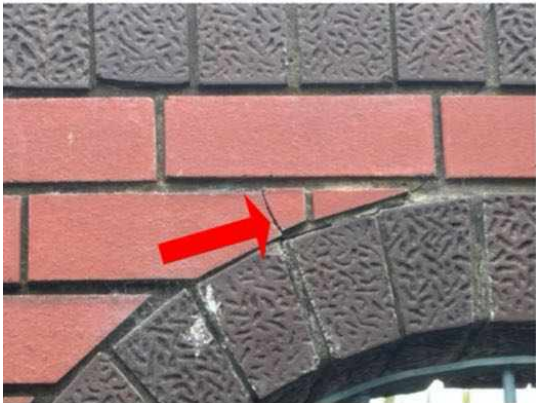
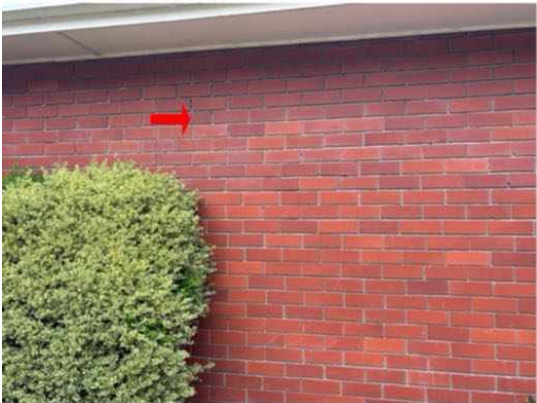
Defects 3.10

Building:	Main Building
Location:	Multiple locations
Finding:	Minor brick cracking
Information:	There was minor brick cracking identified to the brickwork in multiple locations. When this property was constructed, there were no control joints installed. Therefore the bricks crack where there is pressure.

Brick cracking, which is similar to other forms of cracking, has a variety of possible causes. However, the most common is the subsidence of adjacent footings. Minor brick cracking can be used as a warning sign to address factors causing stress to the wall, which can include the effect of surrounding trees, water leaks, soil erosion, or even the presence of reactive soils in the surrounding area. The cracking can also be seasonal with the size of cracks increasing or decreasing in response to moisture levels changing.

Brick cracking is a relatively common defect, and is most likely to occur adjacent to

windows, doors and other openings. Mortar failure in the gaps between affected bricks indicates the stresses and tensions affecting the wall.

Recommend client monitor.

If the cracking increases contact a Building Inspector to assess as soon as possible.

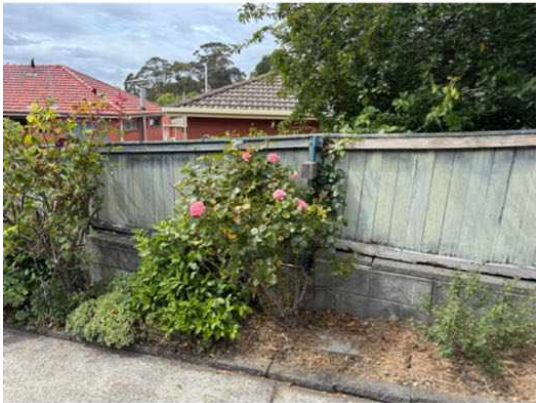
Defects 3.11

Building: Main Building
 Location: Multiple locations
 Finding: Fences deteriorated
 Information: The fences on the both sides of the house and the rear of the house are badly deteriorated. These will need replacing in the near future.

Failure to rectify will lead to further deterioration.

Recommend client engage a Handy Person or Fencing Contractor to rectify at clients convenience.

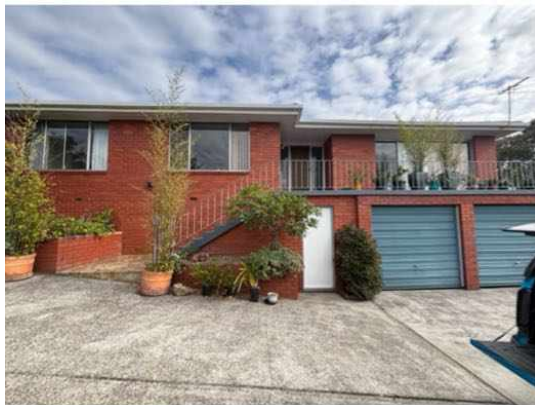
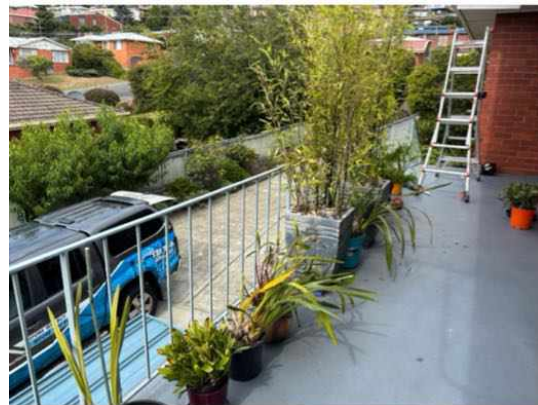
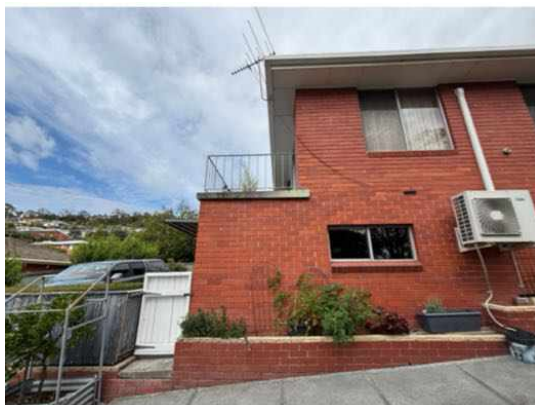
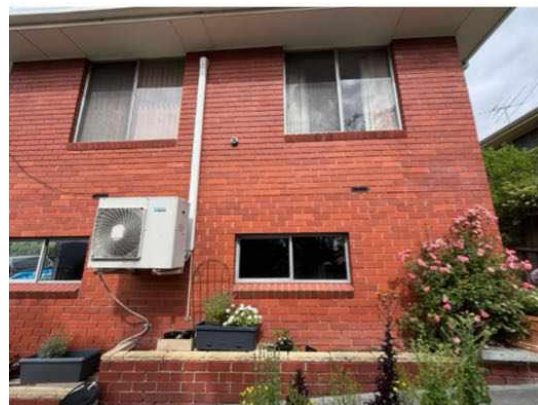
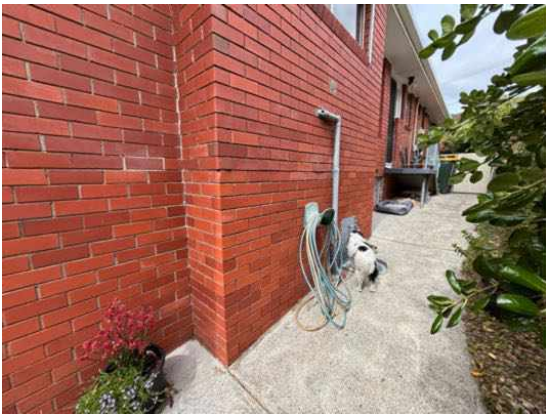
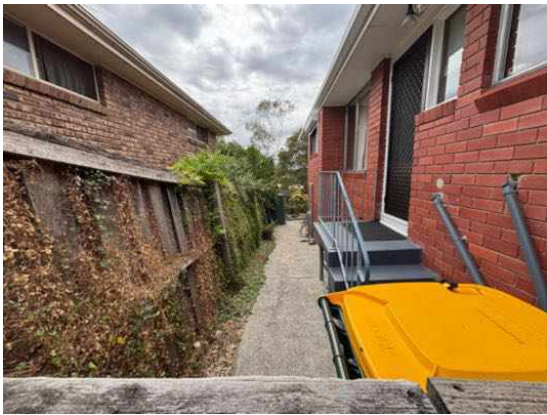
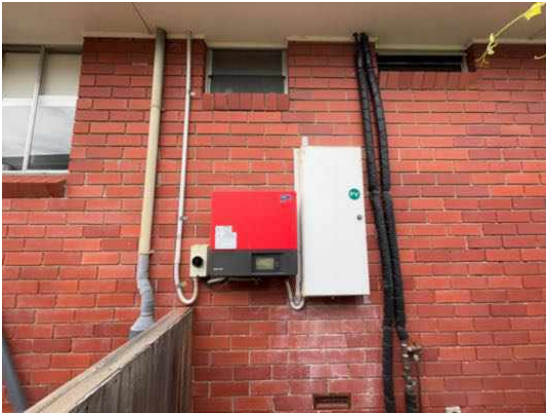
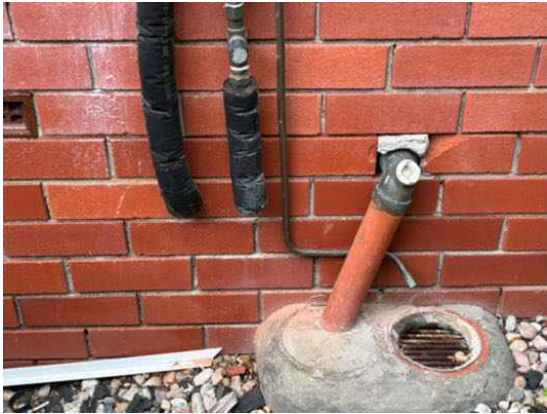
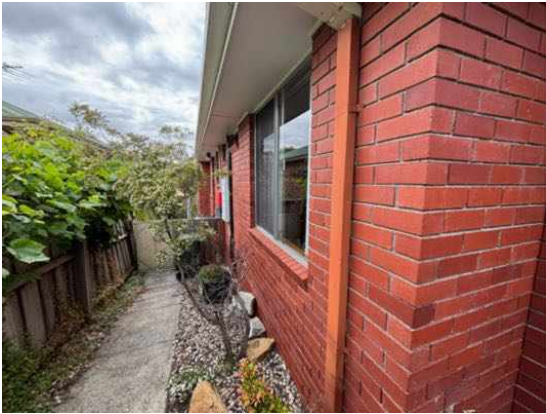
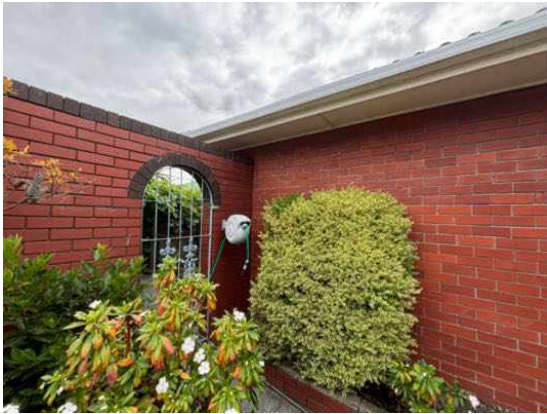
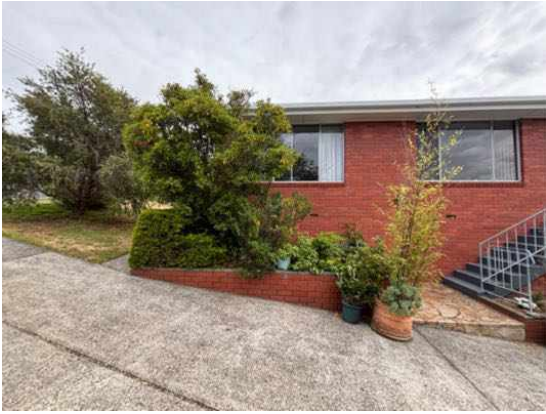
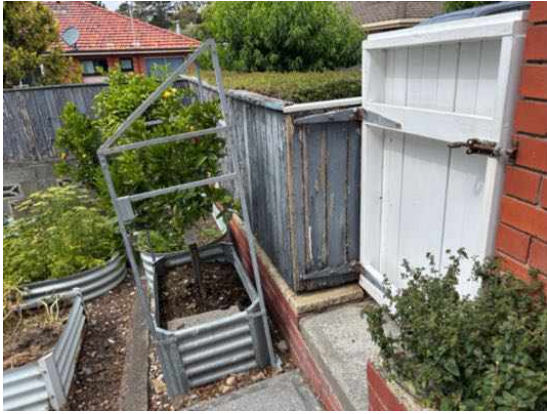
Finding: Additional Photos - Obstructions and Limitations

Information: These photographs are an indication of the obstructions and limitations which impeded full inspection of the property at the time of inspection. These obstructions can hide an array of defects and should be removed to allow full inspection to be carried out. A re-inspection is recommended once the areas are made accessible.

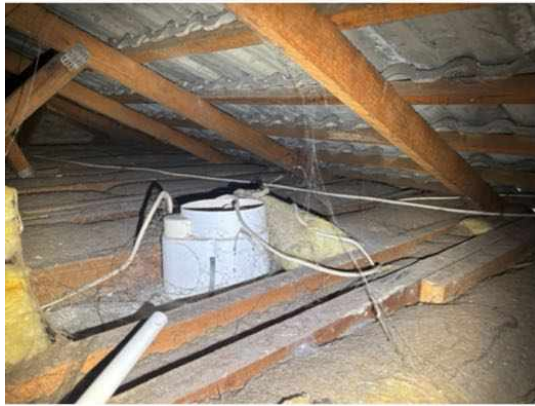
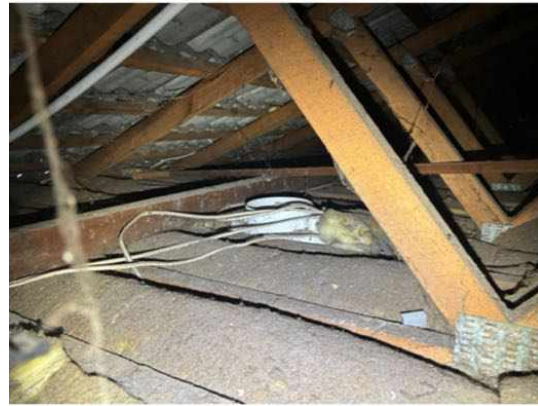
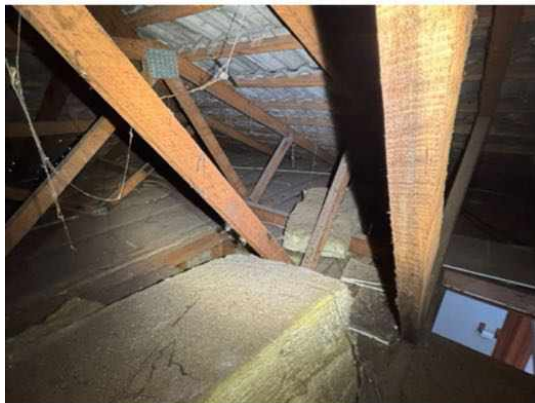
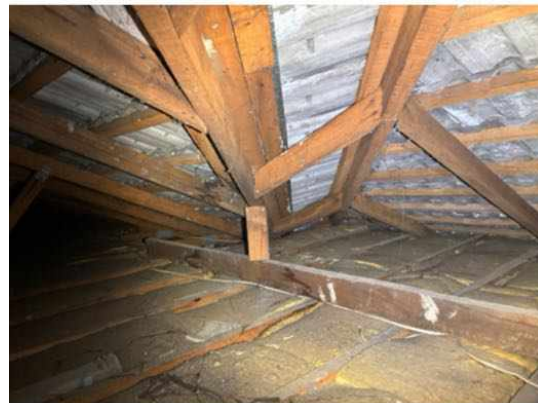
Building: Main Building
Location:
Finding: Additional Photos - Obstructions and Limitations
Information: These photographs are an indication of the obstructions and limitations which impeded full inspection of the property at the time of inspection. These obstructions can hide an array of defects and should be removed to allow full inspection to be carried out. A re-inspection is recommended once the areas are made accessible.

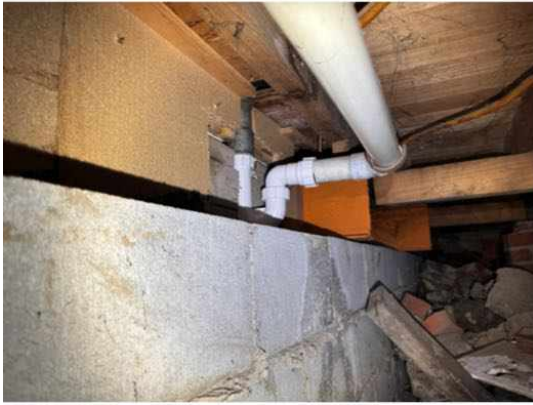
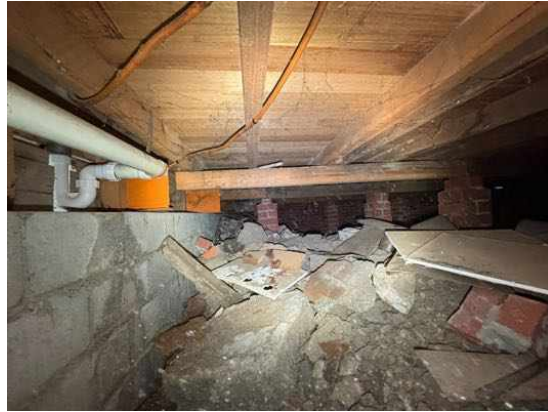
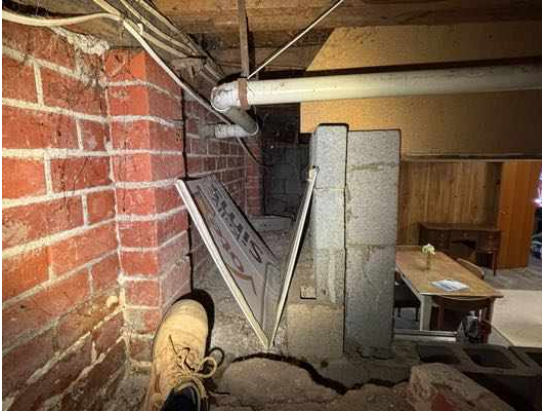
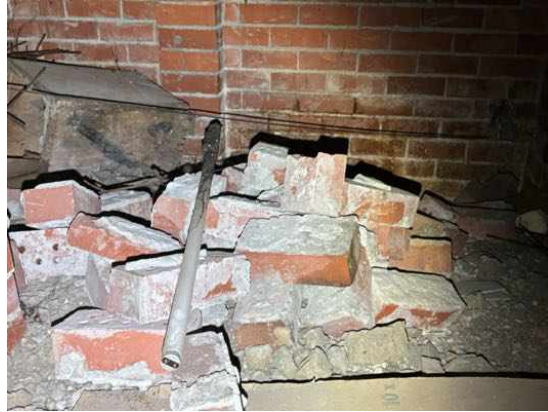
Building: Main Building
Location:
Finding: Additional Photos - Obstructions and Limitations
Information: These photographs are an indication of the obstructions and limitations which impeded full inspection of the property at the time of inspection. These obstructions can hide an array of defects and should be removed to allow full inspection to be carried out. A re-inspection is recommended once the areas are made accessible.

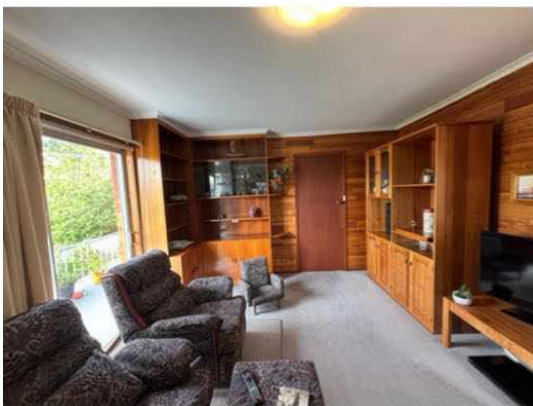
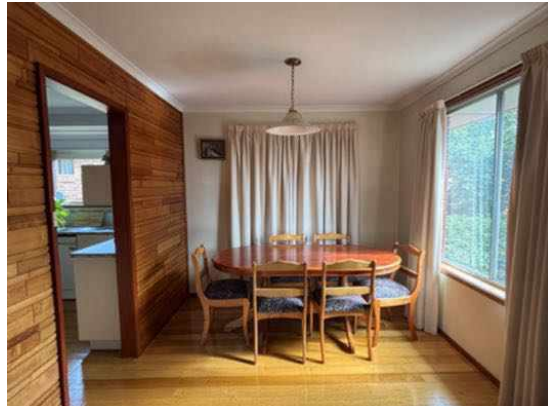
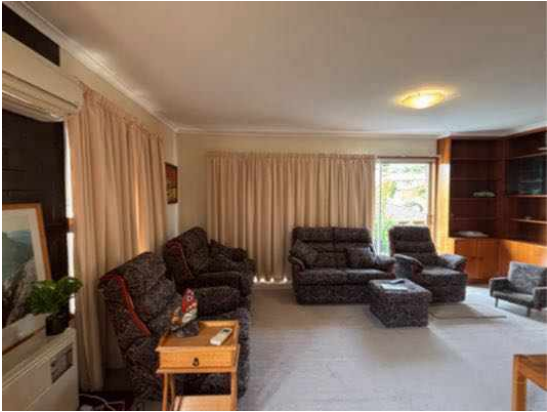
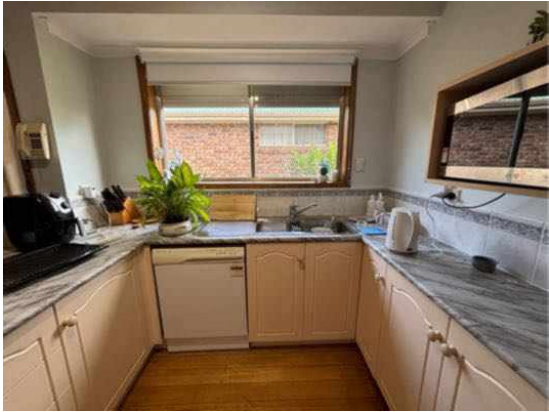
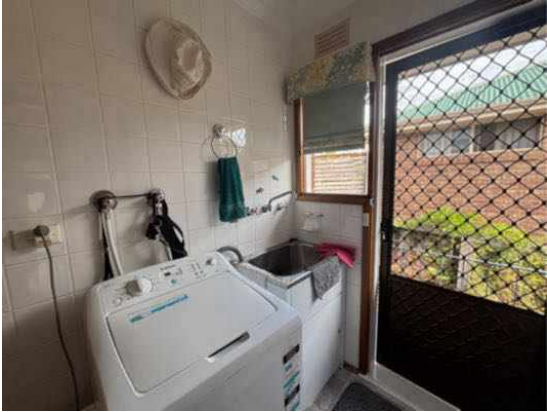
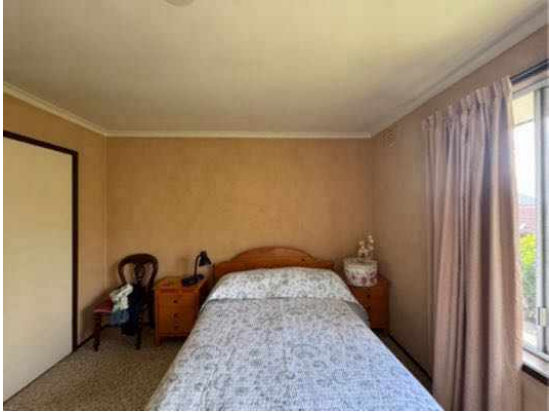
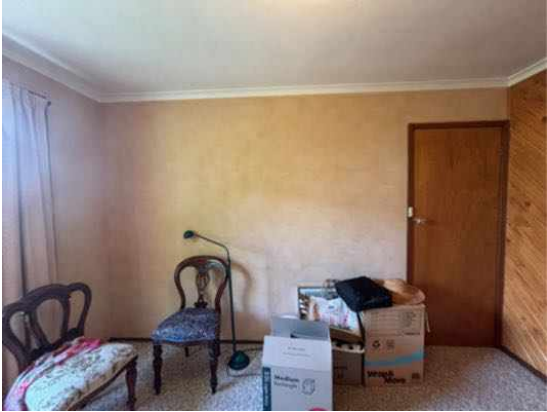
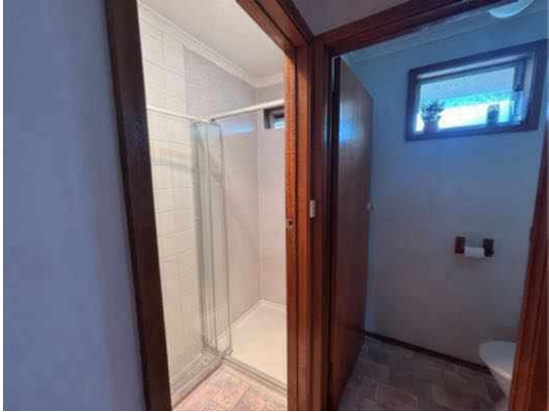
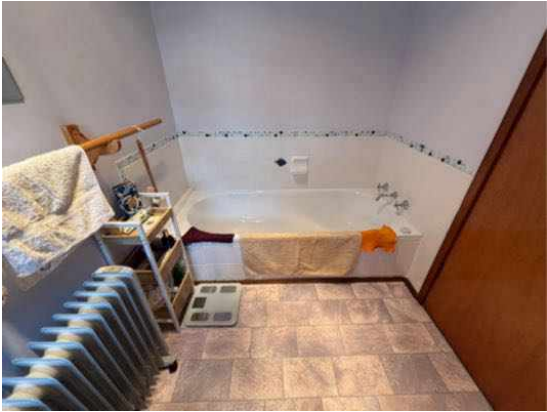
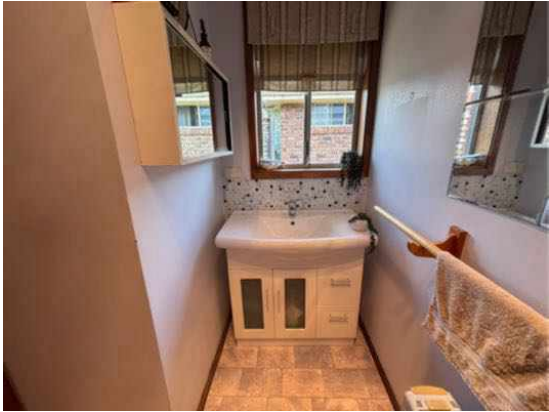
Finding: Additional Photos - Obstructions and Limitations

Information: These photographs are an indication of the obstructions and limitations which impeded full inspection of the property at the time of inspection. These obstructions can hide an array of defects and should be removed to allow full inspection to be carried out. A re-inspection is recommended once the areas are made accessible.
