Building Inspection Report

Inspection Date: Thu, 29 Jan 2026

Property Address: 4 Edwin Pl, Austins Ferry TAS 7011,
Australia

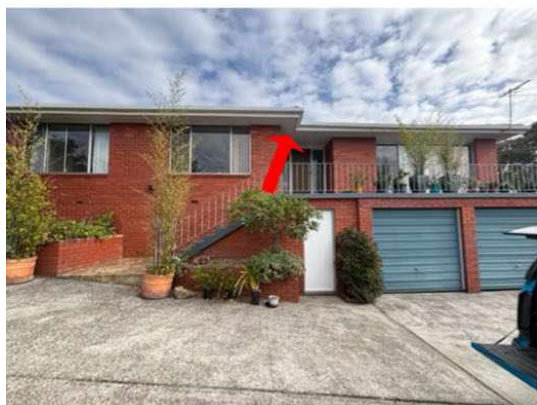
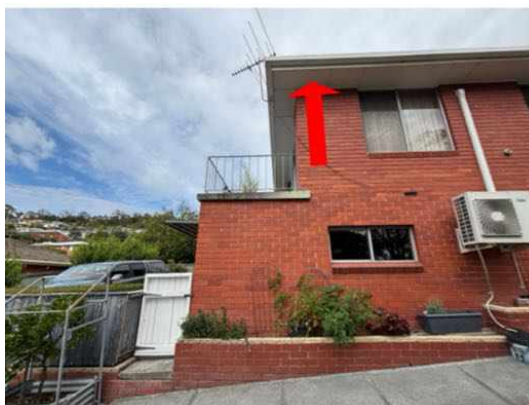
Building: Main Building
 Location: Multiple locations
 Finding: A Asbestos - Suspected ACM Identified on Site
 Information: Suspected Asbestos Containing Material (ACM) was identified in the:

Photos are indicative only (not all photos are shown).

As definitive Asbestos Reporting is outside the scope of this report, we advise that you consider a separate Asbestos Inspection and Condition Audit, which includes the taking of samples for definitive confirmation of the presence of Asbestos. Only scientific testing of those samples of material by an accredited National Association of Testing Authorities (NATA) asbestos testing laboratory can confirm the presence of asbestos.

In the interim, the client is advised to act with caution when considering any damage to building materials general wear and tear renovations extensions demolition and general maintenance activities due to the suspected presence of Asbestos. Client should make any contractors aware of the suspected ACM before any works commence.

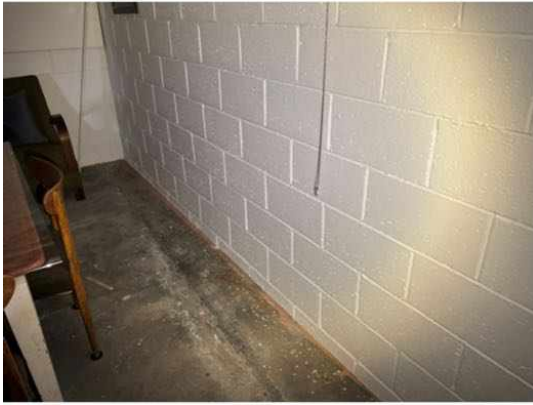
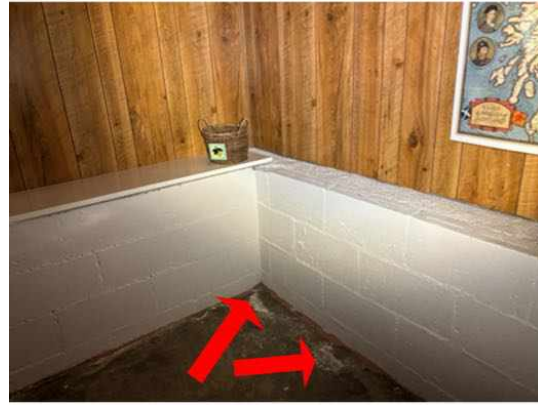
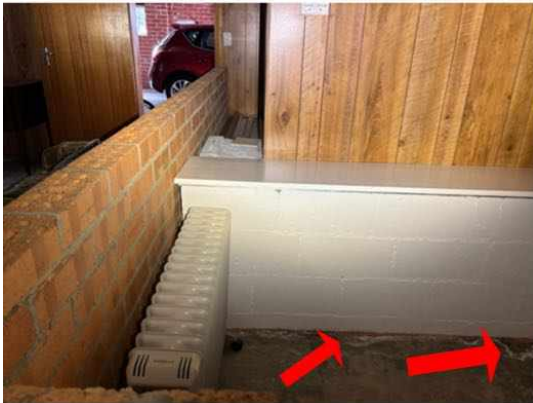
There is some efflorescence to the floor of the rumpus room (which generally indicates moisture). This rumpus area is below ground level. Recommend client does not carpet this area. Recommend that if the client wishes to utilise this area they should engage a Water Proofing Contractor to install a waterproofing system to the walls and floors. Once a system has been installed then tiles/vinyl would be more suitable for the flooring.

Efflorescence typically occurs when excess salts within the concrete or cement mortar is leached to the surface due to water transfer.

It is typically seen as white salt deposits on the surfaces of concrete pavement or mortar between bricks or tiles. While detracting from the overall appearance of the affected area, efflorescence is not likely to develop into secondary damage if left unmanaged. Generally, soluble salt deposits can be removed by dry brushing with a stiff bristled brush. A cleaning contractor or handy person may appointed to perform these works at the discretion of the client.

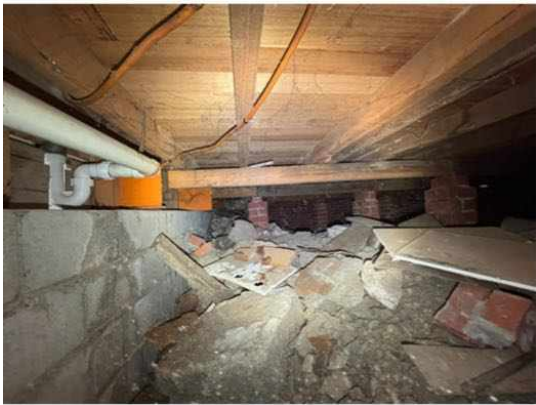
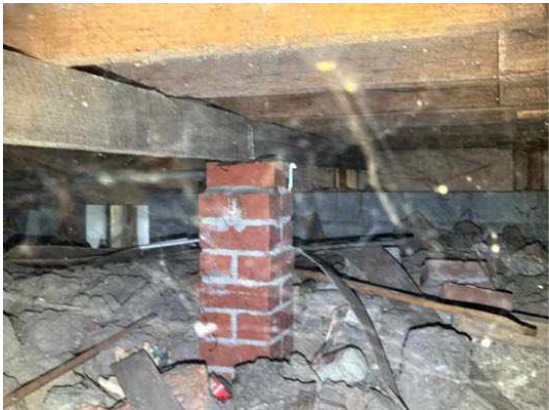
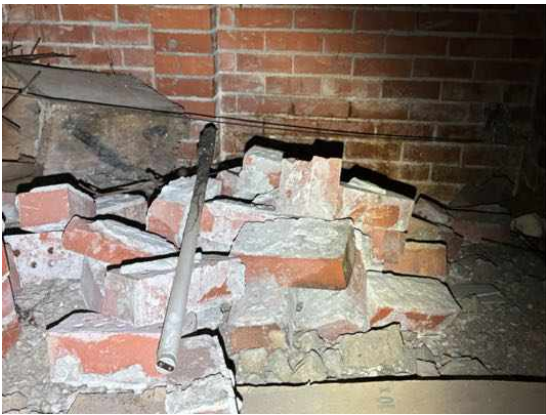
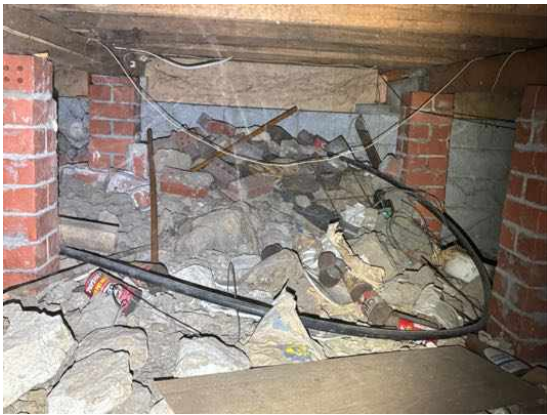
Information: An array of debris was found in the subfloor at the time of inspection. Debris in this area restricts ventilation and creates potential for concealed pest entry. Stored timbers and other materials may also make the area susceptible to wood rot.

A clear and empty subfloor will be better ventilated and easier to maintain in a dry condition.

Debris in the subfloor should be removed as soon as practicable.

Recommend client engage Rubbish Removal Contractor to rectify at clients convenience.

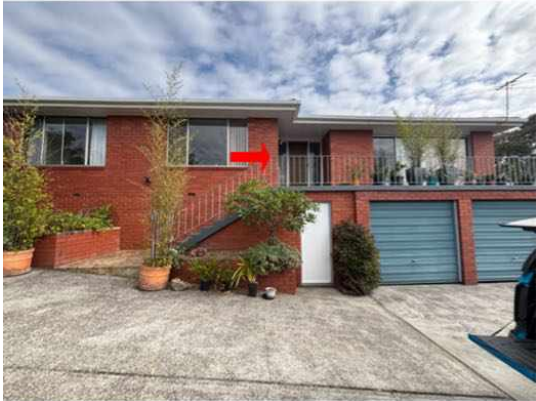
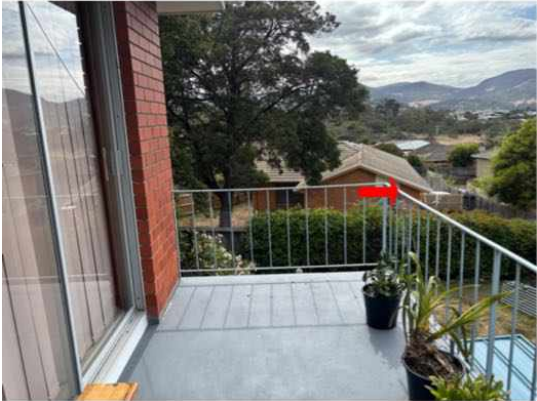
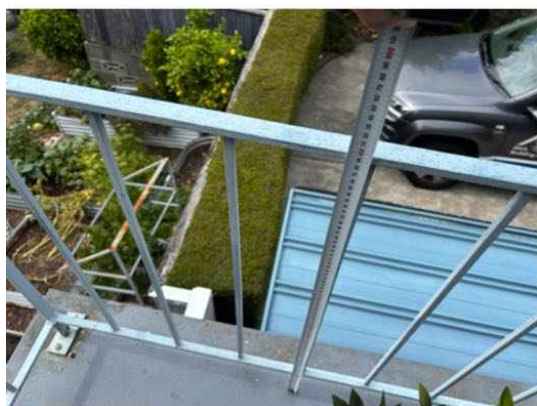
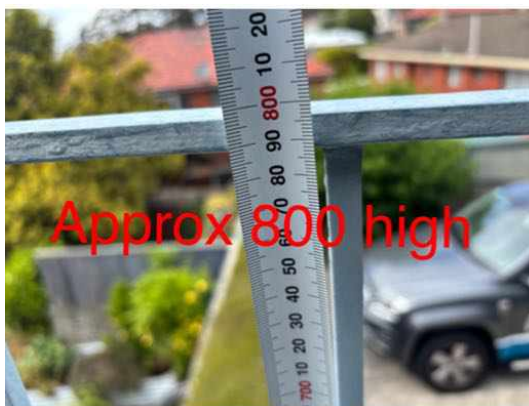
Building: Main Building
 Location: Front balustrade
 Finding: A Balustrade - low
 Information: FYI the balustrade was measured and found to less than the present building regulation requirement of 1000mm high.

Some changes to the building regulations are made to ensure the safety of all inhabitants and balustrades are definitely one of those crucial regulations.

Recommend client contact a Lic Builder at clients convenience to discuss possible rectification solutions.
