Building and Timber Pest Inspection Report

Inspection Date: Wed, 18 Mar 2026

Property Address: 6 Middleton Avenue, Cranebrook NSW
2749

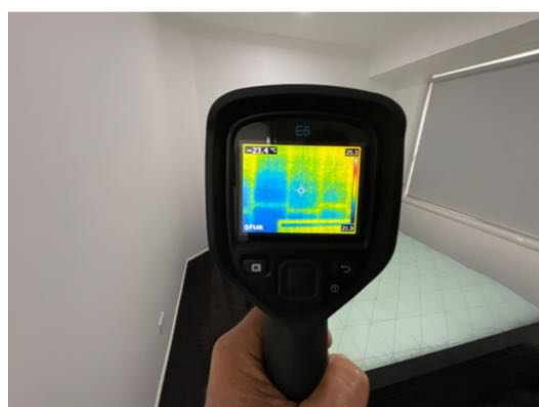
Termites release heat in the form of carbon dioxide and build mud tubes with high moisture content, which can create irregular heat patterns on surfaces such as walls, ceilings, and floors.

At the time of the inspection, no abnormalities indicating live termite activity were observed. However, it's important to note that various factors—such as obstructions, ambient temperature, and wall material/thickness—can impact the accuracy of thermal readings. In cases where surfaces are visually restricted or obstructed, a comprehensive thermal scan may not always be feasible.

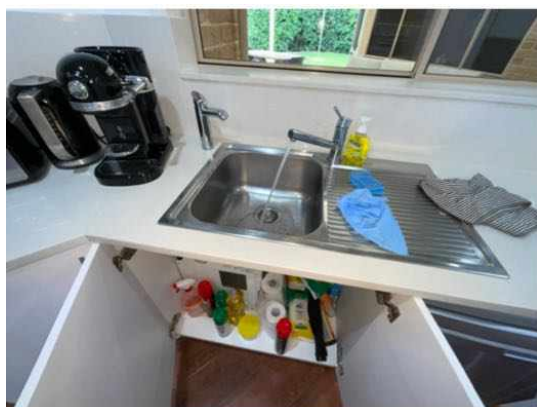
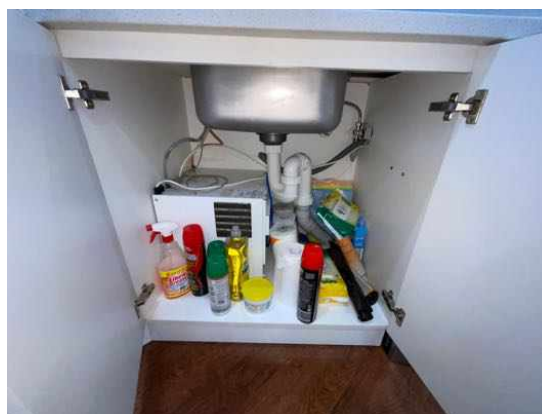
Building: Main Building
 Location: Kitchen
 Finding: Kitchen Sink – Overall Condition & Recommendations.

- Further monitoring and testing are recommended once the tap(s) are in constant use, to identify any drainage issues or signs of slow leaks not evident during the limited inspection.
- For long-term property care, it is advised that sealant and grouting in water-exposed areas be regularly inspected and maintained.
- It is recommended that the stored items beneath the sink be removed to allow for a full re-inspection of the plumbing and cabinetry, ensuring no concealed defects are present.

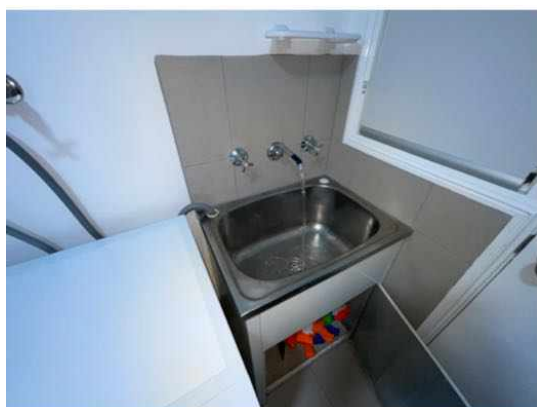
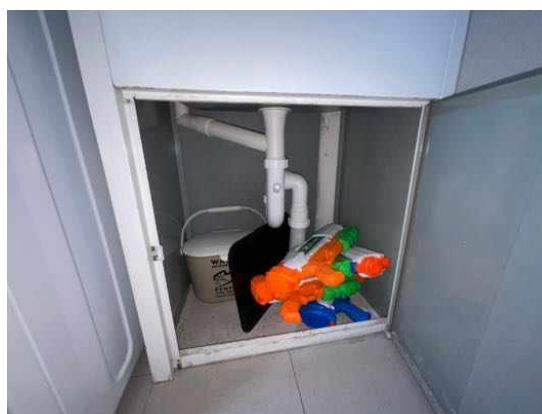
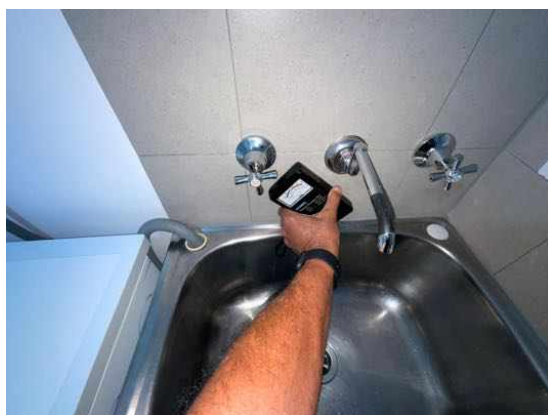
Building:

- Further monitoring or testing is recommended once the taps are placed into regular use, to ensure no leaks develop over time and that the drainage system continues to perform adequately.
- Sealant and grouting in wet areas should be maintained as part of the long-term care and upkeep of the property.

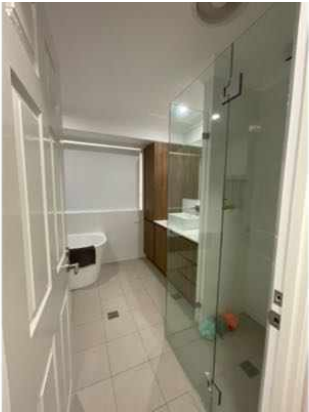
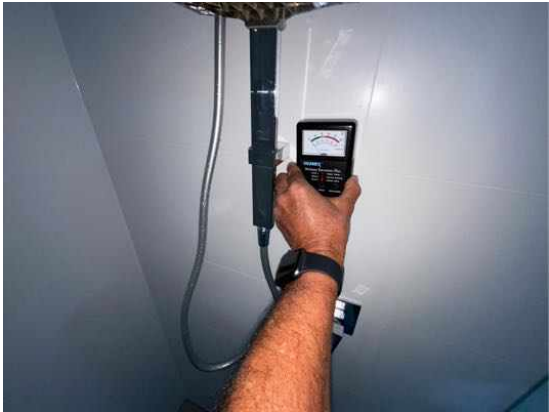
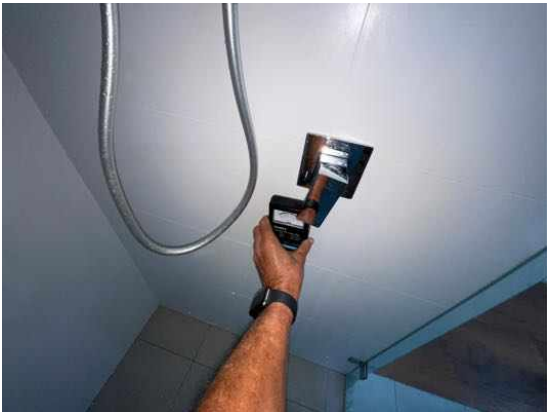
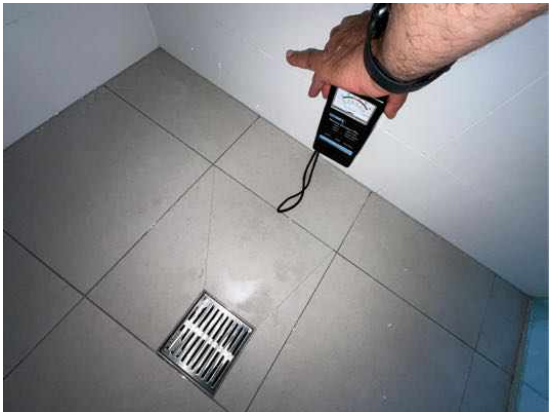
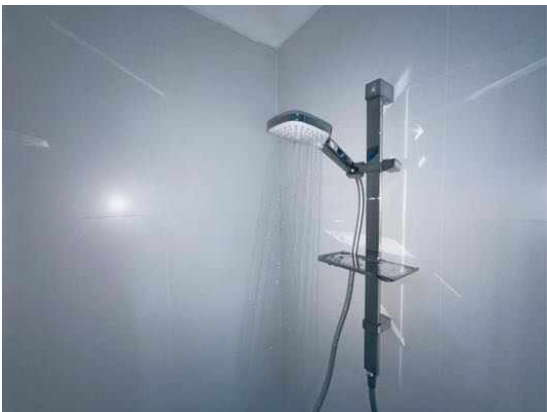
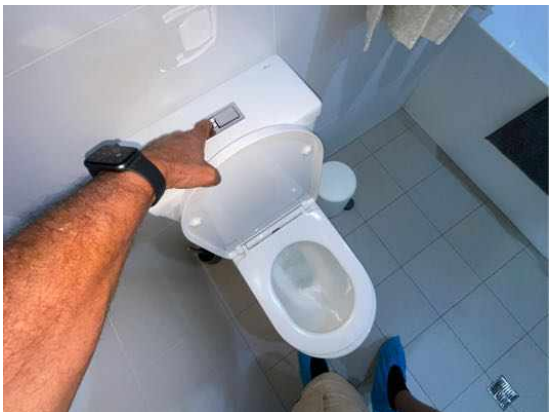
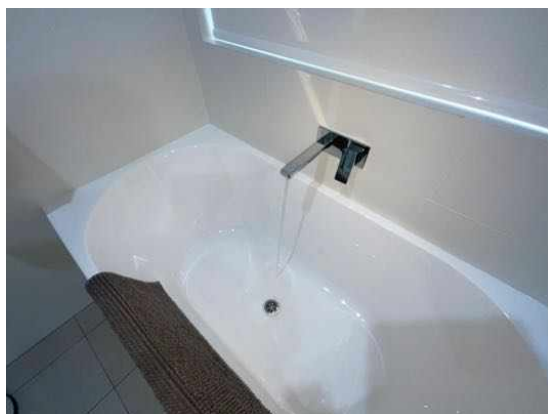
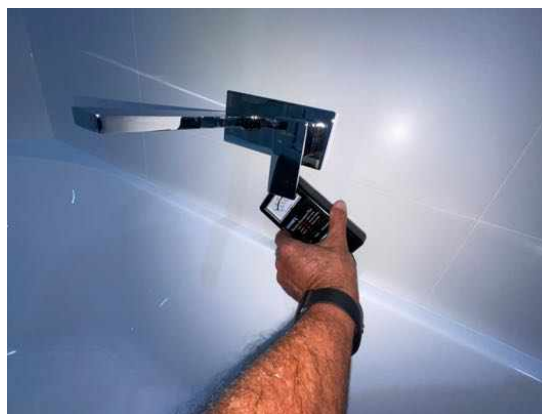
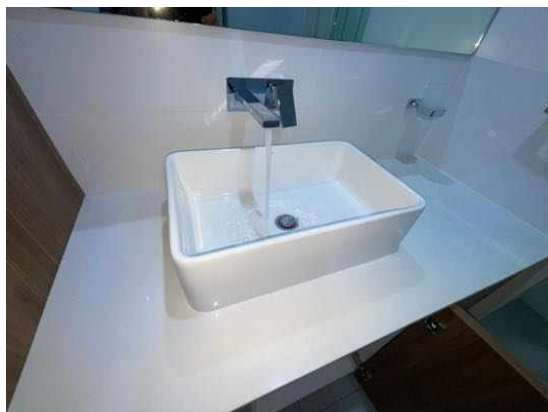
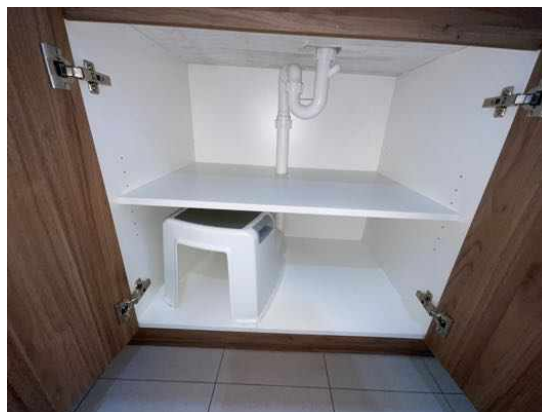
Building: Main Building
Location: Bathroom
Finding: Wet Areas - Bathroom(s) - Overall Condition & Recommendations.
Information: Overall Condition & Recommendations

to categorically determine if leaks are present. If a more detailed or accurate assessment is required, a special-purpose inspection should be undertaken.

Alternatively, the assumption should be made that leakage may occur, particularly where historical or environmental conditions are conducive. The visual nature of this inspection cannot detect issues concealed behind wall/floor linings or cabinetry, and invasive investigation may be necessary to confirm the true condition of adjacent or hidden structures.

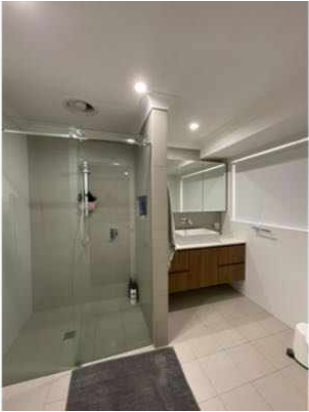
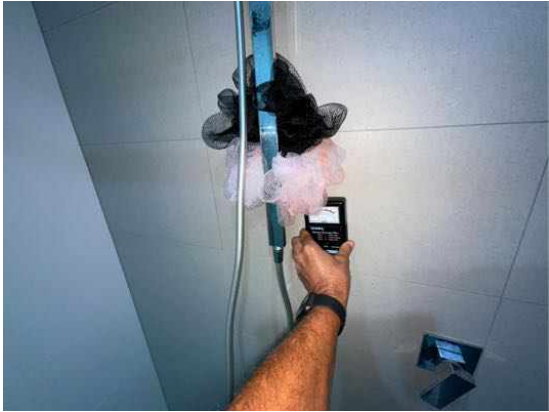
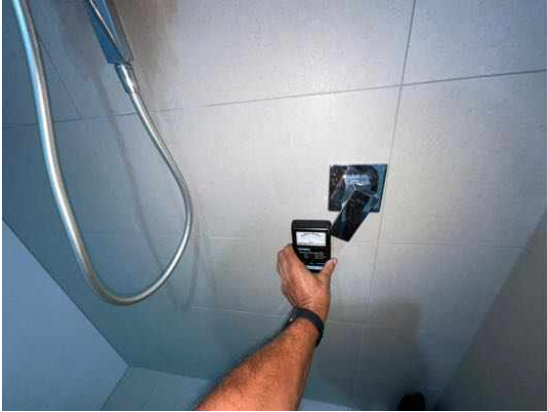
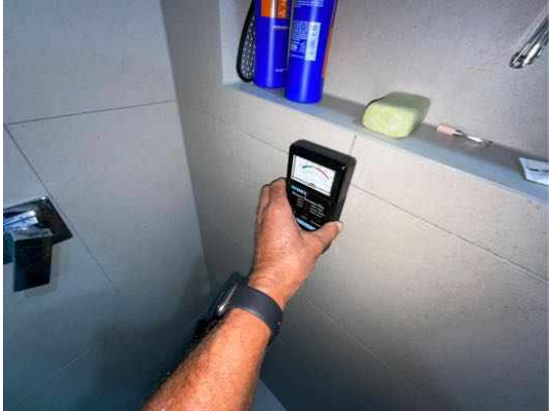
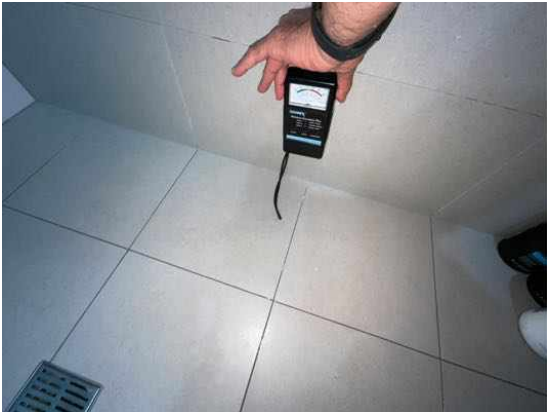
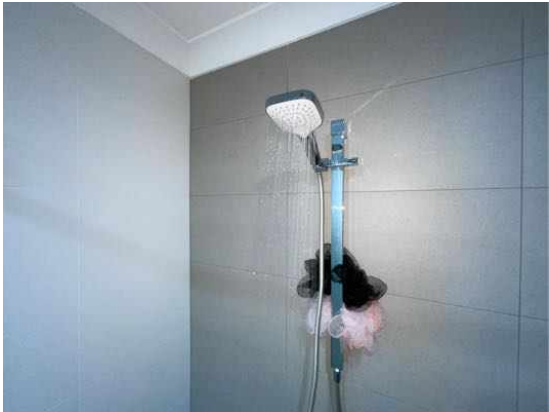
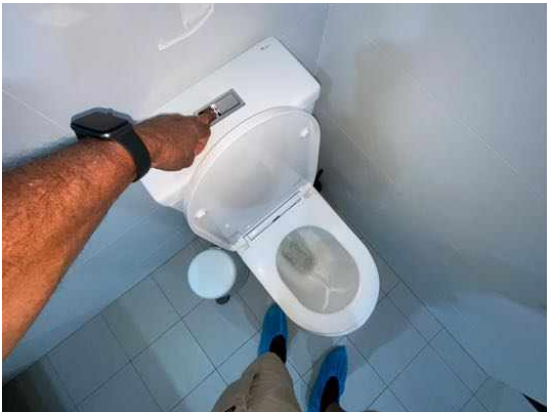
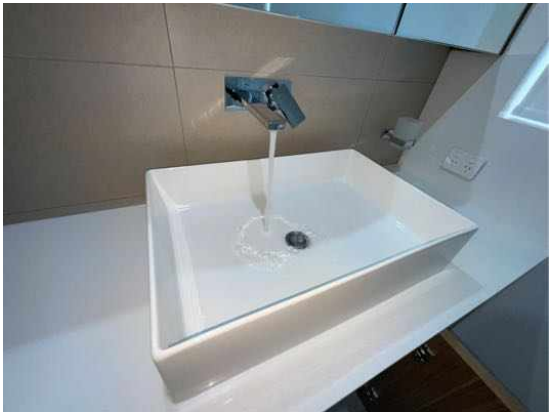
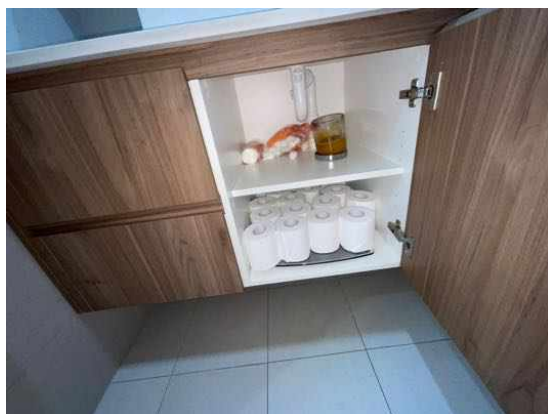
Building: Main Building
 Location: Ensuite
 Finding: Wet Areas - Bathroom(s) - Overall Condition & Recommendations.
 Information: Overall Condition & Recommendations

It is not possible under the visual inspection criteria of a standard pre-purchase report to categorically determine if leaks are present. If a more detailed or accurate assessment is required, a special-purpose inspection should be undertaken.

Alternatively, the assumption should be made that leakage may occur, particularly where historical or environmental conditions are conducive. The visual nature of this inspection cannot detect issues concealed behind wall/floor linings or cabinetry, and invasive investigation may be necessary to confirm the true condition of adjacent or hidden structures.

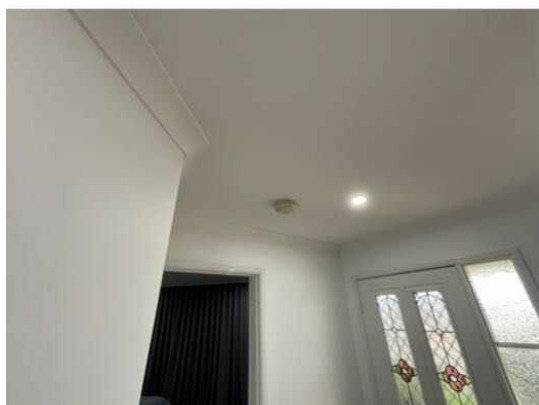
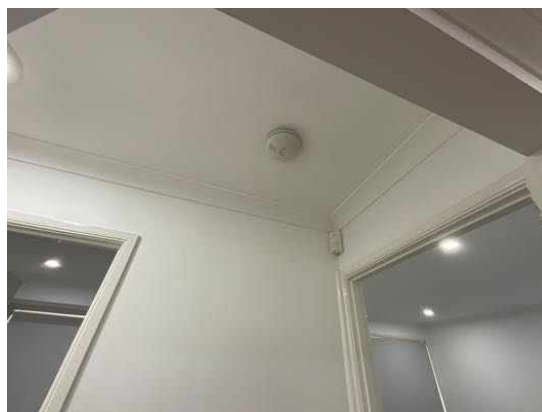
Noted Item

To ensure compliance and safety, further inspection and/or advisory services from a qualified specialist are recommended. These services can confirm the sufficiency, type, location, and functionality of all smoke detection devices within the property.

Failure to comply with these requirements may pose a serious risk to occupant safety.

- All smoke detectors be tested monthly by the homeowner.
- All systems comply with the requirements of AS 3786 and any applicable state-based legislation.

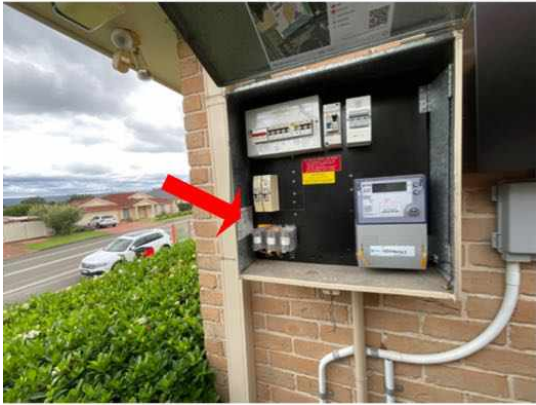
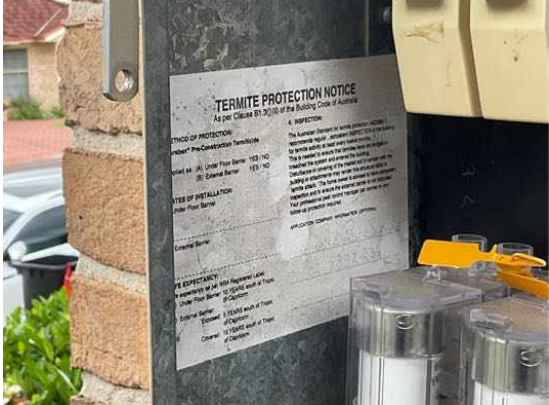
Noted Item

Building:	Main Building
Location:	All Areas
Finding:	Termite Management System – Previous Barrier Noted..
Information:	Observation:

At the time of inspection, evidence of a previous termite management system was noted, indicated by the presence of a durable notice affixed to the electrical switchboard.

- The installation of a termite management system is strongly recommended for all properties, particularly those with timber building elements. These systems provide a proactive defence against termite attack and are effective in minimising the risk of concealed termite entry and structural damage.
- The client is advised to contact the pest control provider listed on the durable notice (if identifiable) to obtain further information regarding:
 - The type of system installed (e.g., chemical barrier, baiting system, or physical barrier)
 - The installation date
 - Any warranty conditions, service history, or ongoing maintenance requirements
- If no reliable information can be obtained, or if the existing system is found to be outdated or non-functional, it is recommended that a new termite management system be installed by a licensed pest control professional.

- Chemical treatments
- Baiting systems
- Regular inspections and monitoring
