Building and Timber Pest Inspection Report

Inspection Date: Thu, 29 Jan 2026

Property Address: 2/9 Boobook Ct, Buderim QLD 4556,
Australia

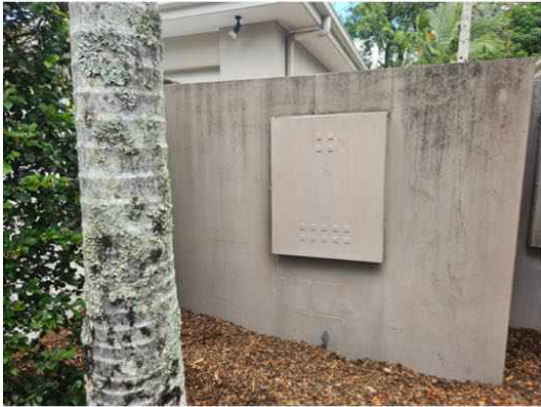
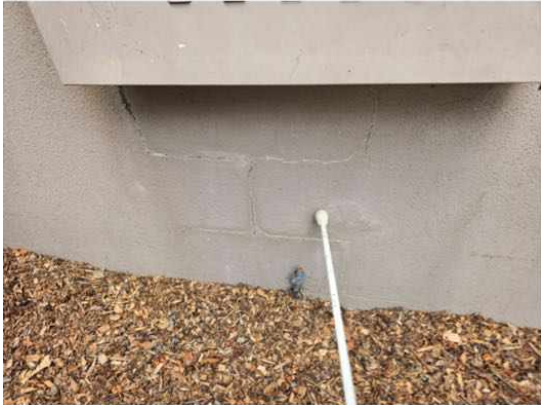
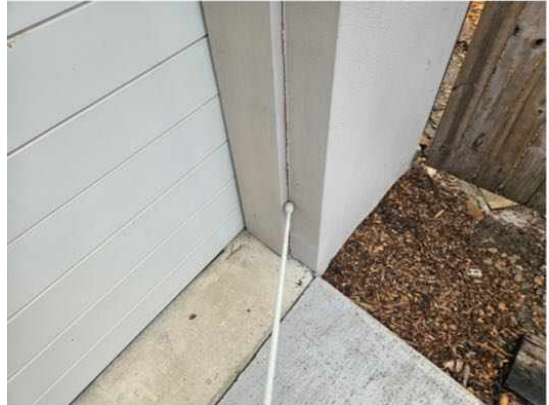
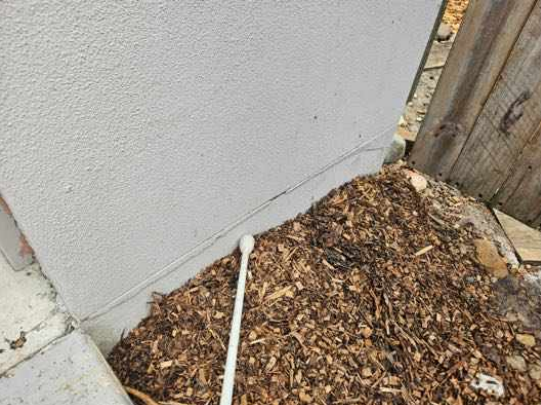
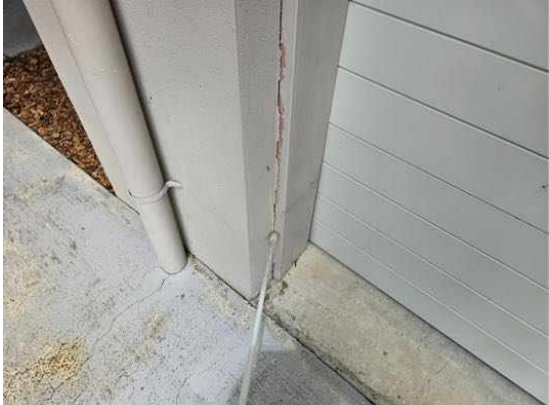
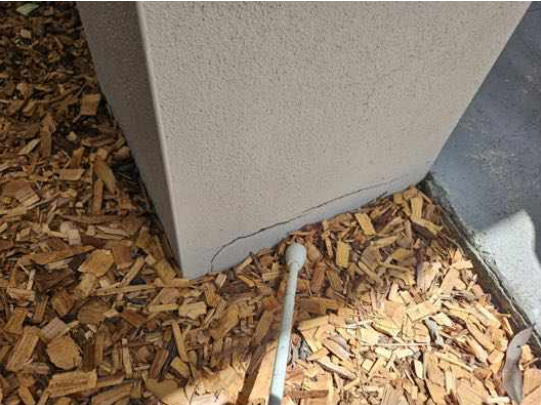
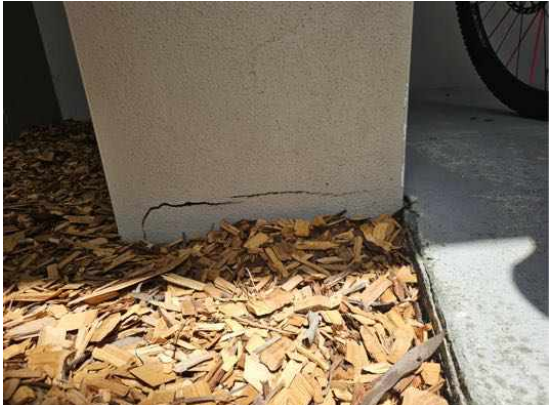
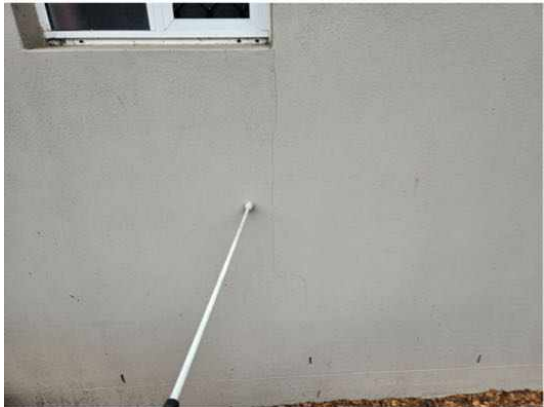
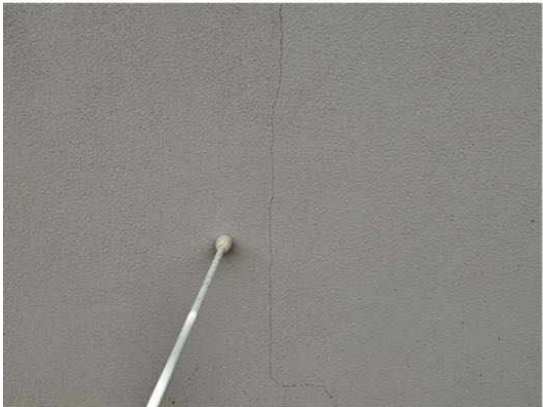
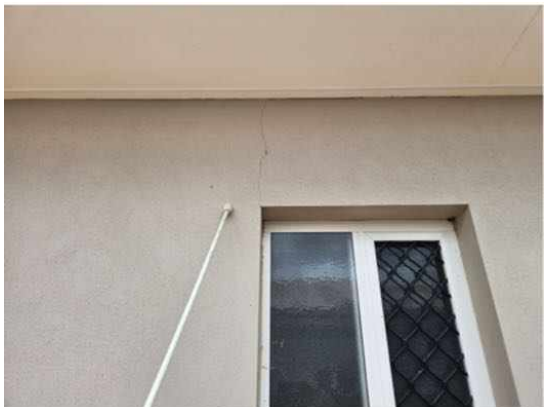
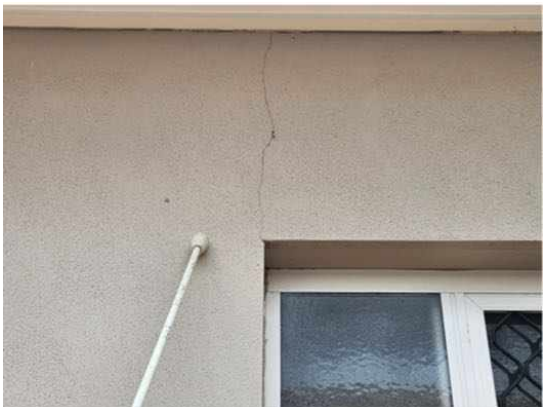
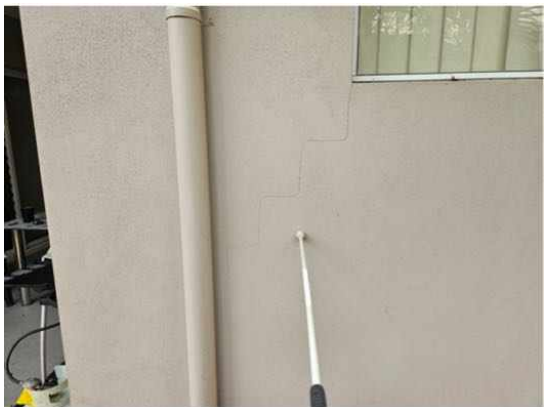
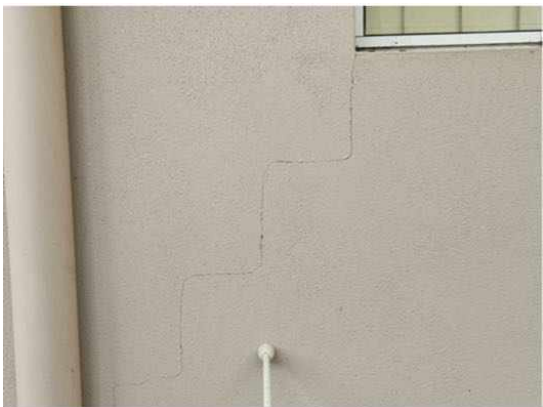
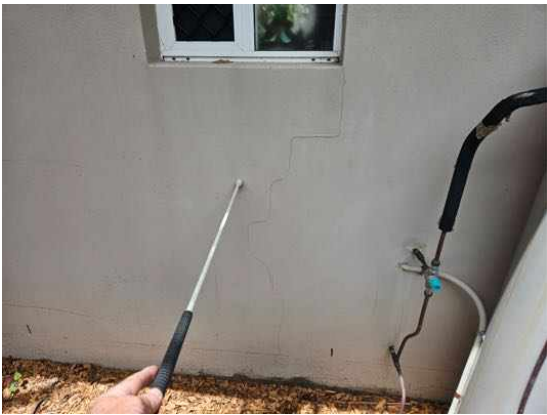
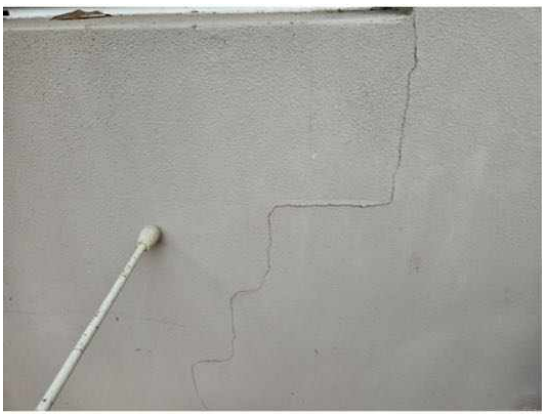
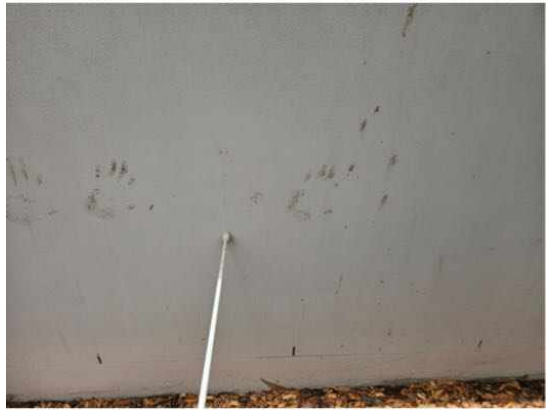
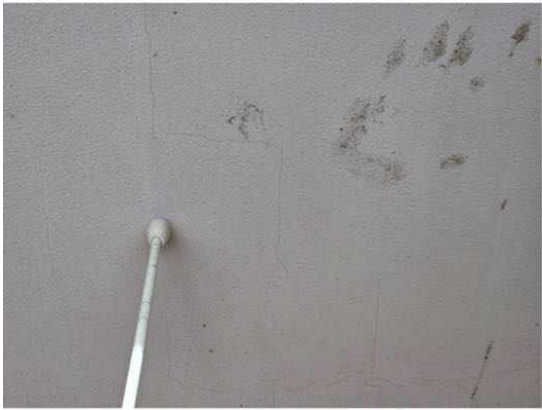
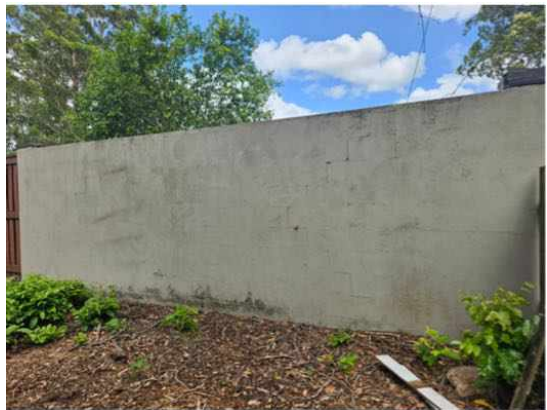
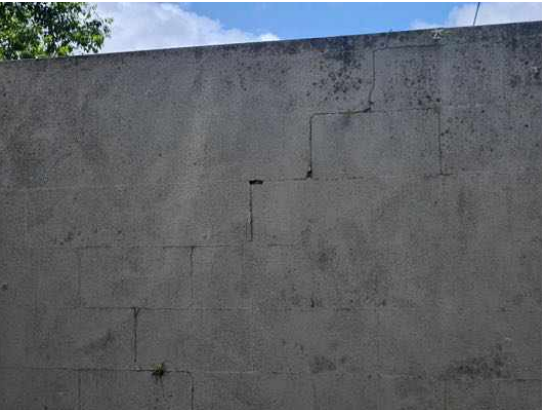
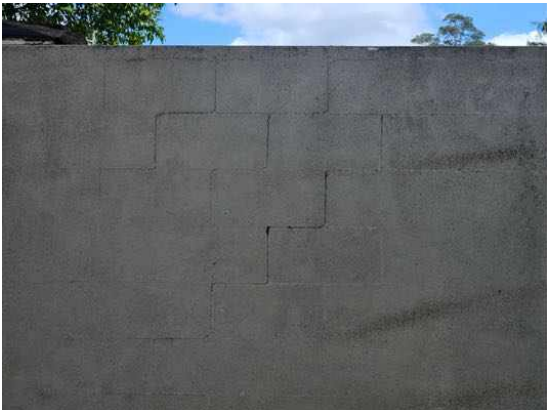
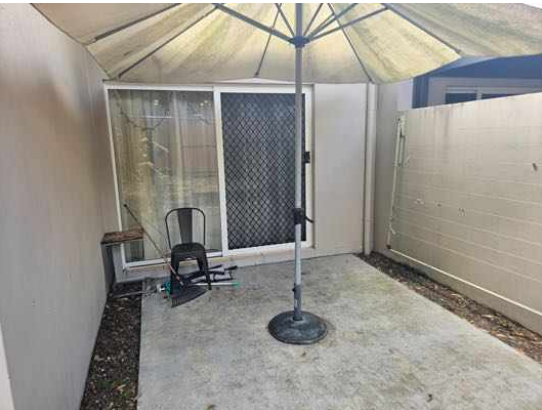
Building:	Main Building
Location:	All External Areas
Finding:	Brickwork - Step & shear cracking, general building movement
Information:	Step and shear cracking was identified to the brickwork throughout the exterior of the property at the time of inspection. Step cracking, which is similar to other forms of cracking, has a variety of possible causes, including the lack of control joints provided at construction. However, minor subsidence and movement of adjacent footings could be the cause.

Step cracking is a relatively common defect, and is most likely to occur adjacent to windows, doors and other openings. Mortar failure in the gaps between affected bricks indicates the stresses and tensions affecting the wall. A large movement gap was noted in the dividing wall at the rear of the property, showing significant movement in this area.

Minor step cracking and exterior movement can be used as a warning sign to address factors causing stress to the wall, which can include the effect of surrounding trees, water leaks, soil erosion, or even the presence of reactive soils in the surrounding area. Large trees are located in the rear yard area and excessive moisture from leak roof plumbing could also be a contributing factor.

This has been given a minor defect rating at this time; however, this has the potential to become a major defect issue if not addressed when any change is noted.

Where step cracking is extensive or severe, the client is advised to consult a structural engineer. These should be monitored and if any increase is noted, seek professional advice.

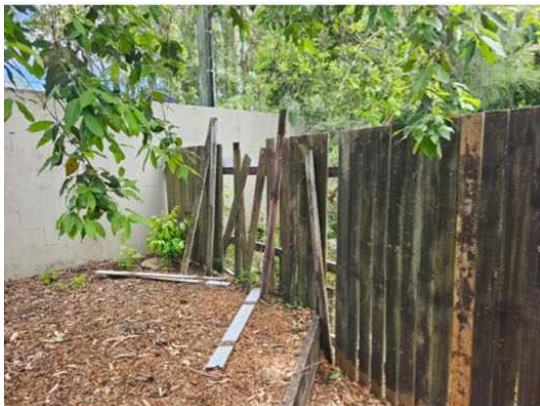
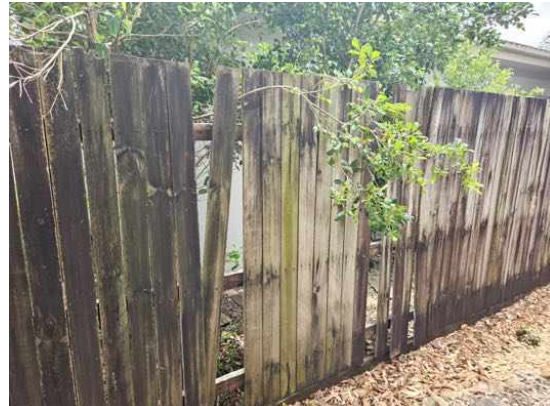
Finding 3.02

If left unattended, it is likely that further damage will occur. It is suspected that repair of several elements of the fencing may be required however replacement may be a consideration of the client also.

A licensed fencing contractor should be appointed to provide further advice and perform rectification works as necessary.

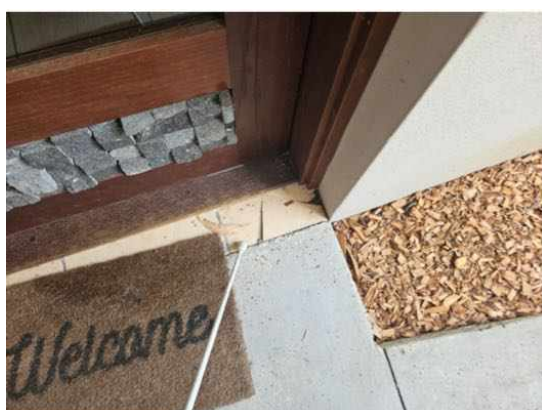
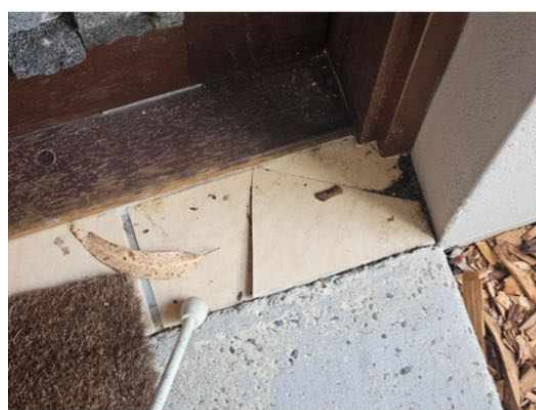
Finding 3.03

Cracked tiles detract from the overall appearance of the affected areas however, it is unlikely to create or lead to any secondary defects.

While not considered a matter of urgency, replacement of cracked tiles is recommended at the client's discretion. A tiling contractor may be appointed to perform these works.

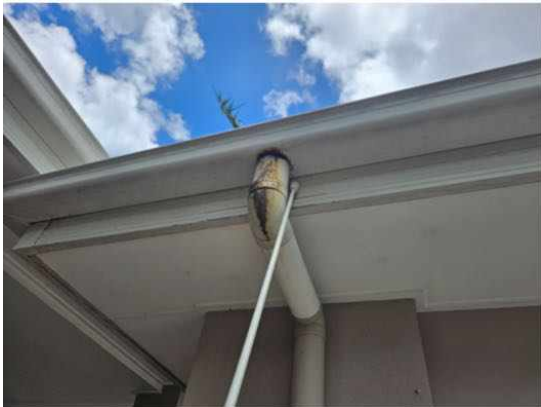
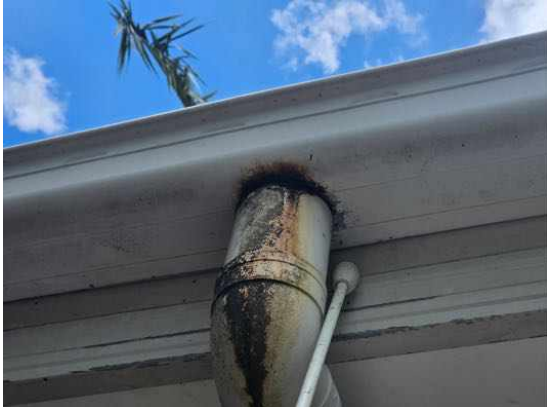
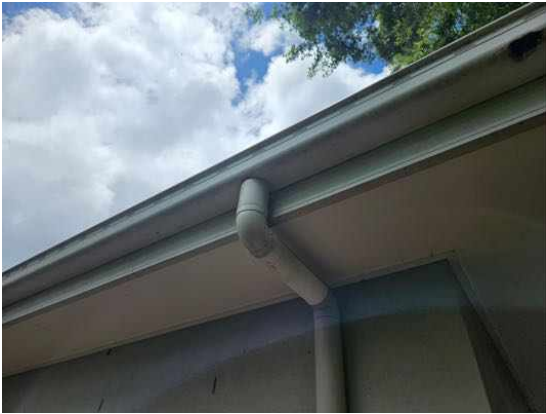
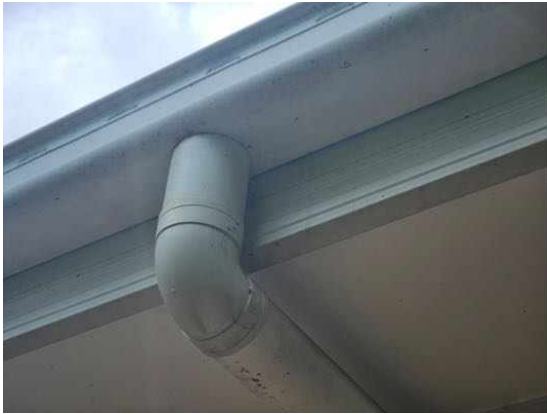
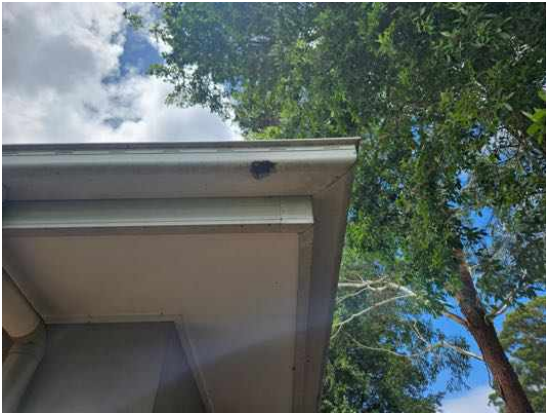
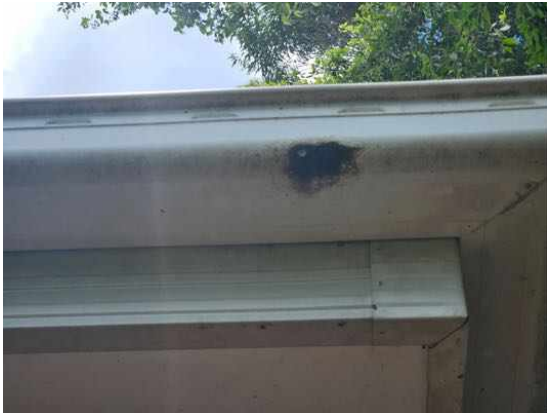
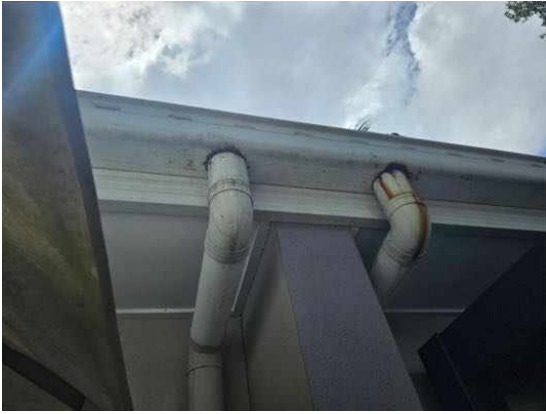
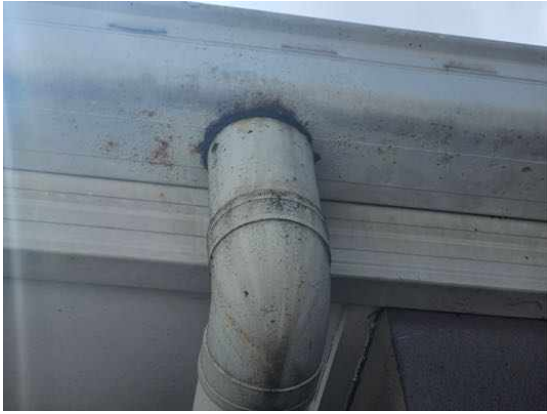
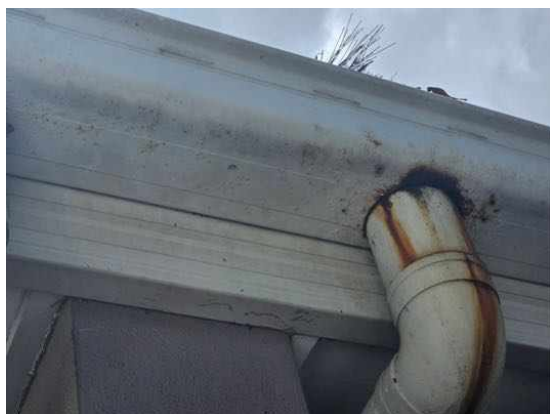
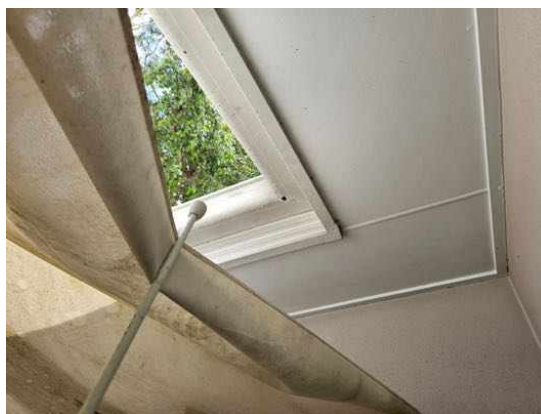
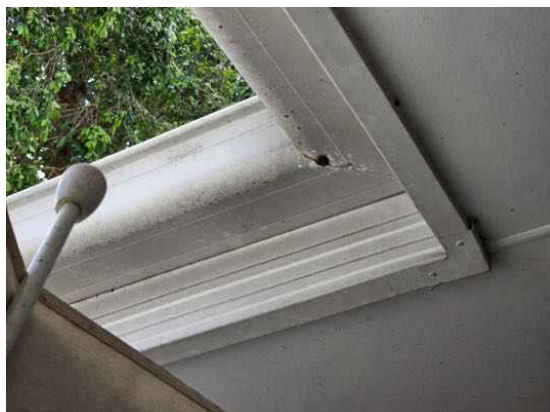
Finding 3.04

Building:	Main Building
Location:	All External Areas
Finding:	Downpipe dropper and gutter - rusting
Information:	On the day of inspection it was noted that the downpipe droppers around the perimeter of the property were rusted and functioning effectively. Some rust was

noted in the gutter itself.

This should be repaired without delay to reduce further damage to the roof plumbing, reduce the moisture around the foundations, and to reduce the possibility of increased timber pest activity.

The attendance of a roofing contractor or plumber with roofing experience is strongly recommended.

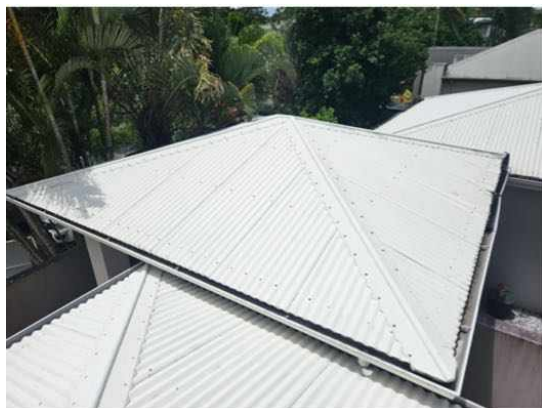
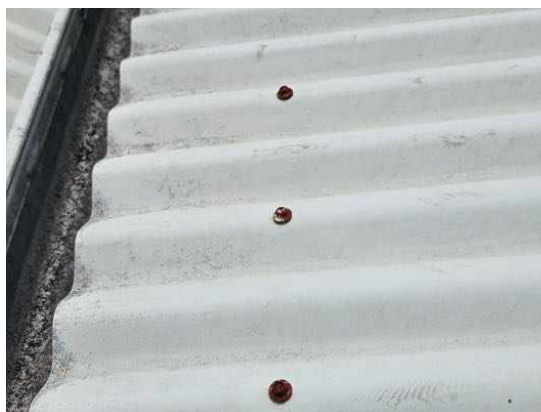
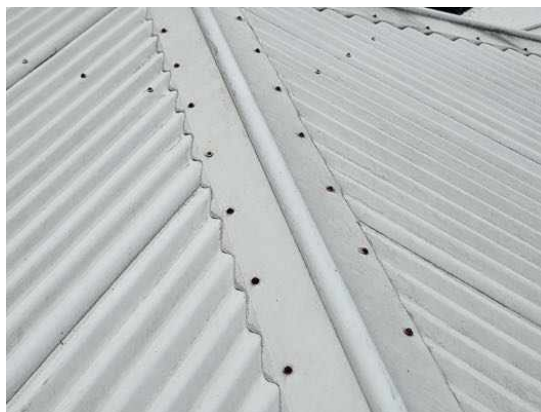
Building:	Main Building
Location:	Entry portico
Finding:	Roof screws - rusting
Information:	It was noted during inspection, that throughout the roof surface of the entry portico the majority of roof screws are showing signs of rust at varying degrees ranging from minor to moderate.

This should be monitored over time, and should the condition worsen, consider replacement of the screws. As roof screws deteriorate they can have an effect on the adjoining roof materials.

A roofing plumber could be appointed at the clients discretion to replace the screws in question.

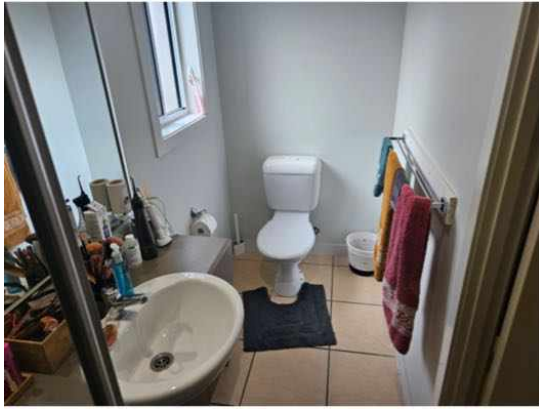
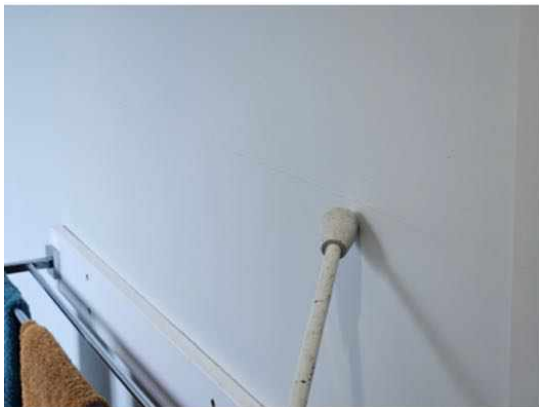
Finding 3.06

Building:	Main Building
Location:	Ensuite - Master
Finding:	Minor movement cracking
Information:	Minor movement cracking and repairs to the ensuite walls, were observed at the time of the inspection.

Cracking of this nature is expected in this type of building and it appears to be associated with movement of the building elements. Should there be further greater movement, always contact a structural engineer or a licensed builder.

The fine but visible cracks can be patched and painted over by an experienced painter or handyman at the clients discretion.

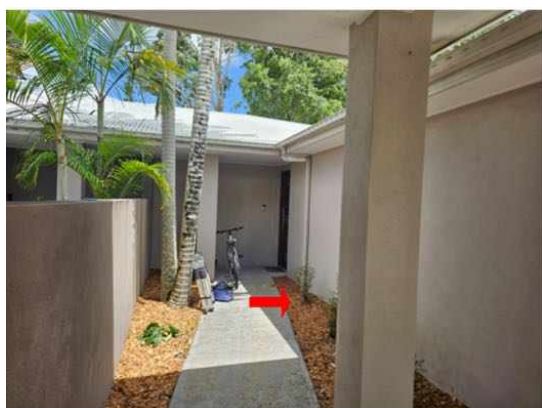
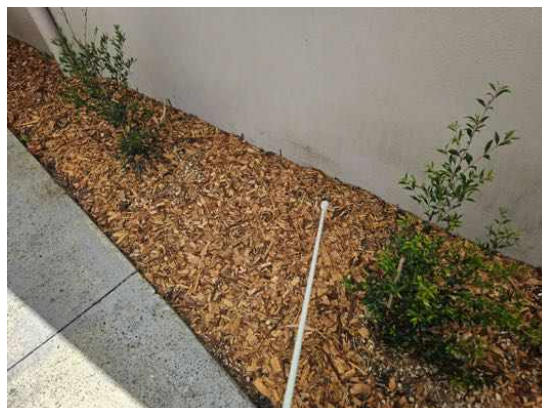
Building: Main Building
 Location: Front garden
 Finding: Garden / landscaping debris - against building perimeter
 Information: It was noted on the day of inspection that there was garden debris, soil and landscaping litter against the building perimeter and covering the physical barrier and weep holes. This can be at risk of creating an environment for timber pests and vermin to enter the building.

Allowing the build up of leaf litter and other foliage debris, the area can become a high risk environment by creating conditions such as moisture and cover for timber pests to build concealed mud leads under the cover; therefore, being able to enter the building unnoticed and unhindered.

It is recommended that the garden and debris be raked back to provide a of 75mm clearance below the nearest building elements to the ground. Ideally there would be complete clearance against the building edge.

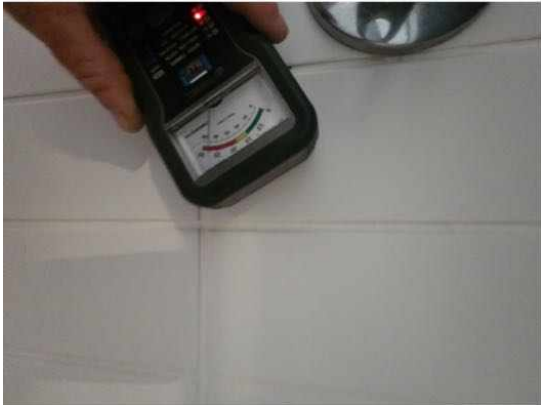
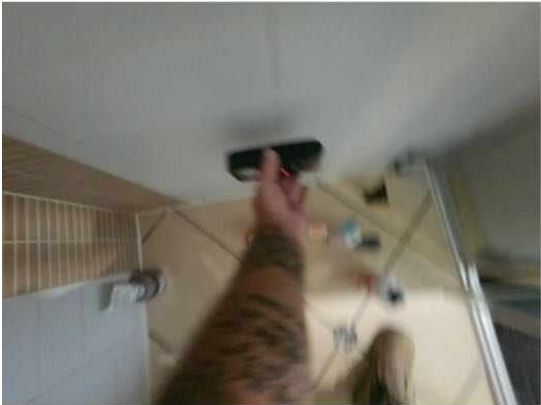
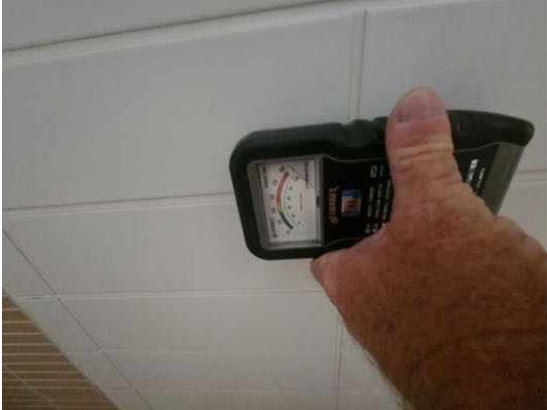
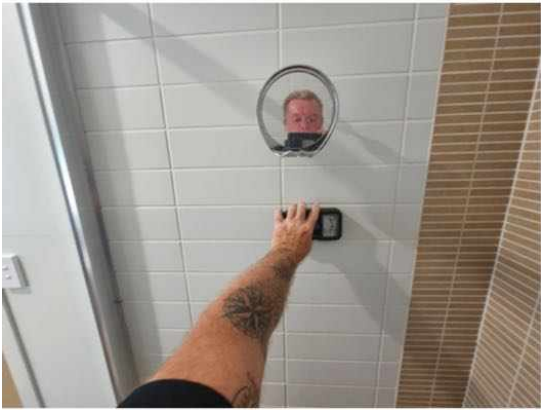
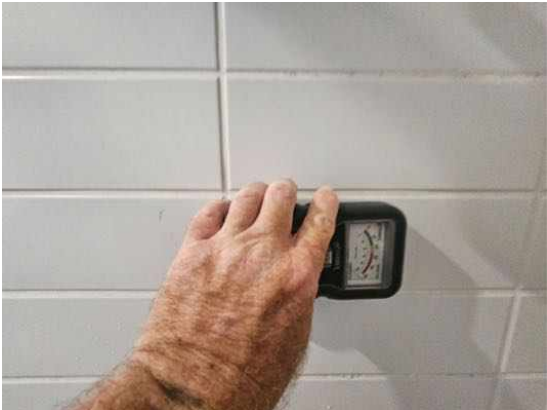
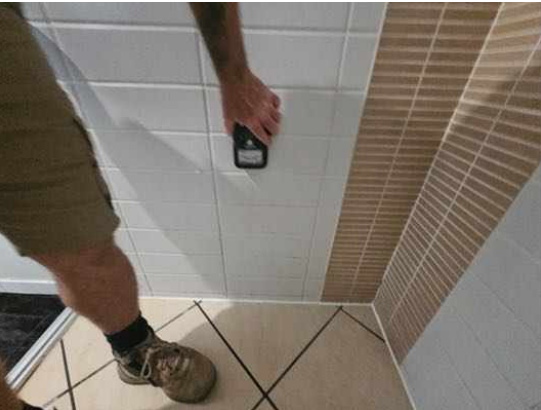
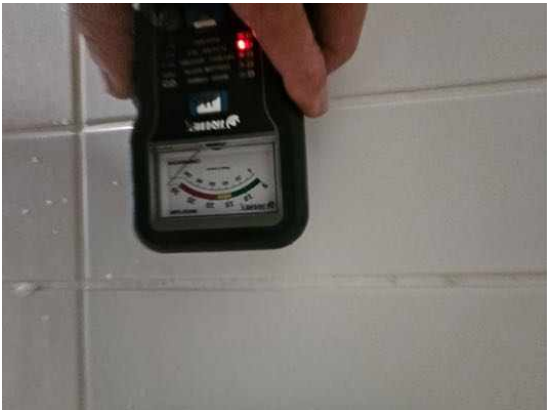
Building:	Main Building
Location:	Ensuite - Master
Finding:	Elevated moisture present at the time of inspection - ensuite
Information:	Elevated moisture was noted in the tiled wall surfaces of the ensuite shower.

The levels varied at differing points throughout the recess. This could possibly be due to deteriorated grout and silicone sealants. These can break down over time and become porous, allowing moisture to enter the wall sheet surface behind the tiles. Moisture was also found around the penetration for shower rose, this should be checked for integrity.

Elevated moisture can attract timber pests and vermin, and produce conditions that promote timber pest attack, fungal growth and wood decay.

The moisture readings in the ensuite shower recess are contained in the tiles to approximately 2/3 the height of the tiled walls, which can usually indicate grout and silicone degradation. The bathroom is mainly concentrated around and below the mixer tap.

It is recommended that the moisture levels in these areas be minored over time and the grout and silicone be renewed to possibly eliminate any further moisture penetration. No moisture was detected on the reverse side of the wall.

A licensed tiler and / or sealant specialist could be engaged to renew these elements.

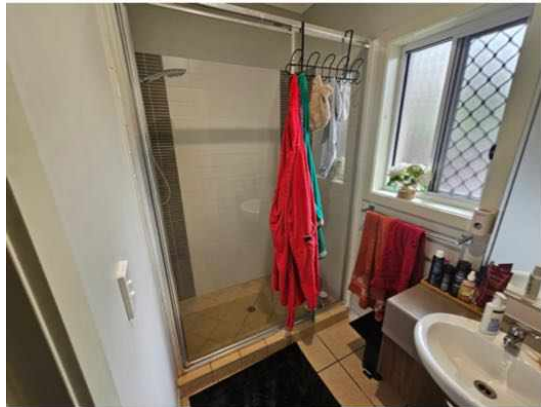
Finding 6.04

Building: Main Building
Location: Bathroom
Finding: Elevated moisture present at the time of inspection - bathroom
Information: Elevated moisture was noted in the tiled wall surfaces of the bathroom shower around and below the mixer tap.

The levels appeared to be isolated in the zone shown in the photographs. This could possibly be due to deteriorated grout and silicone sealants. These can break down over time and become porous, allowing moisture to enter the wall sheet surface behind the tiles. It is most likely that there is some ingress at the tap penetration or from the fitting itself.

Elevated moisture can attract timber pests and vermin, and produce conditions that promote timber pest attack, fungal growth and wood decay.

It is recommended that the plumbing service be assessed for integrity.

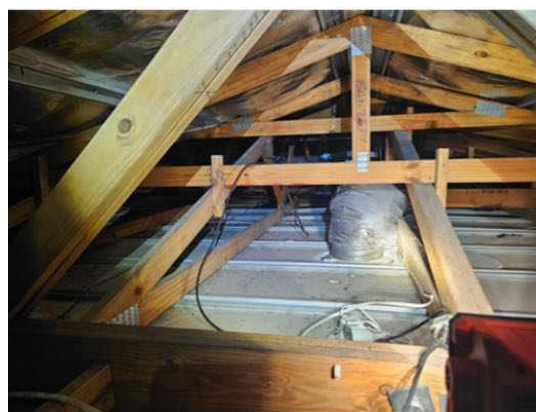
Building: Main Building
Location: Garage
Finding: Unable to access ceiling space - congested framing
Information: On the day of inspection the ceiling space was not able to be inspected due to the congested and narrow roof framing from the garage access hatch to main areas of the home. An alternative access hatch location is recommended to facilitate better access to the ceiling void.

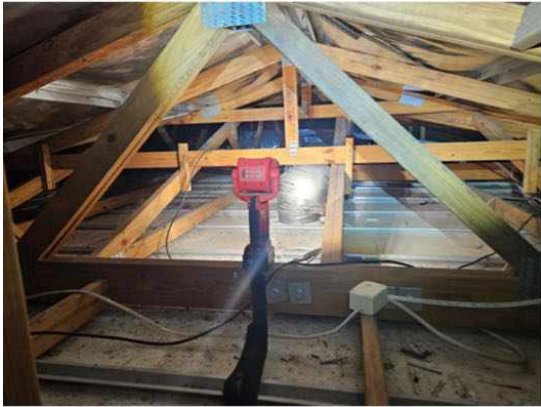
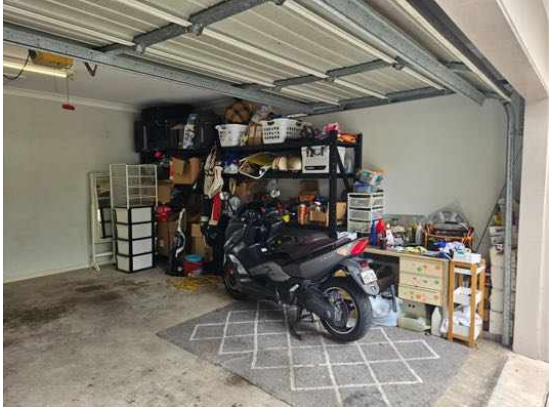
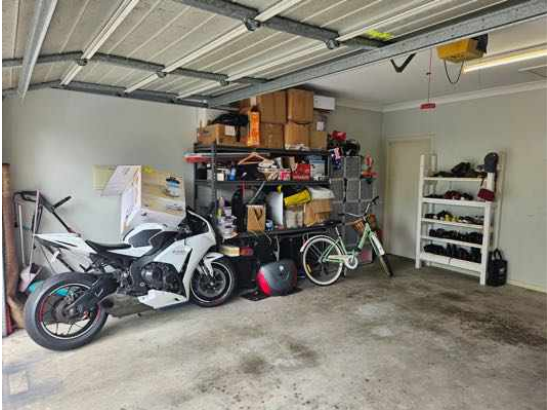
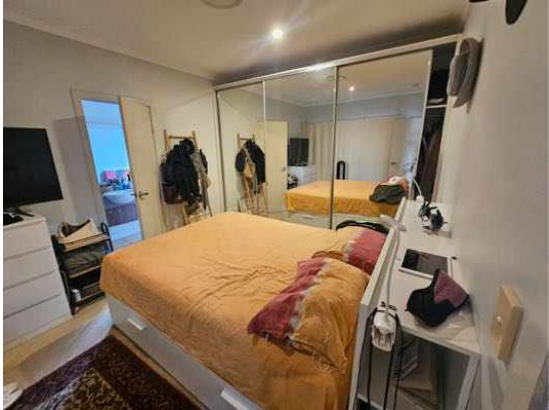
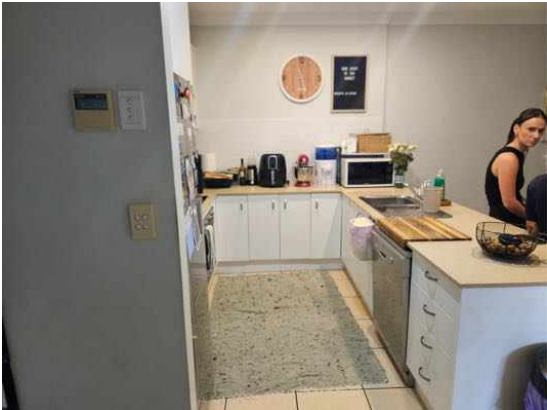
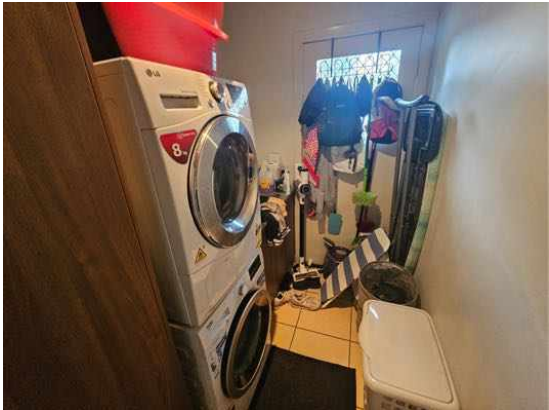
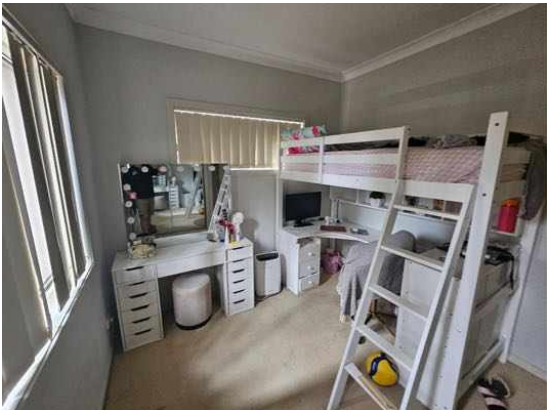
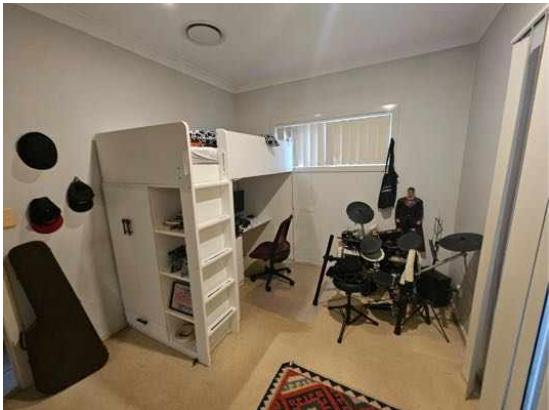
Building: Main Building
Location: All Areas
Finding: Additional Photos - Obstructions and Limitations
Information: These photographs are an indication of the obstructions and limitations which impeded full inspection of the property at the time of inspection. These obstructions can hide an array of defects and should be removed to allow full inspection to be carried out. A re-inspection is recommended once the areas are made accessible.

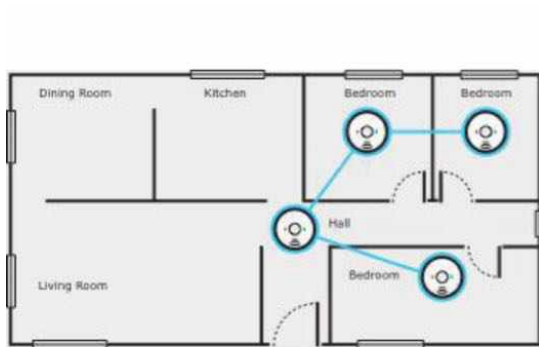
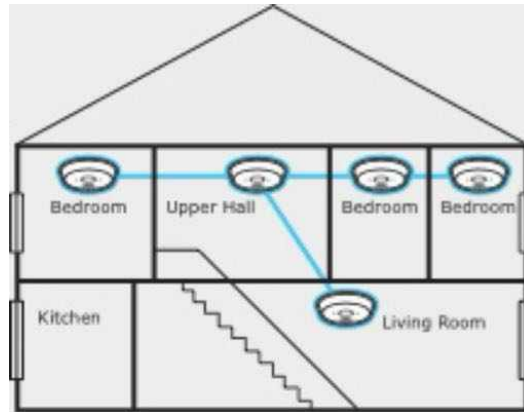
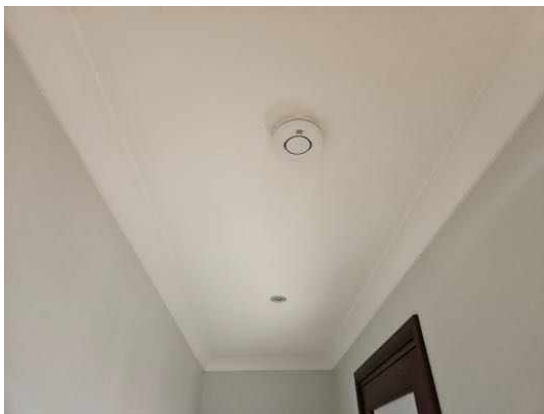
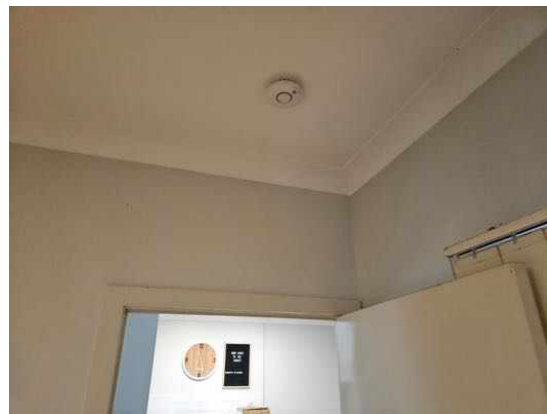
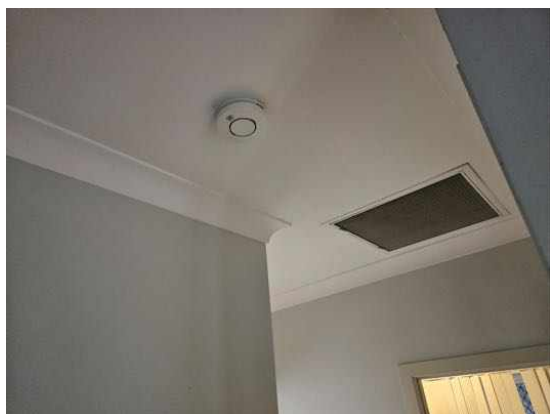
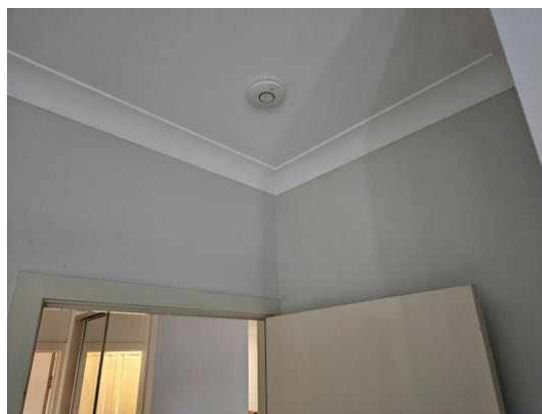
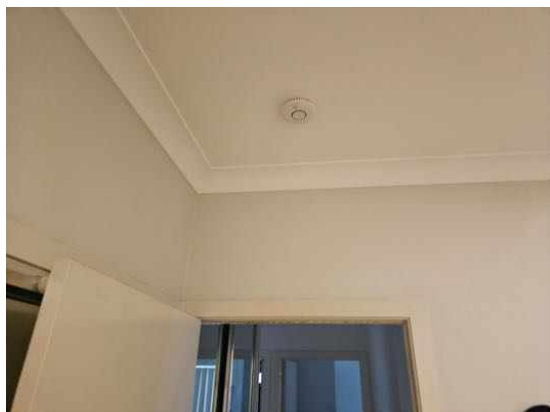
Building:	Main Building
Location:	All Areas
Finding:	Smoke Detectors and Alarms. AS 3786:2014
Information:	Reporting on Smoke Detectors or Alarms, including hard wired smoke detection systems and their legislative requirements, is outside the Scope of this Report.

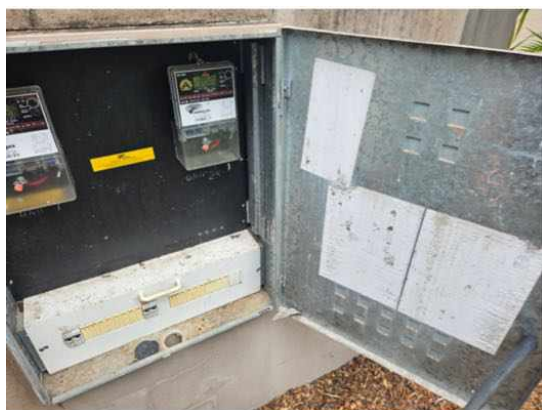
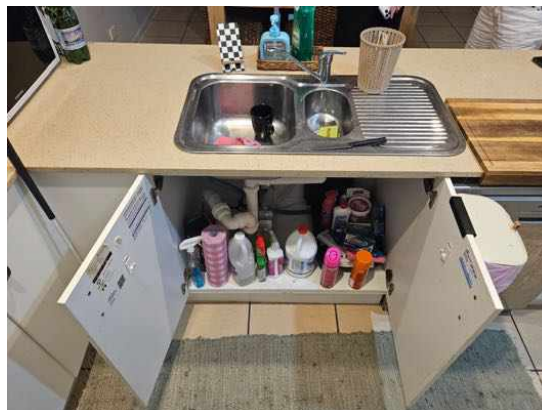
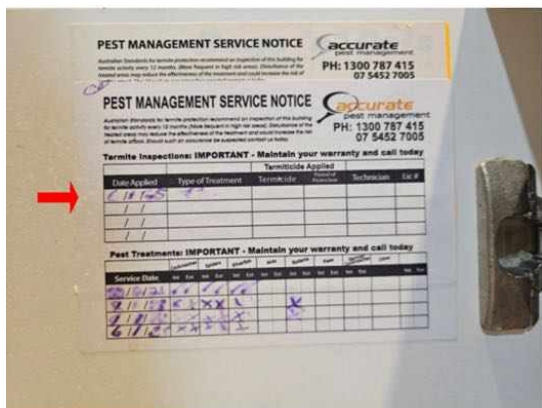
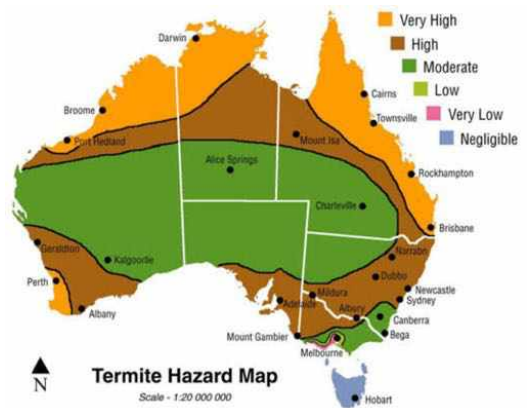
Building: Main Building
Location: Meter box, kitchen cupboard
Finding: Durable pest inspection notice
Information: On the day of inspection it was noted that the durable pest inspection / treatment notice was in place and the most current inspection was notated and in date. These notices / stickers are to verify the timber pest inspection dates, the inspector, and, at times, the currency and type of timber pest system / barrier in place or being used in and around the property.

The client is advised to maintain annual inspections with the company listed or a company of their choosing.
