Building and Timber Pest Inspection Report

Inspection Date: Wed, 18 Feb 2026

Property Address: 121 Burrumbuttock Brocklesby Rd,
Burrumbuttock NSW 2642, Australia

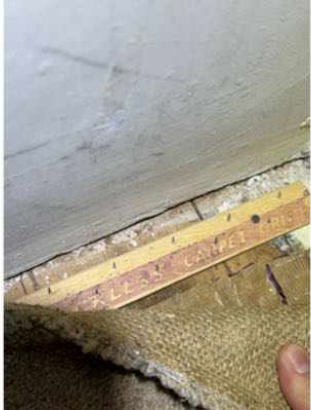
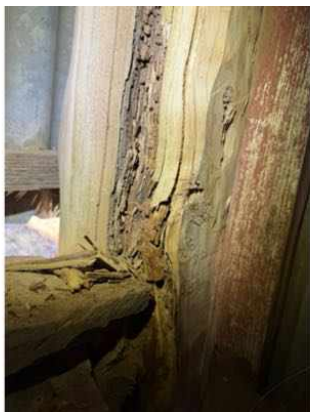
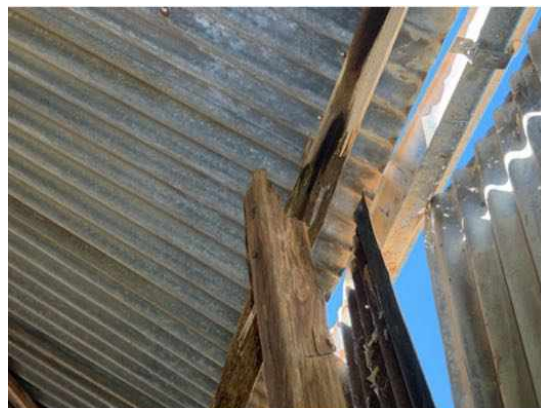
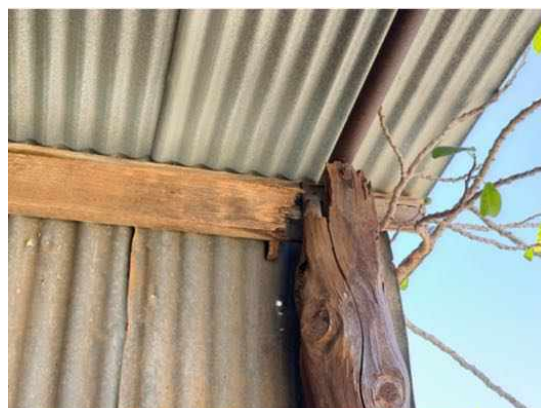
Building: Main Building
Location: Subfloor, Outside Sheds, Cupboards, Garage Window
Finding: Evidence of termite workings & damage

Although no live termite activity was identified at the time of inspection, previous termite damage & workings were identified at, but not limited to, areas of the subfloor, outside sheds, cupboards & garage window. Damaged materials such as the shed framing should be replaced promptly, to avoid further deterioration, and ensure the shed is secure.

A more invasive inspection is also advised to identify the extent of the damage. 6 monthly ongoing termite inspections, conducted by a qualified termite inspector, are also recommended

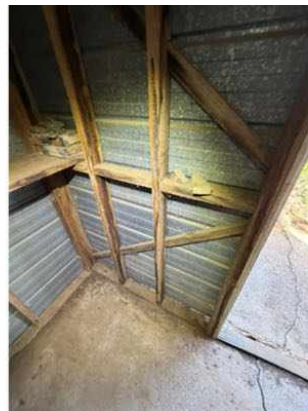
Finding 6.01

Building:	Main Building
Location:	All External Areas, Shed Framing
Finding:	Timber in direct ground contact & trees - conducive to termites
Information:	Where timber materials are in direct contact with the ground and consequently moisture, they become conducive to termite activity. The tree stumps, shed framing, and trees surrounding the building create an environment conducive to termite infestation.

Where feasible, any timbers in direct contact with the ground should be removed and any trees in close proximity to the building should be removed or test drilled (inspected) at least annually to reduce the risk of termite infestation & detect any early signs of termite activity.

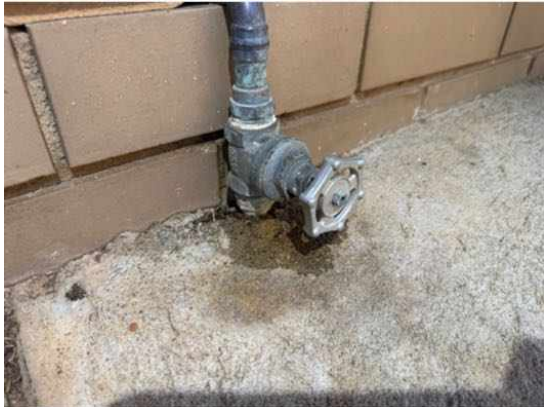
Finding 6.02

Building:	Main Building
Location:	All External Areas
Finding:	Potential Water pooling - against property
Information:	It appears that there are potential areas around the perimeter of the property that could be susceptible to water pooling.

Where insufficient site drainage and garden beds against the house are present, water pooling is likely to occur, and can create areas conducive to timber pests and potential damage to the subfloor structure overtime, if neglected. Recommend consulting with a licensed plumber and/or landscaping contractor in the short term to further assess and provide remedial advice.

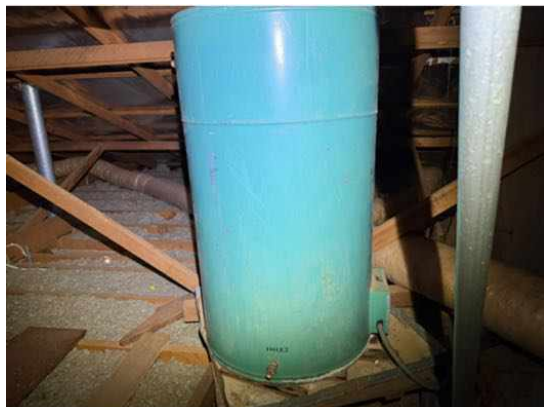
Building: Main Building
 Location: Roof Void
 Finding: Gravity-Fed HWS - Disconnected
 Information: A disconnected gravity-fed hot water system (HWS) remains in the roof void. Despite this plumbing system being unused, it may contain residual water. If neglected, rust of the system overtime, may lead to residual water leaking.

Recommend that the client either monitor the condition of the system or get the system drained by a licensed plumber to prevent any potential future leaks.

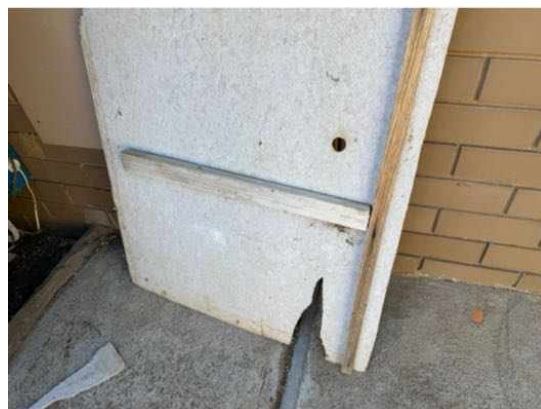
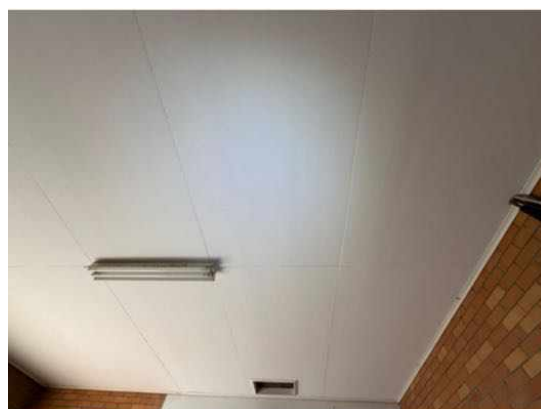
It is advised that the client consider a separate Asbestos Inspection and Condition Audit, which can include the taking of samples for definitive confirmation of the presence of Asbestos, carried out by a licensed Asbestos Inspector.

In the interim, no works should be conducted to these areas without further specialist advice.
