# Building and Timber Pest Inspection Report

Inspection Date: Tue, 24 Feb 2026

Property Address: 6/65 Pommel Cres, Epping VIC 3076,  
Australia

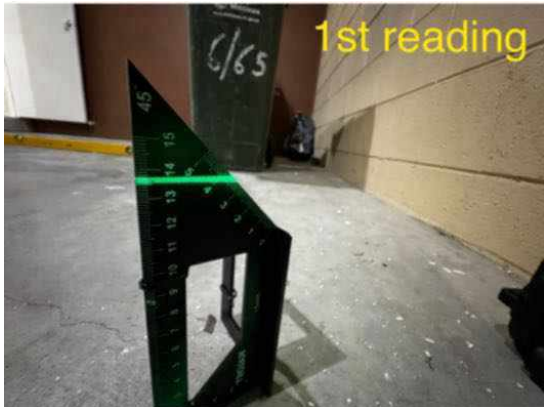
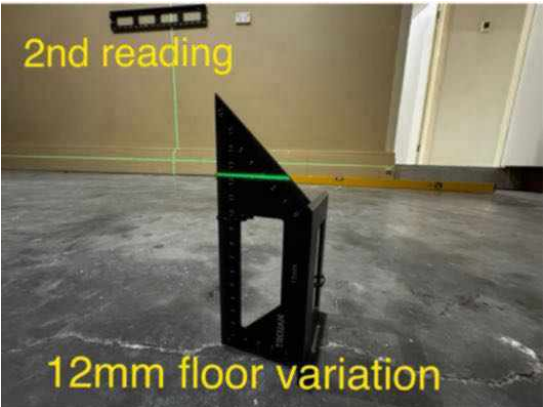
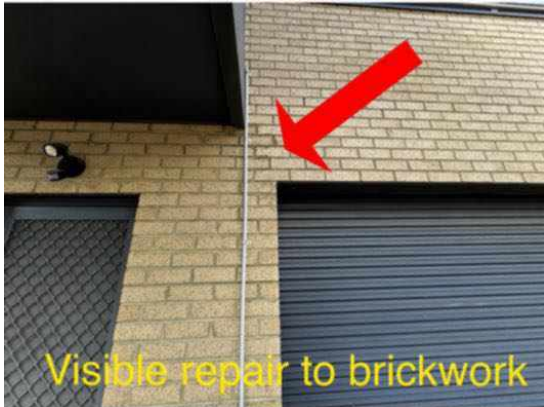
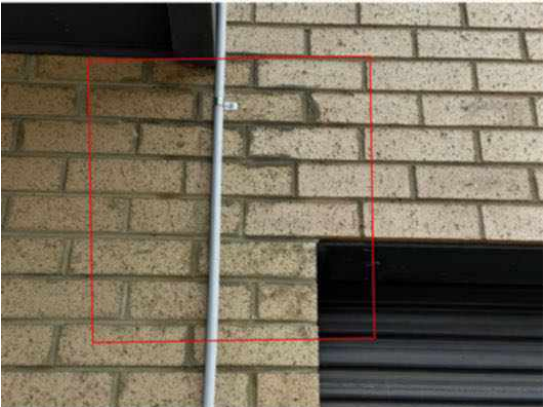
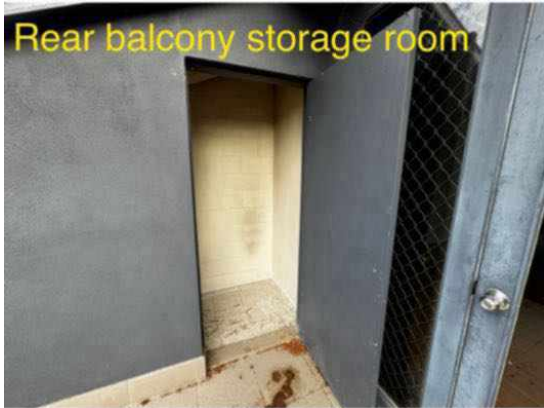
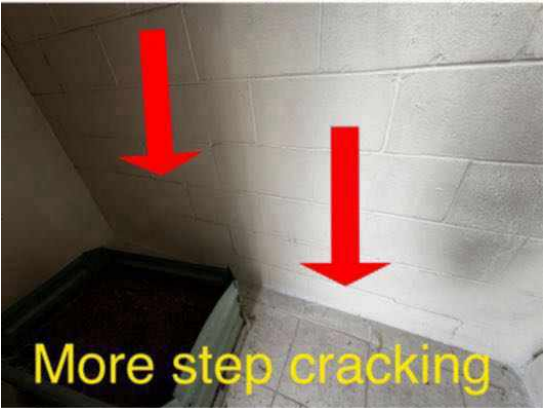
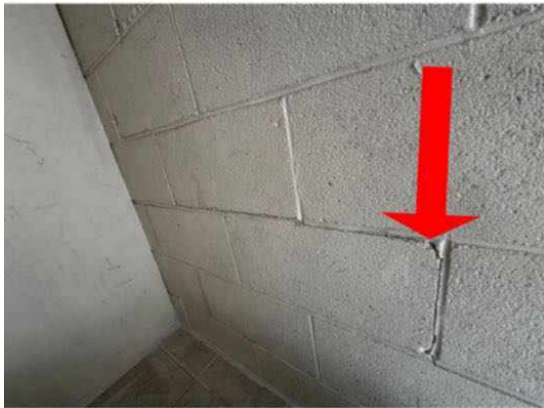
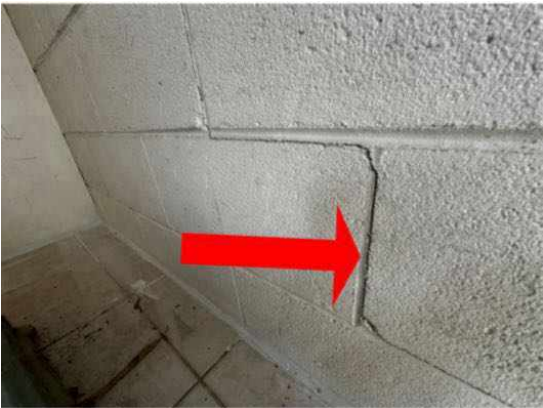
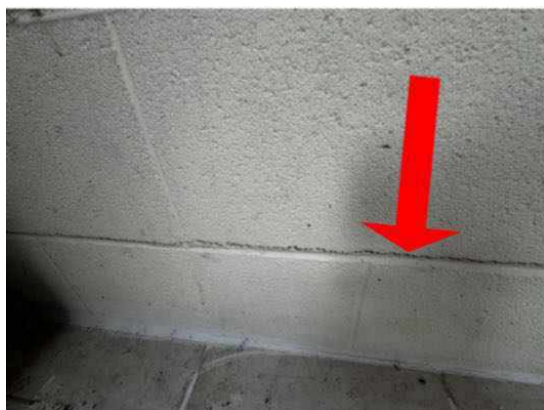
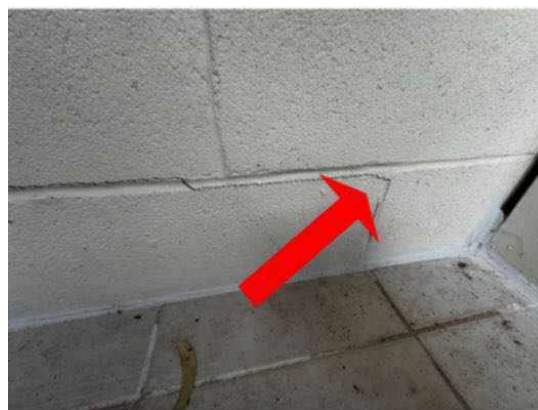
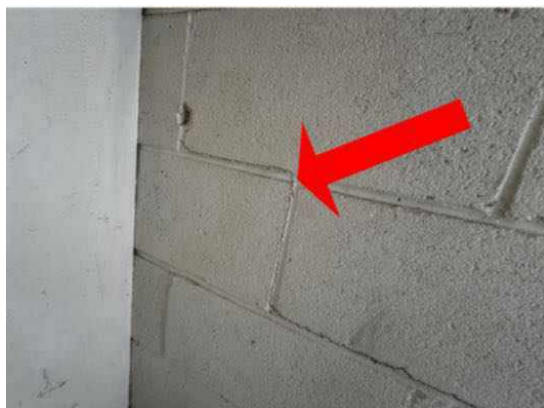
Building: Main Building  
 Location: Boundary wall, garage floor, front elevation > Front,Front Right,Level 1,Rear Right  
 Finding: Suspected Structural Movement – Step Cracking and Garage Floor Heave  
 Information: Step cracking to boundary blockwork was observed within the garage and was also visible in the first-floor storage room off the balcony. The cracks measured up to approximately 5mm in width. The step cracking to the first-floor area was clearly visible and consistent with structural movement.

A substantial crack was observed to the centre of the garage concrete floor slab. Laser level measurements indicated that the centre of the garage floor was raised by approximately 12mm. This level of heave over a relatively short span is indicative of slab movement, likely associated with reactive soil conditions, moisture variation, or foundation-related movement.

The internal garage door was also observed to be binding and difficult to operate, which is consistent with distortion of the surrounding structure due to movement.

There was evidence of previous repair to the brickwork above the garage door to the front elevation. Fresh, uncleaned mortar was visible in this area, suggesting that cracking has previously occurred and that the front façade has been affected by structural movement.

The combination of blockwork step cracking, slab heave, door binding, and evidence of prior façade repairs indicates ongoing or historical building movement. Given the elevated moisture conditions previously noted and the property being vacant for an extended period, moisture variation within reactive soils may be a contributing factor.

Further structural assessment recommended in the short term due to measurable slab heave and visible structural cracking.

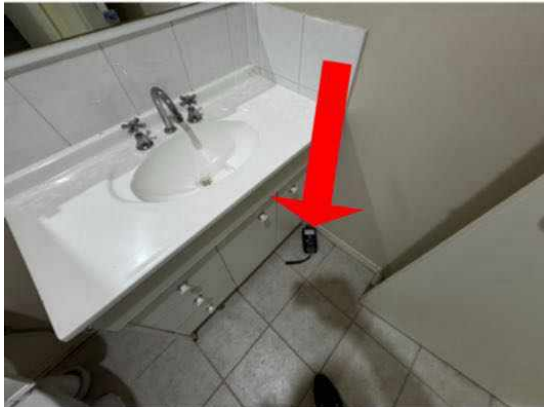
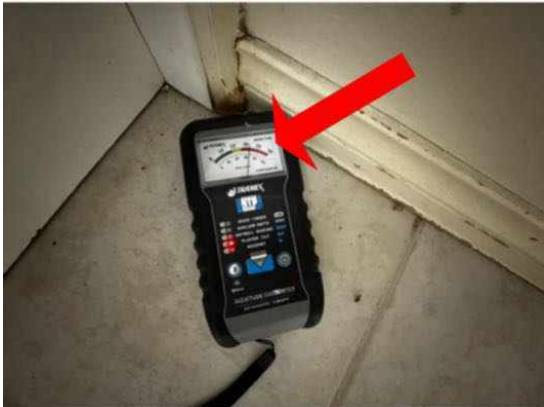
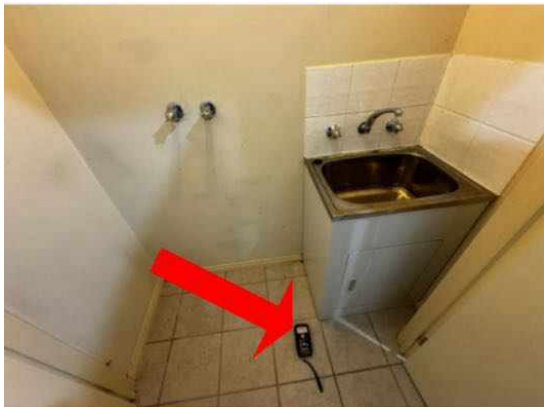
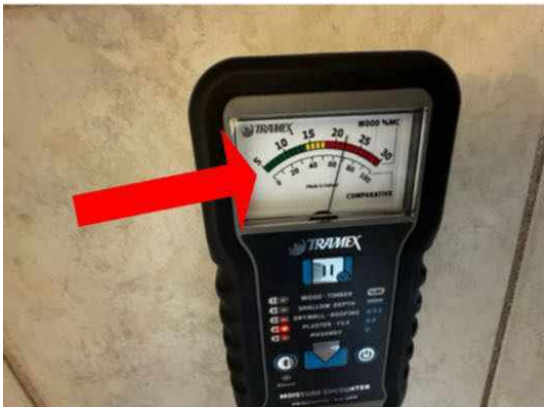
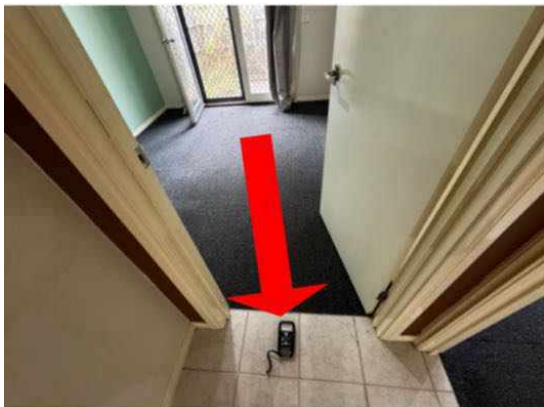
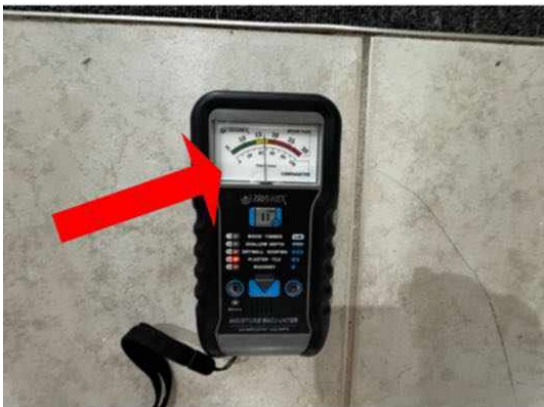
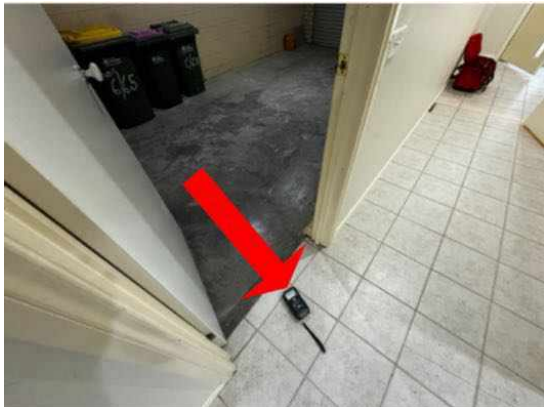
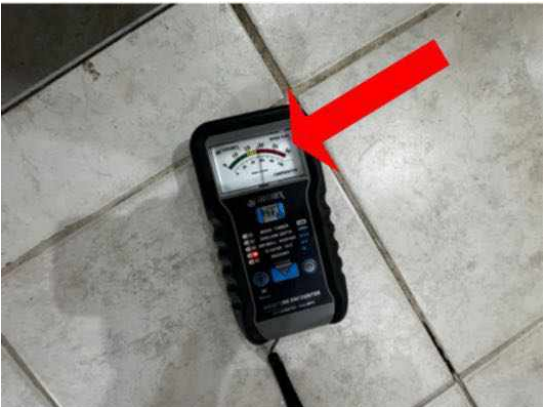
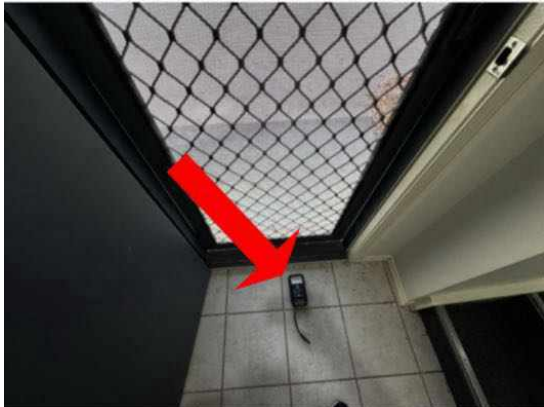
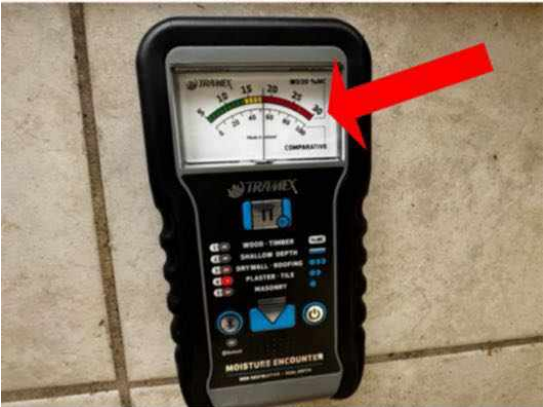
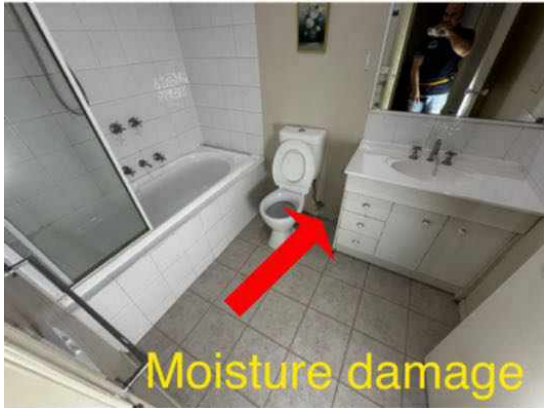
## Finding 2.02

Building:	Main Building
Location:	Tiled areas > Ground Level
Finding:	Widespread Elevated Moisture – Ground Floor (Suspected Concealed Leak)
Information:	Elevated moisture readings were detected to the entire tiled area on the ground floor, including the bathroom, hallway, laundry, and entry. Moisture testing confirmed consistent elevated readings across these areas.

Immediate. Further investigation recommended immediately to due to widespread elevated moisture readings and high risk of concealed structural damage.

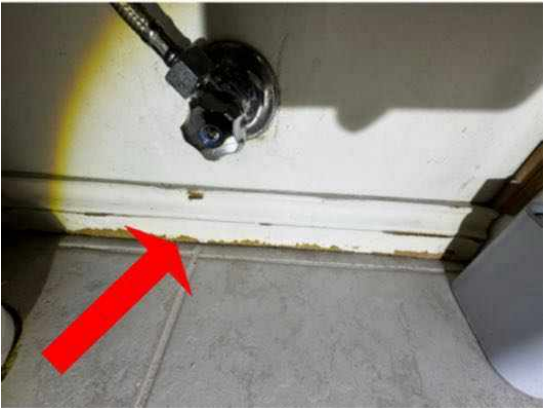
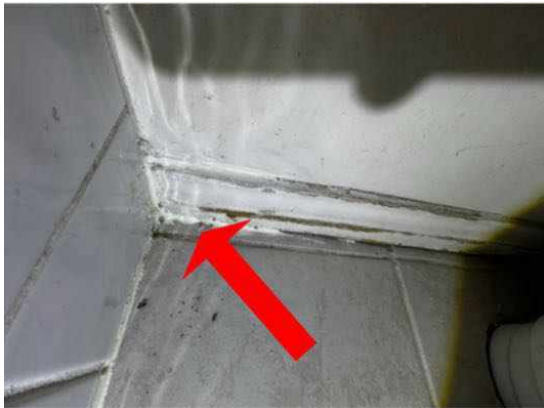
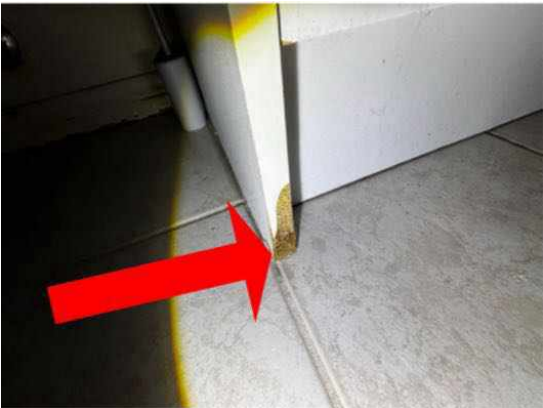
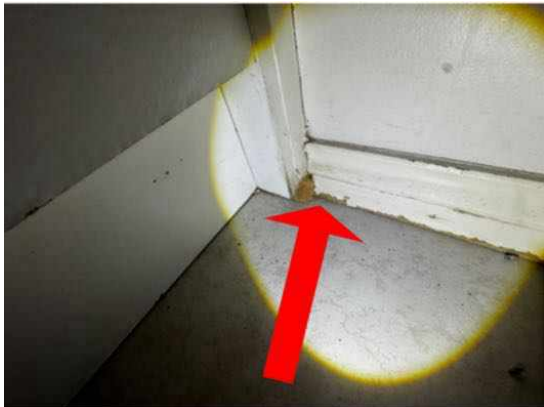
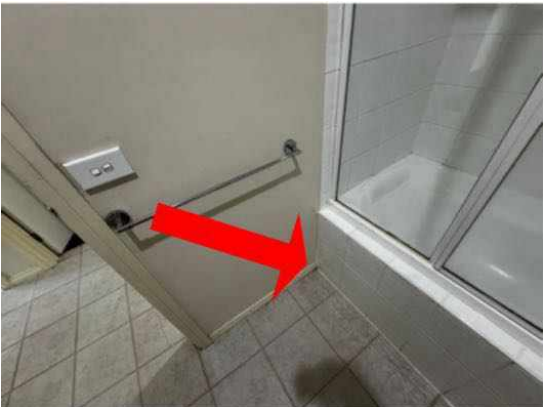
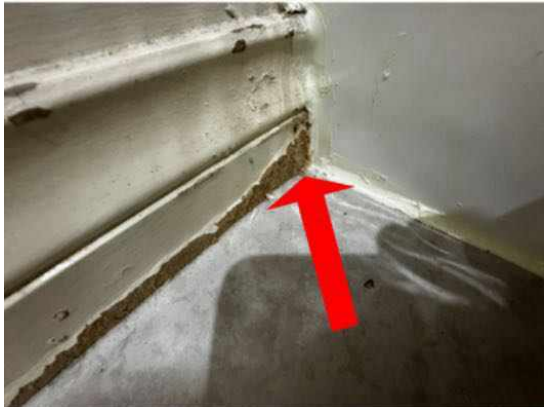
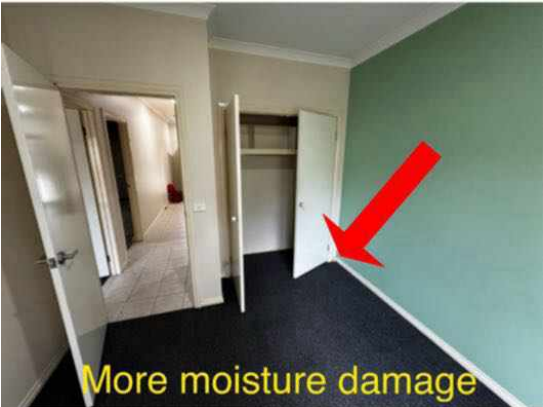
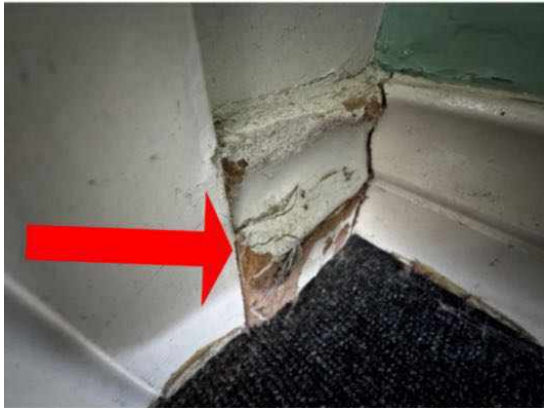
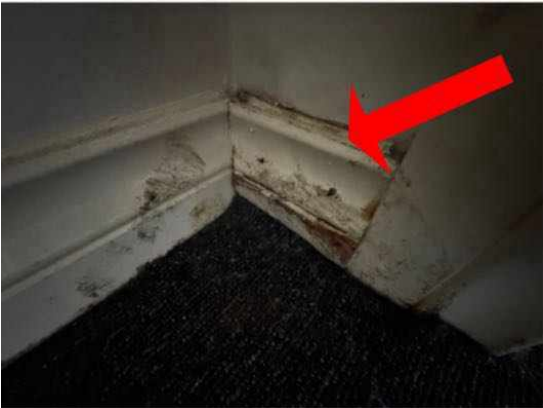
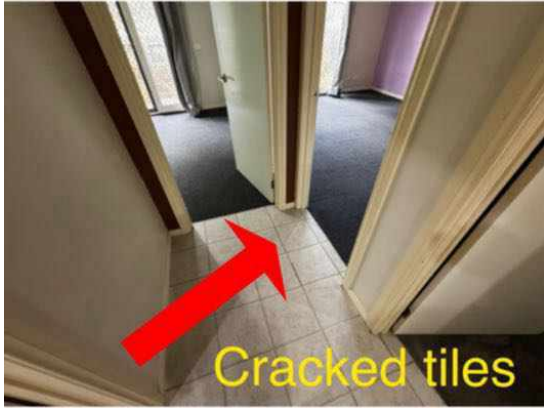
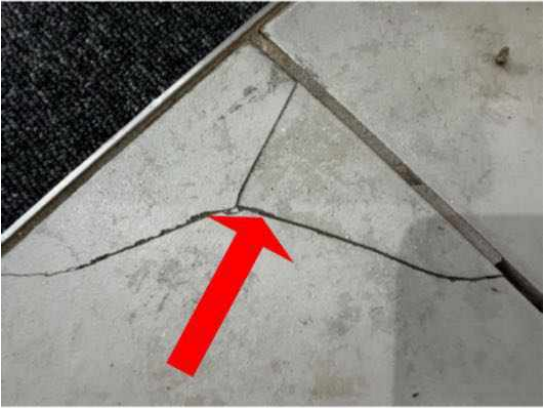
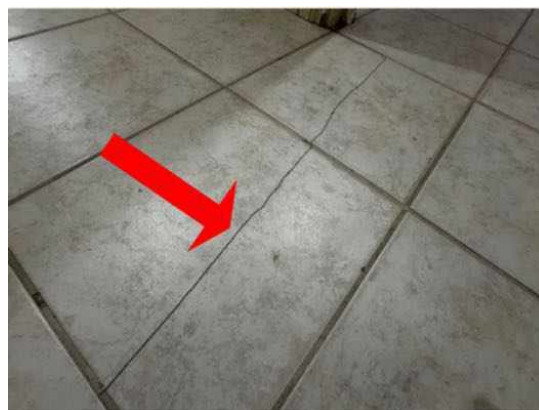
Moisture damage

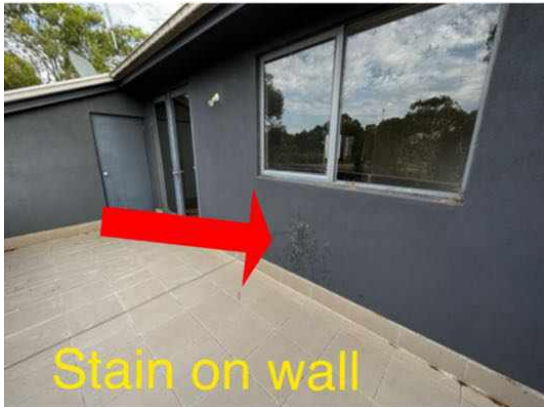
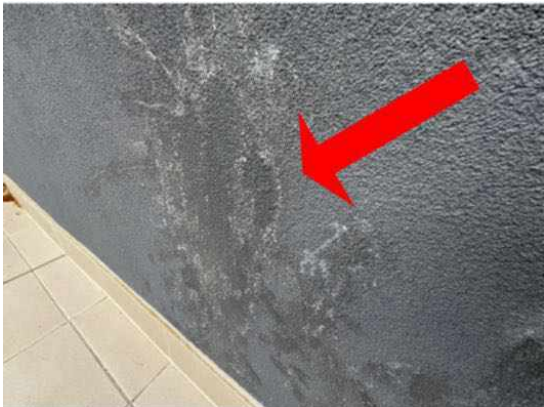
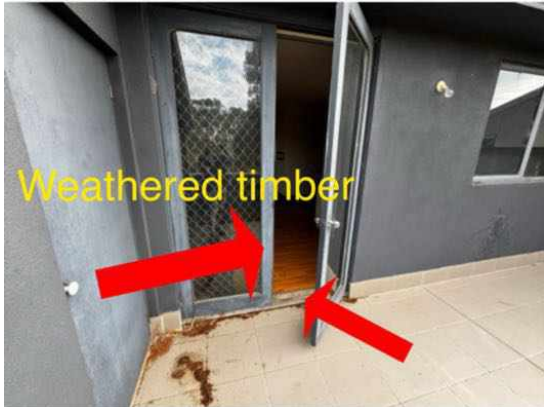
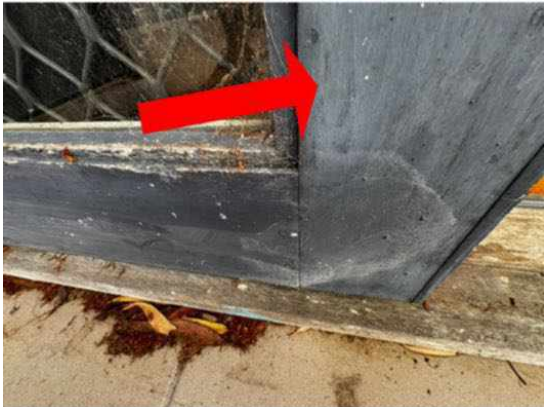
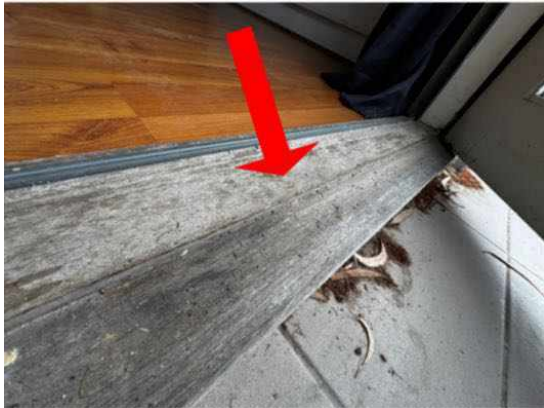
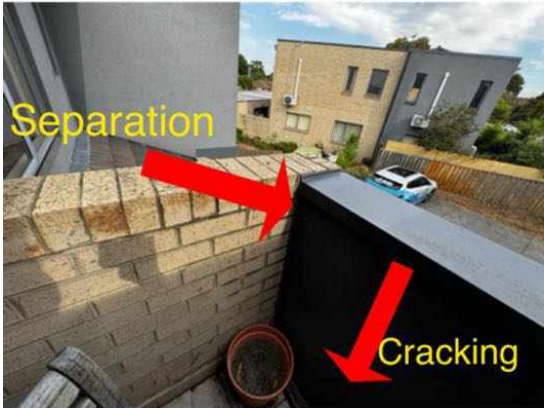
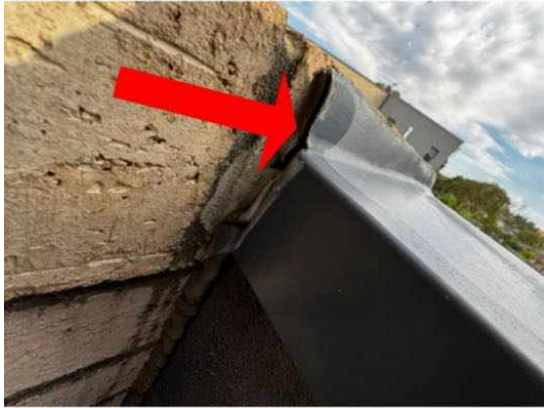
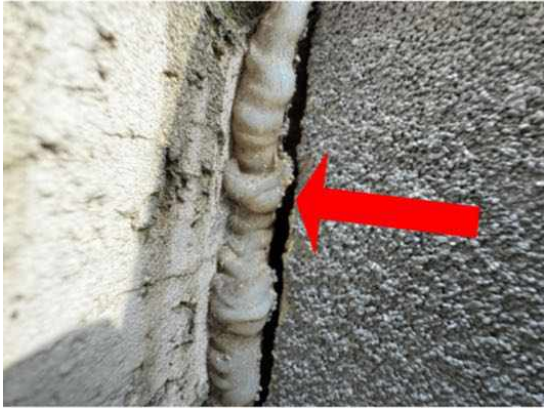
Weathering was noted to the external timber doors and door sills, indicating the need

for maintenance to preserve the timber and prevent deterioration.

The front balcony wall was observed to be cracked and separating at a corner junction. Gaps at this location will require re-caulking to prevent moisture penetration into the building envelope.

It is recommended that control joints be properly sealed with suitable flexible sealant, the damaged downpipe be repaired or replaced, and the stained balcony wall be monitored and investigated if staining worsens. Weathered timber doors and sills should be sanded and sealed. Cracked and separating balcony junctions should be cleaned and re-caulked to prevent moisture ingress.

Maintenance recommended in the short to medium term to prevent further deterioration and moisture-related issues.

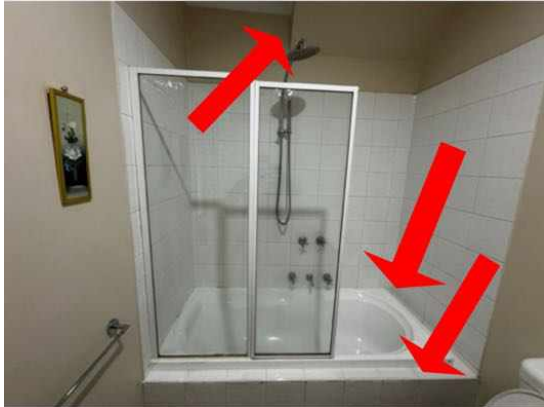
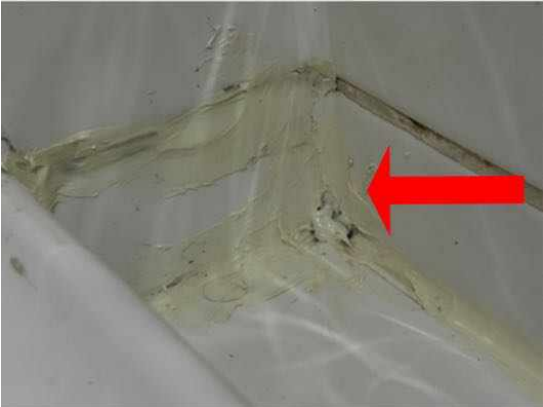
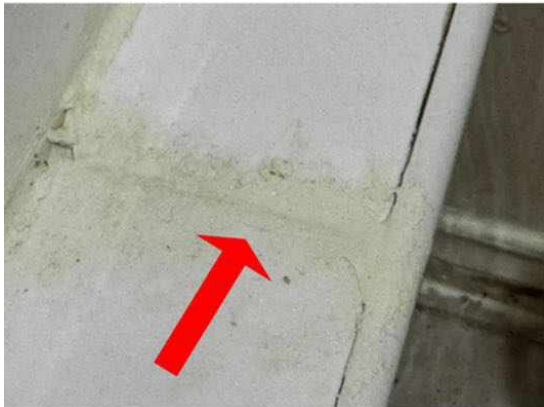
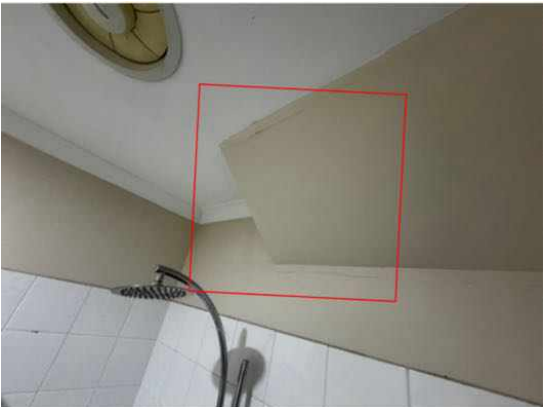
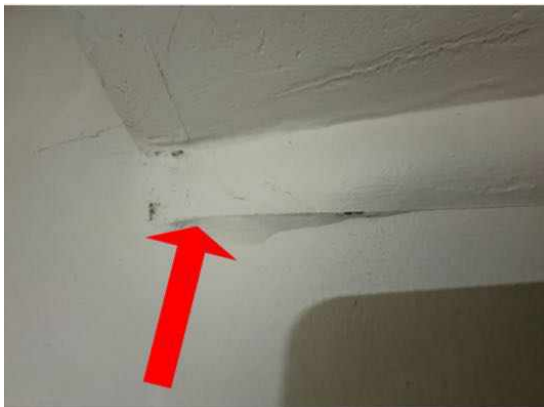
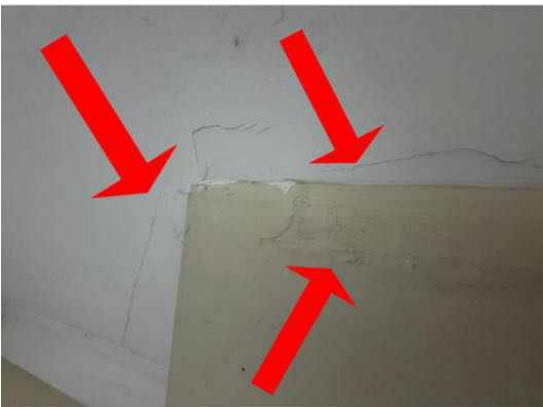
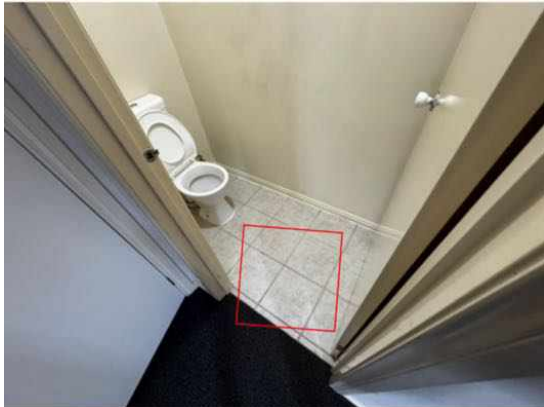
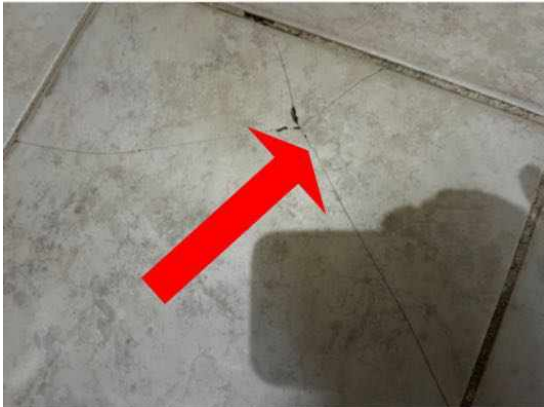
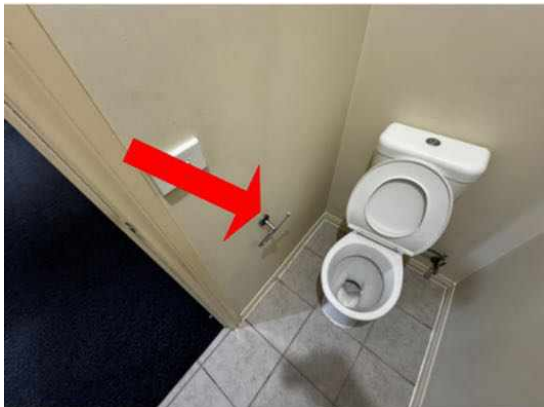
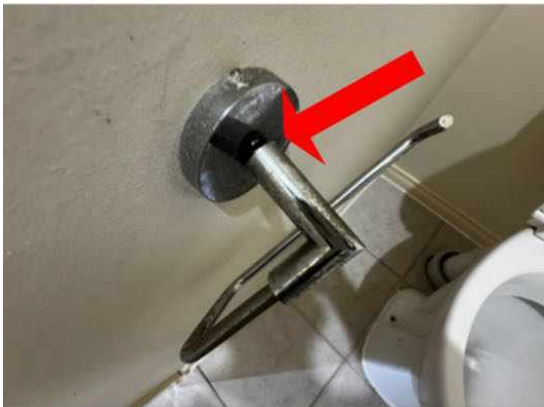
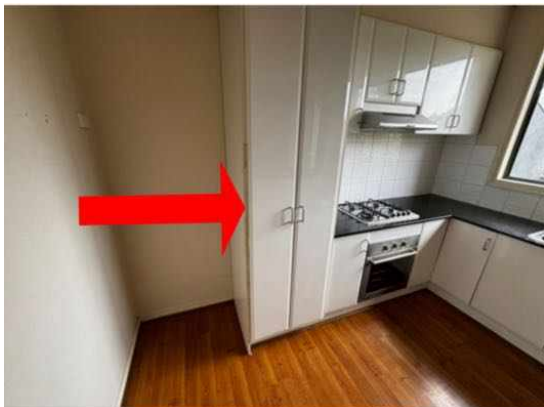
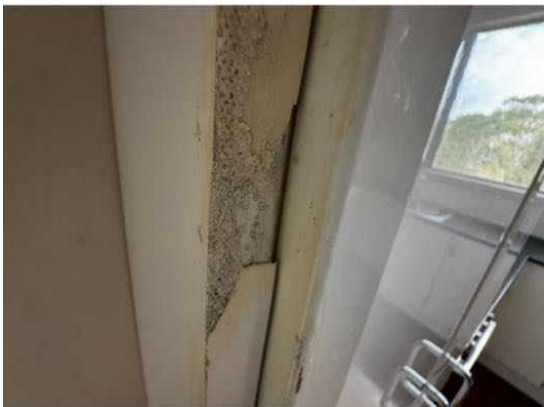
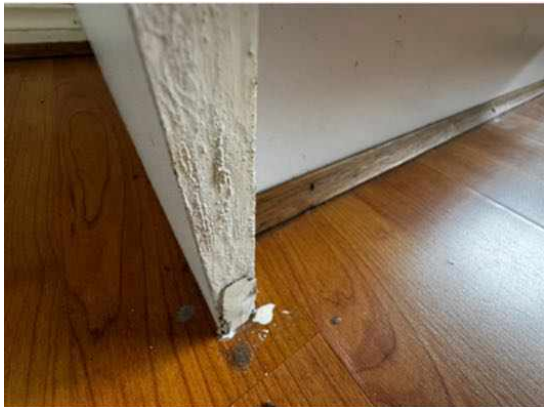
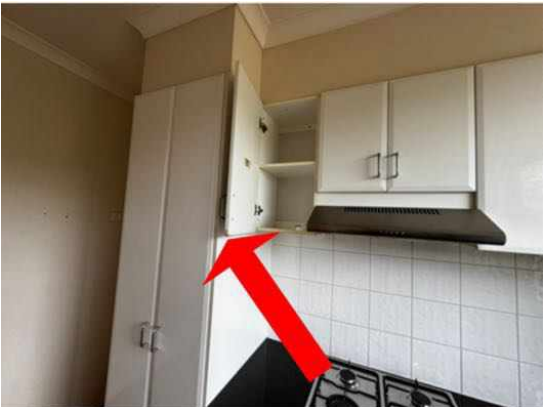
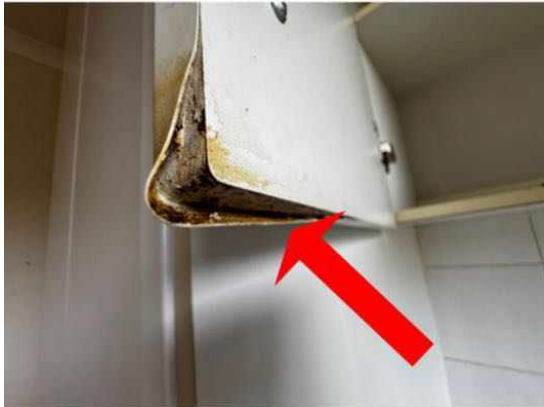
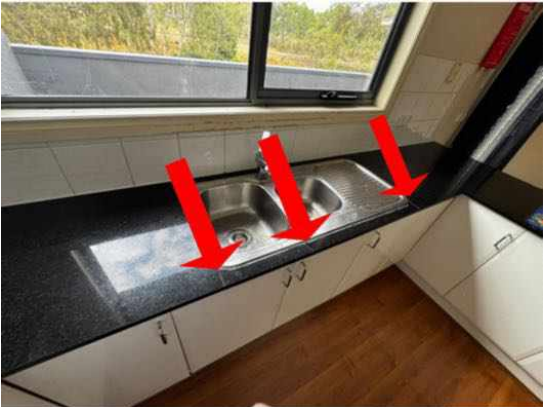
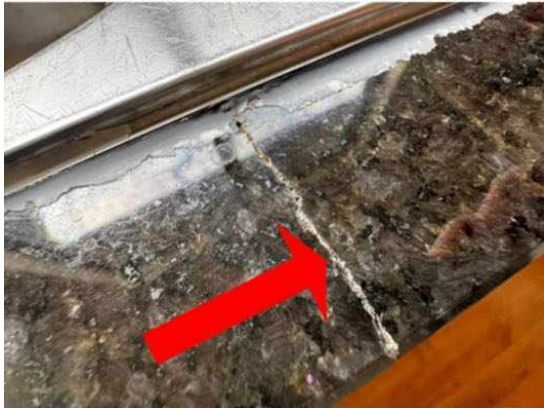
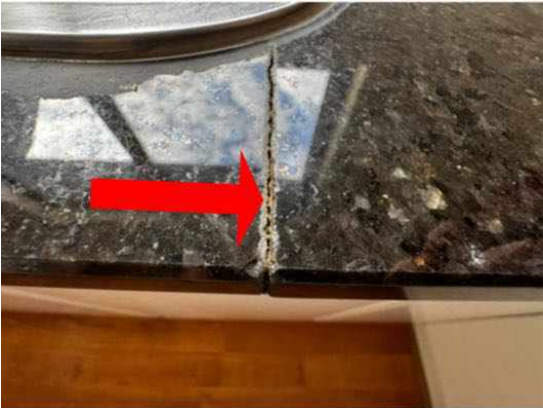
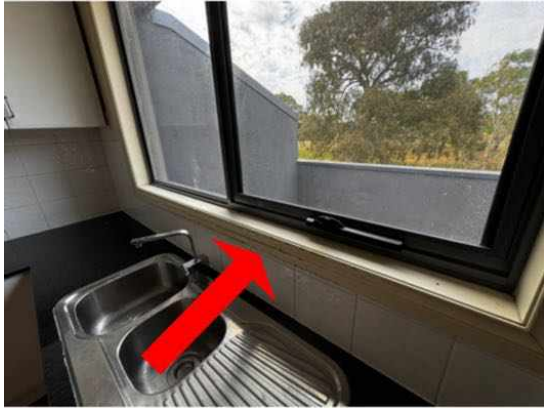
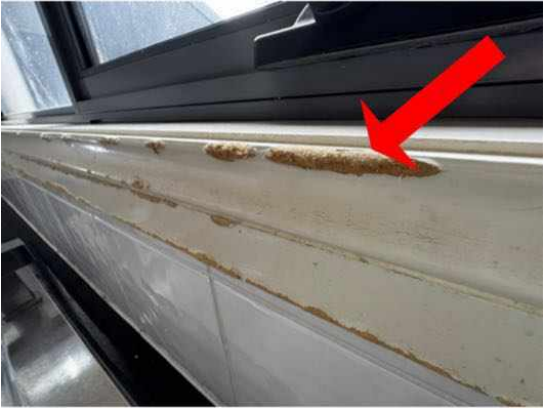
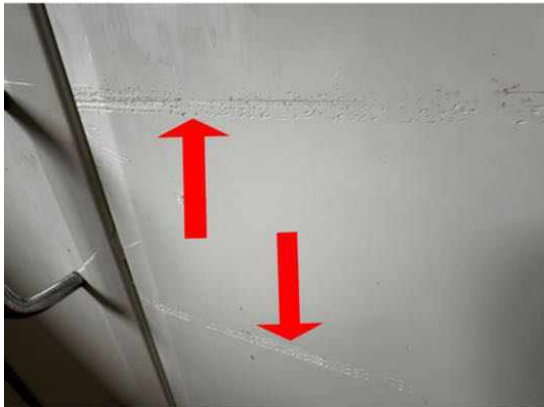
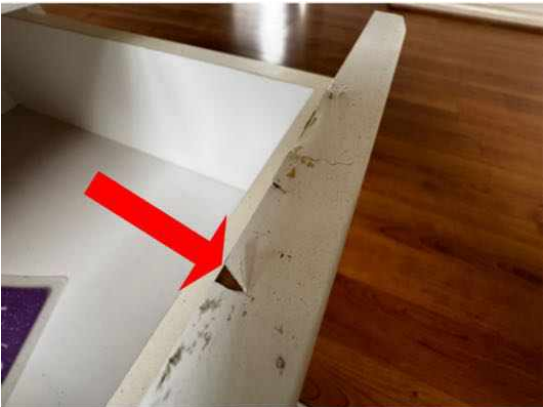
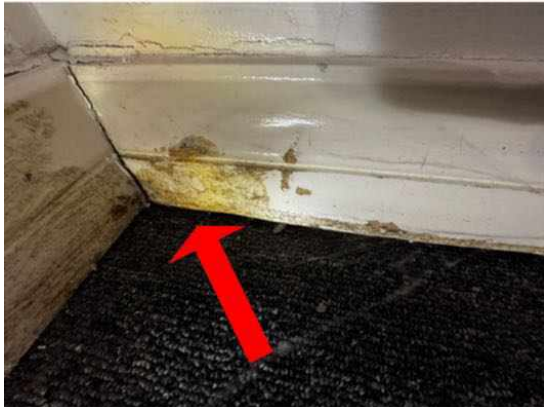
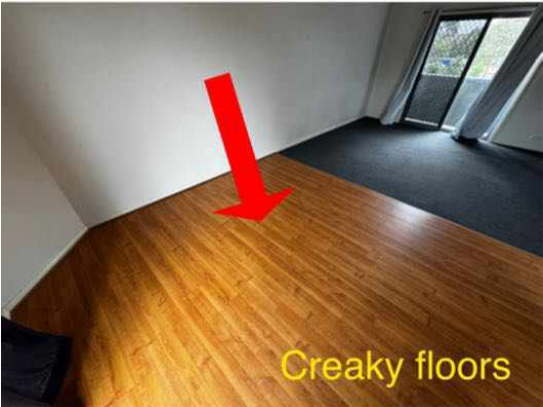
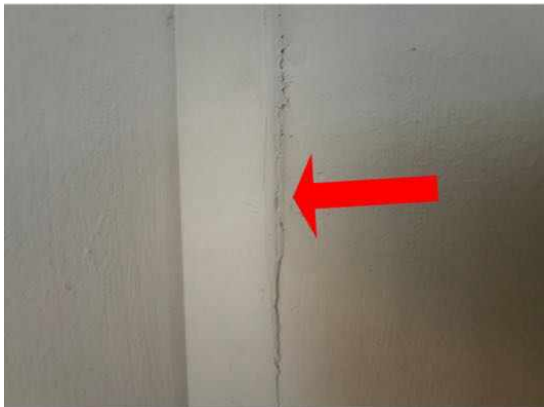
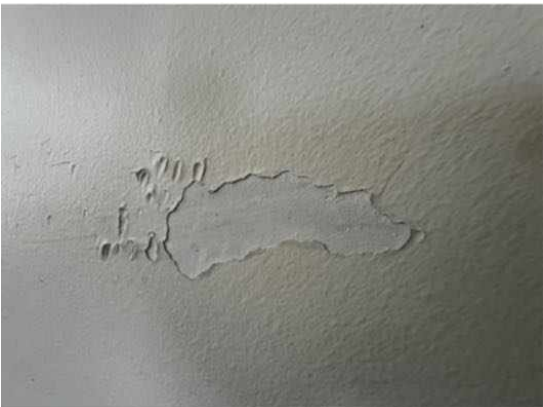
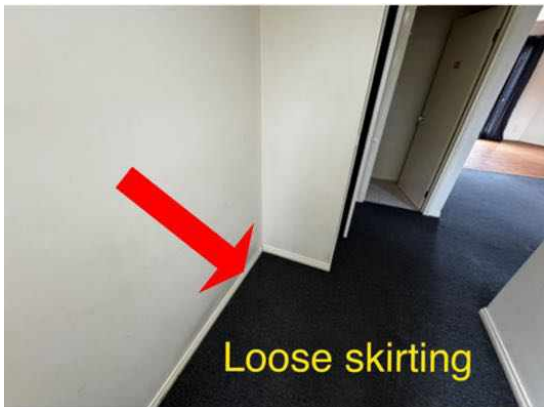
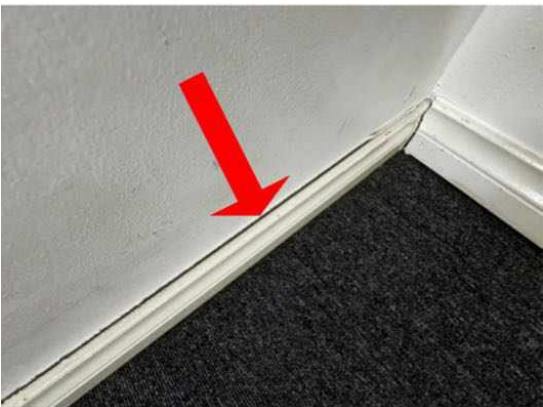
### Finding 3.02

Building:	Main Building
Location:	All Areas > All Areas
Finding:	Internal Defects – Poor Workmanship and General Deterioration
Information:	The following internal defects were observed during the inspection:

Substandard caulking/sealant was applied to the bathtub junctions and grout lines. The finish was inconsistent and may not provide adequate waterproofing protection. Plaster above the bathtub exhibited signs of deformation and cracking, which may be associated with moisture exposure or building movement.

Substandard plaster repairs were evident to walls and ceilings throughout the property. General cosmetic damage was noted, including marks, scratches and damage to walls, ceilings, doors, architraves, staircase components, skirting boards and door jambs.

Cracked floor tiles were observed to the first-floor toilet area, and the toilet roll holder was damaged. Damage to kitchen joinery and cracked kitchen benchtops were also noted. Creaking floors were observed to the first-floor dining area, which may indicate movement in the subfloor structure or floor sheeting.

The rear bedroom fly door was damaged. The garage door was binding during operation, and the step-down transition from the hallway into the garage was found to be out of alignment and out of level. The overall standard of workmanship observed throughout the unit was poor, with multiple defects indicative of substandard installation and repairs.

These defects are largely maintenance-related and workmanship issues; however, when considered alongside previously noted structural movement and moisture concerns, they may also be symptomatic of broader building performance issues.

It is recommended that a qualified tradesperson rectify defective caulking, plaster repairs, cracked tiles, damaged joinery and other cosmetic defects. The garage door

alignment and step-down level difference should be assessed and corrected. Creaking floors should be further investigated if movement worsens. Any areas affected by moisture should be monitored and repaired once the moisture source is identified and rectified.

Rectification recommended in the short to medium term, with moisture-affected areas addressed as a priority.

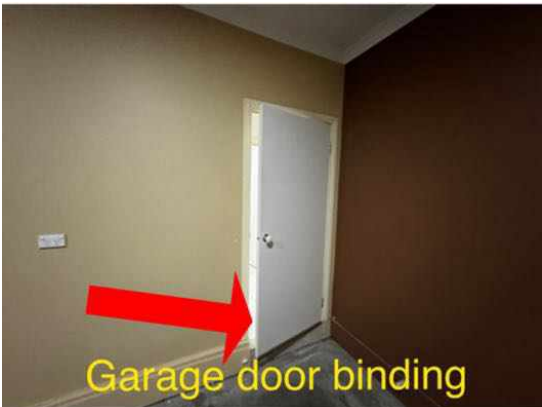
Garage door binding

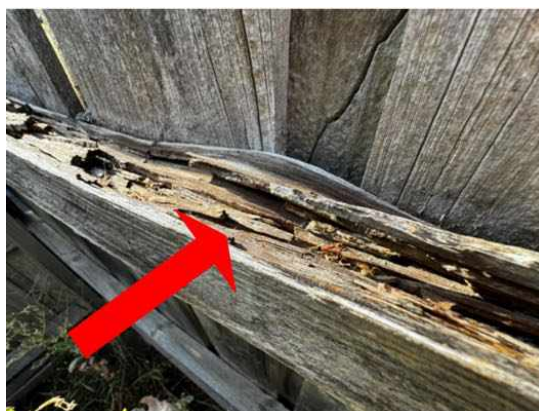
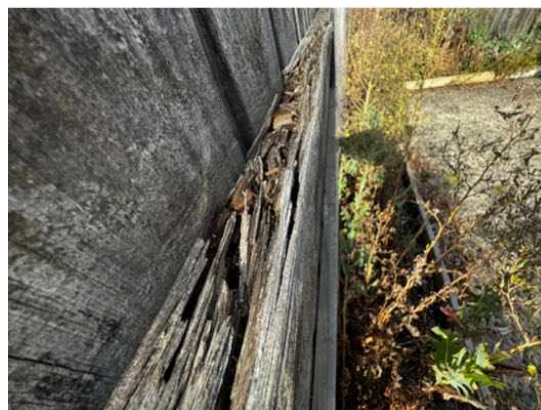
Building: Main Building  
Location: Yard - Front > Front Right  
Finding: Suspected Termite-Damaged Timber – Front Yard  
Information: Suspected termite damage was observed to a length of timber located on the ground beneath the boundary fence in the front yard. The damage is consistent with past termite activity, however no live termite activity was detected at the time of inspection.

Given the property is a double-storey townhouse approximately 20+ years old, with no visible termite management system or durable notice, and is located adjacent to a reserve and public park with mature trees, the overall termite risk profile of the site is considered elevated. The presence of timber in direct ground contact in the front yard constitutes a conducive condition for termite activity.

Remove all timber debris from the ground, eliminate any timber in direct soil contact, and reduce vegetation against the building perimeter. It is strongly recommended that a licensed termite management specialist be engaged to assess the property and implement an appropriate termite management system.

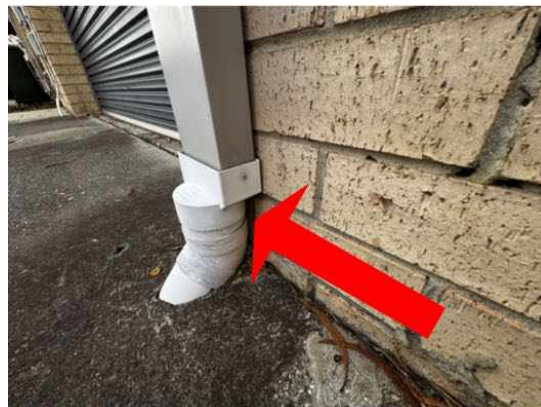
### Finding 6.01

Building:	Main Building
Location:	Walls > Front,Rear
Finding:	Downpipes hard against brickwork concealing inspection zones (TP)
Information:	At the time of inspection, several downpipes were observed to be installed hard against the external brick walls. This configuration restricts visual access to the wall surface and slab edge behind the downpipes, making it difficult to identify early signs of termite activity.

Effective termite risk management relies on maintaining clear and accessible inspection zones to allow early detection of termite activity. Where services such as downpipes are installed directly against masonry walls, concealed termite entry paths may develop behind these elements without being readily visible, increasing the likelihood of undetected termite ingress.

As a result, the positioning of downpipes hard against the brickwork is considered to increase the risk of concealed termite entry. It is recommended that a licensed termite management or pest control contractor be engaged to assess these locations and provide advice on improving inspection access or implementing supplementary termite management measures to address the increased risk.

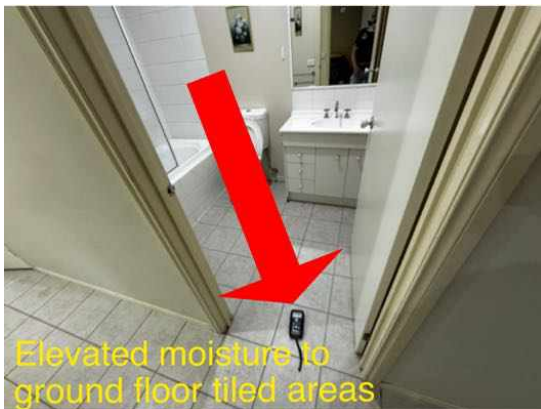
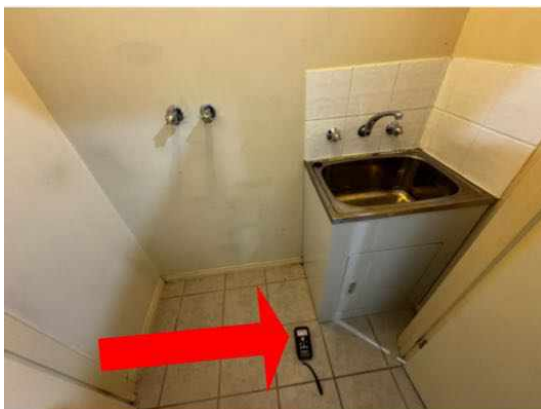
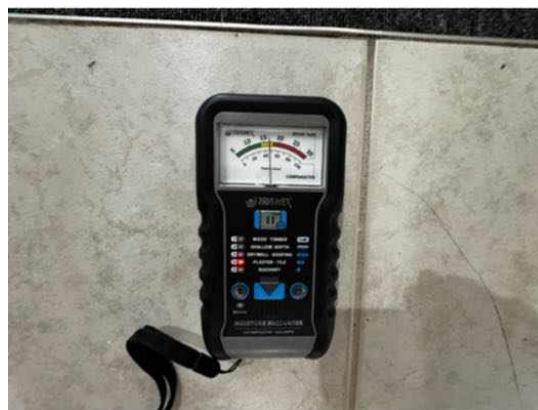
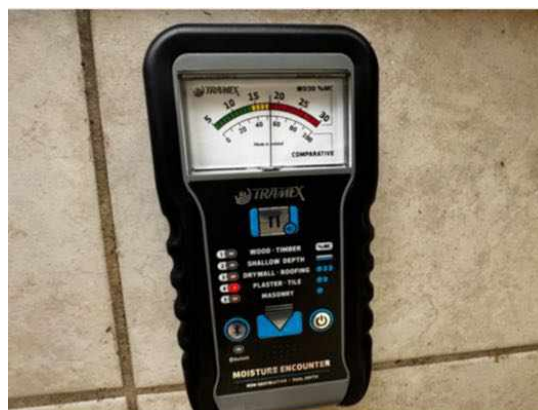
### Finding 6.02

Building:	Main Building
Location:	Kitchen, laundry, toilet > Ground Level
Finding:	Elevated moisture levels to ground floor tiled areas (TP)
Information:	At the time of inspection, elevated moisture readings were detected using a moisture meter to the ground floor tiled areas, including the bathroom, hallway, entry, and laundry areas. No active water leaks were observed during the inspection. Moisture readings to adjoining rooms were within normal range, indicating that the elevated moisture appears to be largely contained to the tiled areas.

Moisture-related damage was observed to adjacent building elements, including skirting boards, door jambs, architraves and sections of joinery. This suggests that moisture may be migrating from the tiled surfaces into surrounding materials.

Given that the property has reportedly been vacant for over twelve months, it is suspected that the elevated moisture may be associated with an ongoing concealed leak, potentially from plumbing or waterproofing failure, rather than day-to-day occupant use. Long-term vacancy can also allow minor leaks to persist undetected, increasing the risk of deterioration.

Prolonged elevated moisture levels create conducive conditions for termite and timber

pest activity and increase the likelihood of concealed structural damage, fungal decay, and mould growth.

It is recommended that a licensed plumber be engaged to investigate for concealed plumbing leaks and that further invasive investigation be undertaken if necessary to determine the source of moisture. A waterproofing assessment of wet areas may also be required. Damaged skirting boards, door jambs, and other affected materials should be repaired or replaced once the source of moisture has been rectified.

Further investigation recommended in the short term due to high moisture readings and increased risk of concealed structural and timber pest damage.

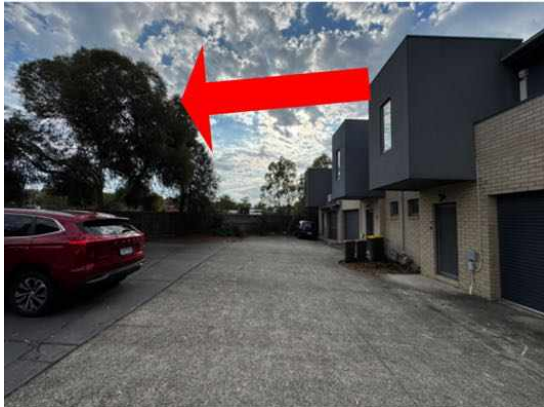
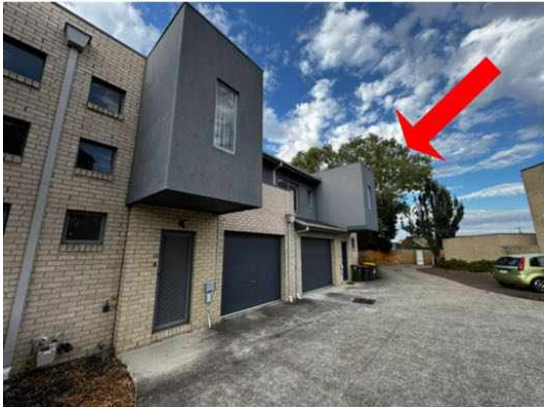
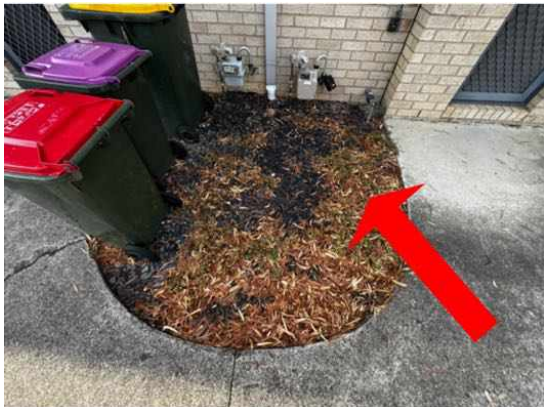
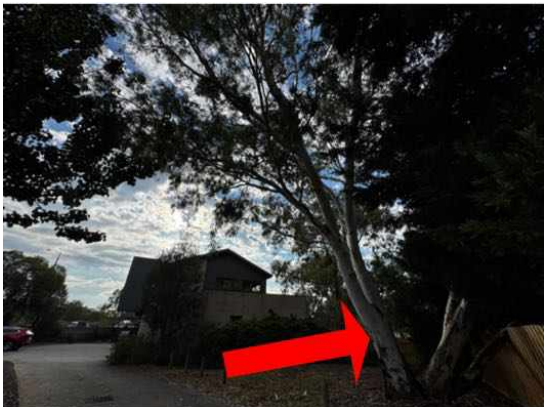
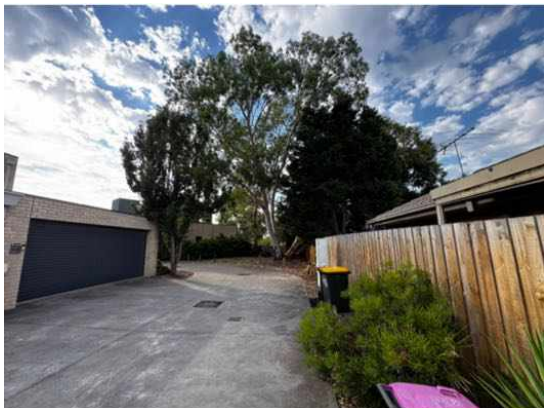
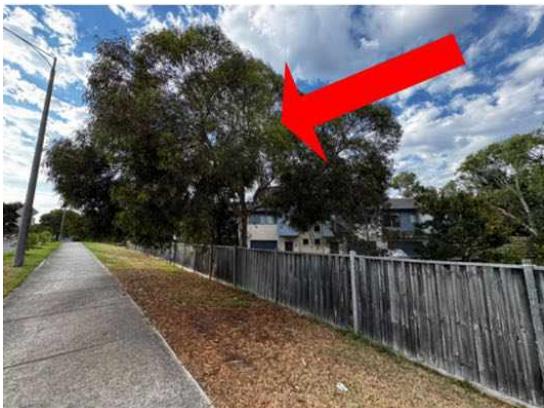
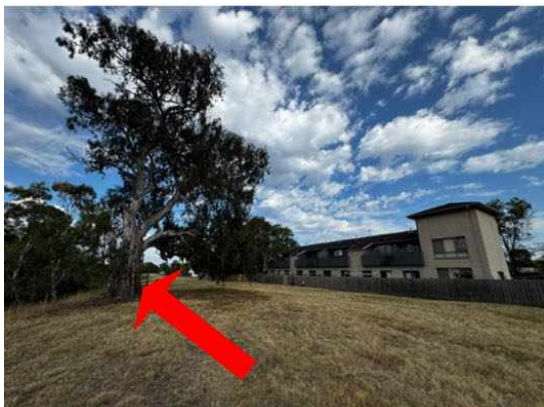
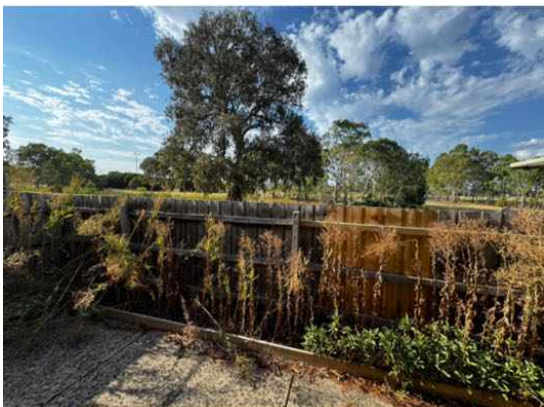
Building:	Main Building
Location:	All Areas > All Areas
Finding:	Landscaping & vegetation increasing termite risk (TP)
Information:	At the time of inspection, vegetation and mulching was observed around the property, including garden beds, shrubs and plants in close proximity to the dwelling and mature trees located within the common property as well as along the outside boundary of the property. The property borders a public reserve with mature trees in close proximity to the property.

Environmental conditions that promote moisture retention, provide concealed shelter, or support termite foraging activity are recognised as increasing termite risk to existing buildings. Mature trees, mulched garden beds, irrigation systems can all maintain damp soil conditions and may harbour termite colonies, allowing concealed termite activity to develop and potentially extend toward the building without early detection.

As a result, the extent of vegetation and moisture-retaining landscaping is considered to significantly increase the overall risk of termite activity to the property. It is recommended that a licensed termite management or pest control contractor be engaged to assess the site conditions and provide advice on appropriate risk reduction measures, which may include managing vegetation and mulch, controlling moisture sources, and integrating suitable termite management strategies appropriate for the existing building and site conditions.
