# Building and Timber Pest Inspection Report

Inspection Date: Tue, 24 Feb 2026

Property Address: 6/65 Pommel Cres, Epping VIC 3076,  
Australia

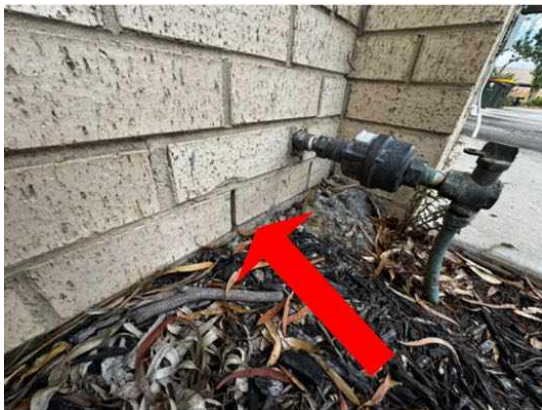
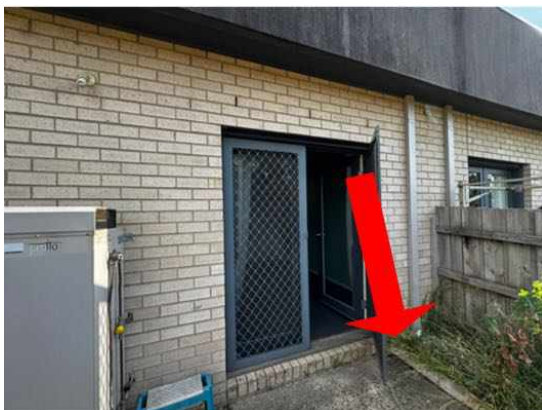
## Finding 6.04

Building: Main Building  
 Location: All Areas > All Areas  
 Finding: Slab edge - concealed (TP)  
 Information: At the time of inspection, the slab edge to most areas of the building was observed to be concealed behind concrete paving and landscaping. This condition restricts clear visibility of the slab perimeter and limits the ability to visually inspect critical inspection zones intended for the early detection of termite activity.

Where slab edges and inspection zones are concealed, concealed termite entry paths may develop without early warning. In accordance with AS 3660.2, existing buildings are required to maintain conditions that allow for effective inspection and management of termite risk, noting that obstructions such as paving, paths, or landscaping can compromise the effectiveness of termite management measures. Where inspection zones are obstructed, the likelihood of undetected termite activity is increased.

As a result, the current configuration is considered to increase the risk of concealed termite entry to the building. It is recommended that a licensed termite management or pest control contractor be engaged to assess the extent of the concealed slab edges and provide advice on rectification options, which may include modifying paving or landscaping to reinstate suitable inspection access and integrating appropriate termite management measures to suit the existing conditions.

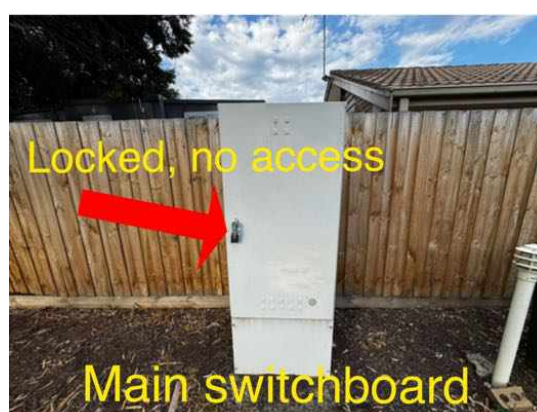
## Finding 6.05

Building:	Main Building
Location:	Meter Box > Front Left
Finding:	Termite management system - no evidence of chemical installation (TP)
Information:	At the time of inspection, there was no visible evidence to suggest that a chemical termite management system has been installed or remains effective. In addition, no durable notice was observed within the electrical switchboard to identify the presence, type, or date of any termite protection measures.

For this reason, the installation of a post-construction chemical termite management system is highly recommended to reduce the risk of termite activity. A durable notice should also be installed within the electrical switchboard to clearly identify the treatment provided and support ongoing inspection and maintenance.

Engagement of a licensed termite management or pest control contractor is recommended as a matter of priority to assess the site conditions, consider local termite risk, and determine the most appropriate treatment method and procedures for this property.

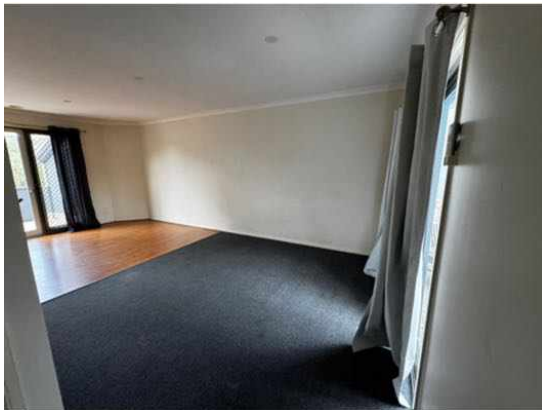
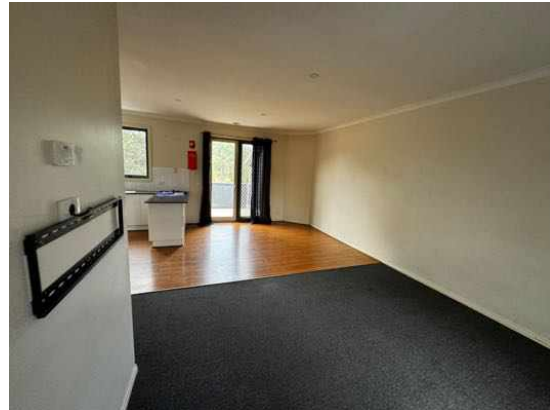
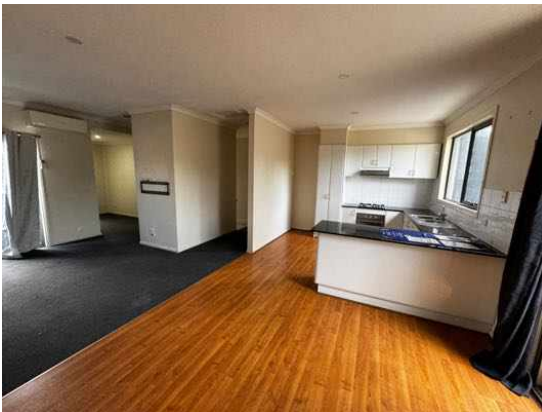
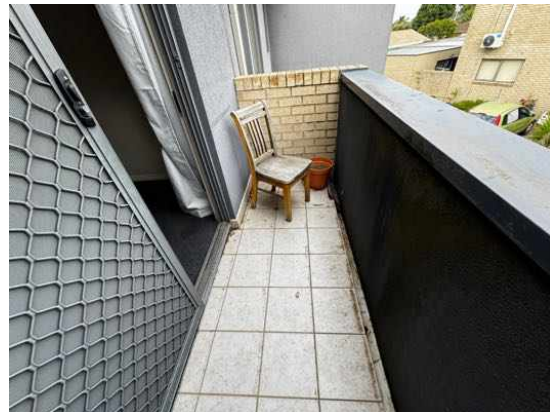
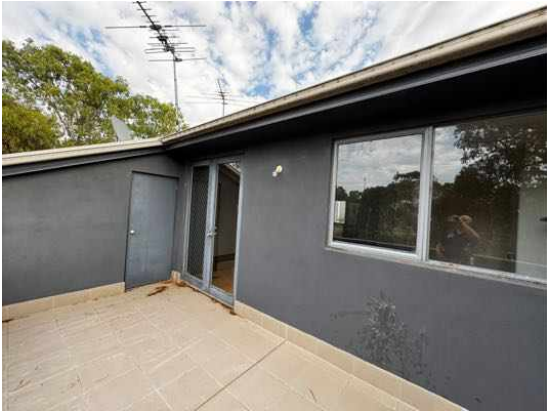
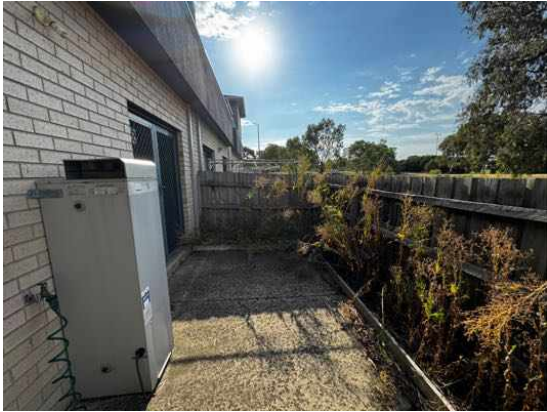
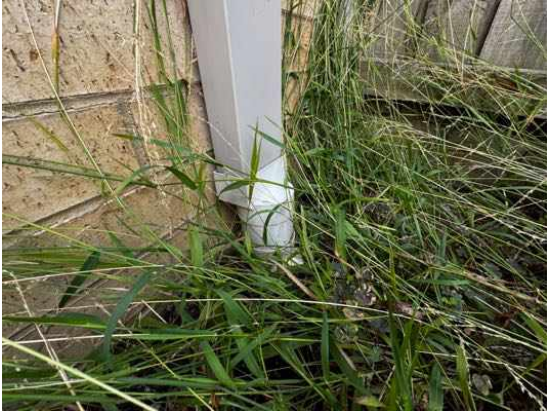
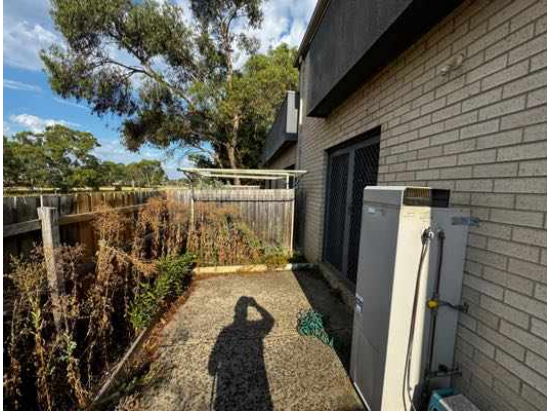
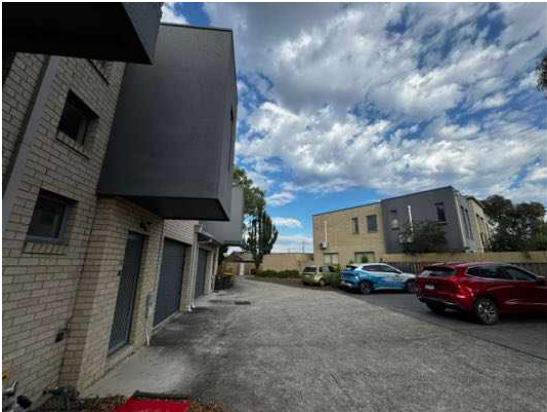
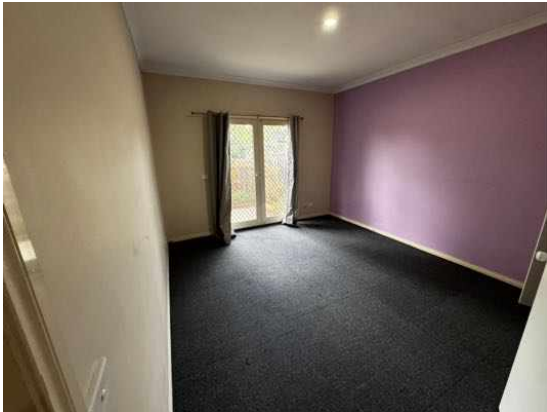
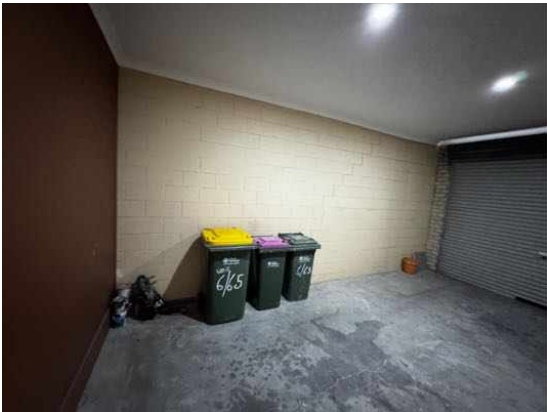
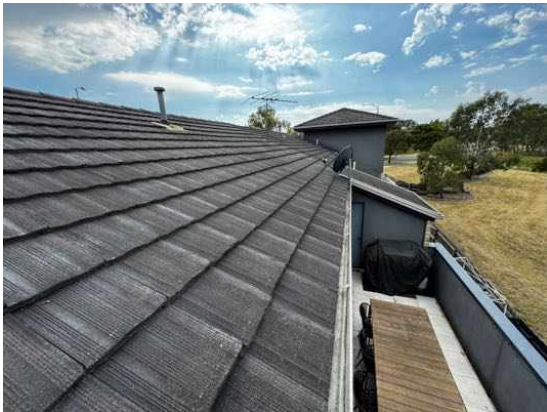
#### Noted Item

Building: Main Building  
Location: All Areas > All Areas  
Finding: Additional Photos - Obstructions and Limitations  
Information: These photographs are an indication of the obstructions and limitations which impeded full inspection of the property at the time of inspection. These obstructions can hide an array of defects and should be removed to allow full inspection to be carried out. A re-inspection is recommended once the areas are made accessible.

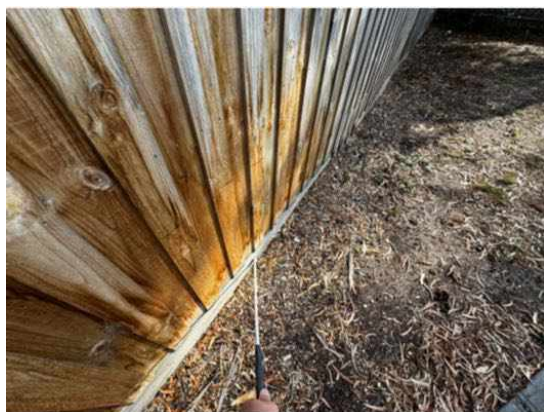
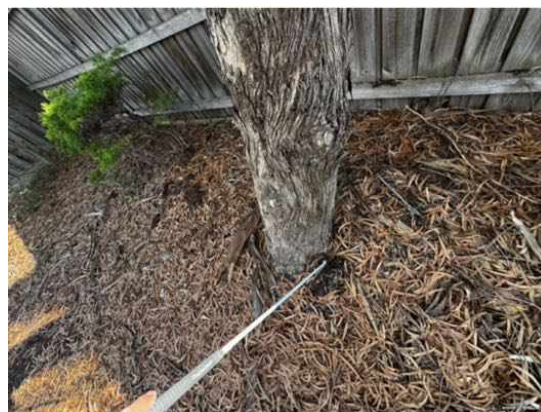
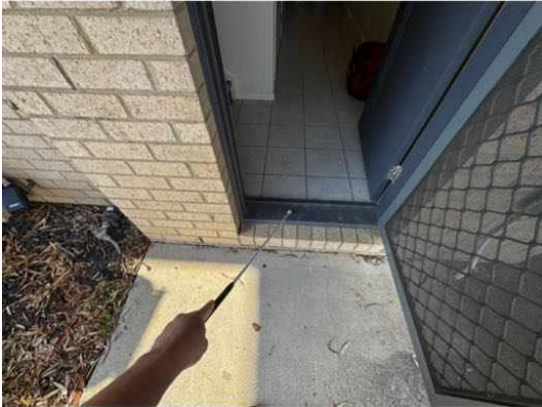
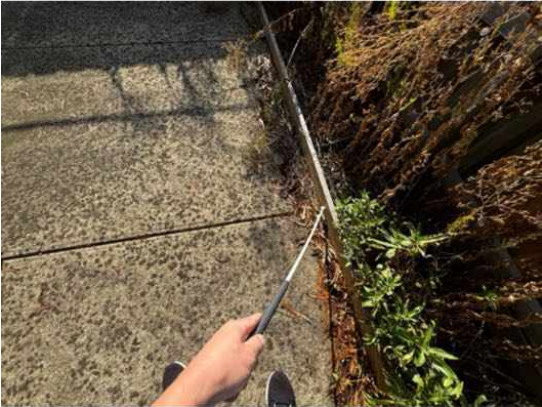
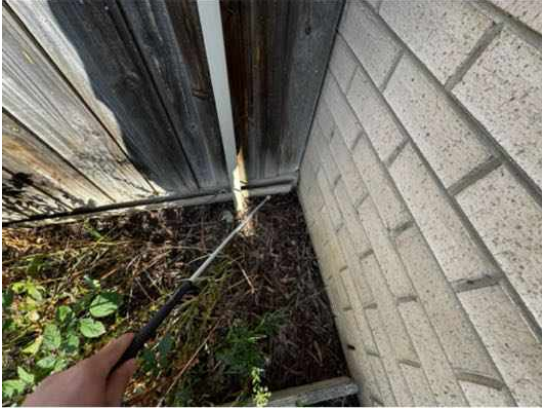
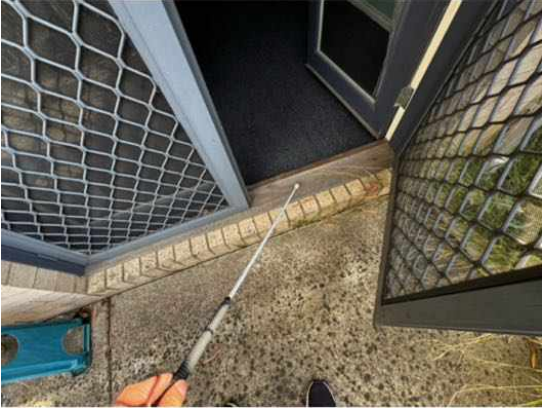
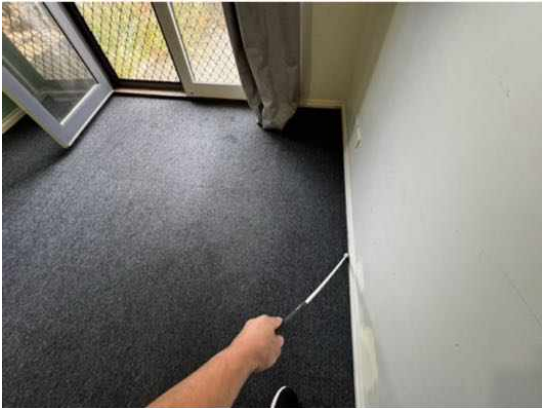
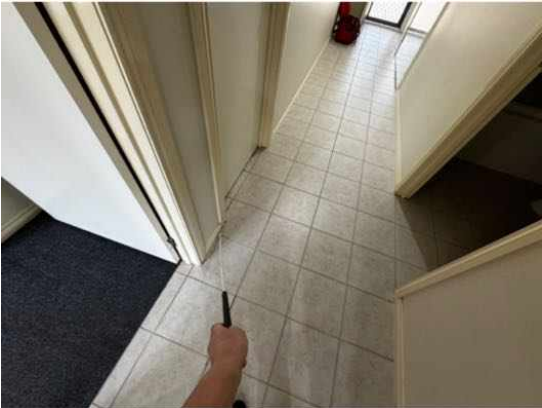
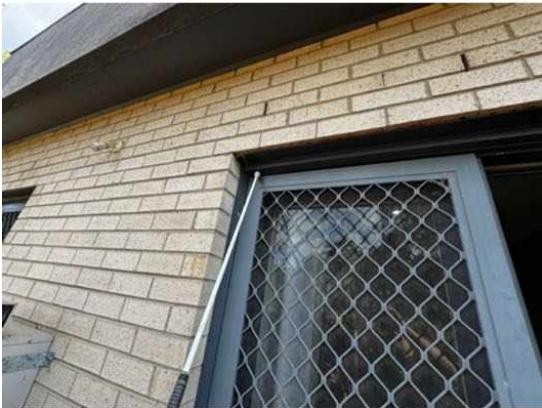
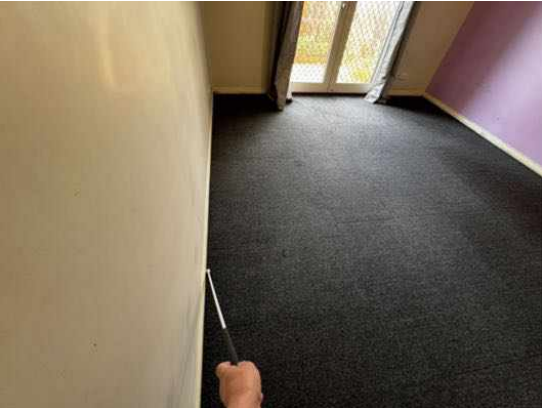
Building: Main Building  
Location: All Areas > All Areas  
Finding: Termite investigation techniques (TP)  
Information: All accessible areas of the dwelling were inspected, with particular attention paid to wet areas, which were closely assessed for elevated moisture levels and temperature anomalies that may indicate conditions conducive to termite activity. No evidence of termite activity was identified within the interior of the dwelling at the time of inspection.

In an attempt to identify concealed or hidden timber pest activity, a range of inspection techniques were adopted. These included the use of a moisture meter to assess susceptible areas, sounding of timber elements using a handheld probing device, and visual assessment of materials for signs commonly associated with termite activity. These signs include moisture-related deterioration, deformation of timber, termite mud leads or bridging, and irregular or regular shaped holes within timber elements that may indicate pest-related damage.

It is noted that termite activity can generate increased moisture and localized temperature variations, and where such irregularities are detected, further investigation may be warranted. However, it is also acknowledged that certain obstructions, including floor coverings, wall linings, wall tiles, and fixed cabinetry such as bathroom fit-offs, can conceal termite activity and limit the effectiveness of visual inspection. As a result, the absence of visible evidence at the time of inspection does not eliminate the possibility of concealed termite activity within inaccessible or obstructed areas of the building.
