Building and Timber Pest Inspection Report

Inspection Date: Wed, 11 Mar 2026

Property Address: 48A Napoli St, Padstow NSW 2211,
Australia

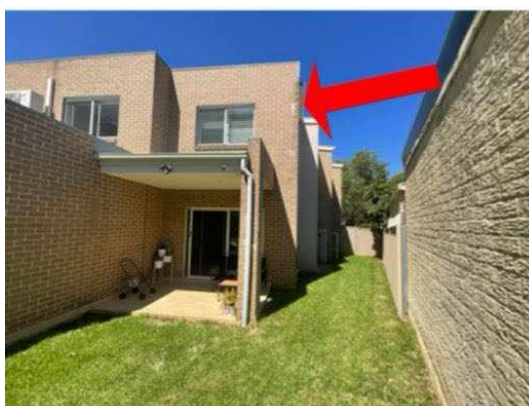
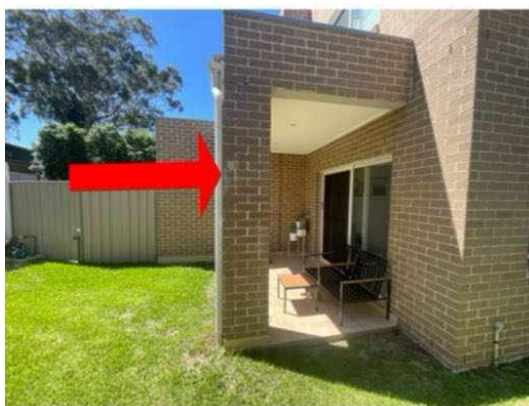
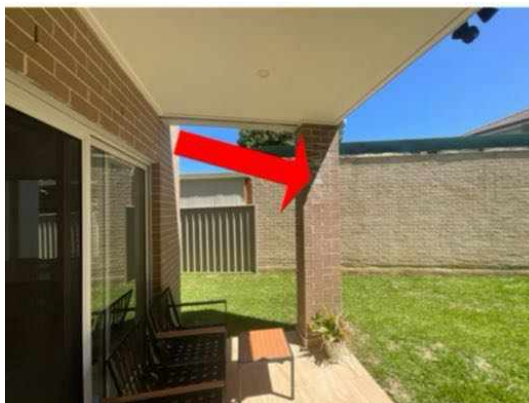
It is typically seen as white salt deposits on the surfaces of concrete pavement or mortar between bricks or tiles. While detracting from the overall appearance of the affected area, efflorescence is not likely to develop into secondary damage if left unmanaged.

Generally, soluble salt deposits can be removed by dry brushing with a stiff-bristled brush. Repeated dry brushing is an ideal treatment for eliminating this forming of efflorescence. A cleaning contractor or general handyperson may be appointed to perform these works at the discretion of the client.

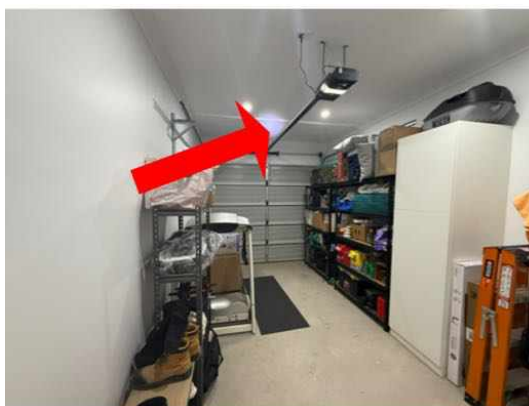
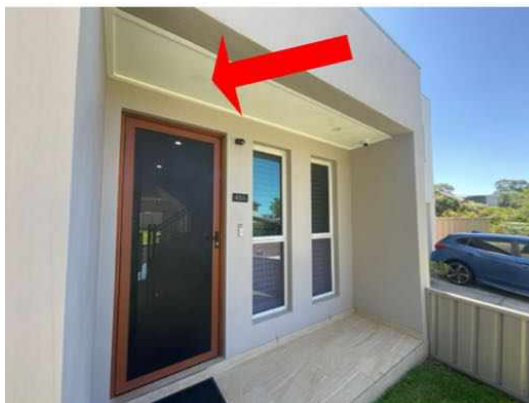
Finding 3.02

Building:	Main Building
Location:	Garage / Porch
Finding:	Painted surface - Bubbling
Information:	Sections of paint in this area was found to have bubbled and deteriorated. Paint bubbling is generally an indication of excessive moisture in the area, that is currently hidden by the painted surface.

The presence of excessive moisture can have major implications on associated building elements if left unattended. While only seemingly minor at this stage, the damage cannot be determined due to the paint obstructing any further inspection of the damage.

It is highly advised that the affected paint be cleaned to allow a further, more invasive inspection by a licensed plumber. Failure to act on this defect may necessitate major works in the future.

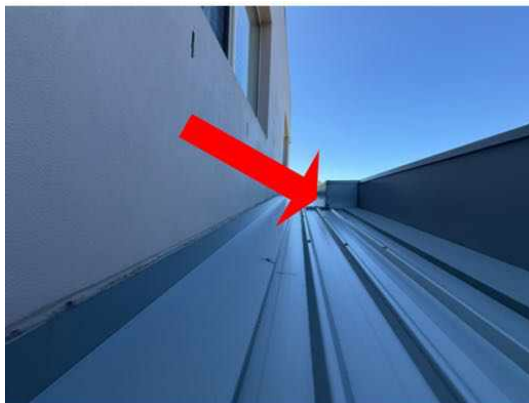
Finding 3.03

Building:	Main Building
Location:	Roof Exterior
Finding:	Roof plumbing - Flashing inadequate
Information:	Some sections of the roof are missing or have inadequate roof flashings. Flashings are metal and other materials which are applied to seals and intersections between roof coverings and building elements. They are designed to aid in weatherproofing of roof joins.

Flashings that are not installed adequately or are missing are likely to result in water penetration to the interior of the property, as well as creating excessively damp conditions against the exterior surfaces and around the base perimeter of the building.

Premature ageing and secondary building defects are imminent where roof plumbing is missing or inadequately installed. Additionally, water pooling also creates an environment that is susceptible to termite and pest infestation.

A roofing plumber should be appointed as soon as possible to install relevant roof plumbing materials, ensuring that no further damage is sustained.

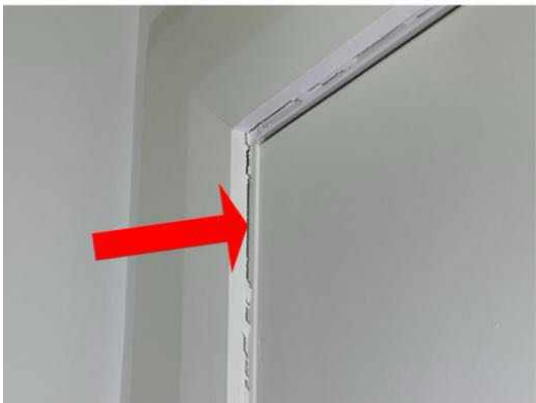
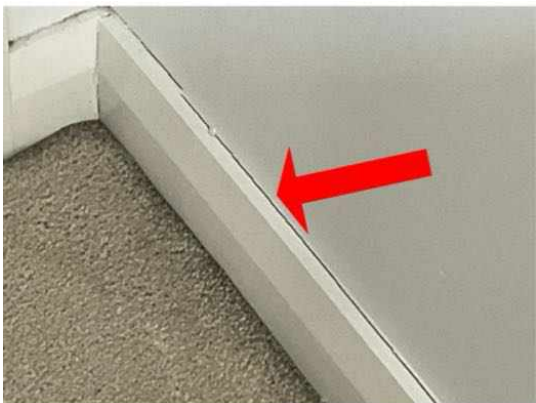
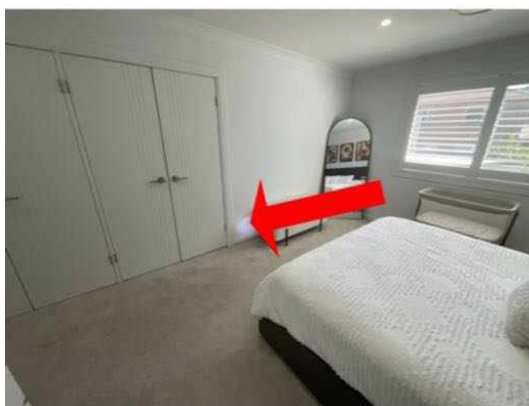
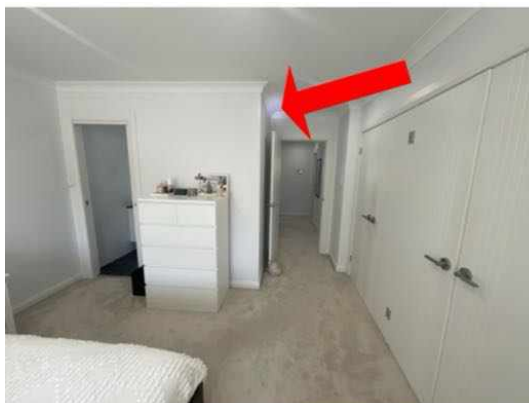
Finding 3.04

Building:	Main Building
Location:	All Internal Areas
Finding:	Paint finish - Substandard, Wear and Tear
Information:	The paint finish in this area was found to have been completed to a substandard level or wear and tear as the normal deterioration of a property from ordinary, everyday use. Exposure to the elements, time, as well as day to day living can cause fair wear and tear.

If this applies, further areas of poor and incomplete finishes could develop over time. Furthermore, substandard, wear and tear paint finishes in areas exposed to moisture, e.g. external areas or wet areas, could lead to deterioration of underlying building materials.

Substandard, wear and tear paint finishes should be sanded back, filled, leveled and repainted, as applicable. Where inadequate paint protection has led to the deterioration of the associated building element, repair and/or replacement of this building element may be required.

A painting contractor should be appointed as soon as possible to perform necessary works to aid the appearance of the affected area and to ensure that the area is protected against further deterioration. Alternatively, the homeowner following manufacturer instructions may be able to provide this service.

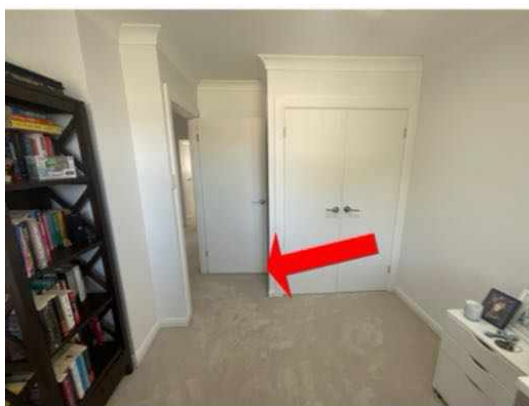
Finding 3.05

Building:	Main Building
Location:	Bedroom
Finding:	Door - Binding/jamming
Information:	Binding and/or jamming of this door is evident during standard operation. This defect inhibits the functionality of the affected door as well as creating potential for secondary defects to associated building elements, such as damage to the floor covering.

A door that binds to flooring or to the associated door frame may have several causes, ranging from minor defects, such as poor installation of the door or deteriorated hinges, through to major structural issues, such as damage to subfloor structures.

Where door binding/jamming appears to indicate major structural issues, a registered builder specialising in re-stumping should be appointed to provide an estimate on the cost of rectification.

For minor causes, a qualified carpenter or general handyperson should be appointed to perform minor rectification works at client discretion.

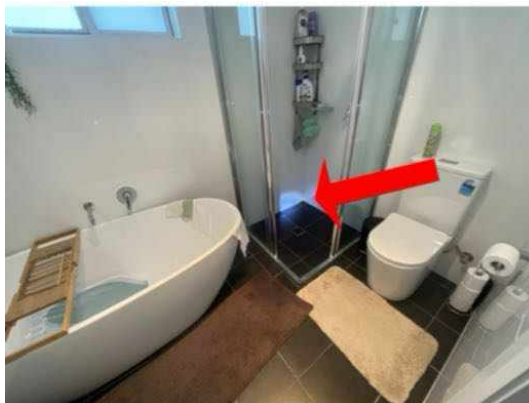
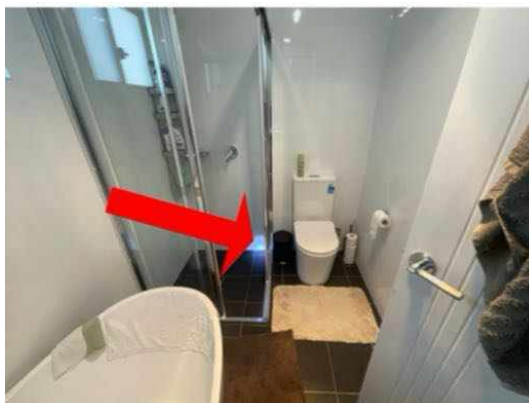
Finding 3.06

Building:	Main Building
Location:	Bathroom
Finding:	Sealant and grouting - Missing or damaged
Information:	It was noted on inspection that sealant or grout is degraded to the tiled shower alcove and or other areas of the bathroom.

Different materials and floor areas move at different rates, generally causing cracking to grout or sealant at this point. A flexible sealant is required to allow for expected expansion and contraction, while keeping the joint water tight and protective of all associated building materials.

There appears to be excessive mould to the sealant and grout which will likely require scraping out and replacement.

Flexible and mould resistant materials should be applied to affected areas to prevent any subsequent water damage that is likely to occur. Regular maintenance and replacement of damage or missing or damaged sealant and grout is highly recommended to the wet areas, as this is a regular wear and tear defect. Sealant and grouting in areas that come into regular contact with water should be maintained for the long term care of your property.

A sealant specialist or tiling contractor should be appointed to complete these works as soon as possible

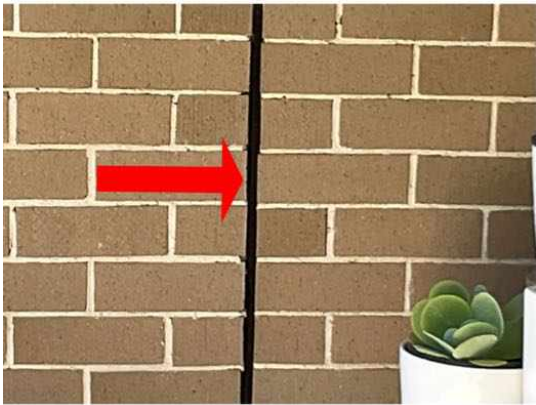
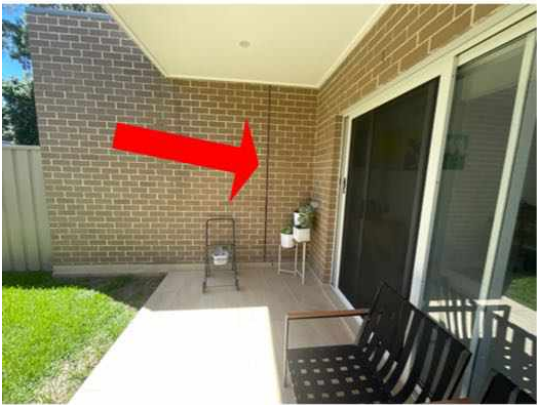
Finding 3.07

Building:	Main Building
Location:	All External Areas
Finding:	Articulation joints - Inadequate
Information:	The articulation or control joints throughout the exterior brickwork were deemed as insufficient at the time of inspection. Mortar, a non-compressive material, is still evident in some of the joints, not allowing the joints to do their job and allow the brick walls to expand and contract as required during different weather conditions.

Articulation joints must be cleaned of all non-compressive material and then sealed with an appropriate flexible sealant. Failure to perform these necessary works is likely to lead to excessive moisture ingress into these joints, or cracking to the brick walls during extreme weather conditions, which may carry major implications for associated building elements if left unmanaged.

These preventative works are important in ensuring the structural integrity of the associated brickwork. Appointment of a qualified builder or bricklayer is advised to perform remedial works as necessary.

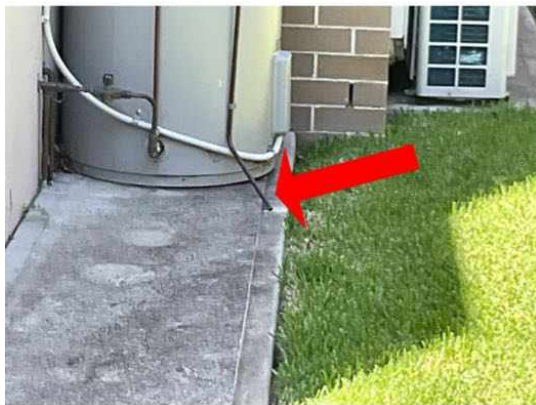
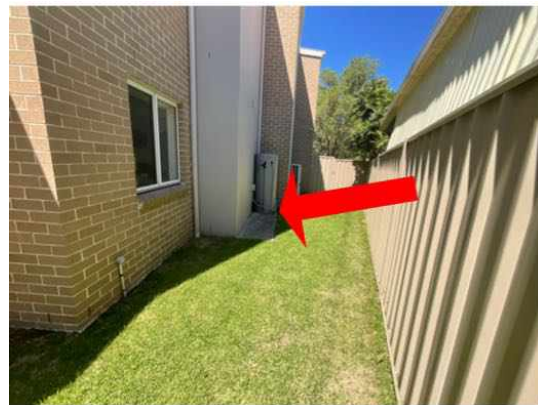
Building:	Main Building
Location:	All Areas
Finding:	HWS Overflow - Not Connected
Information:	The Hot Water System (HWS) overflow was found to be disconnected from storm water drainage and is creating excessive moisture in the surrounding area.

These damp conditions can lead to secondary defects such as rot, rust or corrosion of associated building elements, the formation of fungal decay, or even the creation of potential slip hazards. When coupled with poor site drainage, pooling of water may also attract termite activity to this area.

It is highly recommended that a licensed plumber be appointed to connect the HWS overflow in order to prevent such an environment from being created. These minor works should be carried out as soon as possible.

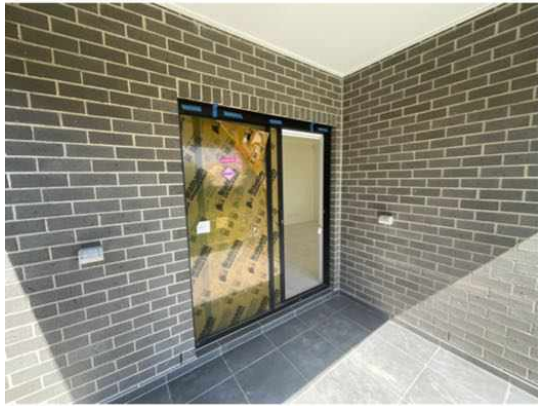
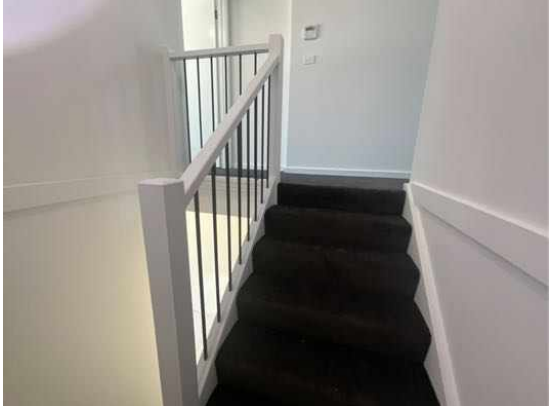
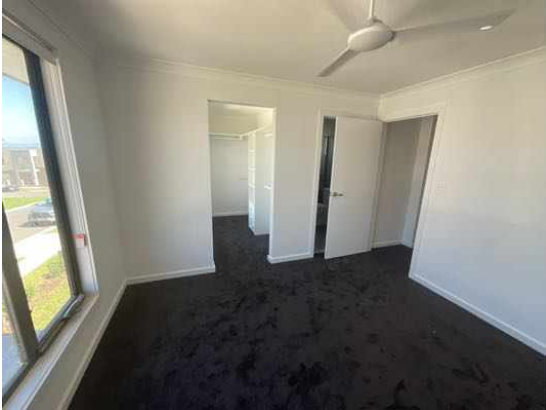
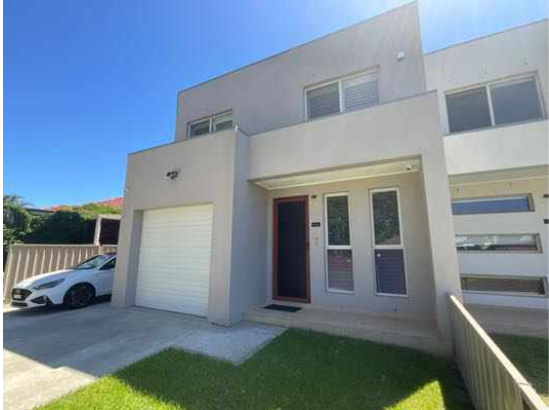
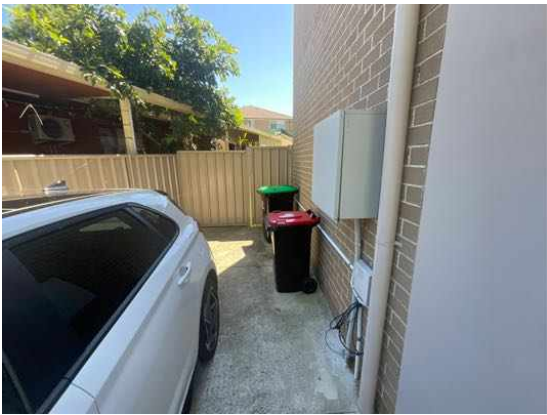
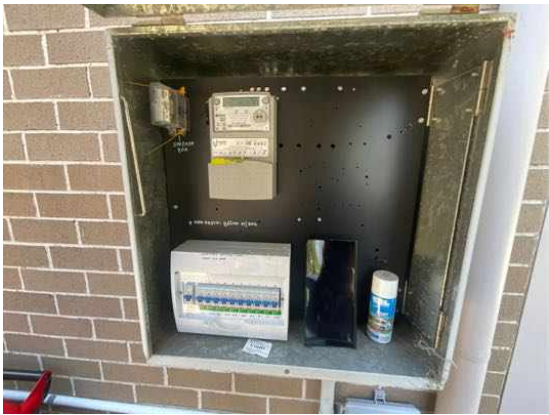
Noted Item

Building: Main Building
Location: All Areas
Finding: Additional Photos - Obstructions and Limitations
Information: These photographs are an indication of the obstructions and limitations which impeded full inspection of the property at the time of inspection. These obstructions can hide an array of defects and should be removed to allow full inspection to be carried out. A re-inspection is recommended once the areas are made accessible.
