Building and Timber Pest Inspection Report VR

Inspection Date: Fri, 9 Jan 2026

Property Address: 139 Catherine St, Leichhardt NSW 2040,
Australia

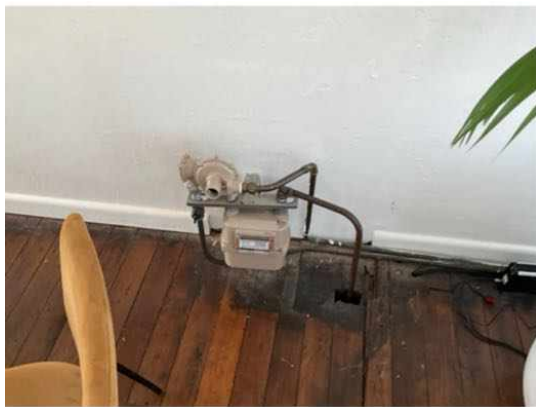
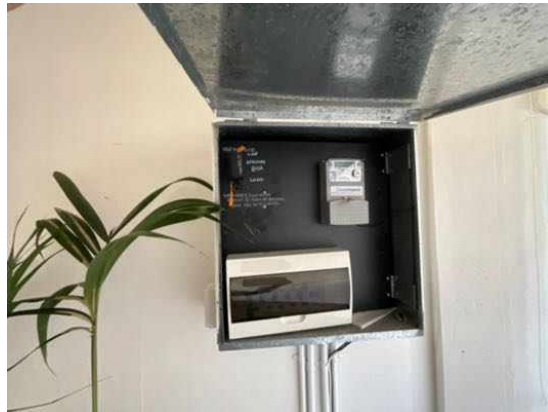
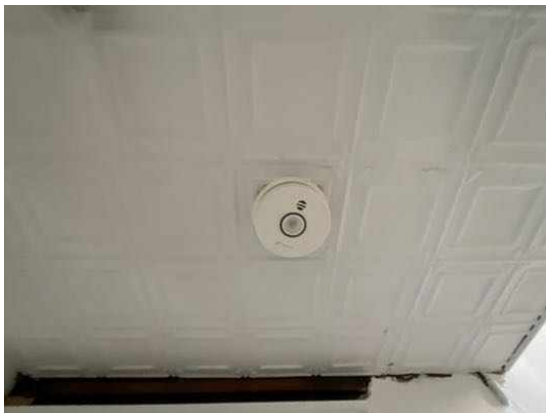
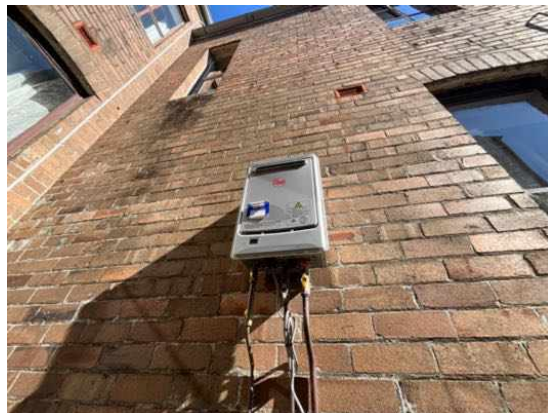
Building: Main Building
Location: All Areas
Finding: Photos Added
Information: Additional photos are provided for your general reference.

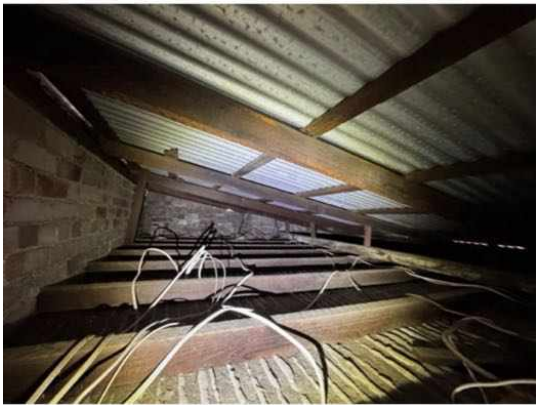
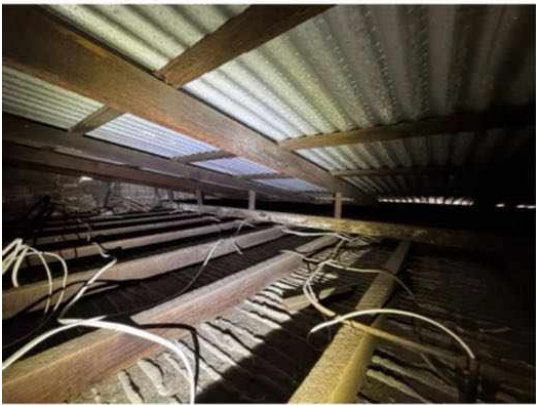
Building: Main Building
Location: Roof Exterior
Finding: Photos Added
Information: Additional photos are provided for your general reference.
