Building and Timber Pest Inspection Report

Inspection Date: Sat, 28 Feb 2026

Property Address: 1/510 Butson Ave, South Albury NSW 2640,
Australia

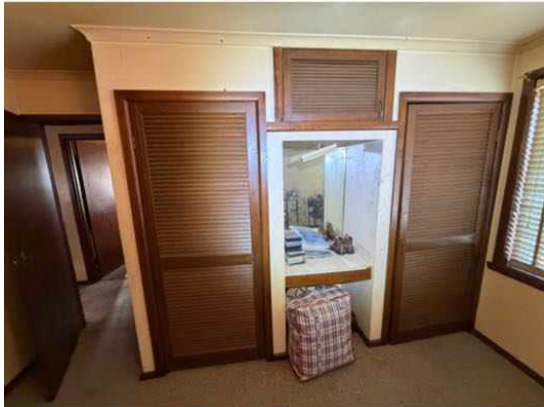
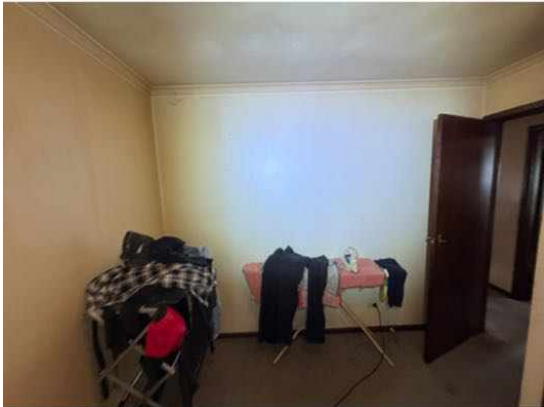
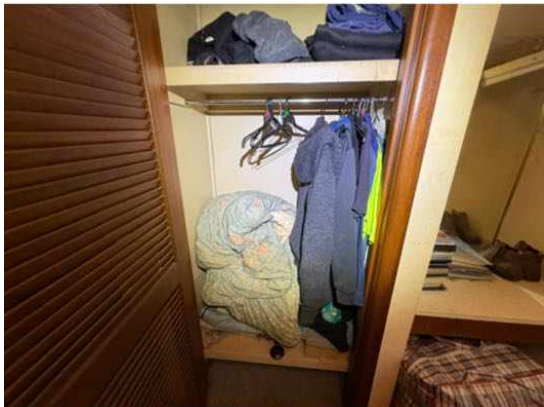
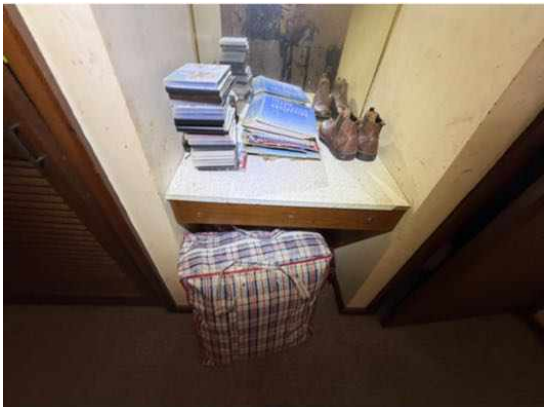
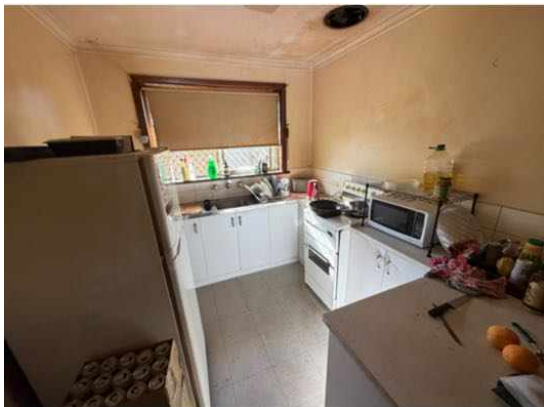
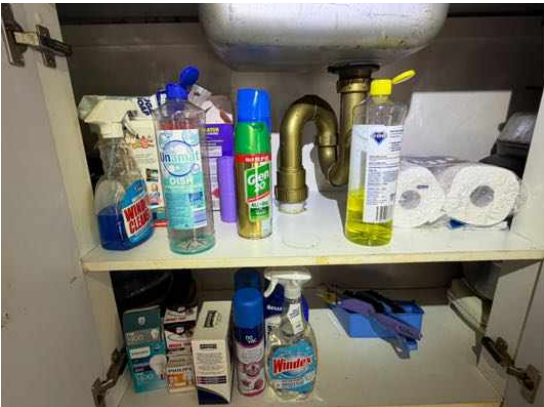
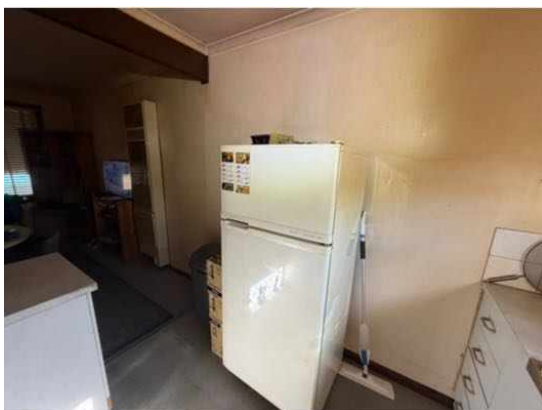
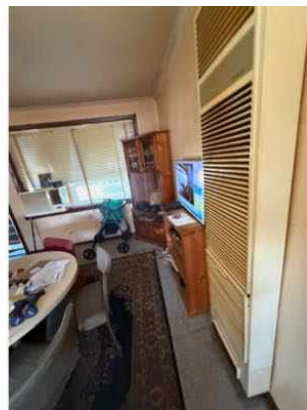
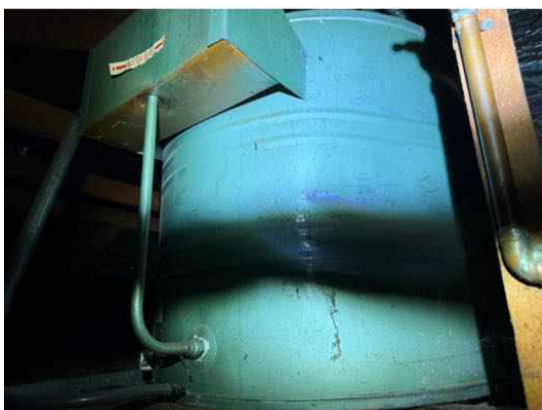
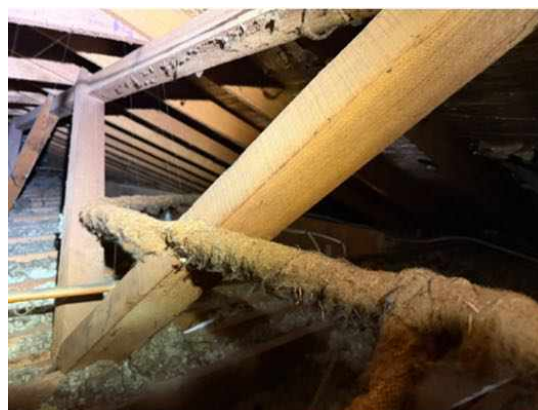
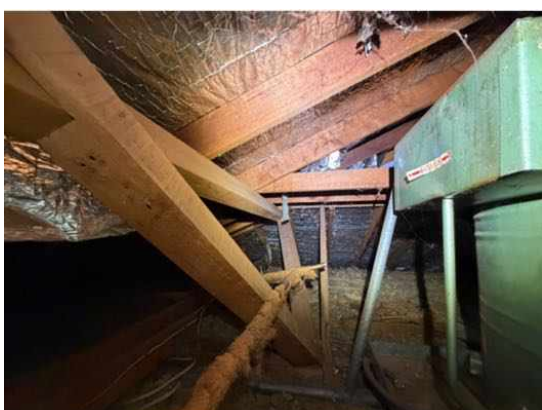
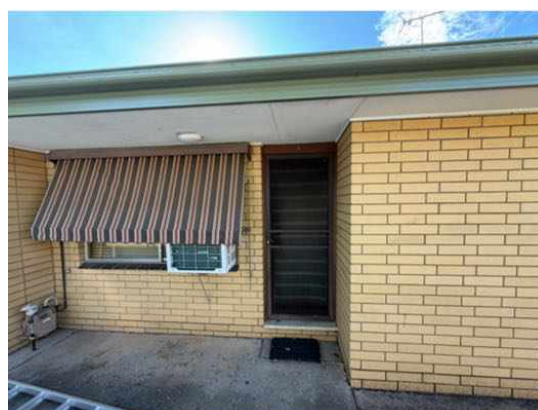
Building: Main Building
Location: All Areas
Finding: Additional Photos - Obstructions and Limitations
Information: These photographs are an indication of the obstructions and limitations which impeded full inspection of the property at the time of inspection. These obstructions can hide an array of defects and should be removed to allow full inspection to be carried out. A re-inspection is recommended once the areas are made accessible.
