# Building and Timber Pest Inspection Report

Inspection Date: Wed, 28 Jan 2026

Property Address: 29 Sweetgum St, Ashmore QLD 4214,  
Australia

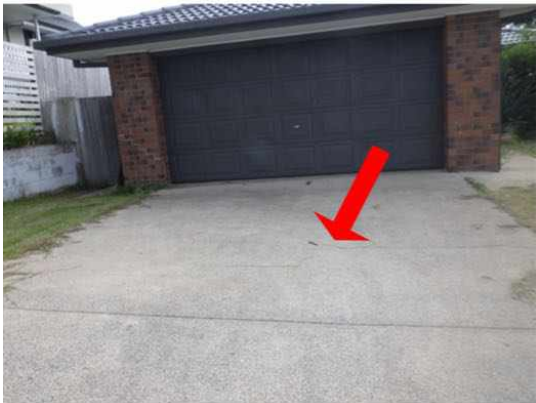
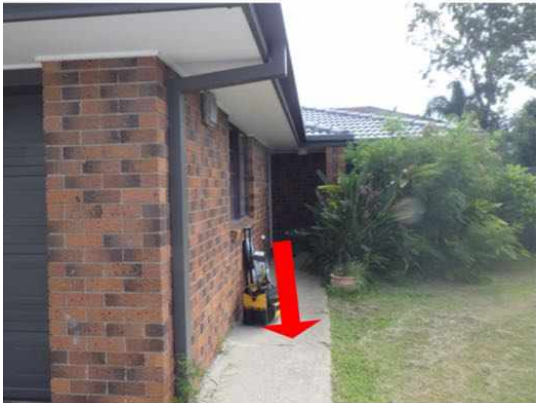
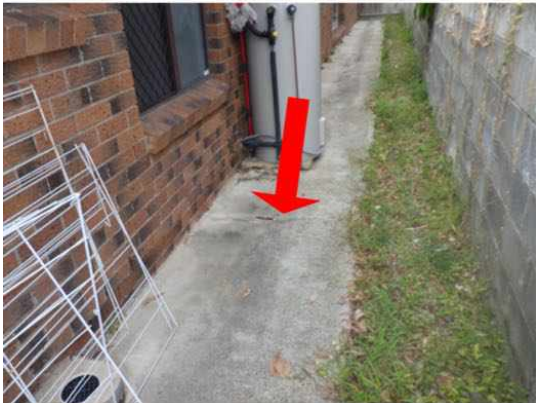
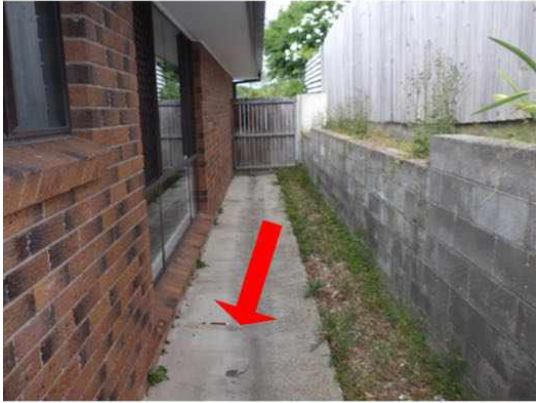
Building: Main Building  
Location: Driveway > Existing  
Finding: Cracking in concrete slab - Category 1  
Information: Cracking coded as Category 1 - 2 was identified in the driveway and footpaths concrete slabs (as per example photos). A Category 1 crack is described as a fine but noticeable crack, with the slab at an otherwise reasonable level.

To be considered Category 1, the approximate width of the crack is less than 1.0mm, or a less than 10mm change in offset when a 3m straight edge is placed over the defect.

Category 1 cracks should be monitored for a period of 12 months. At the end of the monitoring period, identified cracks that are rated greater than Cracking above category 2 is considered a defect which requires rectification.

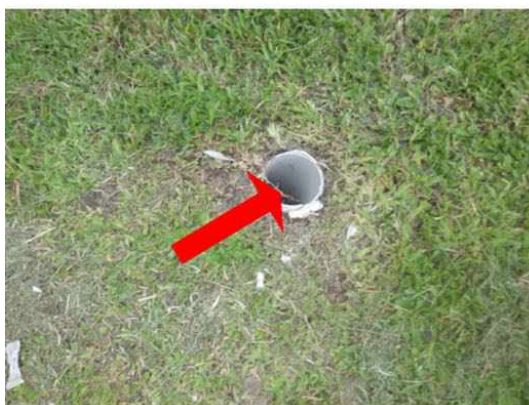
Finding 3.02

Building: Main Building  
Location: Yard - Front > Front Left  
Finding: Sewer line - Caps Missing  
Information: At the time of inspection it was noted the sewer or stormwater line on the left side of the property was missing the protective riser cap.

The missing sewer or stormwater line cap creates the potential for sewer line blockages.

A licensed plumber or general handyman should be engaged to replace the sewer line cap as soon as possible.

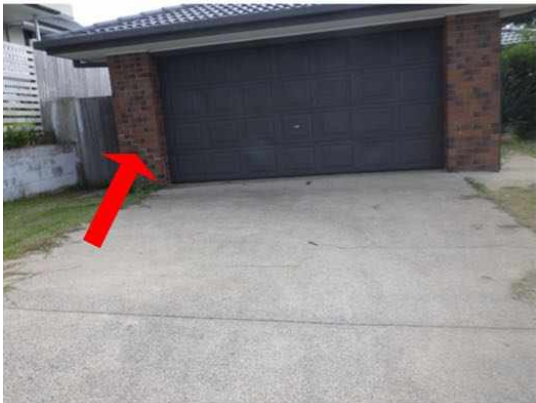
### Finding 3.03

Building: Main Building  
Location: Exterior walls - front > Front Left  
Finding: Evidence of previous repairs  
Information: At the time of inspection it was noted there appears to have been previous repair work to the brickwork on the front left side of the garage.

The cause or reason for the repair work is unknown but may be the result of impact damage.

The client is advised to monitor the area for any signs of change.

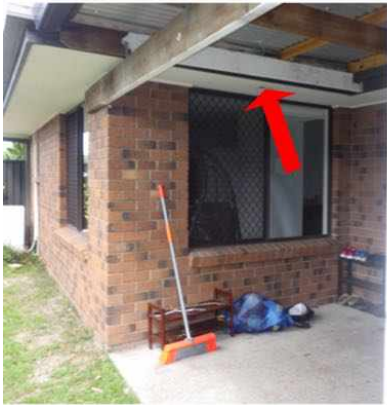
**Finding 3.04**

Building: Main Building  
 Location: Eaves > Centre Right  
 Finding: Eaves - Holes  
 Information: Holes were identified in the eaves linings in the alfresco area. It is suspected that the holes are from a previously removed fixture or fittings.

All excessive holes, gaps or cracks should be adequately filled by a suitable sealant or trimmings.

Such works may be conducted by a general handyman or licensed painter.

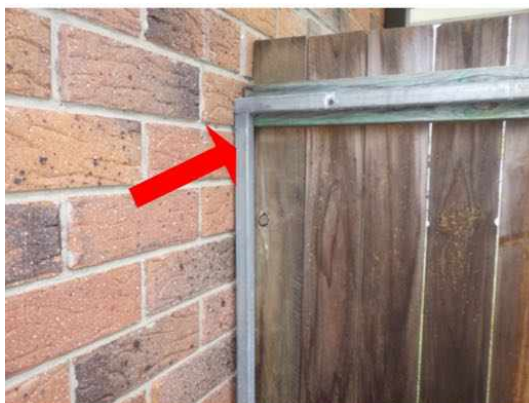
### Finding 3.05

Building: Main Building  
 Location: Exterior walls - left side > Front Left  
 Finding: Gate - Sticking/ jamming  
 Information: At the time of inspection the gate to the left side of the property was sticking or jamming on the exterior walls brickwork during standard operation.

A fencing contractor or general handyman could be engaged to adjust or repair the gate as required.

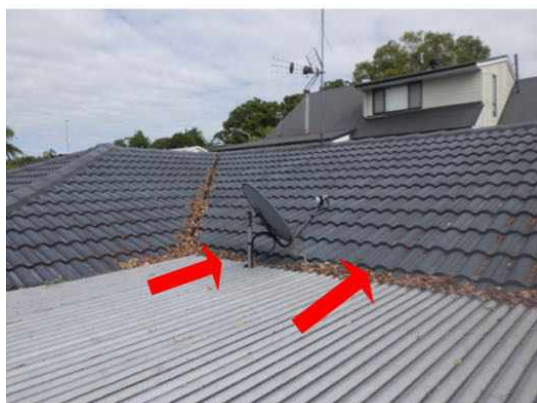
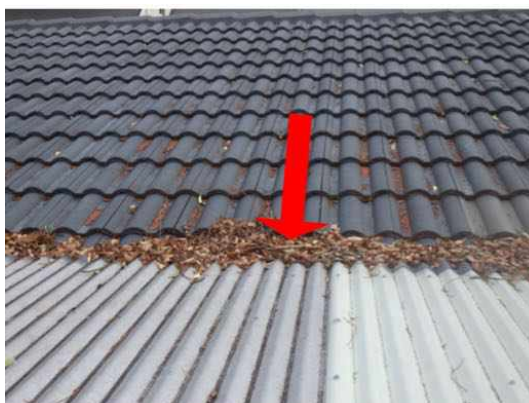
### Finding 3.06

Building: Main Building  
 Location: Roof Exterior > Rear Right  
 Finding: Debris  
 Information: At the time of inspection there was vegetation type debris on the exterior roof areas. Any debris on roof areas has the potential to restrict roof gutters or valley flashings effectiveness and creates the potential for stormwater line blockage.

A general handyman should be engaged to remove the roof debris.

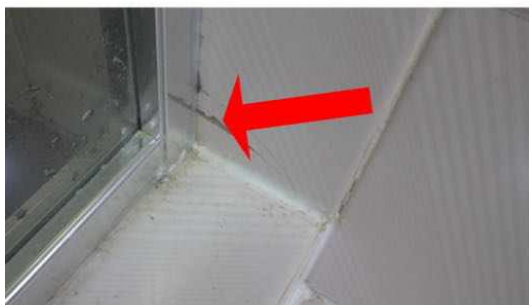
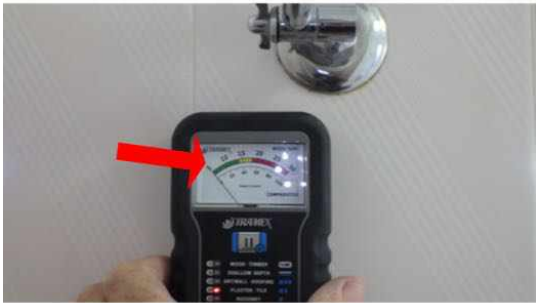
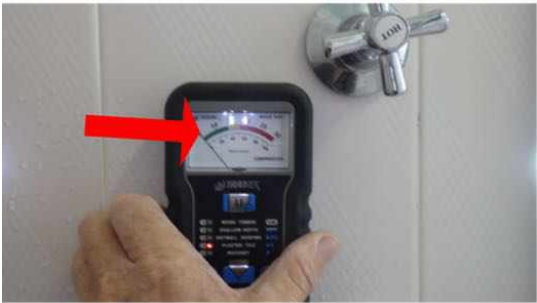
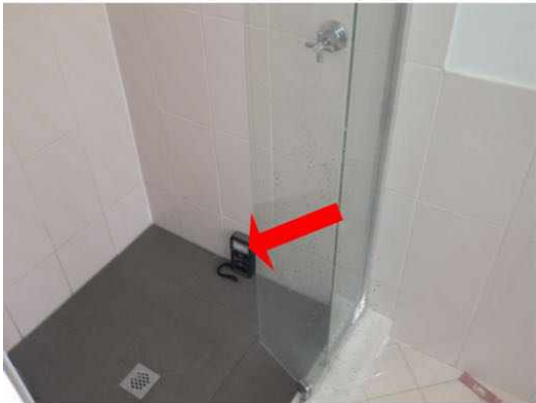
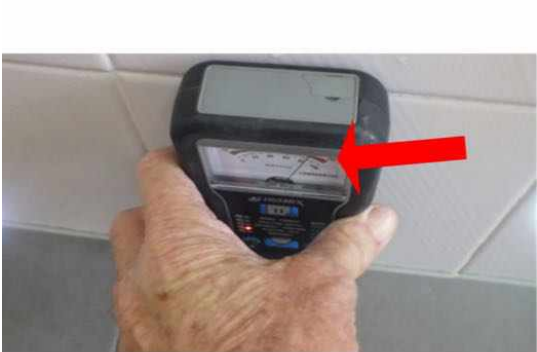
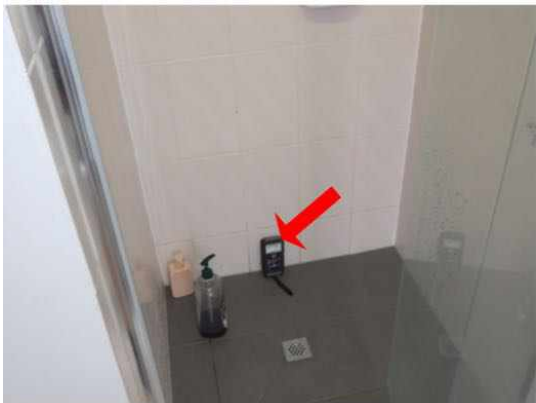
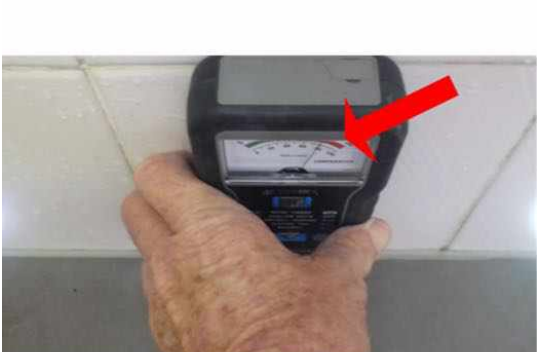
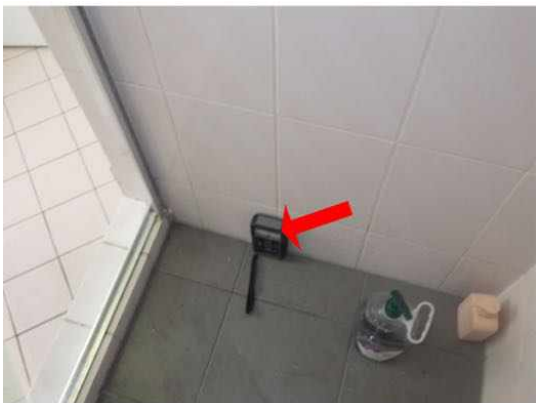
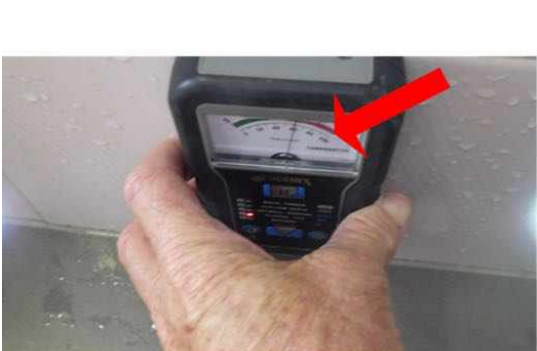
### Finding 3.19

Building:	Main Building
Location:	Bathroom > Rear Left
Finding:	Shower - Monitor
Information:	Elevated moisture level readings were recorded to the lower 200mm of wall to the bathroom shower alcove at the time of inspection. There was no elevated moisture level readings around the tap area, and no elevated readings transferring to the other side of the wall in the areas where moisture readings were able to be obtained. Both sealant and grout appear in fair condition at present.

This defect is quite common, and is suspected to have been caused by moisture permeating or leaching through the grouting and perhaps gaps in the sealant.

Monitoring the area is advised and if any visual signs of excessive moisture appear (peeling paint, mould) then consultation with a qualified plumber or bathroom specialist would be advised to identify the cause of damp and to perform remedial works as required.

Always ensure that sealant and grout is in good condition to prevent any moisture issues occurring in the future.

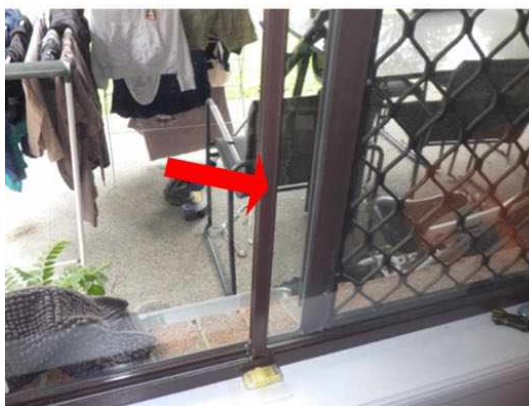
### Finding 3.21

Building: Main Building  
 Location: Bedroom 3 > Centre,Rear  
 Finding: Window - missing latch  
 Information: The window latch to the bedroom 3 area aluminium sliding window was found to be missing at the time of inspection. Breakage occurs generally when the building materials have aged and decayed.

Replacement of the missing window catch is advised to improve the operational state of the associated window.

An aluminium window service agent or general handyman should be appointed to replace the window latch at the client's discretion.

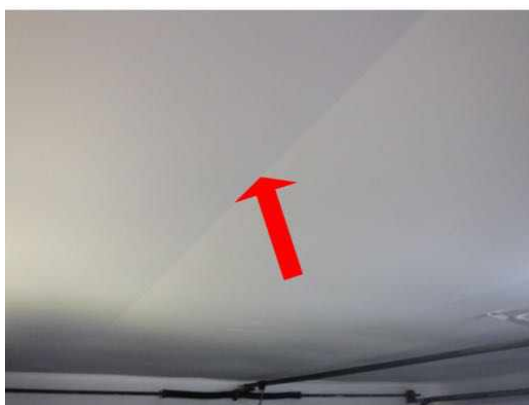
### Finding 3.22

Building:	Main Building
Location:	Garage > Existing
Finding:	Ceiling - Sagging
Information:	The ceiling linings in the garage showed signs of minor sagging at the time of inspection. Sagging to the fixed ceiling structure generally indicates that the building materials have swollen, due to exposure to moisture, or that fixings (e.g. nails or glue) have become loose and require reattachment.

Where minor sagging is evident, comparatively minor works, such as re-gluing and re-screwing of ceiling sheets, may be required.

Such works may be performed by relevant tradespeople, such as plasterers and painters.

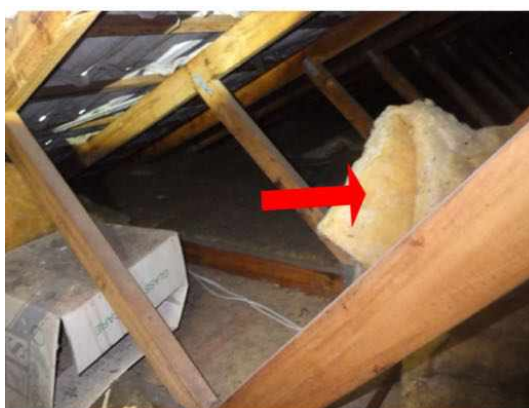
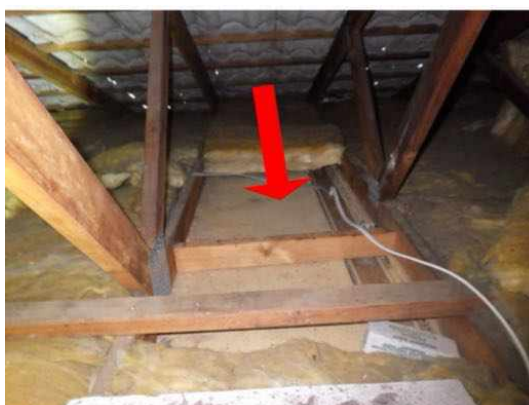
### Finding 3.23

Building:	Main Building
Location:	Attic > Existing
Finding:	Insulation - Poor Installation
Information:	Insulation has been installed in the roof void with some large gaps in the coverage found at the time of inspection. A number of insulation batts have been removed or

Insulation batts should be fitted correctly in the roof void, with no gaps around piping and each insulation batt lying flat on the ceiling surface. As a general rule, a 5% gap in the coverage of the total surface area may lead to an energy loss of up to 50%.

A general handyman could be engaged to undertake rectification work.

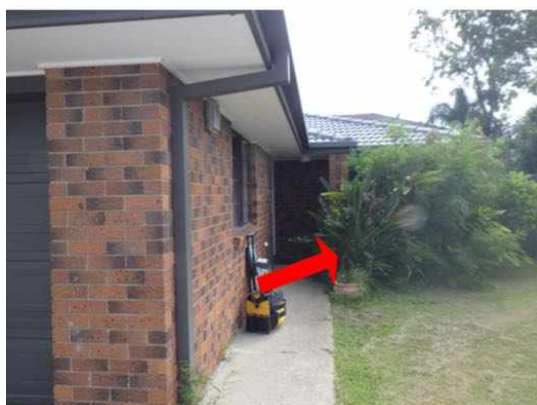
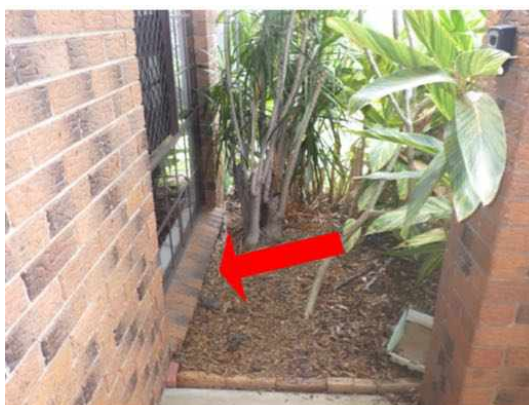
### Finding 6.02

Building: Main Building  
 Location: Exterior walls - front > Centre Right  
 Finding: Gardens  
 Information: At the time of inspection it was observed there is garden beds directly against external walls. Generally placing garden beds directly against a property walls should be avoided as it creates potential nesting sites for termites or rodents and/or moisture related issues.

Any areas where garden beds are directly against exterior walls are considered high risk for timber termite activity.

Frequent pest inspections are advised to readily identify any termite activity in these areas.

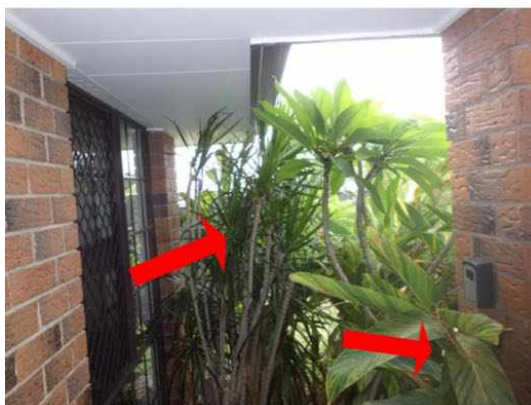
### Finding 6.03

Building: Main Building  
 Location: Exterior walls - front > Centre Left  
 Finding: Vegetation  
 Information: At the time of inspection there was vegetation growing over external wall areas.

The vegetation over growing wall areas should be trimmed back clear of the external

surfaces. The grass and other vegetation heights should be maintained around the perimeter of the building to allow for an inspection zone around the building exterior.

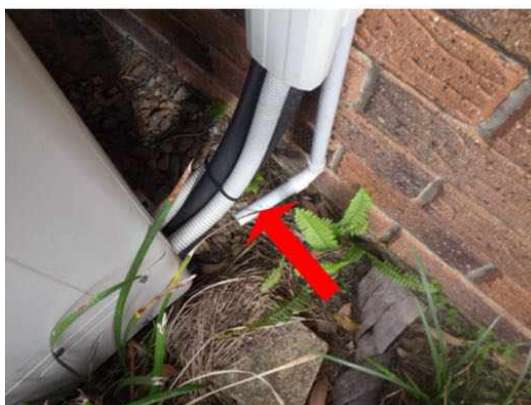
**Finding 6.04**

Building: Main Building  
 Location: Exterior walls - right side > Centre Right  
 Finding: Overflow - Not plumbed for drainage  
 Information: The air conditioning unit overflow is not plumbed or connected to suitable drainage, which can result in the surrounding area becoming excessively damp. These damp conditions can lead to secondary defects such as rot, rust or corrosion of associated building elements, the formation of fungal decay, or even the creation of potential slip hazards. When coupled with poor site drainage, pooling of water may also attract termite activity to this area. It is highly recommended that a qualified plumber be appointed to install adequate drainage to the overflow. These works will ensure that the area remains dry and free of any secondary defects.

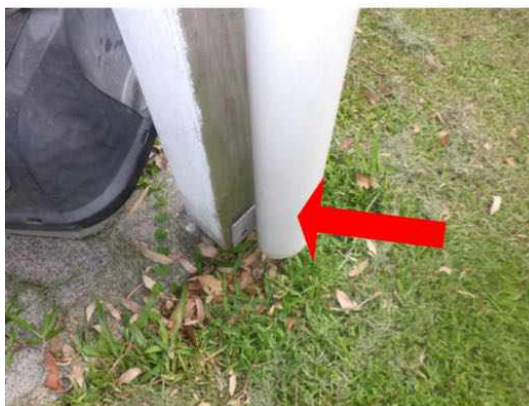
**Finding 6.05**

Building: Main Building  
 Location: Alfresco > Rear Right  
 Finding: Stormwater downpipes

Where roof plumbing doesn't drain as required, the area at the base perimeter can become excessively damp, potentially creating an environment that is susceptible to flooding and rust or corrosion of surrounding building elements, as well as attracting termites and other pests.

It is recommended that a licensed plumber be appointed to further inspect and to extend the down pipes to the properties stormwater line as necessary.

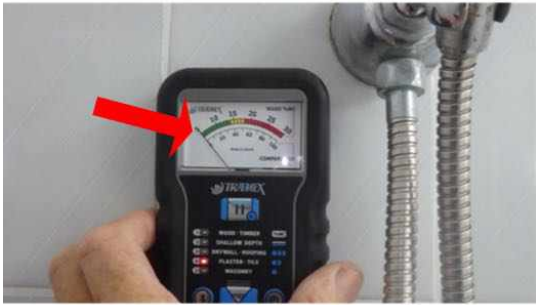
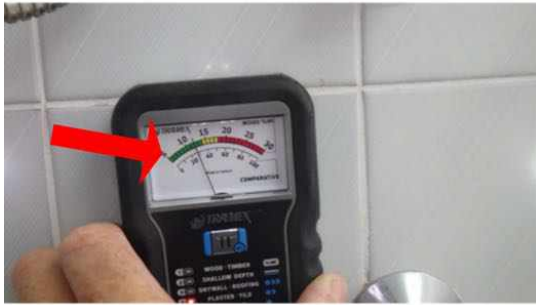
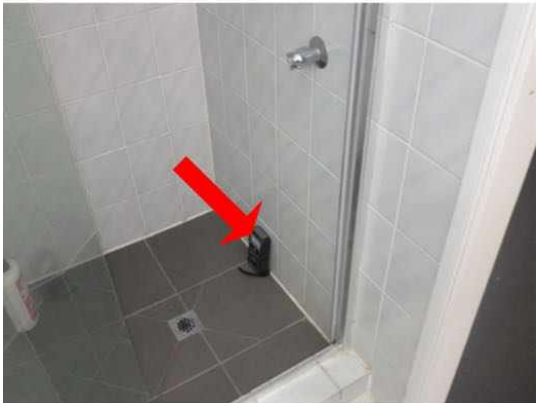
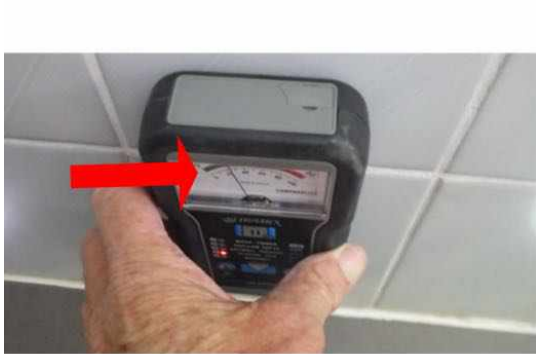
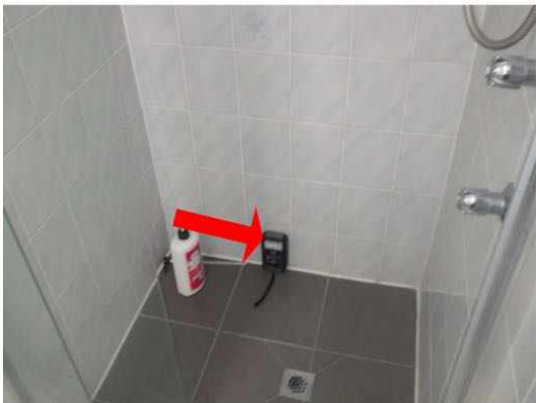
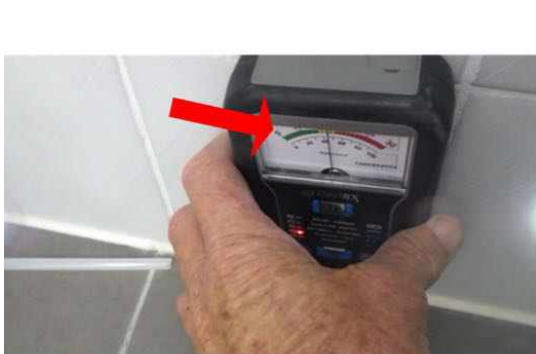
Building: Main Building  
 Location: Ensuite > Centre Right  
 Finding: Moisture Level Readings  
 Information: At the time of inspection the ensuite shower cubicle and surrounding wall areas checked with the Tramex Moisture Meter returned low - mid range moisture level readings.

Monitoring the area is advised and if any visual signs of excessive moisture appear (peeling paint, mould) then consultation with a qualified plumber or bathroom specialist would be advised.

Always ensure that sealant and grout is in good condition to prevent any moisture issues occurring in the future.

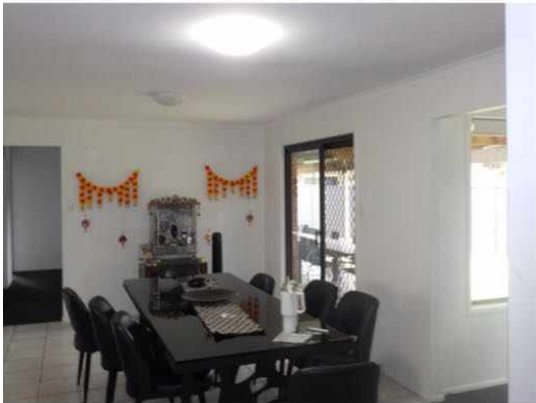
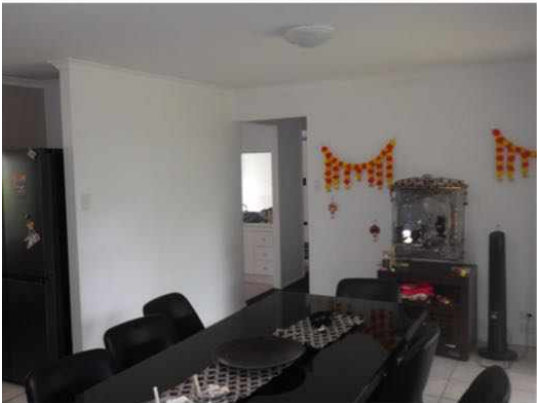
Building: Main Building  
Location: Dining Room  
Finding: No obvious defect  
Information: No obvious defects found at the time of inspection.

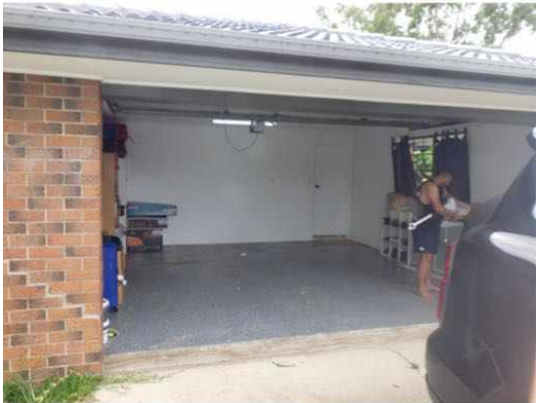
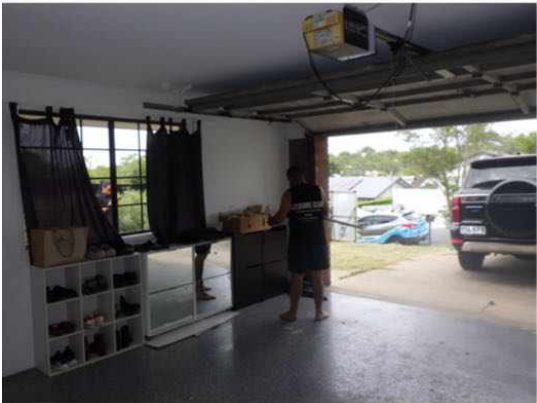
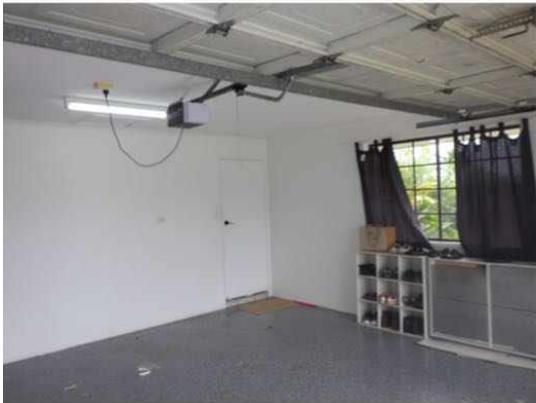
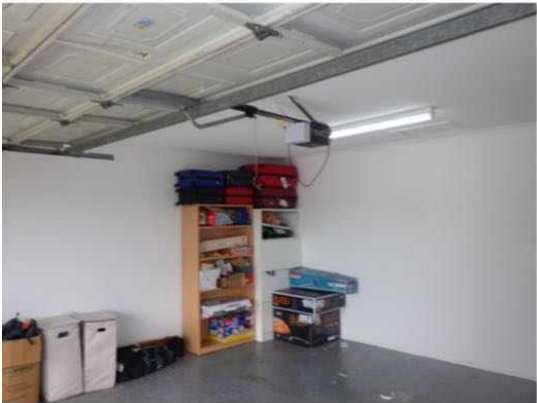
Information: The termitraker itracker was positioned randomly to internal wall, timber skirting and window frame areas checking for signs of termite activity.

No activity was recorded at the time of inspection.
