# Building and Timber Pest Inspection Report

Inspection Date: Tue, 24 Feb 2026

Property Address: 16 Debussy Place, Cranebrook NSW 2749

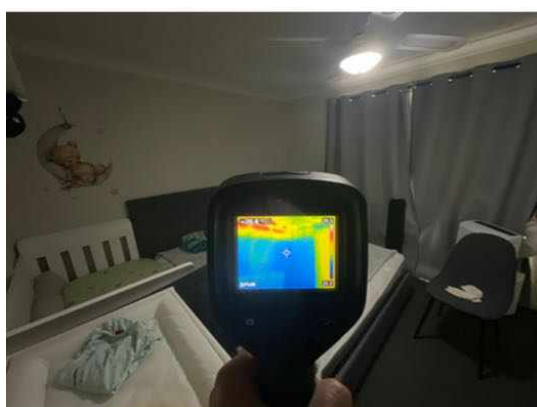
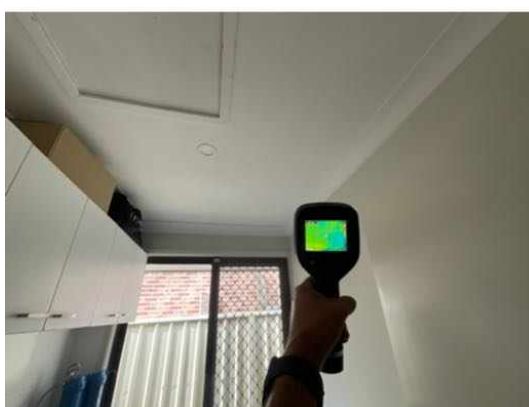
Termites release heat in the form of carbon dioxide and build mud tubes with high moisture content, which can create irregular heat patterns on surfaces such as walls, ceilings, and floors.

At the time of the inspection, no abnormalities indicating live termite activity were observed. However, it's important to note that various factors—such as obstructions, ambient temperature, and wall material/thickness—can impact the accuracy of thermal readings. In cases where surfaces are visually restricted or obstructed, a comprehensive thermal scan may not always be feasible.

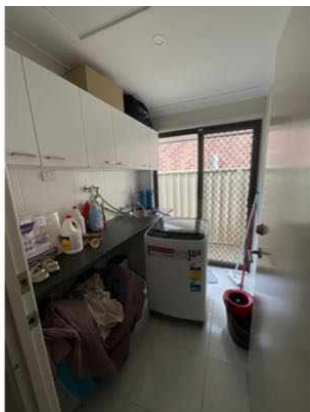
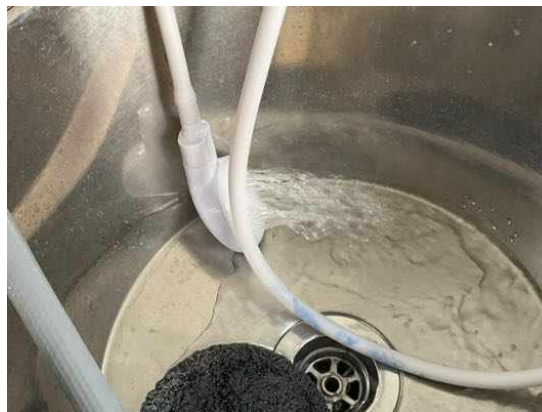
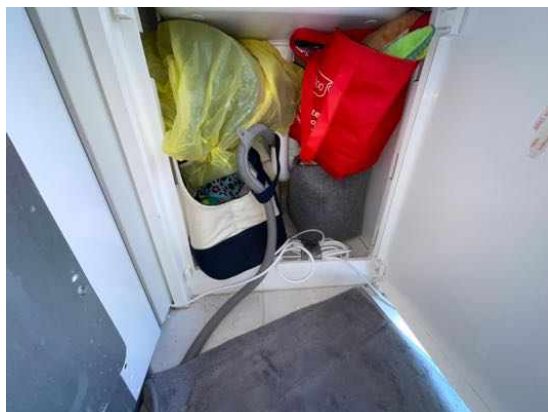
Building: Main Building  
 Location: Laundry  
 Finding: Laundry - Taps/Plumbing/Drainage.  
 Information: Observation: Laundry Tub – Taps, Plumbing, and Cabinetry

- Further monitoring or testing is recommended once the taps are placed into regular use, to ensure no leaks develop over time and that the drainage system continues to perform adequately.
- It is recommended that the stored items beneath the sink be removed to allow for a full re-inspection of the plumbing and cabinetry, ensuring no concealed defects are present.
- Sealant and grouting in wet areas should be maintained as part of the long-term care and upkeep of the property.

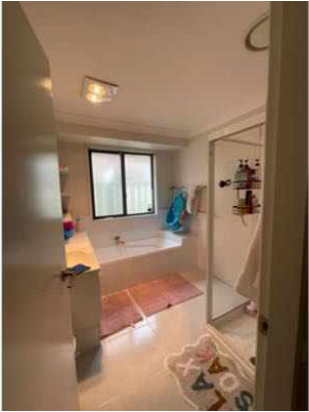
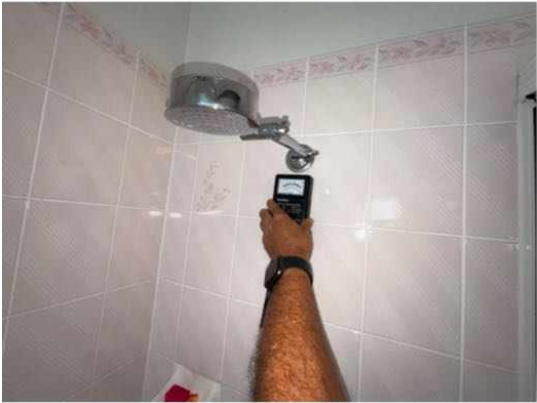
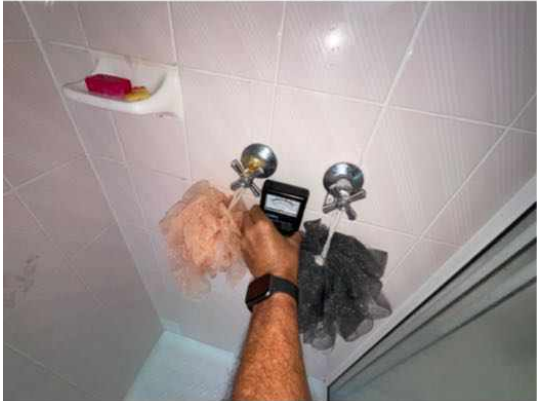
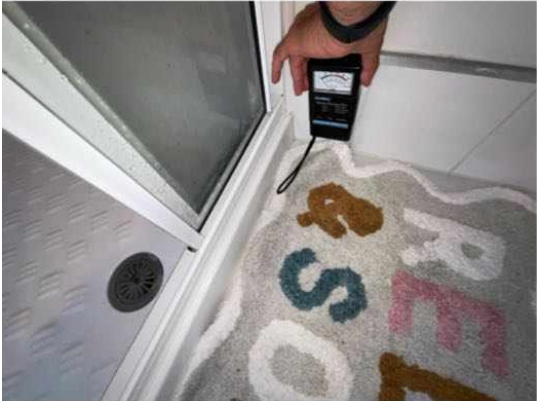
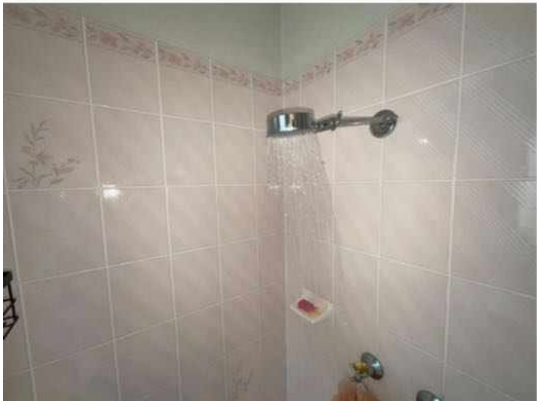
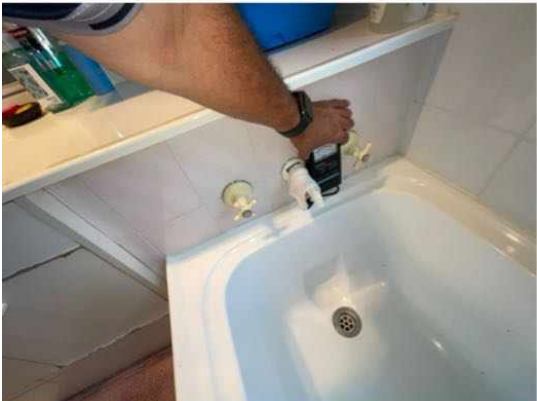
Building: Main Building  
 Location: Bathroom  
 Finding: Wet Areas - Bathroom(s) - Overall Condition & Recommendations.  
 Information: Overall Condition & Recommendations

It is not possible under the visual inspection criteria of a standard pre-purchase report to categorically determine if leaks are present. If a more detailed or accurate assessment is required, a special-purpose inspection should be undertaken.

Alternatively, the assumption should be made that leakage may occur, particularly where historical or environmental conditions are conducive. The visual nature of this inspection cannot detect issues concealed behind wall/floor linings or cabinetry, and invasive investigation may be necessary to confirm the true condition of adjacent or hidden structures.

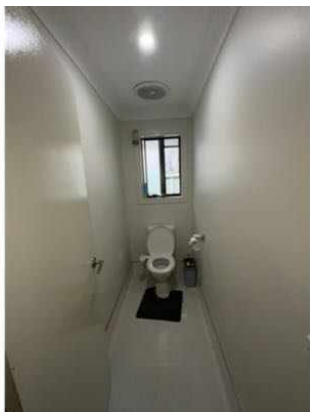
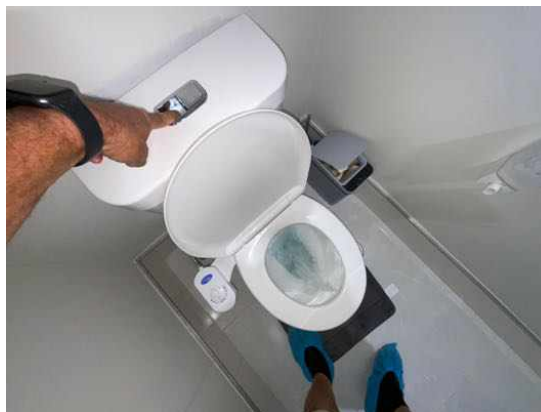
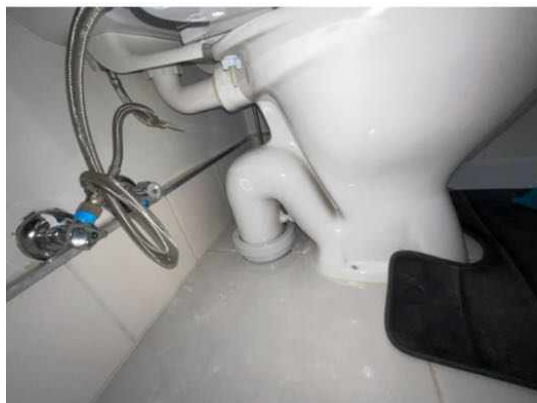
Building: Main Building  
Location: Toilet (WC)  
Finding: Overall Condition: Toilet.  
Information: TOILET ASSESSMENT

Toilet:

- No leaks were observed during the flushing process.
- The toilet operated normally with no signs of malfunction or abnormal water flow.
- The toilet pan was securely fixed to the floor at the time of inspection.

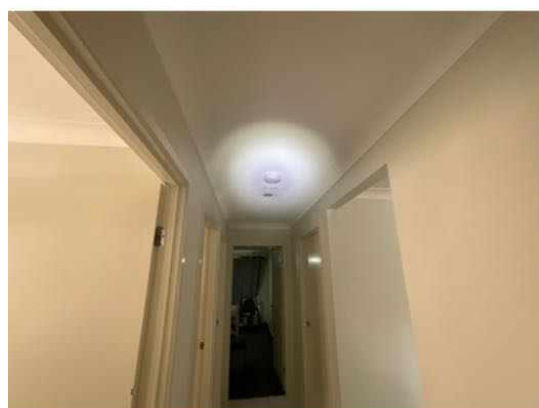
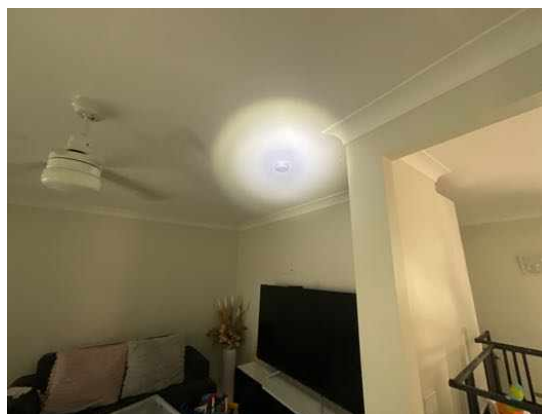
Building:	Main Building
Location:	All Areas
Finding:	Smoke Detectors / Alarms.
Information:	Reporting on the presence, type, location, or compliance of smoke detectors or alarms, including hard-wired smoke detection systems and their legislative requirements, is outside the scope of this inspection report.

Failure to comply with these requirements may pose a serious risk to occupant safety.

- All smoke detectors be tested monthly by the homeowner.
- All systems comply with the requirements of AS 3786 and any applicable state-based legislation.
