Building and Timber Pest Inspection Report

Inspection Date: Wed, 25 Mar 2026

Property Address: 11 Pollard St, Wodonga VIC 3690, Australia

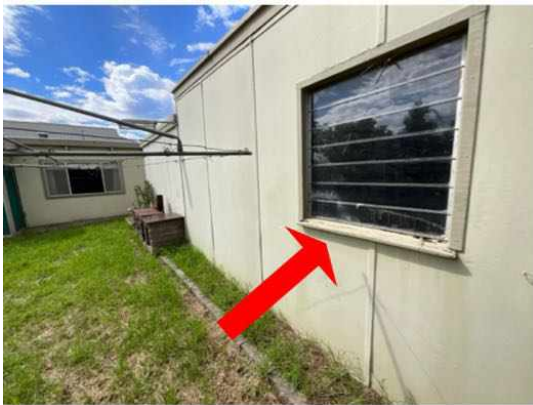
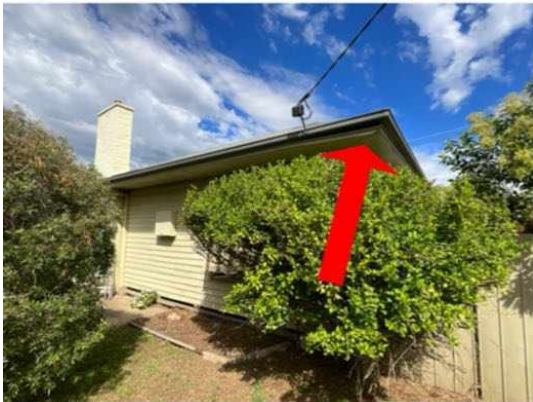
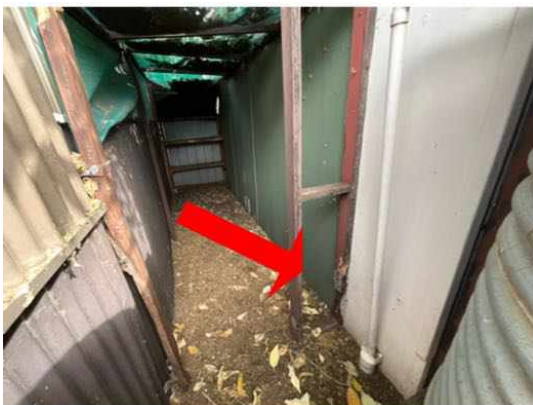
Finding 7.01

The development of fungal decay is accelerated by temperatures in the range of 5degreeC to 40degreeC as well as the presence of oxygen. Generally fungal decay develops on timber elements that are in use in an external environment which are exposed to rain penetration.

In this case although the affected timber element is in a decaying state the extent of any visible damage appears to be localised to a specific area and is yet to spread to other parts of the building element or affect adjoining structures. The fungal decay is therefore likely to be of a relatively superficial nature with minimal impact on the structural integrity or tensile strength of the timber element.

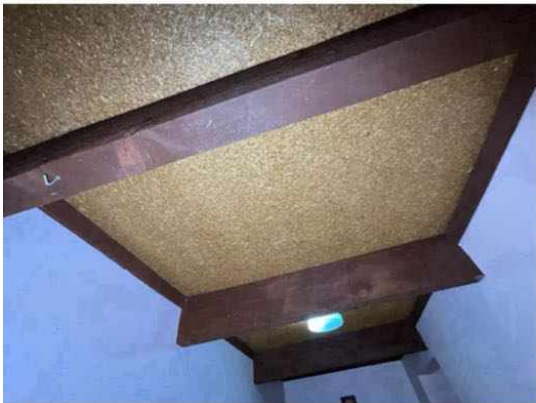
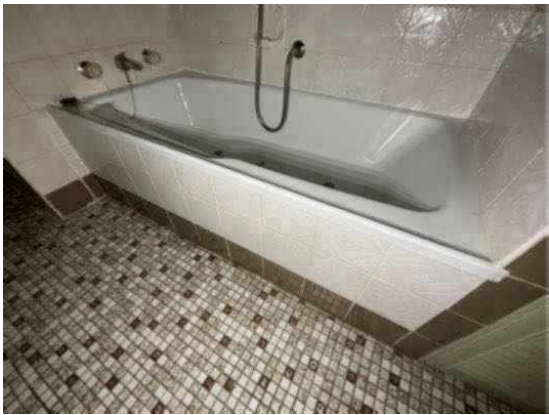
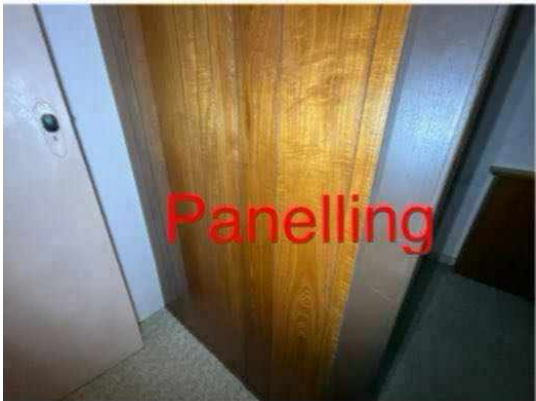
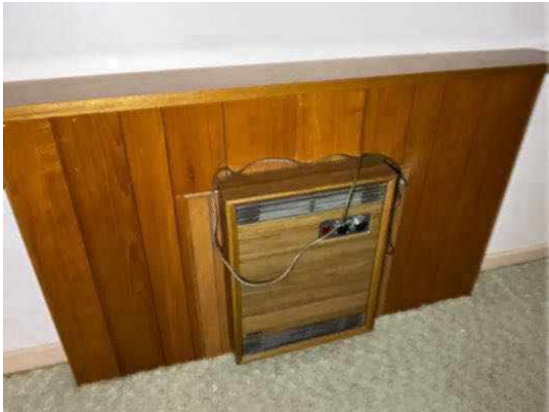
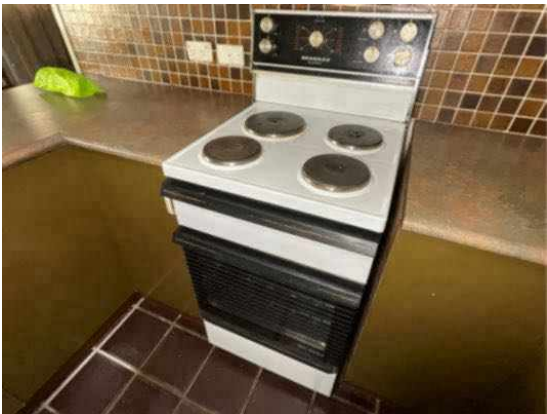
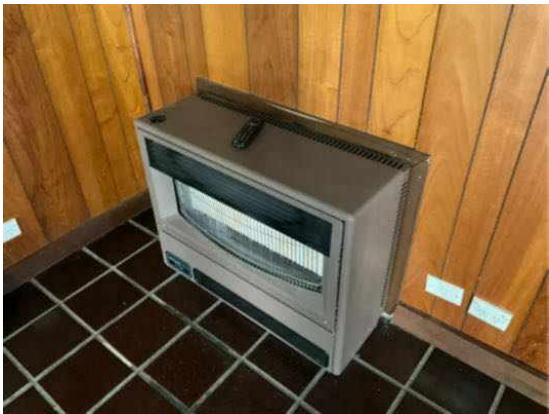
Building: Building 1
 Location: All Areas
 Finding: Additional Photos - Obstructions and Limitations
 Information: These photographs are an indication of the obstructions and limitations which impeded full inspection of the property at the time of inspection. These obstructions can hide an array of defects and should be removed to allow full inspection to be carried out. A re-inspection is recommended once the areas are made accessible.
