Building and Timber Pest Inspection Report

Inspection Date: Thu, 2 Apr 2026

Property Address: 18 Rhonda St, Revesby NSW 2212, Australia

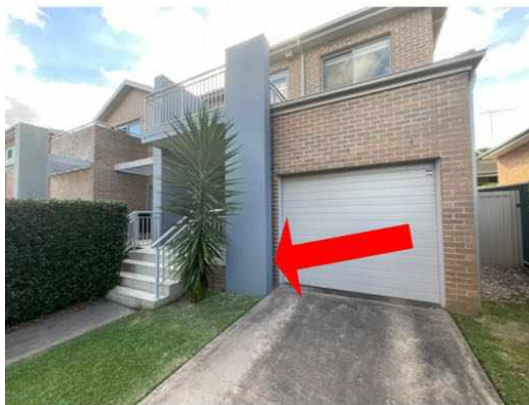
Building: Main Building
Location: All External Areas
Finding: Cracks to external render - Category 1
Information: It has been observed that cracking to external rendered surfaces has occurred. The degree of damage falls within Category 1, described as fine cracks that do not need repair and which are less than 1.0mm in width limit.

Damage of this category is not considered a defect for rectification. Always contact your building inspector should cracks widen, lengthen, or become more numerous.

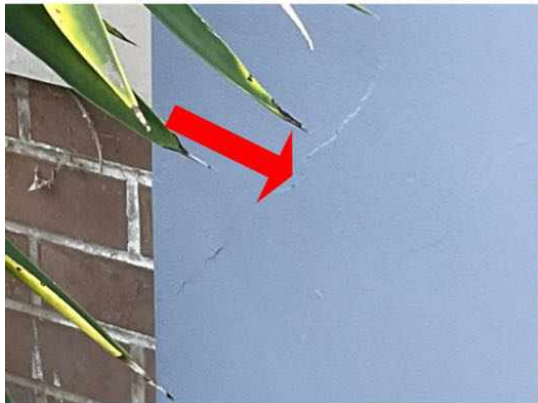
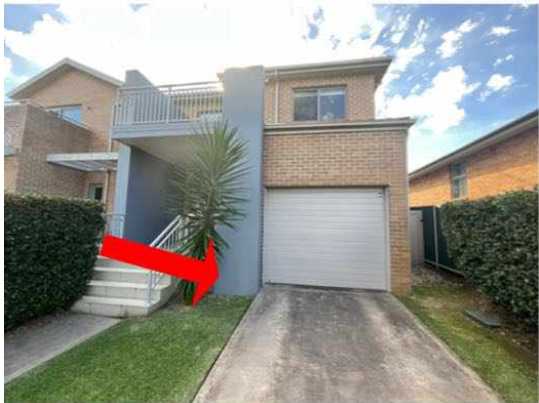
Finding 3.02

Building: Main Building
Location: All External Areas
Finding: Articulation joints - Inadequate of sealant
Information: Articulation joints must be cleaned of all non-compressive material and then sealed with an appropriate flexible sealant. Failure to perform these necessary works is likely to lead to excessive moisture ingress into these joints, or cracking to the brick walls during extreme weather conditions, which may carry major implications for associated building elements if left unmanaged.

Appointment of a qualified tradeperson is advised to perform remedial works as necessary.

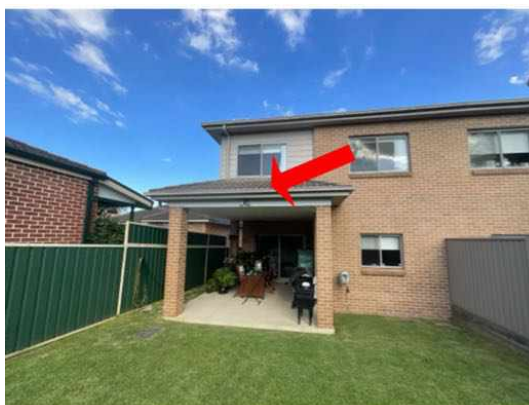
Finding 3.06

Building:	Main Building
Location:	Roof Exterior
Finding:	Water Leak - Gutters
Information:	Water leaks were found to be present to exterior plumbing work. Leaks are generally caused by deterioration of the plumbing elements over time, due to exposure to weather conditions, but may have also been caused by minor impact damage.

Such leaking creates damp conditions in the affected area, causing potential for water pooling and subsequent water damage if left unattended. These conditions may also attract termite attack, particularly if the area is subject to minimal levels of sun throughout daylight hours.

It is highly advised that a licensed plumber be appointed to rectify any water leaks that may be present. Areas of repair and replacement of plumbing fittings and fixtures may be required and, as such, a quotation should be sought.

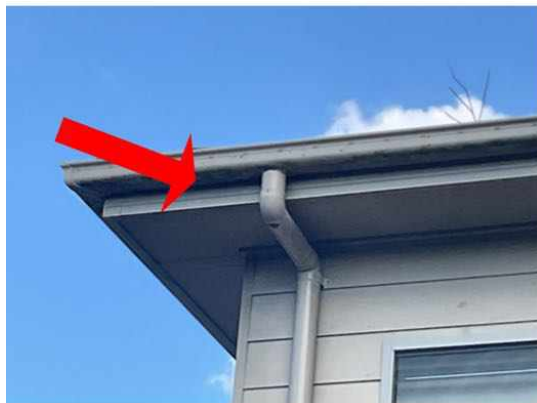
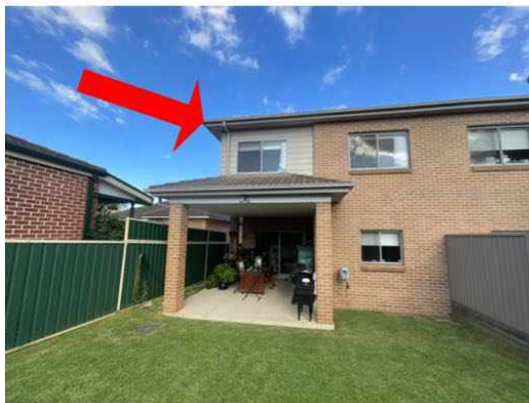
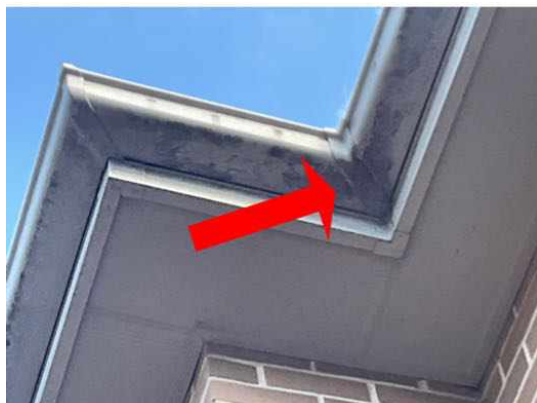
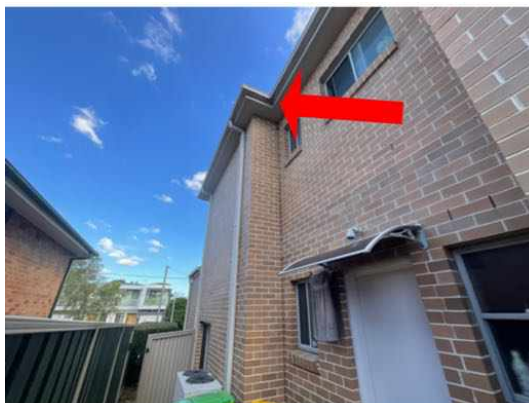
Finding 3.07

Building:	Main Building
Location:	All External Areas
Finding:	Building element - Rusted or corroded
Information:	This building element shows evidence of rusting and corrosion, which is likely to have developed as a result of excessive exposure to moisture and or inadequate coatings.

As surface rust provides no protection to the underlying iron, the deteriorating condition is likely to worsen if not addressed in the short-term future.

Where possible, the use of galvanized (treated) metals or aluminium coated metals aid in rust prevention, as does regular general maintenance. Rust formation can be controlled with coatings, such as paint, that isolate the iron from the environment.

Rusting and corrosion should be managed by ideally removing or limiting the affected surface from exposure to moisture. A registered builder may be appointed to replace any building elements that have been severely affected by rust or water damage.

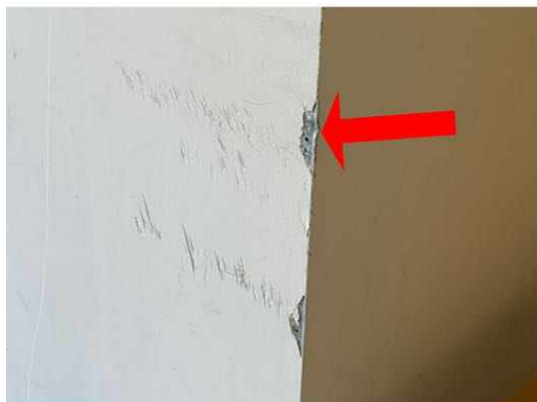
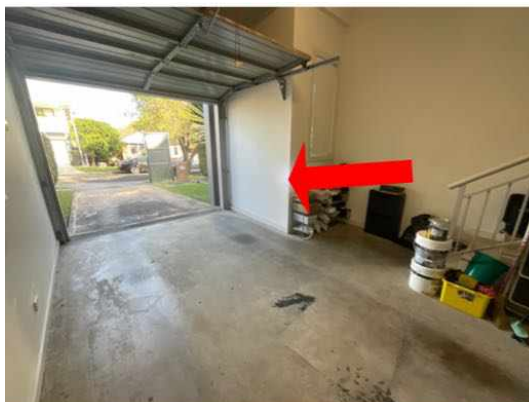
Finding 3.15

Building:	Main Building
Location:	Garage
Finding:	Excessive moisture - identified
Information:	Excessive moisture can attract termites and produce conditions that promote fungal growth and wood decay.

Excessive moisture is generally caused by deteriorated, inadequate or missing roof drainage, leaking plumbing pipes or fixtures, poorly plumbed HWS overflows or condenser units and poor site drainage.

If mould growth has been found there may be environmental biological or health issues involved. In these cases an appropriately qualified inspector should also be contacted.

Prior to any remedial works being performed a qualified plumber should be appointed to further inspect the property and to identify the cause of the excessive moisture. Works to remove affected building elements may then be necessary and should be performed by an appropriate tradesperson.

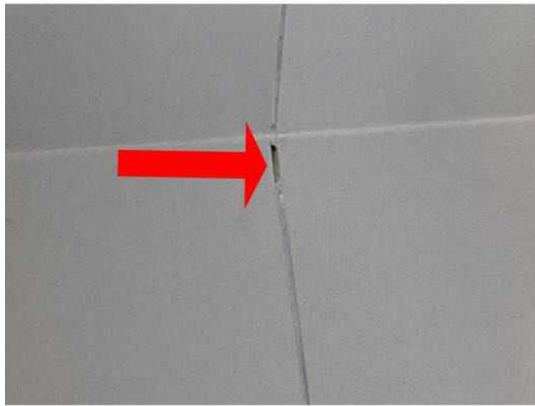
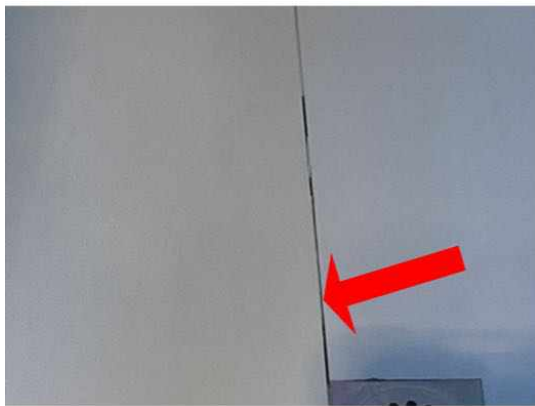
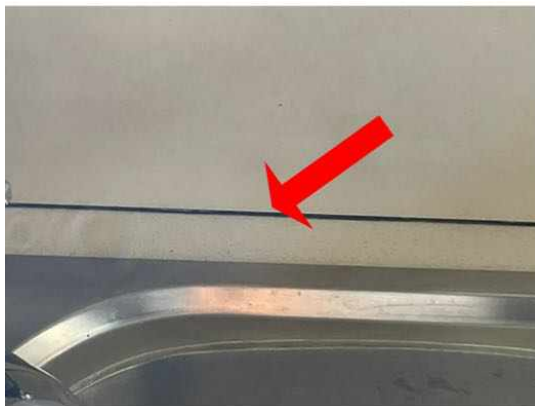
Finding 3.16

Building:	Main Building
Location:	Bathroom / Ensuite / Kitchen
Finding:	Sealant and grouting - Missing or damaged
Information:	It was noted on inspection that sealant or grout is degraded to the tiled shower alcove and or other areas of the bathroom.

Different materials and floor areas move at different rates, generally causing cracking to grout or sealant at this point. A flexible sealant is required to allow for expected expansion and contraction, while keeping the joint water tight and protective of all associated building materials.

There appears to be excessive mould to the sealant and grout which will likely require scraping out and replacement.

Flexible and mould resistant materials should be applied to affected areas to prevent any subsequent water damage that is likely to occur. Regular maintenance and replacement of damage or missing or damaged sealant and grout is highly recommended to the wet areas, as this is a regular wear and tear defect. Sealant and grouting in areas that come into regular contact with water should be maintained for the long term care of your property.

A sealant specialist or tiling contractor should be appointed to complete these works

as soon as possible

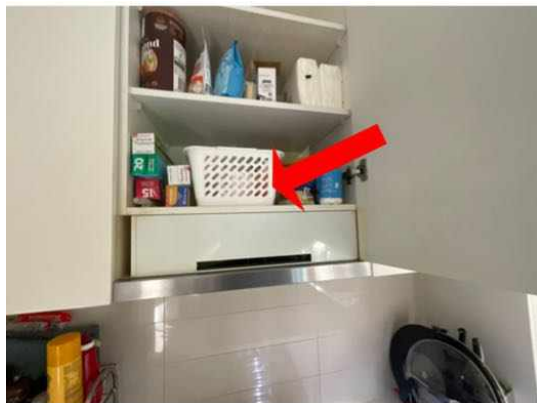
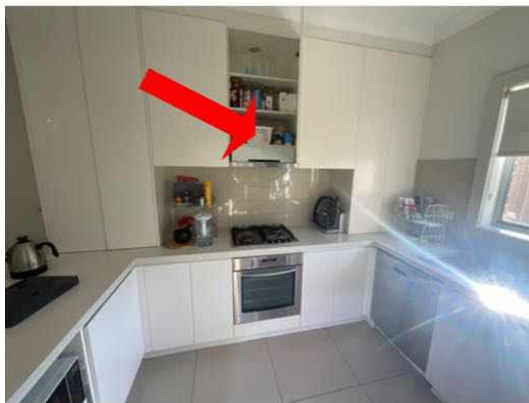
Finding 3.17

Building: Main Building
 Location: Kitchen
 Finding: Rangehood - Flue disconnected
 Information: The range hood flue has become disconnected and is allowing the emission of steam and evaporative moisture into the ceiling space above.

While this does not create high potential for secondary defects, development of grease is likely to occur in the surrounding area, necessitating regular cleaning and

Consultation with a licensed electrician may be required to reconnect the flue and thus allow the emission of gases into the external environment. Works should be completed at client discretion.

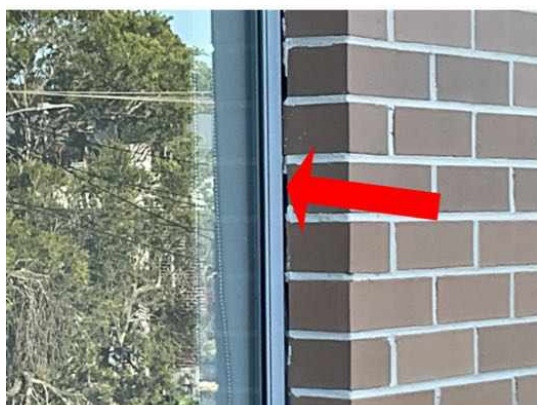
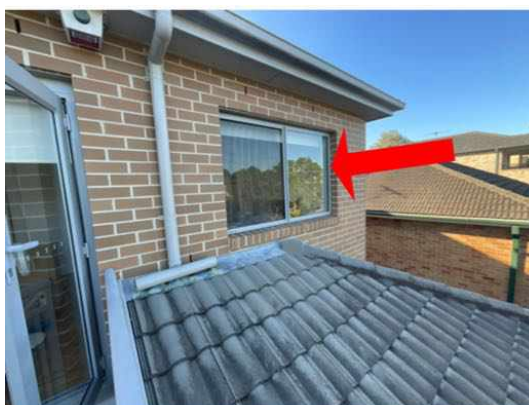
Finding 3.18

Information: A significant gap was identified between the brick and window frame in this area. Where large gaps to the head appear, it may indicate a variety of defects, ranging from uneven framework, sagging hinges or uneven flooring.

A gap to the head of the window may also indicate movement of the foundation of the property, which is a common occurrence and does not indicate structural damage.

A qualified tradesmen should be appointed to perform remedial works to restore the window to a fully operational level.

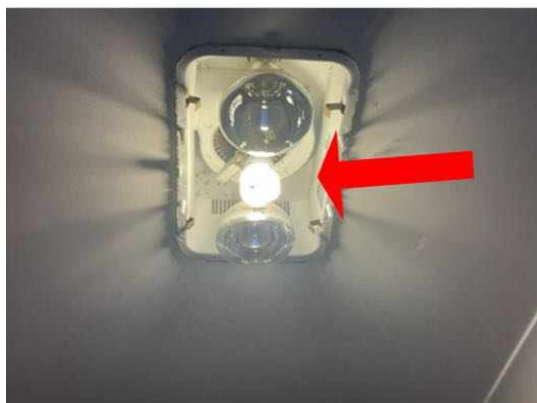
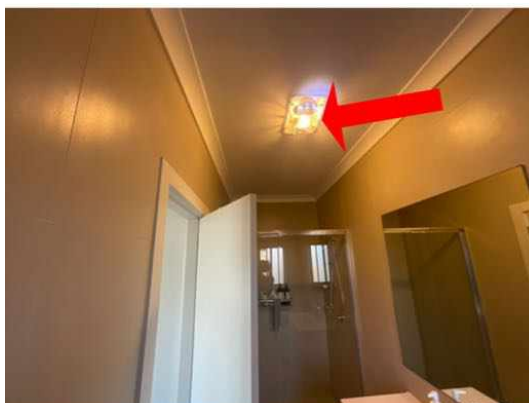
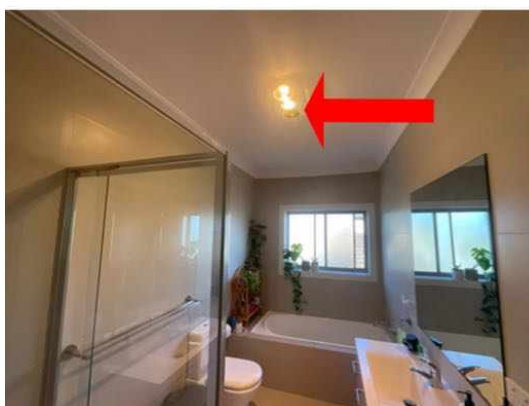
Finding 3.19

Building: Main Building
 Location: Bathroom / ENS
 Finding: Light fitting - Damaged
 Information: The light fitting in this area was found to be damaged at the time of inspection. Damage occurs generally when the building materials have aged and decayed, but may also be indicative of impact damage to the building element (accidental or deliberate).

Left unmanaged, the fitting is unlikely to cause further damage to surrounding building elements. However, the broken light fitting may expose electrical works, and may create a minor safety hazard if there is potential contact with persons in the area.

Repair and/or replacement of the damaged fitting is advised. A Licensed electrician should be appointed to repair/replace the light fitting at the client's discretion.

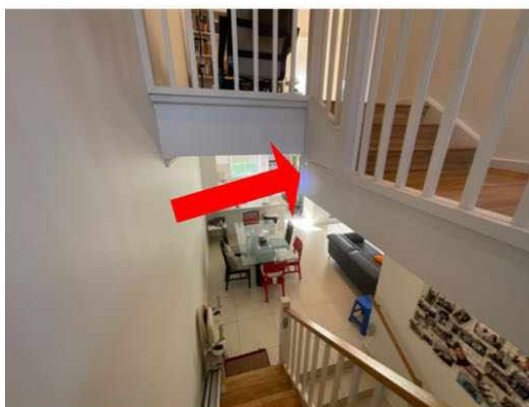
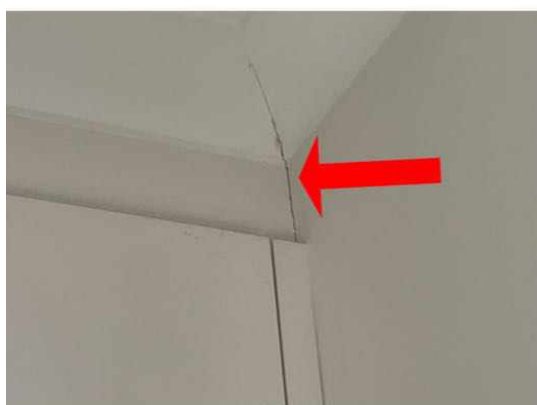
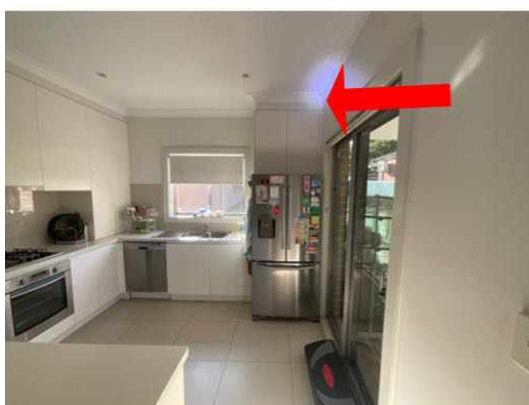
Finding 3.20

Building: Main Building
 Location: All Internal Areas
 Finding: Paint finish - Substandard, Wear and Tear
 Information: The paint finish in this area was found to have been completed to a substandard level or wear and tear as the normal deterioration of a property from ordinary, everyday use. Exposure to the elements, time, as well as day to day living can cause fair wear and

If this applies, further areas of poor and incomplete finishes could develop over time. Furthermore, substandard, wear and tear paint finishes in areas exposed to moisture, e.g. external areas or wet areas, could lead to deterioration of underlying building materials.

Substandard, wear and tear paint finishes should be sanded back, filled, leveled and repainted, as applicable. Where inadequate paint protection has led to the deterioration of the associated building element, repair and/or replacement of this building element may be required.

A painting contractor should be appointed as soon as possible to perform necessary works to aid the appearance of the affected area and to ensure that the area is protected against further deterioration. Alternatively, the homeowner following manufacturer instructions may be able to provide this service.

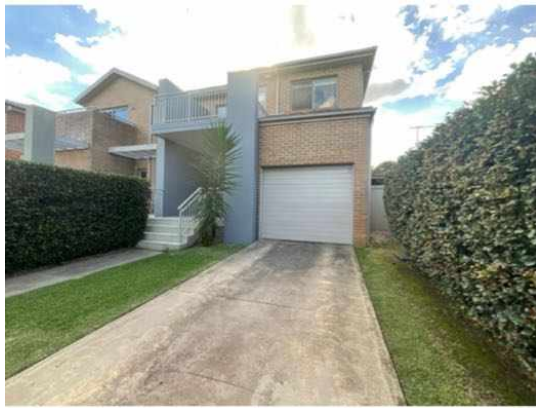
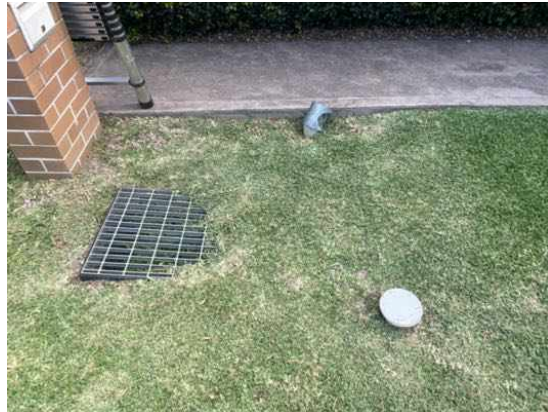
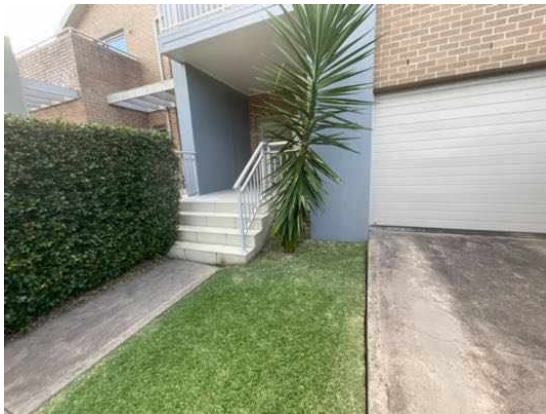
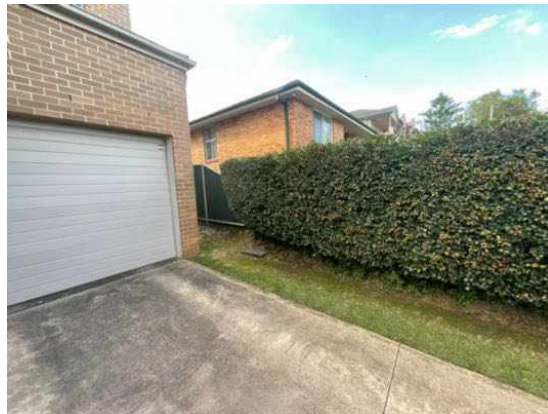
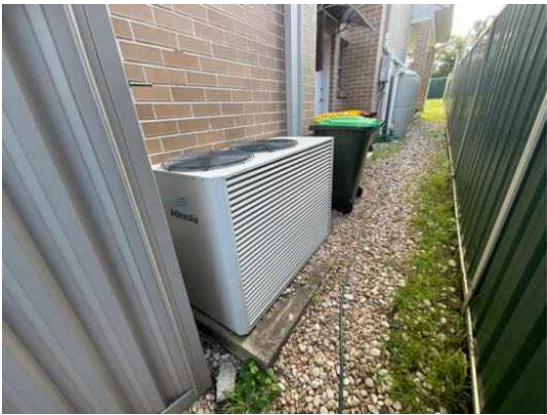
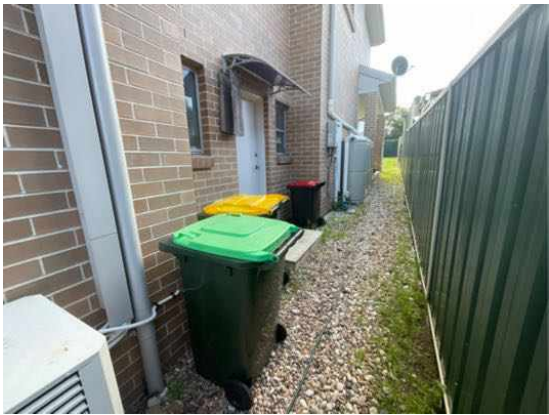
Noted Item

Building: Main Building
Location: All Areas
Finding: Additional Photos - Obstructions and Limitations
Information: These photographs are an indication of the obstructions and limitations which impeded full inspection of the property at the time of inspection. These obstructions can hide an array of defects and should be removed to allow full inspection to be carried out. A re-inspection is recommended once the areas are made accessible.

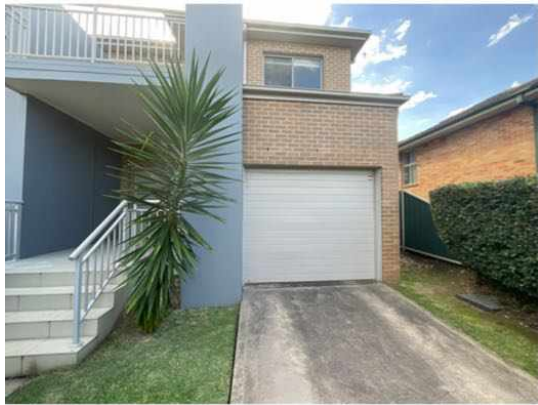
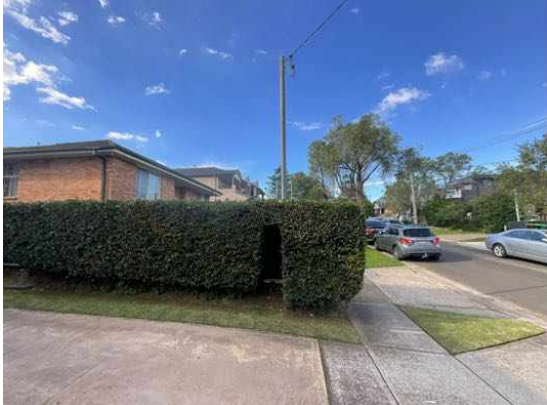
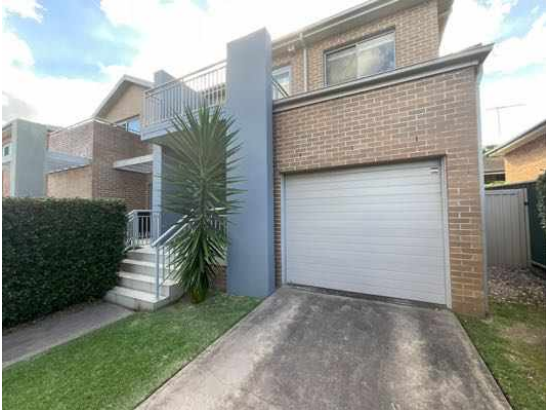
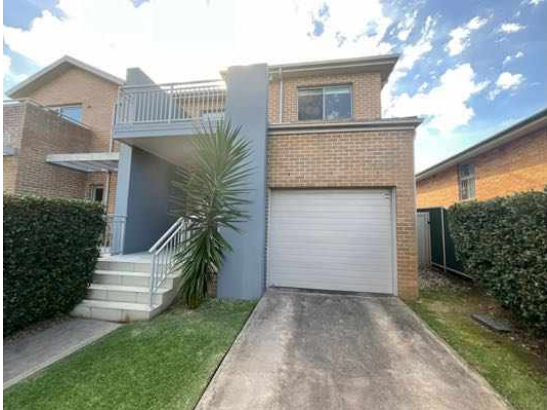
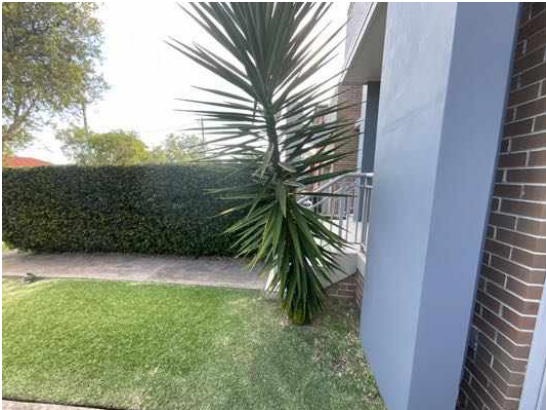
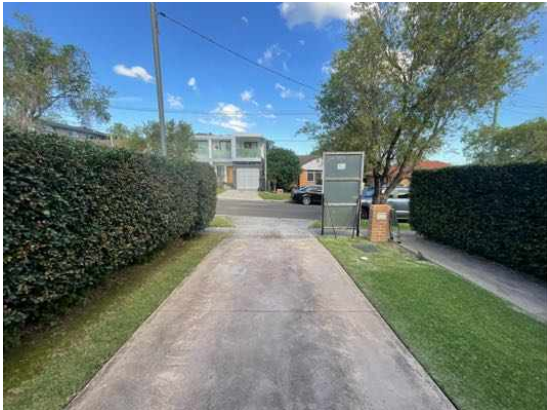
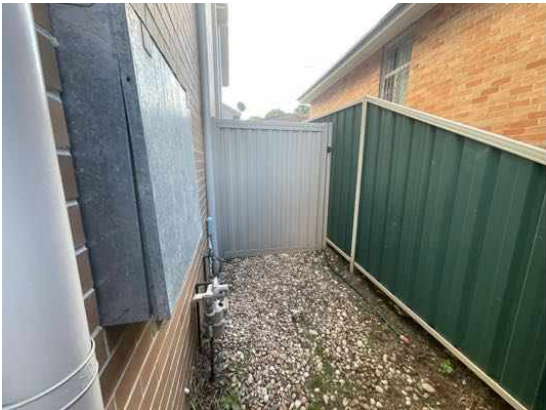
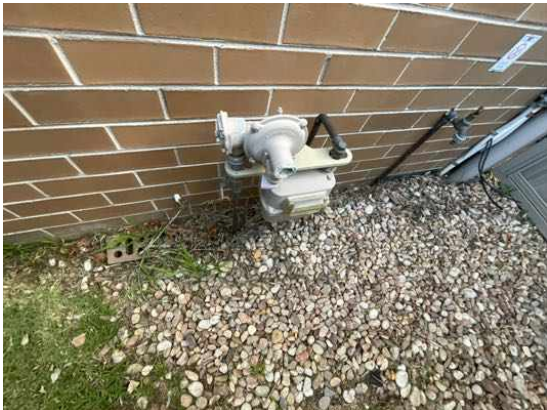
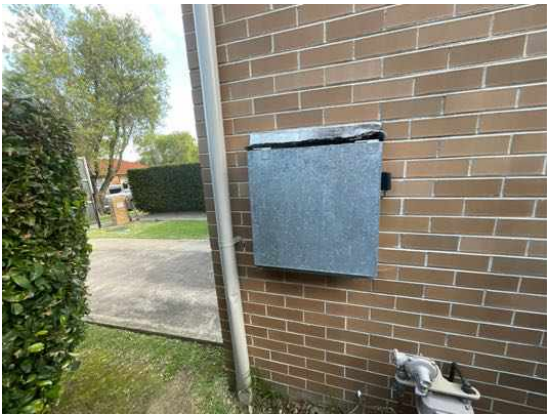
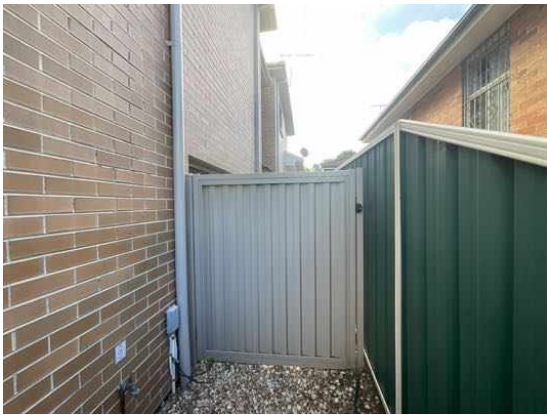
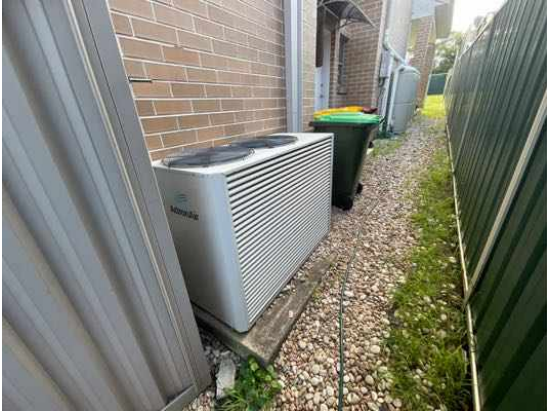
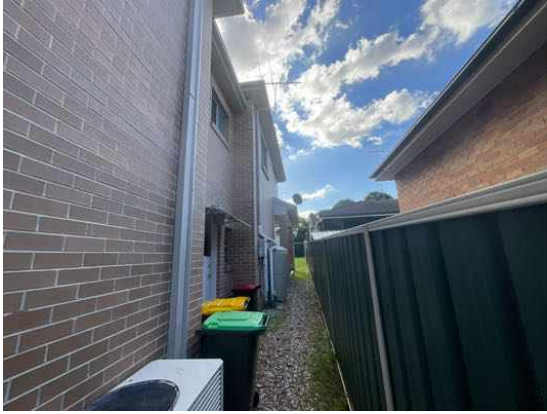
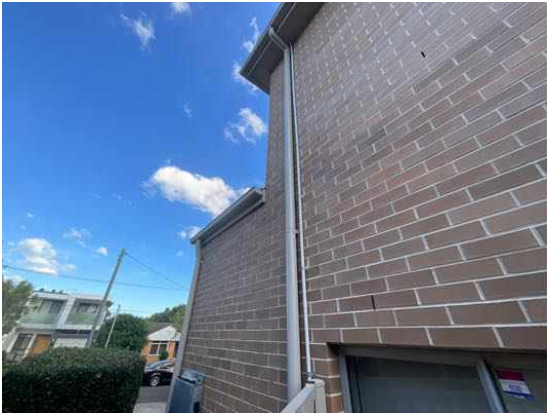
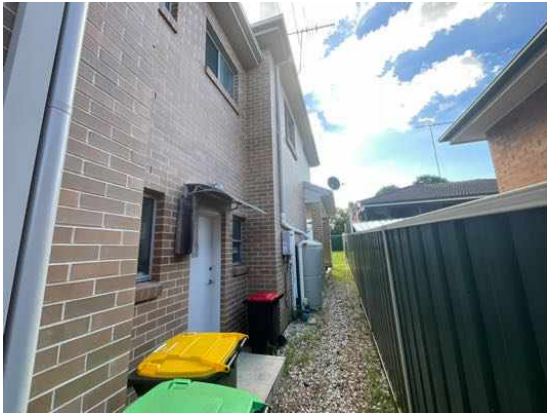
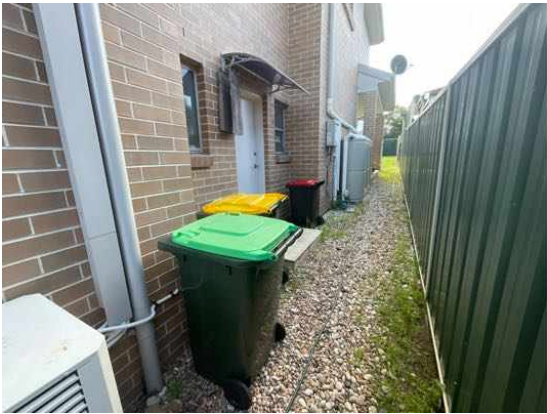
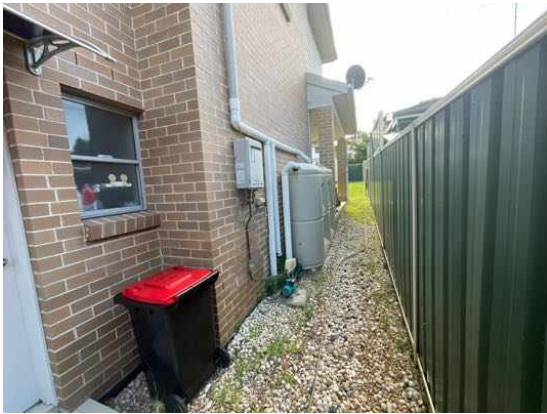
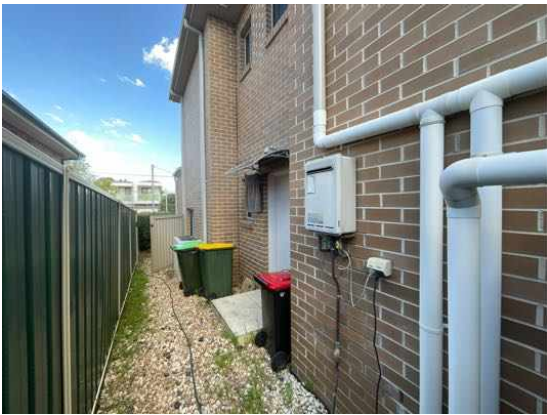
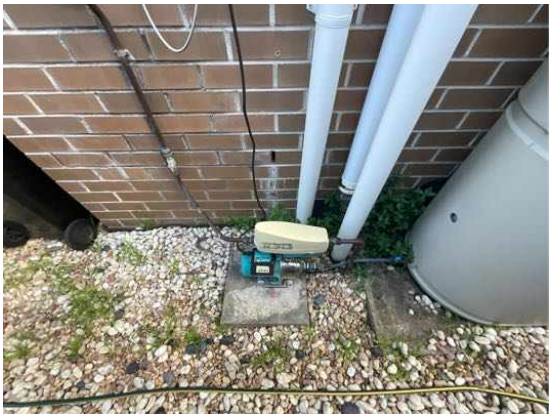
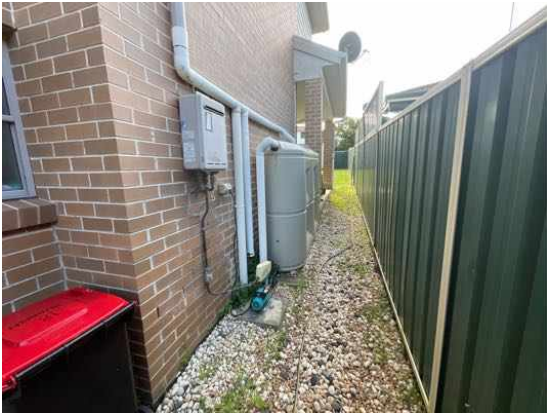
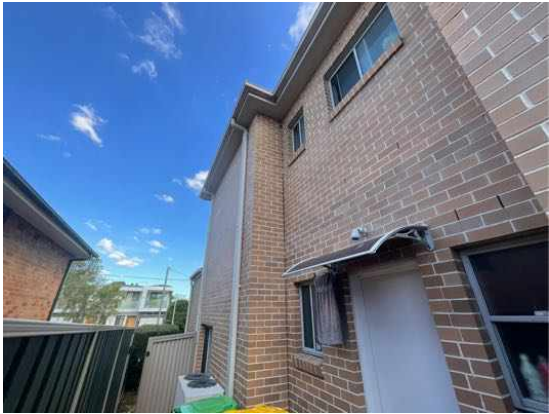
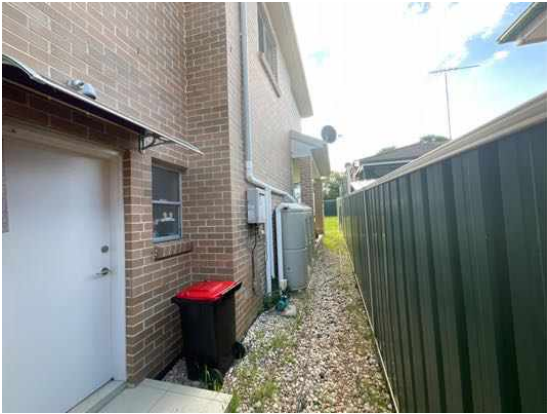
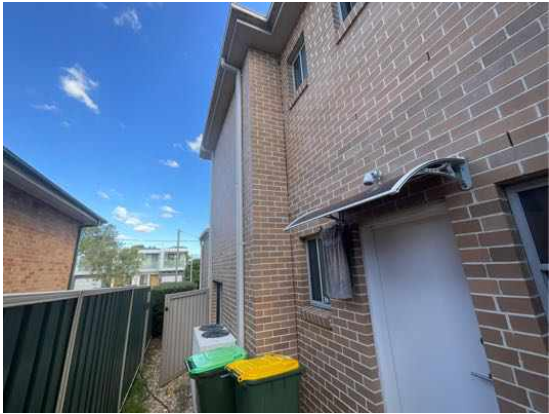
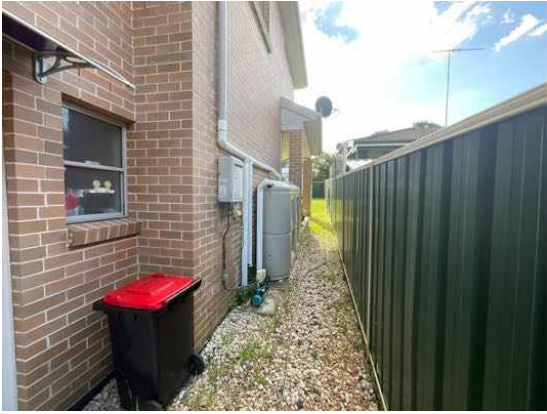
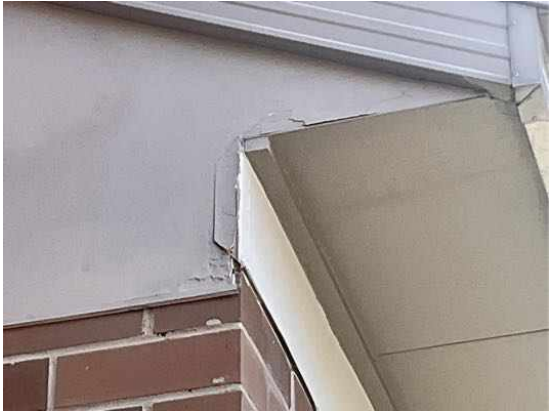
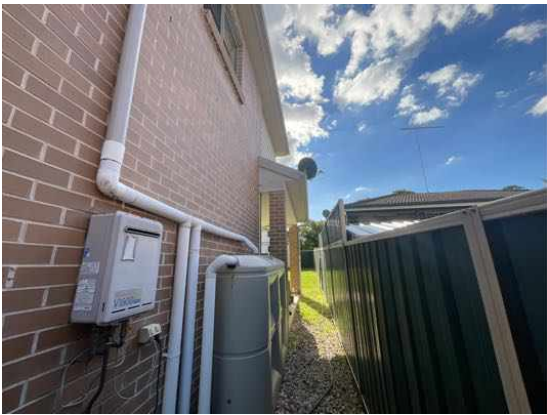
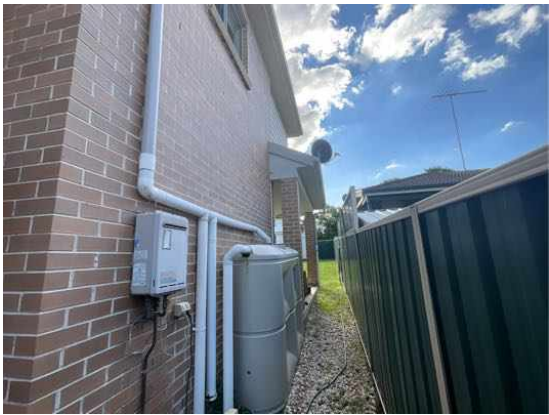
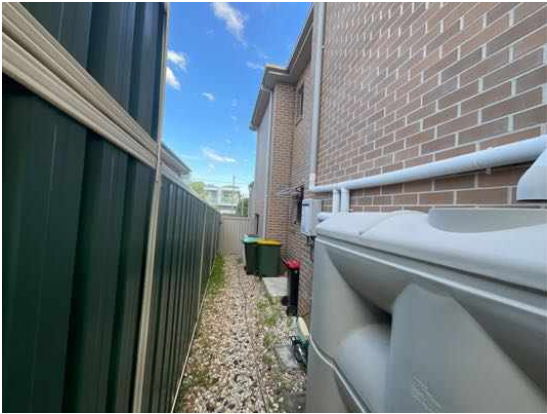
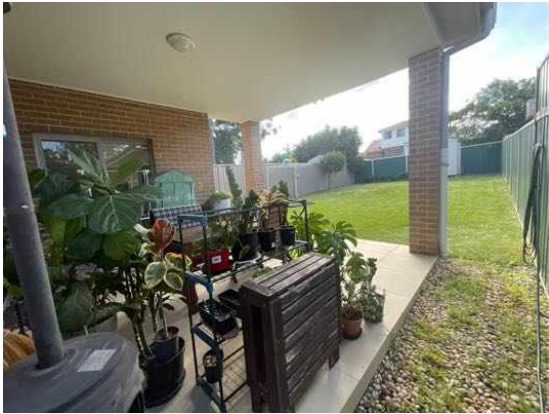
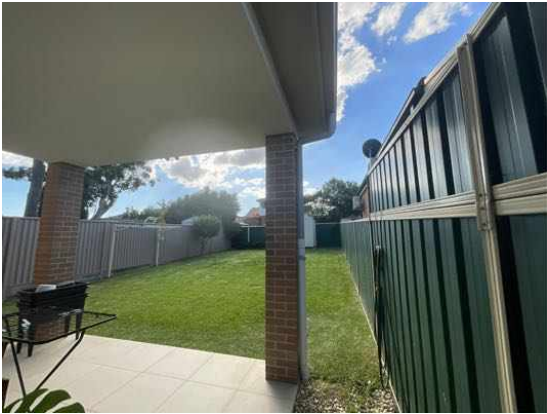
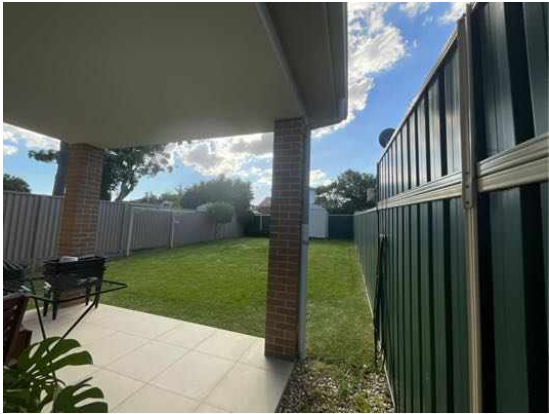
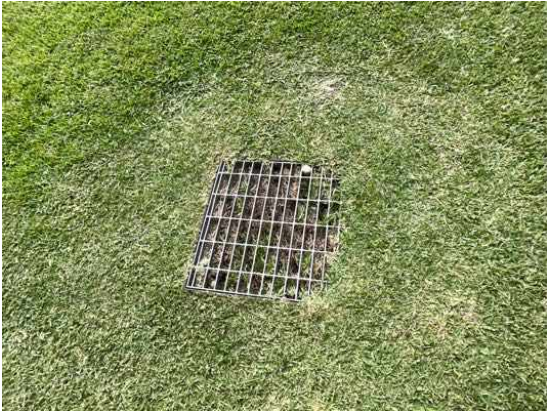
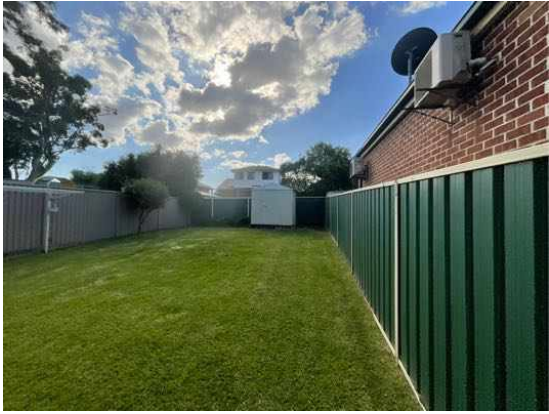
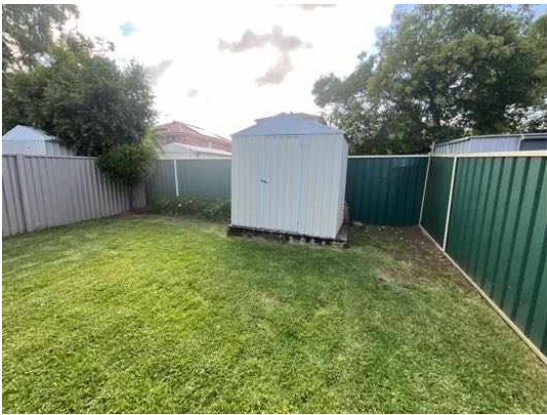
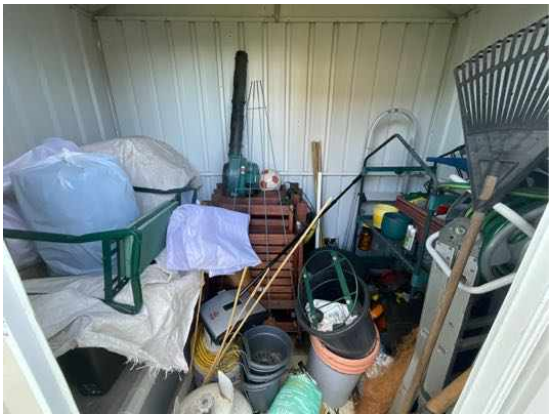
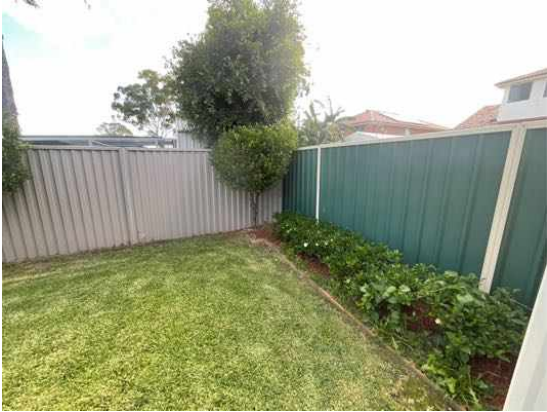
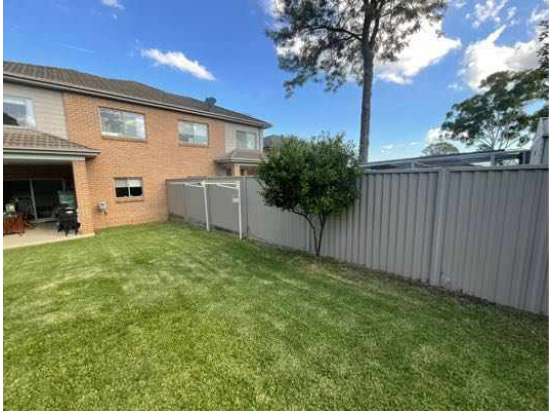
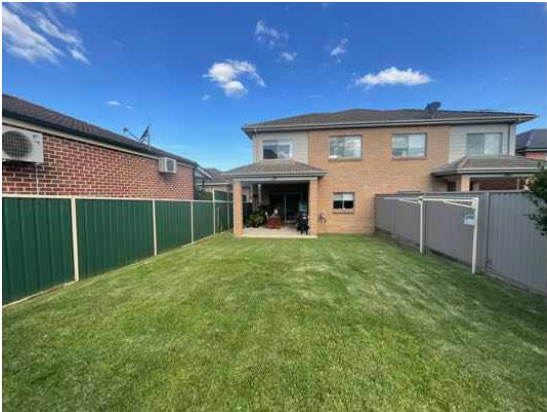
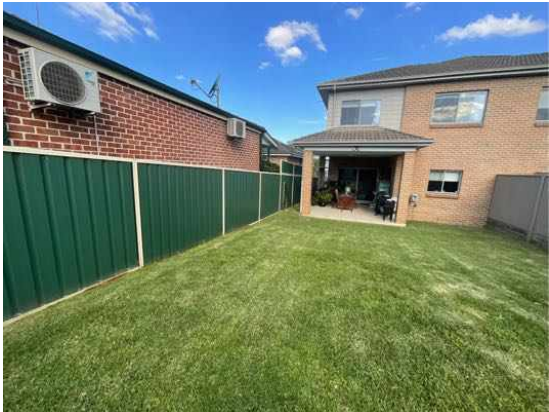
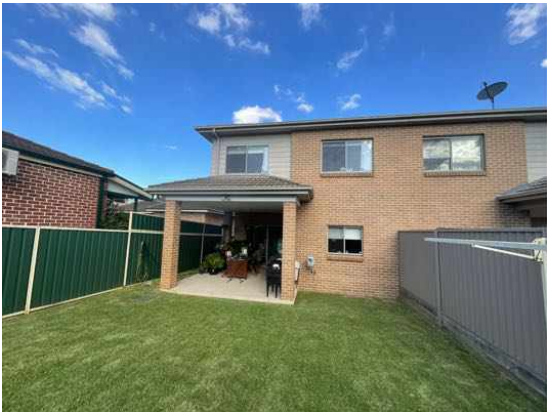
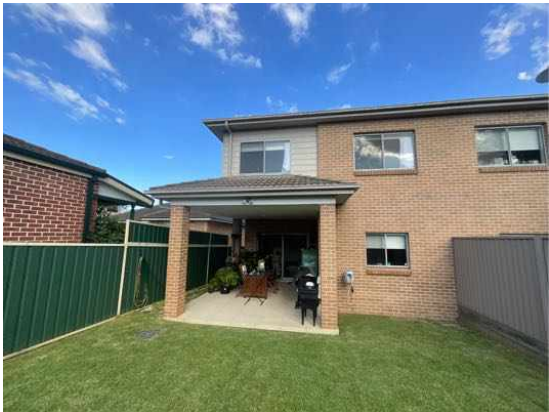
Noted Item

Building: Main Building
Location: All Areas
Finding: Additional Photos
Information: Additional photos are provided for your general reference
