Building and Timber Pest Inspection Report

Inspection Date: Thu, 2 Apr 2026

Property Address: 18 Rhonda St, Revesby NSW 2212, Australia

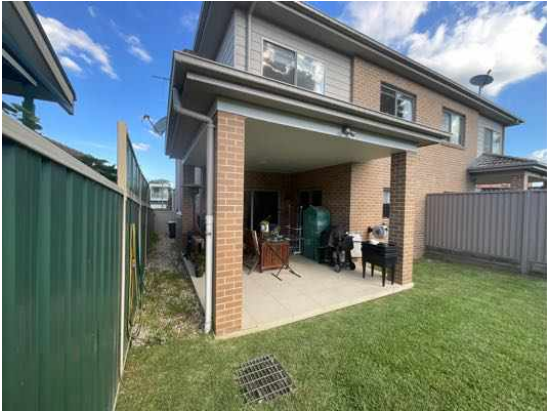
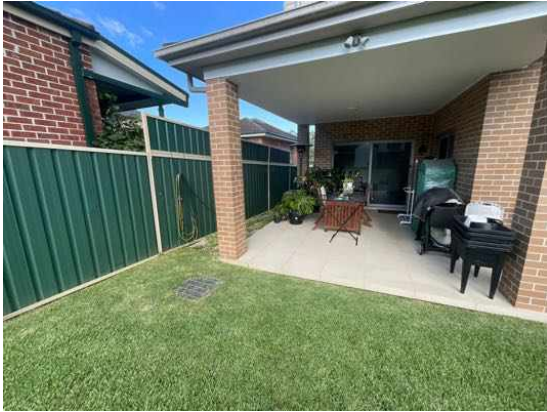
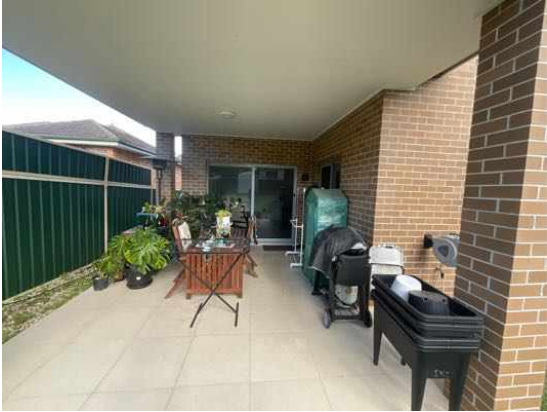
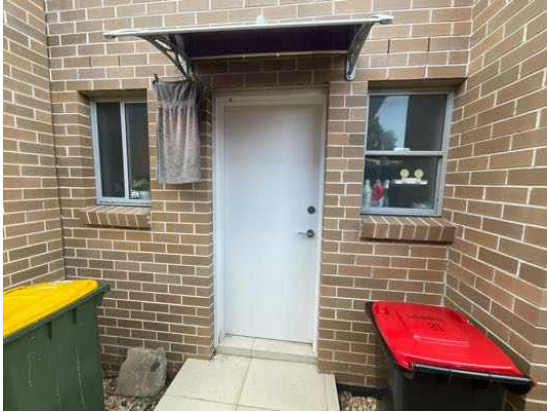
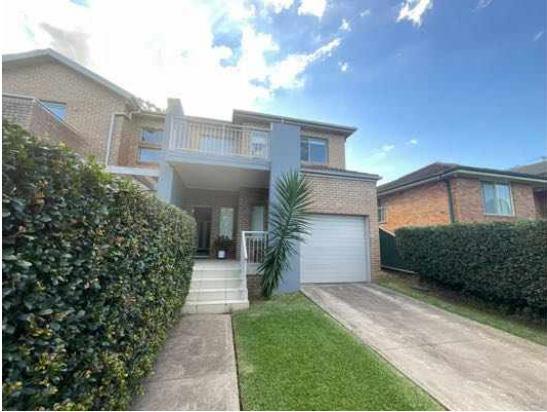
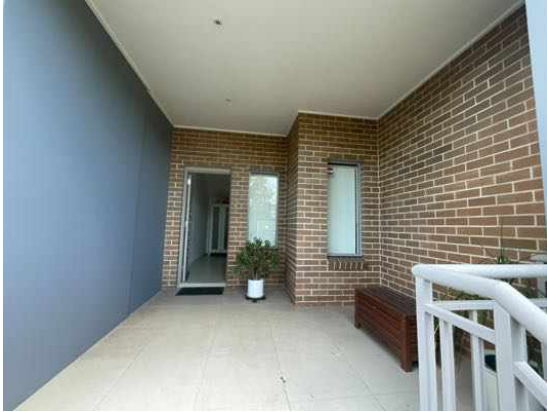
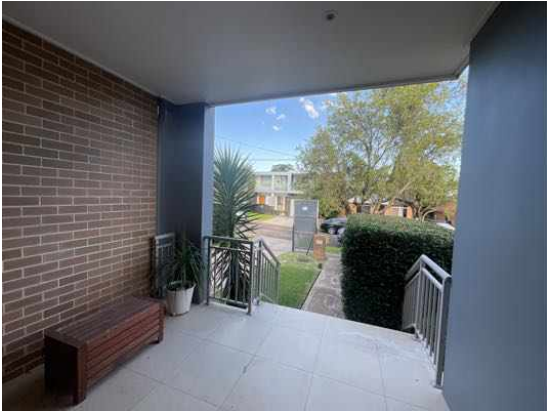
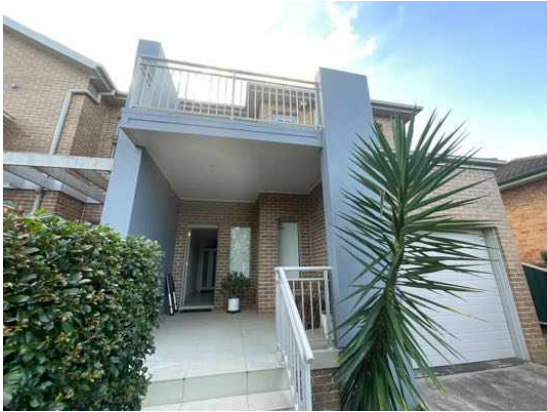
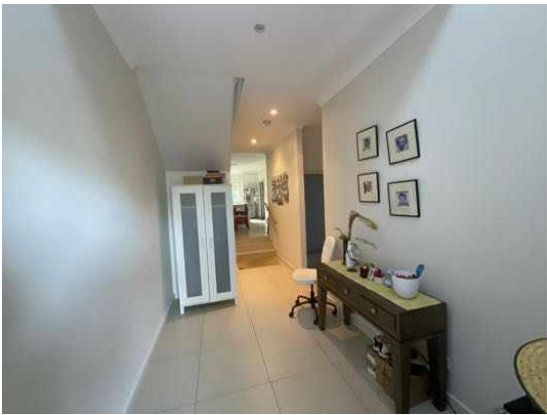
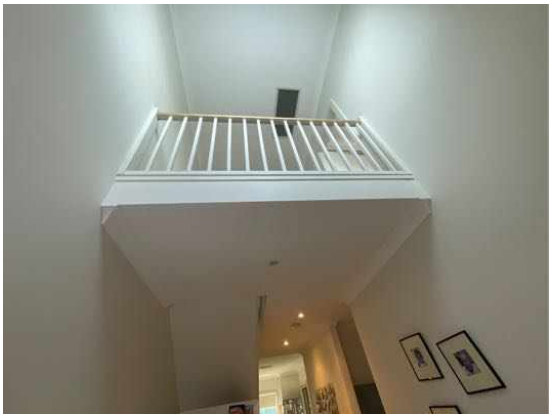
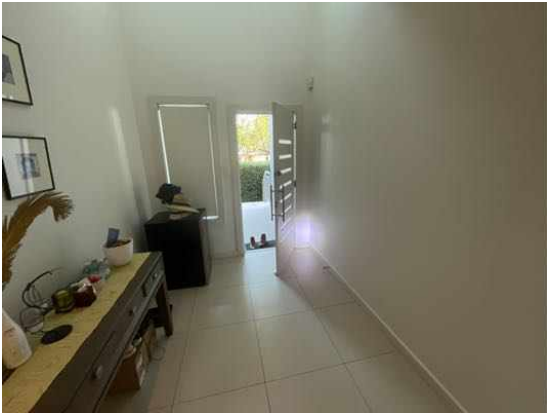
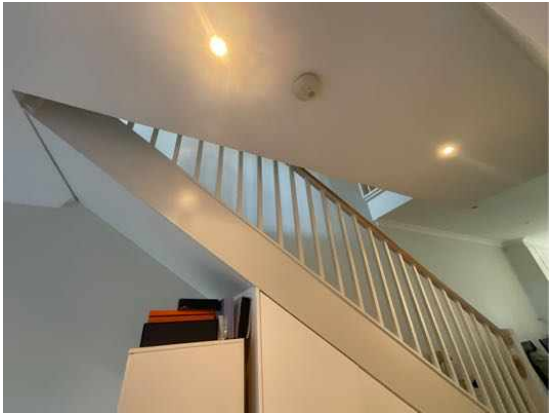
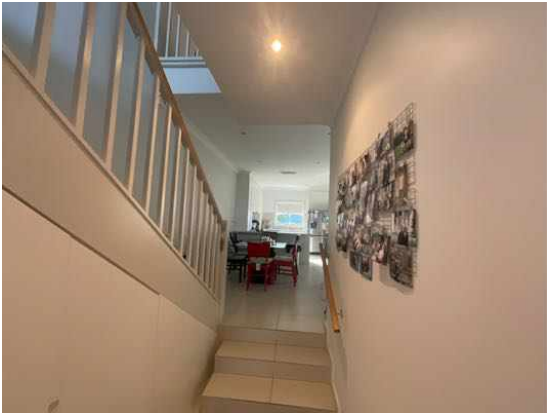
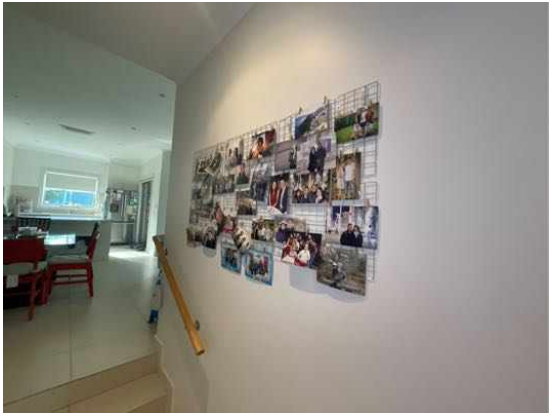
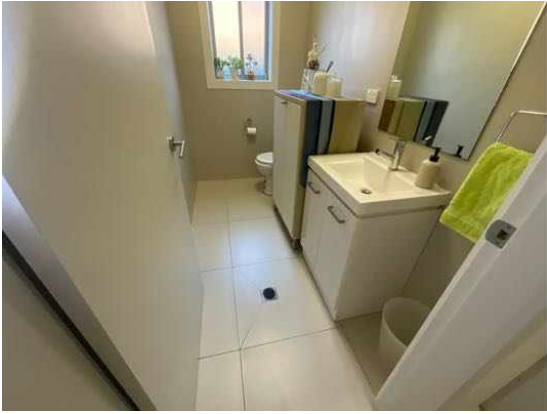
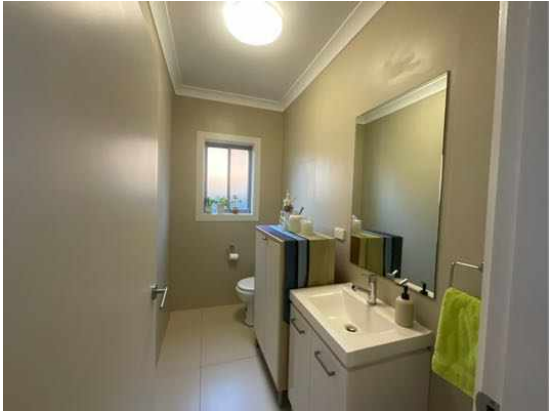
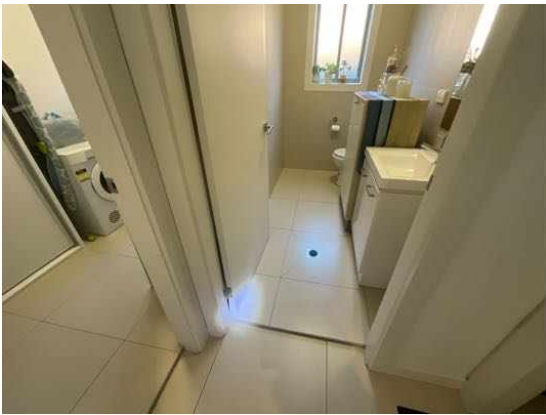
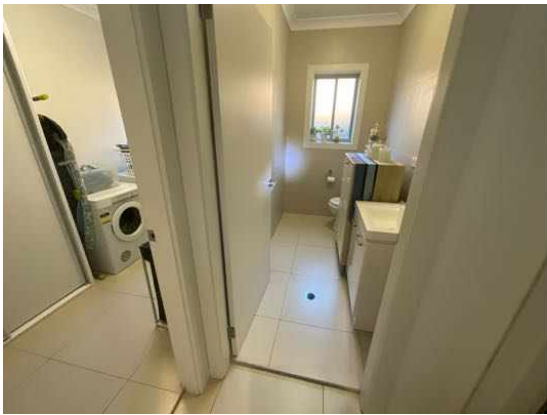
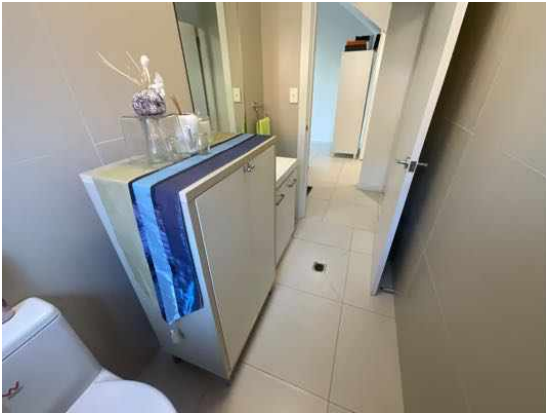
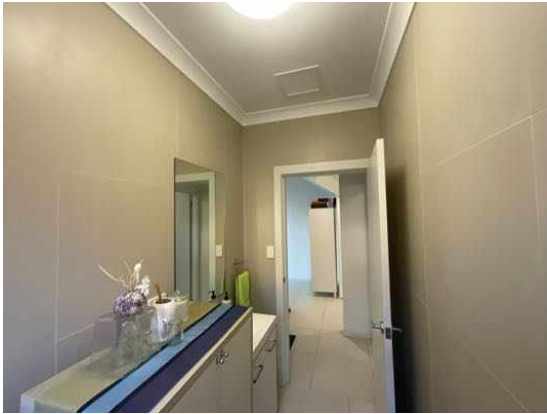
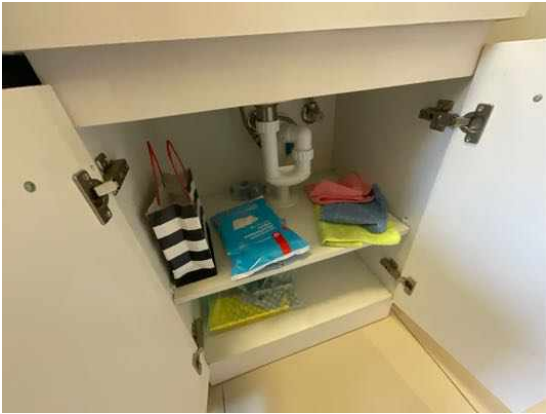
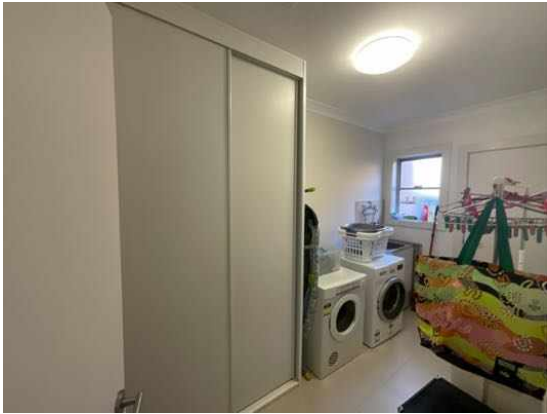
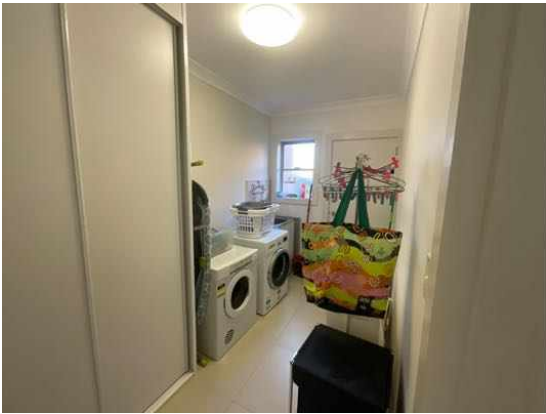
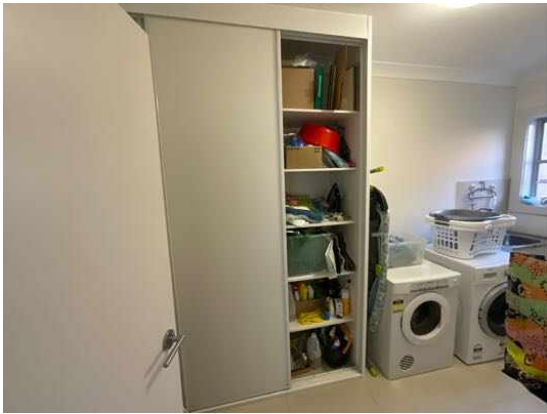
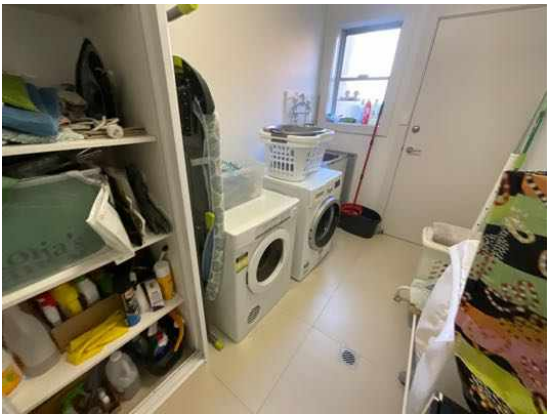
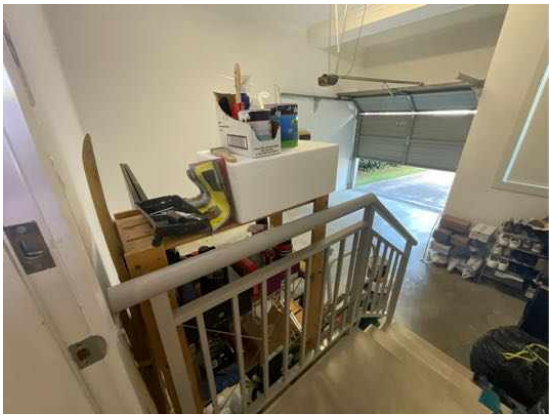
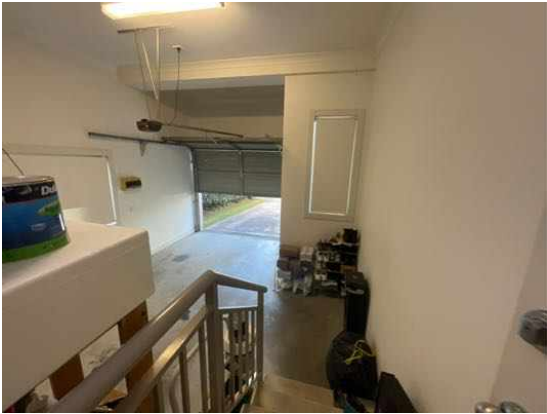
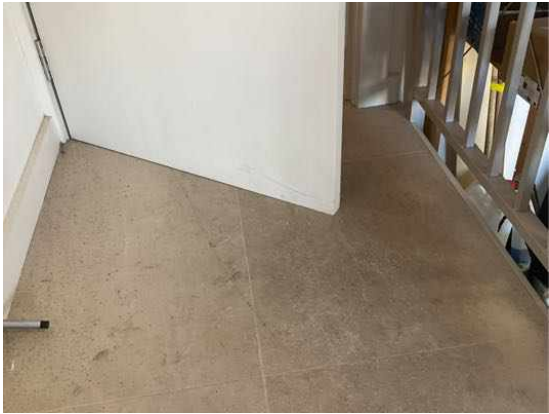
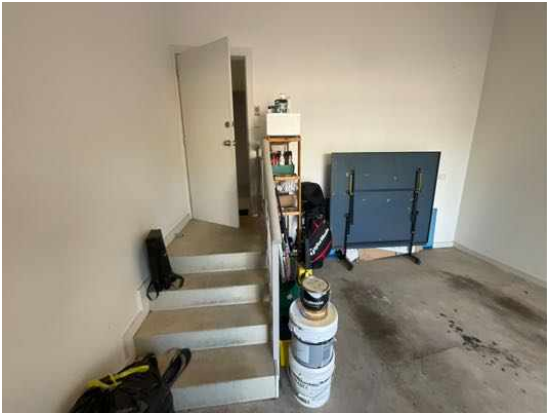
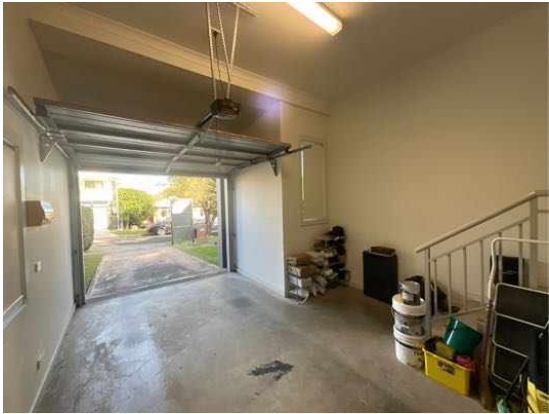
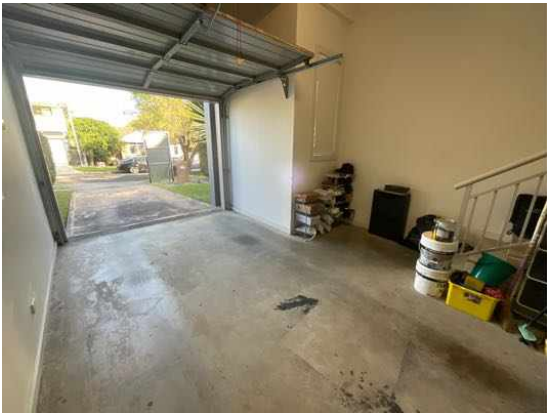
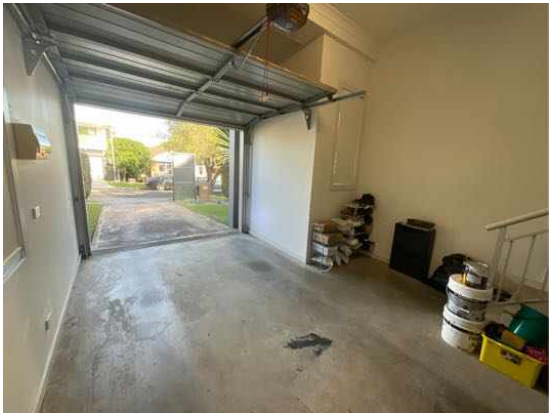
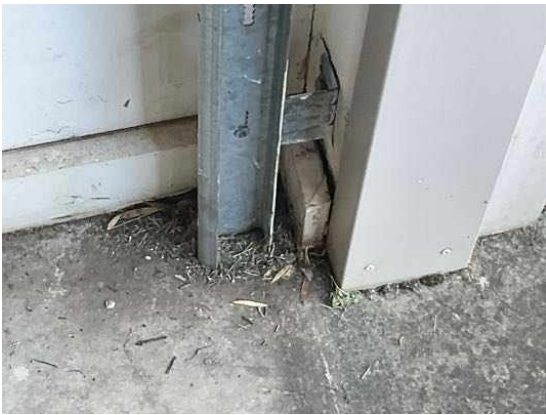
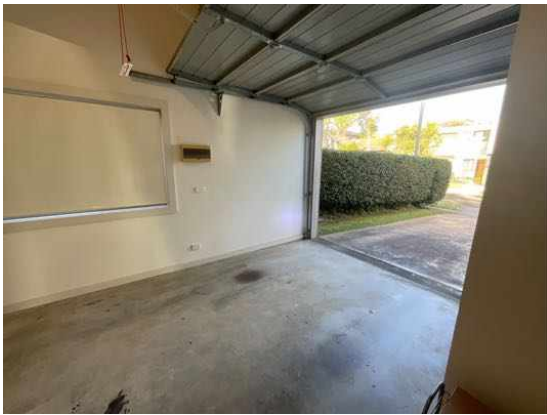
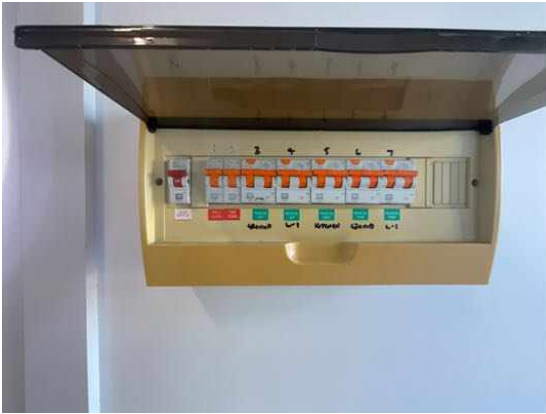
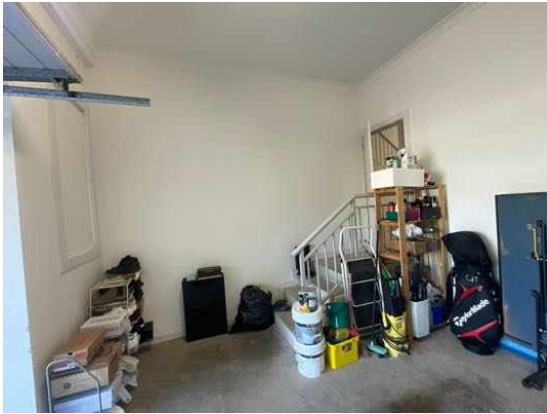
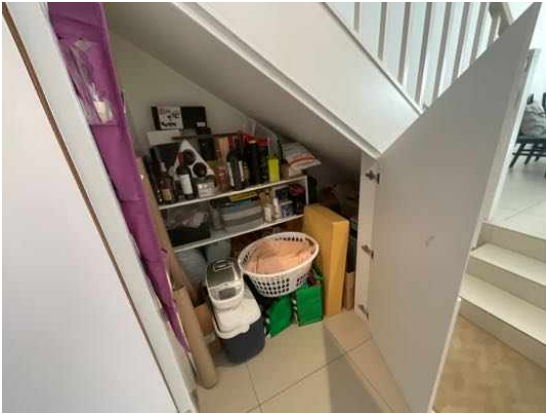
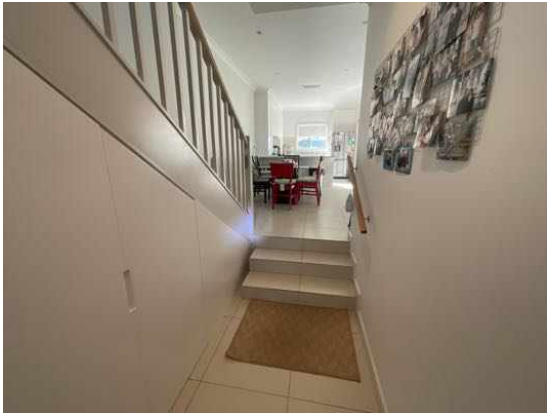
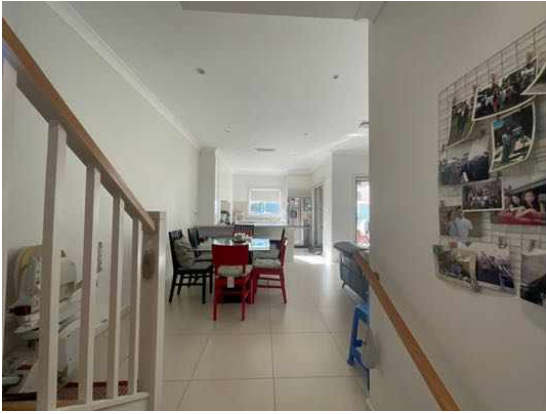
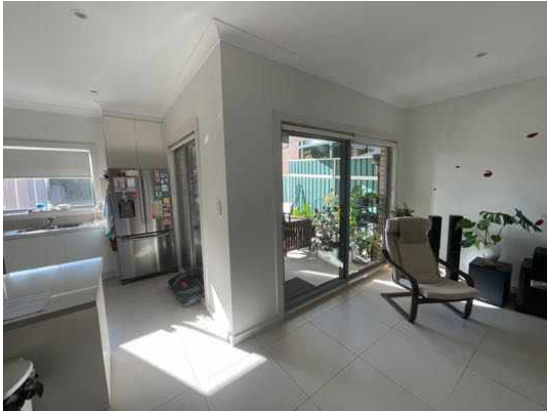
Building: Main Building
Location: All Areas
Finding: Additional Photos - Obstructions and Limitations
Information: These photographs are an indication of the obstructions and limitations which impeded full inspection of the property at the time of inspection. These obstructions can hide an array of defects and should be removed to allow full inspection to be carried out. A re-inspection is recommended once the areas are made accessible.

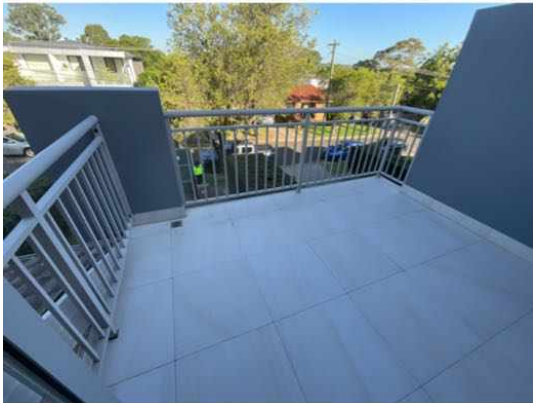
Building: Main Building
 Location: All Areas
 Finding: Water Proofing Membranes - Information Only
 Information: Internal Water Proofing Membranes, are crucial in preventing water ingress into the property is important to know that the Membrane System used is to Australian Standards and has been installed correctly. Please refer to the original Building Documents or Maintenance Schedule for the relevant information including; - Membrane used and Manufacturers Specifications. - The Installer and Installation Certification. Especially with older property's where this information is unavailable, all wet areas should be monitored. Generally new waterproofing with a certificate may

only have a guarantee of 8yrs. If any leaks, water staining, peeling or bubbling of the paint become evident to any adjacent walls or ceilings below a licensed builder or waterproofing specialist is recommended to investigate further.

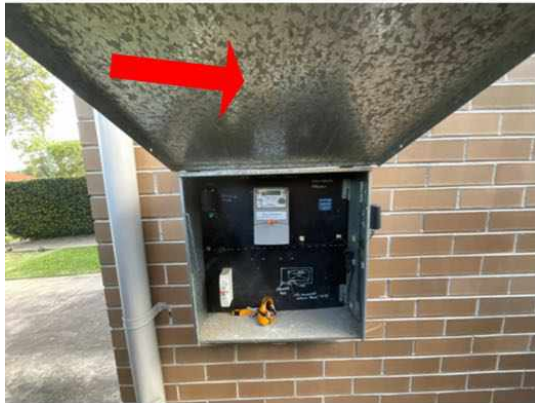
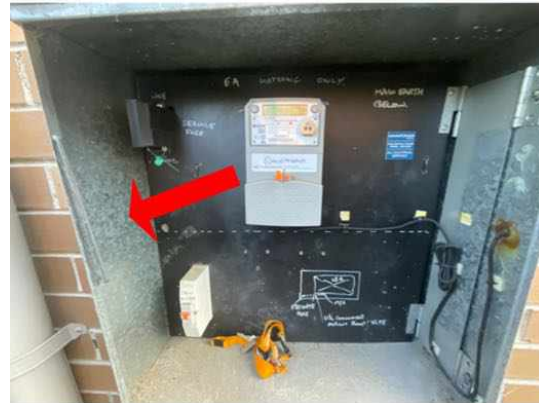
Building:	Main Building
Location:	All Areas
Finding:	Termite Management System - no evidence of a chemical installation
Information:	The application of a post-construction chemical termite barrier is highly recommended for all properties, particularly if live termite activity has been found on the site previously. Such barriers are highly effective in preventing termite attack on any timber

A durable notice should be placed in the switchboard unit to indicate current termite barriers. At the time of inspection, it appeared as though no termite management system has been installed, with no evidence to suggest preventative works taking place.

The client may consider gaining further advice from a pest controller as to the costs and procedures involved with this application. It is recommended that obtaining such advice be a short-term priority.
