# Building and Timber Pest Inspection Report

Inspection Date: Sun, 8 Feb 2026

Property Address: 4/57A-61 millet street Hurstville

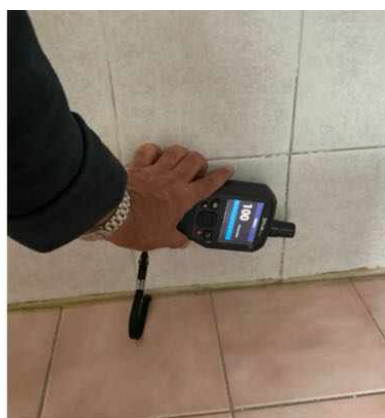
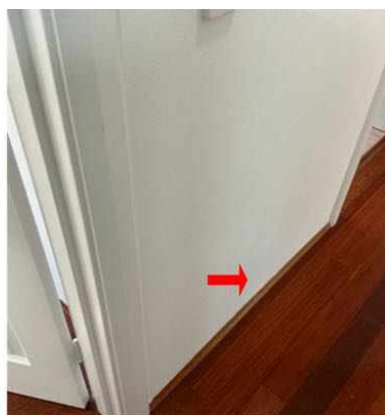
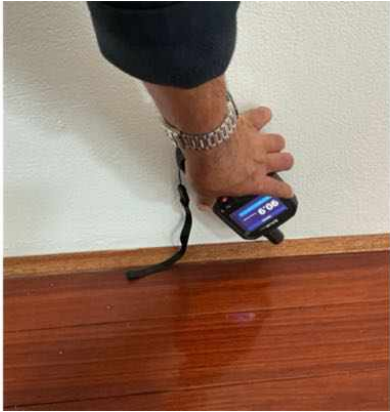
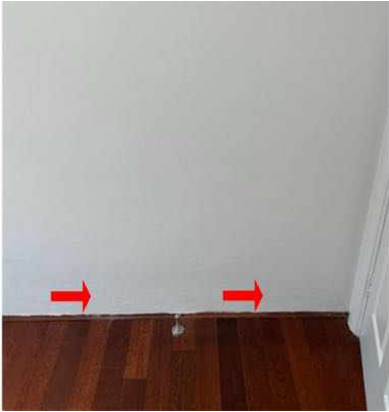
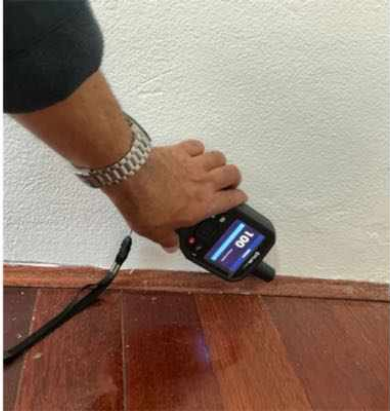
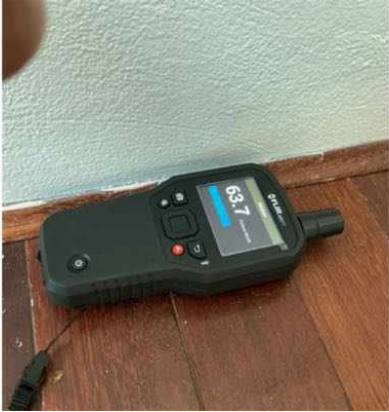
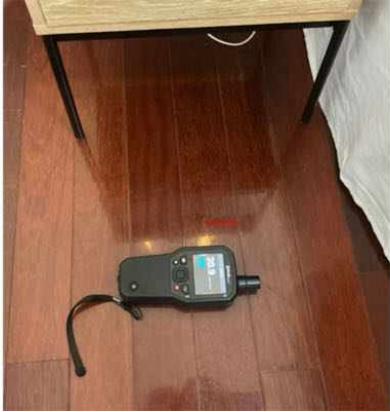
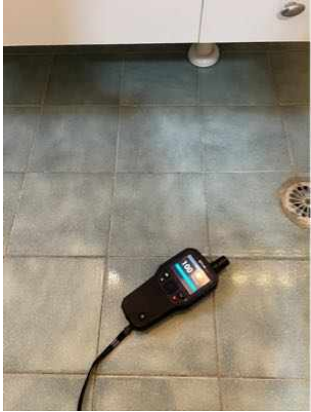
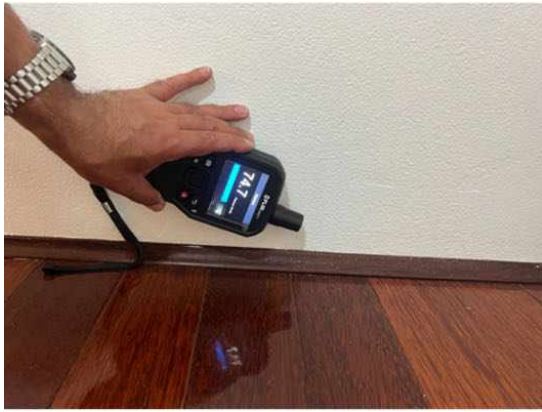
#### Finding 2.01

Building: Main Building  
Location: Bathroom, ensuite  
Finding: Elevated Moisture Bathroom & Back of shower  
Information: Elevated moisture levels were detected to tiled surfaces in bathroom/shower areas. This may be due to porous or missing grout, cracked tiles or recent use, however the possibility of waterproofing membrane failure or plumbing leaks cannot be excluded. Persistent moisture ingress can lead to concealed damage, including timber rot and mould growth. Further investigation by a licensed plumber and/or waterproofing contractor is recommended as soon as possible. The back of shower area also showed elevated moisture with minor surface deterioration evident at the time of inspection.

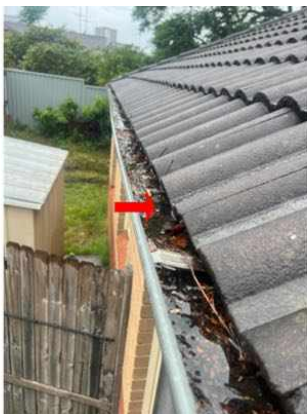
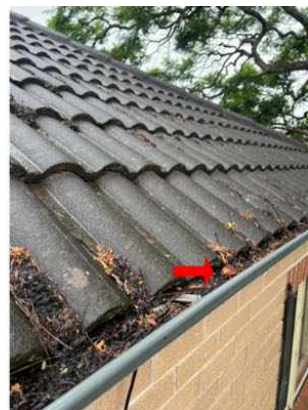
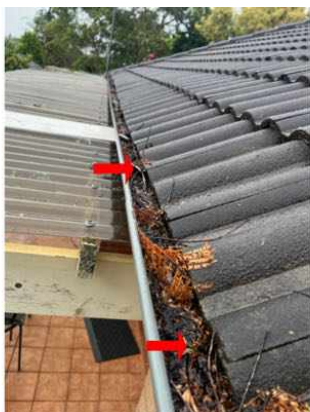
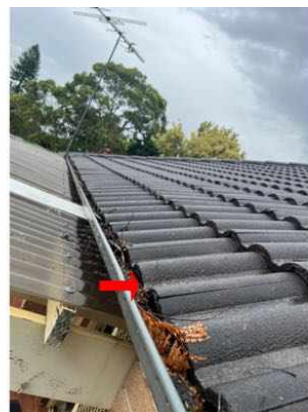
## Finding 2.02

Blocked gutters are likely to lead to high levels of moisture in the affected areas. Such moisture will not only cause rust and decay of the associated building materials, but can also provide conditions that are conducive to termite and timber pest activity. Blockages in gutters should therefore be removed immediately to ensure dry conditions are maintained.

Consult a Licensed Plumber for further specific advice on remedial works that may be required. In the interim, it is highly advised that blocked gutters be removed by the homeowner or a general handyperson as a matter of urgency.

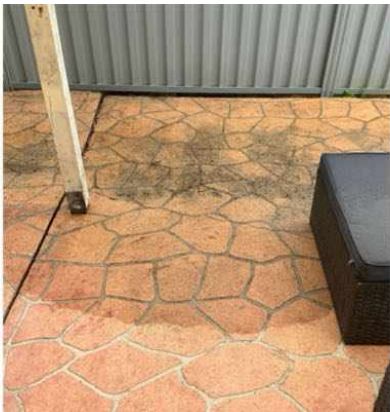
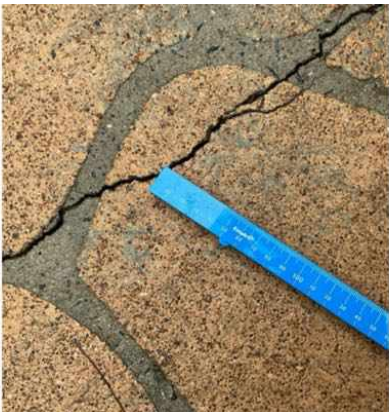
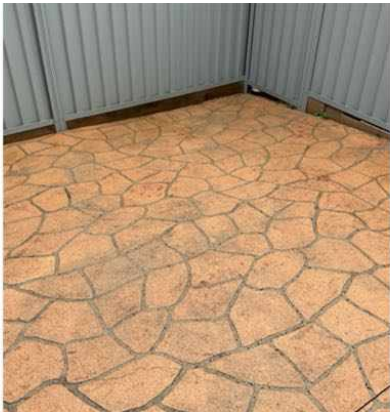
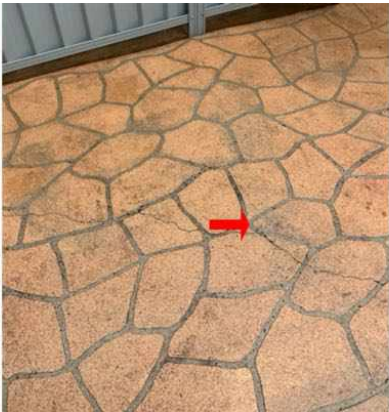
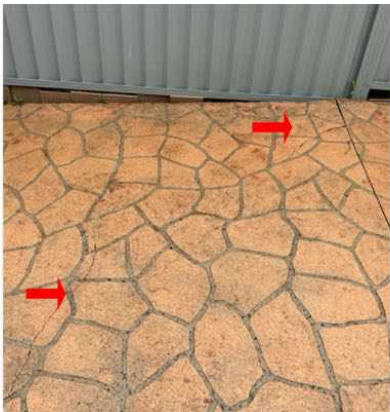
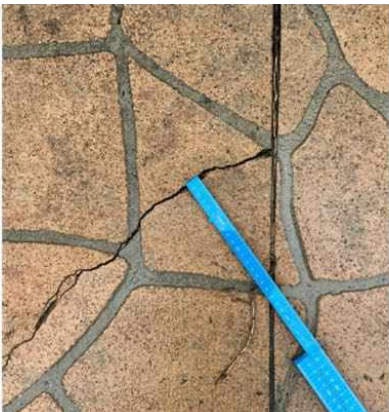
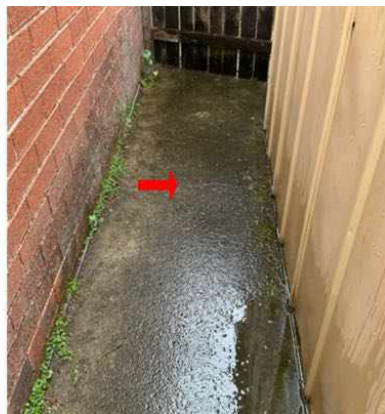
### Finding 3.01

Cracking to this degree may also be due to poor original installation of the concrete. Factors such as poor compaction of the sub surface and/or inadequate reinforcing of the slab may create cracking and other secondary defects. Gaps in the concrete paving may also have a more significant structural cause, such as subsidence of soils.

Where gaps in the concrete paving are adjacent to structural elements of the building, the advice of a Structural Engineer is advisable before undertaking repairs. Significant repair and likely replacement of the concrete paving is probable.

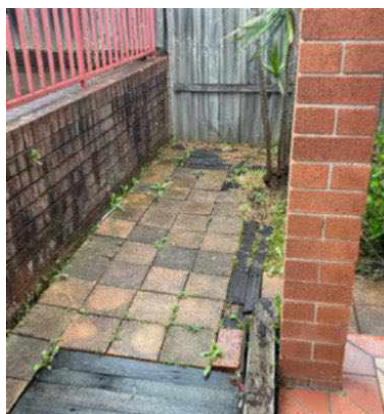
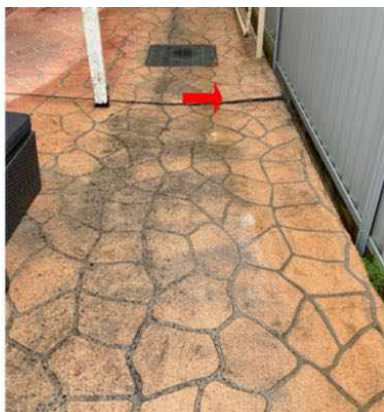
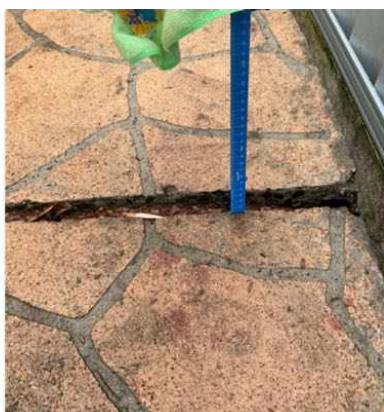
### Finding 3.02

Where paving creates a trip hazard, personal injury may ensue if due caution is not taken by all persons within this area.

Re-paving of the area is required as soon as possible to remedy this situation. Further consultation with a specialist concreter is advised.

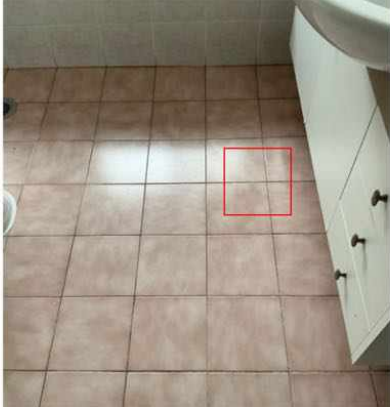
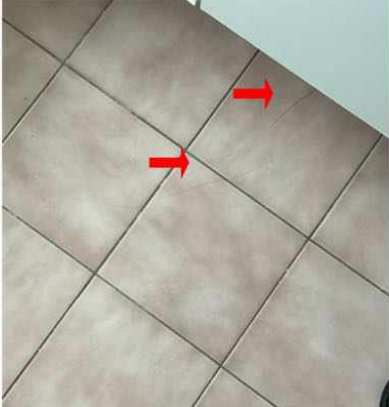
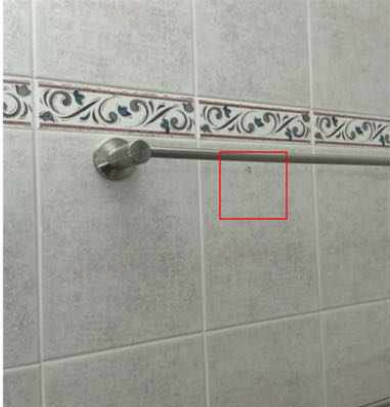
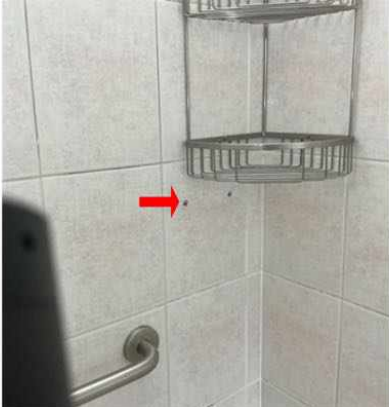
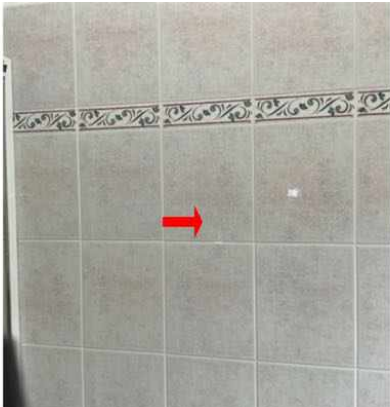
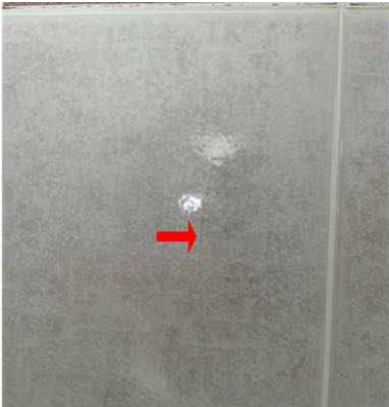
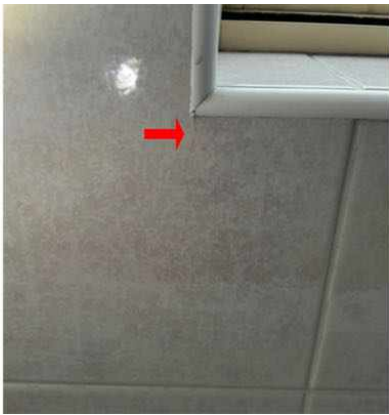
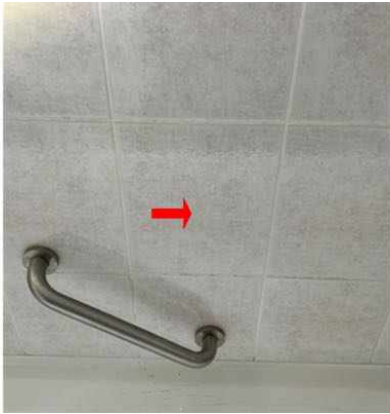
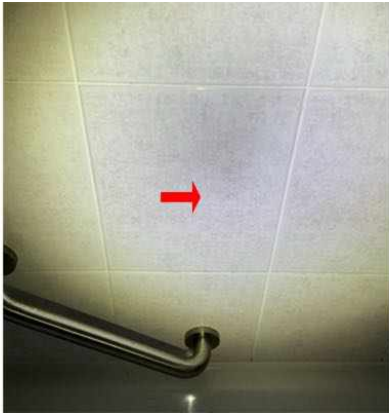
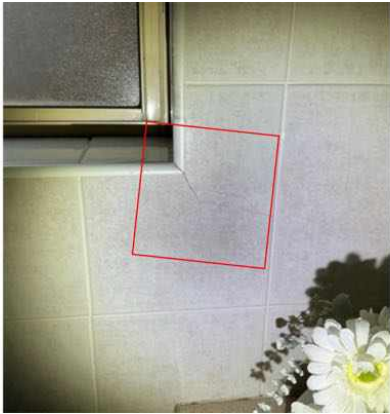
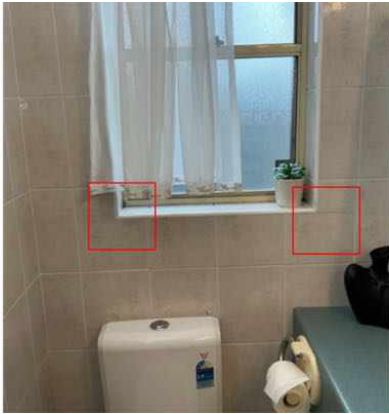
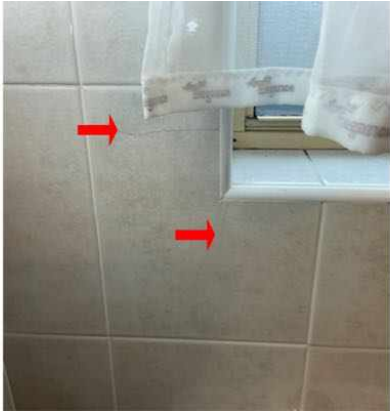
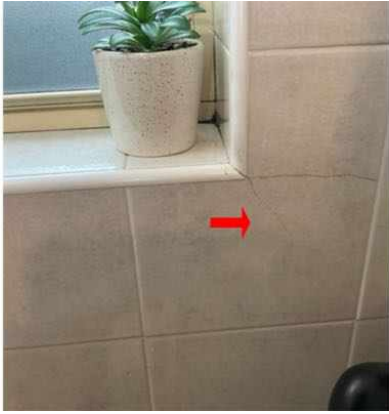
Building: Main Building  
 Location: Bathroom, ensuite, kitchen, garage  
 Finding: Tiles - Cracked or damaged

occurs. The re-application of silicone and grouting throughout remaining tile work is also advised, to further protect the area against water penetration.

Where water penetration has led to water damage, appointment of a relevant tradesperson may be required to repair damaged building elements.

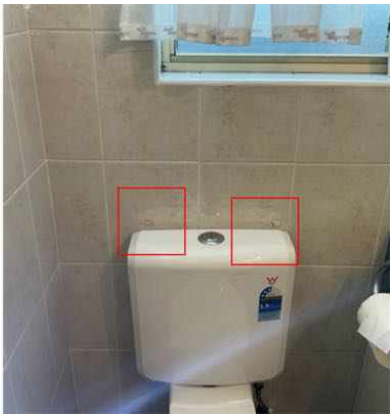
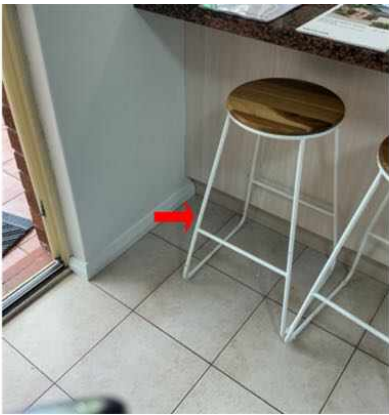
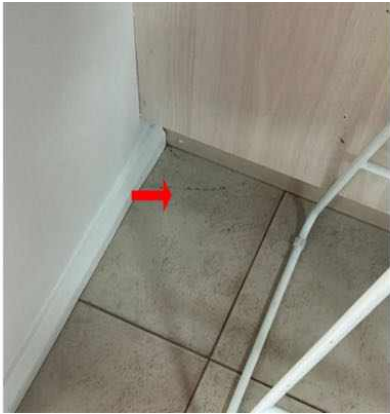
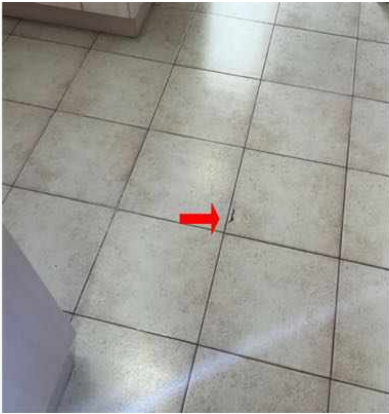
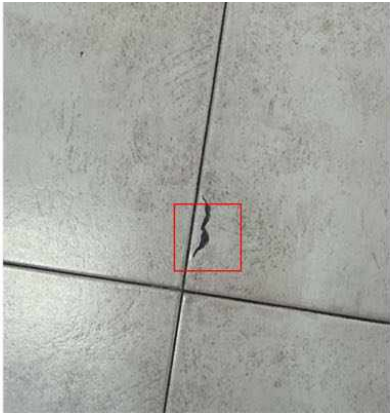
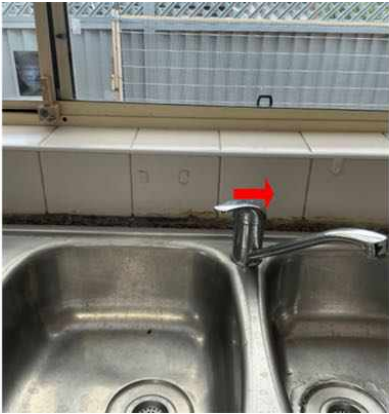
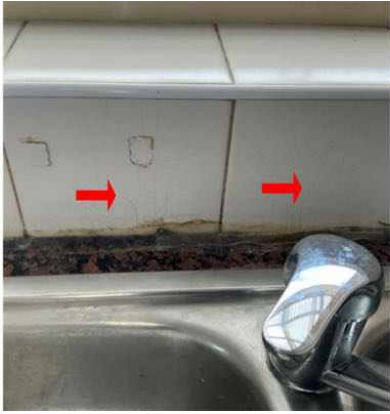
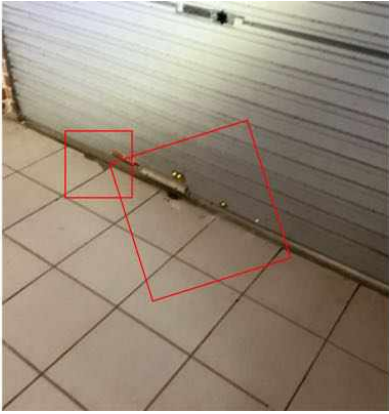
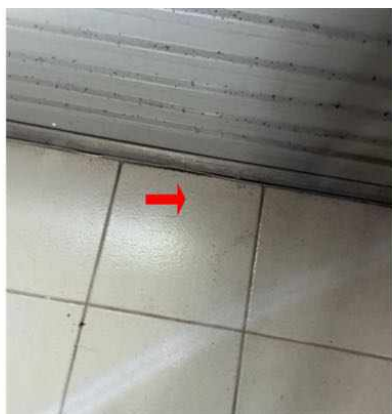
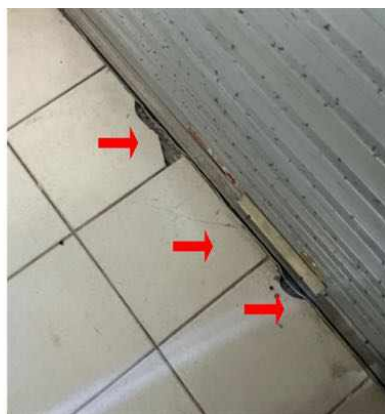
Information: Cracking was evident to the tiling in this area at the time of inspection. While the cracking appears to be minor, this area is frequently exposed to water, allowing potential for water penetration into adjoining sections of walls or flooring.

If left unmanaged, water penetration to these areas may lead to subsequent water damage, which is likely necessitate repair work to affected building elements.

A tiling contractor should be appointed to ensure that no further water damage

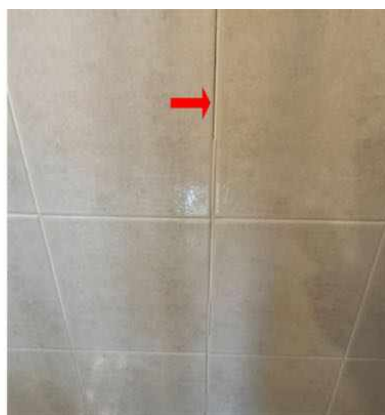
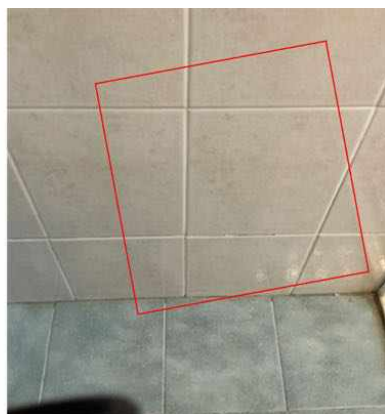
### Finding 3.04

Information: Drummy tiled areas were identified at the time of inspection. The term 'drummy' refers to tiles that have become detached from their fixing, despite otherwise being in relatively good condition. Such defects are generally caused by physical or moisture damage to the area. Drummy tiled areas may also be a direct result of poor workmanship during the construction process.

Tiled areas may swell and shrink with changes in air humidity if the area has sustained moisture damage. Any exposure to moisture is capable of causing tiled areas to become drummy and/or cracked over a prolonged period of time. Drummy tiled areas generally require removal and replacement of affected tiles, with adequate sealant and grouting.

Specialist trades are available for these types of services. A registered builder may be required to undertake works if damage is extensive or if secondary building defects have resulted. Otherwise, it is advised that a tiling contractor be appointed to perform works as necessary. Immediate action is recommended to ensure that no further damage is sustained in the affected area.

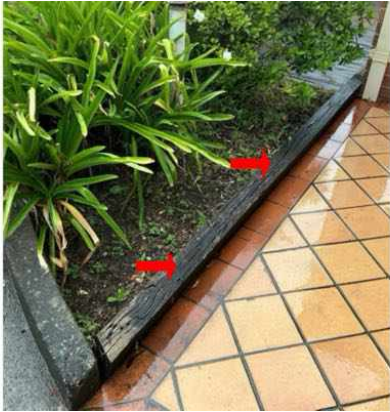
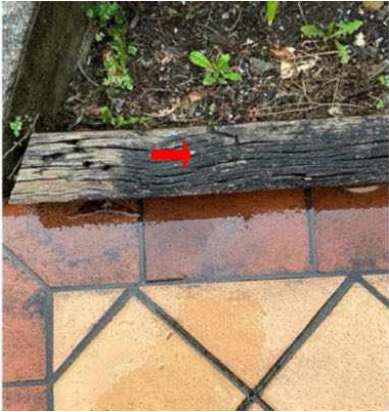
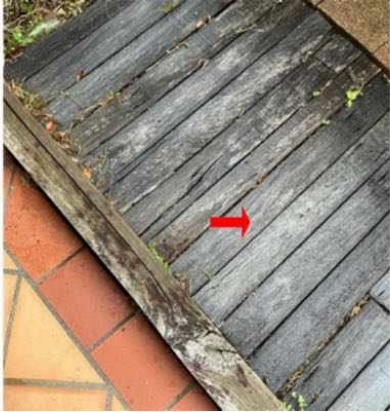
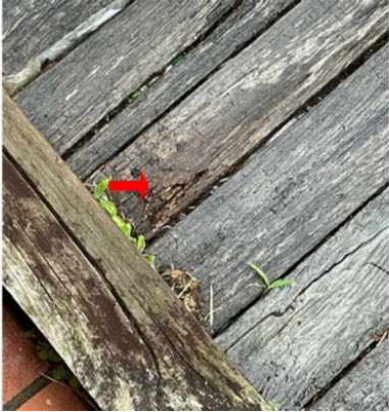
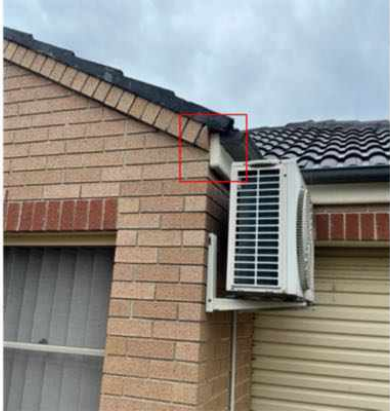
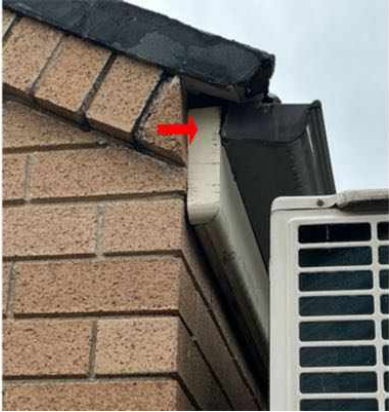
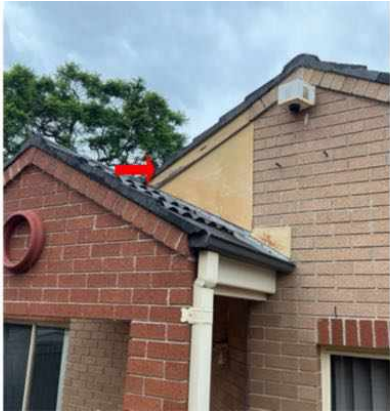
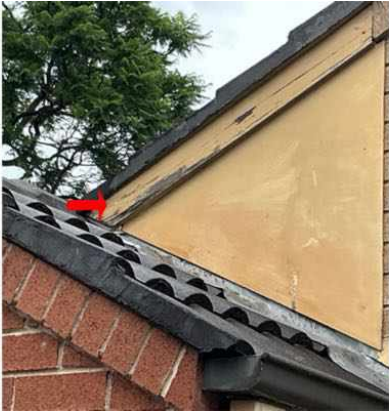
### Finding 3.05

| Finding: | Wood rot to some areas |
| Information: | This building element shows evidence of wood rot. Wood rot, also known as Fungal Decay, occurs when timbers and other cellulose building materials are exposed to damp conditions on an ongoing basis. This could be the result of exposure to weathering over a prolonged period of time, or the attraction of excessive moisture from other abutting building materials. Contributing factors also include poor air ventilation in the area. |

Wood rot is often associated with general damp problems and is evidenced by a 'musty' smell or mould and mildew occurring on surfaces. If left unmanaged, damp conditions can lead to further health problems and the decay of timbers will continue.

Early intervention and regular maintenance, particularly of exterior timbers, will prolong the useful life of these building elements. Prior to any works being performed, the cause of the moisture that has created the visible wood rot should be identified and addressed in a suitable manner. Replacement of affected timbers may then be a necessary step in protecting surrounding building elements from such deterioration.

A qualified plumber may be appointed to assess the cause of excessive moisture and to provide advice on any remedial works as required. A qualified carpenter or registered builder may also be required to replace affected building materials.

Even though Liverpool termite activity was not visible. A further invasive inspection by a licensed termite technician its also highly recommended to eliminate possibility of potential termite activity.

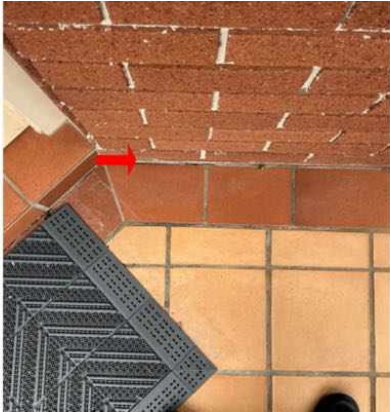
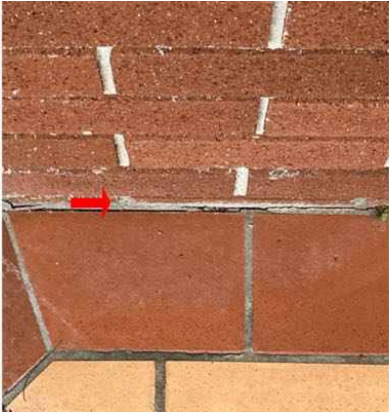
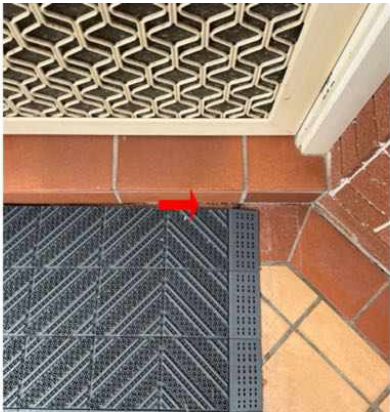
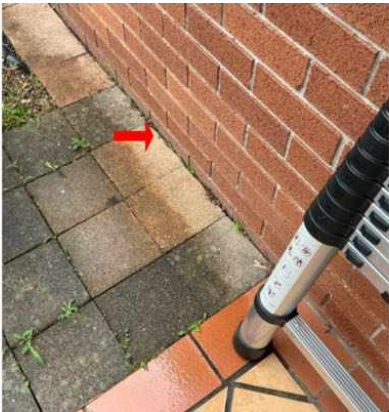
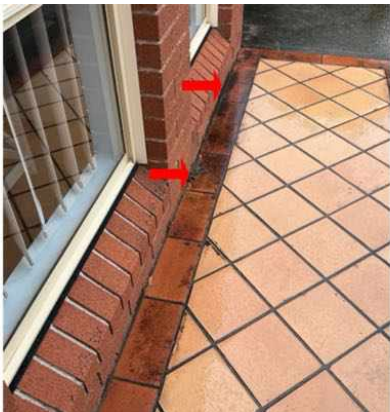
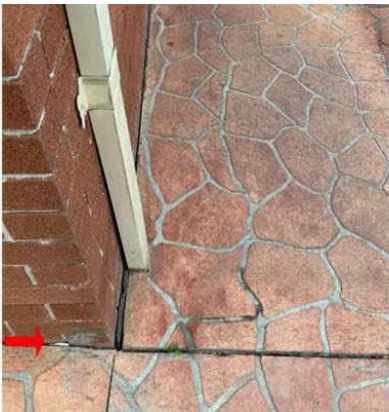
Building: Main Building  
 Location: All External Areas  
 Finding: Gap Between Concrete and External Wall - to some areas  
 Information: Visible gaps were observed between the external masonry wall and adjacent concrete slab at the pathway.

This separation may permit water ingress and contribute to concealed moisture-related damage, pest ingress, or slab movement if left unsealed.

The defect appears consistent with common differential settlement or poor sealant detailing at the slab-to-wall junction. Recommend a licensed contractor seal the gap with an appropriate flexible, UV-stable exterior-grade sealant to prevent moisture entry and pest intrusion.

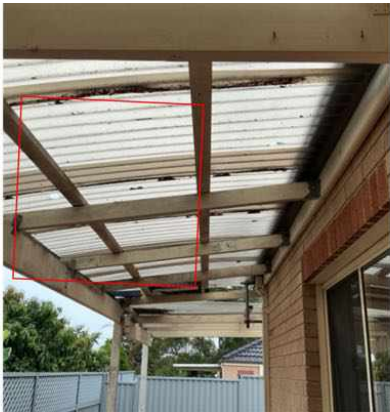
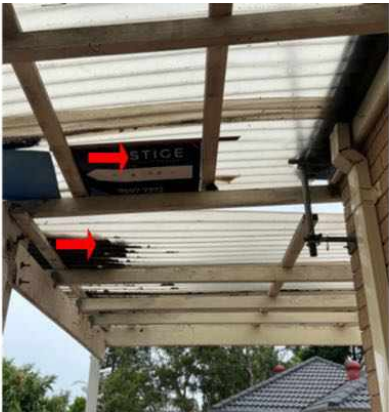
**Finding 3.09**

Building: Main Building  
Location: All External Areas  
Finding: Building element - Damaged - Shed Roof sheeting damaged requires replacement and wood rot to some areas  
Information: Breakage occurs generally when the building materials have either aged and decayed, or as a result of damage (accidental or deliberate).

Repair and/or replacement of broken elements is advised to ensure that additional secondary defects do not arise as a consequence. Such works are necessary, as all building elements play a key role in the operation and function of the overall structure and its performance.

A relevant tradesperson should be appointed to repair or replace the affected building element prior to any subsequent damage being caused.

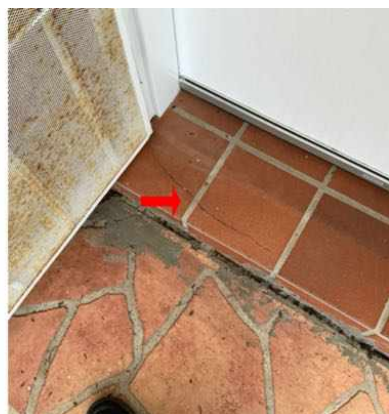
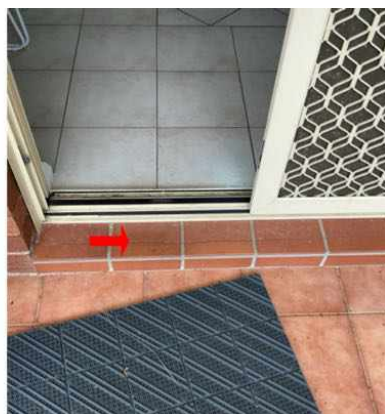
### Finding 3.10

| Finding: | Cracked floor tiles |
| Information: | Cracking in the floor tiles was evident in this area at the time of inspection. It is suspected that this cracking has occurred as a result of minor settlement or shrinkage of the slab. |

Cracked tiles throughout the household detract from the overall appearance of the affected areas however it is unlikely to create or lead to any secondary defects.

While not considered a matter of urgency, replacement of cracked floor tiles is recommended at the clients discretion. A tiling contractor may be appointed to perform these works. Where cracks become more numerous, contact a licensed building inspector for further investigation.

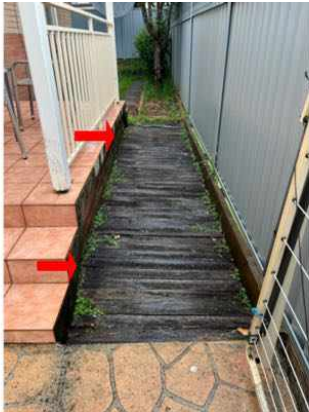
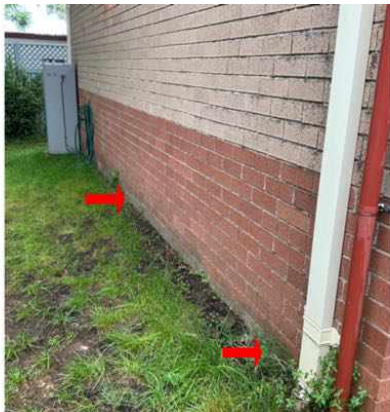
### Finding 3.11

| Finding: | Site drainage - Inadequate |
| Information: | The site drainage in this area was found to be inadequate at the time of inspection, creating potential for subsequent water damage to associated building elements. |

It is important that water does not lie against the base of walls; surrounding paths and ground levels should be sloped to drain water away from walls. Downpipes should not discharge stormwater onto lower walls or plinths. Stormwater should be carried away by large, regularly cleaned drains. Ground levels may need to be lowered to expose a buried DPC.

Where site drainage is inadequate, installation of an Agricultural (Aggie) Drain may be required. A qualified plumber should be appointed to further inspect the property and perform any remedial works as necessary. Water damage and secondary defects are likely to occur if left unmanaged.

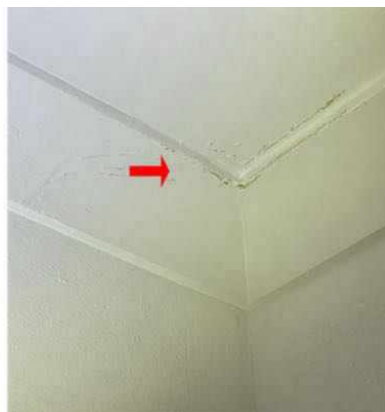
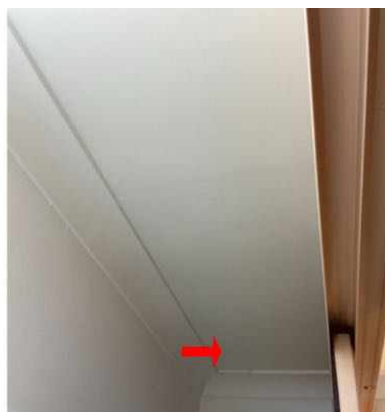
### Finding 3.12

| Finding: | Ceiling - Water damaged |
| Information: | Water damage to the ceiling lining is generally an indication of excessive moisture being present in the roof void, usually via a leak to the roof covering. |

Where water damage is evident to the ceiling, the primary requirement is to identify and rectify the source of the leak. A roofing plumber should be appointed as soon as possible to identify the leak and perform rectification works as necessary, ensuring the water damage is restricted.

Once the leak is repaired, consultation with relevant tradespeople, including plasterers and painters, is advised. Rectification works may include replacement of ceiling lining or minor repainting, depending on the extent of the damage.

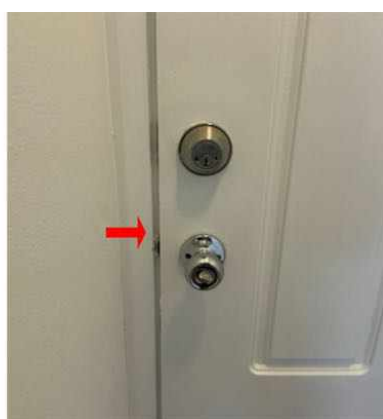
### Finding 3.13

| Information: | Binding and/or jamming of several doors throughout the property were evident during standard operation. This defect inhibits the functionality of affected doors as well as creating potential for secondary defects to associated building elements, such as |

damage to the floor covering.

A door that binds to flooring or to the associated door frame may have several causes, ranging from minor defects, such as poor installation of the door or deteriorated hinges, through to major structural issues, such as damage to subfloor structures.

Where door binding/jamming appears to indicate major structural issues, a registered builder specialising in re-stumping should be appointed to provide an estimate on the cost of rectification.

For minor causes, a qualified carpenter or general handyman should be appointed to perform minor rectification works at client discretion.

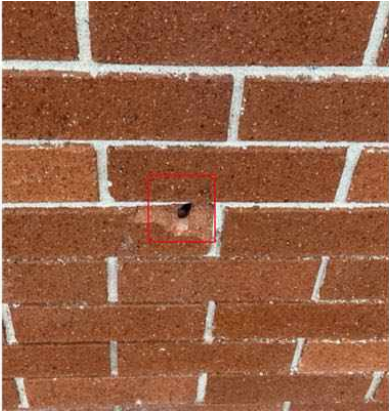
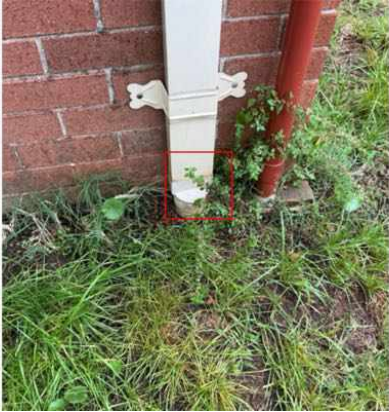
### Finding 3.14

| Finding: | Building element - Damaged- damaged bricks , downpipe damaged side |
| Information: | Breakage occurs generally when the building materials have either aged and decayed, or as a result of damage (accidental or deliberate). |

Repair and/or replacement of broken elements is advised to ensure that additional secondary defects do not arise as a consequence. Such works are necessary, as all building elements play a key role in the operation and function of the overall structure and its performance.

A relevant tradesperson should be appointed to repair or replace the affected building element prior to any subsequent damage being caused.

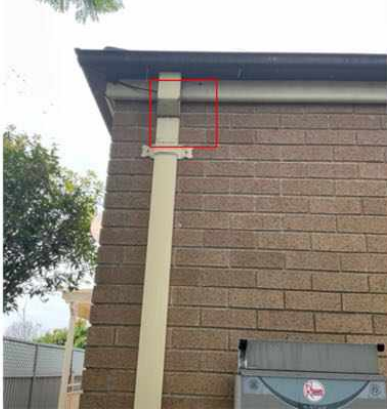
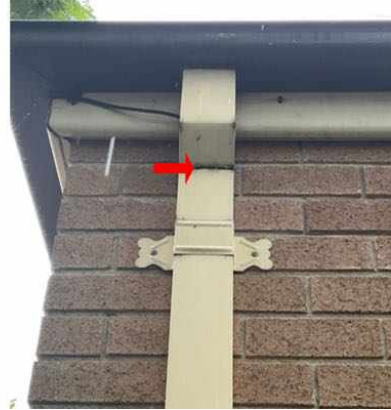
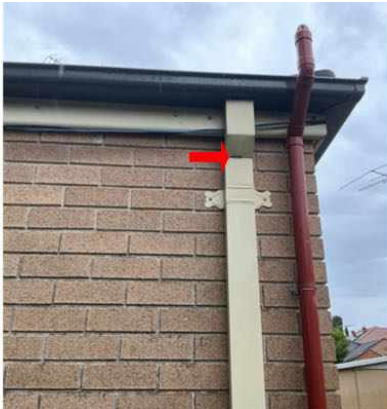
Building: Main Building  
Location: All External Areas  
Finding: Building element - Rusted or corroded  
Information: This building element shows evidence of rusting and corrosion, which is likely to have developed as a result of excessive exposure to moisture and or inadequate coatings.

As surface rust provides no protection to the underlying iron, the deteriorating condition is likely to worsen if not addressed in the short-term future.

Rusting and corrosion should be managed by ideally removing or limiting the affected surface from exposure to moisture. A registered builder may be appointed to replace any building elements that have been severely affected by rust or water damage.

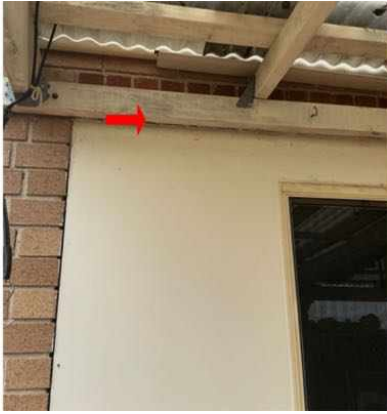
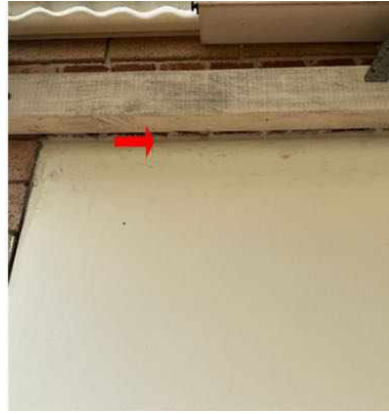
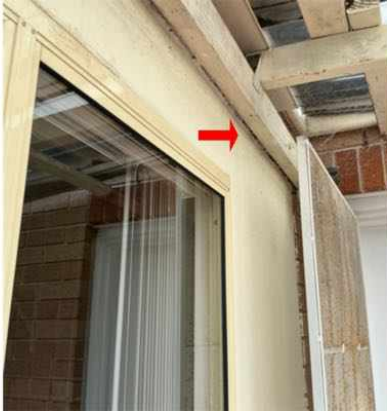
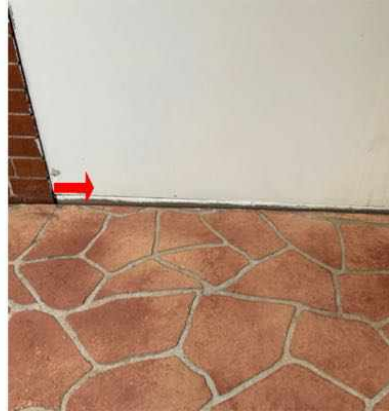
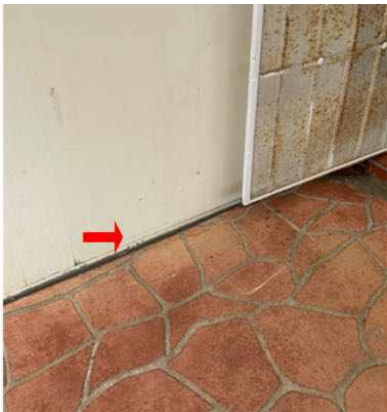
### Finding 3.16

| Finding: | Incomplete or substandard works - Missing flashing top and excessive use of silicone, bottom not sealed |

Works that have not been completed to a satisfactory level create potential for the development of building defects and may impede on the safety and integrity of the overall structure.

It is highly recommended that the relevant trades be appointed to complete these works and ensure the safety of the area and the longevity of all associated building elements.

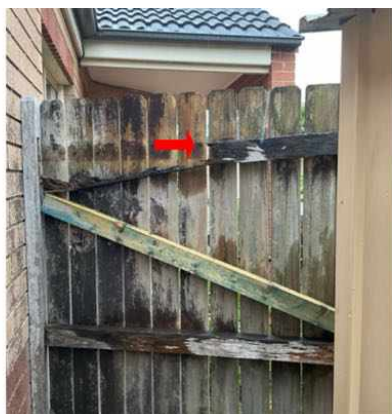
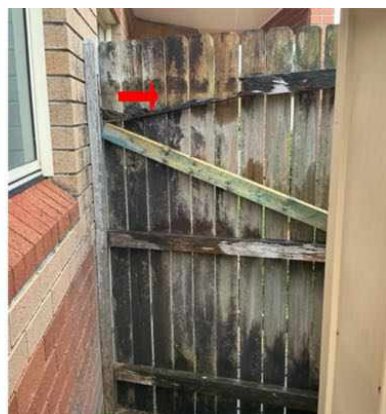
### Finding 3.17

| Finding: | Building element - Damaged - Fence support damaged |
| Information: | Breakage occurs generally when the building materials have either aged and decayed, or as a result of damage (accidental or deliberate). |

Repair and/or replacement of broken elements is advised to ensure that additional secondary defects do not arise as a consequence. Such works are necessary, as all building elements play a key role in the operation and function of the overall structure and its performance.

A relevant tradesperson should be appointed to repair or replace the affected building element prior to any subsequent damage being caused.

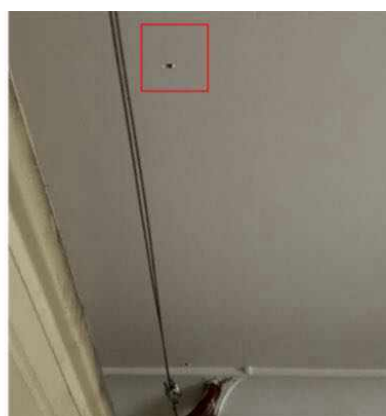
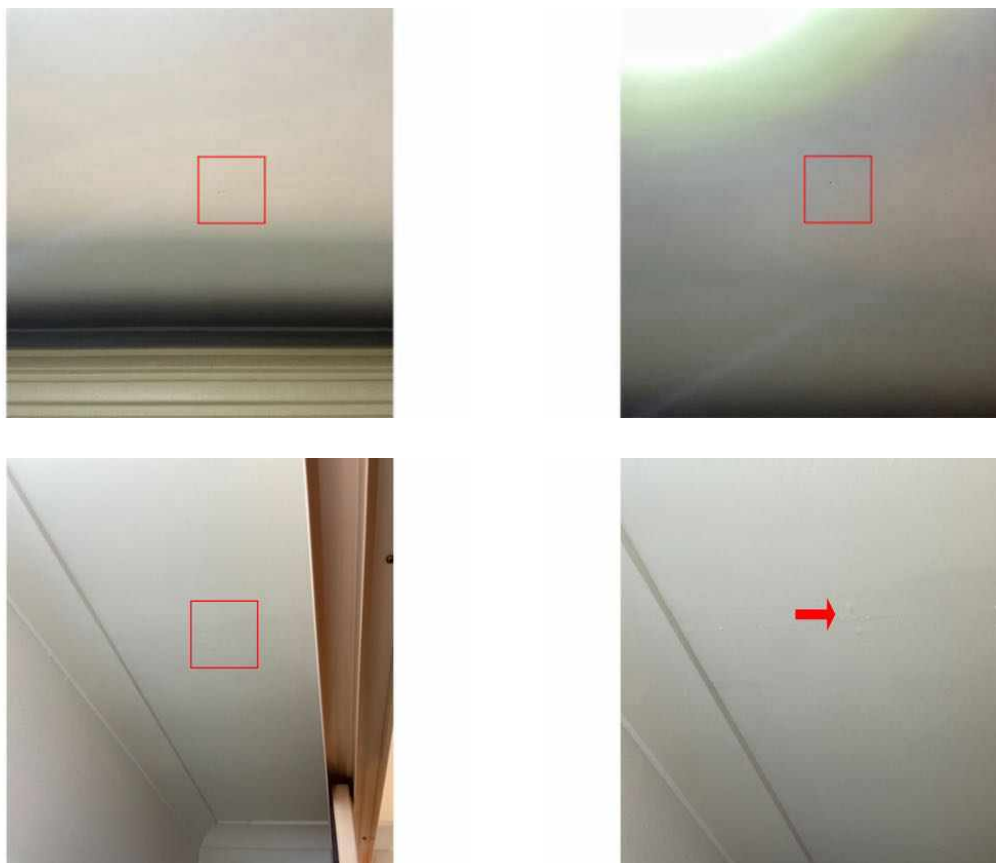
### Finding 3.18

Building: Main Building  
 Location: Garage, Bedroom  
 Finding: Ceiling nails - Popping To some areas  
 Information: Numerous popped nails were identified in the internal ceiling at the time of inspection. Nails and screws hold simply by the friction between them and the surface they are applied to. Over time, the nails and screws can back out, which is often a result of general ageing and deterioration of the building structure.

If left unmanaged, the ceiling sheets may become loose and unstable, increasing the rate of deterioration of the internal ceiling and creating potential for the development of secondary defects.

Re-fastening of popped nails will help to maintain the stability of the internal ceiling and associated building elements. Such minor works will also help to improve the appearance of the affected area and secure the ceiling sheets, so as to prevent the onset of ceiling sagging. These works should be performed by a qualified carpenter or plasterer at client discretion.
