# Building and Timber Pest Inspection Report

Inspection Date: Sun, 8 Feb 2026

Property Address: 4/57A-61 millet street Hurstville

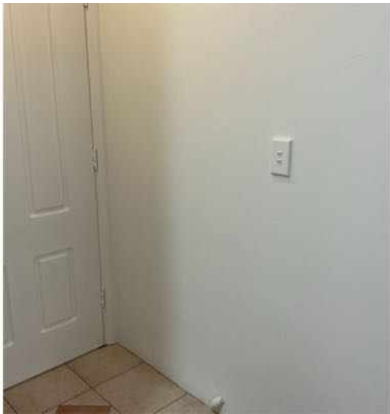
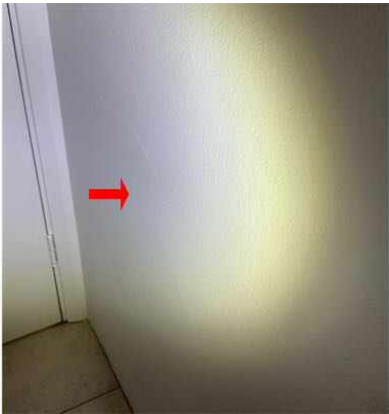
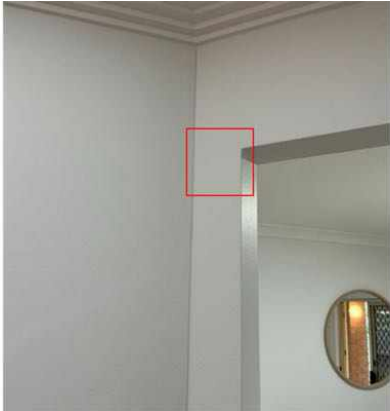
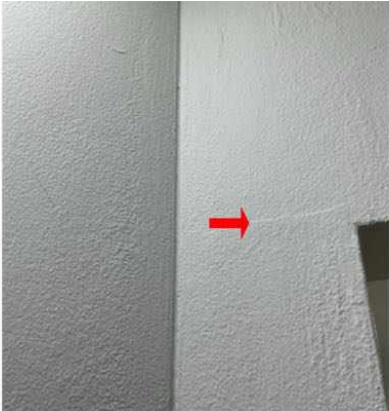
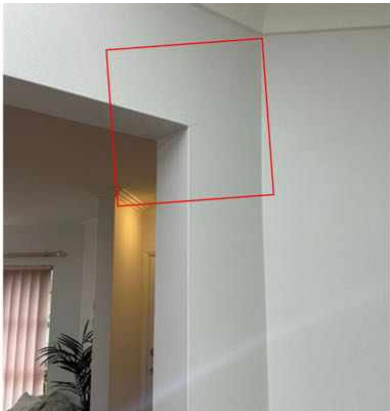
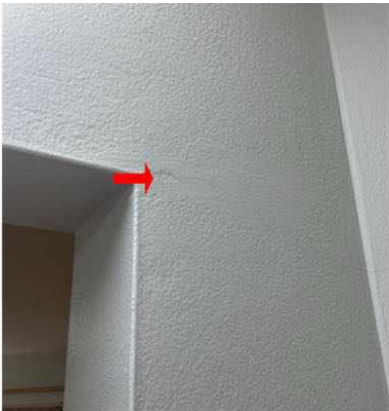
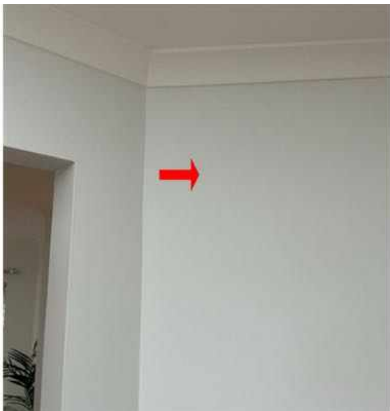
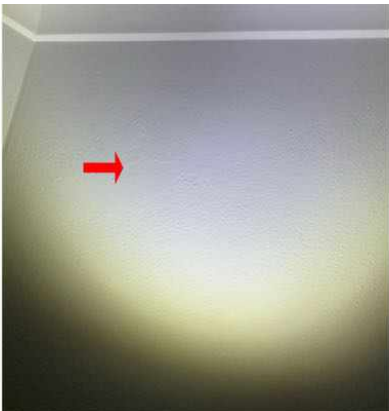
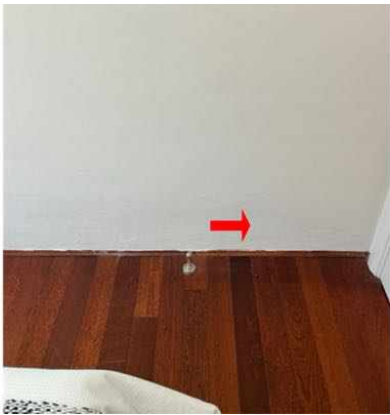
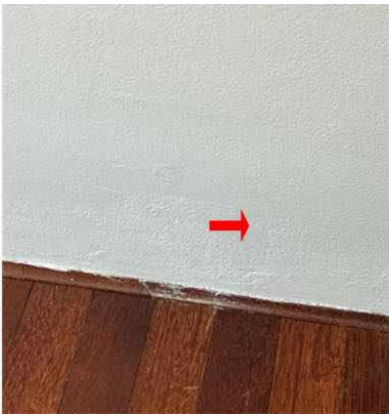
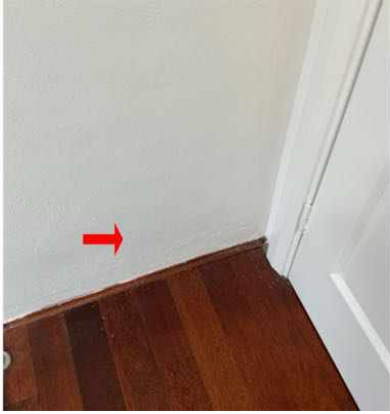
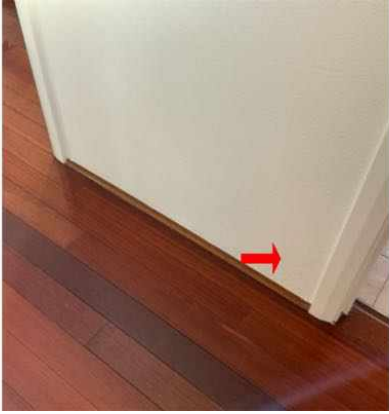
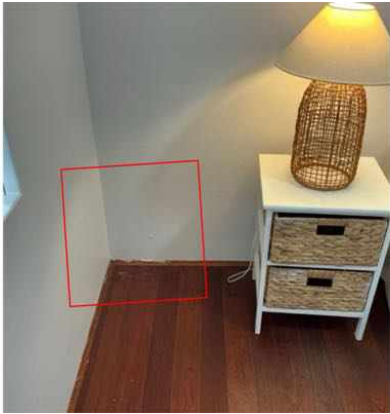
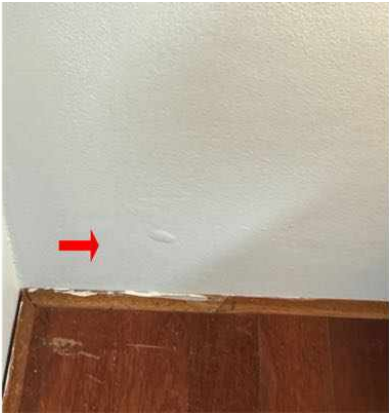
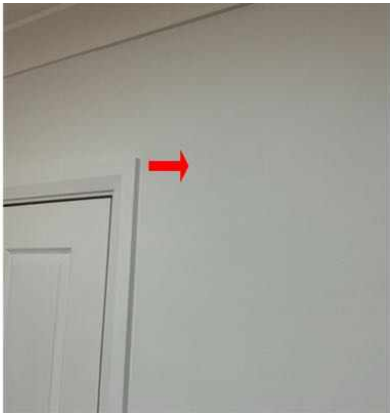
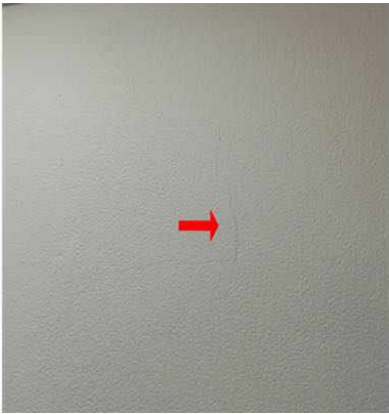
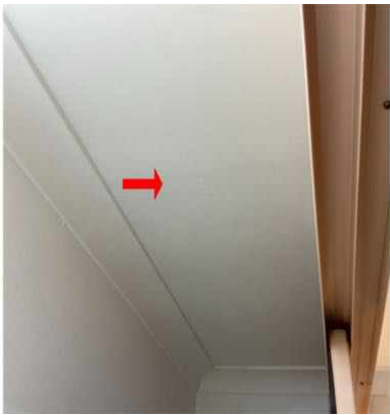
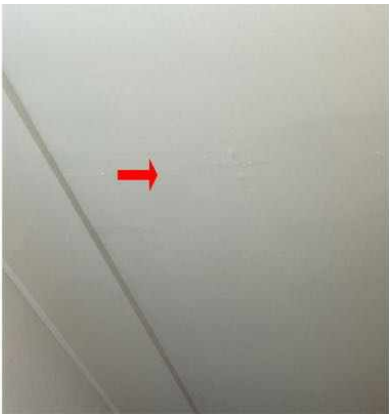
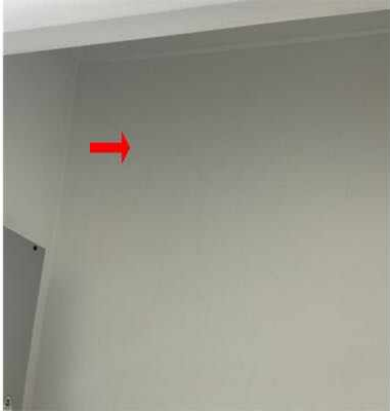
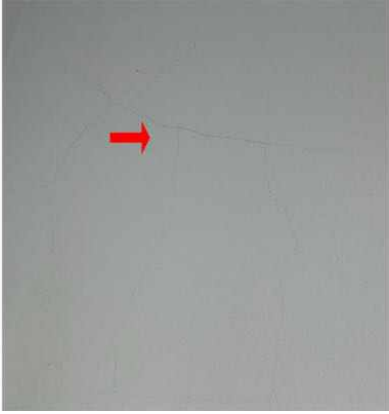
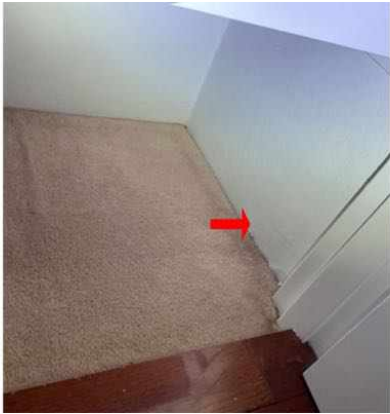
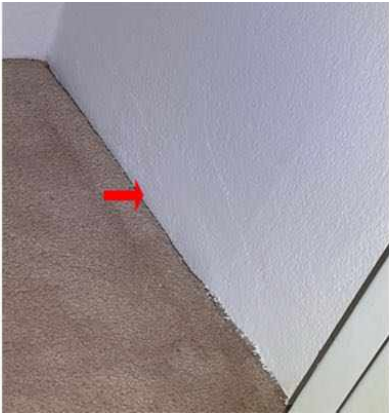
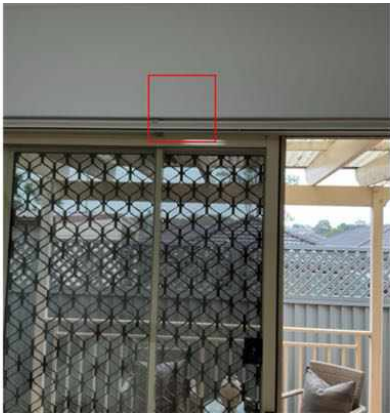
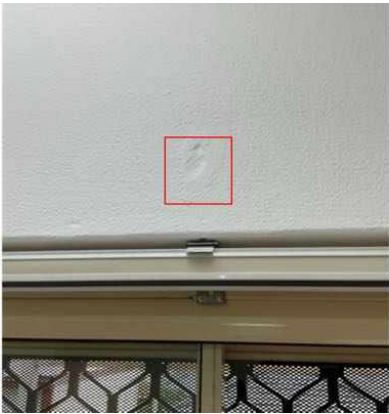
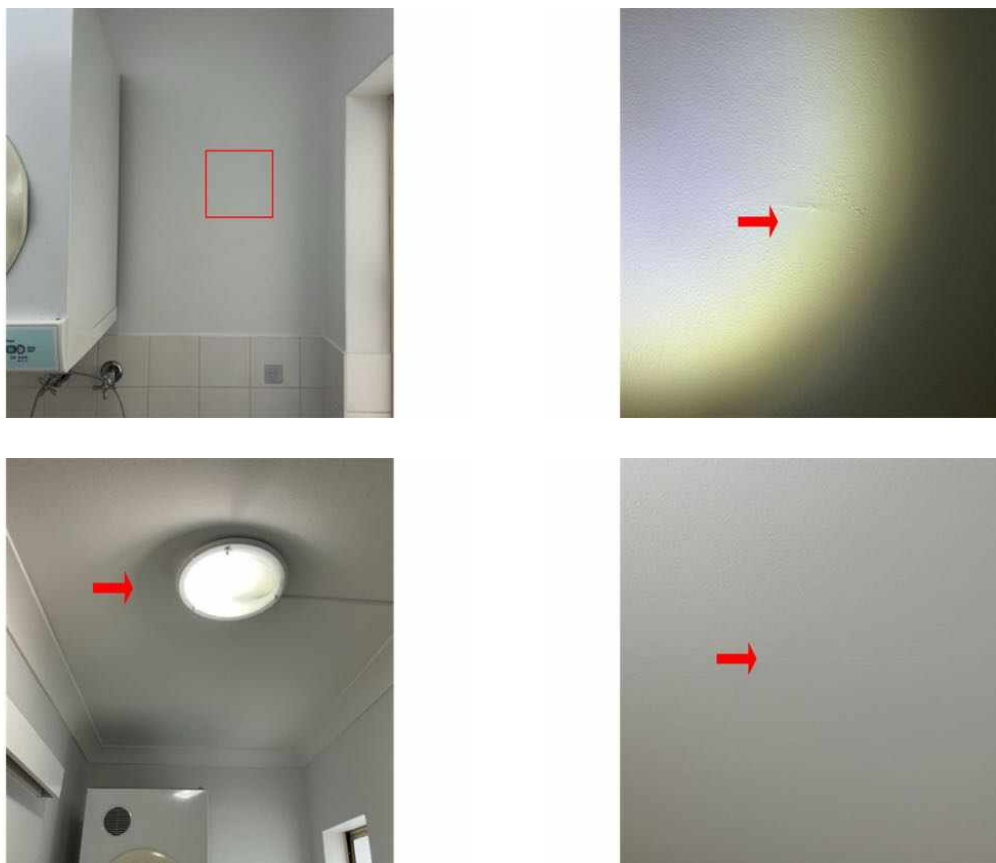
### Finding 3.19

| Finding: | Paint Finish & Hairline Cracking - To some areas |
| Information: | The paint finish in this area was identified as being incomplete or substandard at the time of inspection including some hairline minor cracking/separation. Monitoring is recommended where cracking and separation is evident. |

Whilst incomplete or missing paint finish is generally an appearance defect, it can also lead to the development of secondary building defects over time. Incomplete areas of paint finish expose the area to moisture, potentially accelerating the deterioration of underlying building materials.

Incomplete paint finishes should be sanded back, filled, leveled and painted, as applicable. Where inadequate or missing paint protection has led to the deterioration of the associated building element, repair and/or replacement of this building element may be required.

A painting contractor should be appointed as soon as possible to perform necessary works to aid the appearance of the affected area and to ensure the area is protected against further deterioration. Alternatively, the homeowner following manufacturer instructions may perform these works.

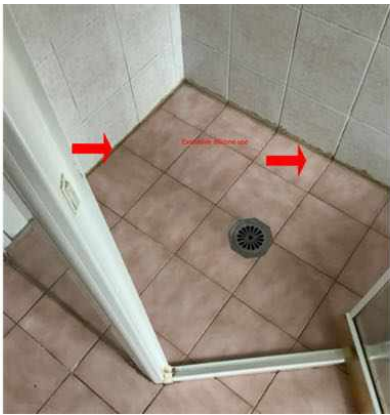
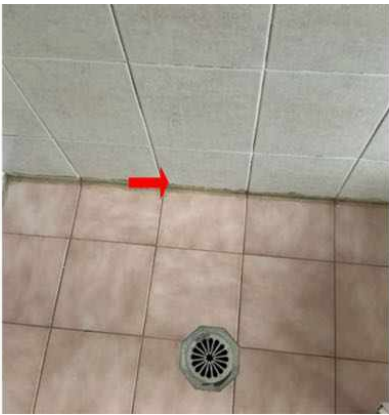
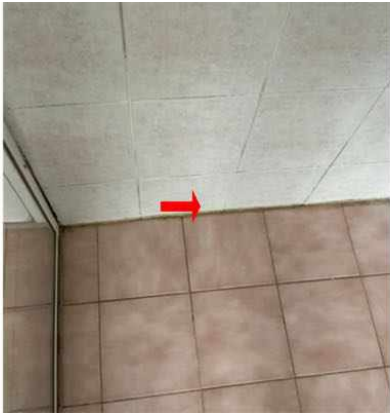
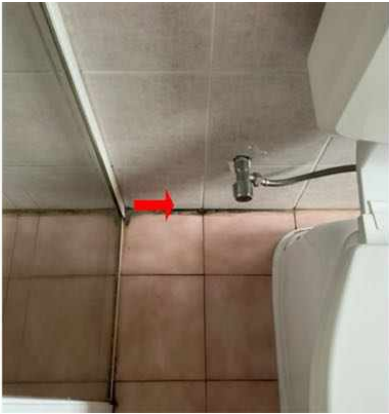
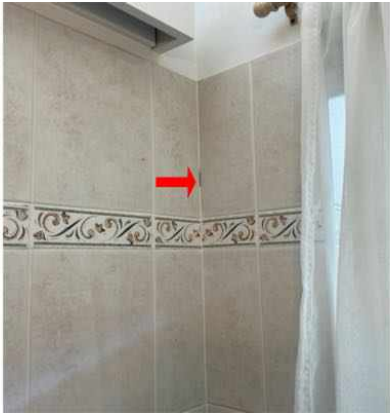
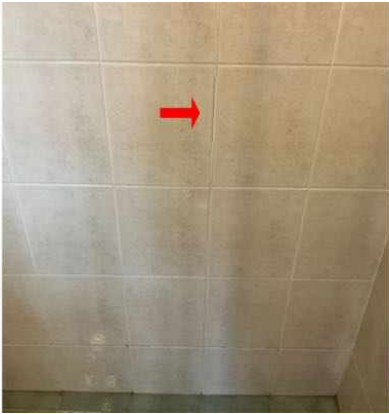
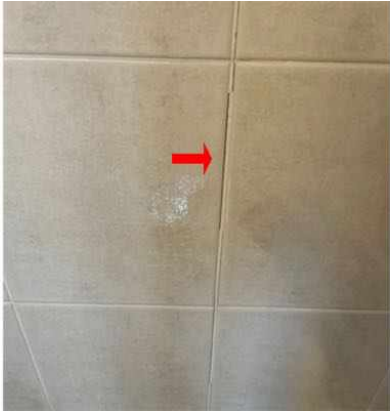
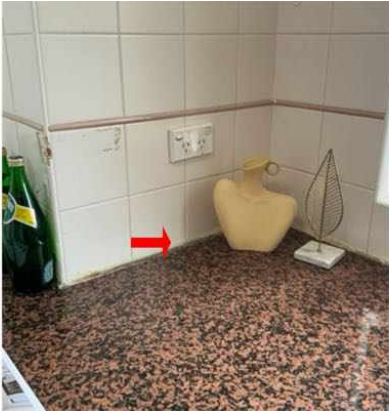
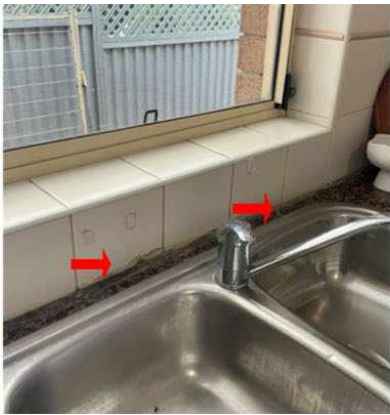
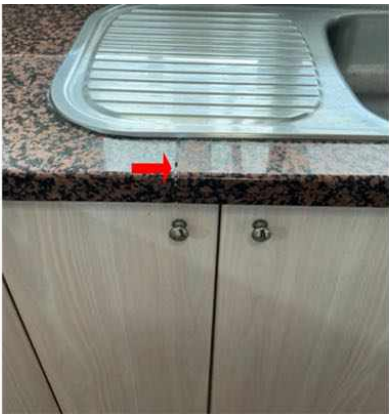
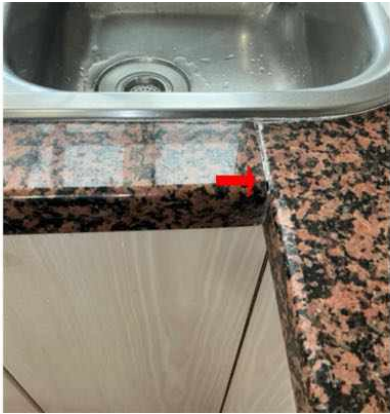
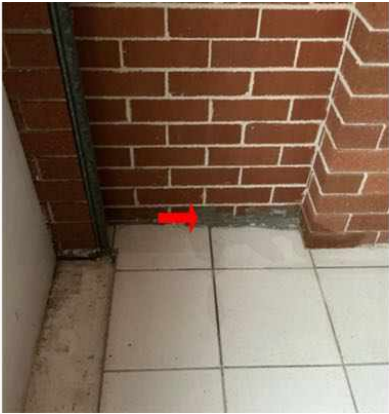
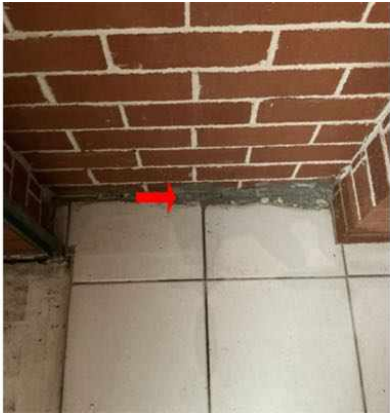
| Finding: | Sealant and grouting - Missing or degraded |
| Information: | It was noted on inspection that sealant or grout is degraded. |

Different materials and floor areas move at different rates, generally causing cracking to grout or sealant at this point. A flexible sealant is required to allow for expected expansion and contraction, while keeping the joint water tight and protective of all associated building materials.

Excessive mould to the sealant and grout may require scraping out and replacement.

Flexible and mould resistant materials should be applied to affected areas to prevent any subsequent water damage that is likely to occur. Regular maintenance and replacement of damage or missing or damaged sealant and grout is highly recommended to the wet areas, as this is a regular wear and tear defect. Sealant and grouting in areas that come into regular contact with water should be maintained for the long term care of your property.

A sealant specialist or tiling contractor should be appointed to complete these works as soon as possible

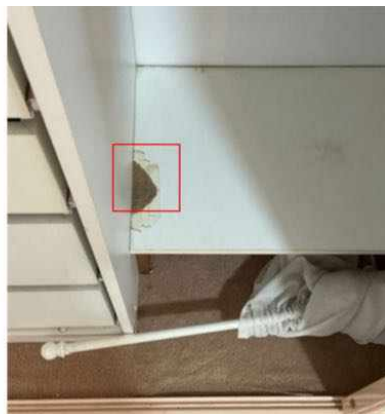
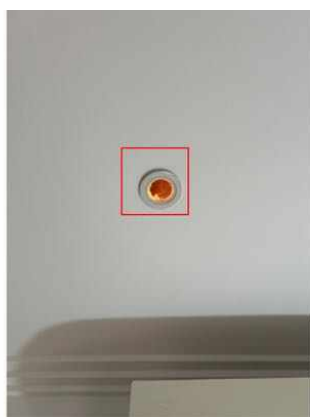
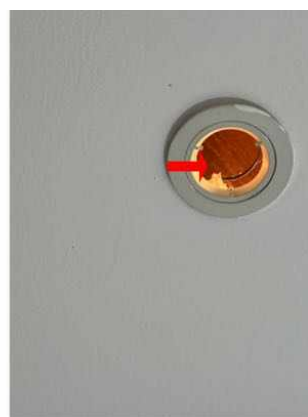
**Finding 3.21**

Building: Main Building  
Location: Bedroom - Master  
Finding: Building element - Damaged - Built in shelf damage , downlight broken lounge  
Information: Breakage occurs generally when the building materials have either aged and decayed, or as a result of damage (accidental or deliberate).

Repair and/or replacement of broken elements is advised to ensure that additional secondary defects do not arise as a consequence. Such works are necessary, as all building elements play a key role in the operation and function of the overall structure and its performance.

A relevant tradesperson should be appointed to repair or replace the affected building element prior to any subsequent damage being caused.

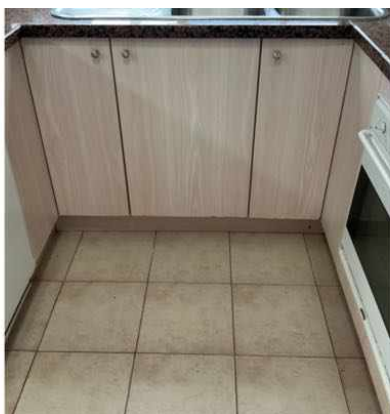
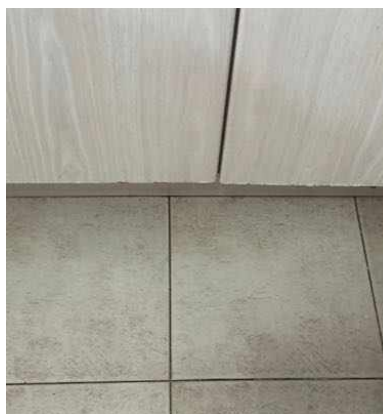
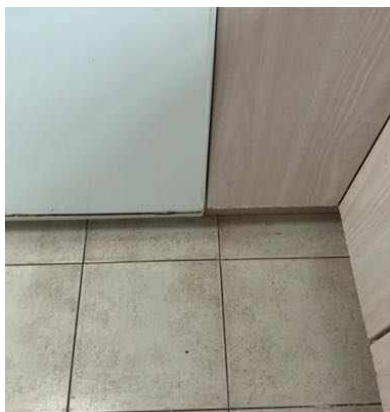
### Finding 3.22

| Finding: | Building element - Damaged - Cabinets moisture damaged |
| Information: | Breakage occurs generally when the building materials have either aged and decayed, or as a result of damage (accidental or deliberate). |

Repair and/or replacement of broken elements is advised to ensure that additional secondary defects do not arise as a consequence. Such works are necessary, as all building elements play a key role in the operation and function of the overall structure and its performance.

A relevant tradesperson should be appointed to repair or replace the affected building element prior to any subsequent damage being caused.

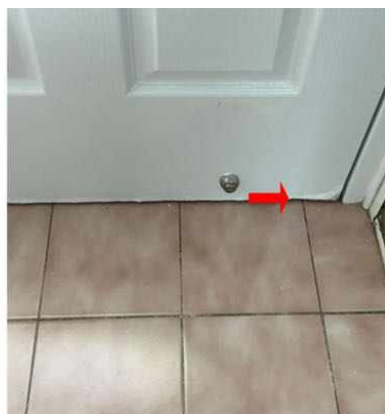
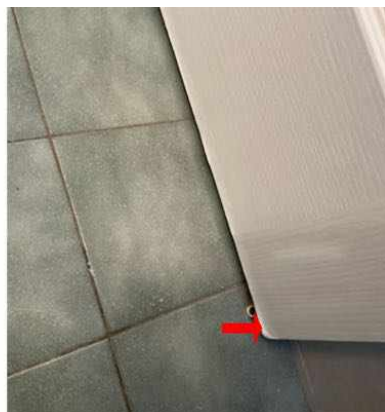
### Finding 3.23

| Information: | Delamination is one means by which composite materials (e.g. layered timber composites) may fail over time. In laminated materials, repeated cyclic stresses may lead to the formation of mini-structures of separate layers, with significant loss of mechanical toughness. Water penetration or the presence of excessive moisture also generally contributes to delamination. |

Where building materials have become delaminated, they lose their structural strength, and are likely to have a variety of appearance and serviceability defects as a result.

Delamination of timbers may be repaired where the area affected is minor and/or easily accessible, by gluing and screwing layers back together. However, this is an interim repair, and where delamination has occurred, the client should plan for the replacement of affected timbers sooner than would otherwise be expected.

All timber structures affected by delamination should be replaced as soon as possible to avoid any further damage. Repair and replacement estimates should be sought from a registered builder or qualified carpenter.

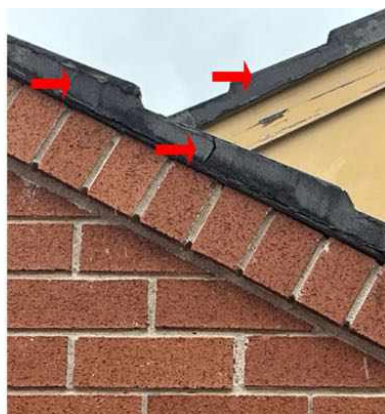
### Finding 3.24

| Finding: | Mortar - Deterioration |
| Information: | Mortar, or 'bedding', is the material which fills joints and intersections between tiles and other building elements on the exterior roof covering, such as gable ends, hip capping and valleys. Upon inspection of the exterior roof, it was noted that sections of the mortar show varying levels of deterioration. |

Mortar generally deteriorates as a result of frequent exposure to weather conditions over a prolonged period of time. Mortar that is deteriorating may allow water ingress into the roof void, putting associated building elements and roofing structures at risk of water damage. Deteriorated mortar also detracts from the functionality of roof tiles and other roofing elements, potentially decreasing weather tightness and roof drainage.

Mortar deterioration can be attended to by a handyperson where areas of deterioration are localised and easily accessible. Otherwise, consultation with a roofing contractor is advised where greater works are required.

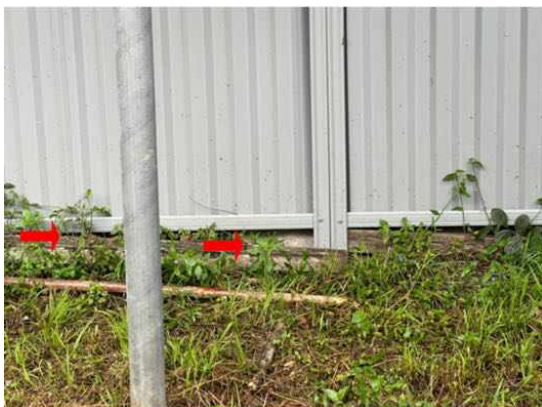
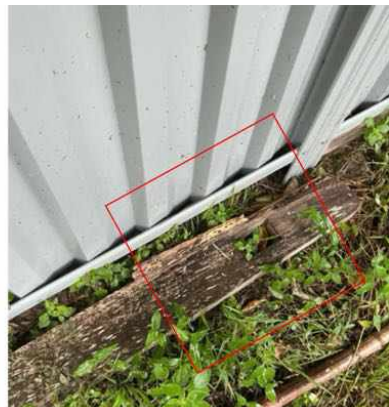
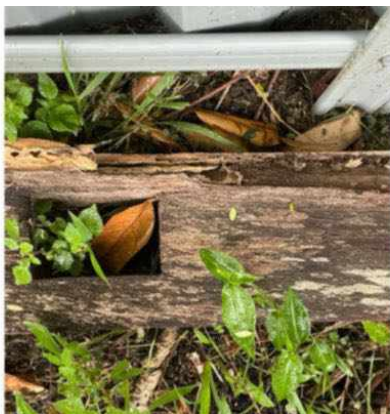
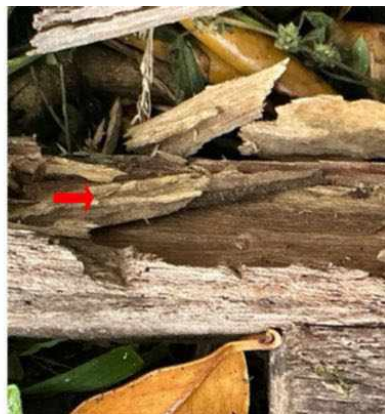
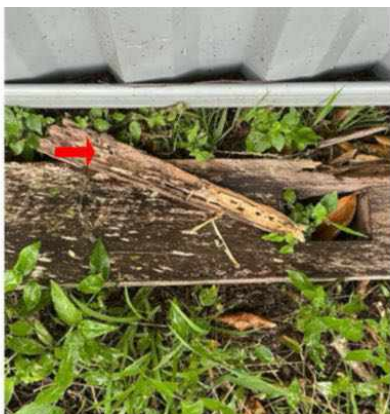
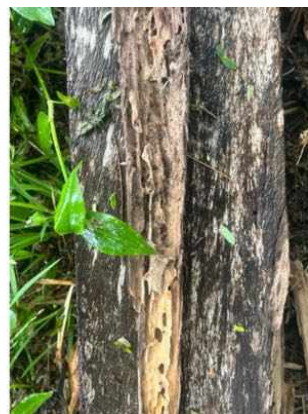
| Finding: | Termite - damage identified |
| Information: | Damage was found within timbers consistent with previous termite activity, though it appears inactive. |

invasive inspection of trees and concealed timber elements within the property by a licensed timber pest technician should be completed.

Installation of a chemical termite management system is also highly recommended.

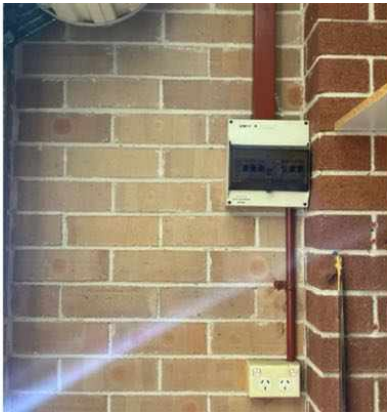
### Finding 6.01

| Information: | The application of a post-construction chemical termite barrier is highly recommended for all properties, particularly if live termite activity has been found on the site previously. Such barriers are highly effective in preventing termite attack on any timber building elements throughout the property. |

A durable notice should be placed in the switchboard unit to indicate current termite barriers. At the time of inspection, it appeared as though no termite management system has been installed, with no evidence to suggest preventative works taking place.

The client may consider gaining further advice from a pest controller as to the costs and procedures involved with this application. It is recommended that obtaining such advice be a short-term priority.

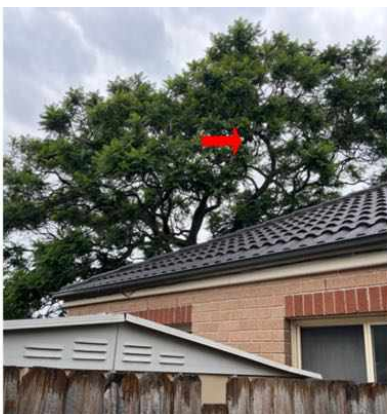
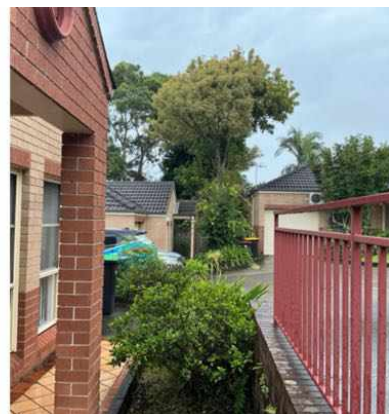
### Finding 6.02

| Finding: | Trees within 50m |
| Information: | Trees within 50m of the property can be conducive to termite activity. It is recommended an invasive inspection of all trees with 50m to the property be carried out by a qualified pest control expert. |

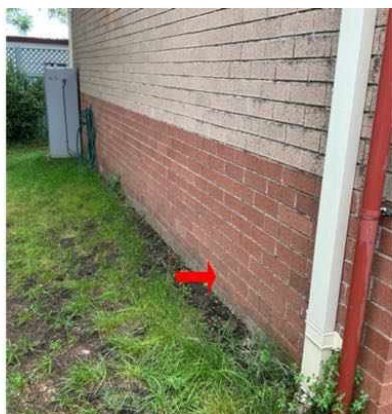
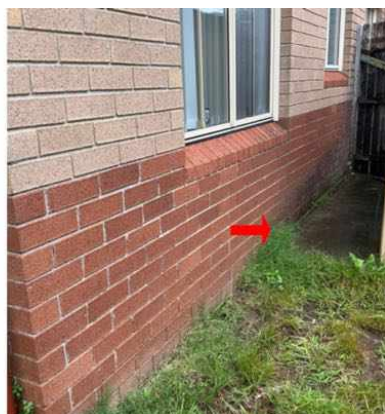
### Finding 6.03

If the slab edge is not properly exposed there is a high risk of termite attack. Sometimes, in order to determine the type of slab, a suitably qualified person such as an architect or builder may be required to consult the construction plans.

Where the slab edge cannot be properly inspected, it is highly recommended that termite or timber pest inspections be carried out every 6-12 months to aid protection of the property against infestation.

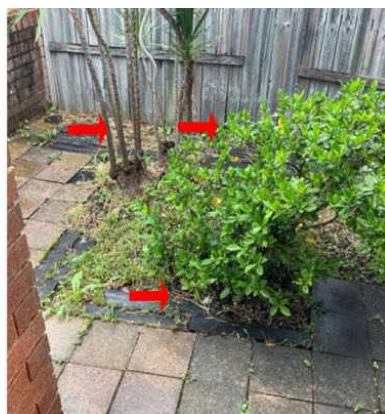
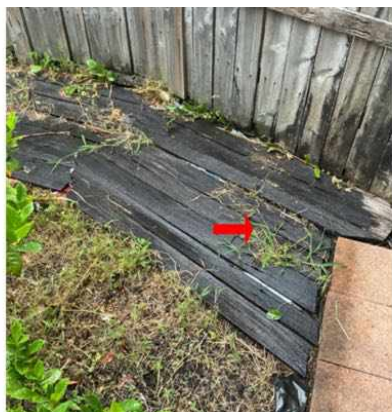
### Finding 6.04

**Building:** Main Building  
**Location:** All External Areas  
**Finding:** In ground contact - Timber  
**Information:** Any timbers in direct ground contact provide opportunity for concealed termite entry and are likely to be subject to premature rot and decay as the soil retains moisture or damp conditions against the timbers.

Remove untreated timber that is in direct contact with external grounds. Consider replacement with more durable materials i.e. treated timber or non timber elements. Frequent pest inspections are advised to readily identify any termite activity in these areas.

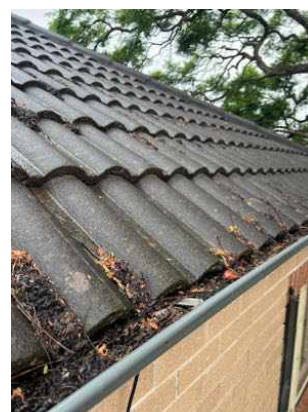
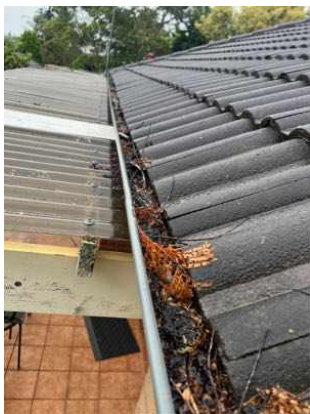
Blocked gutters are likely to lead to high levels of moisture in the affected areas. Such moisture will not only cause rust and decay of the associated building materials, but can also provide conditions that are conducive to termite and timber pest activity. Blockages in gutters should therefore be removed immediately to ensure dry conditions are maintained.

Consult a Licensed Plumber for further specific advice on remedial works that may be required. In the interim, it is highly advised that blocked gutters be removed by the homeowner or a general handyperson as a matter of urgency.

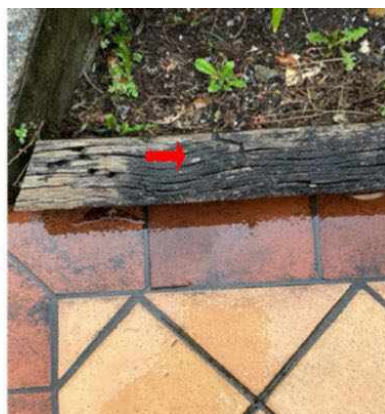
### Finding 7.01

| Finding: | Fungal decay - present |
| Information: | Fungal decay also known as wood decay or wood rot generally refers to the deterioration of timber elements when in contact with excessive levels of moisture for a prolonged period of time. |

The development of fungal decay is accelerated by temperatures in the range of 5degreeC to 40degreeC as well as the presence of oxygen. Generally fungal decay develops on timber elements that are in use in an external environment which are exposed to rain penetration.

In this case although the affected timber element is in a decaying state the extent of any visible damage appears to be localised to a specific area and is yet to spread to other parts of the building element or affect adjoining structures. The fungal decay is therefore likely to be of a relatively superficial nature with minimal impact on the structural integrity or tensile strength of the timber element.

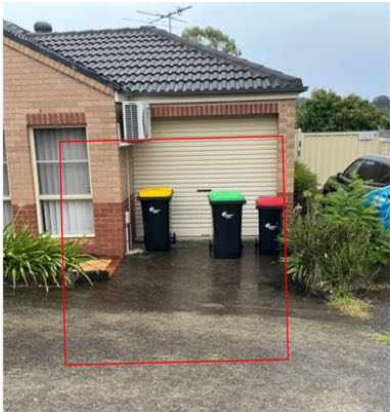
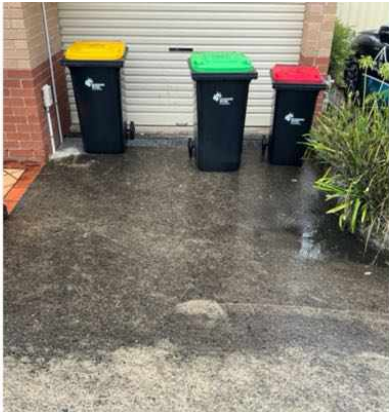
**Noted Item**

Building: Main Building  
Location: All External Areas  
Finding: Drainage Performance Risk  
Information: The driveway and entry path to the property are fitted with drainage provisions, however, due to the flat profile and proximity of the hard surfaces to the building façade, there remains a potential risk of water sheeting toward the garage during periods of heavy rainfall. While the area was dry at the time of inspection and no pooling was evident, it is recommended that drainage performance be monitored during large rain events to confirm effective surface runoff capture. This condition does not currently present as a defect, but proactive maintenance of drainage inlets and consideration of fall adequacy is advised to ensure long-term compliance with NCC FP1.4 and AS/NZS 3500.3 stormwater drainage provisions.

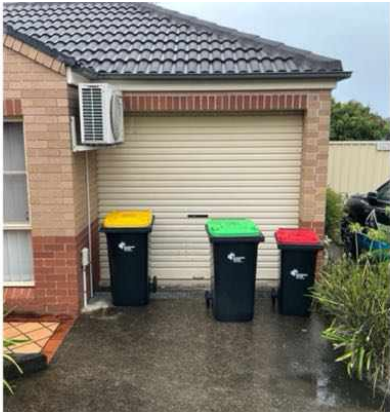
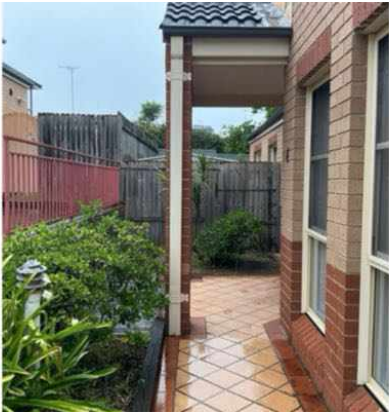
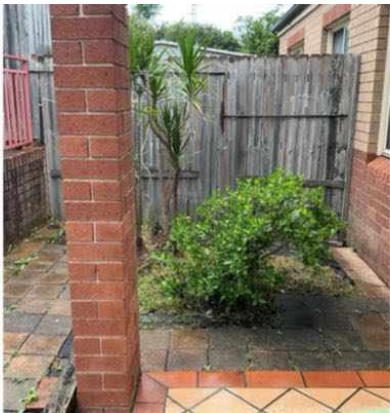
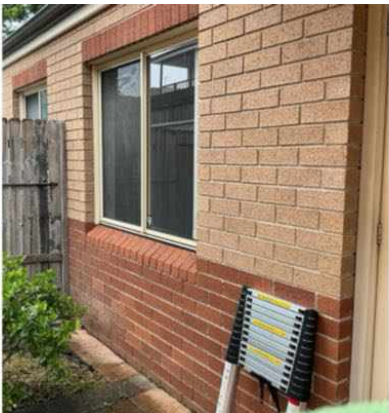
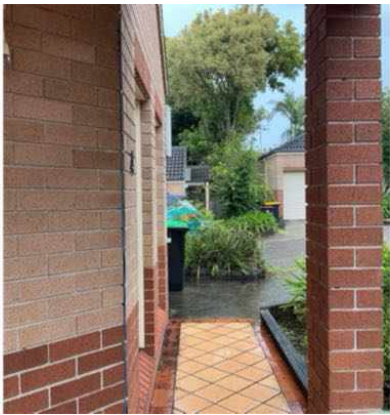
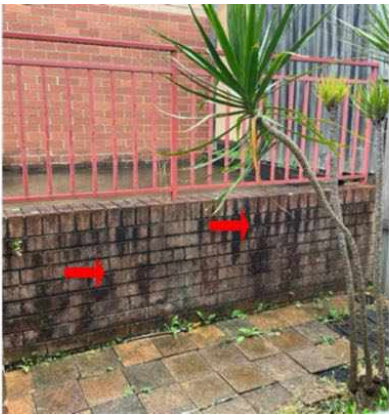
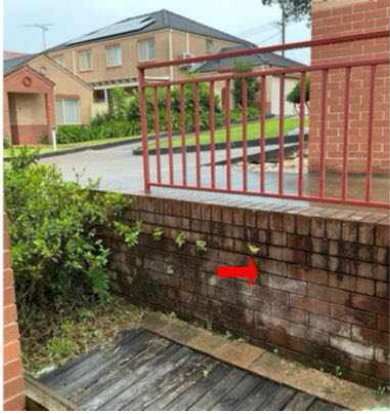
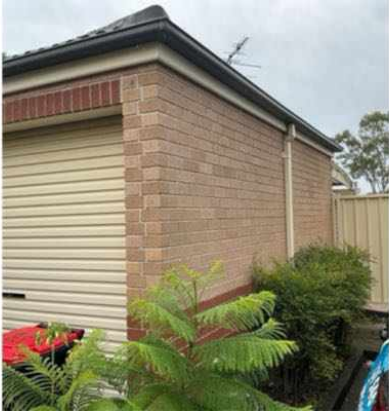
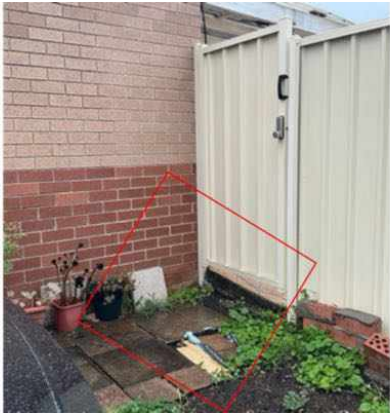
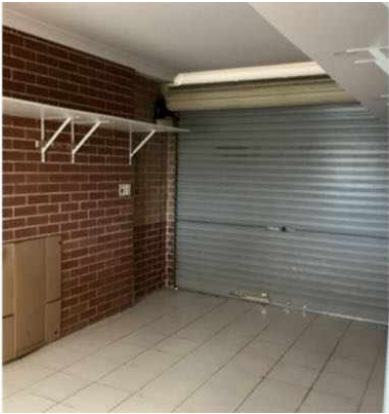
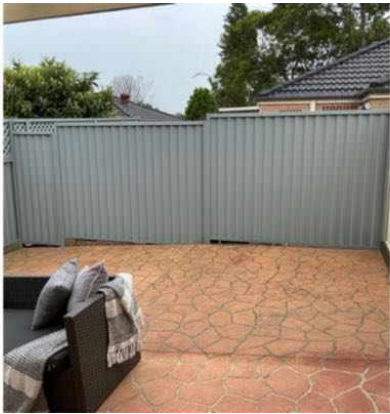
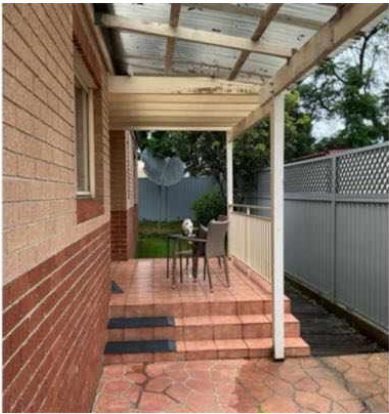
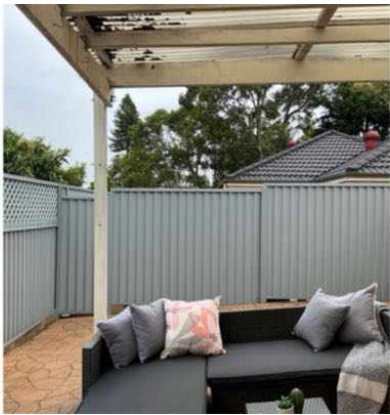
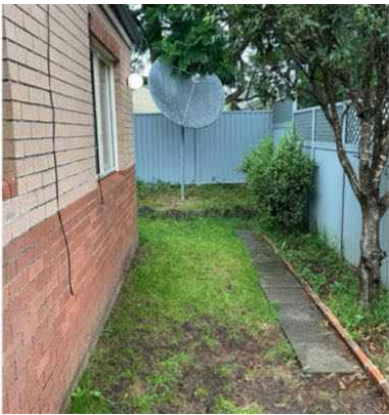
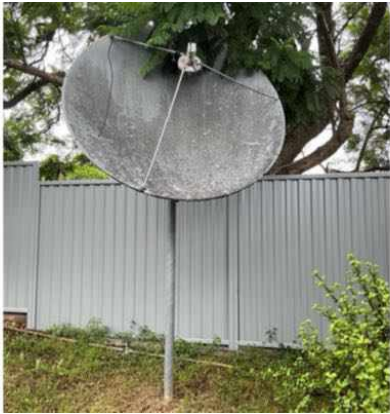
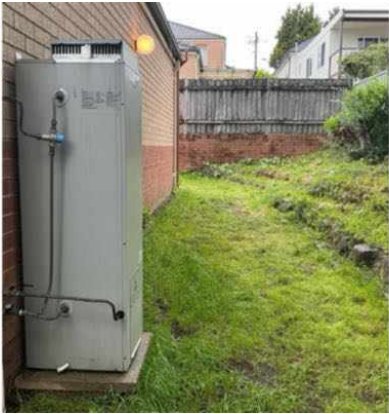
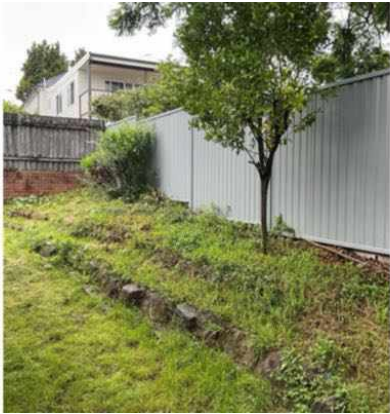
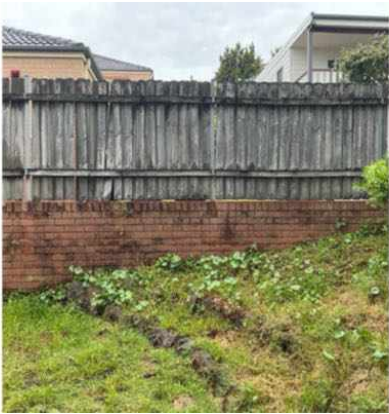
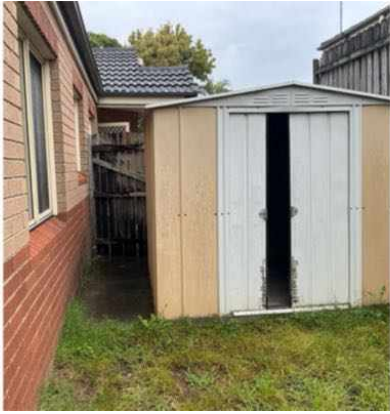
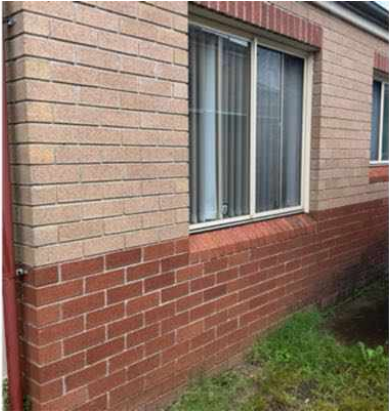
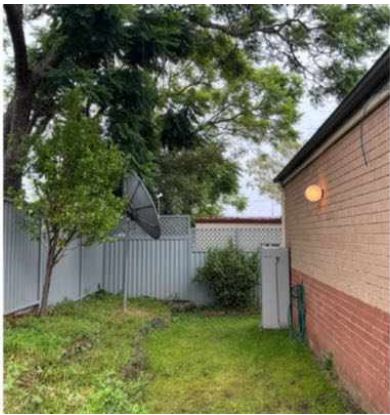
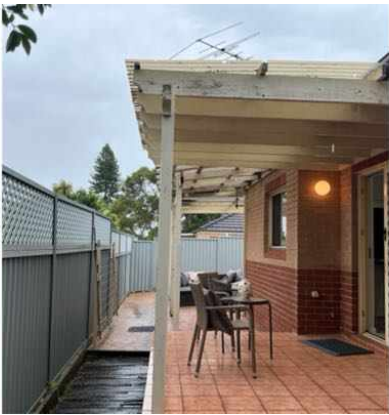
**Noted Item**

Building: Main Building  
Location: All External Areas  
Finding: Additional Photos - Obstructions and Limitations  
Information: These photographs are an indication of the obstructions and limitations which impeded full inspection of the property at the time of inspection. These obstructions can hide an array of defects and should be removed to allow full inspection to be carried out. A re-inspection is recommended once the areas are made accessible.

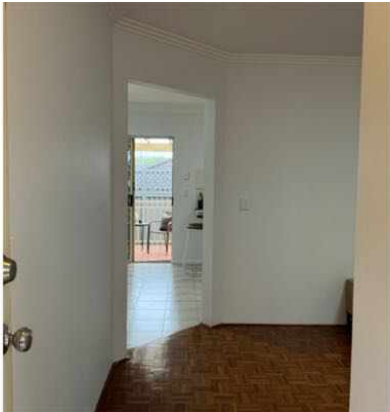
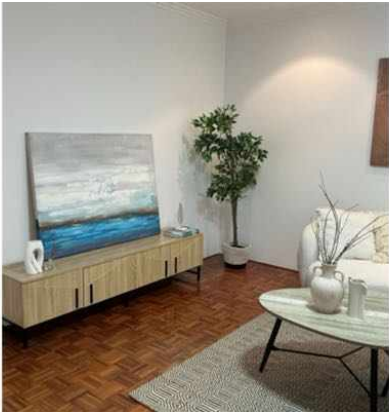
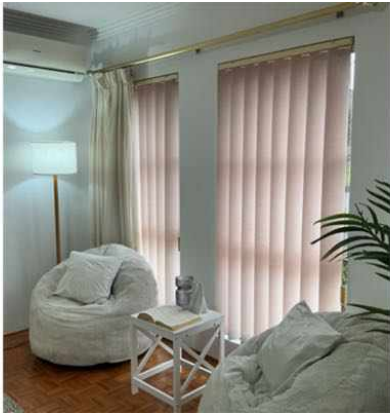
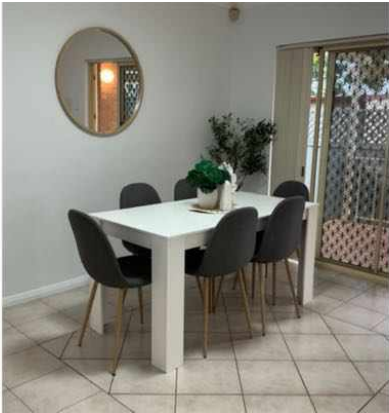
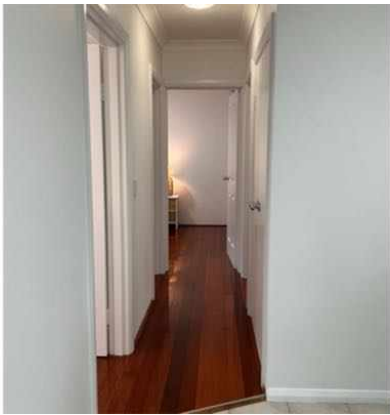
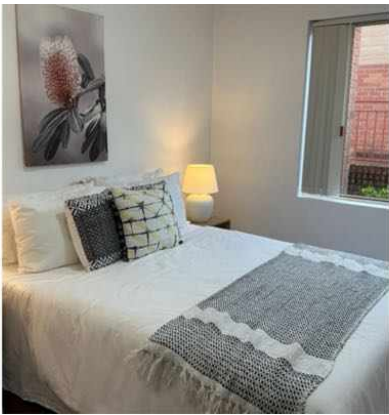
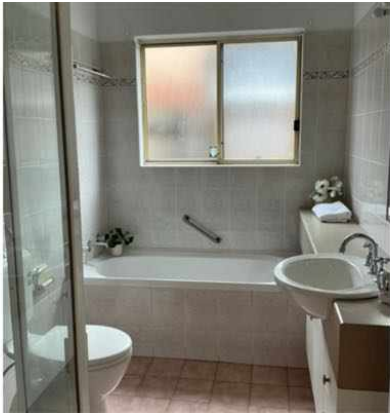
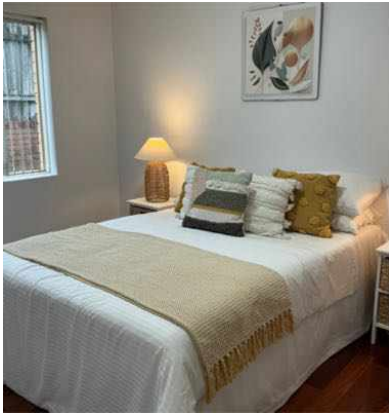
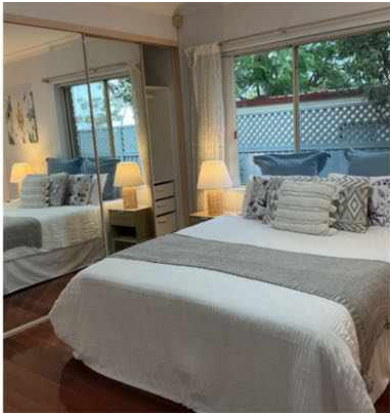
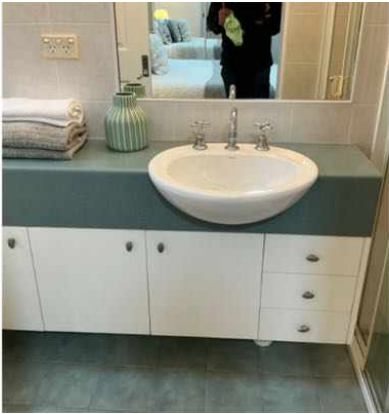
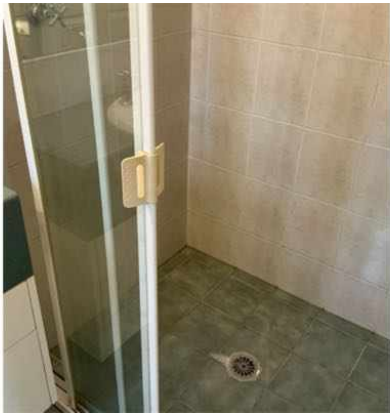
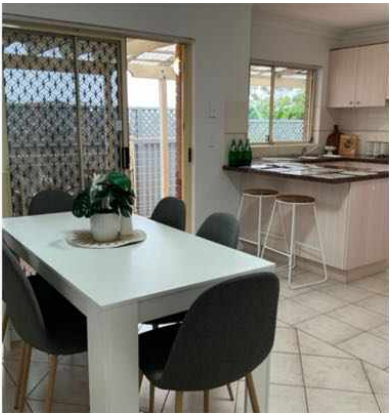
**Noted Item**

Building: Main Building  
Location: All Internal Areas  
Finding: Additional Photos - Obstructions and Limitations  
Information: These photographs are an indication of the obstructions and limitations which impeded full inspection of the property at the time of inspection. These obstructions can hide an array of defects and should be removed to allow full inspection to be carried out. A re-inspection is recommended once the areas are made accessible.

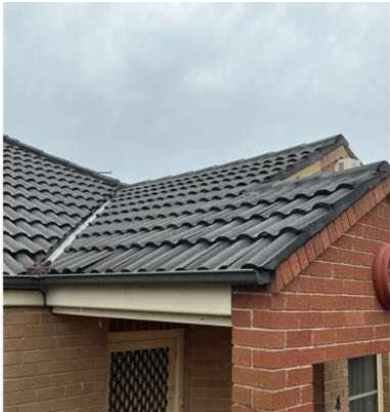
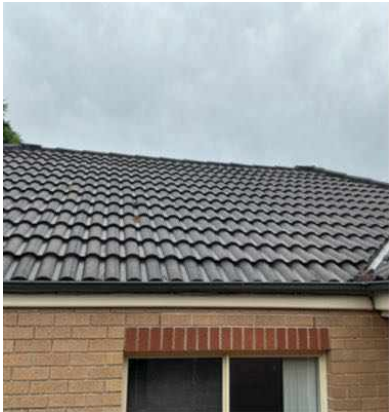
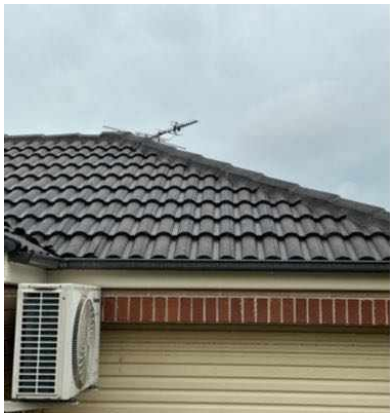
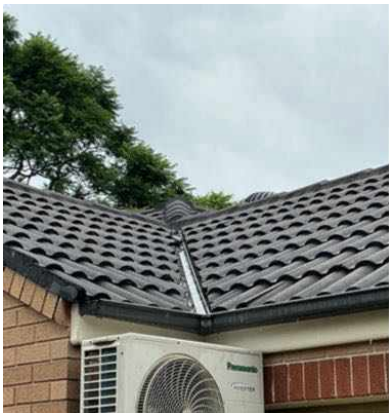
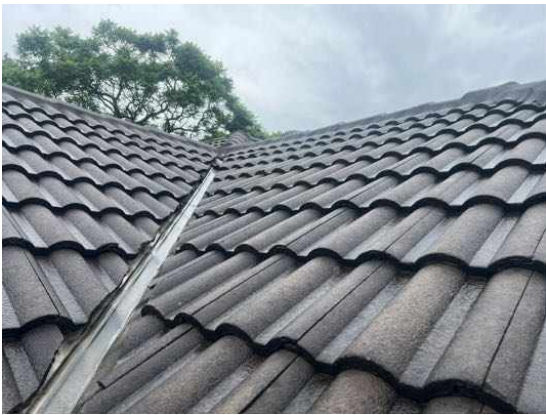
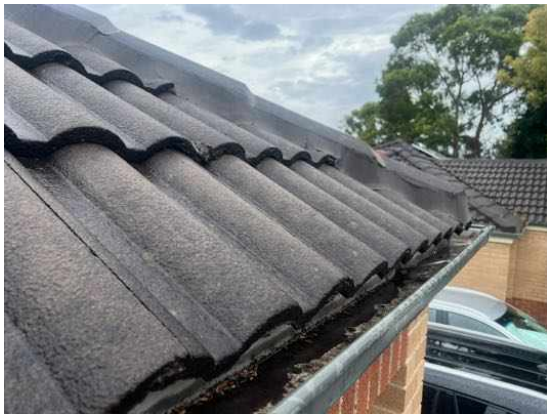
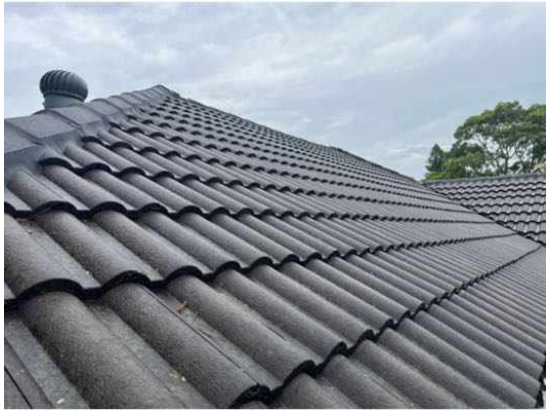
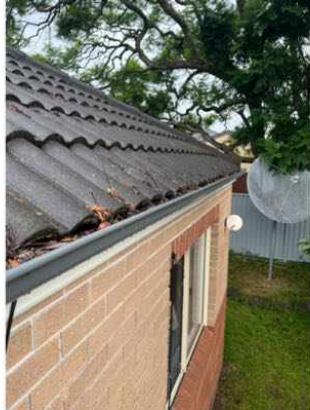
Building: Main Building  
Location: Roof Exterior  
Finding: Additional Photos - Obstructions and Limitations  
Information: These photographs are an indication of the obstructions and limitations which impeded full inspection of the property at the time of inspection. These obstructions can hide an array of defects and should be removed to allow full inspection to be carried out. A re-inspection is recommended once the areas are made accessible.

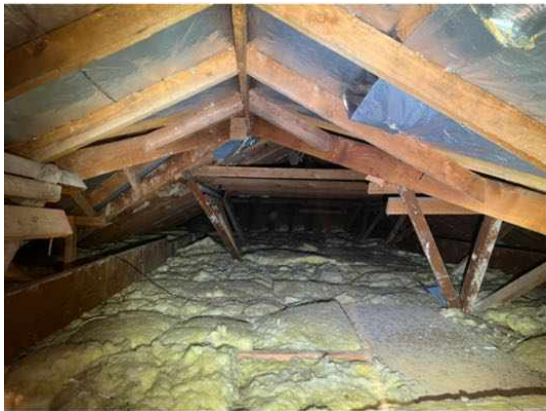
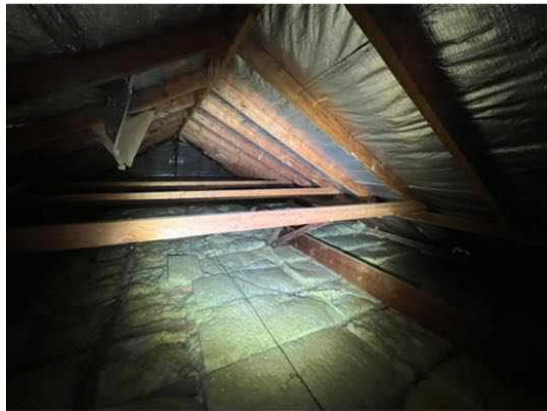
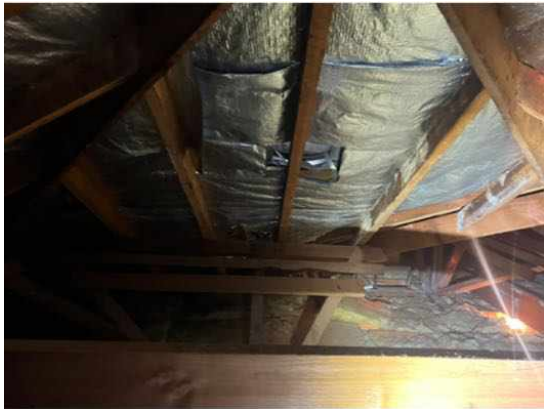
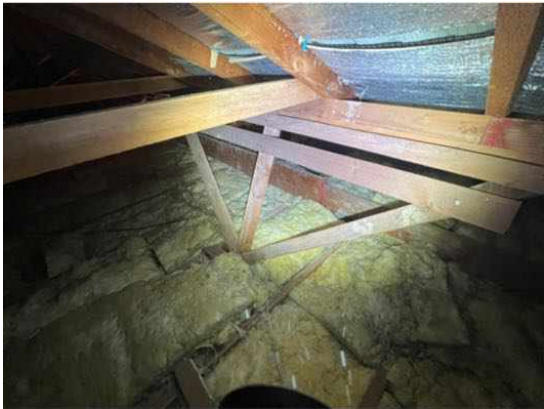
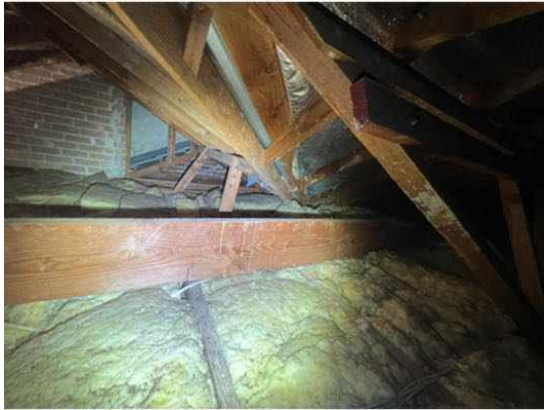
Building: Main Building  
Location: Roof Void  
Finding: Additional Photos - Obstructions and Limitations  
Information: These photographs are an indication of the obstructions and limitations which impeded full inspection of the property at the time of inspection. These obstructions can hide an array of defects and should be removed to allow full inspection to be carried out. A re-inspection is recommended once the areas are made accessible.
