# Building and Timber Pest Inspection Report

Inspection Date: Fri, 13 Feb 2026

Property Address: 31 Margherita Ave, Bateau Bay NSW 2261,  
Australia

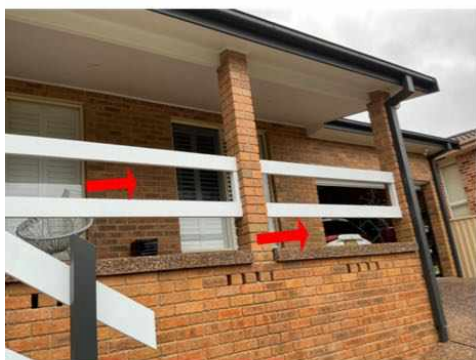
This exceeds the maximum allowable spacing as per Australian safety standards, posing a potential safety hazard, particularly for young children who may be at risk of falling through or getting trapped in the gap. This was not a requirement when the house was built.

Safety Concern: □ The excessive spacing of more than 125 mm between the railings fails to comply with the above standards, creating a risk of injury or entrapment, particularly for young children. This defect could allow a child to slip through the gap or get their head or limbs stuck, leading to potential injury or a fall from height.

Recommendation: □ To rectify this defect, the spacing between the railings should be reduced to 125 mm or less. This can be achieved by installing additional balusters or a secondary barrier (such as a mesh or panel) to close the gap. Any modifications should be carried out in accordance with the NCC and relevant Australian Standards, and a qualified professional should be consulted to ensure compliance.

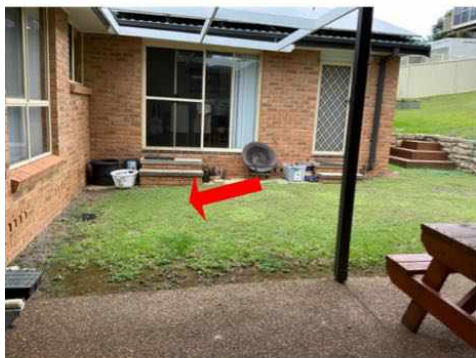
Building:	Main Building
Location:	Yard - Back
Finding:	Inadequate Site Drainage - Exterior Areas
Information:	At the time of inspection, inadequate site drainage was observed around the perimeter of the building, which can lead to water pooling and insufficient runoff management.

This condition may result in moisture being absorbed by the foundation or lower walls, potentially leading to rising damp, cracks in brickwork, erosion of the soil around the building, or structural issues over time. Water pooling can also create ideal conditions for mould growth, contribute to the deterioration of exterior materials, and act as conducive conditions for termite activity, as termites are attracted to areas with elevated and persistent moisture levels.

It is recommended that proper site drainage be installed, such as redirecting water flow away from the building or incorporating drainage systems, to prevent further damage and ensure the long-term stability of the structure.

To address the inadequate site drainage, a qualified landscaper or drainage specialist should be engaged to design and install appropriate drainage solutions, such as grading the ground away from the building or installing French drains, surface drains, or downspout extensions. If more complex issues are present, such as damage to the foundation or moisture entering the walls, a structural engineer may need to assess the situation, and a builder may be required for repairs.

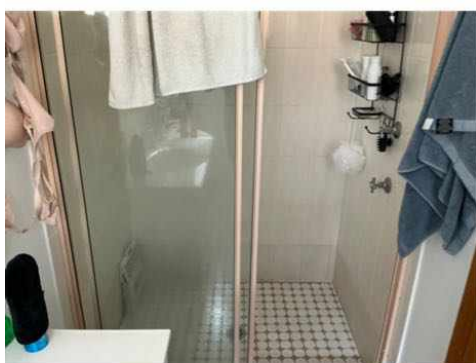
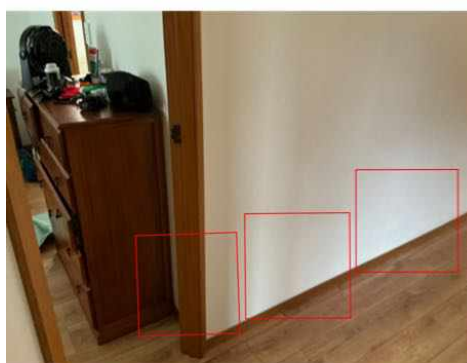
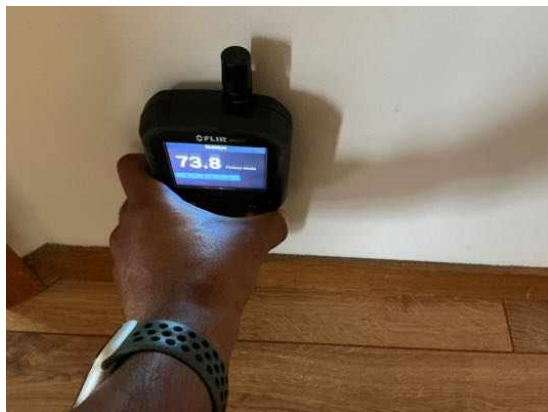
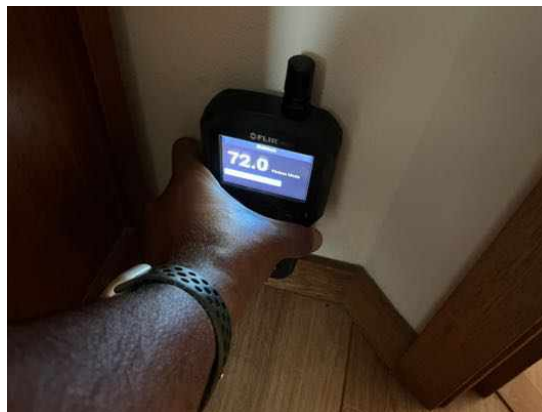
### Finding 3.02

Building: Main Building  
 Location: Hallway Opposite Master En-suite Shower  
 Finding: Shower Damp - Adjacent Bathroom (Monitoring)  
 Information: At the time of inspection, elevated moisture levels were detected on the wall adjacent to the shower area. While no visible water damage or deterioration was noted, the presence of moisture suggests possible seepage or condensation associated with regular shower use.

At this stage, no immediate action is required. However, the area should be monitored over the next 12 months for any signs of deterioration such as staining, bubbling paint, or mould growth. It should be noted that moisture ingress of this nature does not generally resolve without intervention, and at some point remedial works are likely to be required. Should conditions worsen, the client is advised to engage services of a licensed plumber or waterproofing specialist to rectify the issue of moisture before this minor defect turns into major defect.

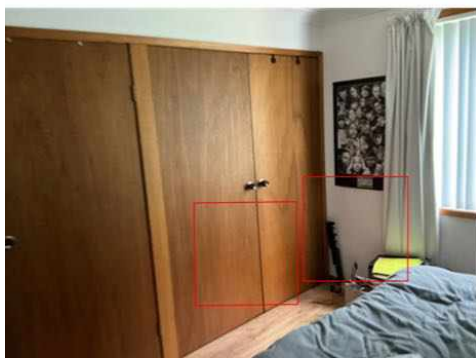
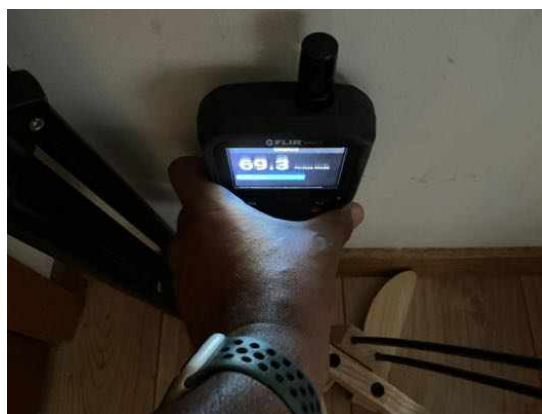
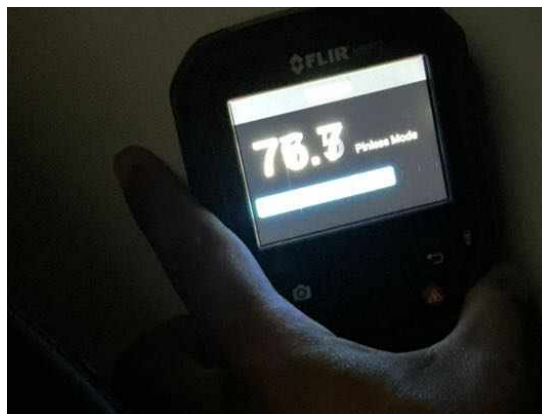
### Finding 3.03

Building:	Main Building
Location:	Bedroom 3
Finding:	Lateral Damp/Rising Damp (Monitoring)
Information:	There are two possible reasons for the type of moisture staining observed: lateral damp or rising damp.

Lateral damp refers to moisture entering from the surrounding ground and moving sideways into the base of the wall. This often appears in walls that retain soil or are close to external ground levels. Over time, this can contribute to deterioration of internal finishes such as bubbling or peeling paint.

Rising damp occurs when moisture travels upward through porous materials like bricks or mortar. This can happen if the original damp proof course (DPC) has deteriorated, been bridged by external ground levels, or if moisture is entering from the opposite side of the wall.

At this stage, no immediate rectification work is required, but the area should be monitored over the next 12 months. If any signs of bubbling paint, peeling, or further moisture staining appear along the bottom of the wall, the client is advised to engage a damp-proofing specialist to confirm whether a membrane, DPC repair, or other moisture management works are required.

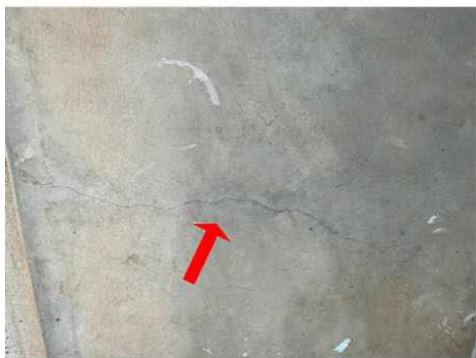
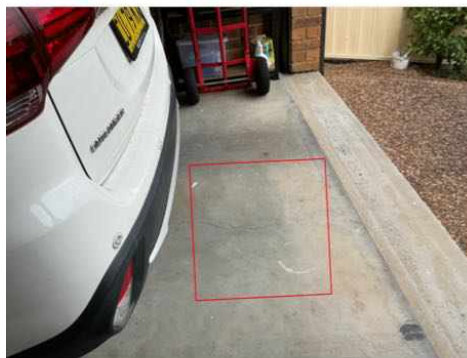
### Finding 3.04

Building:	Main Building
Location:	Garage
Finding:	Crack in concrete slab - Category 2
Information:	A crack coded as Category 2 was identified in the slab. A Category 2 crack is described as a distinct crack, with the slab being noticeably curved or changed in level.

To be considered Category 2, the approximate width of the crack is less than 2.0mm, or a change in offset of less than 15mm when a 3m straight edge is placed over the defect.

Category 2 cracks to slabs should be monitored for a period of 12 months. At the end of the monitoring period, cracks rated greater than Category 2 are considered defects that require rectification.

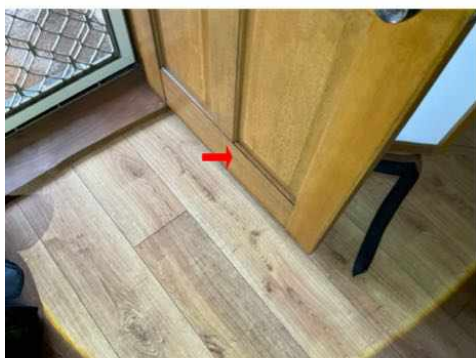
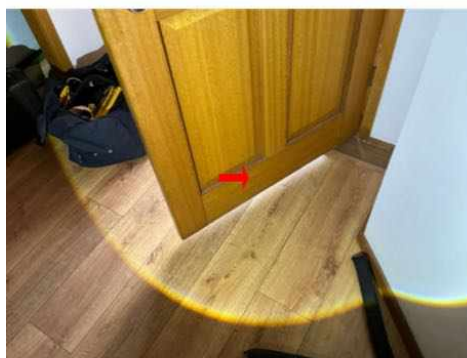
### Finding 3.05

Building:	Main Building
Location:	Entry
Finding:	Door Weatherstrip - Missing
Information:	It was noted at the time of inspection, the door weatherstrip was missing.

The absence of a door weatherstrip could be due to wear and tear, improper installation, or deliberate removal. The implications include increased energy loss, reduced insulation, potential water leaks during rain, and a compromised seal, allowing drafts and noise to enter the space. Replacing the missing weatherstrip is advisable to maintain energy efficiency, weather protection, and overall comfort within the enclosed area.

A general handy man should be appointed to install the weatherstrip at owners discretion.

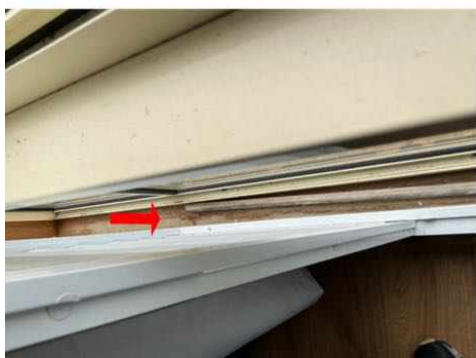
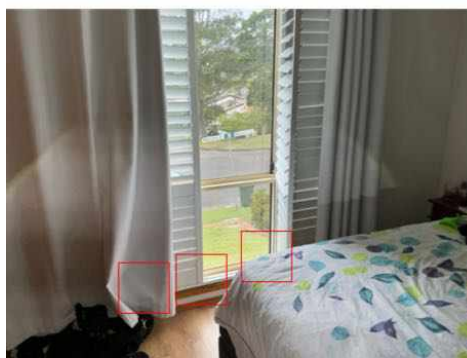
### Finding 3.06

Building:	Main Building
Location:	Bedroom - Master
Finding:	Windows - Moisture
Information:	At the time of inspection, moisture was noted to sections of the window frames. This

condition may be the result of minor water ingress from external sealant deterioration or flashing defects, or alternatively internal condensation build-up, particularly during cooler weather or where ventilation is limited.

The client is advised to ensure that all external window perimeters, joints and sealant lines are properly sealed and maintained to prevent water penetration. It is also recommended that adequate ventilation is maintained internally to minimise condensation build-up.

If staining, deterioration or further moisture becomes evident, a suitably qualified contractor should be engaged to assess and rectify as required.

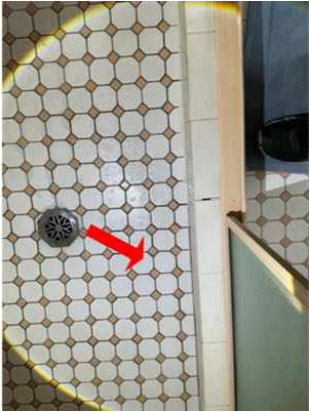
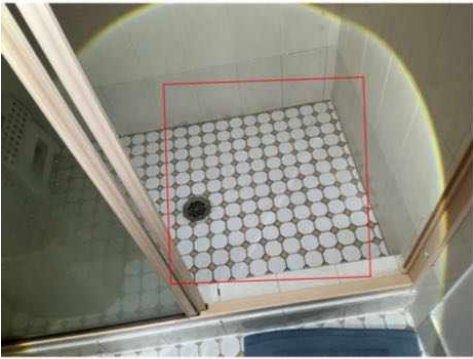
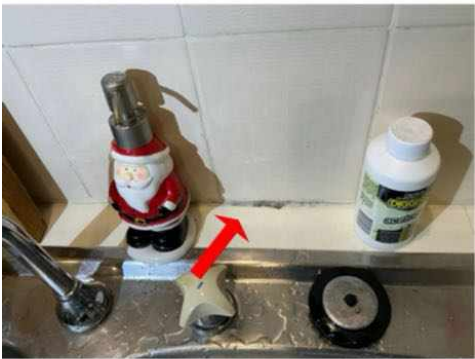
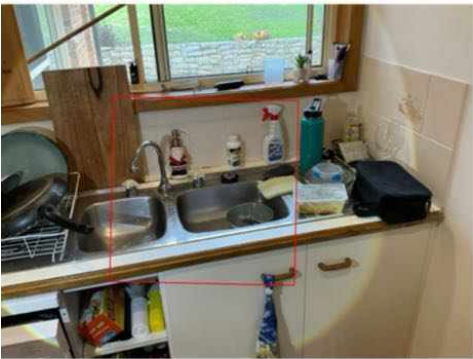
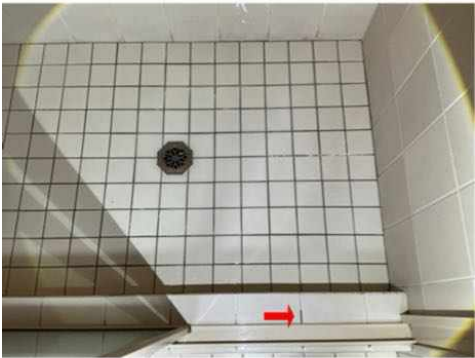
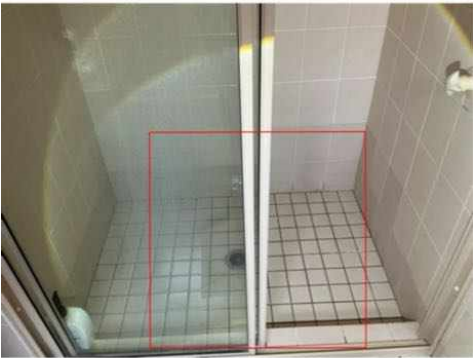
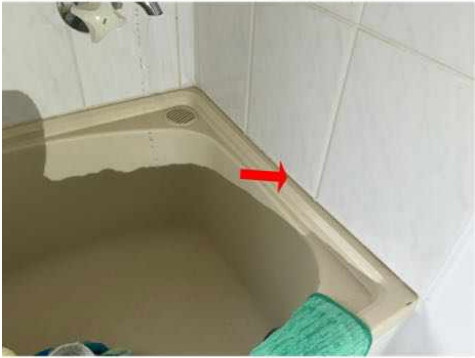
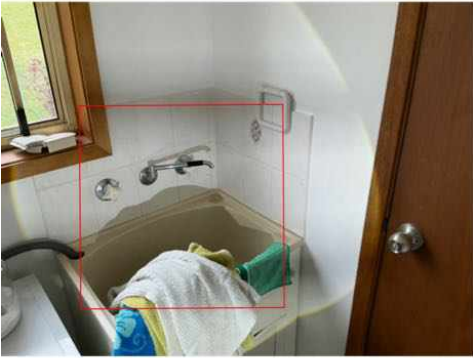
### Finding 3.07

Building:	Main Building
Location:	All Areas
Finding:	Sealant/Grouting - Missing or Damaged
Information:	At the time of inspection, areas of missing and/or deteriorated sealant and grout were noted in this area. This condition can allow water to penetrate behind finishes, which may lead to moisture ingress, deterioration of waterproofing membranes, mould growth, and potential leaks into adjoining areas over time. If left unaddressed, this may result in costly repairs and hidden water damage.

It is recommended that a licensed plumber (or suitably qualified tradesperson experienced in wet area sealing) be engaged to assess the affected areas and reinstate compliant waterproof sealant and grout as required, ensuring all junctions are properly sealed to prevent further water ingress.

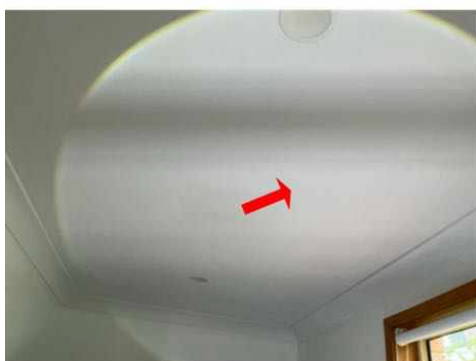
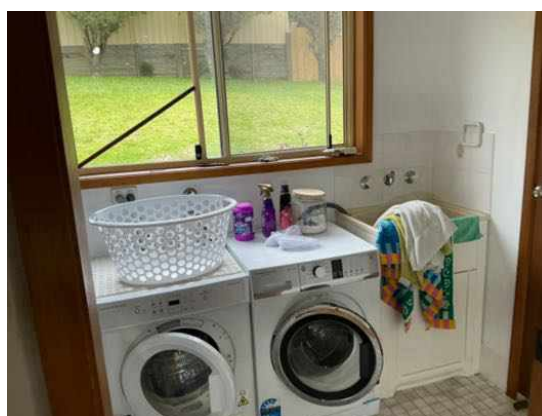
Finding 3.08

Building:	Main Building
Location:	Laundry
Finding:	Laundry - No Exhaust Fan Installed
Information:	At the time of inspection, it was noted that the laundry area is not equipped with an exhaust fan.

The absence of mechanical ventilation in a confined space such as a laundry can lead to the accumulation of excess moisture and humidity, particularly during the use of washing machines and dryers. Over time, this can result in condensation build-up on walls and ceilings, increasing the risk of mould and mildew growth, which may cause health issues such as respiratory irritation and allergies. Additionally, persistent damp conditions can contribute to the deterioration of paint, plaster, and other building materials, potentially leading to more extensive and costly repairs.

A licensed electrician should be appointed to carry out this work to ensure the fan is installed safely and in accordance with Australian electrical standards at clients own discretion.

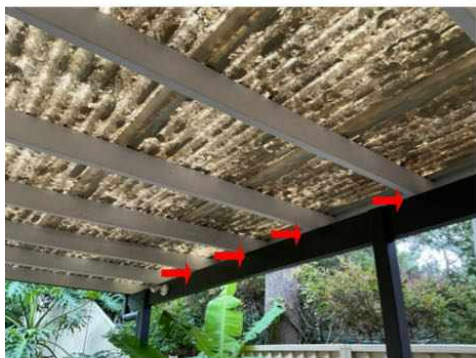
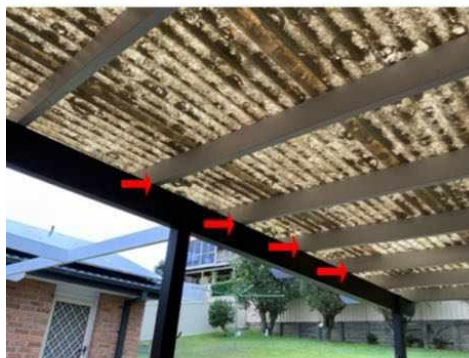
### Finding 3.09

Building:	Main Building
Location:	Under Cover Carport
Finding:	Joist Connection - Insufficient
Information:	The ceiling/floor joist to the whaling plate/beam connection is not sufficient. The joists should be sufficiently fastened with secure connection with joist hangers.

While fastening is insufficient, and there is potential for movement warping or deformation of the joists and potentially structural failures. This generally only occurs in old homes which do not have more contemporary building approaches.

Where the joist to the walling plate/beam is inadequate, repairs are likely to be required as soon as possible. A registered builder or carpenter should be appointed to perform remedial works as soon as possible.

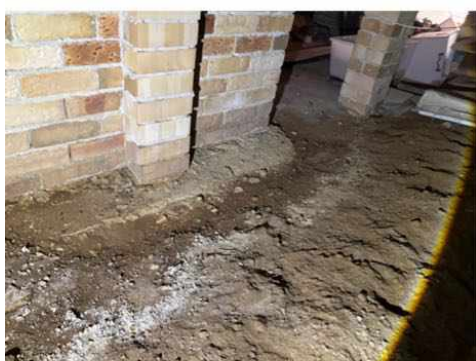
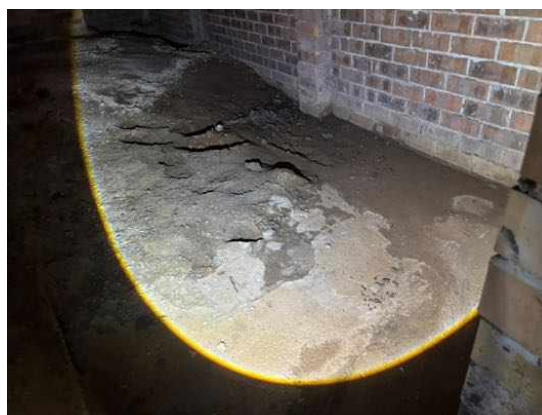
### Finding 3.10

Finding: Subfloor Site Drainage - Inadequate

Information: At the time of inspection, inadequate site drainage was observed under the subfloor, allowing water to accumulate and fail to drain effectively, creating a hazardous condition. This is a common defect in houses constructed on brick stumps, where poor site grading and limited subfloor ventilation can contribute to ongoing moisture retention. The resulting water pooling may lead to structural deterioration from prolonged dampness, mould and mildew growth, and create conditions conducive to termite activity. These issues can also impact indoor air quality and pose safety risks to occupants.

The client is advised to engage a licensed plumber or builder experienced in drainage and foundation work to assess and implement suitable solutions, such as improving site grading, installing appropriate drainage systems, and enhancing moisture barriers. In addition, the installation of mechanical subfloor ventilation is recommended to improve air circulation, assist with moisture control, and reduce the risk of ongoing damp-related issues.

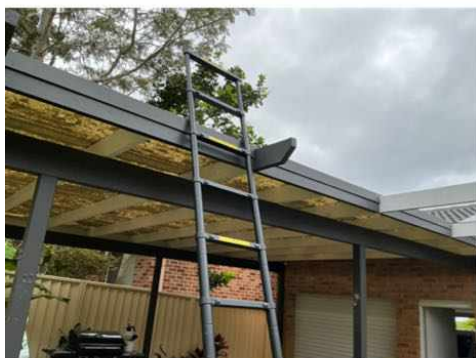
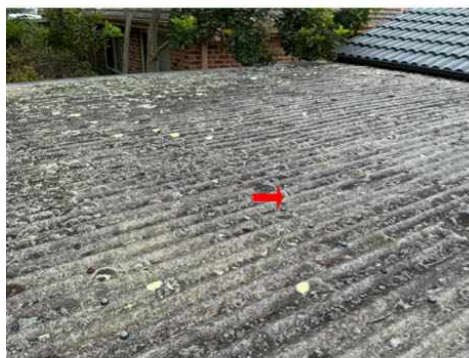
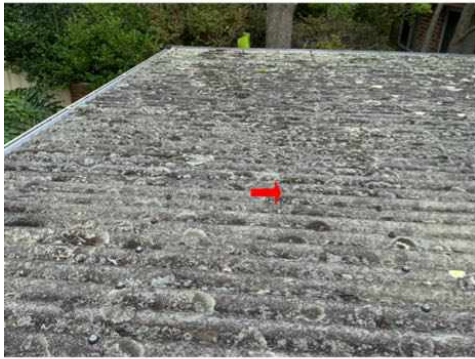
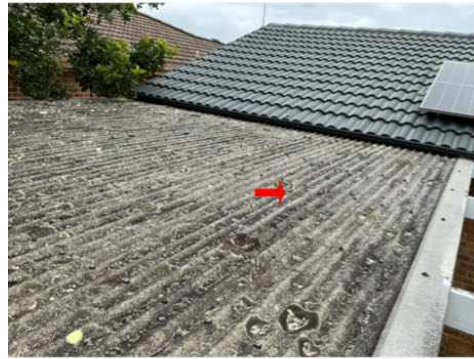
### Finding 3.11

Building: Main Building  
Location: Under Cover Carport  
Finding: Lichen Growth - Roof Sheets  
Information: Lichen growth is observed on the surface of roof sheets. This growth appears as patches of green, gray, or yellowish material adhering to the roofing material.

Lichen is a complex organism resulting from a symbiotic relationship between fungi and algae or cyanobacteria. This growth typically occurs in areas that are damp, shaded, and receive minimal sunlight. Roof sheets that retain moisture due to poor drainage, insufficient slope, or the presence of debris. Rough or porous roofing materials that provide a suitable substrate for lichen attachment and growth.

Lichen retains moisture, which can lead to the growth of other organisms, such as moss, and increase the risk of water damage or leaks. Over time, persistent lichen growth can contribute to the degradation of roofing materials, especially if left untreated.

It can be removed by scraping. Use a soft-bristle brush or plastic scraper to gently remove lichen from the roof surface. Avoid using metal tools that could damage the roofing material. Use a pressure washer with a low-pressure setting to wash away loose lichen. Be cautious to avoid damaging the roof with high-pressure water. Always make sure you have the safety gear on.

Alternatively client is advised to engage services of a professional handyman or landscaper to get it removed.

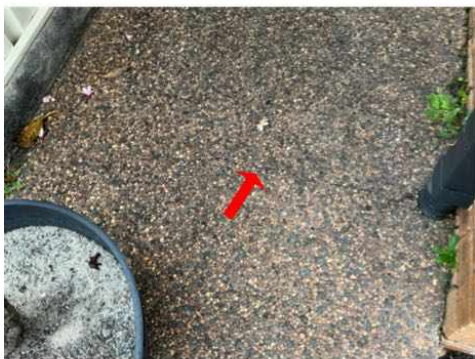
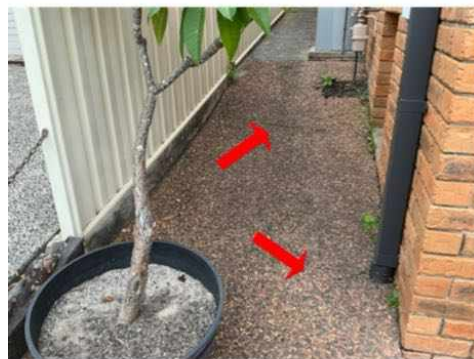
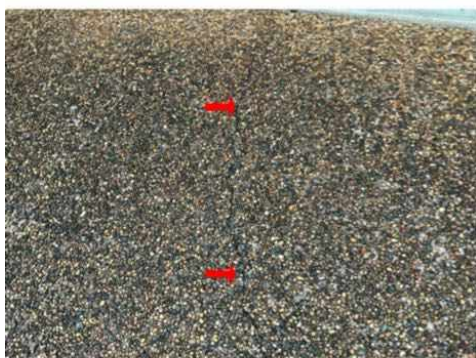
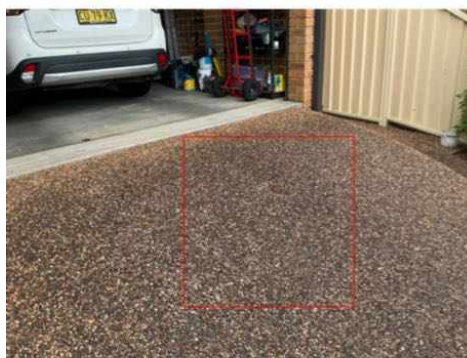
### Finding 3.12

Building: Main Building  
 Location: Driveway, Footpath  
 Finding: Crack in concrete slab - Category 2  
 Information: A crack coded as Category 2 was identified in the slab. A Category 2 crack is described as a distinct crack, with the slab being noticeably curved or changed in level.

To be considered Category 2, the approximate width of the crack is less than 2.0mm, or a change in offset of less than 15mm when a 3m straight edge is placed over the defect.

Category 2 cracks to slabs should be monitored for a period of 12 months. At the end of the monitoring period, cracks rated greater than Category 2 are considered defects that require rectification.

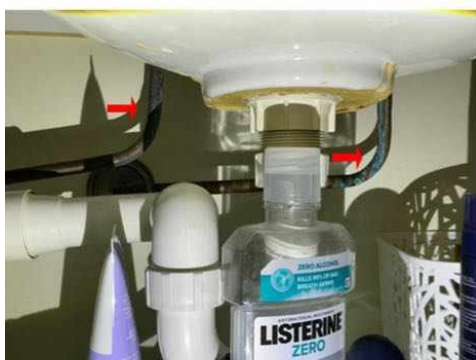
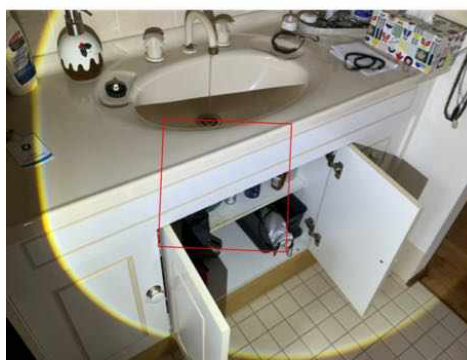
Finding: Plumbing Fixtures - Corrosion

Information: The plumbing fixture has minor corrosion and buildup around the plumbing joints and pipes under a sink, likely resulting from persistent leakage. Over time, continuous leaks can lead to mineral deposits, causing corrosion and weakening the pipes. Additionally, older plumbing materials, such as galvanized steel or iron, are more susceptible to rust and degradation, especially if they have not been regularly maintained or replaced. This issue is exacerbated by improper maintenance, such as neglecting small leaks or failing to clean mineral buildup. To address this, it is crucial to have a professional plumber inspect the system, repair any leaks, and replace corroded sections with modern, durable materials like PVC or copper.

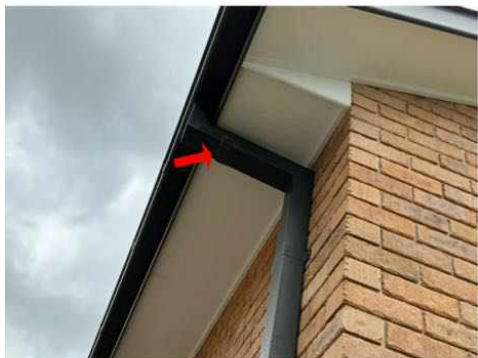
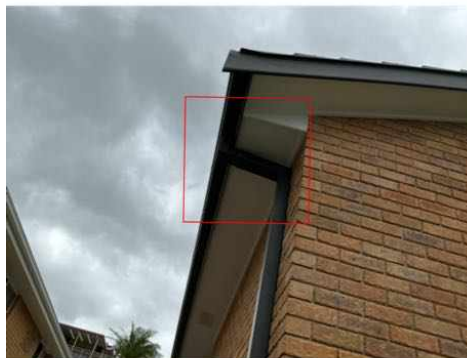
### Finding 3.14

Finding: Downpipe - Rusted/Corroded

Information: At the time of inspection, sections of the downpipe were observed to be rusted and showing signs of corrosion. This deterioration is likely due to prolonged exposure to moisture, standing water within the pipe, or insufficient drainage maintenance. Over

time, corrosion can weaken the pipe, leading to leaks, blockages, or complete failure of the downpipe, reducing the effectiveness of the stormwater drainage system.

It is recommended that a licensed roof plumber be engaged to replace the rusted or corroded sections and ensure the downpipe is securely fitted and functioning correctly. Regular cleaning and inspection are advised to prevent further corrosion and maintain effective water flow.

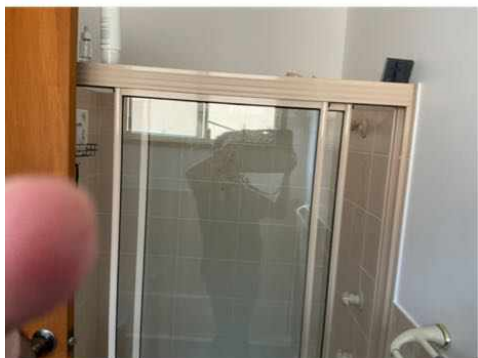
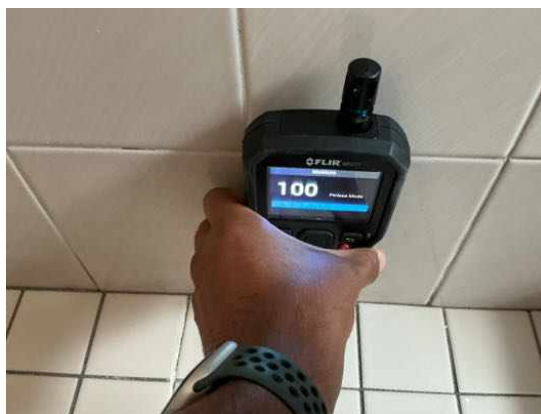
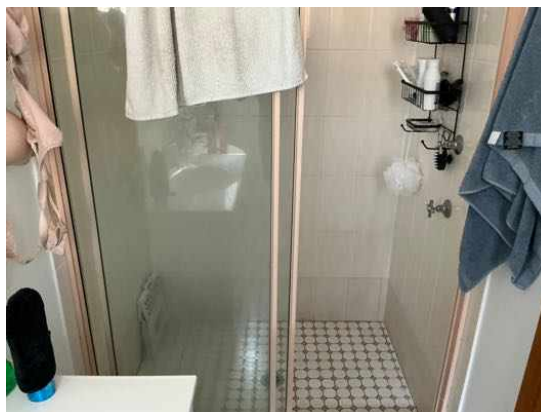
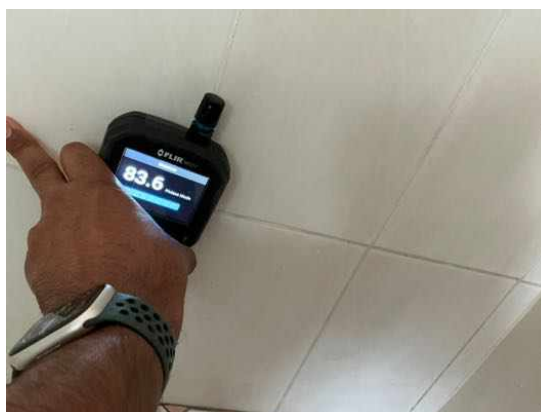
### Finding 3.15

Building:	Main Building
Location:	Both Bathrooms
Finding:	Excessive Moisture - Shower Damp
Information:	At the time of inspection, excessive moisture was noted within the shower area, which is a common issue in wet areas due to the continual exposure to water. This condition is typically caused by moisture seeping through grout lines and settling behind tiles, resulting in localised high-moisture zones. Provided there is no evidence of water staining or elevated moisture readings on the opposite side of the wall, this is considered a minor defect.

However, persistently damp conditions may act as conducive conditions for termite activity, as termites are strongly attracted to moisture-rich environments. It is recommended that the client ensures regular use of the exhaust fan and maintains adequate ventilation after shower use to promote drying and reduce long-term moisture build-up, thereby also reducing the risk of attracting termites.

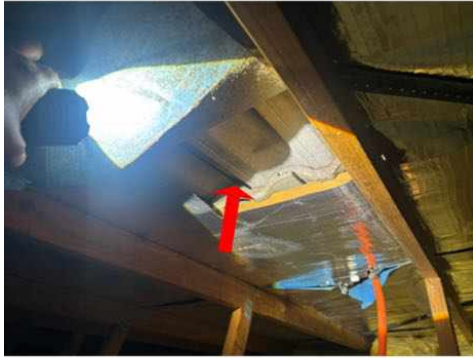
### Finding 3.16

Building: Main Building  
 Location: Roof Void  
 Finding: Sarking - Damaged  
 Information: Sarking, a laminated aluminium foil applied to the interior of the roof covering, assists in insulating the property and acting as a vapour-barrier to the roof void and, subsequently, to the household.

Where sarking is damaged, both insulation and moisture protection of the property are inhibited. This creates a loss of energy and thus negatively impacts the energy efficiency of the property, allowing potential for moisture ingress from condensation or leaking roof tiles.

It is important to repair any holes or damaged sections of sarking to ensure that the building material is fully functional. A registered roofer should be consulted to provide further advice on this defect and to perform rectification works at client discretion.

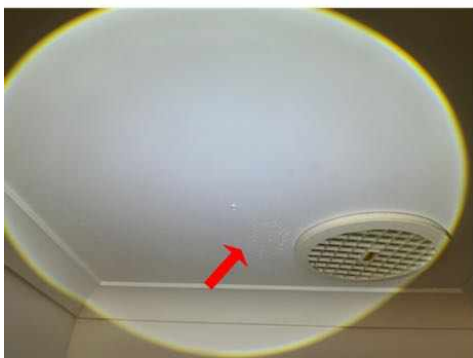
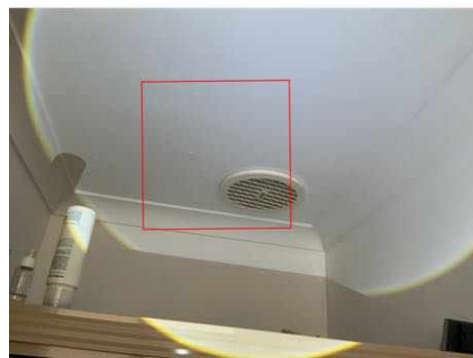
### Finding 3.17

Building:	Main Building
Location:	Bathroom
Finding:	Peeling Paint - Bathroom
Information:	During the inspection, it was observed that the paint in the bathroom is peeling in several areas.

This peeling paint could be indicative of underlying issues such as moisture intrusion, not using the exhaust regularly or inadequate surface preparation prior to painting. If left unaddressed, it can lead to further deterioration of the paint and potential damage to the underlying wall surfaces. It is recommended that the affected areas be properly assessed and repaired, including addressing any moisture sources, before repainting to ensure a durable and aesthetically pleasing finish. Regular maintenance of painted surfaces is essential to prevent similar issues in the future.

The client is advised to engage services of a professional painter to fix the issue.

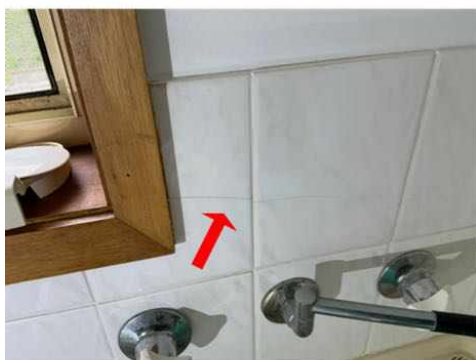
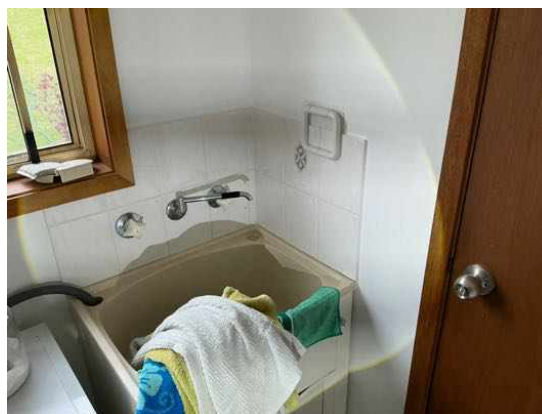
### Finding 3.18

Building:	Main Building
Location:	Laundry
Finding:	Tiles - Cracked and/or Damaged
Information:	Cracking in the tiles was evident in this area at the time of inspection. It is suspected that this cracking has occurred as a result of minor settlement or shrinkage.

While the cracking appears to be minor, this area may be exposed to water, allowing potential for water penetration into adjoining sections of walls or flooring. Cracked tiles throughout the household detracts from the overall appearance of the affected areas however it is unlikely to create or lead to any secondary defects. While not considered a matter of urgency, replacement of cracked floor tiles is recommended at the clients discretion.

A licensed tiling contractor may be appointed to perform these works. Should these cracks become more numerous, a licensed builder should be appointed to inspect and advice on rectification.

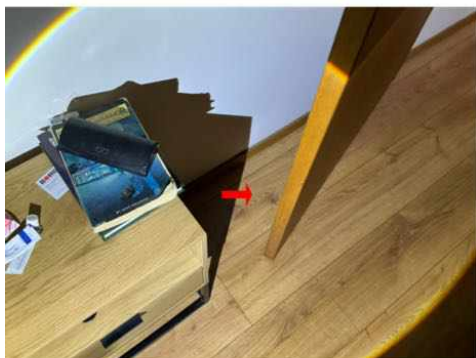
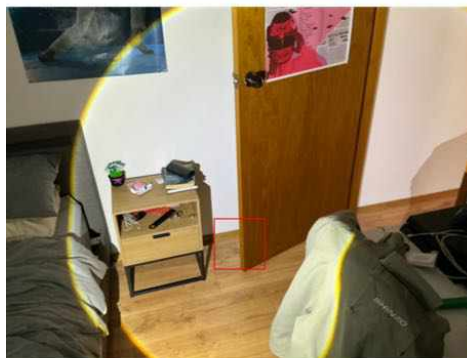
### Finding 3.19

Building:	Main Building
Location:	Bathroom, Bedroom 3
Finding:	Door Stopper(s) - Missing
Information:	At the time of inspection, it was noted that a door stopper was missing in this area.

The absence of a door stopper can lead to potential damage to the door, wall, or surrounding finishes, as the door may swing open too far and impact the wall or adjacent objects. Over time, this can cause dents, scuffs, or even structural damage to the wall or door. It is recommended that a door stopper be installed to prevent further damage and ensure the protection of both the door and the surrounding area.

The client is advised to engage services of a handyman to install the door stopper.

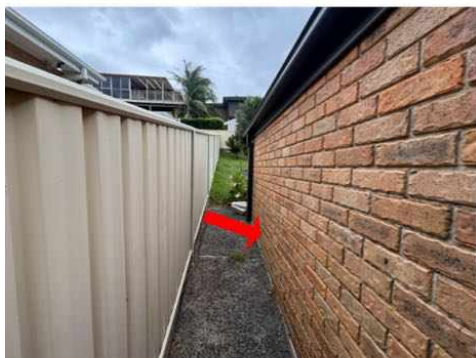
It is important for internal flooring to be raised above adjacent external ground levels. Where external ground levels are above or same level as internal flooring, water pooling and subsequent internal flooding is likely to occur which may attract termite activity to the internal area.

It is highly advised that a landscaper or relevant tradesperson be appointed to lower external grounds that are raised above or same as adjacent internal flooring. Alternatively if external grounds and internal flooring is level installation of a raised door sill may be appropriate in preventing any water pooling in the area. If the client wishes not to make any changes, then a qualified pest controller is recommended for termite treatment around the perimeter of the house and subfloor (if any) as soon as possible.

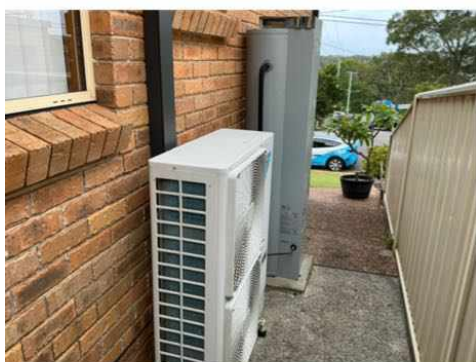
### Finding 6.02

Building:	Main Building
Location:	Exterior walls - left side
Finding:	Bridging Appliances - Attachment to Buildings
Information:	Bridging occurs when items against a building provide a concealed entry point for termites into the building or by passing around a termite management system.

Where any part of an attachment to a building is not isolated and is not provided with a clear gap of not less than 25mm from the building, bridging occurs. Attachments to buildings such as hot water services, downpipes, verandahs, decks, steps, fences, service conduits and the like provide the opportunity for concealed entry.

Building attachments of this nature need to be frequently inspected for termite activity by a qualified inspector.

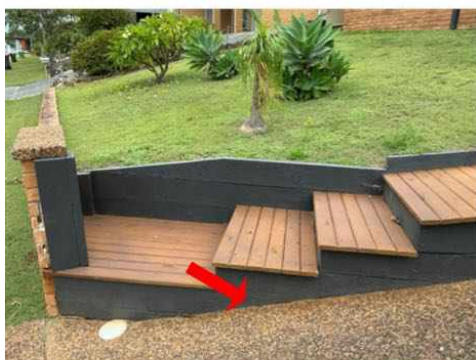
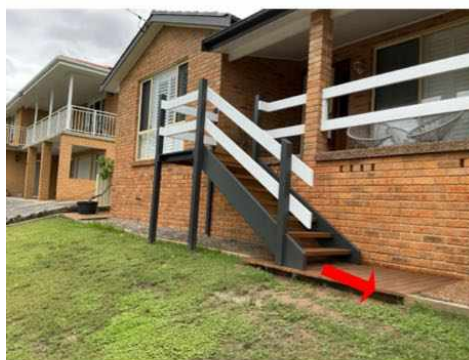
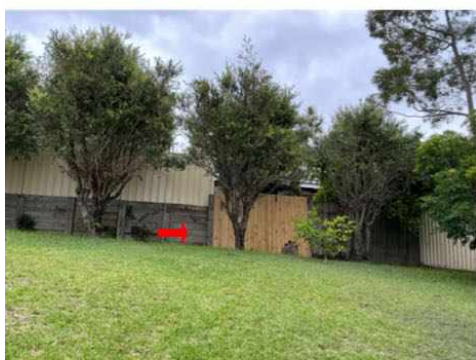
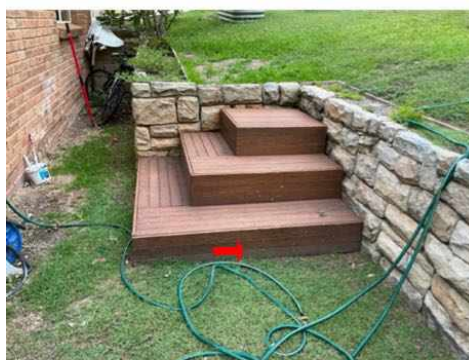
### Finding 6.03

Building:	Yard
Location:	All Areas
Finding:	Building Materials in Direct Ground Contact - Conducive to Termites
Information:	Timber elements that are in direct contact with the ground and exposed to moisture or damp conditions are highly conducive to termite activity. This susceptibility arises

because timber, when in contact with soil and dampness, creates an environment that is particularly attractive to termites, encouraging infestation and potential structural compromise. Whether the timber is used as a part of the building's construction or incorporated into fencing, its presence near or on the ground can become a pathway for termites to access and damage the property.

When exposed to excessive moisture, timber begins to deteriorate, developing conditions such as wood decay and rot. These compromised areas of timber are even more appealing to termites, as they are easier to infest and consume. This is especially true for untreated or non-durable timber, which lacks the protective treatments that can deter or withstand termite attacks. Termites can use these weakened, moisture-laden elements as a bridge into other parts of the structure, creating an entry point for potential infestations that can spread and cause extensive damage if left unchecked.

For any timber in direct contact with the external ground, special attention is required. The combination of moisture, untreated wood, and direct ground contact not only accelerates the decay process but also provides subterranean termites with a straightforward means of ingress into the structure. This entry can lead to termites moving undetected into other vulnerable areas, resulting in potentially significant structural issues and costly repairs.

To mitigate the risk of termite activity, it is imperative that any such materials or timber elements be appropriately treated or removed as soon as possible. Timbers that are necessary for use should be made durable through appropriate treatments and maintained to ensure they do not create conditions conducive to termites. Additionally, the client is advised to schedule regular termite treatments to maintain an effective barrier against infestations and ensure ongoing protection.

The client is strongly advised to assess the property for any timber elements that may be in direct contact with the ground and ensure prompt action is taken to remove or treat them effectively. Regular inspections, proactive maintenance, and consistent termite treatment are essential steps in minimising the risk of termite attack and protecting the structural integrity of the property. Taking these preventive measures is crucial for maintaining a termite-free environment and avoiding potentially costly damage and future repairs.

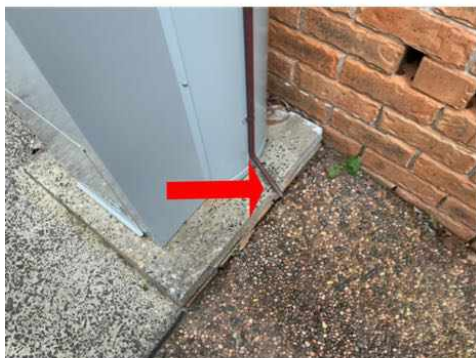
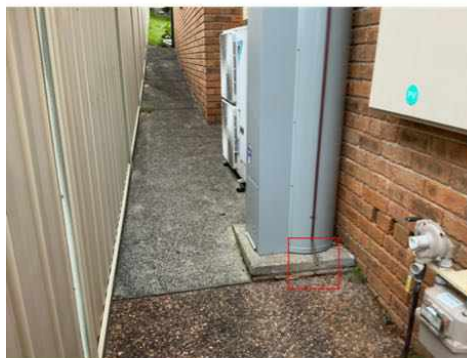
### Finding 6.04

Building:	Main Building
Location:	Exterior walls - left side
Finding:	Overflow Disconnected - HWS/AC/Gas - Conducive Conditions to Termites
Information:	The overflow to this service was found to be disconnected from stormwater drainage and is creating excessive moisture in the surrounding area.

Such leaking creates an environment that is conducive to an array of defects, including water damage to associated building elements and the attraction of termite or timber pest infestation. These damp conditions can lead to secondary defects such as rot, rust, or corrosion of associated building elements, the formation of fungal decay, or even the creation of potential slip hazards. When coupled with poor site drainage, pooling of water may also attract termite activity to this area.

It is highly recommended that a licensed plumber be appointed to connect the overflow in order to prevent such an environment from being created. These minor works should be carried out as soon as possible.

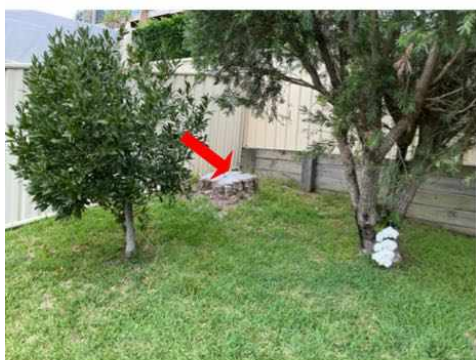
### Finding 6.05

Building: Yard  
 Location: Yard - Back  
 Finding: Tree Stumps - Remove  
 Information: Old tree stumps were found around the property.

Any tree stumps in ground contact provide opportunity for concealed termite infestation and are likely to be subject to decay as the soil retains moisture or damp conditions against the tree stump.

All tree stumps should be removed where possible or alternatively be test drilled and treated. Frequent pest inspections are advised to readily identify any termite activity in these areas.

Timber pest management plan should be implemented and 6-12 monthly Timber Pest inspections carried out in accordance with AS4349.3 or AS 3660.2.

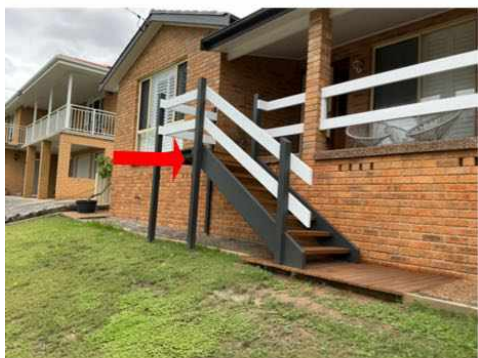
### Finding 6.06

Building: Main Building  
 Location: Exterior walls - front  
 Finding: Timber Directly Attached to Building  
 Information: At the time of inspection, timber materials were noted to be directly attached to the

external wall of the dwelling. This practice is considered a conducive condition for termite activity, as it provides both a potential food source and concealed entry point for termites into the structure.

It is recommended that the timber be removed, isolated, or appropriately treated to reduce the risk of termite infestation. A licensed pest management specialist should be consulted for further assessment and advice in line with AS 3660.2 (Termite Management).

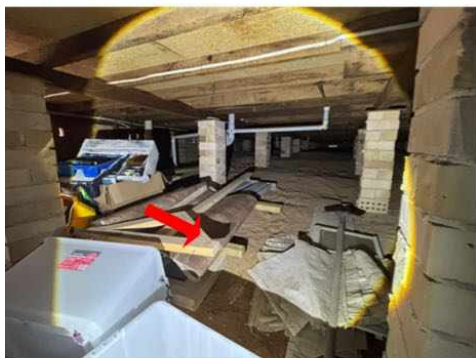
### Finding 6.07

Building:	Main Building
Location:	Subfloor
Finding:	Stored Timbers - On Site
Information:	The storage of timber around external areas or within subfloor spaces poses a significant risk of attracting termite activity. Timber left exposed to moisture can develop wood rot, creating an ideal environment for termites and other timber pests. When placed directly on the ground or in damp, concealed subfloor areas, this timber can act as a bridge for termites to enter the structure, potentially causing serious and costly damage.

In addition to termites, stored timber can promote mould, mildew, and fungal growth, which may affect both the structure and the health of occupants.

To reduce these risks, it is strongly advised that any stored timber be removed.

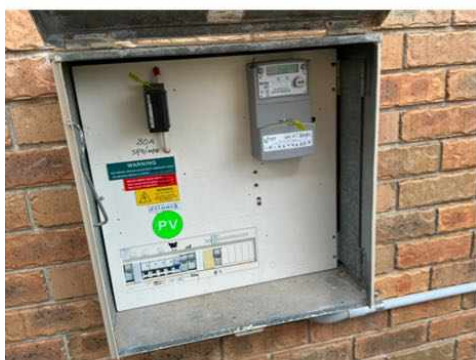
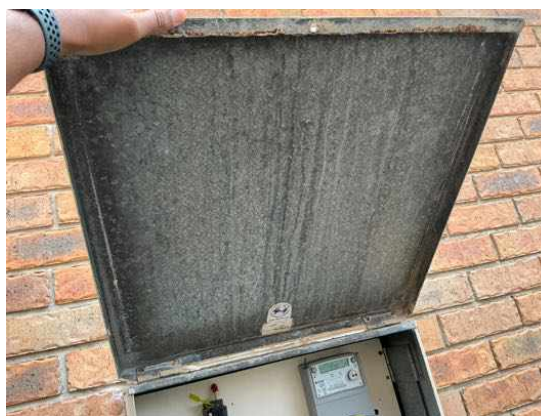
### Finding 6.08

During the inspection, there was no indication that a termite management system had been installed, nor was there any evidence to suggest that preventative measures had previously been undertaken. The client is encouraged to seek further advice from a licensed pest controller regarding the costs and procedures involved in the application of a termite barrier. Prioritizing this step in the short term is strongly advised to ensure long-term protection.

Information: The application of a post-construction chemical termite barrier is strongly recommended for all properties, especially if there has been any history of live termite activity on-site. These barriers are highly effective in protecting timber building elements throughout the property by preventing termite attacks. It is also advisable to install a durable notice within the switchboard unit, indicating the presence of any termite barriers for future reference.

Additionally, the client may want to consult with the vendor to determine whether regular Timber Pest inspections, as per AS4349.3 or AS 3660.2, have been conducted in the past. This will provide further insights into any past termite management practices and help inform the appropriate course of action.

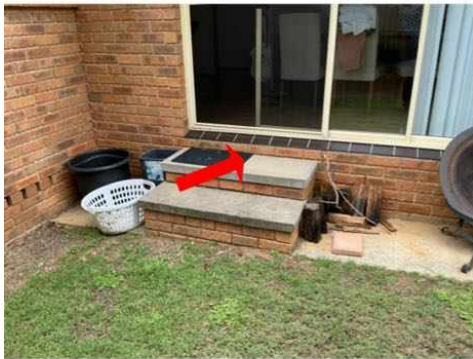
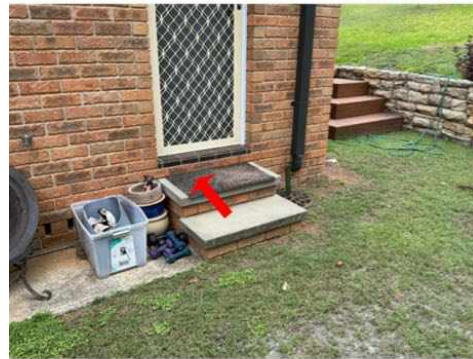
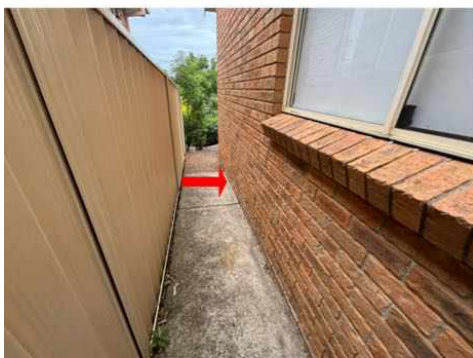
## Finding 6.09

Building: Main Building  
 Location: Yard - Back  
 Finding: Bridging or Breaching of Termite Barriers - Adjacent Internal Flooring  
 Information: Bridging is the spanning of a termite barrier or inspection zone so that subterranean termites are provided with passage over or around that barrier.

It is important for internal flooring to be raised above adjacent external ground levels. Where external ground levels are above internal flooring, water pooling and subsequent internal flooding is likely to occur which may attract termite activity to the internal area.

It is highly advised that a landscaper or paver be appointed to lower external grounds that are raised above adjacent internal flooring. Alternatively if external grounds and internal flooring is level installation of a raised door sill may be appropriate in preventing any water pooling in the area.

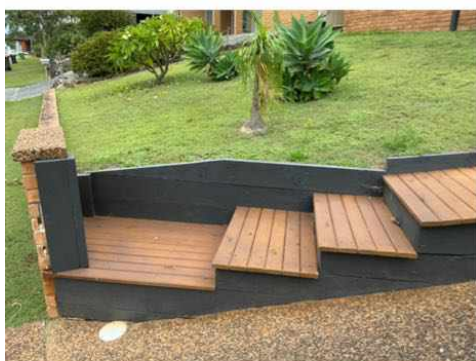
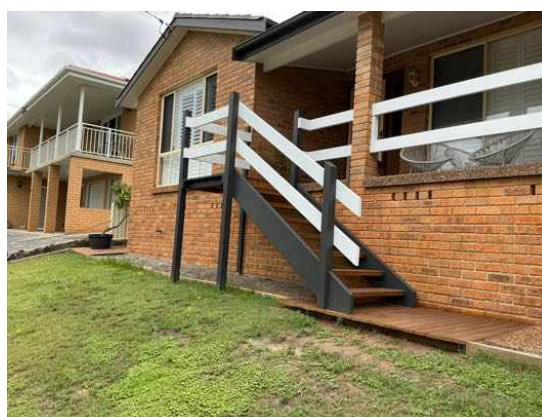
Building: Main Building  
Location: All External Areas  
Finding: Obstructions and Limitations - External Areas  
Information: The attached photographs provide a visual representation of the obstructions and limitations that impeded a full inspection of the external areas of the property at the time of assessment. These obstructions, which may include vegetation, stored items, debris, or other physical barriers, can obscure potential defects and prevent a thorough evaluation of the property's condition. Obstructions of this nature can conceal a wide range of issues, such as structural damage, water ingress, pest infestations, or deteriorating building materials, which may not be visible during the initial inspection.

It is essential that these obstructions be cleared to allow for a comprehensive inspection of the external areas. Removing these barriers will enable a more accurate assessment of the property's condition and allow any hidden defects to be identified and addressed promptly. Failure to do so could result in undetected issues worsening over time, potentially leading to more costly repairs in the future.

Therefore, it is strongly recommended that the obstructions be removed and a re-inspection be scheduled once the affected areas are made fully accessible. This will ensure a complete evaluation of the property's exterior and provide the client with a clear understanding of any potential issues that may have been concealed during the initial inspection.
