# Building and Timber Pest Inspection Report

Inspection Date: Fri, 13 Feb 2026

Property Address: 31 Margherita Ave, Bateau Bay NSW 2261,  
Australia

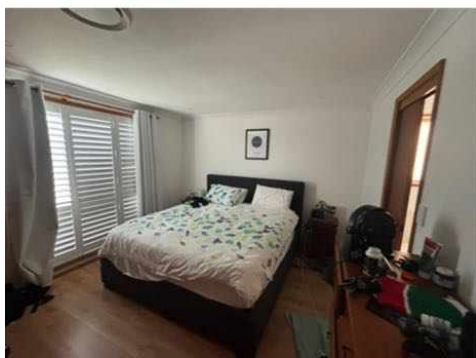
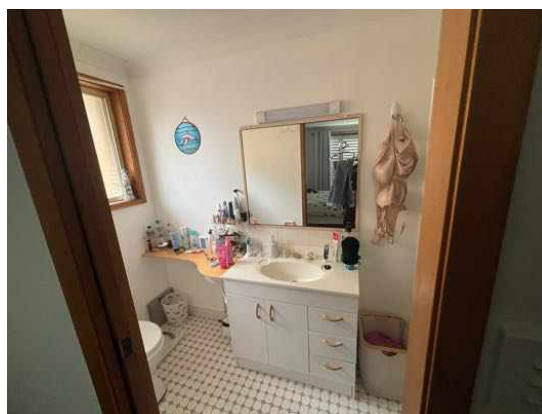
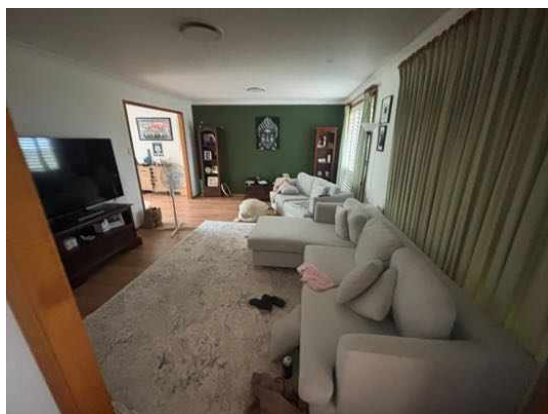
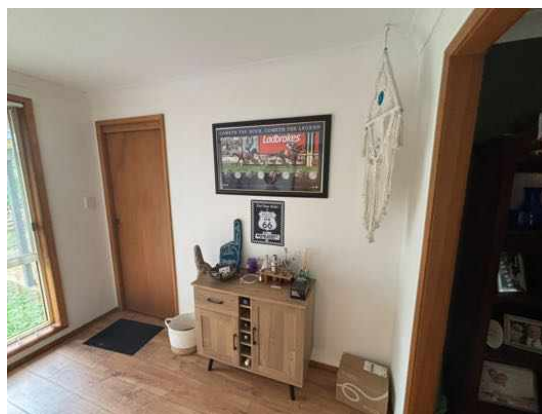
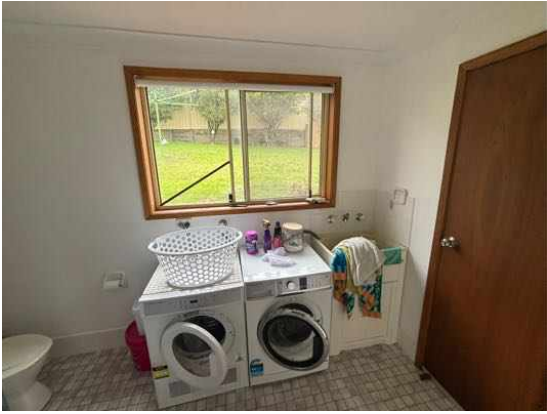
Building:	Main Building
Location:	All Internal Areas
Finding:	Obstructions and Limitations - Internal Areas
Information:	The accompanying photographs provide clear evidence of the obstructions and limitations that restricted a comprehensive inspection of the internal areas of the property at the time of assessment. These obstructions, which may include furniture, personal belongings, stored items, or structural elements such as wall coverings and built-ins, significantly hindered the ability to thoroughly evaluate these areas. It is important to note that such obstructions can potentially conceal a wide array of defects, ranging from hidden structural damage, water leaks, pest infestations, or

electrical issues, to deteriorating materials that may not be visible during the initial inspection.

The presence of these impediments means that critical areas of the property were not accessible, and therefore, any underlying defects that may affect the integrity and safety of the property could remain undetected. These hidden defects, if left unaddressed, could worsen over time and may result in costly repairs or pose potential safety hazards to the occupants.

It is highly recommended that all obstructions be cleared to facilitate a complete and thorough inspection of the internal areas. Once the obstructions have been removed and full access is available, a re-inspection should be carried out to ensure that any previously concealed issues can be properly identified and rectified. This follow-up inspection will provide a more accurate assessment of the property's internal condition and help the client make informed decisions about any necessary repairs or maintenance.

In summary, the limitations encountered during the inspection highlight the importance of ensuring full access to all areas of the property to accurately assess its overall condition. A re-inspection is strongly advised once these areas are made accessible.

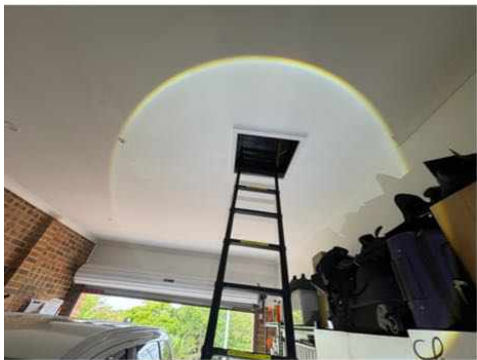
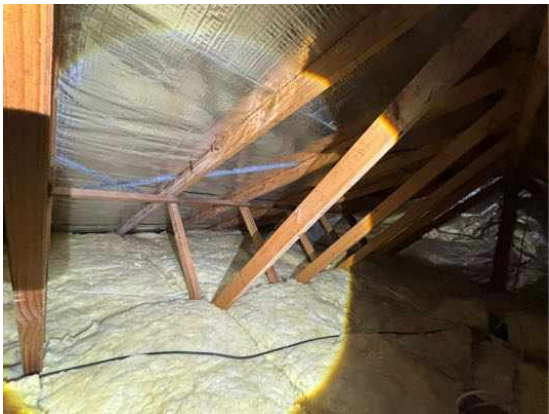
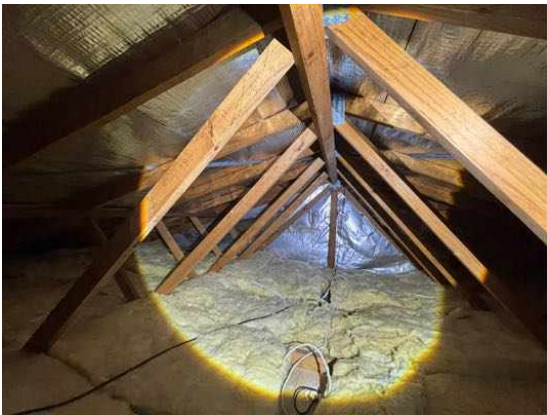
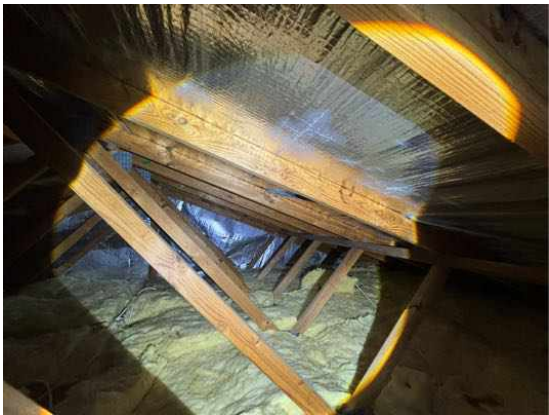
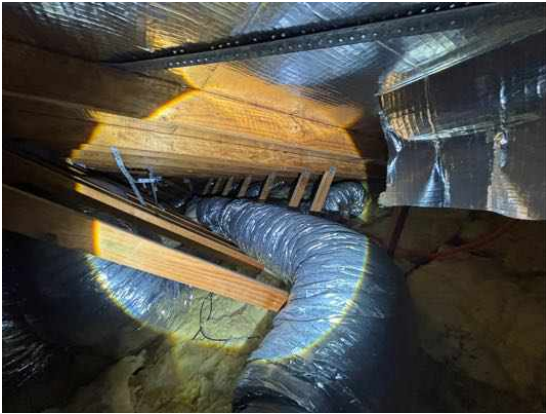
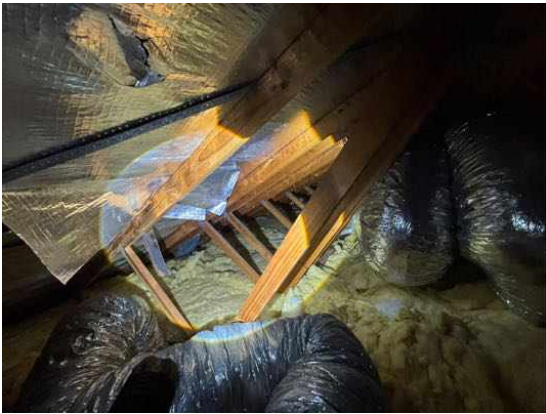
Building: Main Building  
Location: Roof Void  
Finding: Obstructions, Limitations, and General Roof Space Condition  
Information: The photographs provided document both the general condition and the obstructions and limitations that were present in the roof cavity of the main building at the time of inspection. These obstructions—such as insulation materials, stored items, structural elements, or electrical wiring—restricted safe and adequate access to key areas within the roof space. As a result, a comprehensive inspection of all components could not be completed.

Obstructions of this nature may conceal a variety of potential defects, including damaged framing, compromised insulation, evidence of moisture ingress, pest activity, or electrical hazards. While no major issues were observed in the visible areas, the presence of these limitations means that some defects may remain undetected.

It is recommended that these barriers be removed or repositioned to facilitate full and safe access to the roof space. Once clear, a follow-up inspection should be conducted to allow for a thorough assessment of all concealed areas. This will help ensure that the condition of the roof cavity is accurately evaluated and any hidden issues are appropriately identified and addressed.

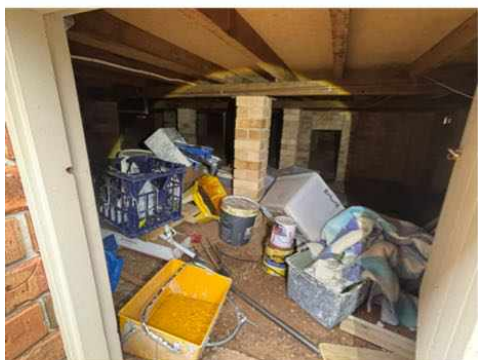
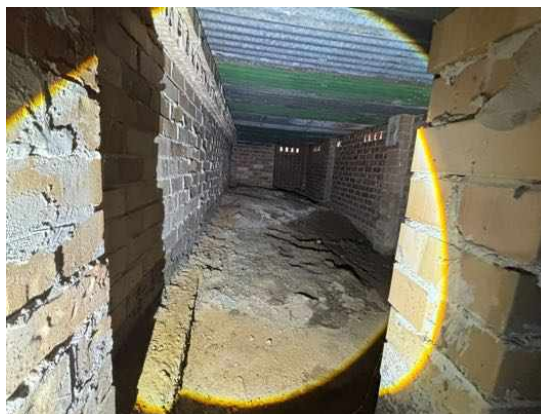
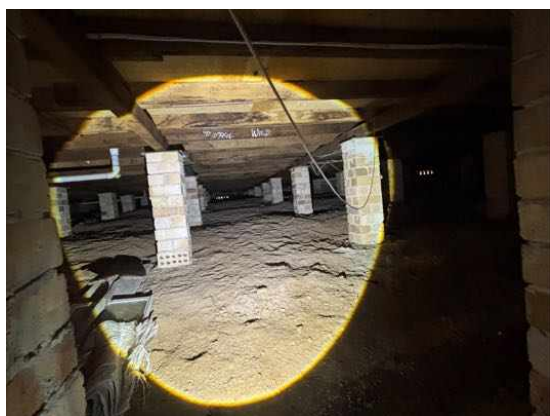
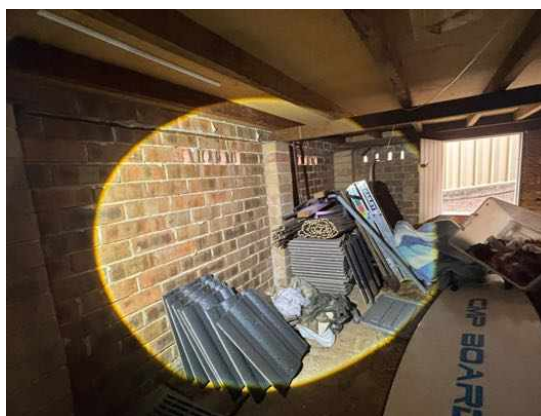
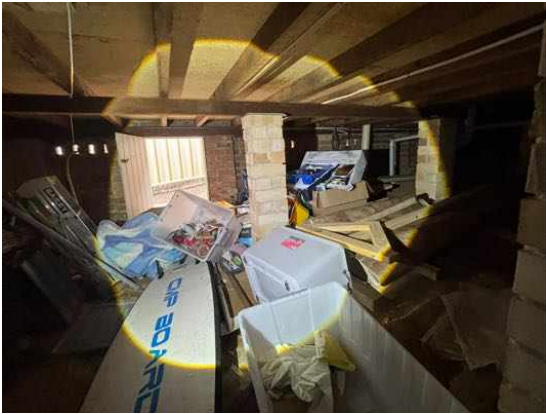
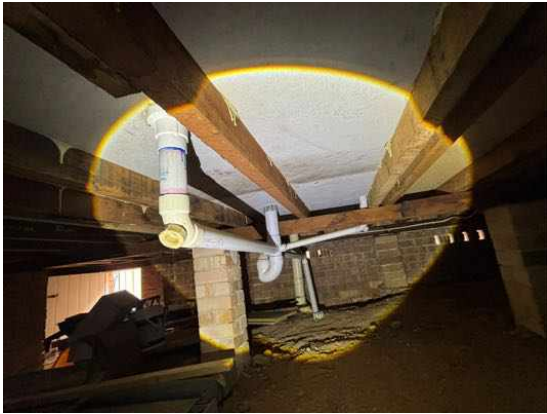
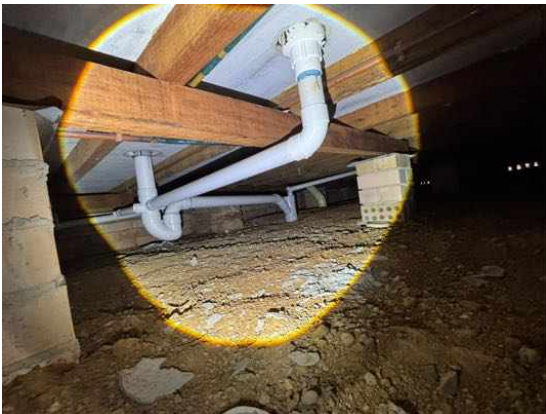
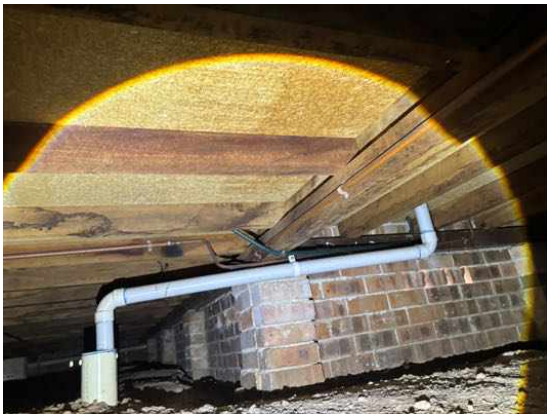
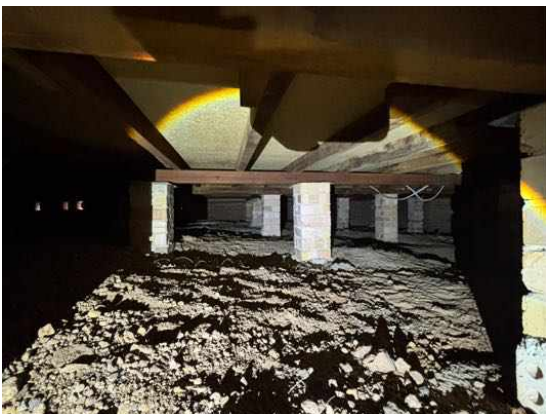
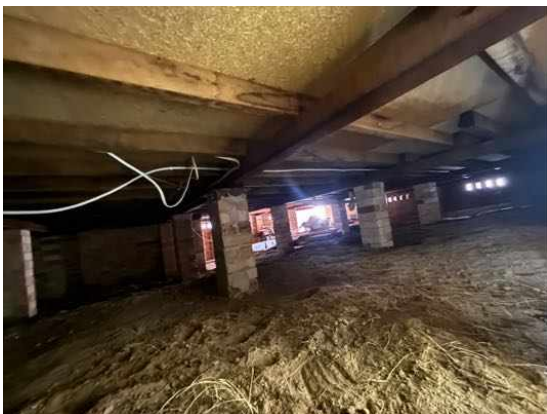
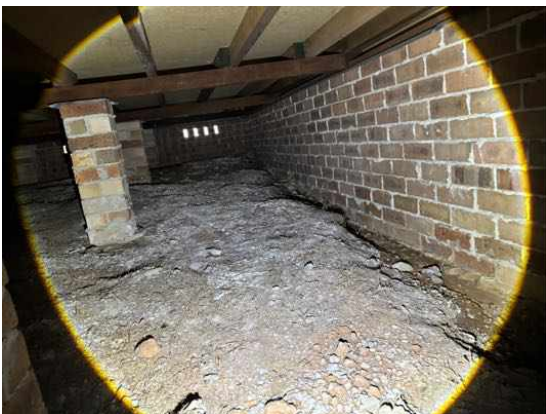
Building: Main Building  
 Location: Subfloor  
 Finding: Obstructions, Limitations, and General Subfloor Condition  
 Information: The attached photographs illustrate the obstructions and access limitations that restricted a full inspection of the subfloor area of the main property at the time of assessment. Items such as stored materials, construction debris, low-hanging services, and insulation impeded movement and visibility within key sections of the subfloor. In addition, the limited crawl height further restricted safe access to inspect critical structural components.

Restricted access and confined spaces can significantly hinder the ability to evaluate important elements such as floor joists, bearers, stumps, drainage, subfloor ventilation, and signs of moisture or pest activity. These obstructions may also conceal defects such as timber decay, water ingress, termite damage, inadequate support, or ventilation issues that are not immediately visible during a limited inspection.

While no major concerns were identified in the accessible areas, a full and unobstructed inspection is necessary to properly assess the overall condition of the subfloor. It is recommended that obstructions be removed and access improved where possible. Once adequate clearance is provided, a re-inspection should be arranged to ensure that any concealed defects can be identified and addressed accordingly. This will assist in providing a more comprehensive understanding of the subfloor's condition and reduce the risk of unforeseen issues.

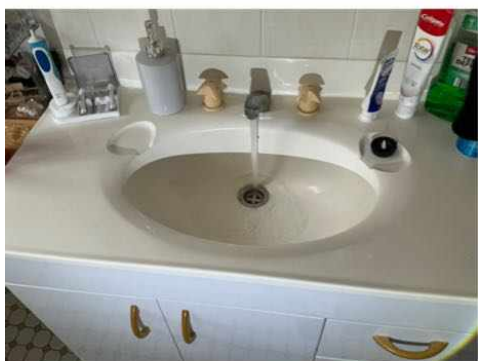
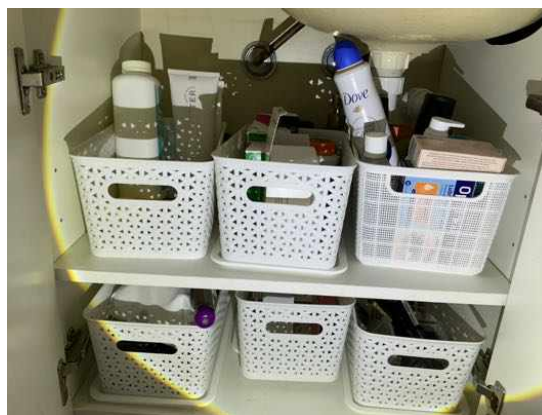
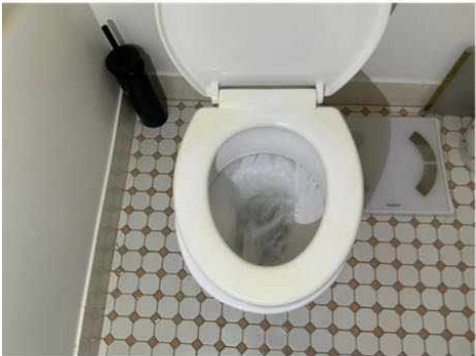
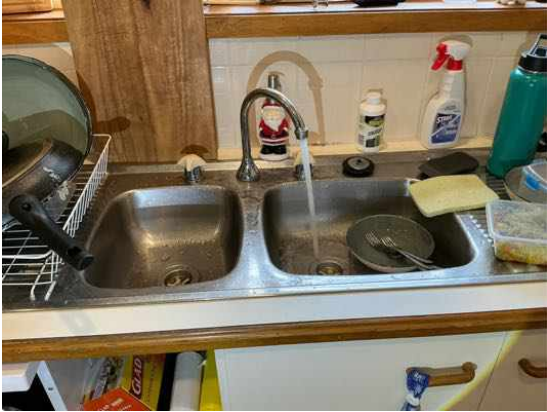
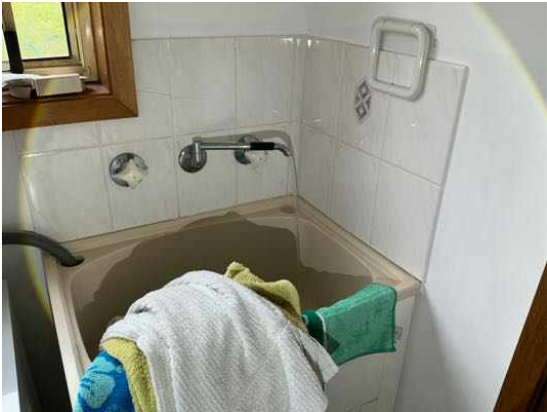
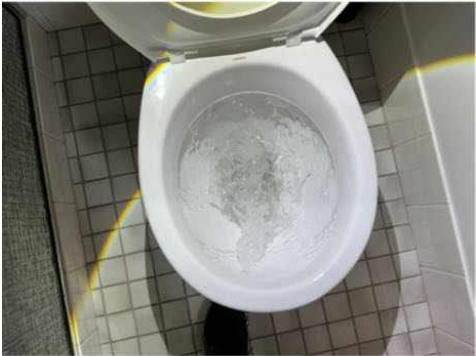
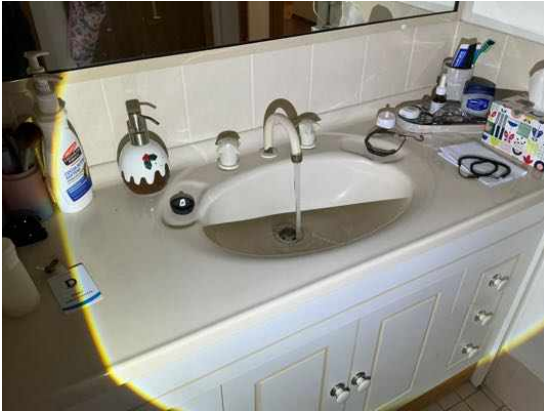
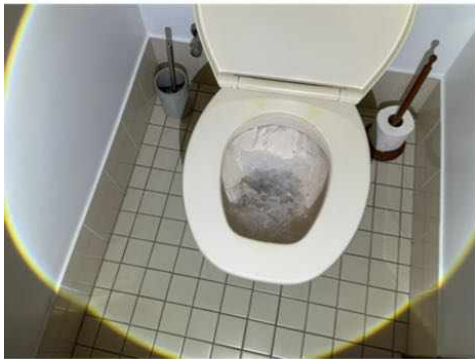
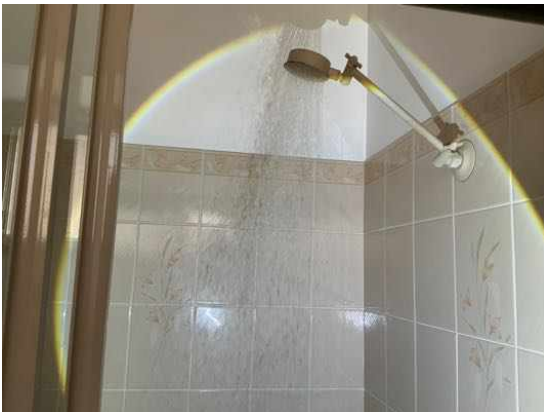
Building: Main Building  
 Location: All Areas  
 Finding: FYI - Taps, Drainage & Toilets Tested and Cabinetry Obstructions  
 Information: During the inspection, all accessible taps, drainage systems, and toilets were tested for water flow and drainage efficiency, and checked for any visible signs of leakage. At the time of the inspection, no issues were noted in these areas. Unless highlighted in a separate defect statement, no immediate remedial work appears necessary. Supporting images may be found in the additional photos section for reference.

It is important to note that while a visual inspection of cupboards and cabinetry beneath sinks and vanities was undertaken, stored personal items and fixtures presented obstructions that limited full visibility of the internal areas. As per standard inspection practices, inspectors are not permitted to move or disturb personal belongings during the inspection process. Therefore, only visible and accessible sections were inspected, and concealed water damage or plumbing defects may not have been detected.

Given this, a re-inspection is recommended after all obstructions have been cleared to allow for a comprehensive assessment of these areas. Regular maintenance and monitoring of plumbing and drainage systems is also advised to ensure ongoing functionality and early detection of potential issues.

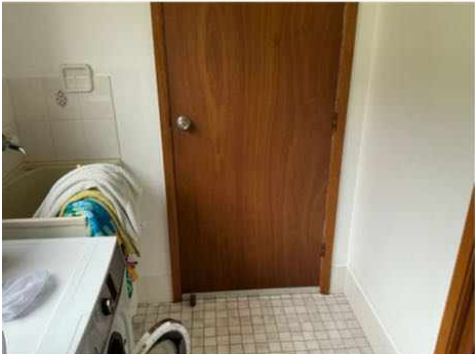
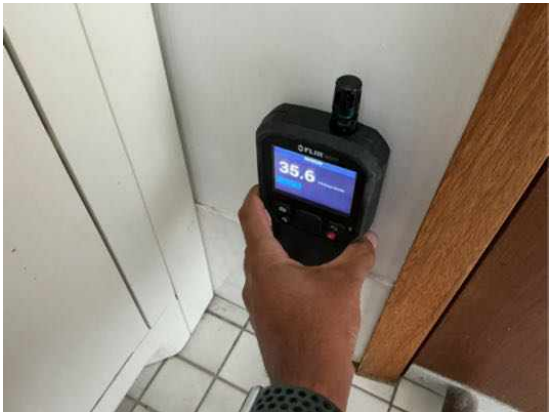
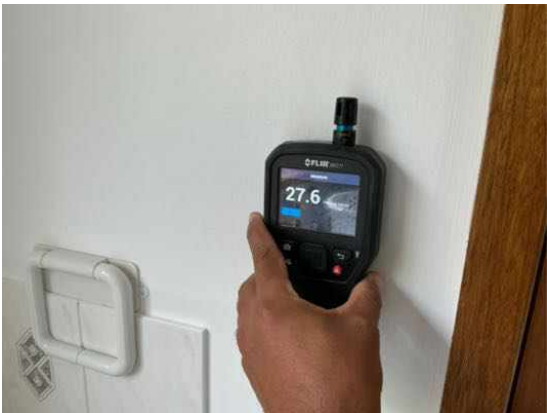
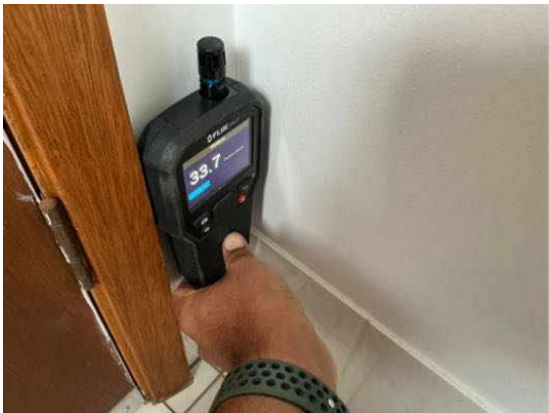
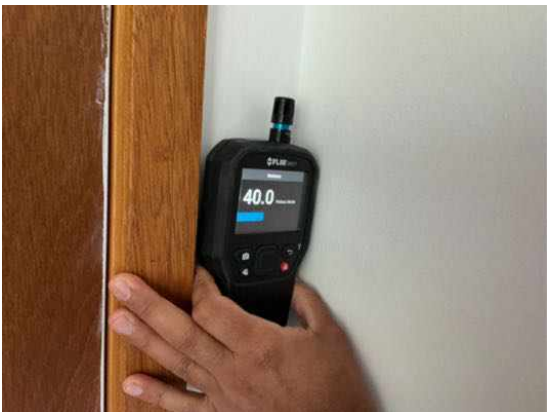
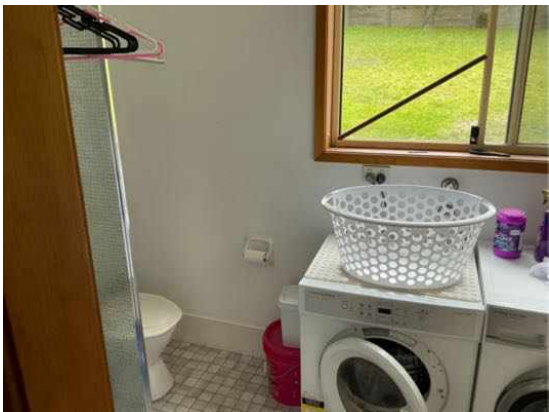
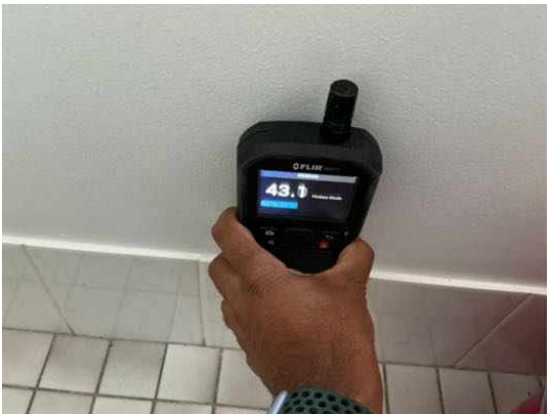
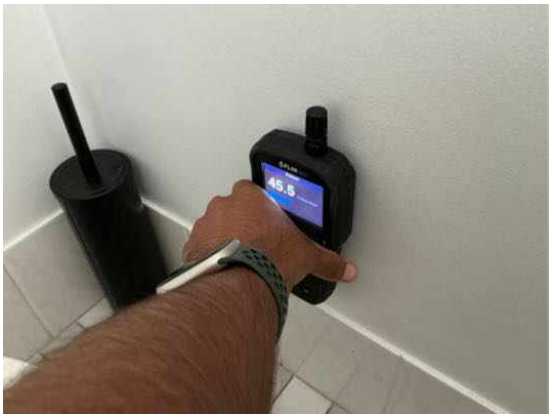
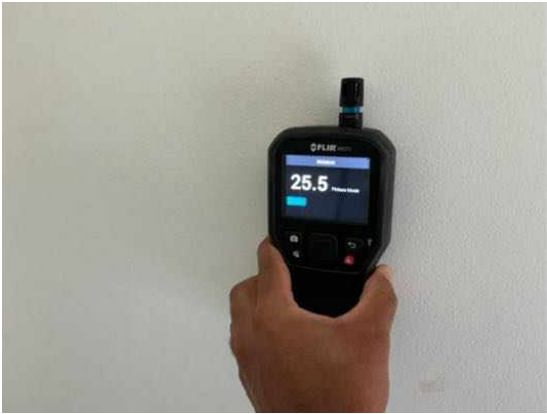
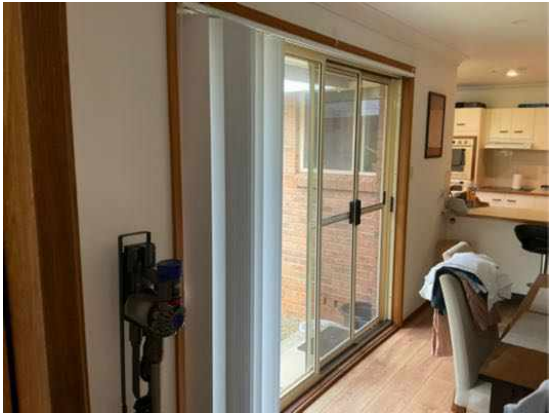
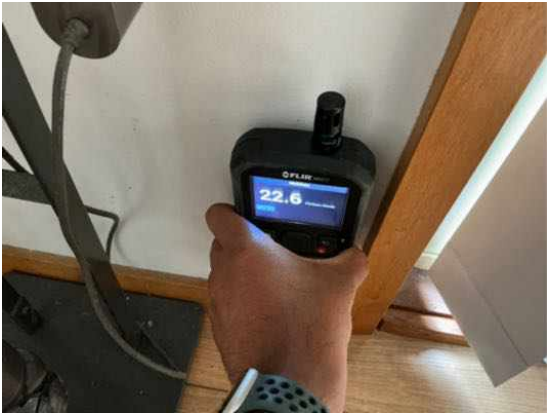
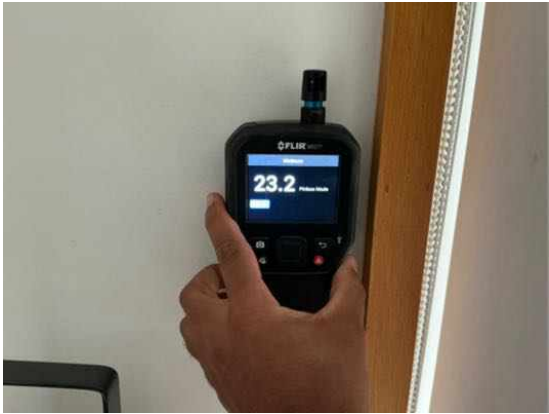
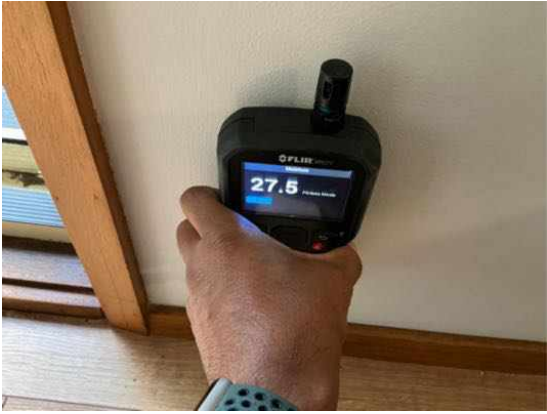
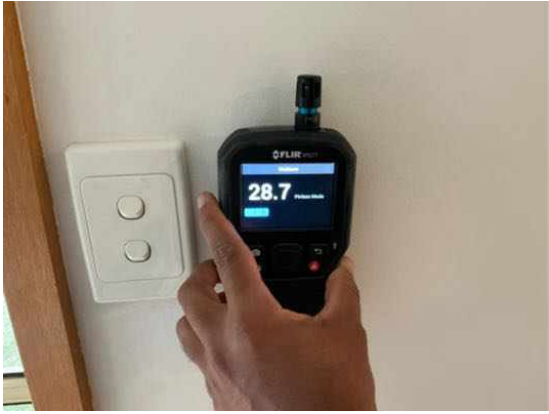
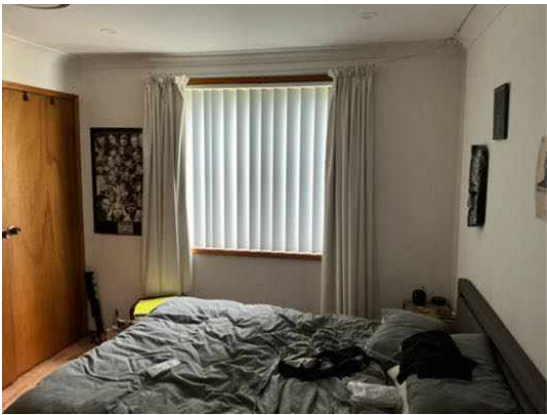
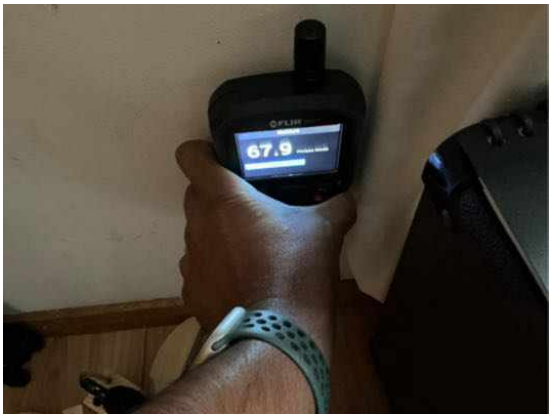
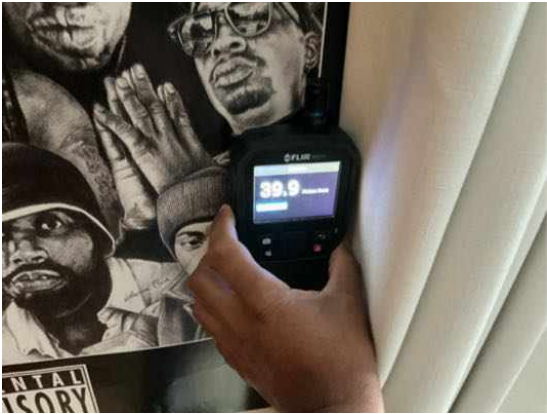
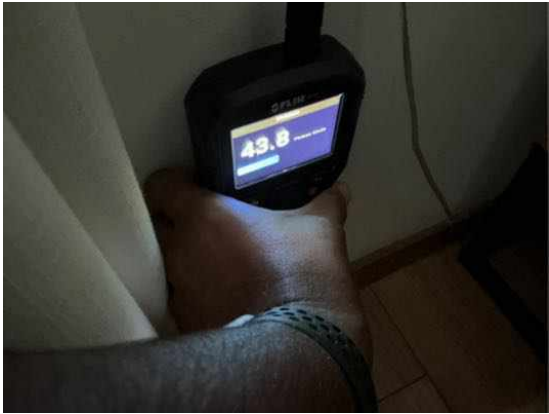
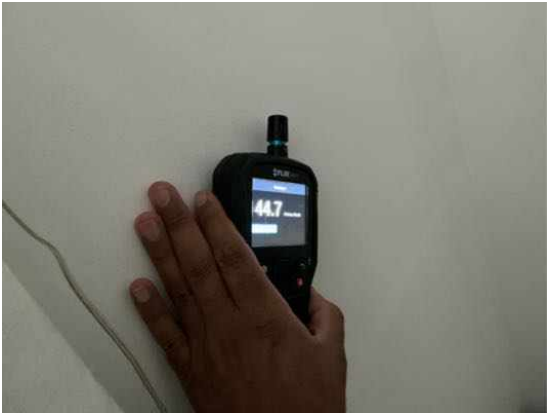
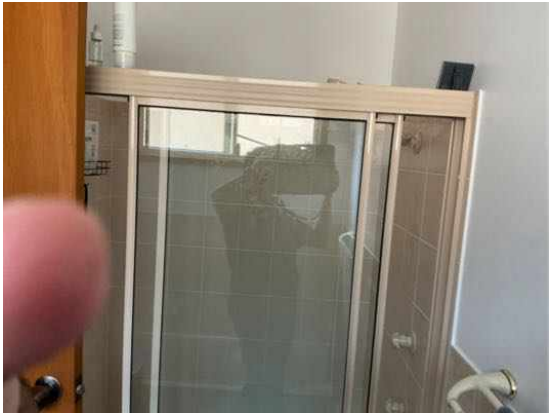
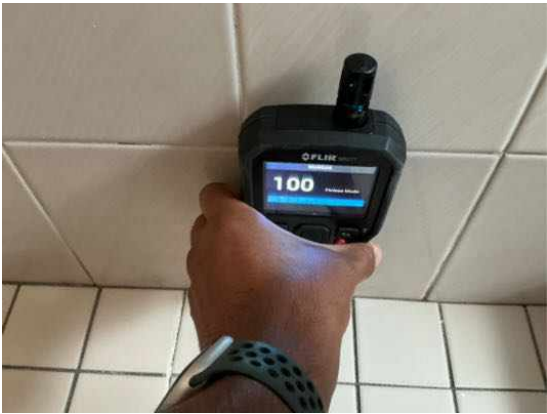
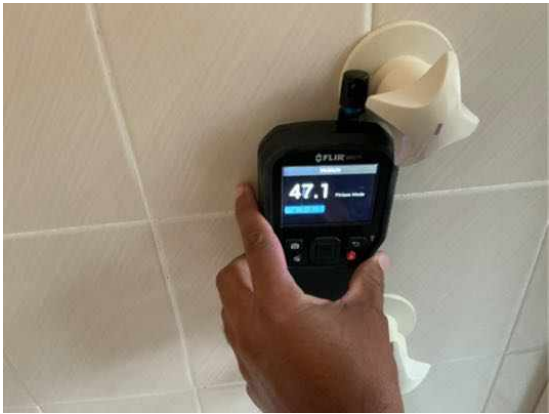
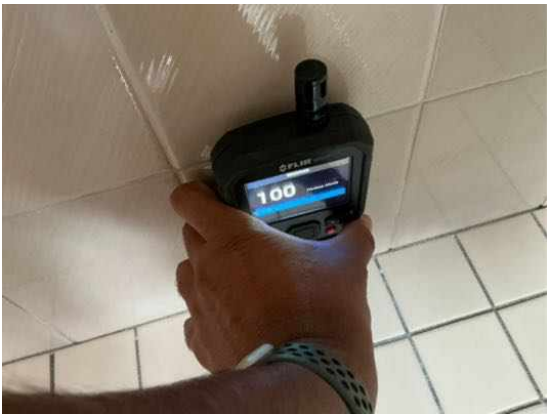
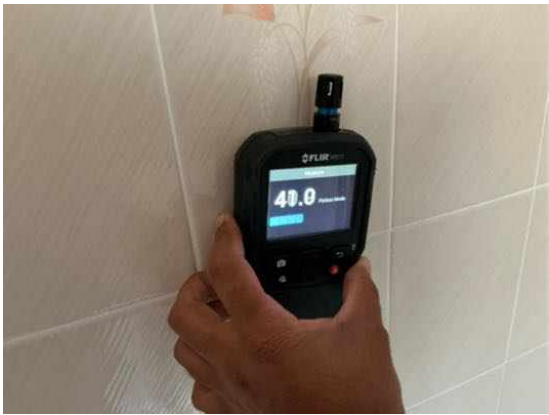
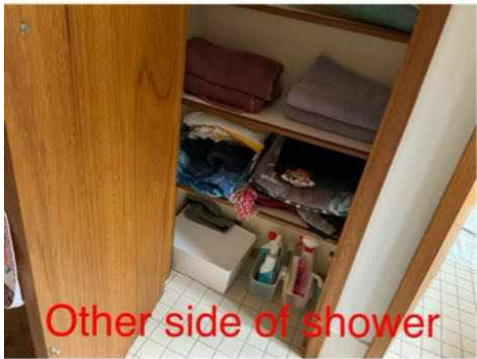
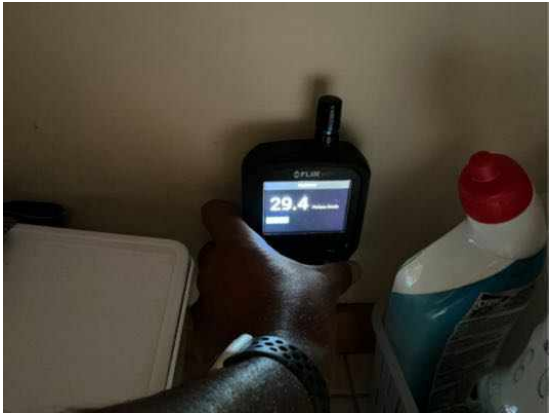
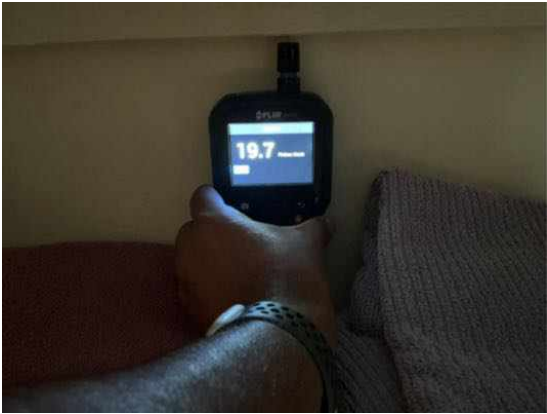
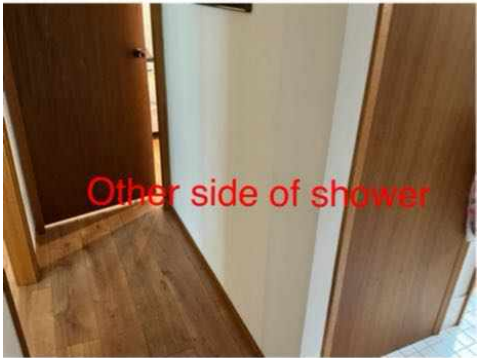
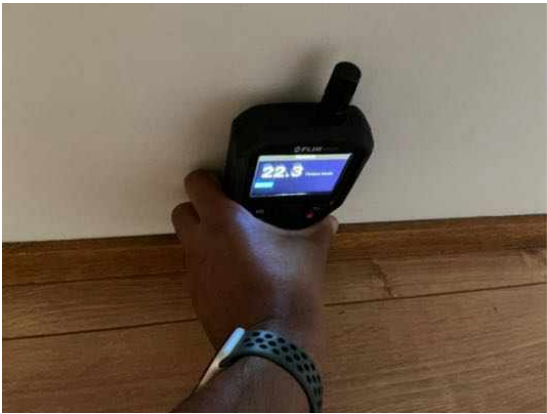
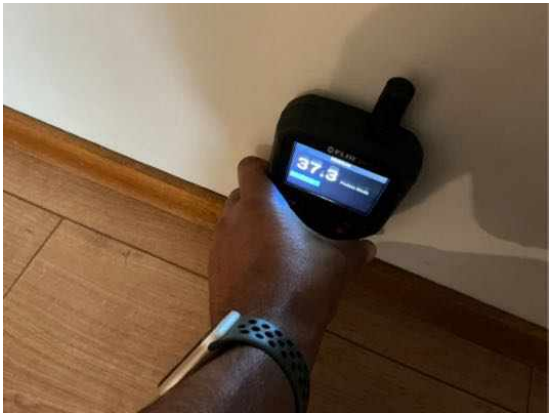
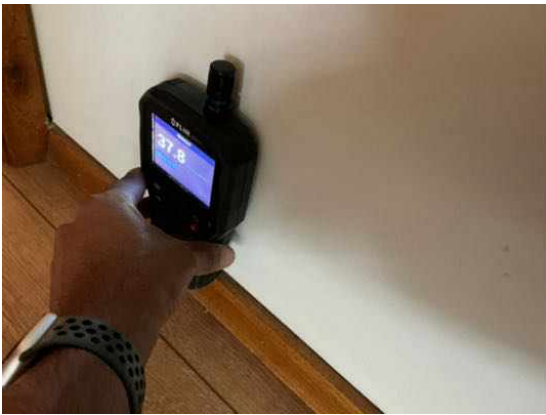
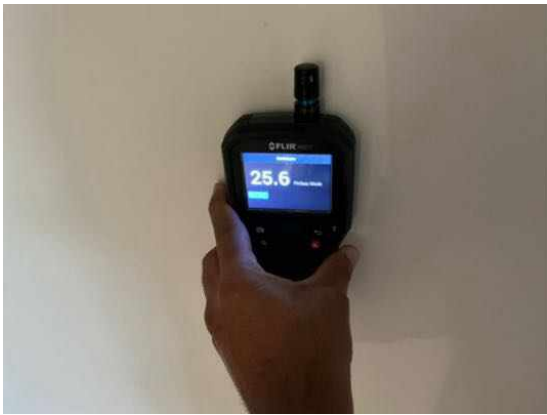
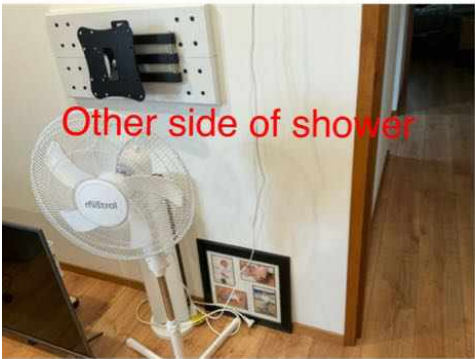
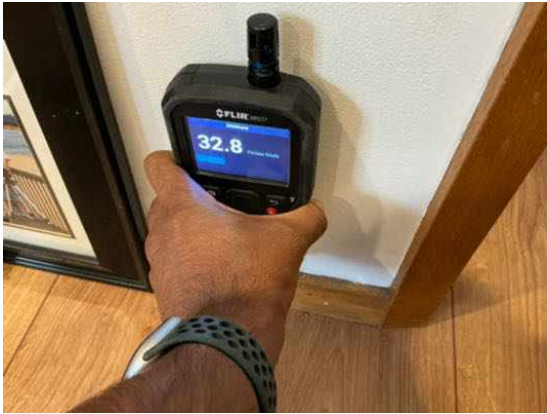
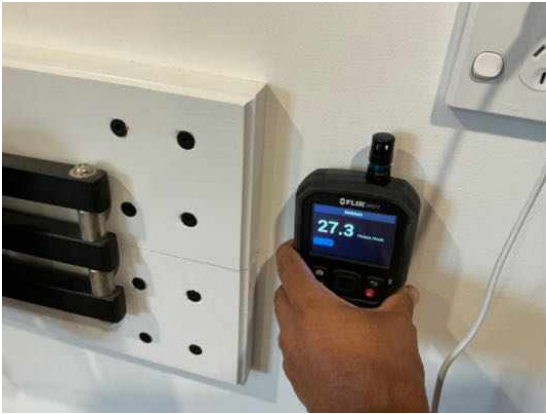
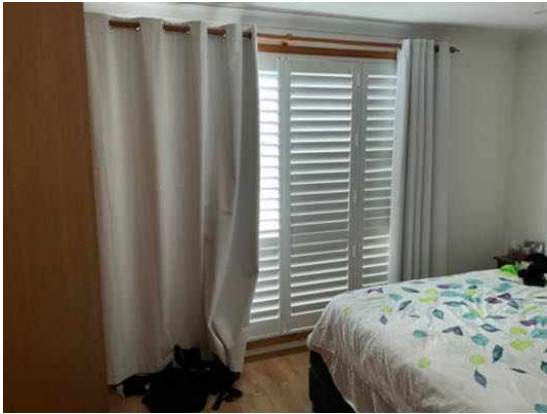
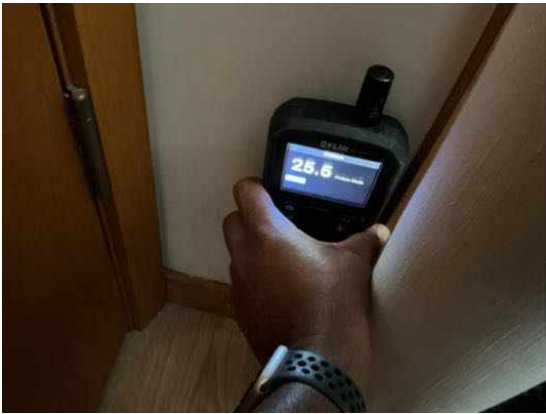
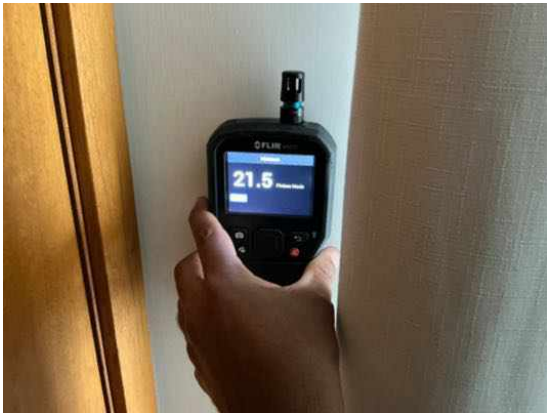
Building:	Main Building
Location:	All Areas
Finding:	Additional Photos - Moisture Meter Readings
Information:	Additional moisture meter reading photos have been provided for the property to offer further clarity on areas tested during the inspection. These photos are intended to give a visual reference for the specific locations where moisture levels were measured. These readings were taken at the time of the inspection to assess any potential moisture-related issues within the property. Any defects related to moisture that were identified during the inspection have been separately mentioned in the defect statements within the report.

It is important for the client to understand that moisture levels can fluctuate over time due to various factors, including changes in weather, humidity, and environmental conditions. While the readings reflect the property's moisture levels during the inspection, they may not represent future conditions, and increased moisture could lead to issues such as dampness, mould growth, or deterioration of building materials if left unmonitored.

For further clarification or additional information regarding the moisture readings, the client is encouraged to contact the building inspector directly. Regular monitoring of moisture-prone areas is recommended to ensure any emerging concerns are addressed promptly, particularly during wetter seasons or in high-humidity conditions.
