# Building and Timber Pest Inspection Report

Inspection Date: Fri, 13 Feb 2026

Property Address: 31 Margherita Ave, Bateau Bay NSW 2261,  
Australia

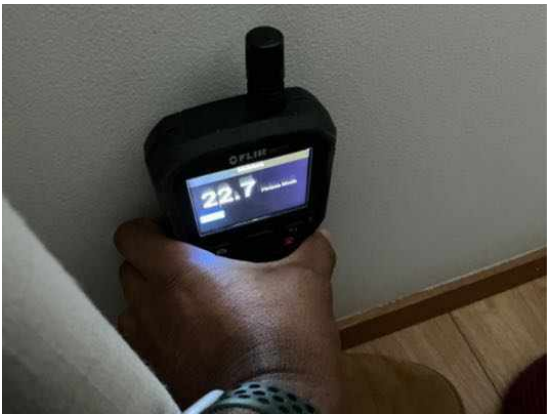
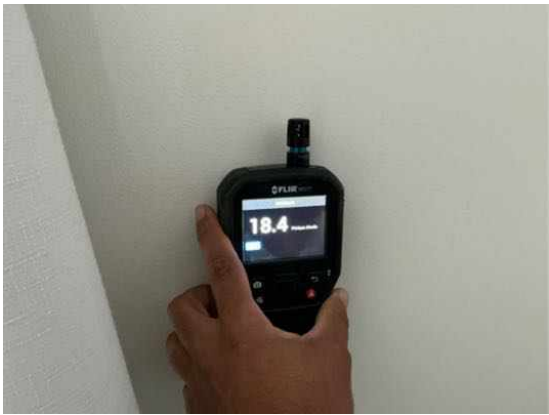
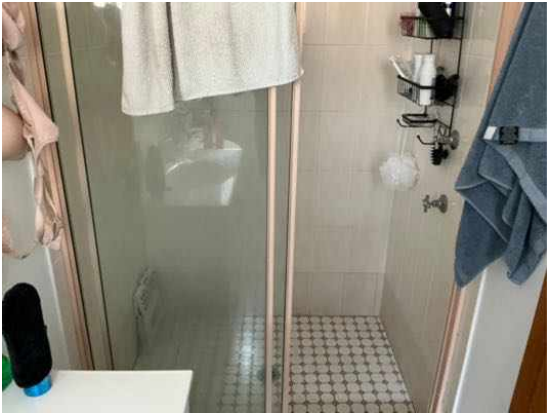
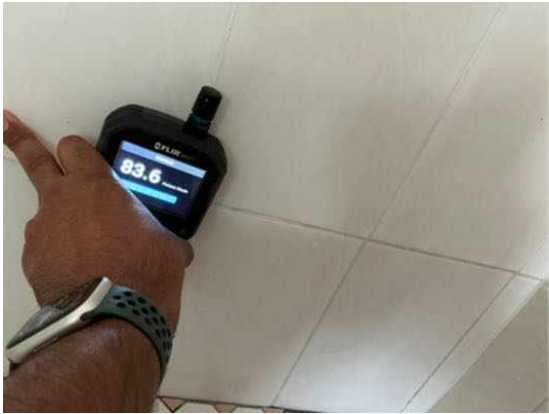
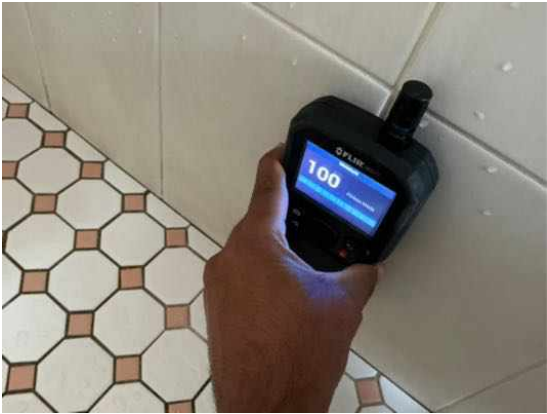
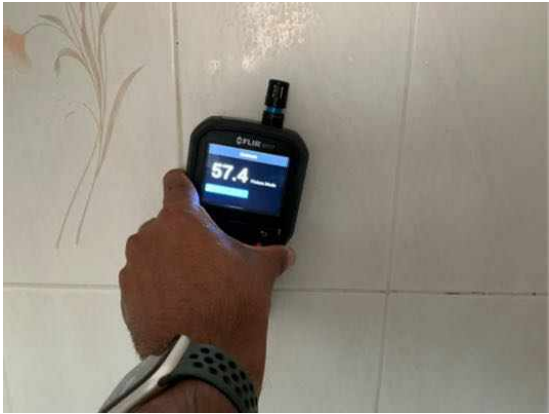
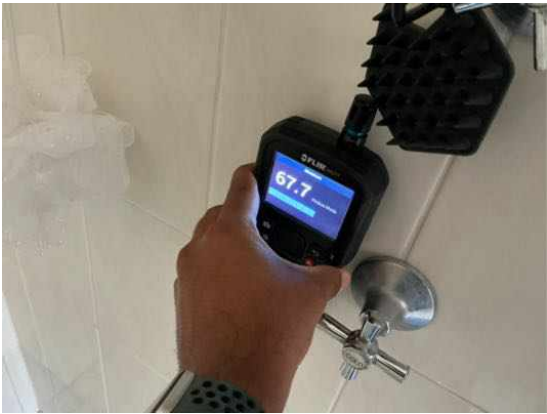
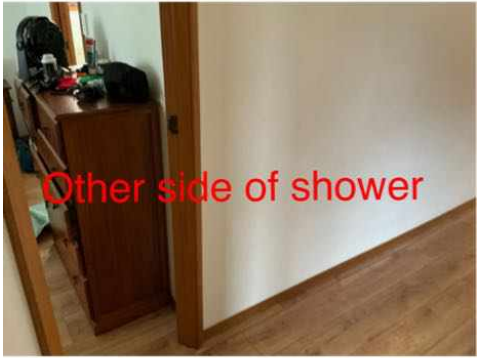
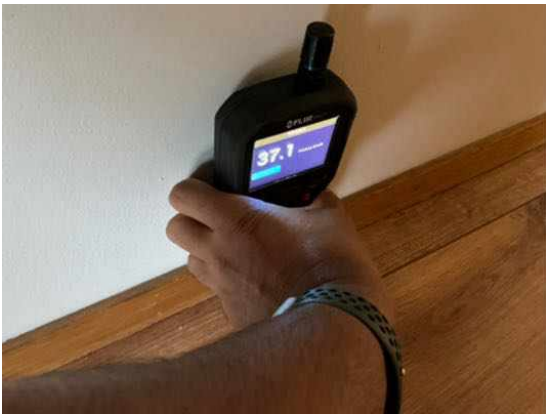
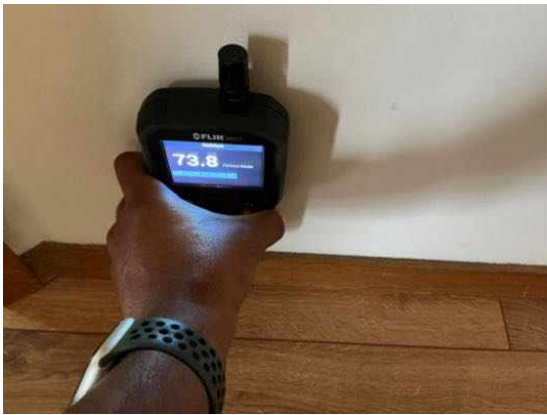
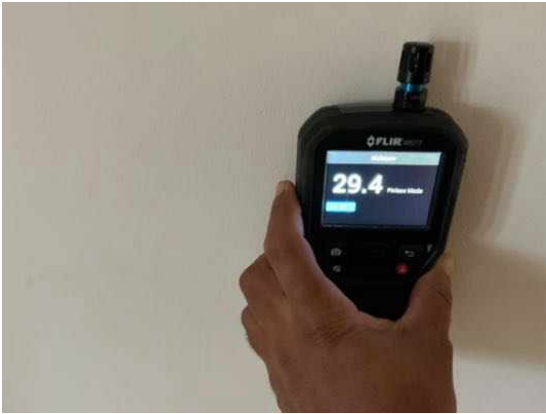
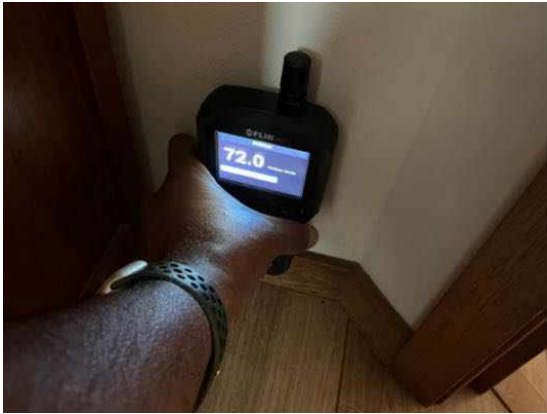
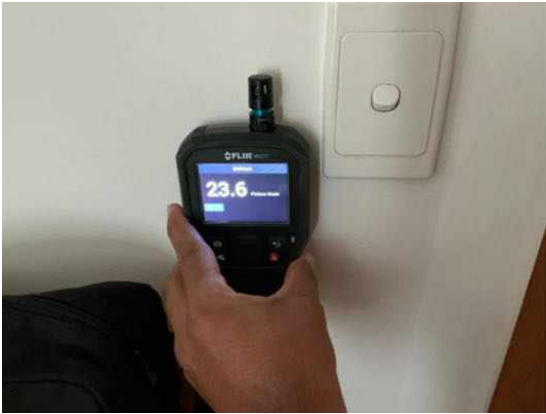
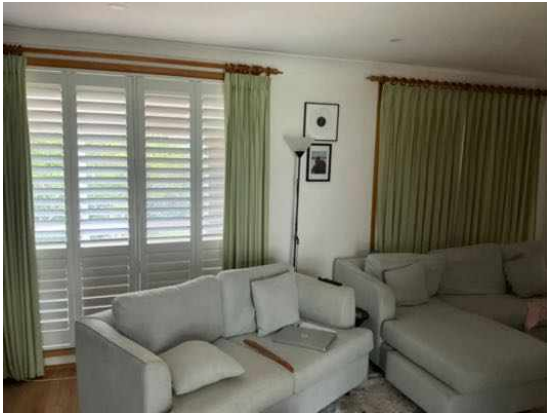
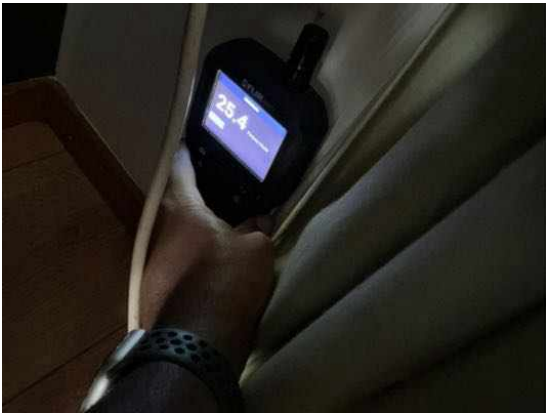
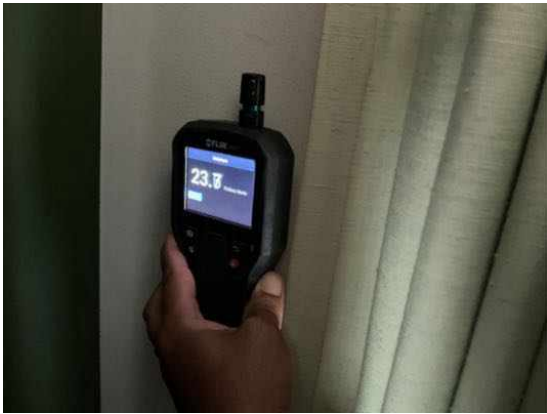
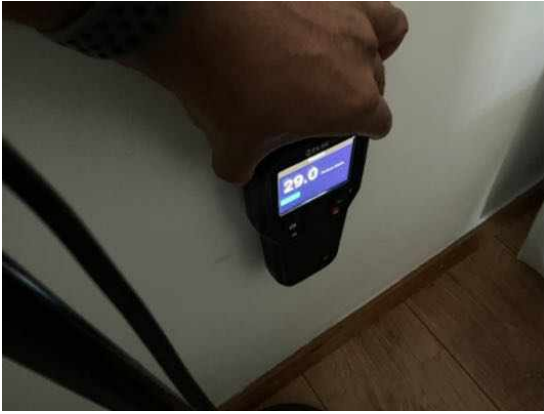
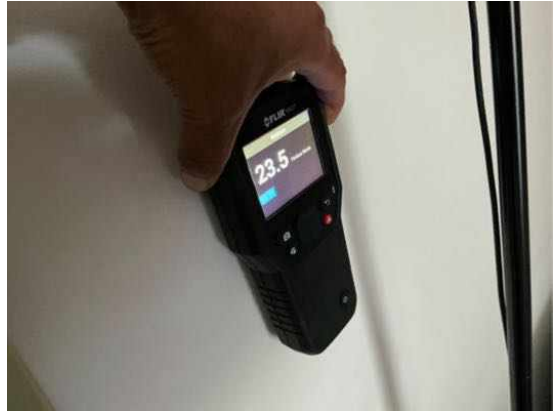
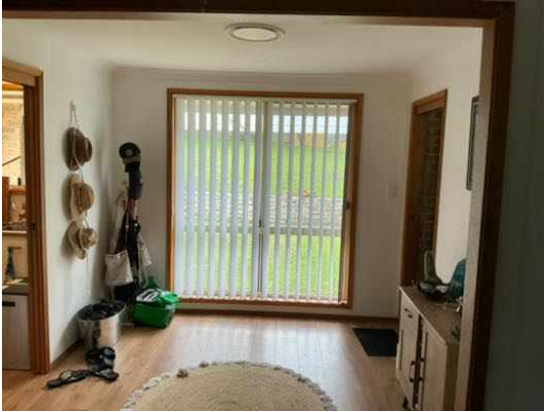
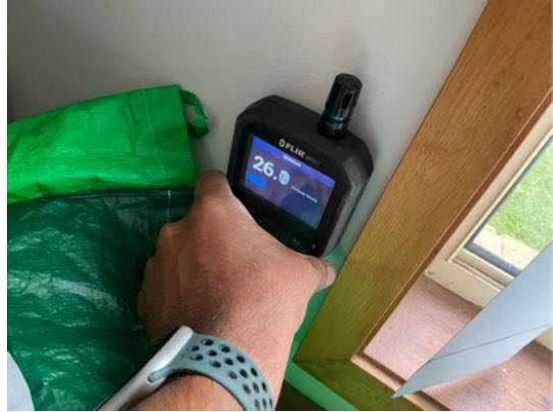
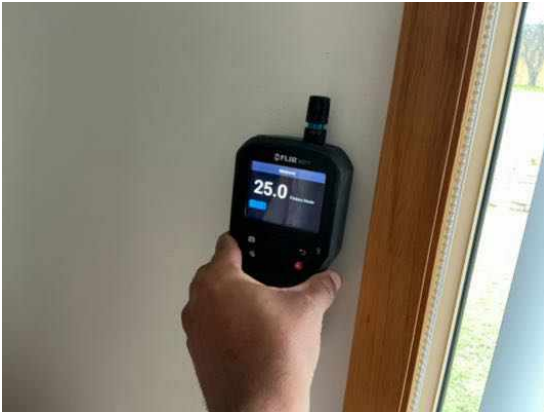
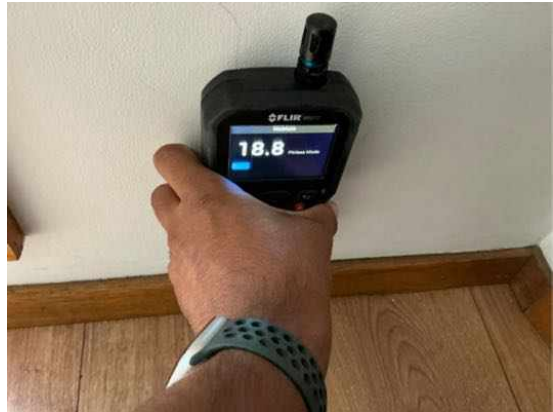
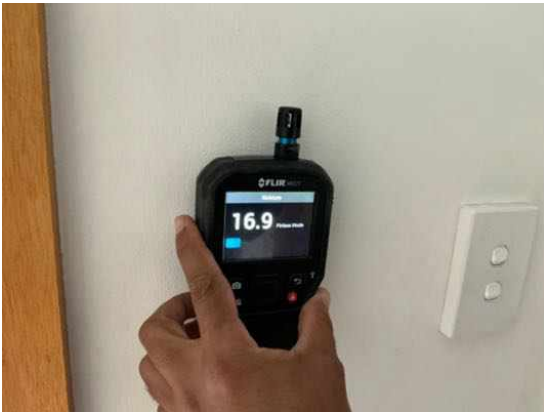
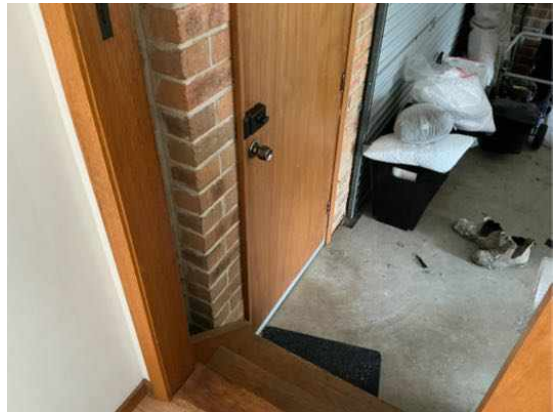
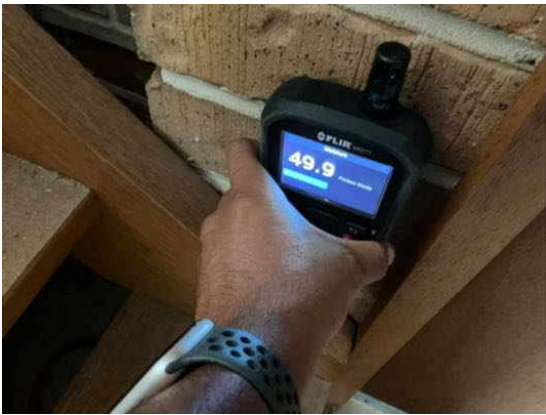
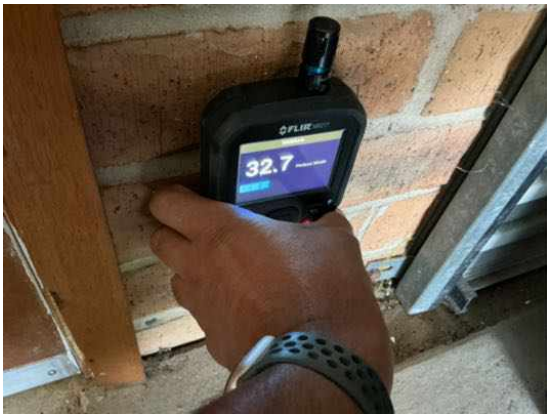
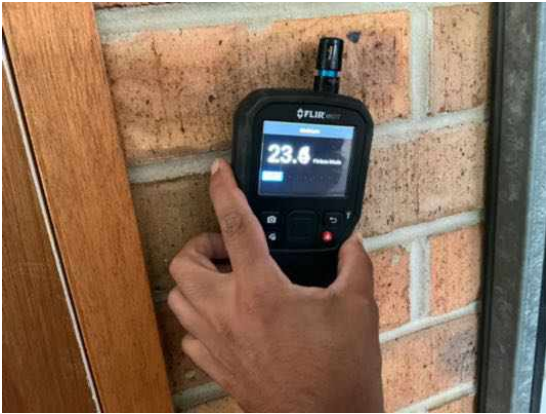
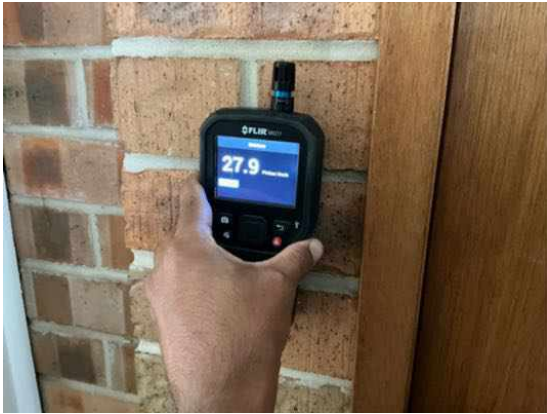
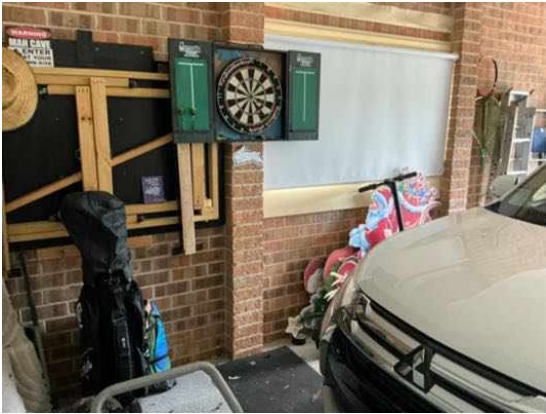
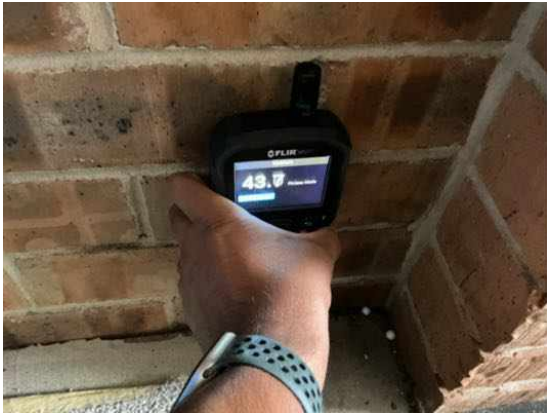
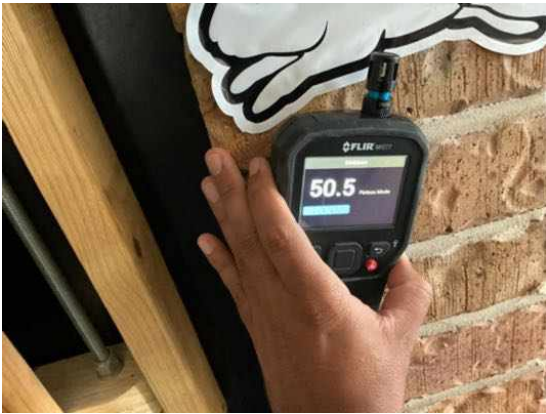
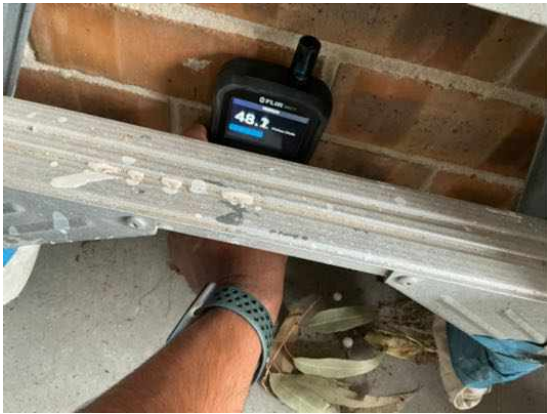
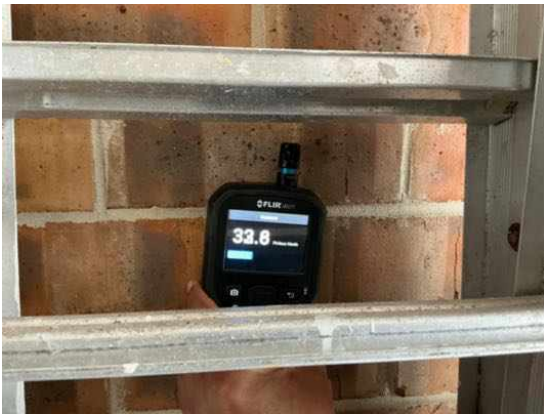
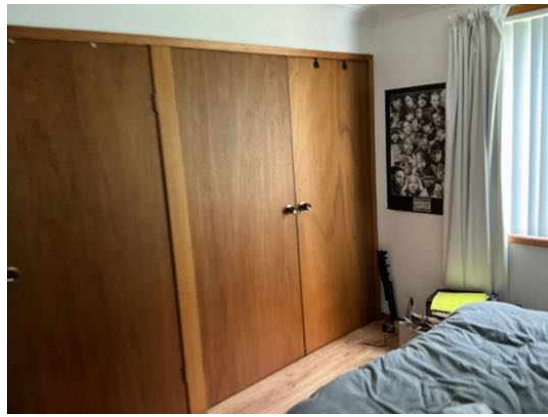
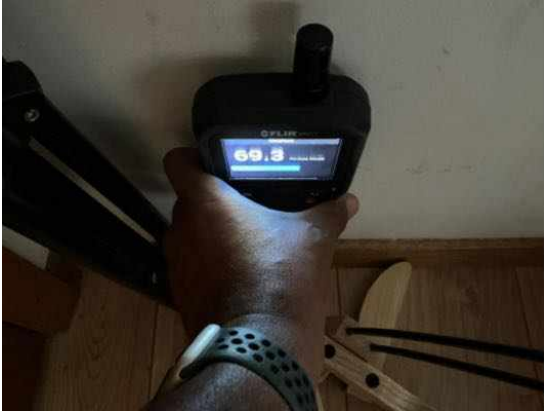
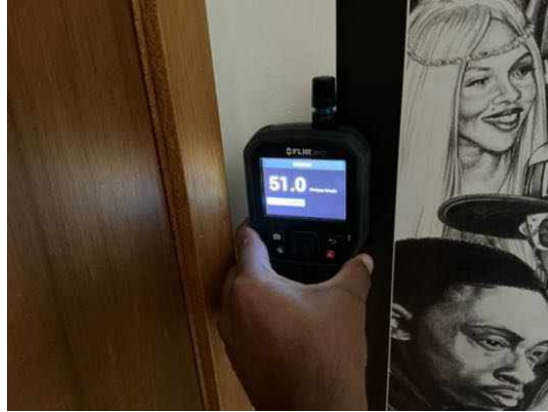
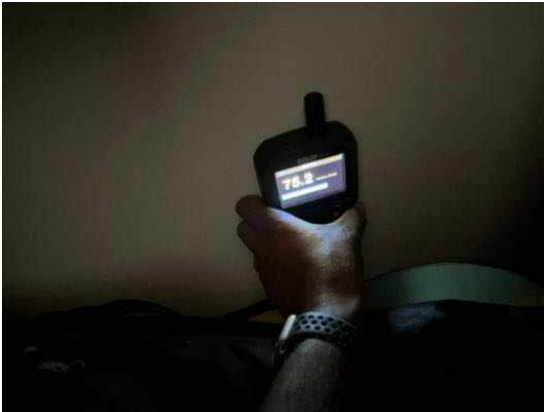
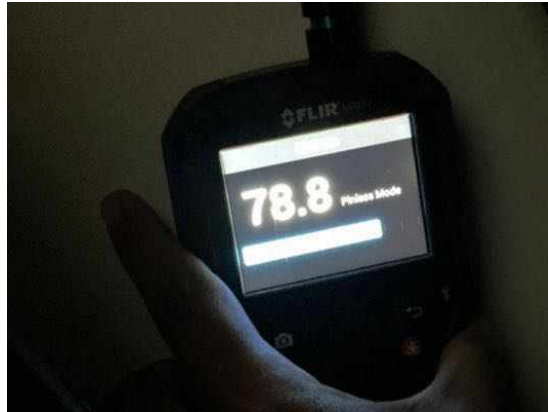
Building:	Main Building
Location:	All Areas
Finding:	Additional Photos - Moisture Meter Readings
Information:	Additional moisture meter reading photos have been provided for the property to offer further clarity on areas tested during the inspection. These photos are intended to give a visual reference for the specific locations where moisture levels were measured. These readings were taken at the time of the inspection to assess any potential moisture-related issues within the property. Any defects related to moisture that were identified during the inspection have been separately mentioned in the defect statements within the report.

It is important for the client to understand that moisture levels can fluctuate over time due to various factors, including changes in weather, humidity, and environmental conditions. While the readings reflect the property's moisture levels during the inspection, they may not represent future conditions, and increased moisture could lead to issues such as dampness, mould growth, or deterioration of building materials if left unmonitored.

For further clarification or additional information regarding the moisture readings, the client is encouraged to contact the building inspector directly. Regular monitoring of moisture-prone areas is recommended to ensure any emerging concerns are addressed promptly, particularly during wetter seasons or in high-humidity conditions.

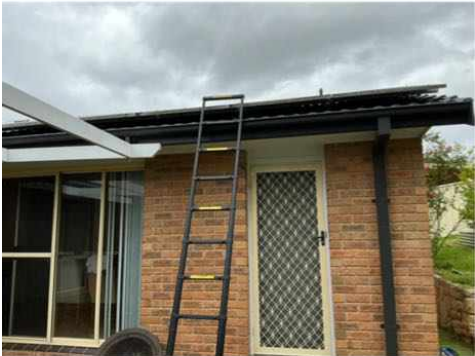
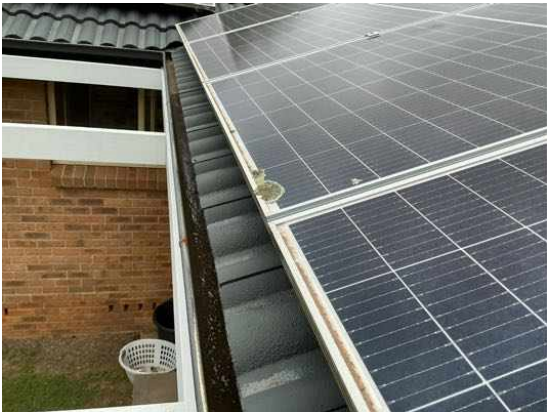
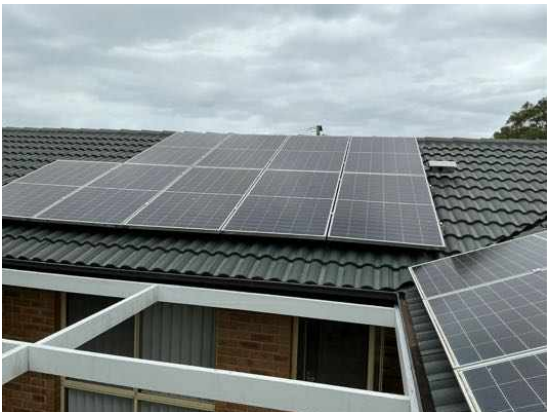
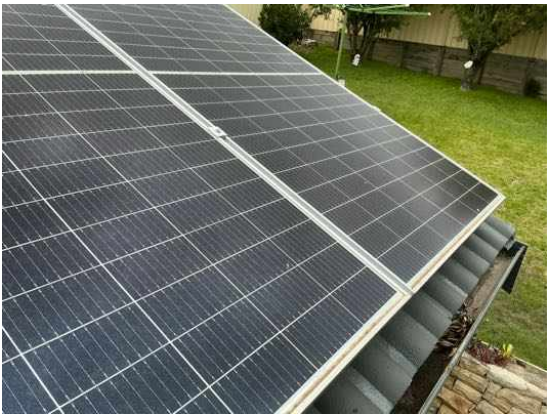
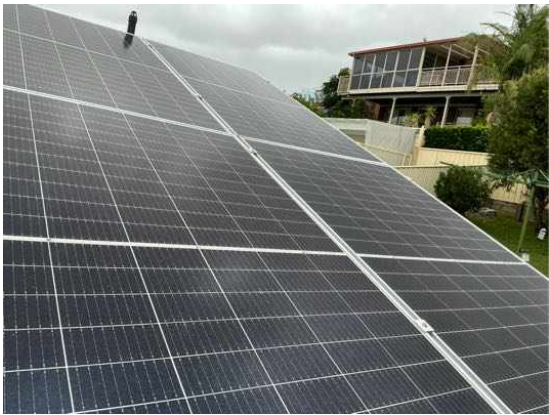
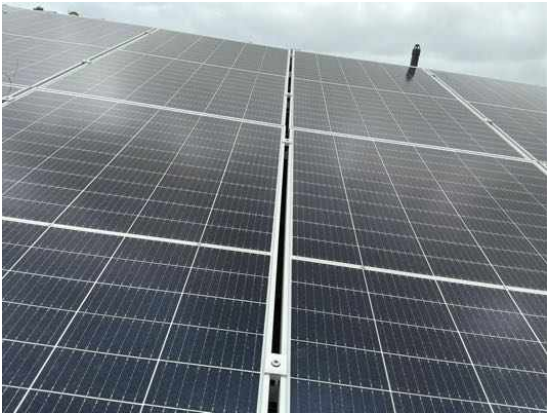
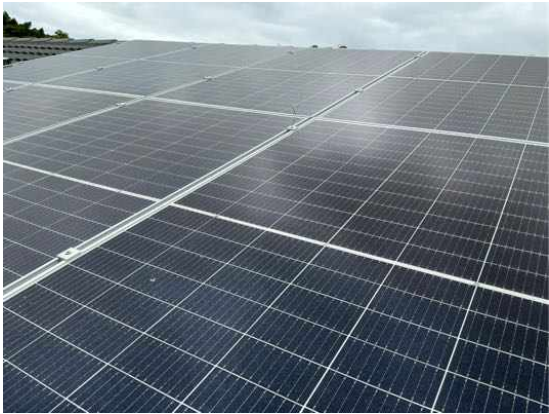
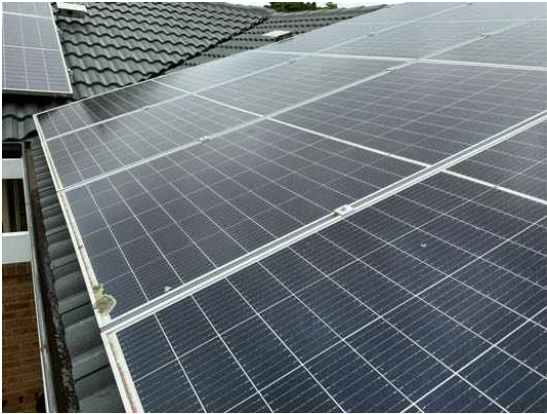
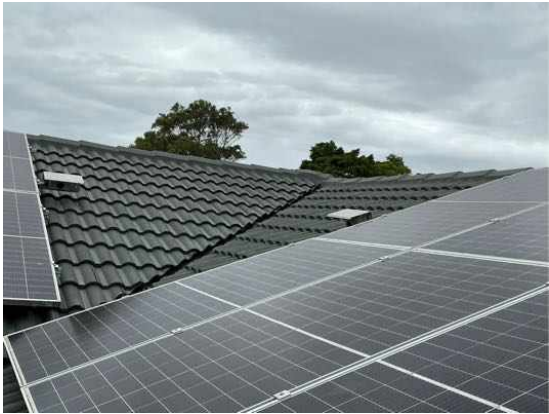
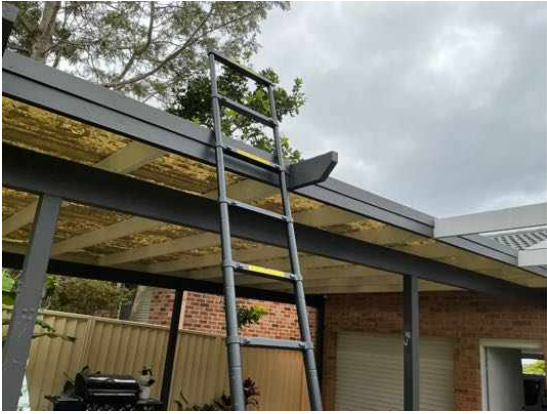
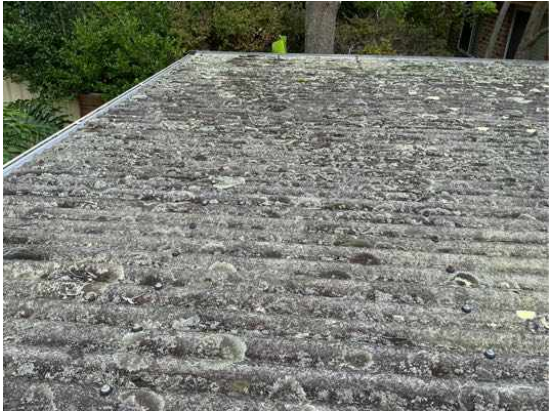
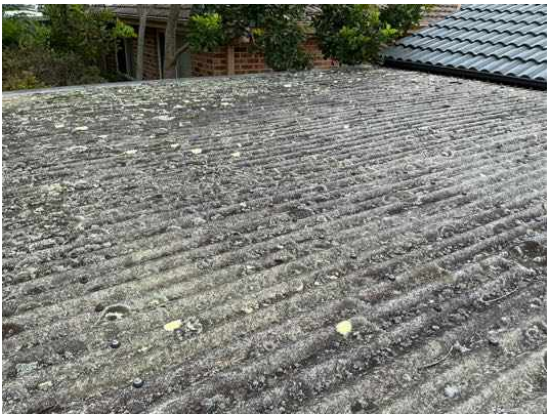
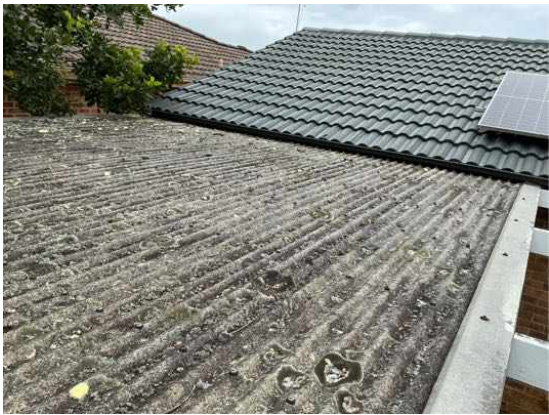
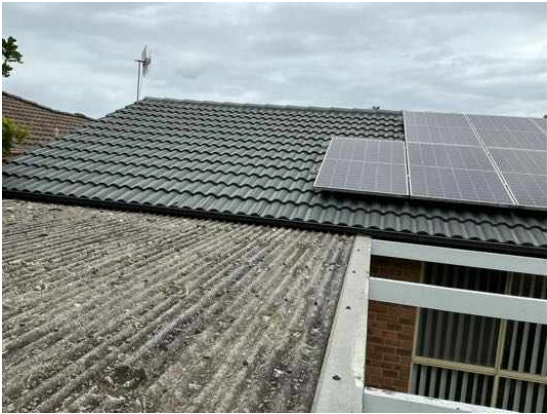
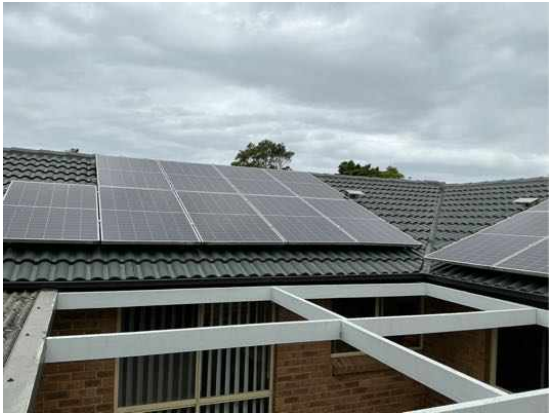
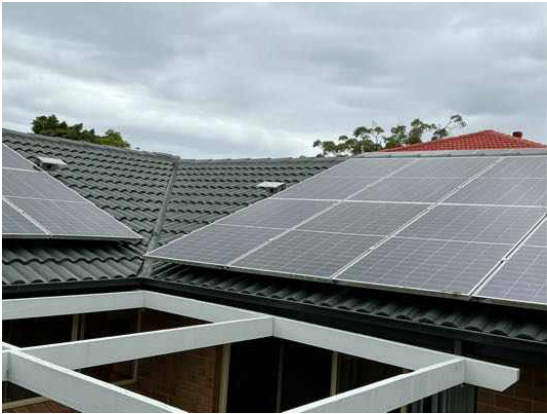
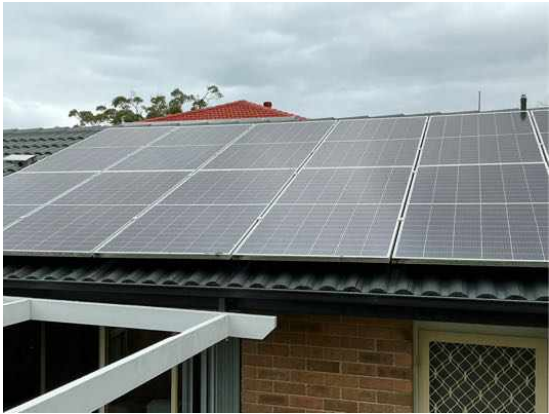
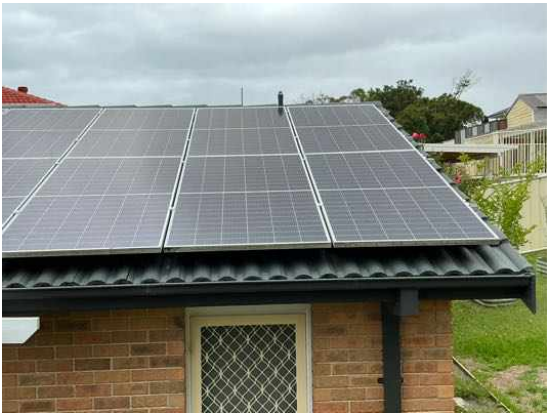
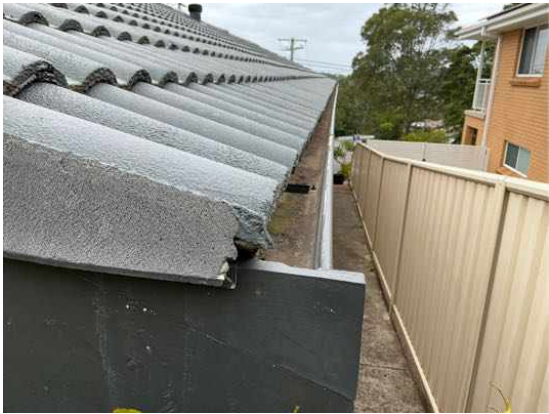
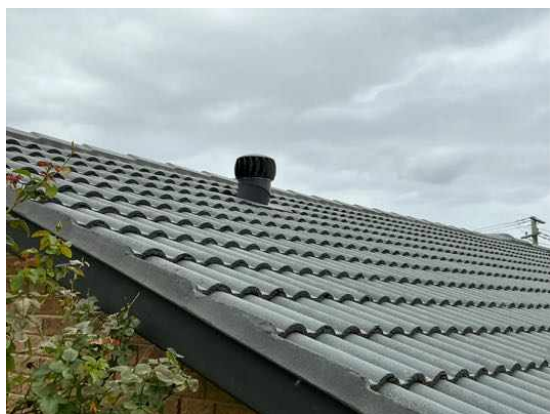
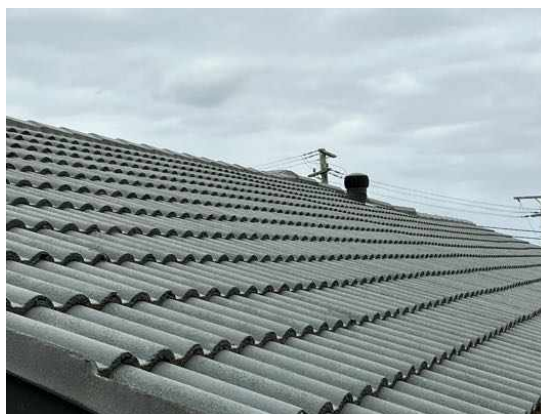
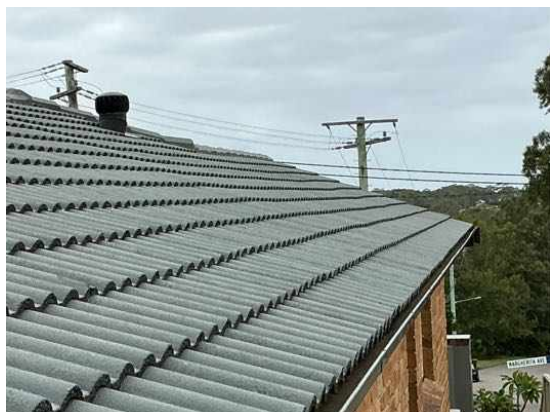
Building:	Main Building
Location:	Roof Exterior
Finding:	Additional Roof Photos
Information:	As part of the information provided, please note that the attached roof photos represent the condition of the roof at the time of inspection. These photos are for visual reference only and do not constitute a detailed roofing assessment. Any defects or issues identified with the roof are mentioned separately in the defect statements. It is strongly recommended that the client engage a qualified roofer to conduct a thorough inspection of the roof, ensuring that any potential issues, such as leaks, structural integrity, or wear and tear, are properly identified and addressed.

Additionally, the condition of the roof may change over time due to weather, natural wear, or other unforeseen factors. Regular maintenance and inspections by a licensed professional are advised to ensure the roof remains in good condition and to avoid costly repairs in the future. The information provided in these photos should be considered a snapshot of the roof's condition during the time of inspection and not a guarantee of its future performance.

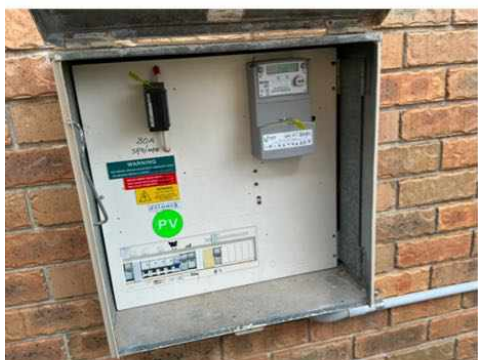
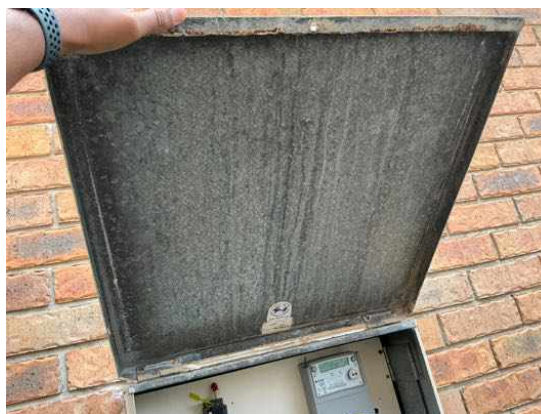
Building:	Main Building
Location:	Meter Box
Finding:	Termite Management Recommendation – No Evidence of Chemical Installation
Information:	At the time of inspection, there was no visible evidence of a chemical termite management system installed around the property. Chemical barriers are a key component of termite protection and are particularly important in preventing concealed termite entry into timber elements of the structure.

In accordance with standard requirements, a durable notice should be located within the electrical switchboard to detail any termite protection systems applied, including chemical treatments. No such notice was observed during the inspection.

It is recommended that the client engage a licensed pest controller to assess the suitability of installing a chemical barrier, and to provide advice on associated costs and procedures. This should be considered a short-term priority, particularly if the property has any history of termite activity or is located in a high-risk area.
