Building Inspection Report

Inspection Date: Tue, 10 Mar 2026

Property Address: 1/26 Narcissus Ave, Boronia VIC 3155,
Australia

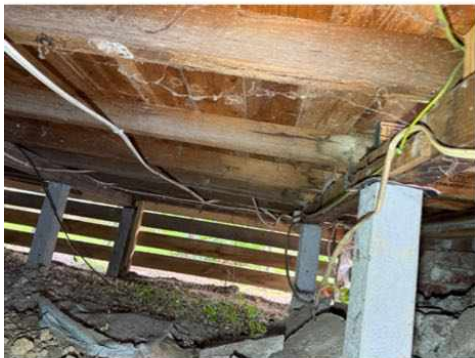
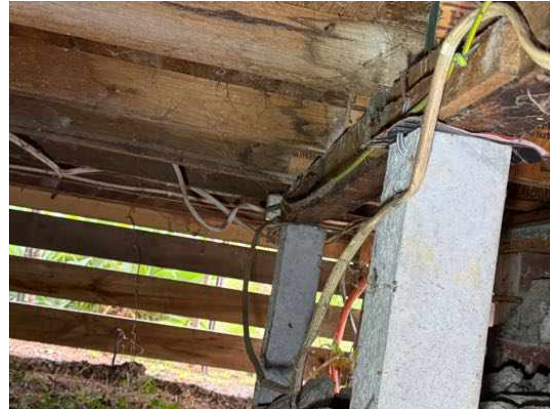
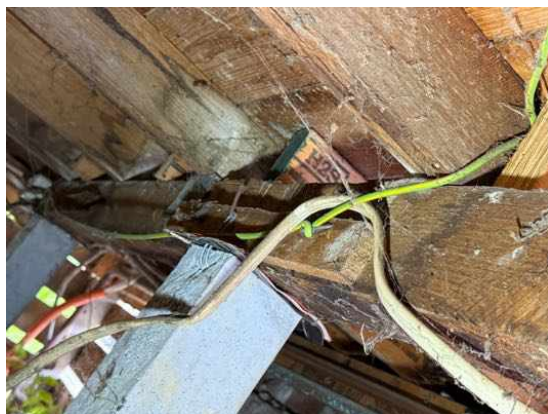
Defects 1.01

Building: Building 1
Location: All Areas > All Areas
Finding: Electrical wiring in subfloor area
Information: Please note that commenting on electrical works are outside the scope of this inspection. At the time of the inspection the subfloor area was considered to be a safety hazard to tradespersons and occupants that enter the subfloor area. Electrical wiring was observed in numerous areas not to be adequately clipped off and showed numerous areas of unprofessional work practices. Electrical wiring or fittings that are not installed in a tradesmen like manner may have been installed by un-registered persons.

With un-tradesmen like work practices shown in the subfloor areas, it is suspected that some areas may not have been installed by a licensed electrician and are considered a potential safety hazard including for fire and personal contact. It is recommended that the client contact a licensed electrician to investigate and carry out further inspection, where deemed necessary.

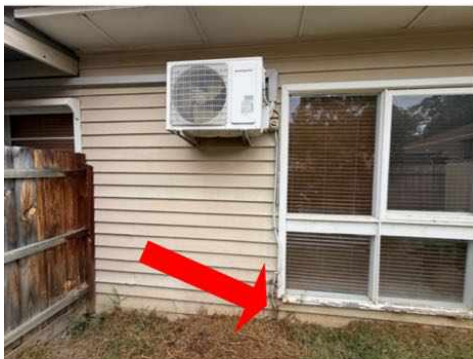
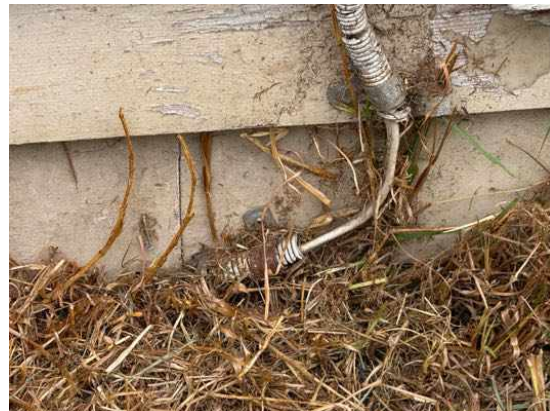
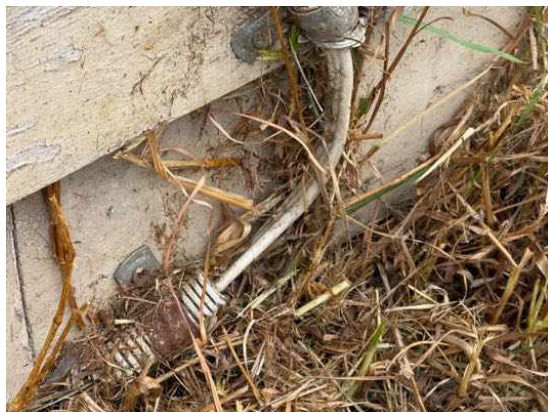
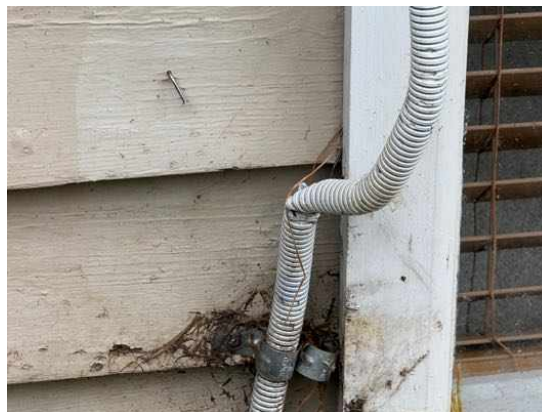
Defects 1.02

Building:	Building 1
Location:	All Areas > All Areas
Finding:	Electrical cabling exposed below the exterior A/C unit
Information:	Please note that commenting on electrical works are outside the scope of this inspection. Please engage a licensed electrician to further inspect the property. All exposed cabling is recommended to be in conduits or boxed in. so.

Under the air-conditioning unit exposed electrical cabling was able to be touched and accessed by occupants, children, pets, and whipper snipers etc. These electrical cables should never be exposed due to the possibility of electrocution, fire hazards or safety hazards. Client should appoint a qualified licensed electrician immediately for further investigation and rectification.

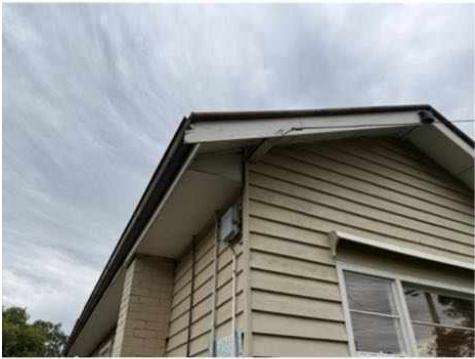
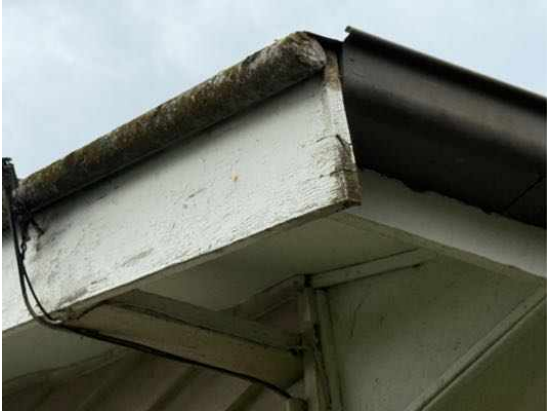
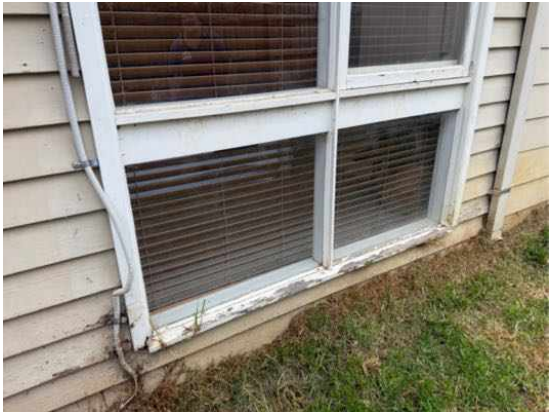
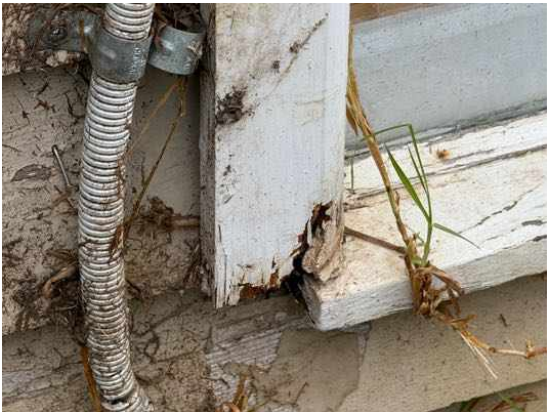
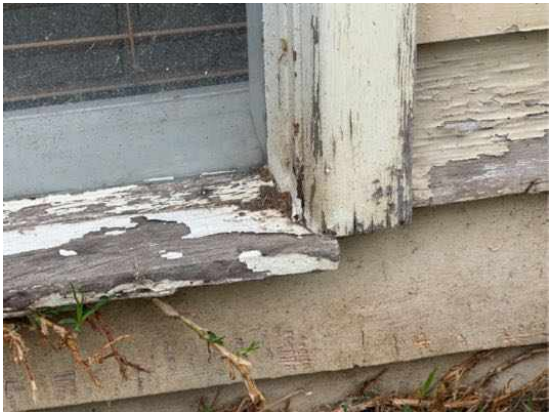
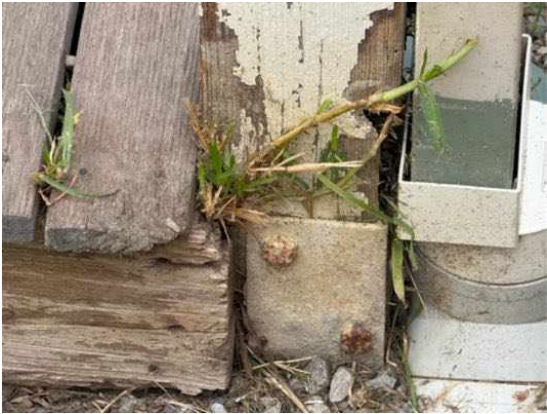
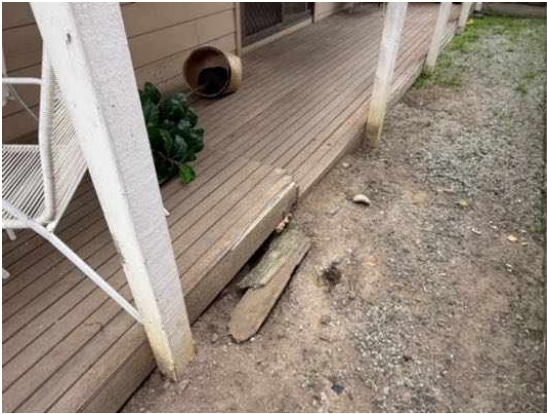
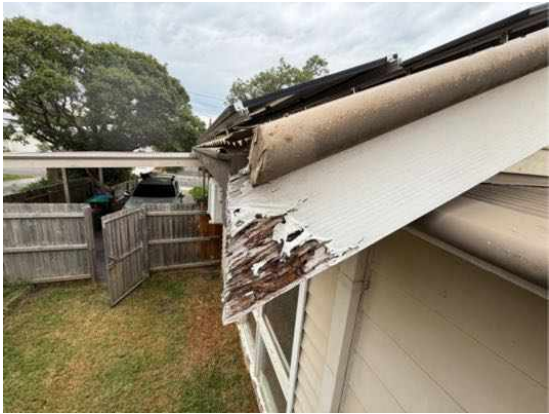
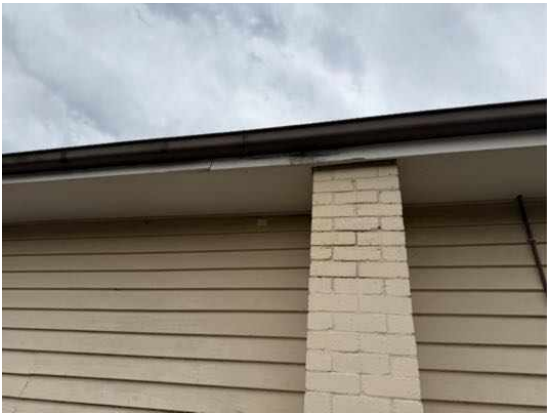
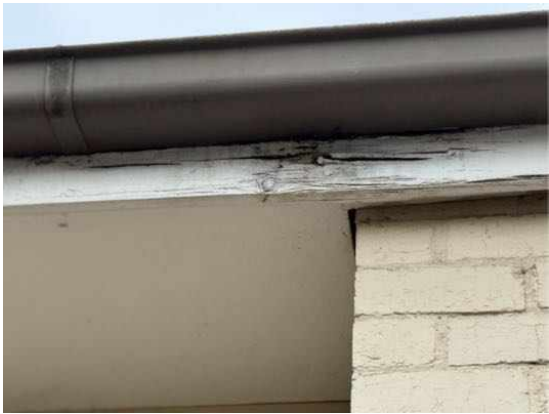
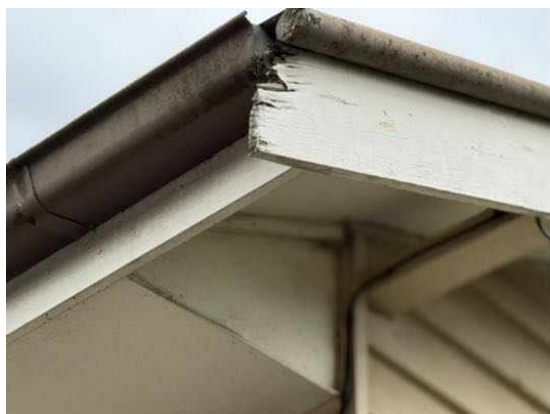
Defects 3.01

Building:	Building 1
Location:	All Areas > All Areas
Finding:	Wood rot
Information:	Wood rot was found to be affecting some fascias, decking timbers, fences and numerous other building elements around the exterior areas. The roof plumbing in these areas may be creating excessive moisture in this areas and or it may be due to frequent exposure to rain and other weather conditions, they also make fascias and other building elements susceptible to accelerated wood rot and further deterioration.

Wood rot, also known as Fungal Decay, occurs when timbers and other cellulose building materials are exposed to damp conditions on an ongoing basis. Early intervention and regular maintenance such as painting will prolong the useful life of these building elements. Prior to any works being performed, the cause of the moisture that has created the visible wood rot should be identified and addressed in a suitable manner.

It is advised that a licensed plumber be appointed to inspect all roof plumbing and subsequently identify the cause for the wood rot. Replacement of affected fascias and or other building elements may then be a necessary step in protecting surrounding areas from such deterioration. A qualified plumber may be appointed to assess the cause of excessive moisture and to provide advice on any remedial works as required. A qualified carpenter or registered builder may also be required to replace affected building materials.

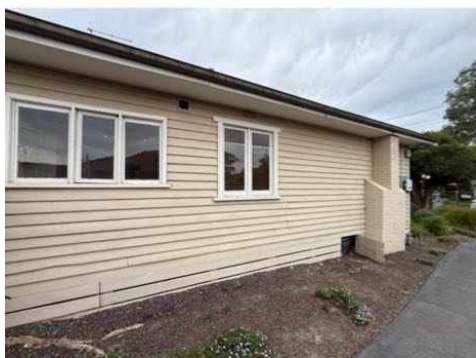
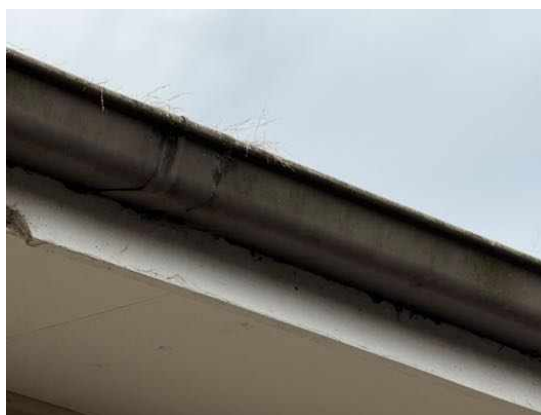
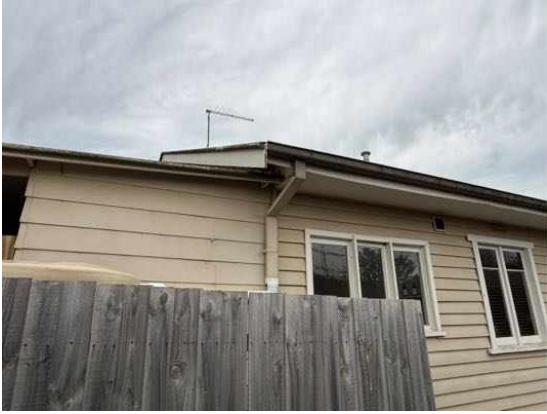
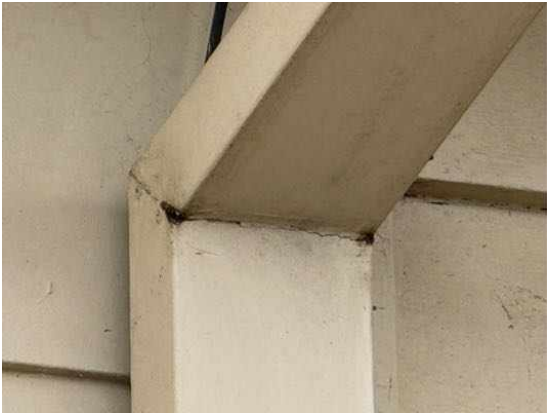
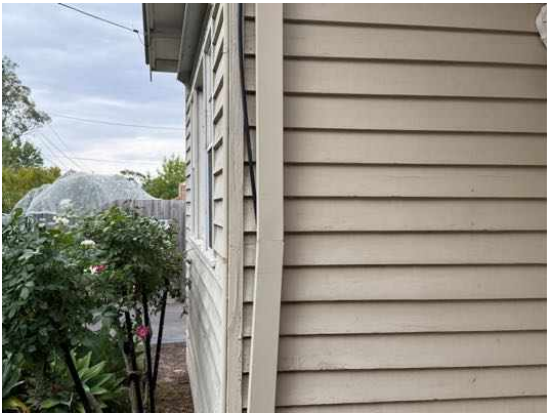
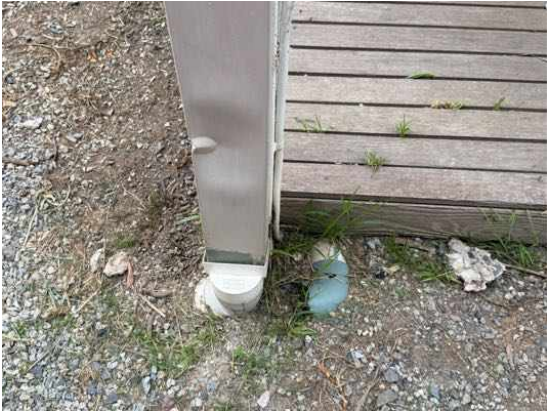
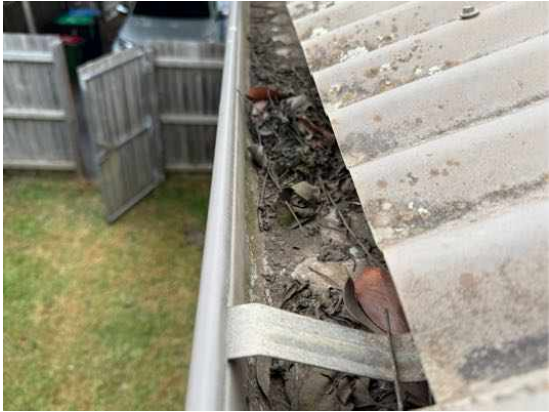
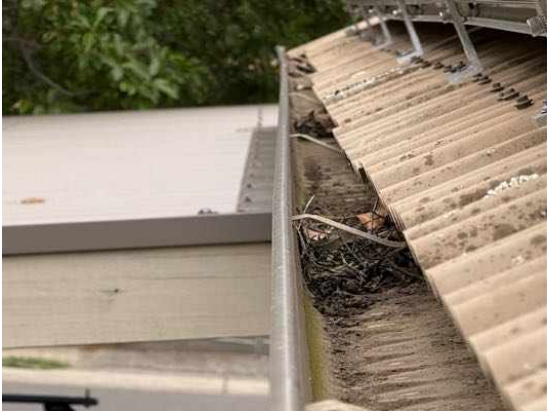
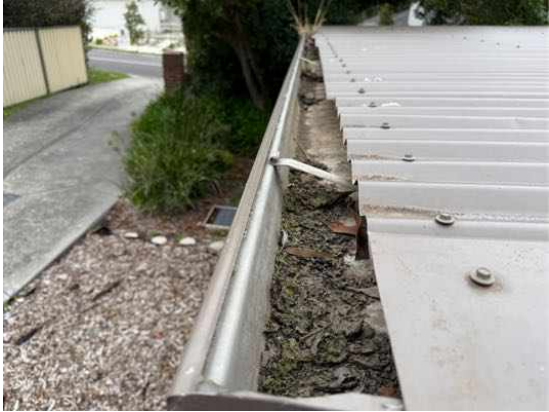
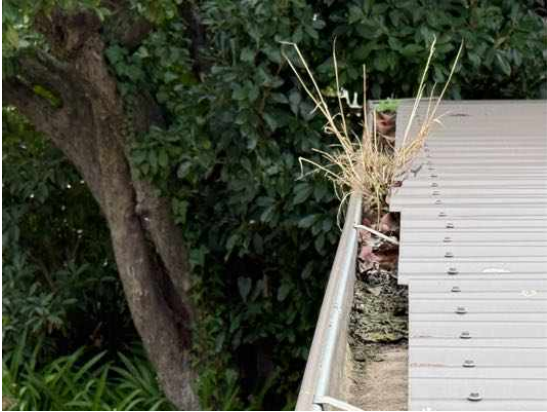
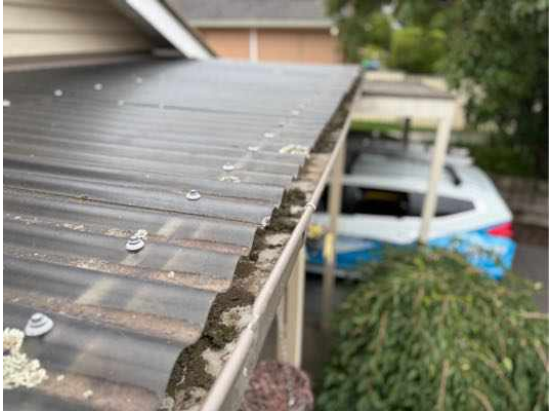
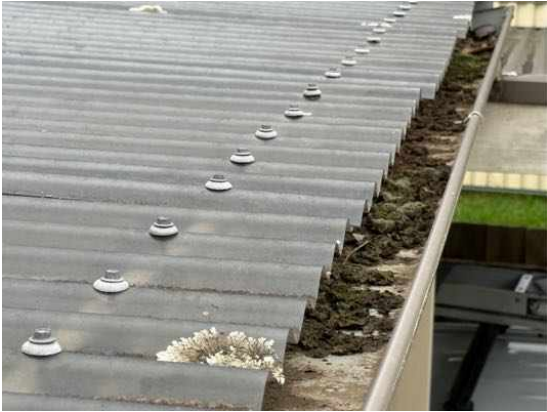
Defects 3.02

Building:	Building 1
Location:	All Areas > All Areas
Finding:	Gutters - Partially blocked
Information:	Roof plumbing structures, such as guttering and downpipes, should be free of all leaf matter and debris to prevent blockages. Blockages of the guttering and downpipes will lead to pooling and accumulated water overflows, which is likely to subsequently flood eaves and exterior walls. Blocked gutters are likely to lead to high levels of moisture in the affected areas. Such moisture will not only cause rust and decay at an accelerated rate to the associated building elements, but can also provide conditions that are conducive to termite and timber pest activity.

Blockages in gutters should therefore be removed immediately to ensure dry conditions are maintained at all times. Client should consider the appointment of a gutter cleaning company to carry out these works periodically or with a licensed plumber gain some further specific advice on remedial works that may be deemed to be required. In the interim, it is highly advised that blocked gutters be removed by the homeowner or others, a gutter cleaning company or a general handy-person in the short term future.

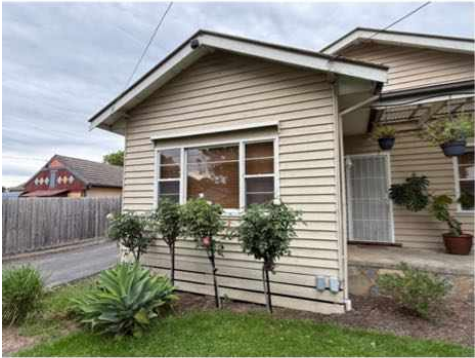
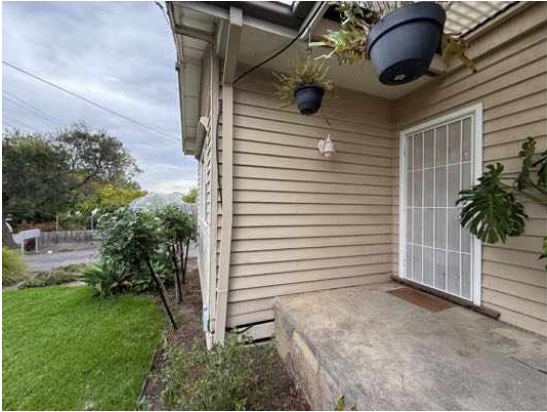
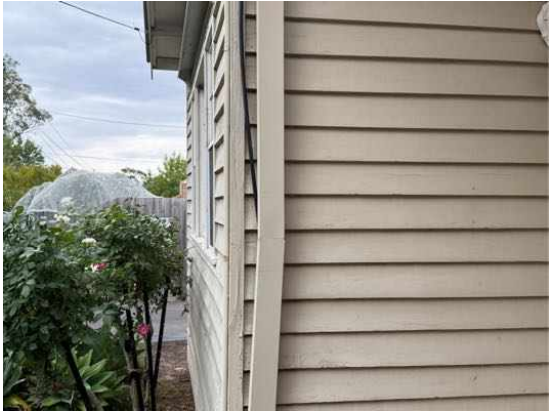
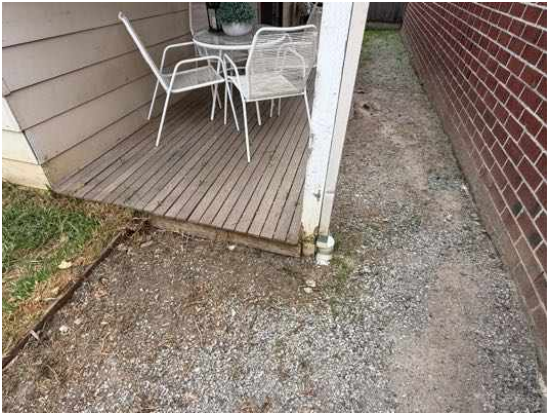
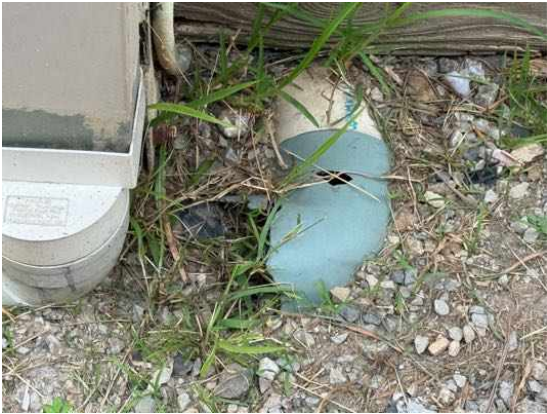
Defects 3.03

Building: Building 1
Location: All Areas > All Areas
Finding: Down-pipe boots broken and deteriorated
Information: It was observed at the time of inspection that the rear down-pipe boots at the bottom of the down-pipes were broken and deteriorated from suspected impact damage. These down-pipe boots are considered to be beyond repair and will need to be replaced, these broken down-pipe boots are making these areas susceptible to excessive water and moisture. This will therefore make these areas susceptible to excessive moisture, wood rot, rust, corrosion, termite and pest. If left unmanaged, the excessive moisture and water surrounding these adjacent areas is likely to lead to secondary damage to adjoining areas and or other building elements, this also makes these areas more susceptible to termite or timber pest activity. It is recommended that client appoint, seek advise from a licensed plumber to rectify and repair all deterioration in downpipes, gutters, fixtures and fittings.

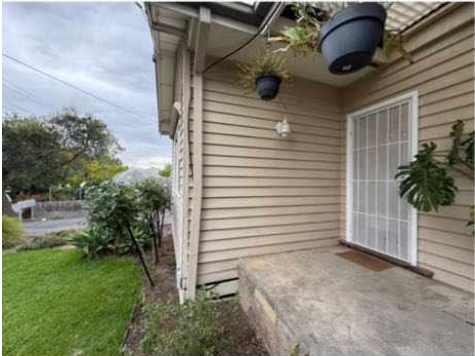
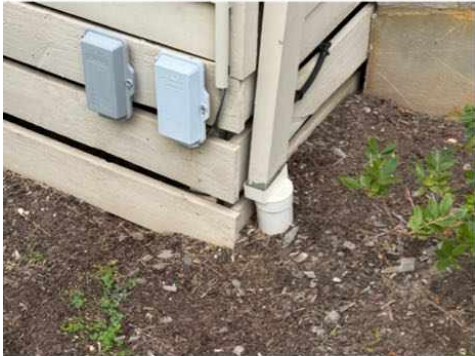
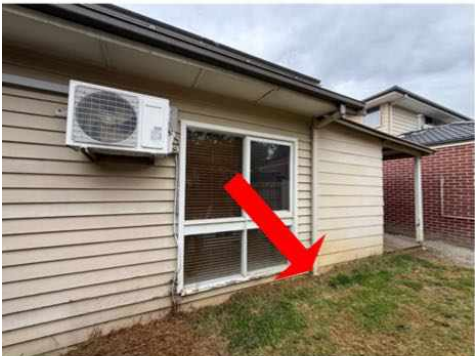
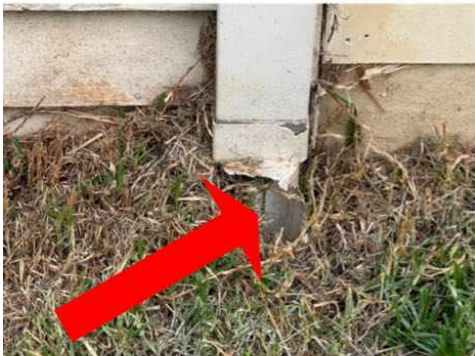
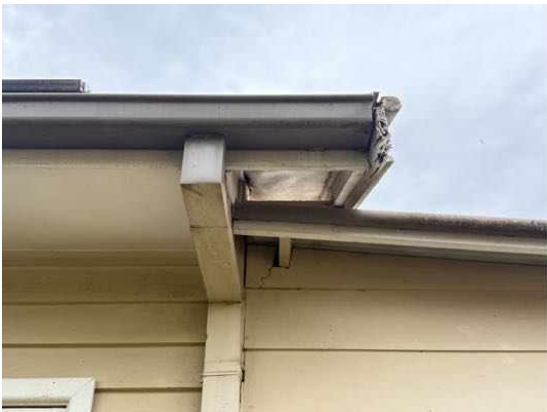
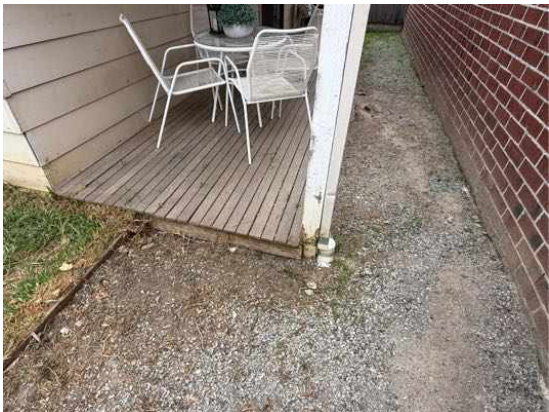
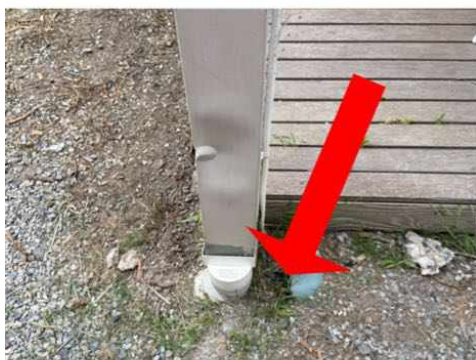
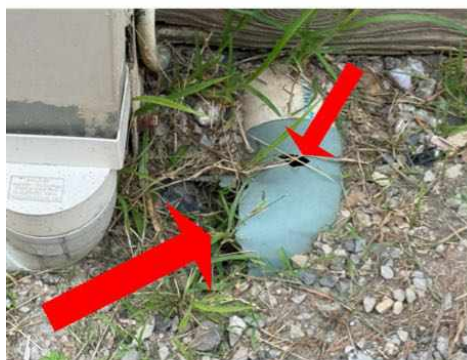
Defects 3.04

Information: It was observed at the time of inspection that some of the down-pipes were not adequately connected or situated over stormwater point and not sealed adequately, these should be all connected properly into the stormwater drainage system and fully inserted into stormwater drainage point. Where these sit above the stormwater point, the surrounding areas are highly susceptible to excessive moisture from splashing out.

If left unmanaged wood rot, rust, corrosion, termite and pest. If left unmanaged wood rot, rust and corrosion is likely to lead to secondary damage and defects to the

surrounding building elements, adjoining these areas, this also makes these areas more susceptible to termite or timber pest activity. It is highly recommended that client appoint and seek advice and consultation with a licensed drainage plumber to gain advice and rectify affected down-pipes.

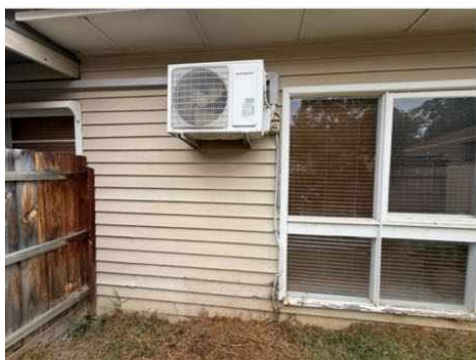
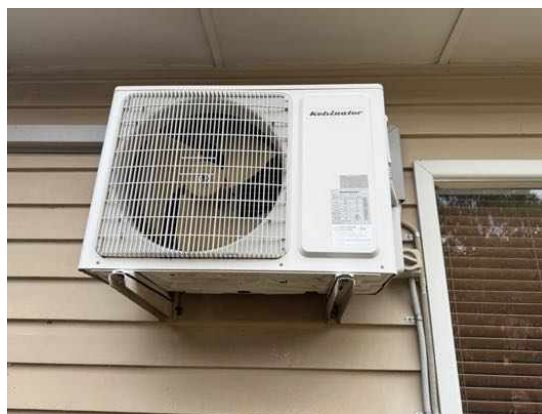
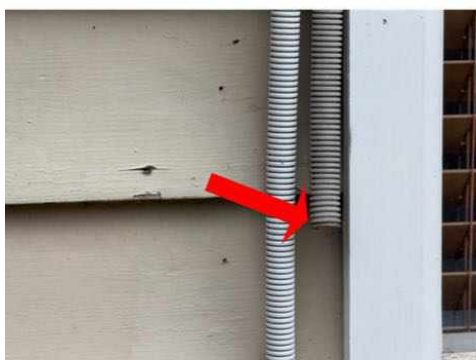
Defects 3.06

Building:	Building 1
Location:	All Areas > All Areas
Finding:	Air conditioner - disconnected overflow
Information:	The Air Conditioners (A/C) overflows were observed to be disconnected from storm water drainage point and may be creating excessive moisture during extended use, in the surrounding area. Such leaking from the waste pipe of the air conditioner creates an environment which is conducive to an array of defects, including water damage to associated building elements and the attraction of termite or timber pest infestation. It is highly recommended that a licensed plumber be appointed to connect the A/C overflow to a stormwater point in order to prevent such an environment from being created. These minor works should be carried out in the near future.

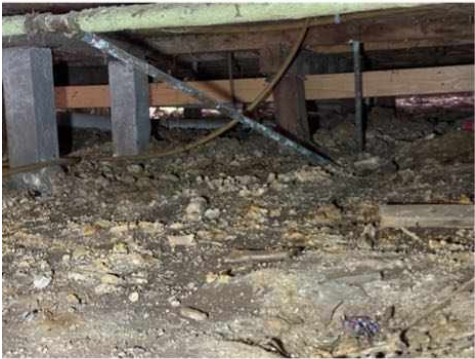
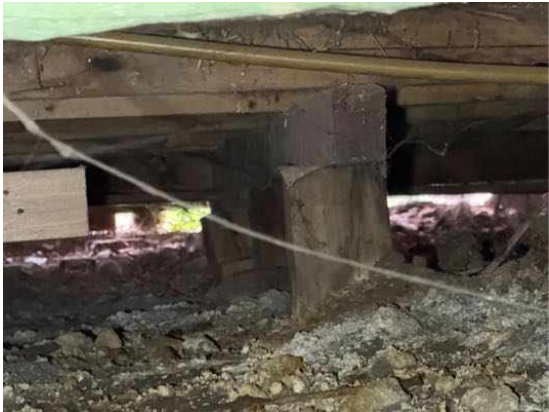
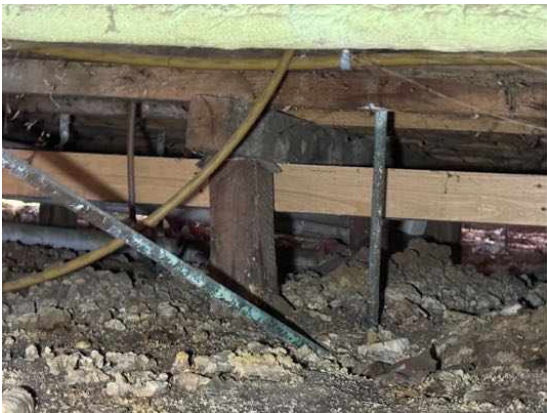
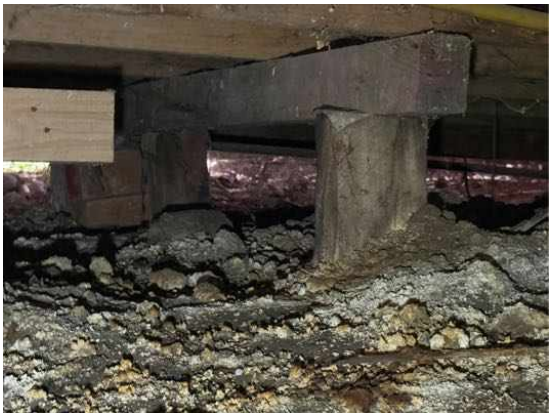
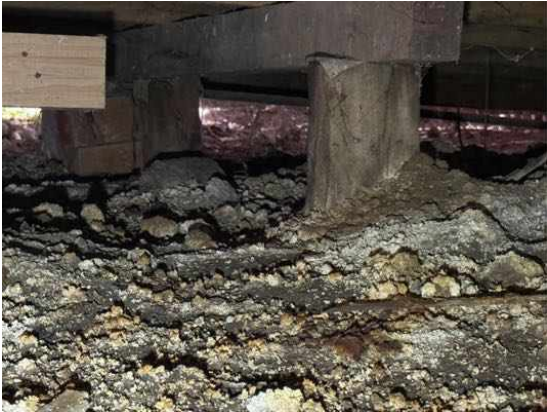
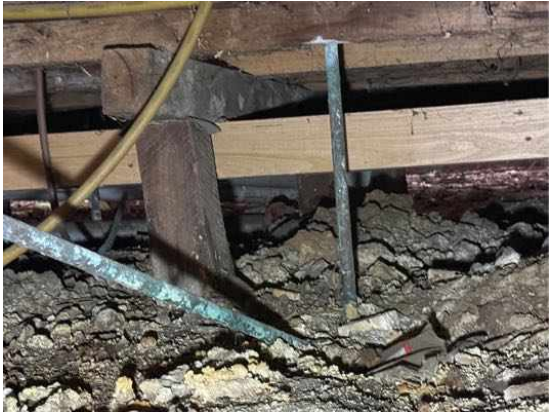
Defects 3.07

Building:	Building 1
Location:	All Areas > All Areas
Finding:	Timber stumps - Suspected deterioration
Information:	It was noted that the property has timber stumps at the rear areas of the home. Inspection of the condition of the timber stumps - below the surface of the ground - is excluded from the scope of this report. However, it is suspected that several timber stumps are deteriorating, evidenced by secondary defects such as uneven flooring, visually-observable subsidence or major cracking within the property. Even without these secondary defects, deteriorated stumps may still be present.

Where timber stumps are failing, a high degree of maintenance or even replacement of stumps may be required in the short- to medium-term future. It is probable that there is some degree of wood rot or deterioration beginning to occur in areas that are currently inaccessible for inspection. Timber stumps are no longer used in current building practices due to their susceptibility to wood rot and deterioration over a prolonged period of time.

A registered builder specialising in re-stumping may be appointed to provide a more

invasive inspection of the timber stumps and provide estimates on any works that may be required.

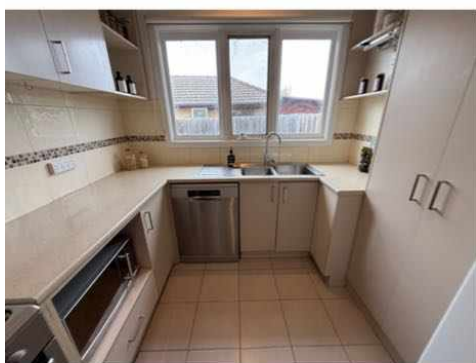
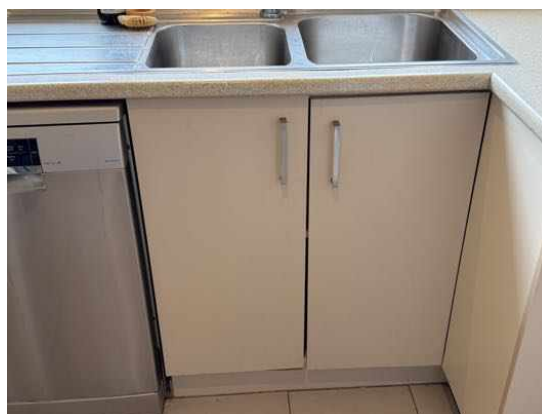
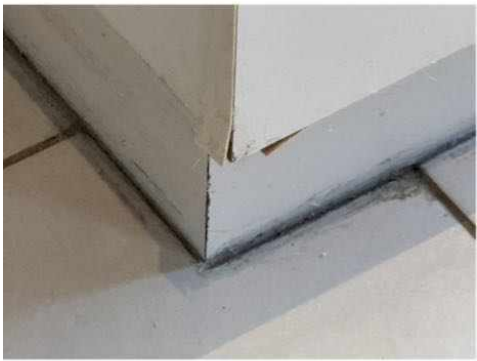
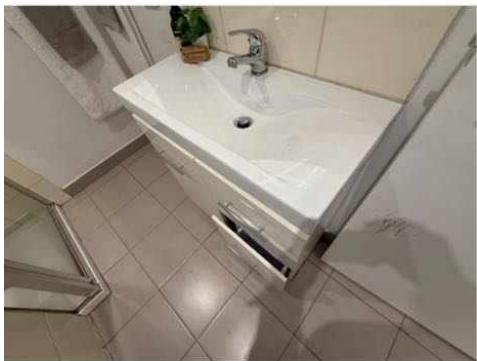
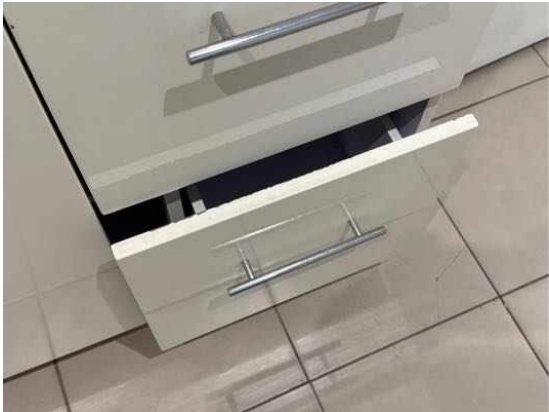
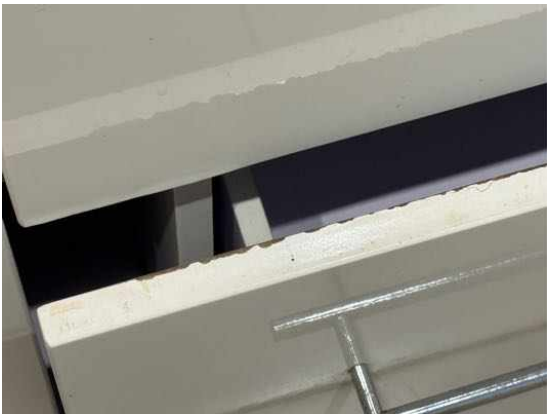
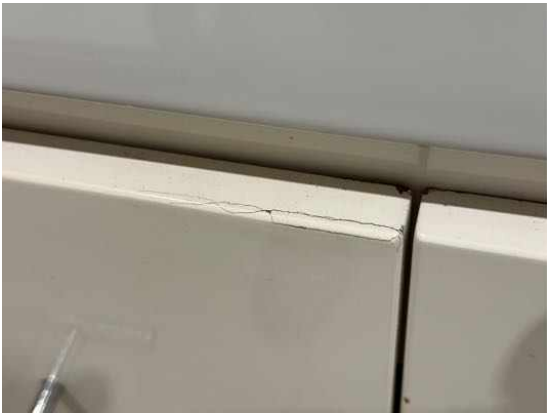
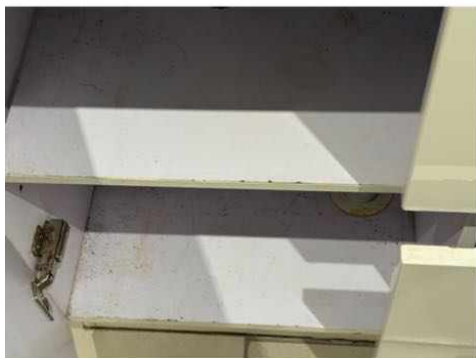
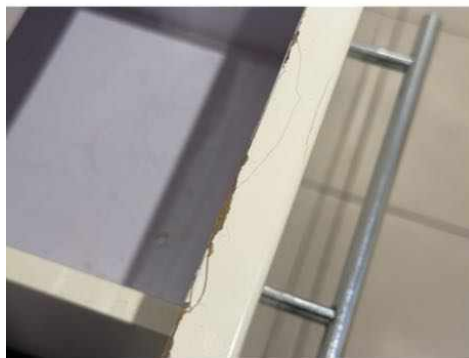
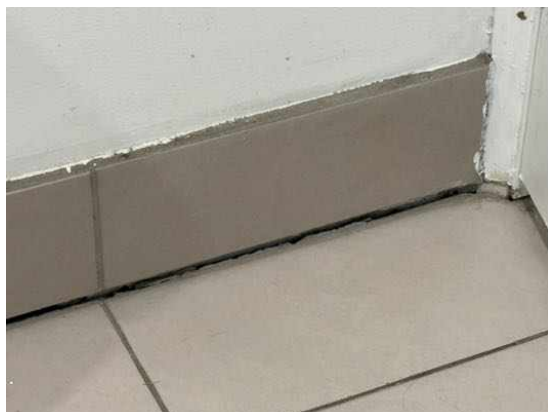
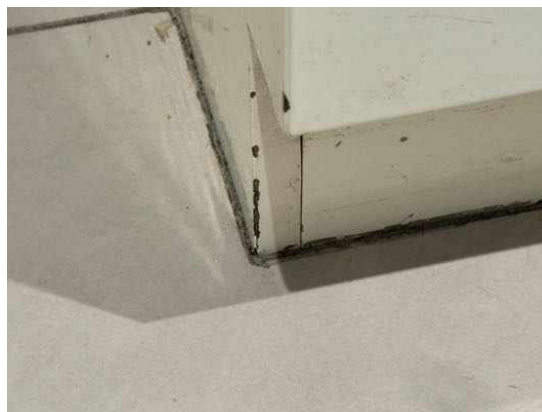
Defects 3.08

Building:	Building 1
Location:	Kitchen > All Areas
Finding:	Kitchen and bathroom cabinets
Information:	The kitchen and bathrooms cabinet doors showed signs of lack of maintenance to the doors, drawers and cabinet carcasses. These were observed to have some damage or wear and may require some maintenance, remedial work or repair to ensure further deterioration does not continue further. Although these defects may detract from the overall looks of the cabinetry, in most cases it does not necessarily affect the operational state of the cabinetry.

To improve the operation of these affected cabinets, cabinet doors or drawers, a qualified cabinet maker or carpenter may be appointed to either replace, rejuvenate, rectify or repair any cabinetry as deemed to be necessary. Such works should be completed at discretion of the client.

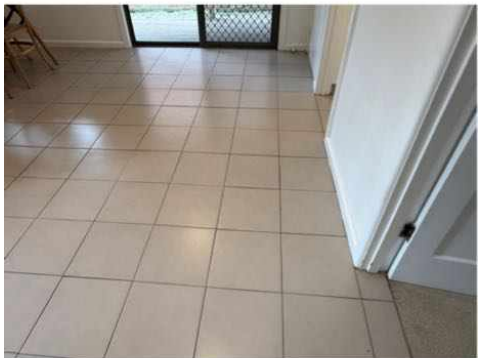
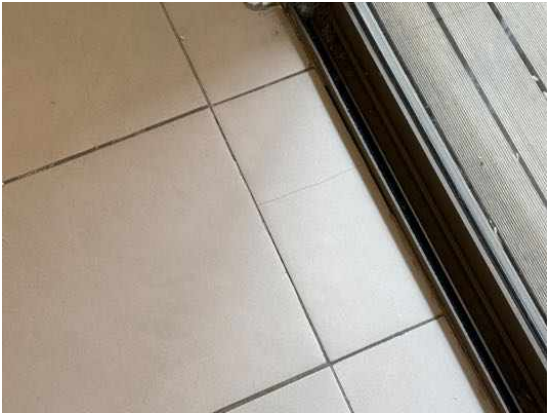
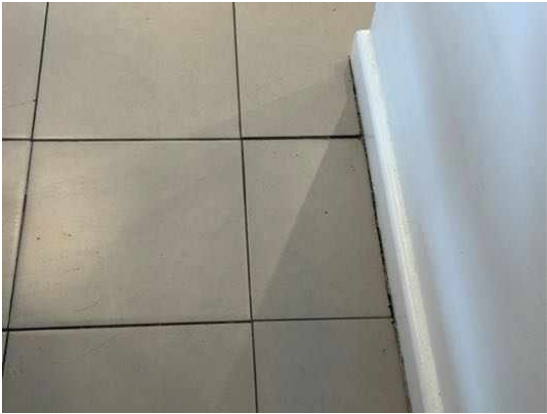
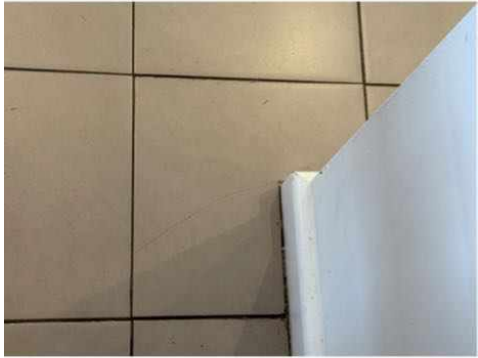
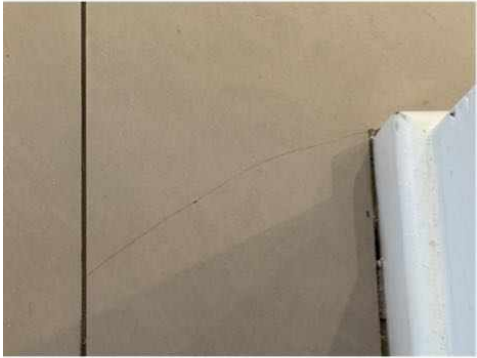
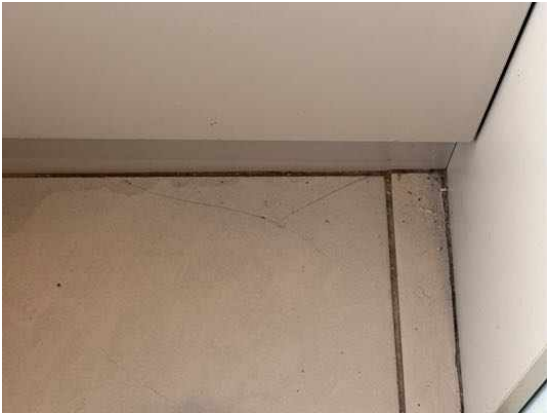
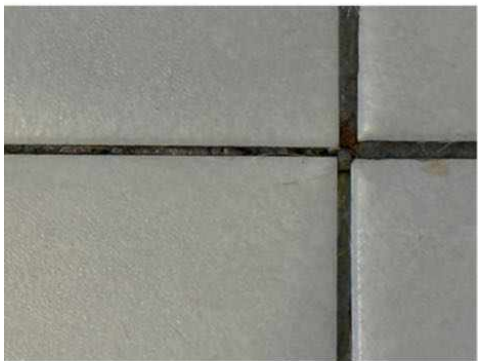
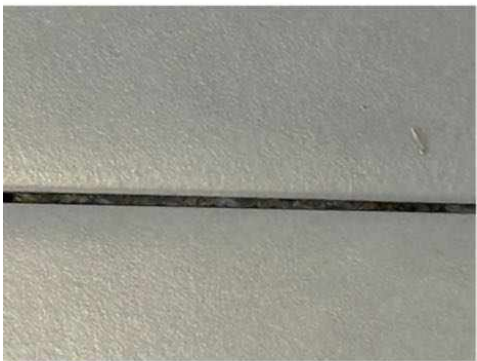
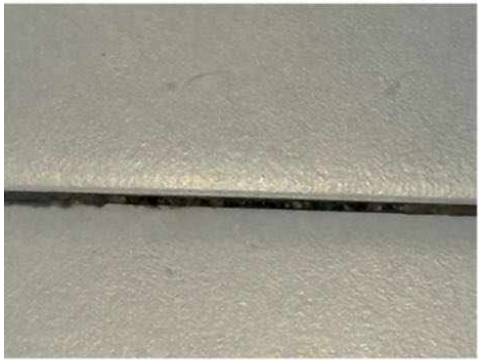
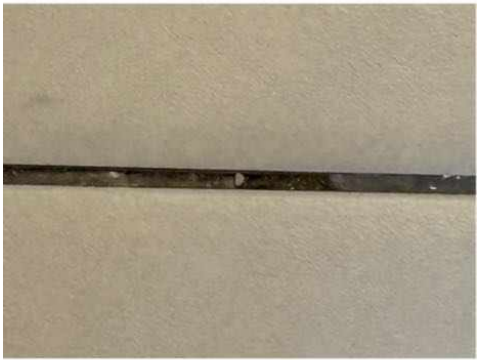
Defects 3.09

Building:	Building 1
Location:	Dining Room > All Areas
Finding:	Cracks in numerous floor tiles throughout the rear areas of the home
Information:	Cracked and poor substrate was suspected to be affecting the rear dining room and kitchen area floor tiles at the time of inspection. It is suspected that this cracking has occurred as a result of excessive movement of the substrate and flooring structures. Cracked tiles detract from the overall appearance of the affected areas, cracked tiles in this area may create or lead to secondary defects, due to the vicinity of moisture and wet areas, tiling should be rectified.

A qualified contractor or a licensed builder may be required to carry out an invasive inspection as to the cause of the numerous areas of cracking throughout the home. A tiling contractor should be appointed to perform the remedial works to the tiled areas. Although not considered to be a matter of high importance, replacement of cracked floor tiles is recommended in the short to medium term future. Where cracks become more numerous, contact a licensed Registered builder for further investigation.
