Building Inspection Report

Inspection Date: Tue, 10 Mar 2026

Property Address: 1/26 Narcissus Ave, Boronia VIC 3155,
Australia

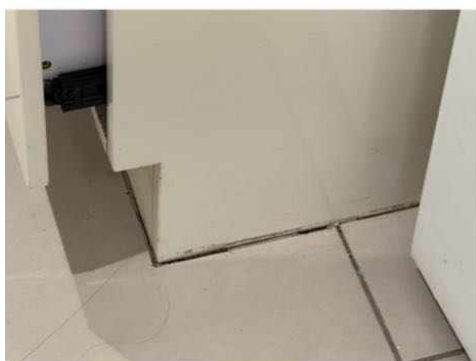
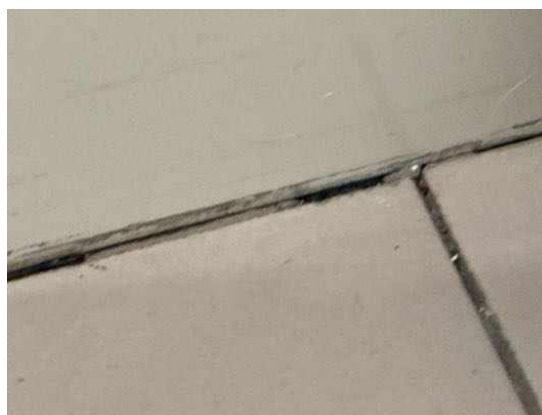
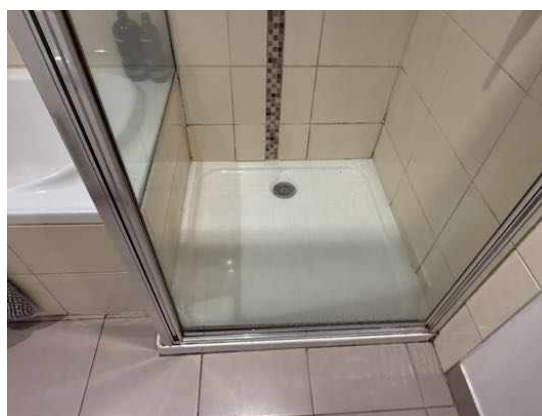
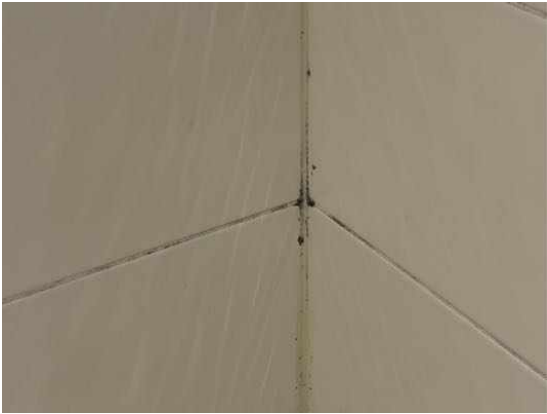
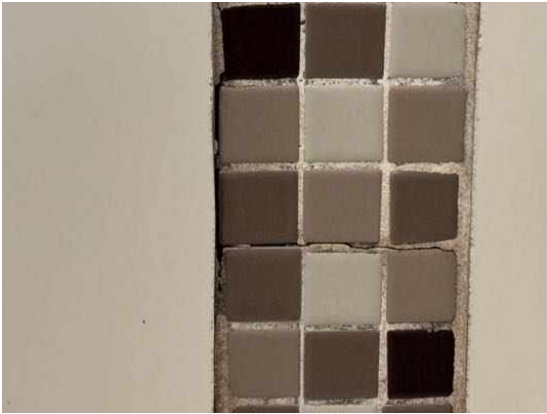
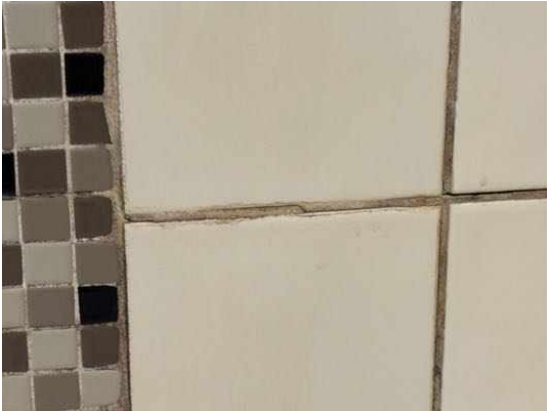
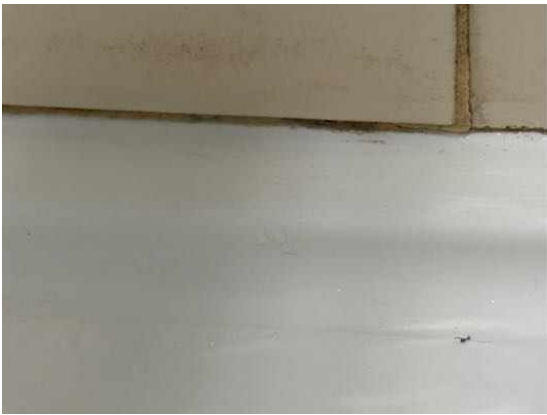
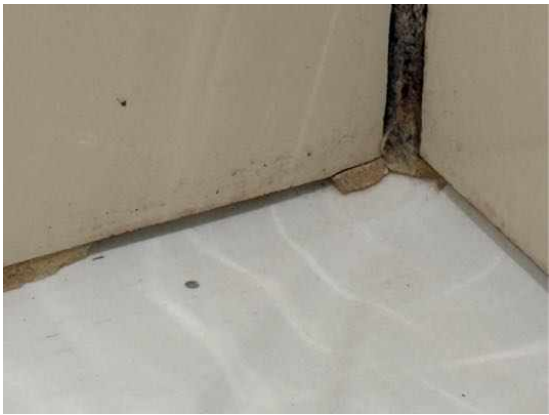
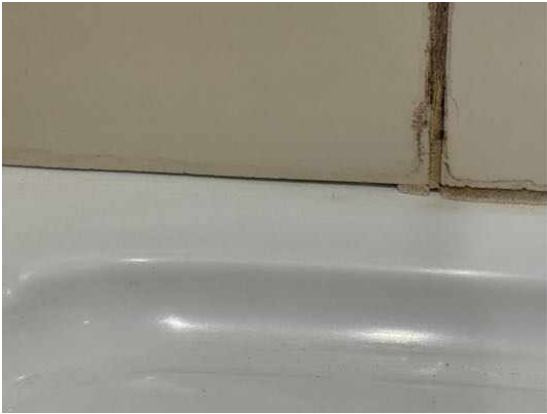
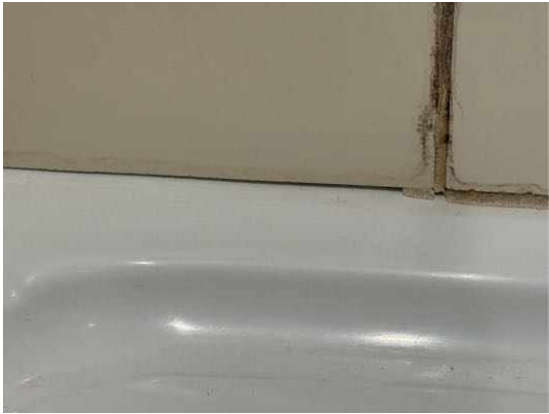
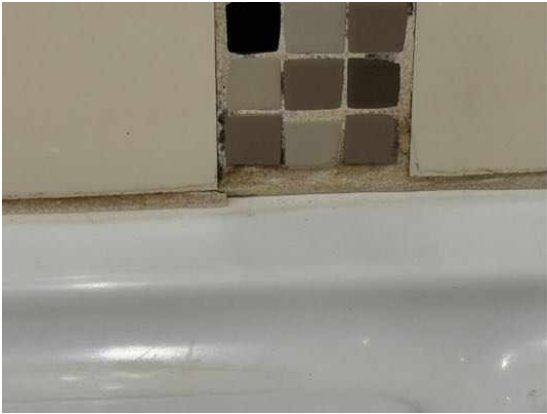
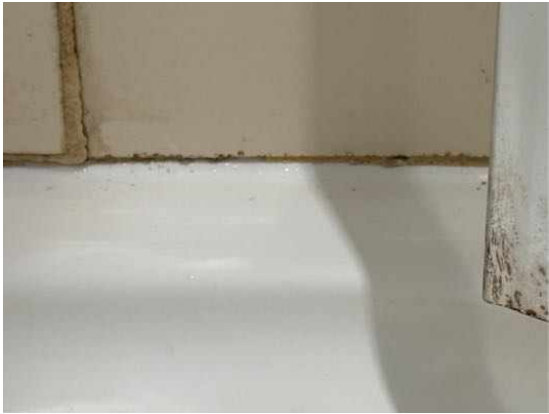
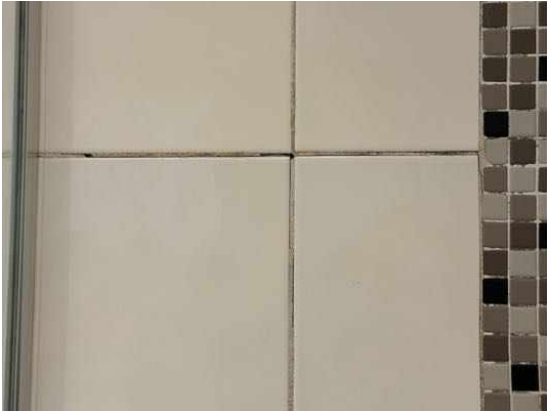
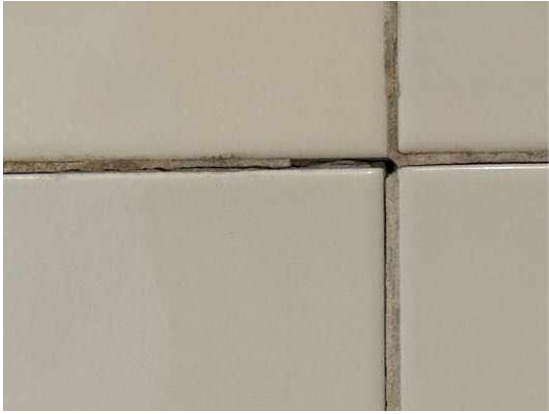
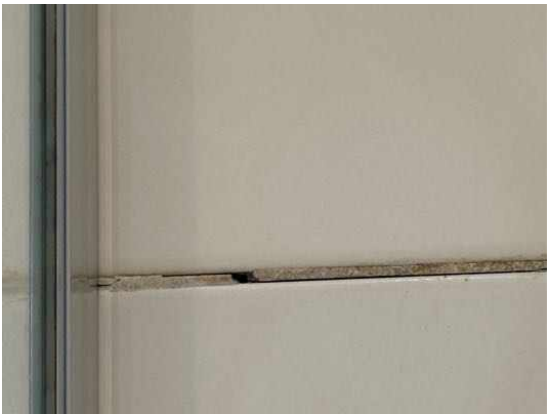
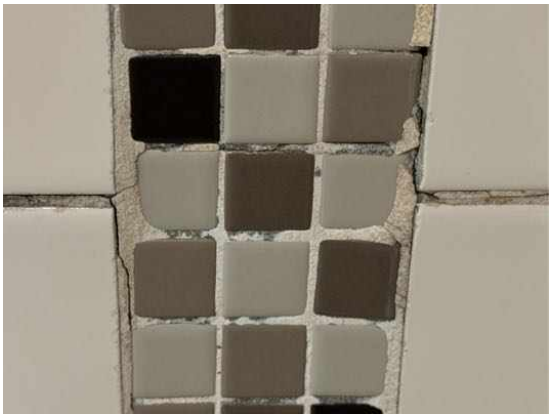
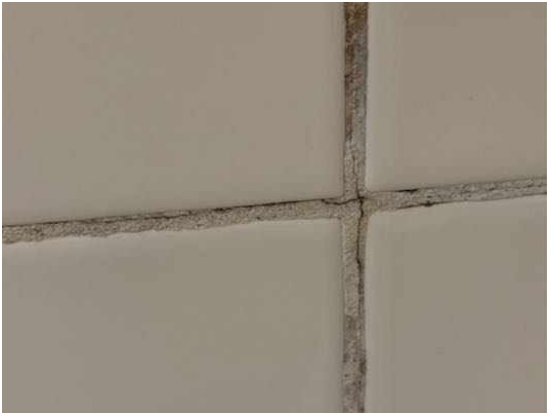
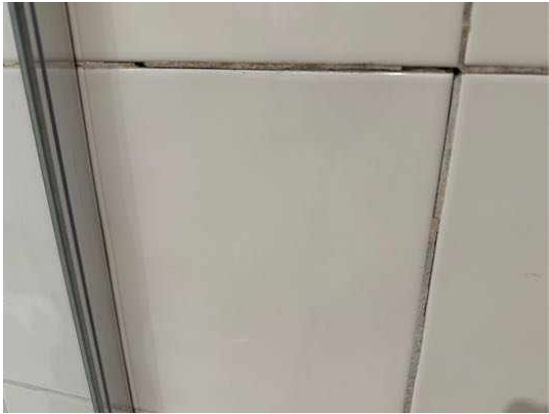
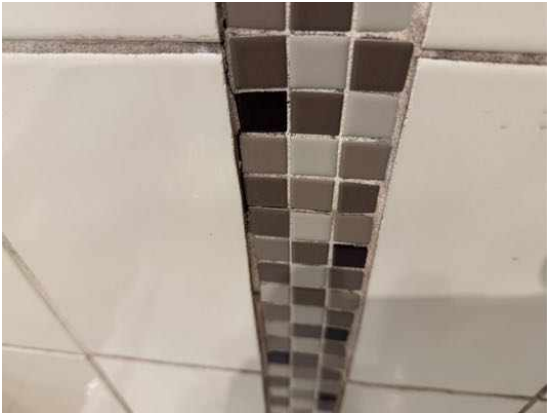
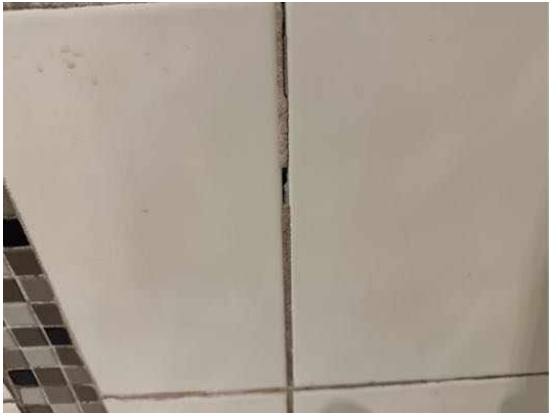
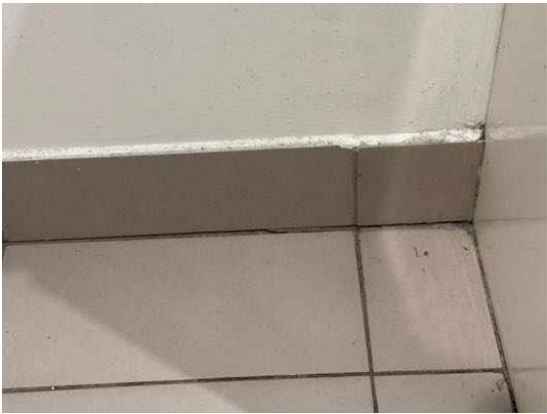
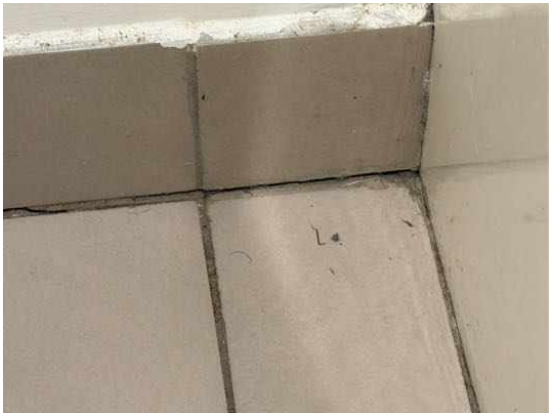
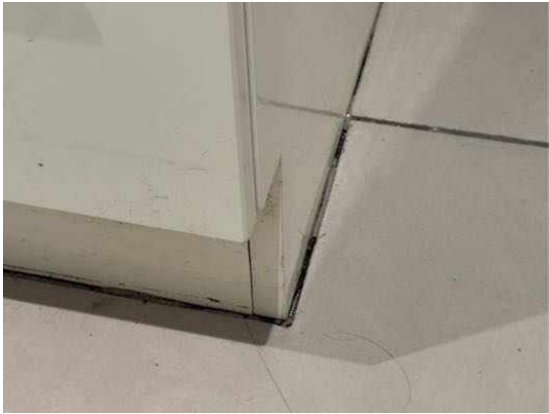
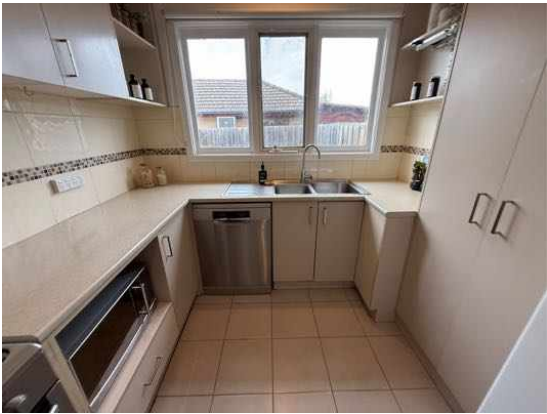
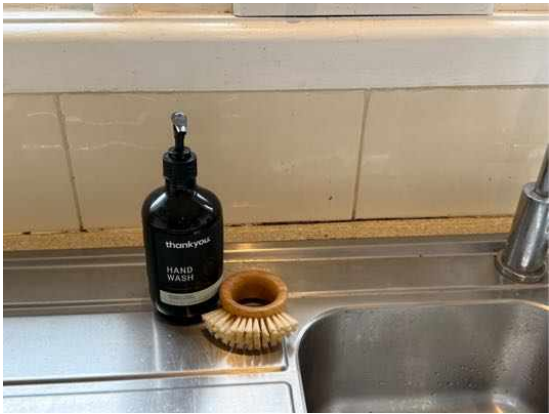
Defects 3.10

Building:	Building 1
Location:	All Areas > All Areas
Finding:	Maintenance on sealant and grout throughout the balcony areas
Information:	<p>It was observed at the time of the inspection that some of the sealant or grout is deteriorating through exterior weather conditions and normal age and deterioration. Different materials on the balcony areas will move at different rates, generally causing the sealant move and crack at these junctions and joints over time. It is essential that maintenance is kept up in these areas with the appropriate flexible sealants and materials where deemed to be required to allow for expected expansion and contraction, while keeping the joint water tight and protective of all associated building materials. Flexible and mould resistant materials should be applied to any affected areas to prevent any subsequent water damage that is likely to occur if not maintained.</p> <p>Regular maintenance and replacement of any missing or damaged sealant and grout is highly recommended to the wet areas, as this is a regular wear and tear defect. Sealant and grouting in areas that come into regular contact with water should be maintained for the long term care of your property. A sealant specialist or tiling contractor should be appointed to complete these works where deemed to be necessary.</p>

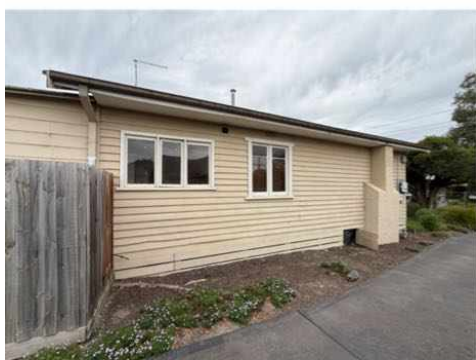
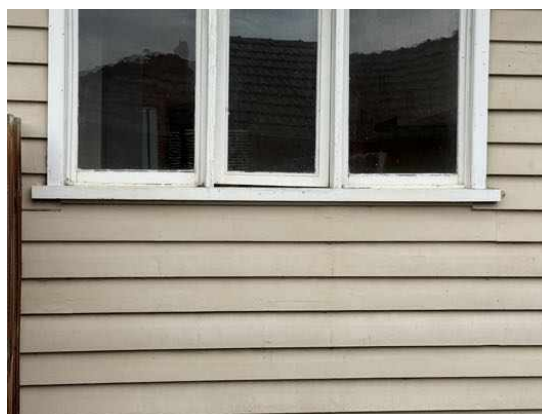
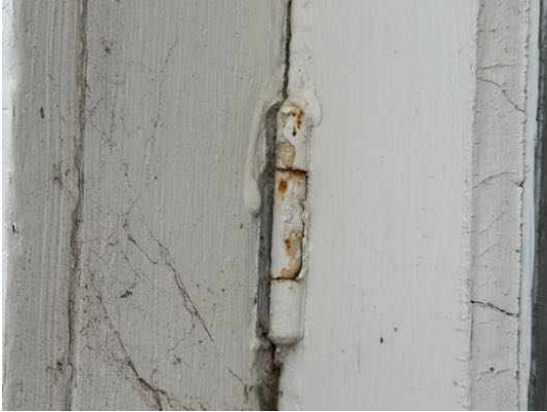
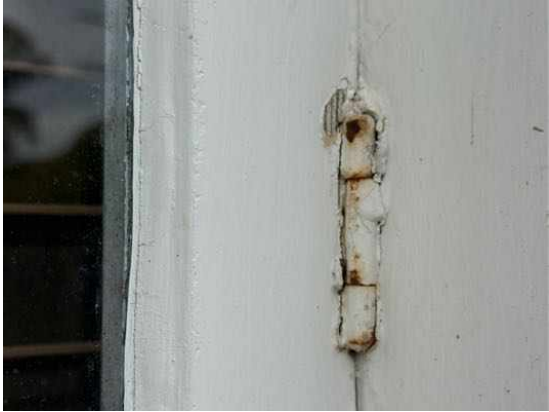
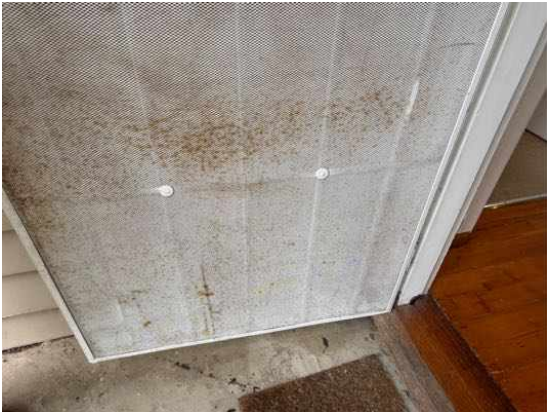
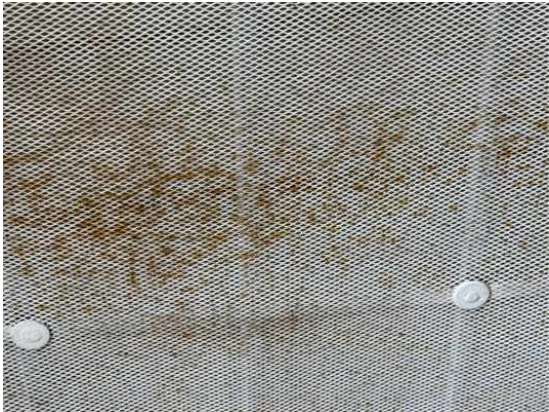
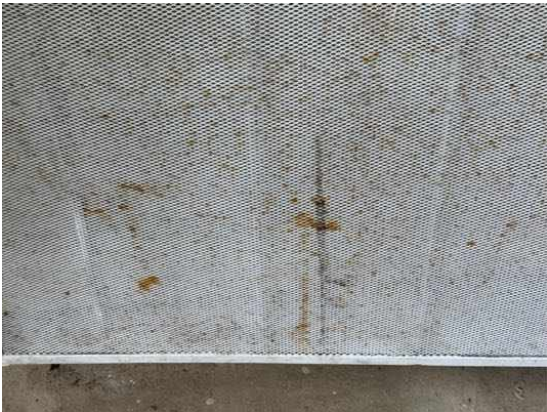
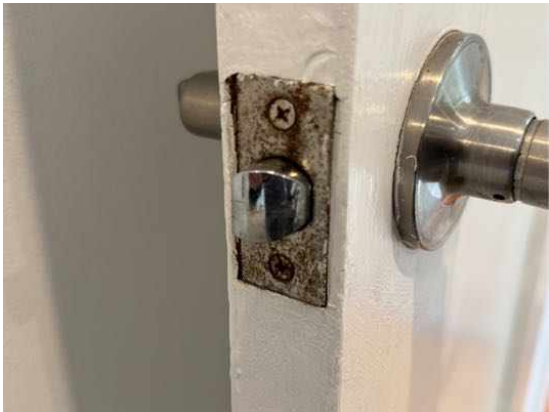
Defects 3.11

Building:	Building 1
Location:	All Areas > All Areas
Finding:	Building elements - Rusted or corroded
Information:	Some exterior building elements and materials that show evidence of rusting and corrosion, has likely developed as a result of excessive exposure to moisture, harsh weather conditions and or inadequate coatings. A surface that is found to be rusted provides no protection to the underlying iron, the deteriorating condition is likely to worsen if not addressed and left unmanaged, it is therefore recommended that the relevant tradespersons remove as much rust as possible, clean and re-paint these areas.

Where possible, the use of galvanized (treated) metals or aluminium coated metals aid in rust prevention, as does regular general maintenance. Rust formation can be controlled with coatings, such as paint, that isolate the iron from the environment. Rusting and corrosion should be managed by ideally removing or limiting the affected surface from exposure to moisture and harsh weather conditions. A qualified painter or other relevant tradespersons may be appointed to paint affected areas and a qualified carpenter to replace any building elements that have been severely affected by rust or water damage.

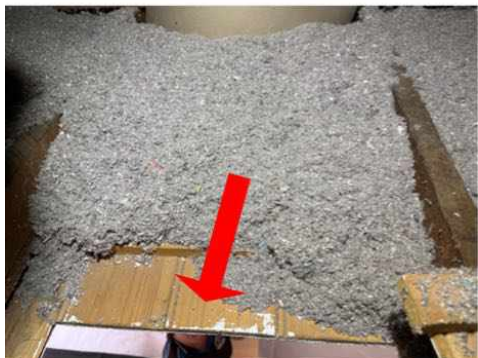
Defects 3.13

Building: Building 1
 Location: All Areas > All Areas
 Finding: Roof space manhole
 Information: Roof space manhole was observed to be missing some of the surrounding trimming required for safe ingress and egress from the roof space. All trimming and noggings should be installed and all sides of the manhole opening ensuring there is adequate support for tradesman and occupants to safely enter or wish to access these areas.

The lack of adequate trimming and or support around the roof space manhole is considered to show poor trade practices. If the manhole framing gave way and dislodged from the opening it is highly likely to cause serious injury to tradespersons

and or occupants. This is considered a safety hazard for any persons wishing to access to roof space.

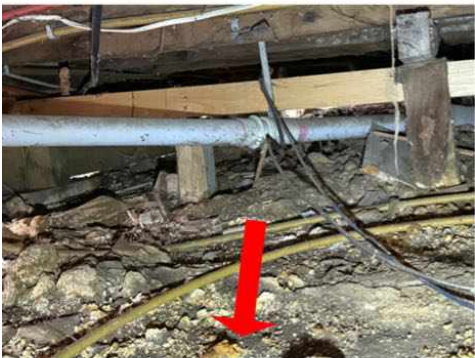
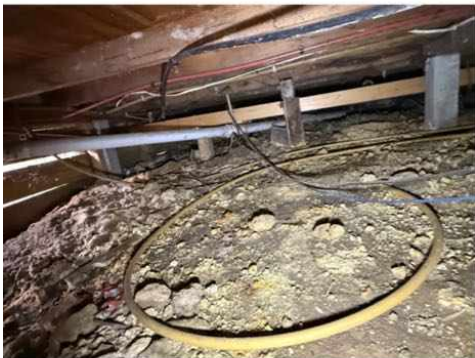
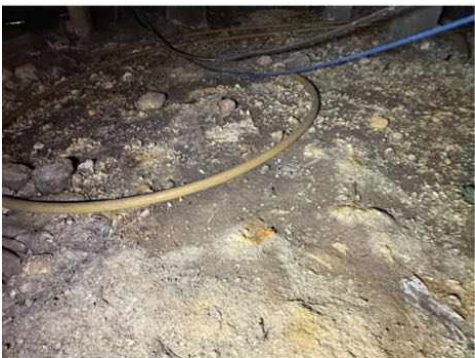
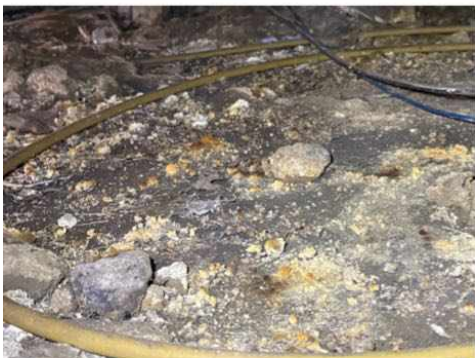
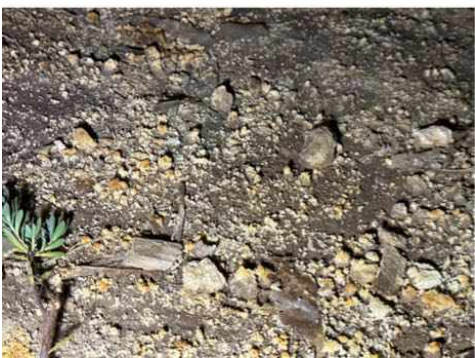
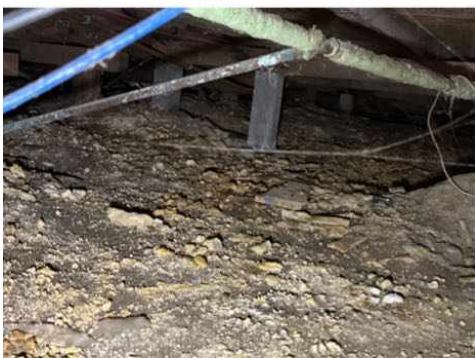
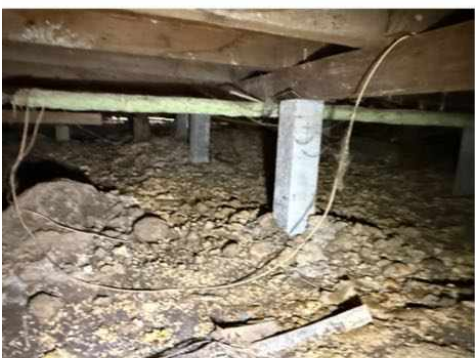
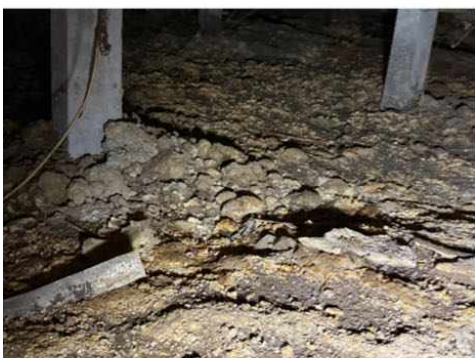
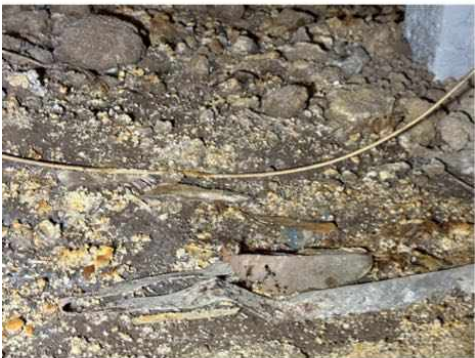
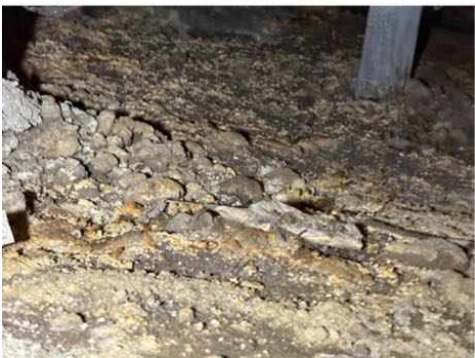
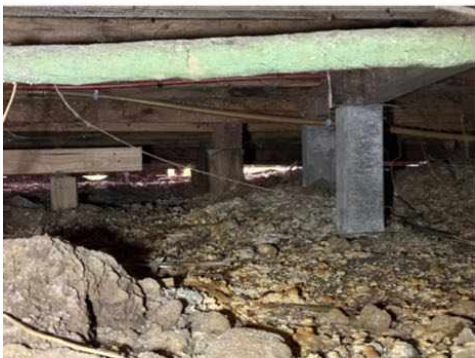
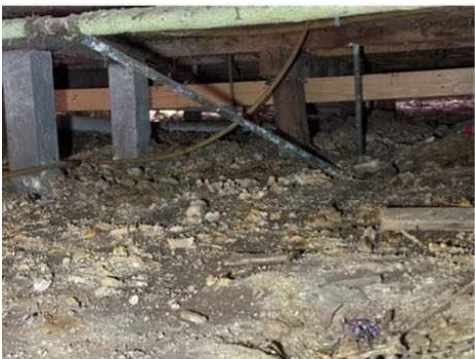
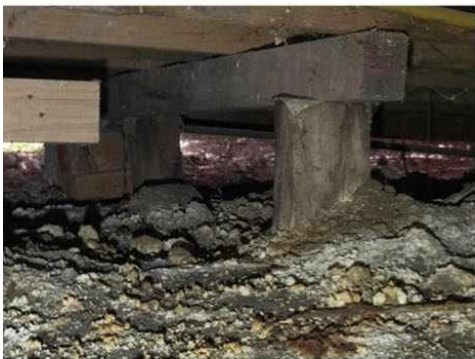
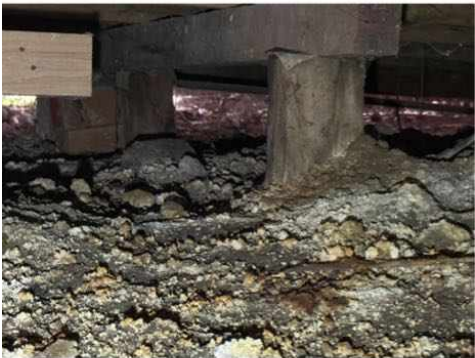
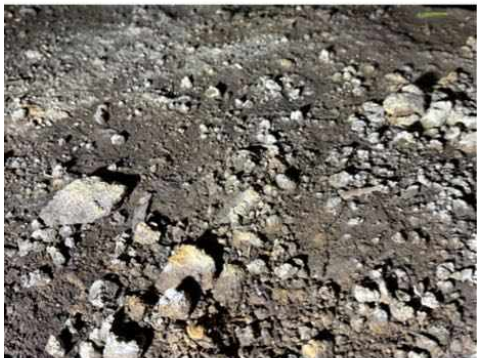
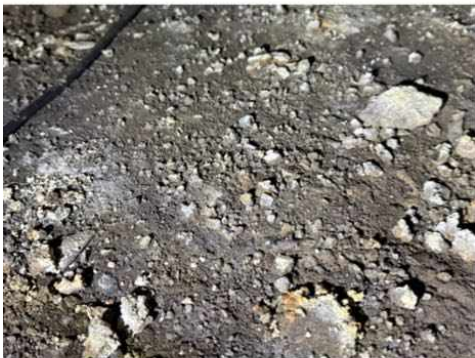
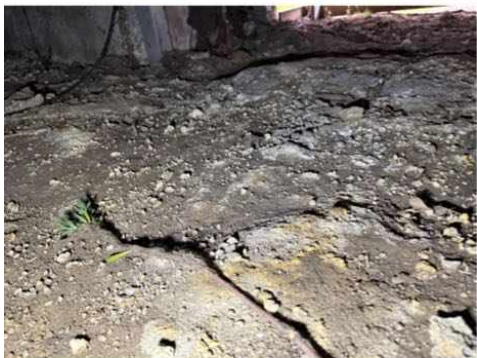
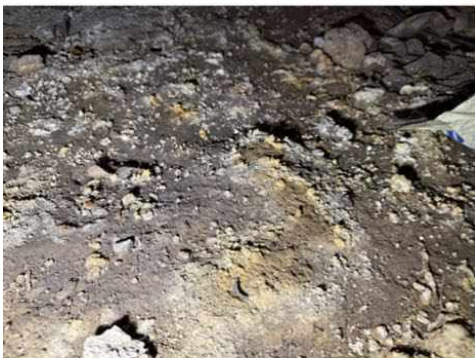
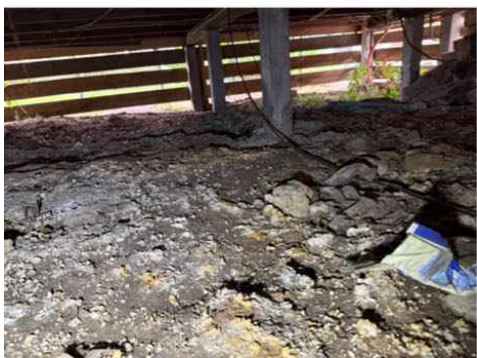
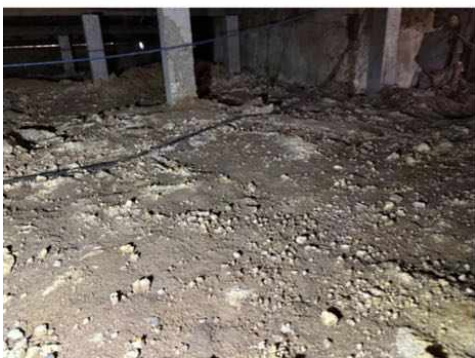
Defects 3.14

Building:	Building 1
Location:	All Areas > All Areas
Finding:	Subfloor excessive moisture producing mould
Information:	It was noted that moisture was travelling through the subfloor ground soil producing mould within the subfloor areas. Remedial work to rectify the moisture from entering the subfloor will be required in the medium term future. A plumbing contractor should be appointed to investigate the surrounding stormwater drainage around the home and if necessary add additional site drainage such as agriculture drainage and rectify any drainage not adequately working, broken or not connected to stormwater drainage on the site. Any disconnection or broken stormwater drainage problems can negatively impact the functional capacity of the site drainage system.

Where roof plumbing doesn't drain adequately, the area at the base perimeter can become excessively damp, potentially creating an environment that is susceptible to rust and corrosion of surrounding building elements, as well as attracting termites and other pests. It is highly recommended that a licensed plumber be appointed to further inspect the exterior and subfloor areas and to install adequate aggy drainage and equipment where deemed to be necessary.

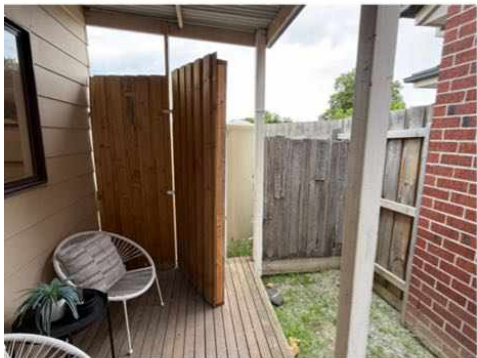
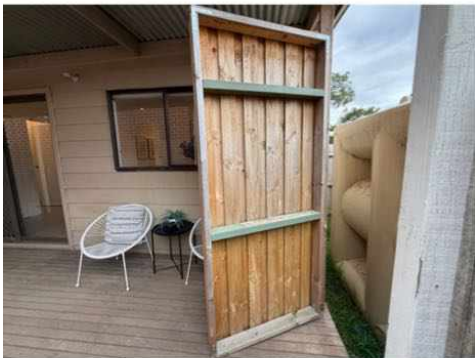
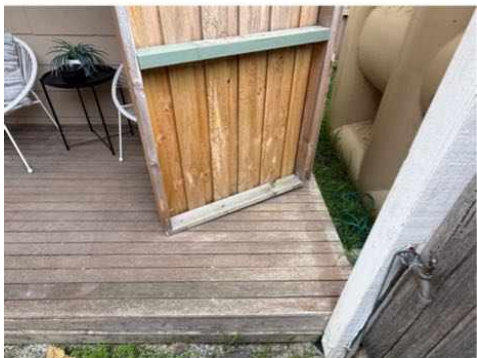
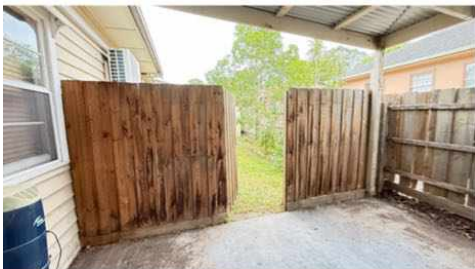
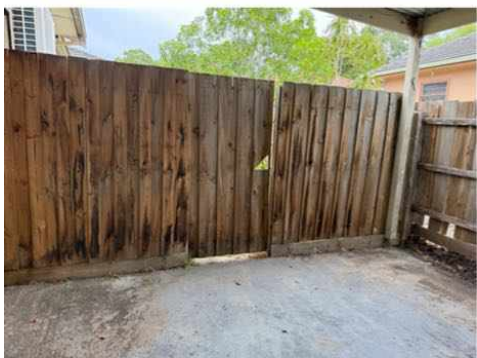
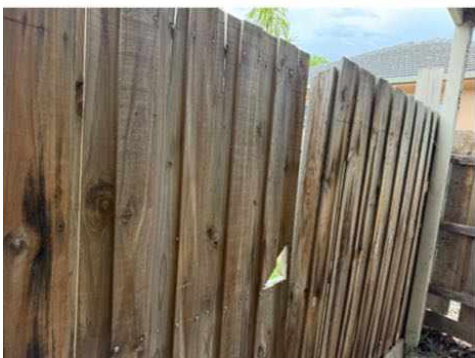
Defects 3.15

Building: Building 1
Location: All Areas > All Areas
Finding: Front and rear gates - hanging poorly
Information: At the time of the inspection it was observed that the front right hand side gate and the gate leading to the tank area did not operate as intended. A fencing contractor should be appointed to rectify and repair damage and deteriorated areas to the gate to prevent further damage if not rectified.

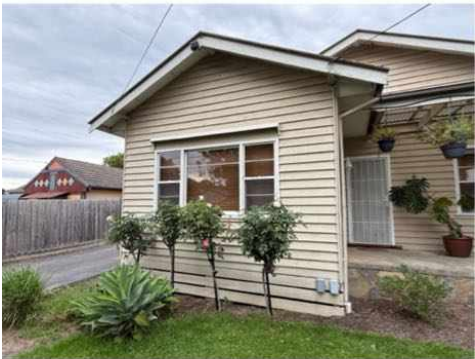
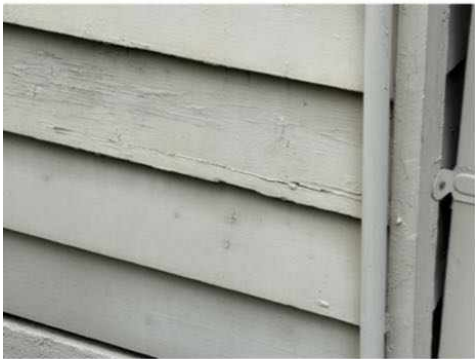
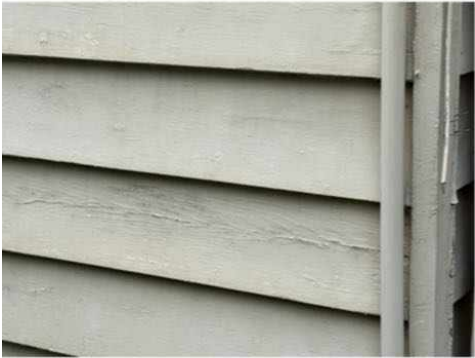
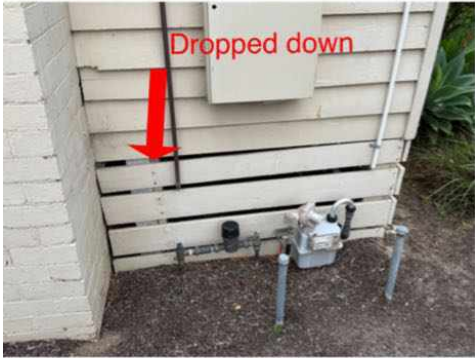
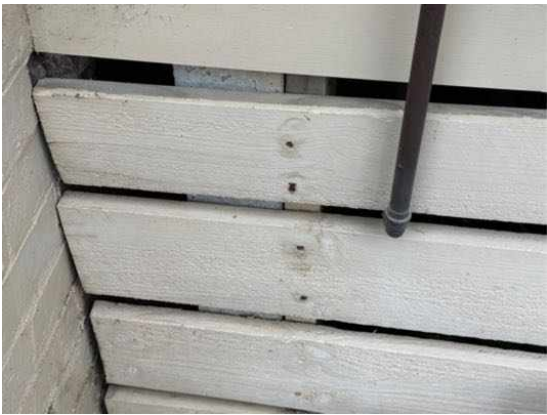
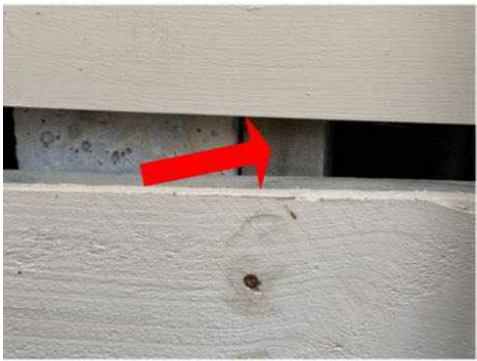
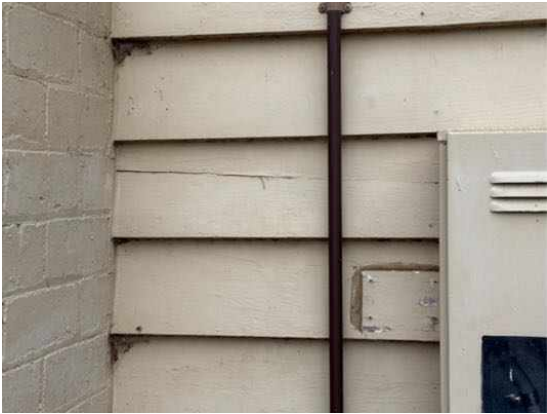
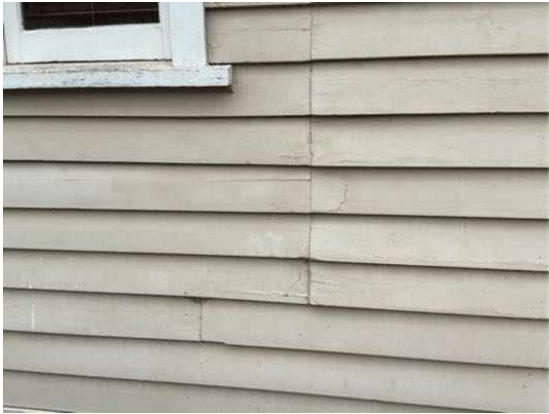
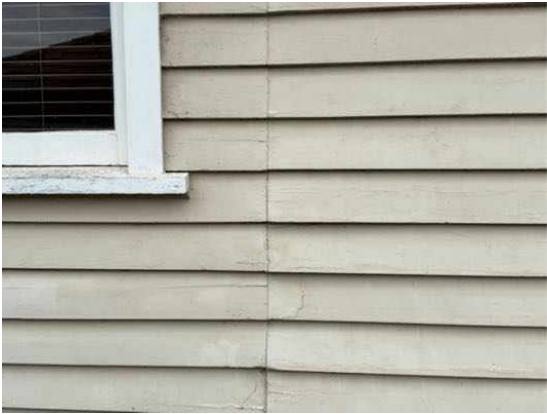
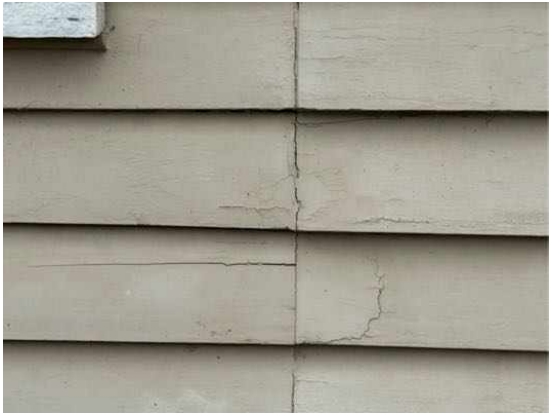
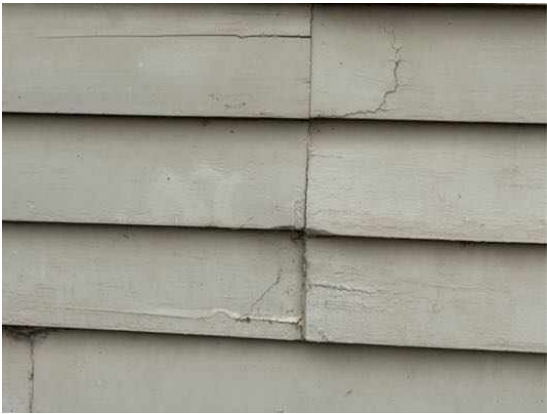
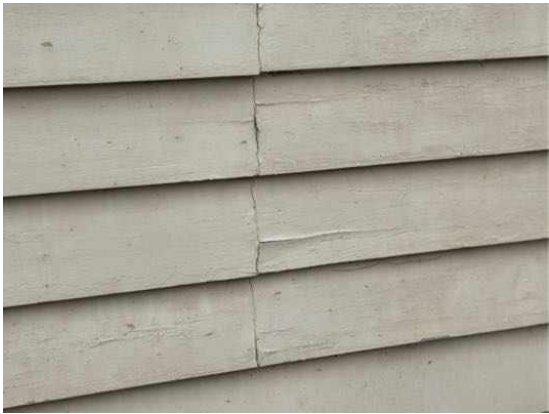
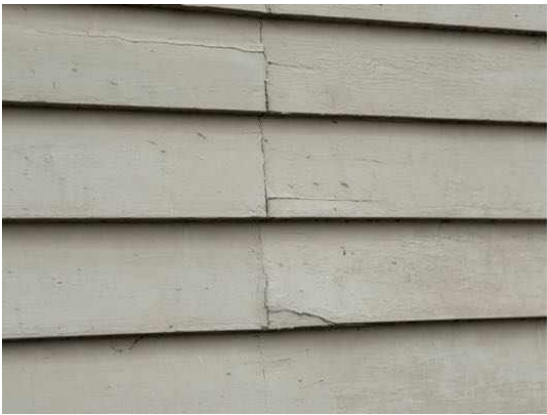
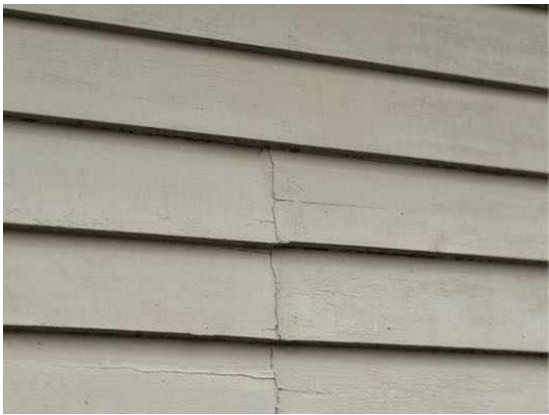
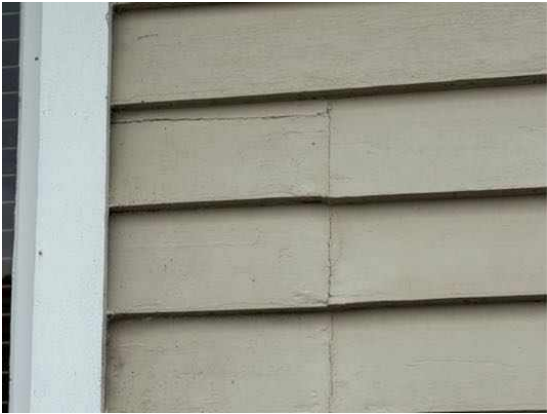
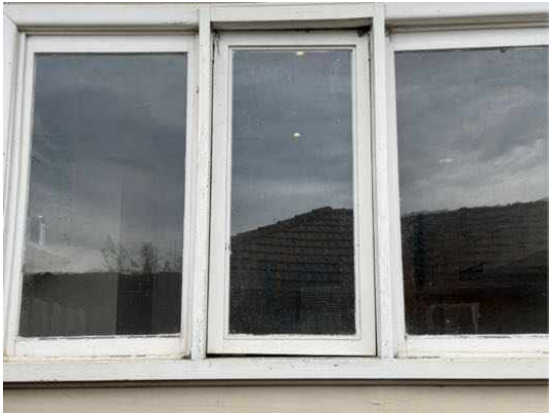
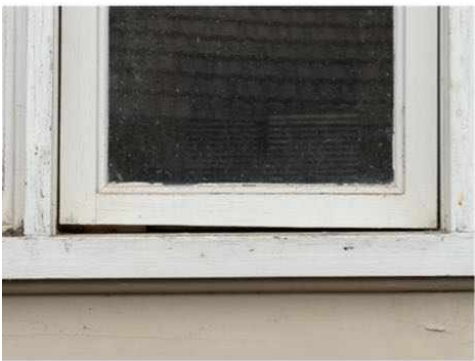
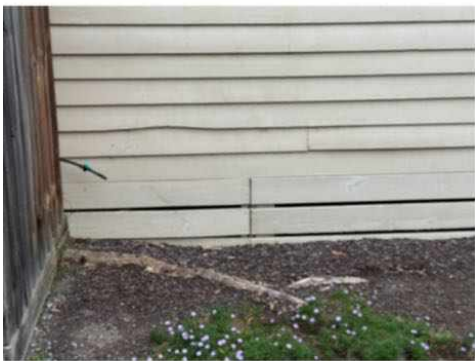
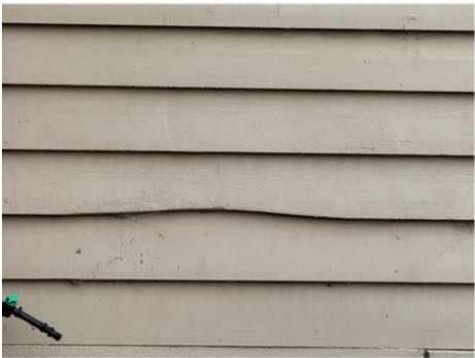
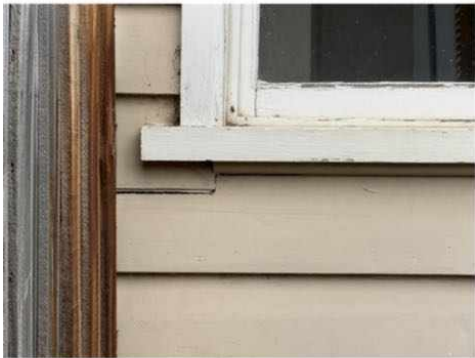
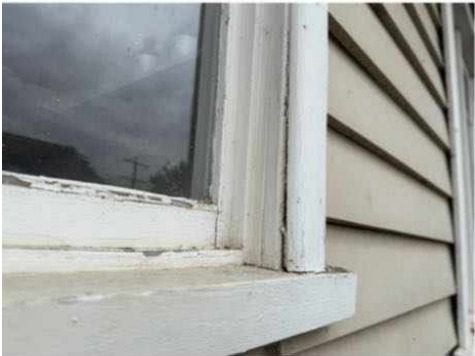
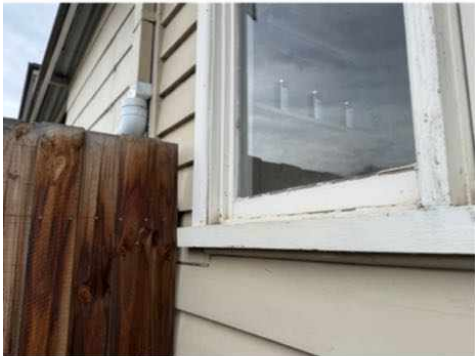
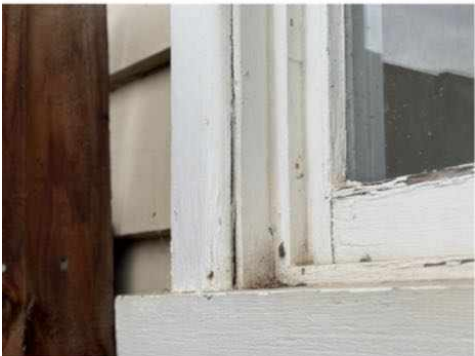
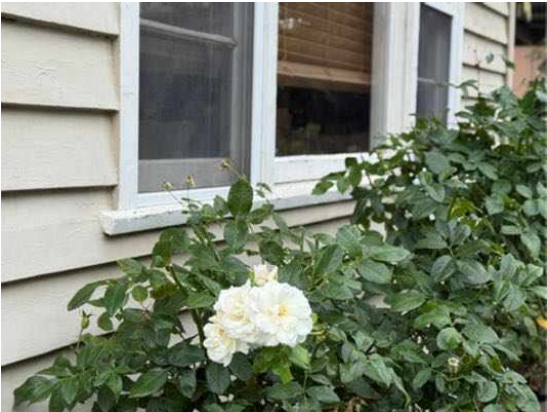
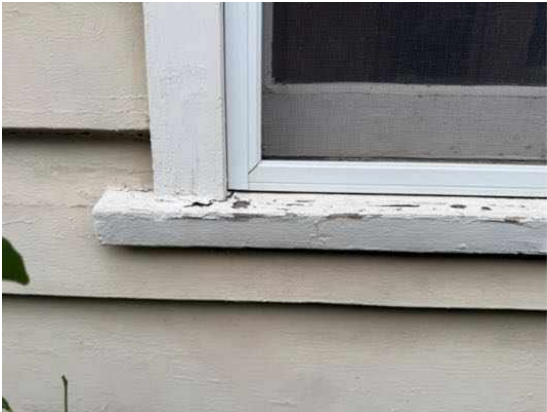
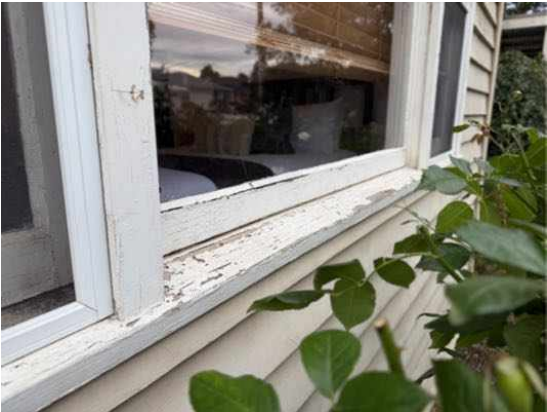
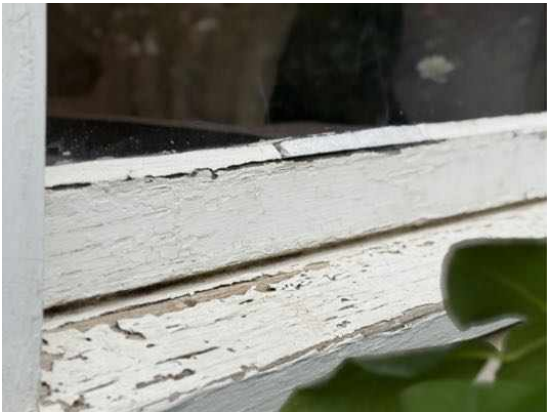
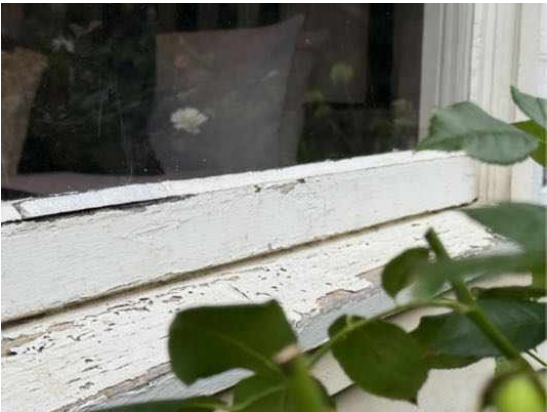
Building: Building 1
Location: All Areas > All Areas
Finding: Additional Photos
Information: Additional photos are provided for either future maintenance items for clients attention and or general reference. Arrows may have been included to highlight areas of importance. Please discuss these photos with your building consultant for clarification.

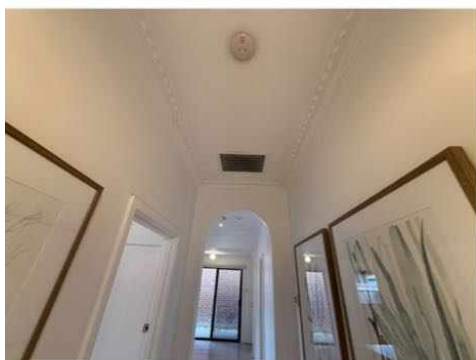
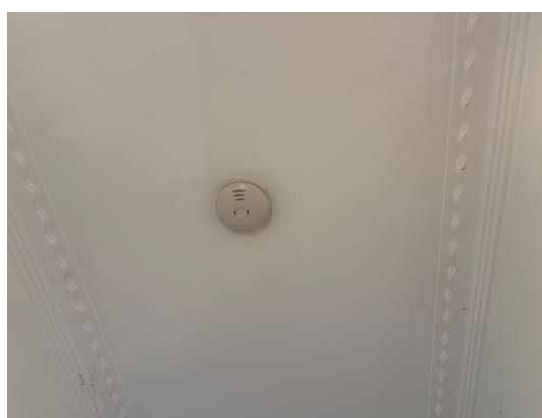
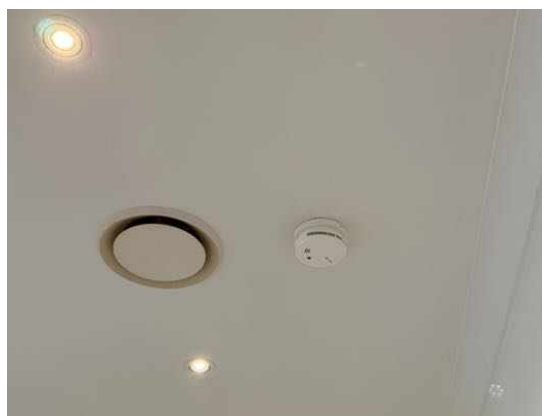
Building: Building 1
 Location: All Areas > All Areas
 Finding: Smoke detectors and alarms
 Information: Reporting on Smoke Detectors or Alarms, including hard wired smoke detection systems and their legislative requirements, is outside the Scope of this Report. Please note that this defect is highlighted as a caution only. We suspect, based on our experience in the building industry, that smoke detectors are sometimes get overlooked, or they may be in a poor condition, so we recommend that they always should be addressed prior to occupation to improve occupant safety.

Always ensure sufficient working and suitable smoke detectors are installed prior and during to occupying any building. Additionally, it is advised that all smoke detectors be tested by the homeowner on a monthly basis.

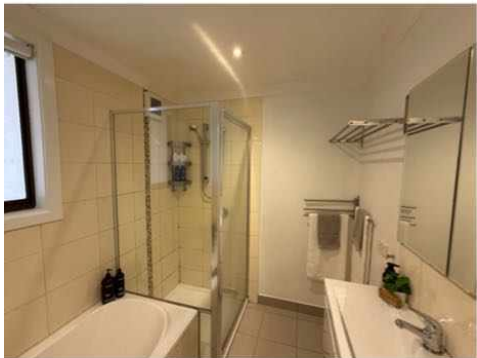
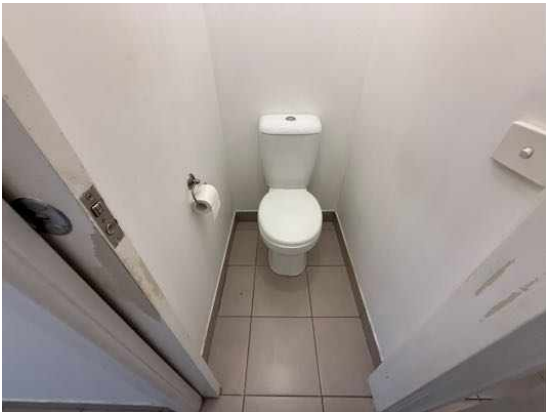
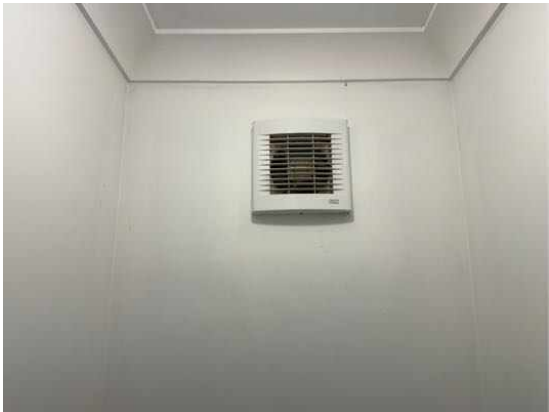
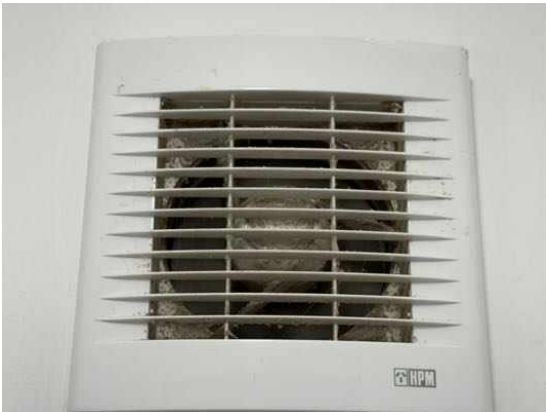
Building: Building 1
 Location: All Areas > All Areas
 Finding: Air filters, grilles and fans - require maintenance and cleaning
 Information: Air grilles and fan covers need regular maintenance and cleaning. Dust, debris and dirt accumulated on the grill mesh will obstruct the normal air flow, these should be cleaned to prevent impairment of their intended functions. This includes such grilles and air filters from rangehood sis, ducted heating / cooling units, ceiling and bathroom

fans.

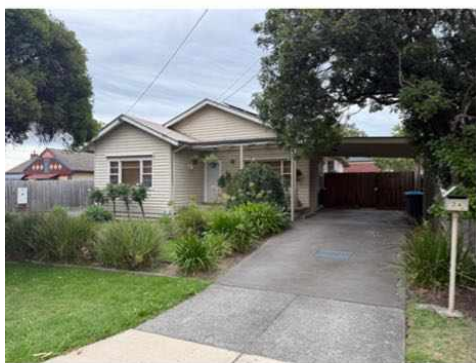
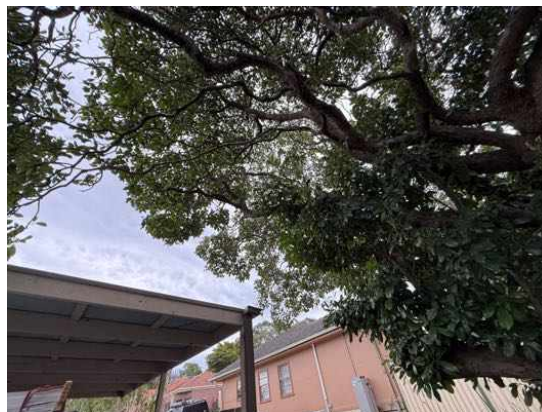
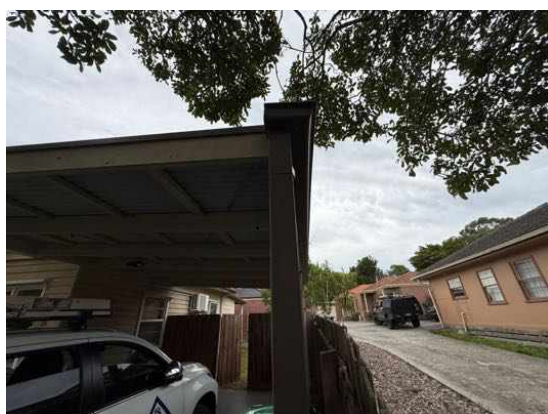
Building: Building 1
 Location: All Areas > All Areas
 Finding: Trees - Overhanging and filling gutters
 Information: Overhanging trees often result in excessive amounts of leaf debris accumulating in gutters. Gutters are a critical part of the building's management of storm water and rain. It is therefore important that they be kept clear to prevent secondary damage to associated building elements, including exterior and interior walls, ceiling linings and any adjoining building elements.

Where gutters get blocked from excessive leaf matter, water pooling is highly likely to occur more frequently, fast-tracking, rust and corrosion of the roof plumbing elements and making these areas even more susceptible to secondary defects. It is highly recommended that if at all possible, all overhanging tree branches be removed to prevent further damage. Such works can be performed by the homeowner; however, appointment of a landscape contractor or an arborist may be required. Consultation with a licensed roof plumber is required where guttering has been damaged.
