Building Inspection Report

Inspection Date: Tue, 10 Mar 2026

Property Address: 1/26 Narcissus Ave, Boronia VIC 3155,
Australia

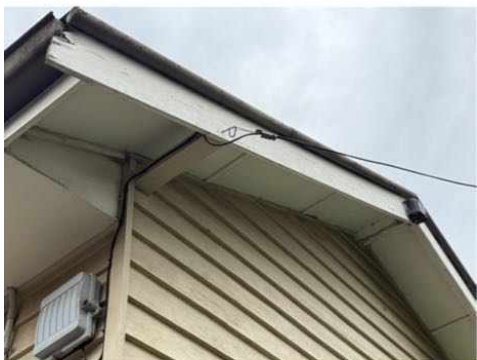
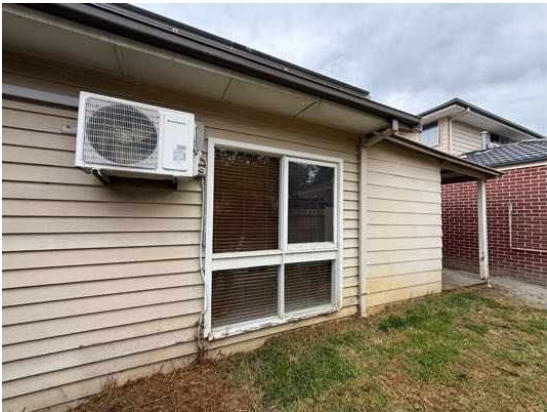
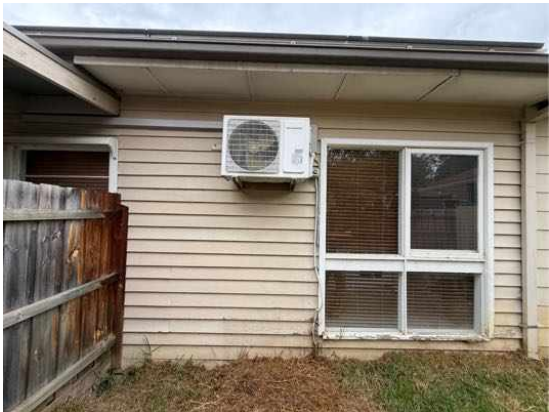
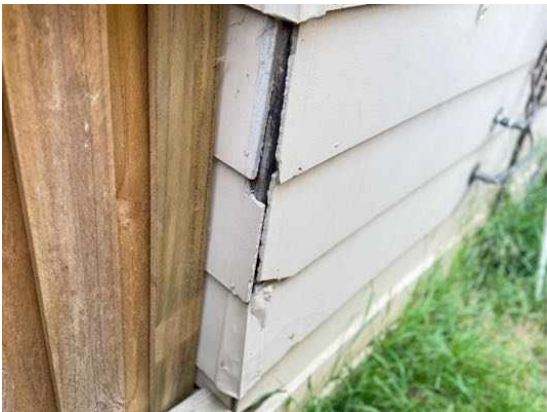
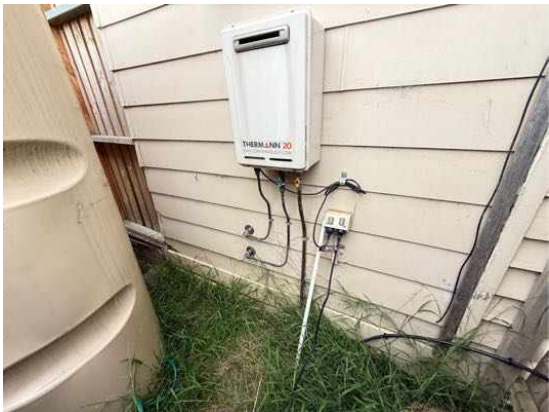
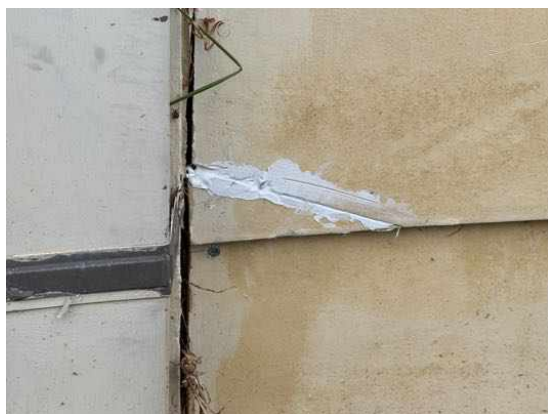
Building:	Building 1
Location:	All Areas > All Areas
Finding:	Asbestos - Suspected ACM Identified on Site
Information:	Reporting on Asbestos is outside the Scope of this Report. This suspected defect is highlighted as a caution only. We suspect, based on our experience in the building industry, that there is a higher risk of the identified building element containing asbestos.

As Asbestos Reporting is outside the scope of this report, we advise that you consider a separate Asbestos Inspection and Condition Audit, which can include the taking of samples for definitive confirmation of the presence of Asbestos. Asbestos sampling can only be taken upon ownership of the property only, due to being an invasive procedure.

In the interim, the client is advised to act with caution, especially when considering any damage to building materials general wear and tear renovations extensions demolition and general maintenance activities due to the suspected presence of Asbestos.

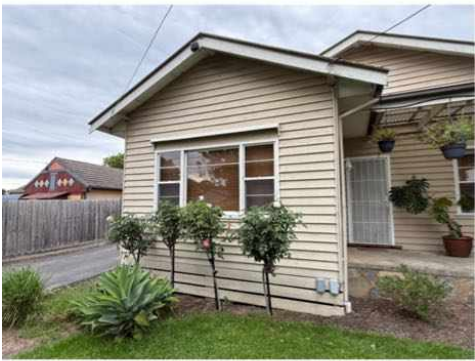
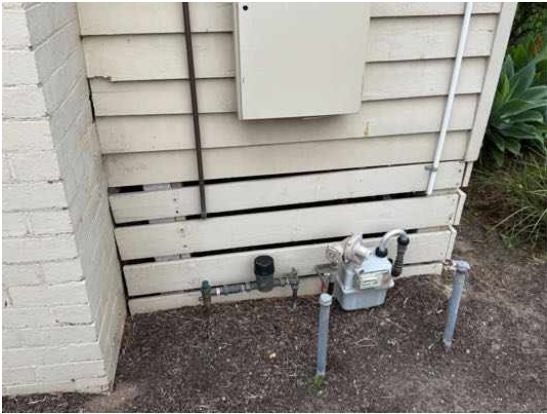
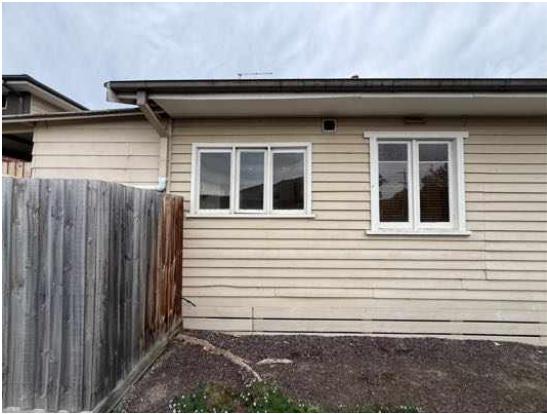
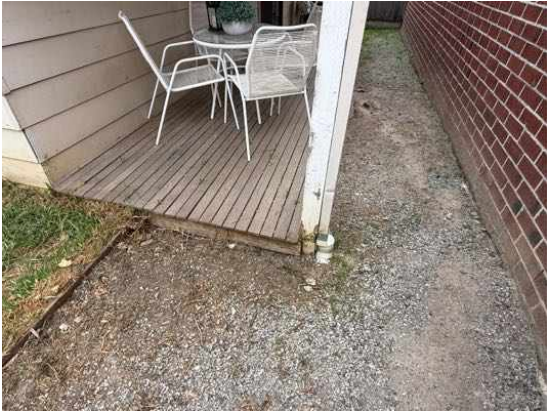
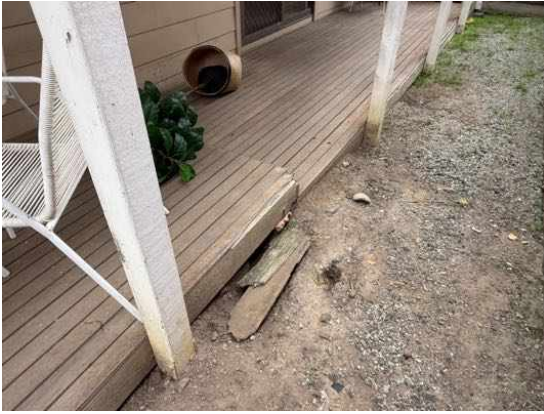
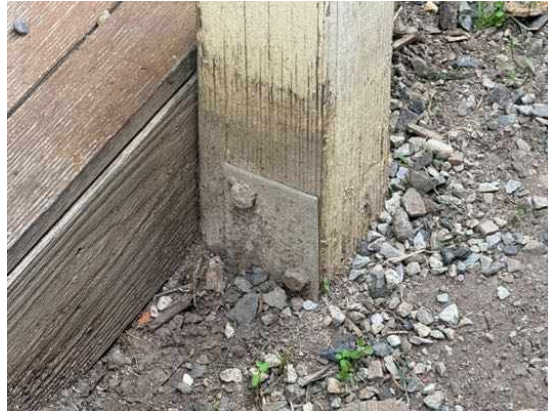
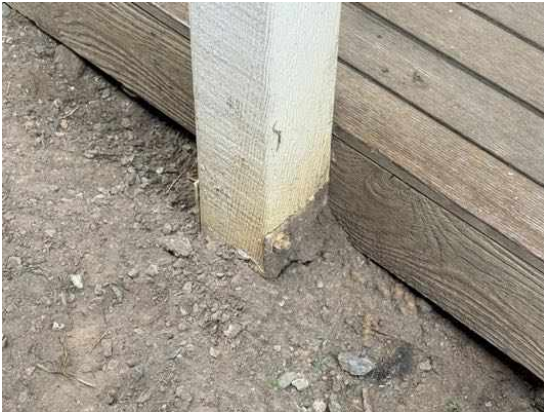
Building: Building 1
 Location: All Areas > All Areas
 Finding: Timber in the ground and exposed to excessive weather conditions
 Information: External timbers in the ground and are frequently exposed to harsh and extreme weather conditions, will require adequate protection and maintenance in order to maintain their condition. Other timbers are exposed to moisture from ground contact which exposes these areas to accelerated wood rot and decay, damage and deterioration. Where timbers have not been painted properly or treated adequately, general deterioration is likely to occur at an accelerated rate.

If left unattended, replacement of these timbers is likely to be necessary in the future. Adequate treatment of these timbers is required to ensure excessive weathering does not occur, painting of these areas may be carried out by the client or by a painting contractor or general handyman.

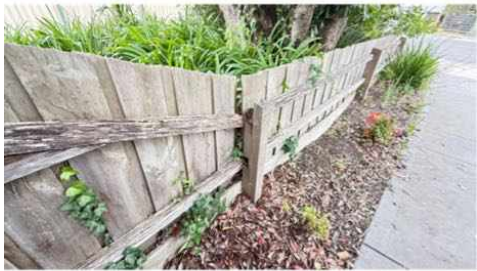
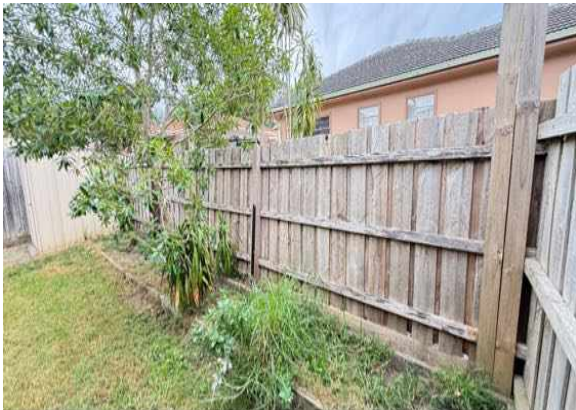
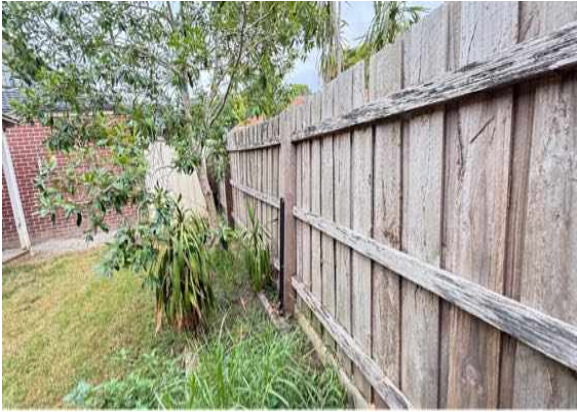
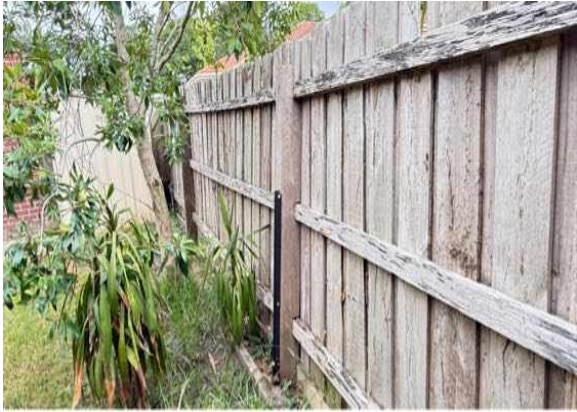
Building: Building 1
 Location: All Areas > All Areas
 Finding: Post and rail fences
 Information: Post and rail fences showed damage and deterioration at the time of the inspection. This deterioration is suspected to have developed over a prolonged period of time due to frequent weather exposure, which is expected in a property of this age and condition.

Left unmanaged, further deterioration is likely to develop further, necessitating in extensive repair or replacement areas of the timber fences, this will depend on the age and deterioration and or wood rot, further damage is suspected of occur.

To maintain the condition of the external timber building elements, any affected areas should be substituted as soon as possible with pre-treated replacements. A qualified fencing contractor should be appointed to repair and replace post and rail fencing where deemed to be necessary.
