Building and Timber Pest Inspection Report

Inspection Date: Fri, 27 Mar 2026

Property Address: 131 Woodcourt Rd, Berowra Heights NSW
2082, Australia

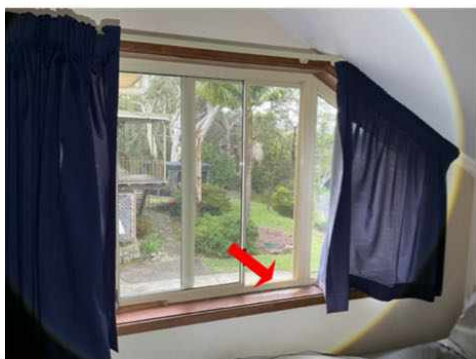
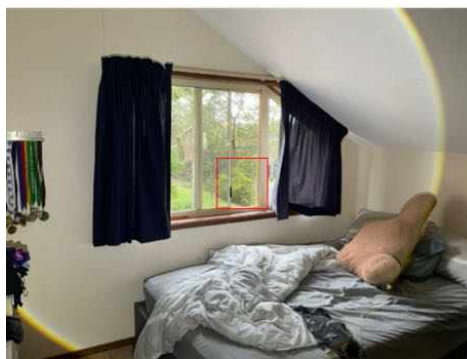
Building:	Main Building
Location:	All Windows Upstairs
Finding:	Window Restrictors - Recommended
Information:	Upstairs windows did not have window restrictors installed. Although not a requirement at the time of construction, it is advisable to install window opening restrictors on all second storey windows with sill heights below 1.7 meter and potential fall of 2 meters or more.

If you live in a strata scheme, window safety devices must be installed on all applicable windows by 13 March 2018. Residents with safety devices installed can still fully open their windows but it's recommended that devices be engaged whenever children are present, to prevent falls.

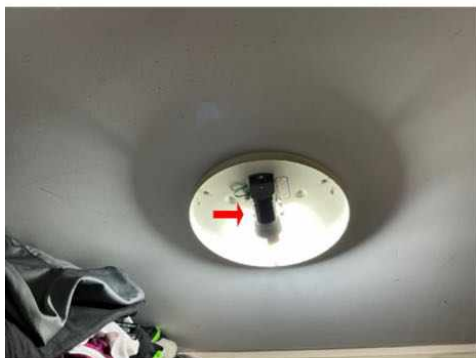
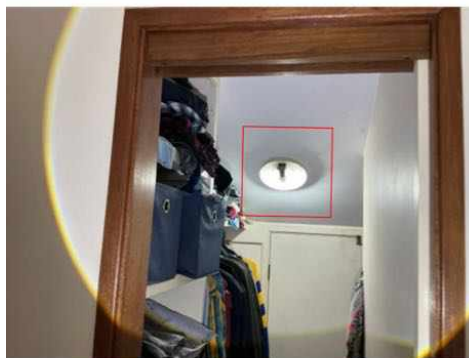
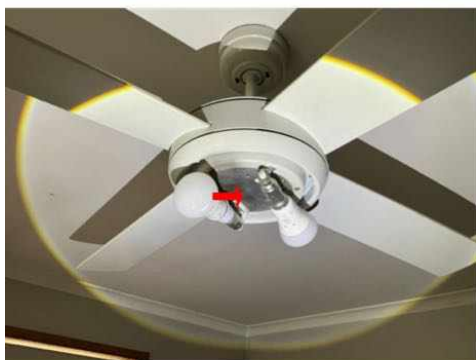
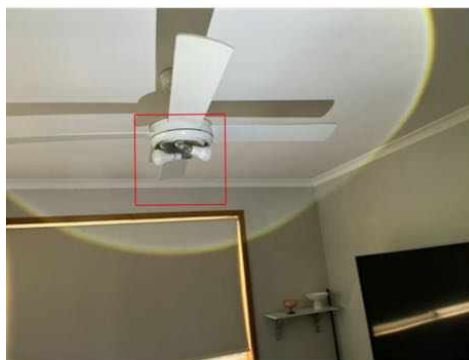
Finding 1.02

Building:	Main Building
Location:	Master Bedroom Closet, Bedroom 6
Finding:	Light Cover - Missing
Information:	At the time of inspection, it was observed that the light cover for the ceiling light fixture is missing. The absence of the light cover exposes the bulbs and internal components, posing potential safety hazards such as electrical shock and increased risk of bulb damage. Additionally, the missing cover detracts from the aesthetic appeal of the room, giving it an unfinished and neglected appearance. It is recommended to replace the missing light cover promptly to ensure safety and restore the visual integrity of the lighting fixture.

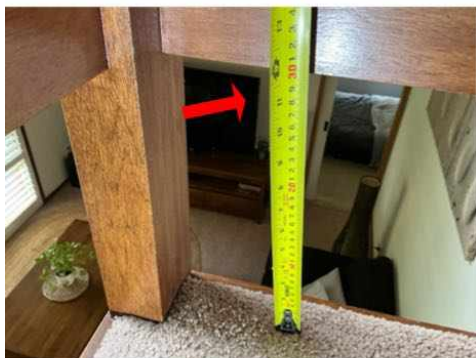
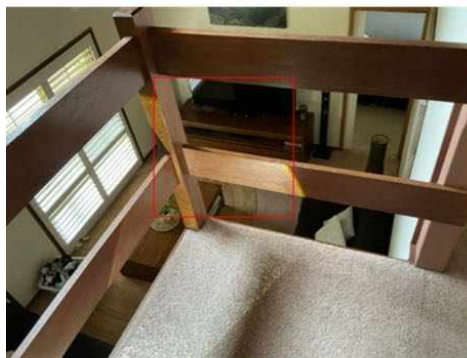
Finding 1.03

Building:	Main Building
Location:	Stairs - Internal
Finding:	Spacing Between Balusters - Non Complaint
Information:	At the time of inspection, it was observed that the spacing between the balusters exceeds 125 mm. In accordance with the National Construction Code (NCC) 2022 Volume Two and referenced standards, any openings in a balustrade or barrier must be constructed to prevent a 125 mm sphere from passing through, in order to minimise the risk of falls or entrapment, particularly for young children.

The current baluster spacing does not comply with these safety requirements and may pose a fall or injury hazard. While this may have been acceptable at the time of original construction, it does not meet current Australian safety standards.

It is recommended that the balustrade be modified to reduce the openings between balusters to no greater than 125 mm, in accordance with current NCC requirements, to ensure occupant safety and compliance.

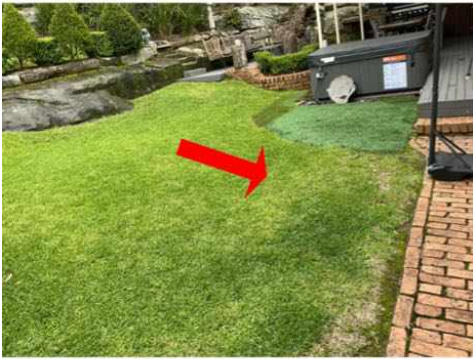
Building:	Main Building
Location:	Yard - Back
Finding:	Inadequate Site Drainage - Exterior Areas
Information:	At the time of inspection, inadequate site drainage was observed around the perimeter of the building, which can lead to water pooling and insufficient runoff management.

This condition may result in moisture being absorbed by the foundation or lower walls, potentially leading to rising damp, cracks in brickwork, erosion of the soil around the building, or structural issues over time. Water pooling can also create ideal conditions for mould growth, contribute to the deterioration of exterior materials, and act as conducive conditions for termite activity, as termites are attracted to areas with elevated and persistent moisture levels.

It is recommended that proper site drainage be installed, such as redirecting water flow away from the building or incorporating drainage systems, to prevent further damage and ensure the long-term stability of the structure.

To address the inadequate site drainage, a qualified landscaper or drainage specialist should be engaged to design and install appropriate drainage solutions, such as grading the ground away from the building or installing French drains, surface drains, or downspout extensions. If more complex issues are present, such as damage to the foundation or moisture entering the walls, a structural engineer may need to assess the situation, and a builder may be required for repairs.

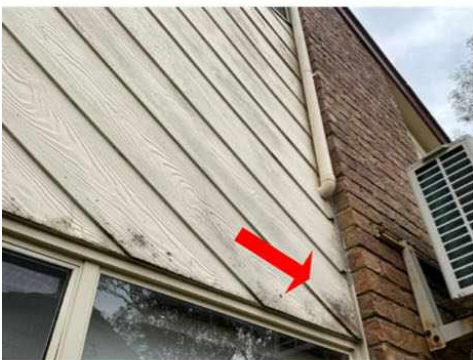
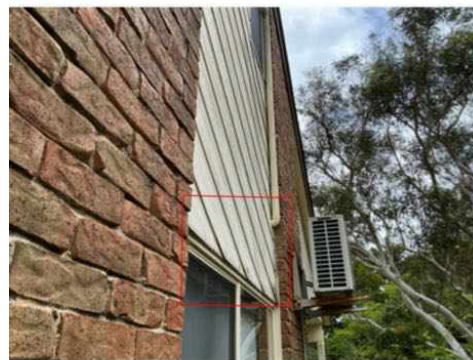
Finding 3.02

Building:	Main Building
Location:	Exterior walls - left side
Finding:	Weatherboards/Cladding - Weathered
Information:	During the inspection, it was noted that the weatherboards have weathered over time.

This weathering is evident through the visible discolouration and potential degradation of the material and some minor damage at the corners. Prolonged exposure to the elements has likely contributed to this condition, which may lead to further deterioration if not addressed. It is recommended that the weatherboards be thoroughly assessed and maintained to prevent potential damage to the underlying structure. Regular maintenance, including cleaning, sealing, and painting, should be considered to restore the appearance and functionality of the weatherboards and to protect the property from the effects of weathering.

Consider hiring a professional painter to paint the affected area at client discretion.

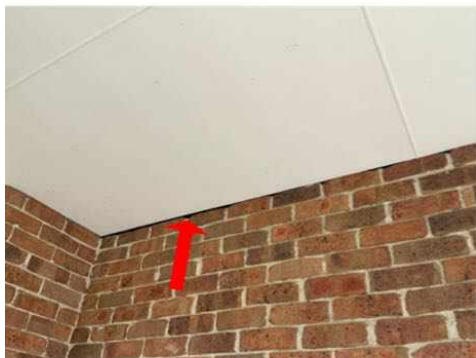
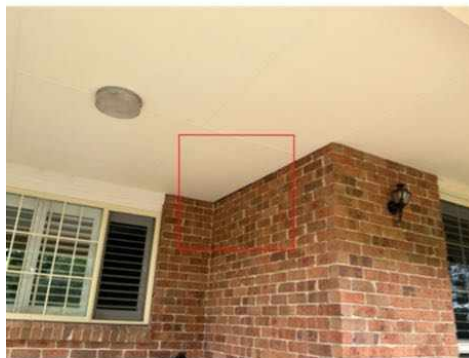
Finding 3.03

Building:	Main Building
Location:	Carport
Finding:	Areas - Not Sealed

Information: At the time of inspection, certain areas were found to be unsealed, which may allow moisture ingress, pest entry, or air leaks. Gaps and unsealed sections can contribute to deterioration over time and reduce the overall integrity of the structure. It is recommended to seal the affected areas to prevent potential damage and ensure better protection against environmental factors.

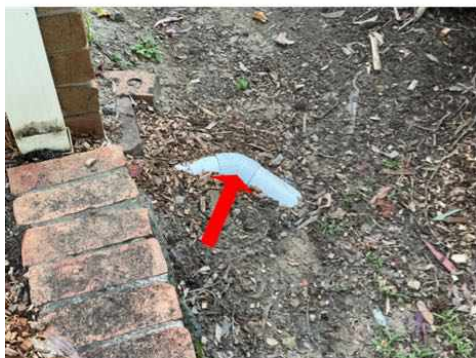
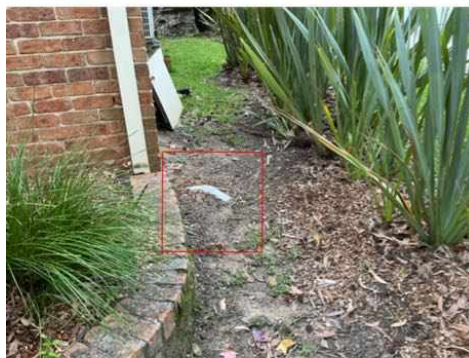
Finding 3.04

Information: At the time of inspection, the drainpipes were observed to be improperly installed, as they were visible on the ground rather than being adequately buried underground.

Properly burying drainpipes is essential to protect them from physical damage, such as cracking or displacement, and to shield them from exposure to environmental elements that could accelerate wear and tear. This improper installation may lead to long-term durability issues and compromise the functionality of the drainage system.

Immediate rectification by a licensed plumber is recommended to ensure compliance with standard installation practices and to prevent potential damage or system failure.

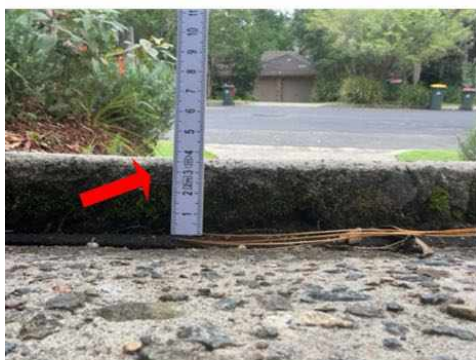
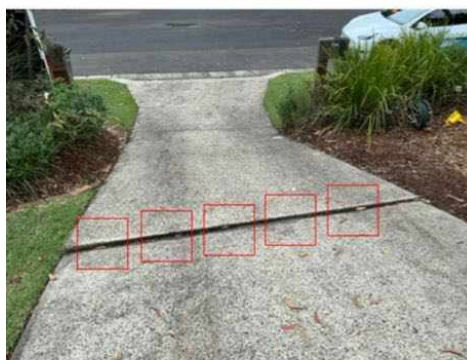
Finding 3.05

Building:	Main Building
Location:	Driveway
Finding:	Sinking Driveway Section
Information:	At the time of inspection, sections of the concrete driveway were observed to be sinking, resulting in an uneven surface and visible separation between slabs. Measurements indicate a noticeable height difference across the affected joint, which suggests possible ground movement, inadequate compaction, or soil settlement beneath the slab. If left unaddressed, this condition may worsen over time, leading to further displacement, increased trip hazards, and potential damage to the surrounding concrete.

It is recommended that the client engage the services of a qualified concrete specialist to assess the extent of the settlement and carry out appropriate remedial works.

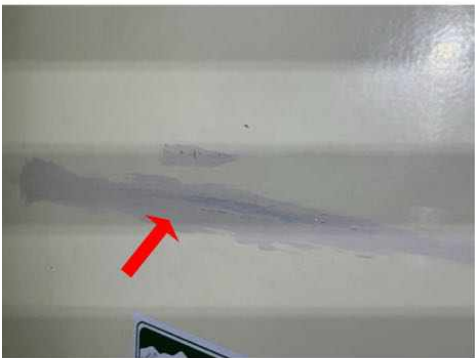
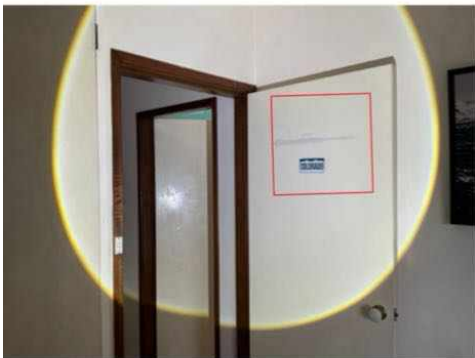
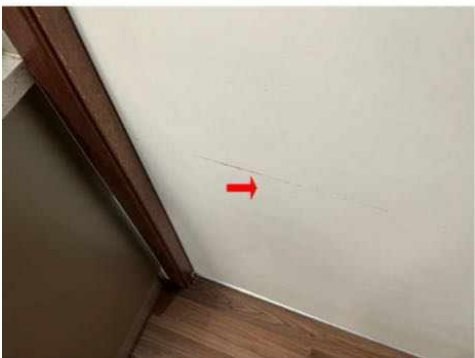
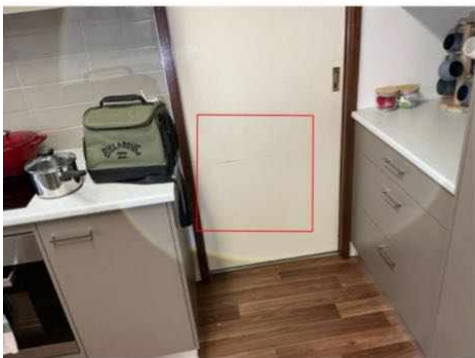
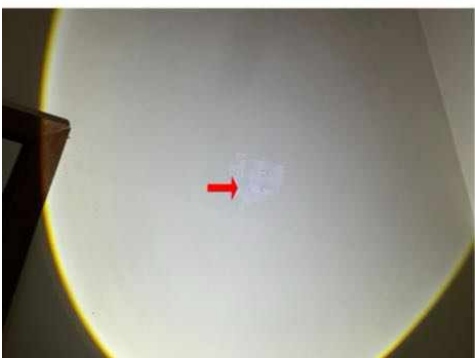
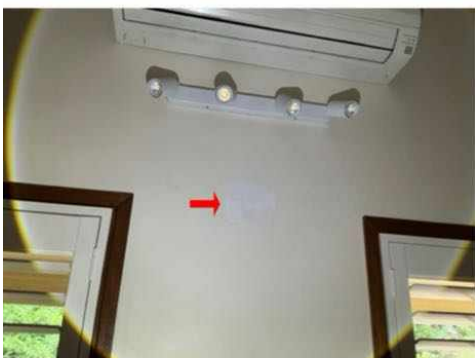
Finding 3.06

Building:	Main Building
Location:	All Areas
Finding:	Maintenance and/or Wear and tear on building elements
Information:	It was observed at the time of inspection that some building elements and areas around the property require general maintenance and/or exhibit signs of wear and tear. These typically include minor imperfections such as paint scuff marks, scratches on surfaces, small chips, nails or hooks left in walls from previous picture hanging, and other superficial blemishes.

These are generally considered minor items that are common in established homes. While they may be noticeable on visual inspection, they do not affect the structural integrity or functionality of the property. In most cases, these issues can be easily addressed by a qualified handyman as part of routine maintenance.

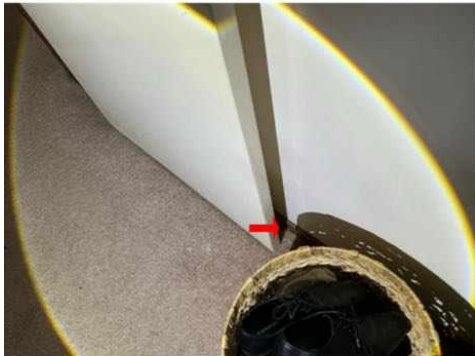
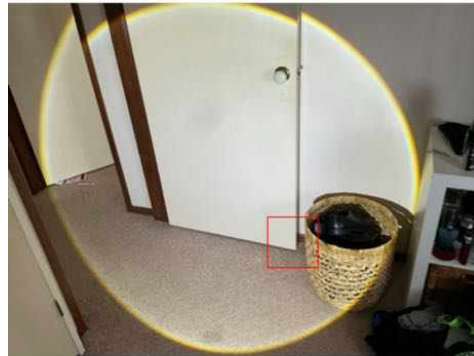
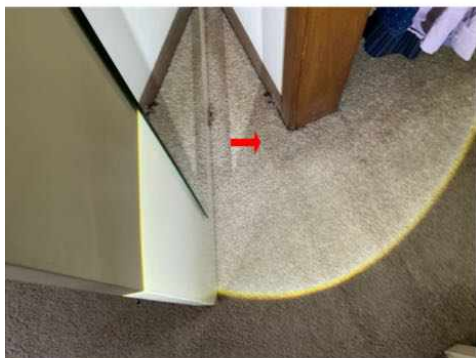
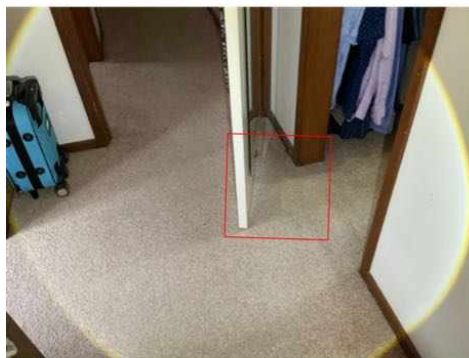
Finding 3.07

Building: Main Building
 Location: Bedroom - Master, Bedroom 4
 Finding: Door Stopper(s) - Missing
 Information: At the time of inspection, it was noted that a door stopper was missing in this area.

The absence of a door stopper can lead to potential damage to the door, wall, or surrounding finishes, as the door may swing open too far and impact the wall or adjacent objects. Over time, this can cause dents, scuffs, or even structural damage to the wall or door. It is recommended that a door stopper be installed to prevent further damage and ensure the protection of both the door and the surrounding area.

The client is advised to engage services of a handyman to install the door stopper.

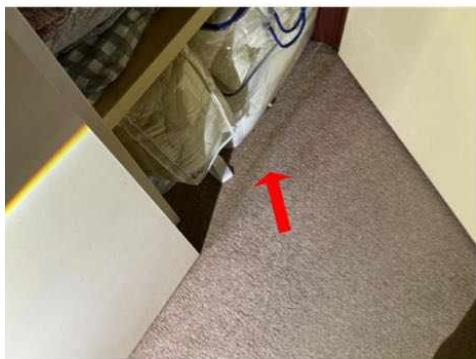
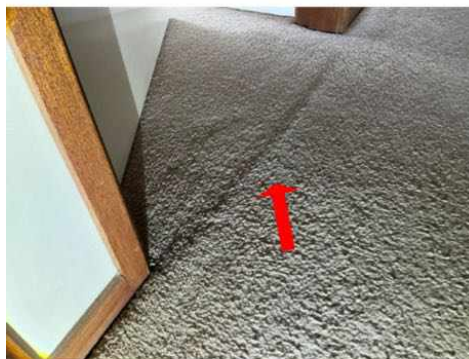
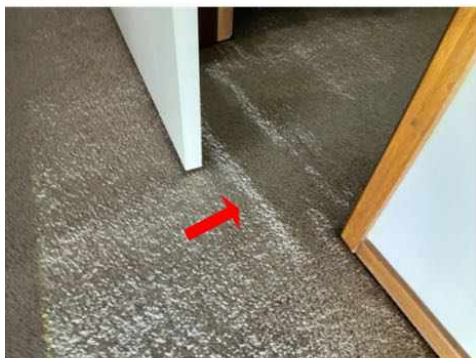
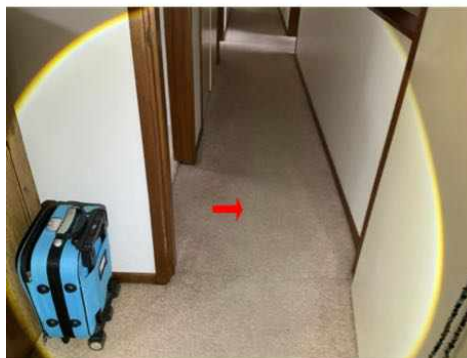
Finding 3.08

Finding: Carpet - Buckling & Stained

Information: At the time of inspection, the carpet was noted as stained in several areas and also showing signs of buckling, creating uneven surfaces. These conditions detract from the overall appearance of the flooring and may present a trip hazard if left unaddressed.

It is recommended that a professional carpet cleaner be engaged to treat and clean the stained areas. In addition, a qualified carpet specialist should be engaged to re-stretch or otherwise repair the carpet to eliminate the buckling and restore a safe, even surface.

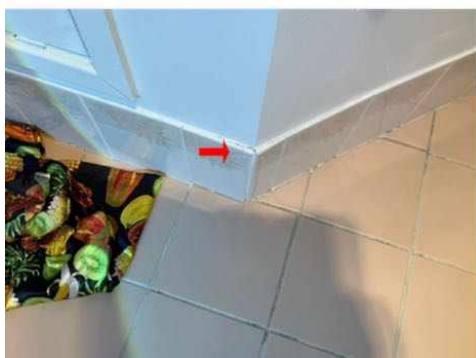
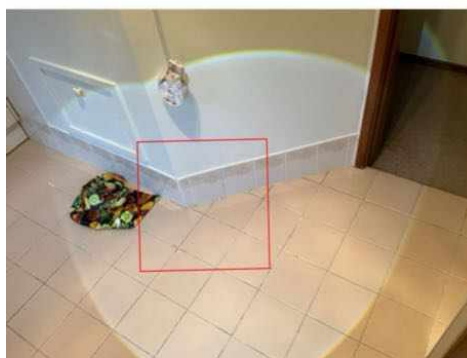
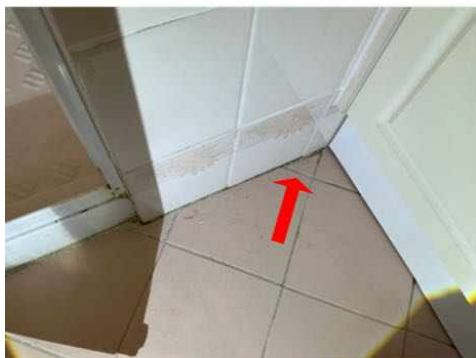
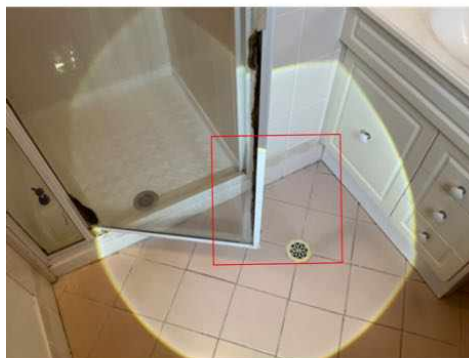
Finding 3.09

Finding: Sealant/Grouting - Missing or Damaged

Information: At the time of inspection, areas of missing and/or deteriorated sealant and grout were noted in this area. This condition can allow water to penetrate behind finishes, which may lead to moisture ingress, deterioration of waterproofing membranes, mould growth, and potential leaks into adjoining areas over time. If left unaddressed, this may result in costly repairs and hidden water damage.

It is recommended that a licensed plumber (or suitably qualified tradesperson experienced in wet area sealing) be engaged to assess the affected areas and reinstate compliant waterproof sealant and grout as required, ensuring all junctions are properly sealed to prevent further water ingress.

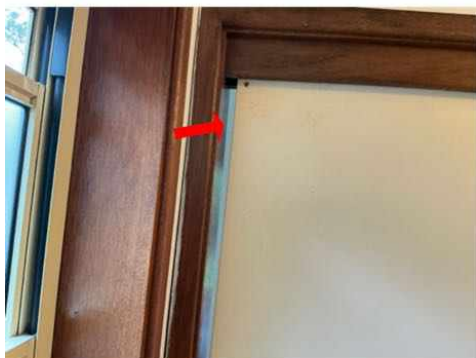
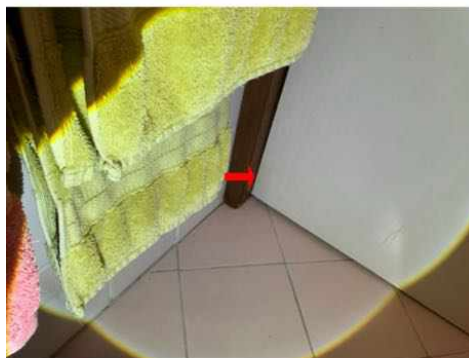
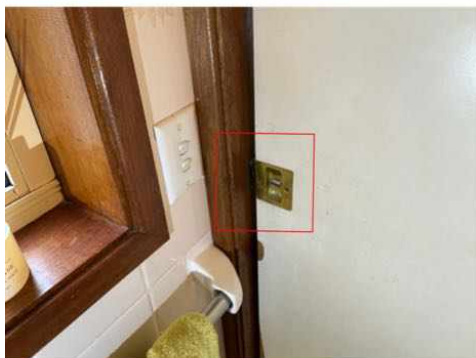
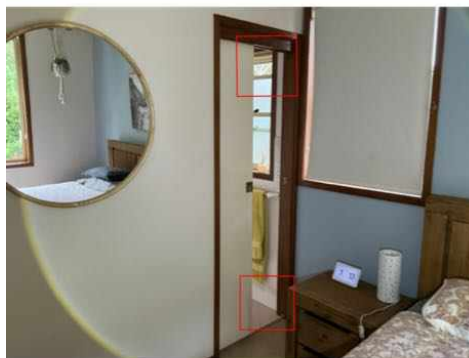
Building: Main Building
 Location: Ensuite - Master
 Finding: Misaligned Sliding Door
 Information: At the time of inspection, the sliding door was observed to be misaligned within its frame. An excessive gap was noted at the top of the door, while little to no clearance was present at the bottom. This misalignment is preventing the door from closing and locking properly. Such conditions are typically associated with wear to rollers, track issues, or movement in the frame.

This defect compromises the security and functionality of the door and may worsen over time if not addressed. It is recommended that the client engage the services of a qualified handyman to realign the door, adjust or replace the rollers if required, and ensure the locking mechanism operates correctly.

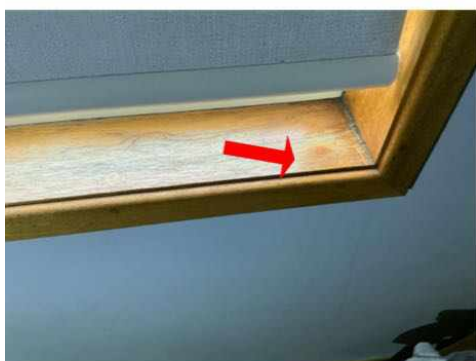
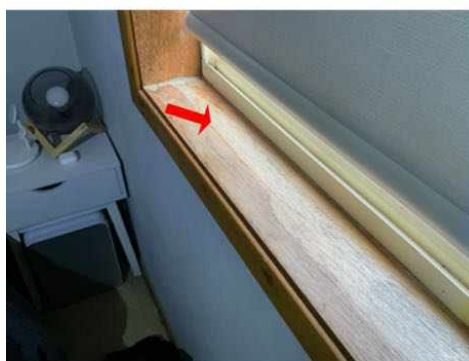
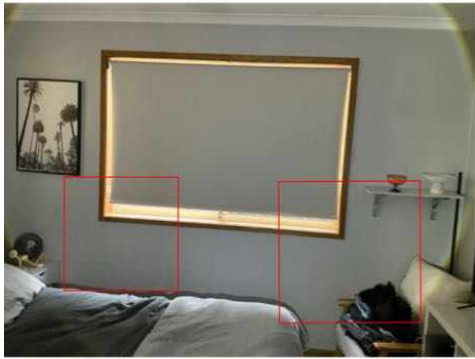
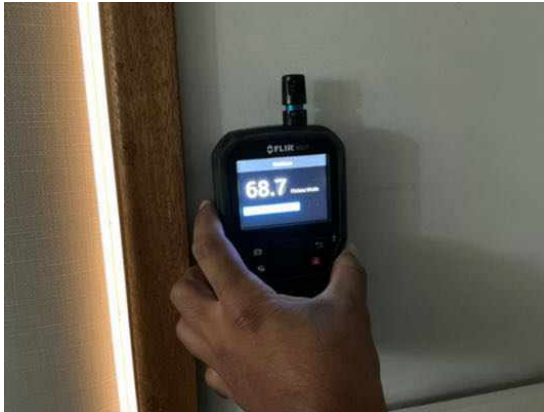
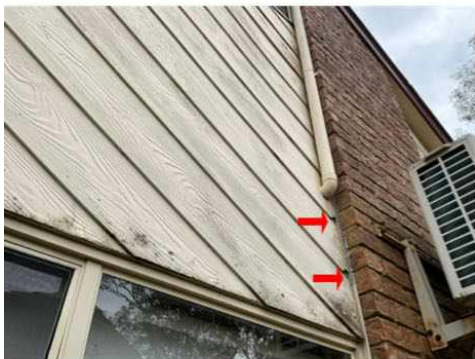
Finding 3.11

Finding: Moisture Ingress to Wall and Window Frame

Information: At the time of inspection, elevated moisture readings were recorded to the internal wall adjacent to the window, indicating the presence of excessive moisture. Water staining was also observed on the timber window frame, which is consistent with previous or ongoing moisture ingress.

Upon external inspection, it was noted that sections of the cladding above the window are damaged, particularly at the corner areas. These defects may allow rainwater penetration, which could be contributing to the moisture detected internally.

If left unaddressed, this condition may lead to deterioration of internal finishes, timber elements, and potential mould growth. It is recommended that the client engage the services of a qualified builder to inspect and repair the damaged external cladding and ensure all areas are properly sealed to prevent further water ingress.

The client is also advised to monitor the internal wall over the next 12 months for any signs of deterioration such as bubbling paint, staining, or changes in surface texture, and take further action if conditions worsen.

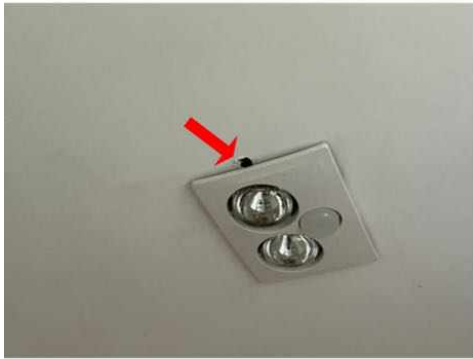
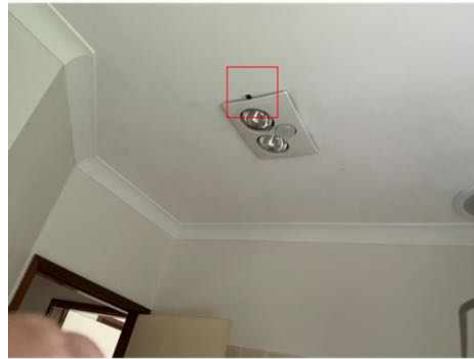
Finding 3.12

Building:	Main Building
Location:	Bathroom
Finding:	Plasterboard - Holes
Information:	A hole has been observed in the ceiling plasterboard at the time of inspection.

This damage can lead to several issues, including compromised structural integrity of the ceiling, potential water damage if located near plumbing or roof leaks, and an entry point for pests. Additionally, the hole detracts from the aesthetic appeal of the room and may impact insulation efficiency, leading to increased energy costs. It is essential to repair the plasterboard promptly to prevent further deterioration and maintain the overall safety and appearance of the property.

The client is advised to hire services of a handyman or plasterer to fix the issue.

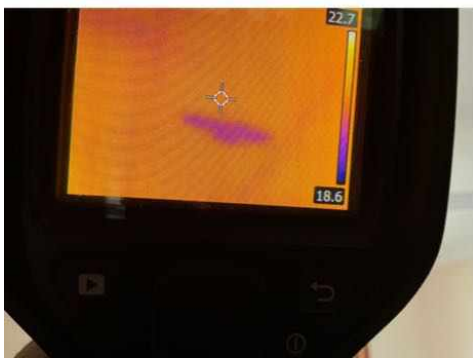
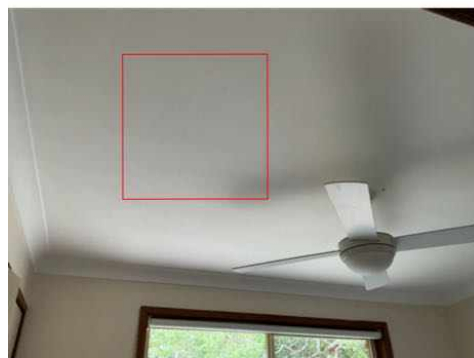
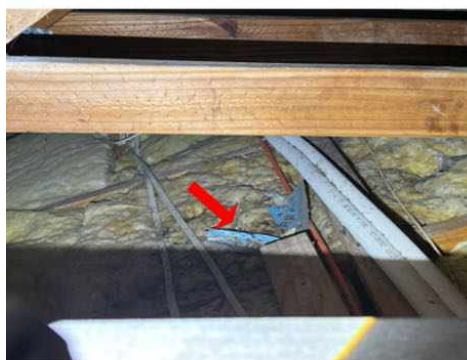
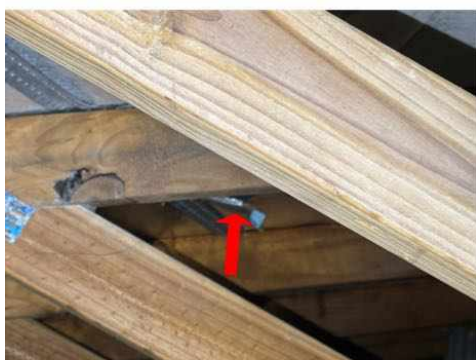
Finding 3.13

Building:	Main Building
Location:	Bedroom 2
Finding:	Minor Roof Leak – Bedroom Two Ceiling
Information:	At the time of inspection, a minor leak was noted on the ceiling of Bedroom Two, evidenced by visible staining. Thermal imaging indicated a temperature variation consistent with possible moisture presence. Upon inspection of the roof space directly above this area, damaged sarking was observed along with staining to the insulation, which is indicative of previous or ongoing water ingress.

This condition suggests that water may be entering through compromised roofing components such as loose flashings, deteriorated seals, or gaps in roof coverings. Although currently minor, this issue may worsen over time and lead to further internal damage if not addressed.

It is recommended that the client engage the services of a qualified roofer to inspect the affected roof area, identify the exact point of entry, and carry out necessary repairs, including sealing any gaps or loose sections to prevent further water ingress.

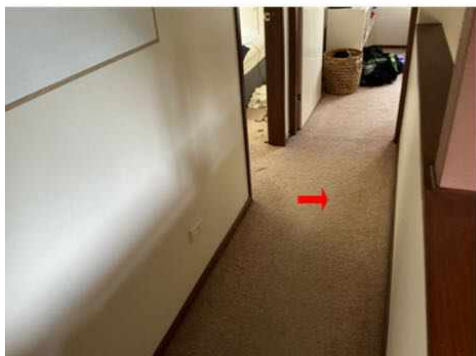
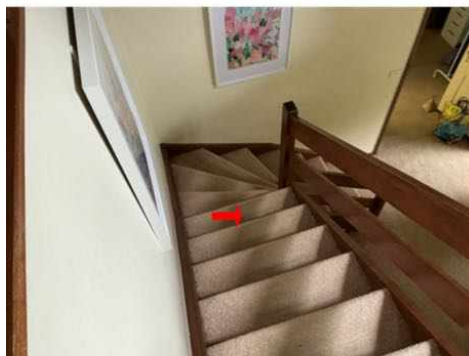
Finding 3.14

Building:	Main Building
Location:	All Areas
Finding:	Floors & Stairs - Noisy
Information:	At the time of inspection, noise was observed when walking on the stairs and adjoining flooring, along with a slightly bouncy feel underfoot in certain areas. This condition is typically associated with movement between structural components such as stair elements, floorboards, or supporting structures, and may also be influenced by timber expansion and contraction due to changes in humidity.

While commonly related to general wear and tear, if left unaddressed this condition may worsen over time and lead to further movement or deterioration.

It is recommended that the client engage the services of a qualified carpenter or flooring specialist to inspect the affected areas and carry out necessary repairs, including securing, tightening, or packing where required to improve stability and reduce movement and noise.

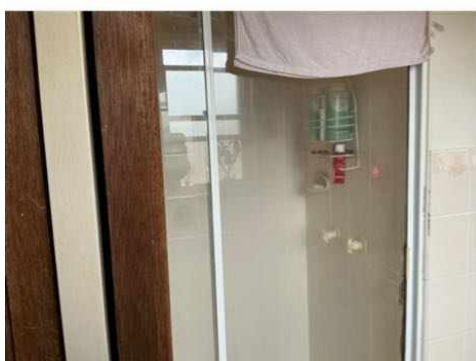
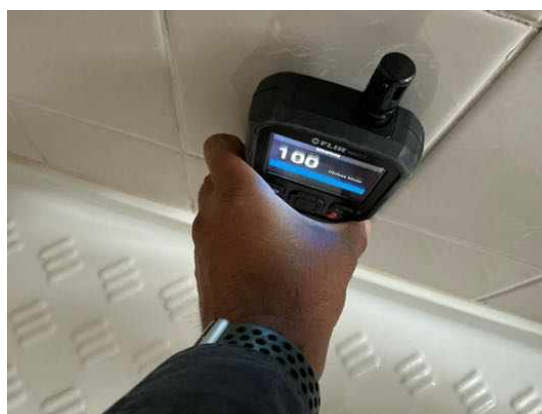
Finding 3.15

Building:	Main Building
Location:	Ensuite - Master
Finding:	Excessive Moisture - Shower Damp
Information:	At the time of inspection, excessive moisture was noted within the shower area, which is a common issue in wet areas due to the continual exposure to water. This condition is typically caused by moisture seeping through grout lines and settling behind tiles, resulting in localised high-moisture zones. Provided there is no evidence of water staining or elevated moisture readings on the opposite side of the wall, this is considered a minor defect.

However, persistently damp conditions may act as conducive conditions for termite activity, as termites are strongly attracted to moisture-rich environments. It is recommended that the client ensures regular use of the exhaust fan and maintains adequate ventilation after shower use to promote drying and reduce long-term moisture build-up, thereby also reducing the risk of attracting termites.

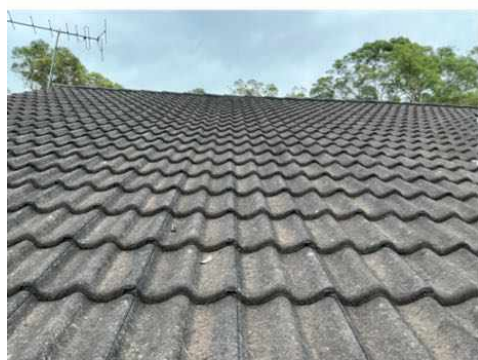
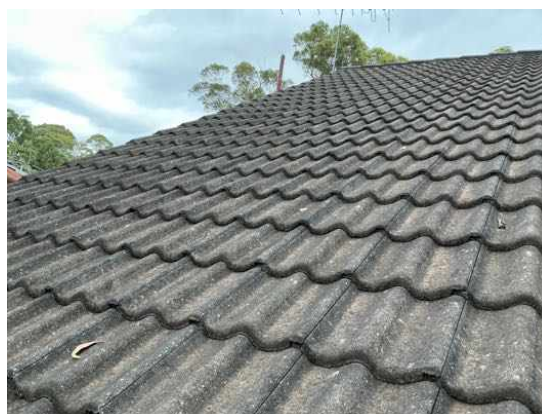
Finding 3.16

Building:	Main Building
Location:	All Areas
Finding:	Roof Tiles - Weathered
Information:	It was noted at the time of inspection, the roof shows clear signs of weathering, with visible wear on the tiles and accumulated debris, such as leaves and branches. The tiles appear aged, which could lead to reduced durability if left unaddressed. There is also potential for moss, lichen or algae growth, which could exacerbate the degradation of the tiles and result in water ingress. It is recommended that the roof undergo a thorough cleaning and inspection to assess for any underlying damage. Regular maintenance is advised to preserve the roof's integrity and prevent further deterioration.

The client is advised to engage services of a qualified roofer to undergo complete assessment of the roof.

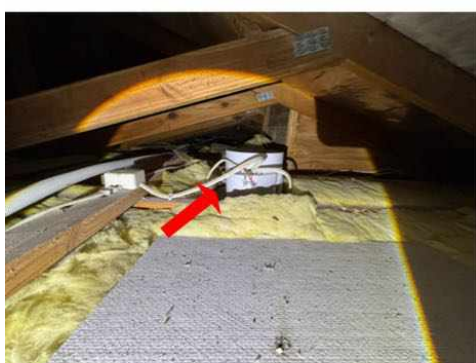
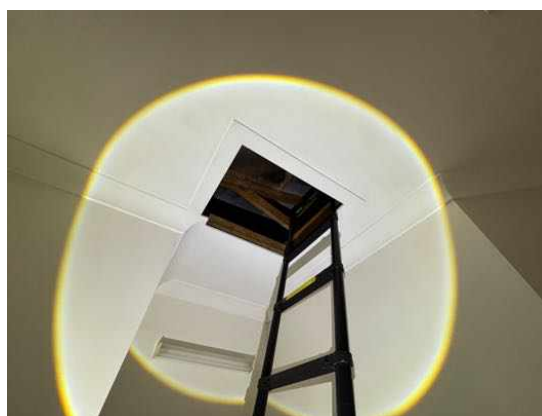
Finding 3.17

Building:	Main Building
Location:	Roof Void
Finding:	Vent - Extracted into Roof Space
Information:	During the inspection, it was noted that the exhaust vent has been improperly

This configuration is a defect as it allows moist air to accumulate within the roof cavity, increasing the risk of condensation, mould growth, and deterioration of insulation or timber framing. Proper ventilation is essential to maintain a healthy indoor environment and protect the structural integrity of the building. It is recommended that the vent be appropriately re-routed to discharge externally in compliance with relevant building standards.

A licensed mechanical ventilation contractor/electrician should be appointed as soon as possible to provide further consultation on the scope of these works and to provide quotations for any necessary works.

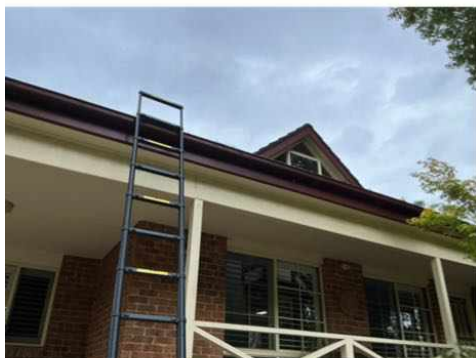
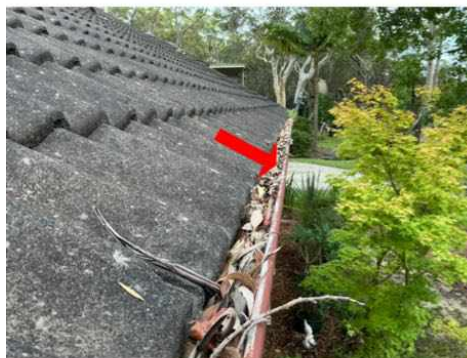
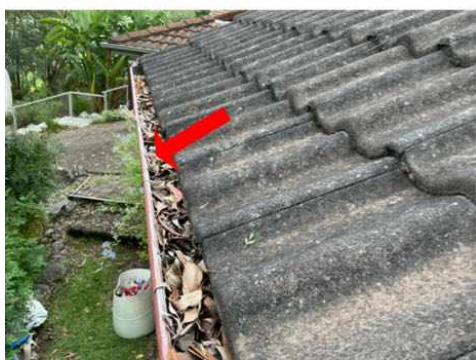
Finding 3.18

Building:	Main Building
Location:	All Areas
Finding:	Debris in Gutters
Information:	Debris, including leaves and organic matter, was observed in the gutters and roof valleys at the time of inspection. This build-up can obstruct proper water flow, leading to water pooling, overflow, and potential moisture ingress into the roof structure. Prolonged moisture retention in these areas creates damp conditions that are conducive to termite activity, particularly where timber components are present nearby. It is recommended that the gutters and valleys be cleared of all debris and maintained regularly to ensure proper drainage and to reduce the risk of both water damage and termite infestation.

The client is advised to engage services of a lawn maintenance professional or a landscaper at own discretion.

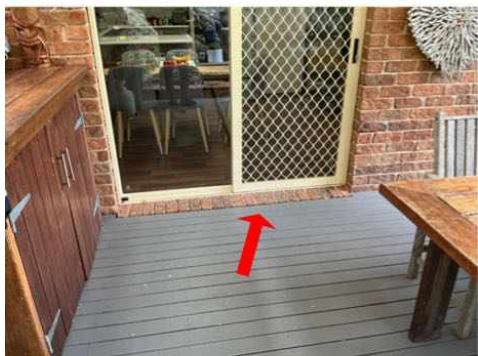
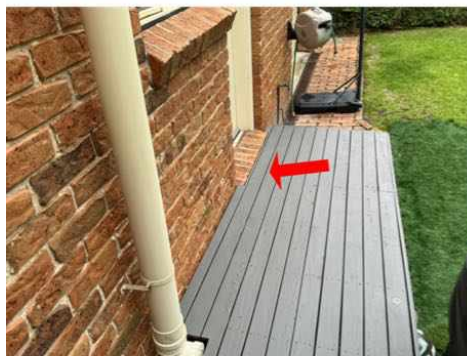
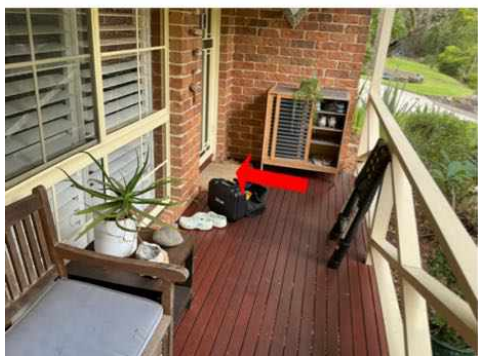
pooling and subsequent internal flooding is likely to occur which may attract termite activity to the internal area.

It is highly advised that a landscaper or relevant tradesperson be appointed to lower external grounds that are raised above or same as adjacent internal flooring. Alternatively if external grounds and internal flooring is level installation of a raised door sill may be appropriate in preventing any water pooling in the area. If the client wishes not to make any changes, then a qualified pest controller is recommended for termite treatment around the perimeter of the house and subfloor (if any) as soon as possible.

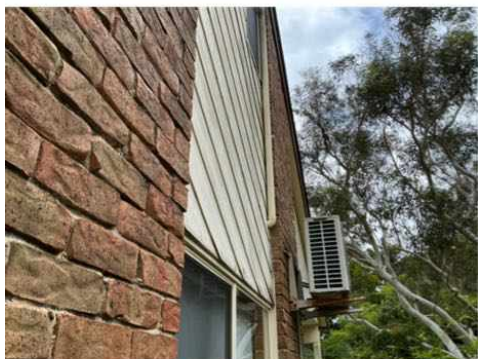
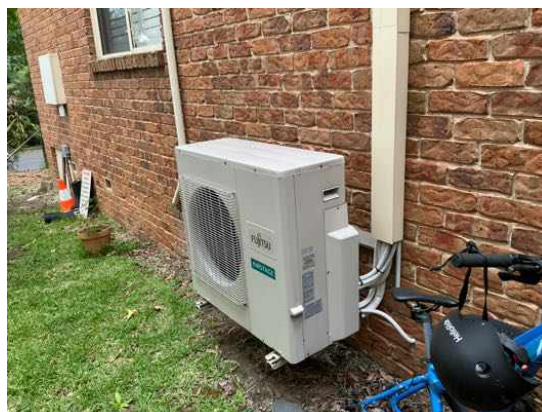
Finding 6.02

Building:	Main Building
Location:	All Areas
Finding:	Bridging Appliances - Attachment to Buildings
Information:	Bridging occurs when items against a building provide a concealed entry point for termites into the building or by passing around a termite management system.

Where any part of an attachment to a building is not isolated and is not provided with a clear gap of not less than 25mm from the building, bridging occurs. Attachments to buildings such as hot water services, downpipes, verandahs, decks, steps, fences, service conduits and the like provide the opportunity for concealed entry.

Building attachments of this nature need to be frequently inspected for termite activity by a qualified inspector.

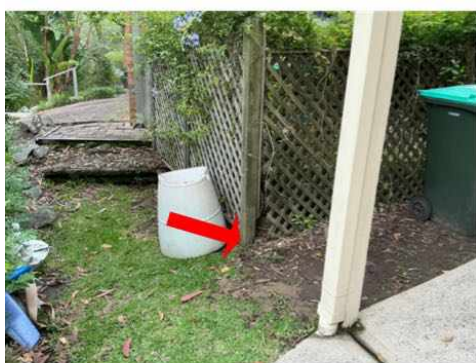
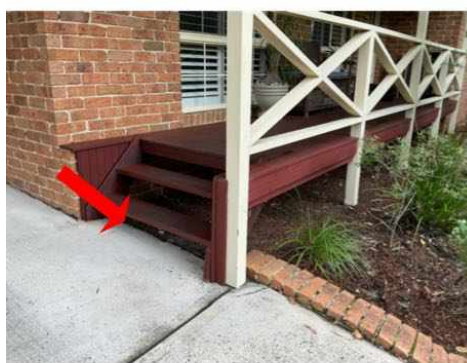
Finding 6.03

Building:	Yard
Location:	All Areas
Finding:	Building Materials in Direct Ground Contact - Conducive to Termites
Information:	Timber elements that are in direct contact with the ground and exposed to moisture or damp conditions are highly conducive to termite activity. This susceptibility arises because timber, when in contact with soil and dampness, creates an environment that is particularly attractive to termites, encouraging infestation and potential structural compromise. Whether the timber is used as a part of the building's construction or incorporated into fencing, its presence near or on the ground can become a pathway for termites to access and damage the property.

When exposed to excessive moisture, timber begins to deteriorate, developing conditions such as wood decay and rot. These compromised areas of timber are even more appealing to termites, as they are easier to infest and consume. This is especially true for untreated or non-durable timber, which lacks the protective treatments that can deter or withstand termite attacks. Termites can use these weakened, moisture-laden elements as a bridge into other parts of the structure, creating an entry point for potential infestations that can spread and cause extensive damage if left unchecked.

For any timber in direct contact with the external ground, special attention is required. The combination of moisture, untreated wood, and direct ground contact not only accelerates the decay process but also provides subterranean termites with a straightforward means of ingress into the structure. This entry can lead to termites moving undetected into other vulnerable areas, resulting in potentially significant structural issues and costly repairs.

necessary for use should be made durable through appropriate treatments and maintained to ensure they do not create conditions conducive to termites. Additionally, the client is advised to schedule regular termite treatments to maintain an effective barrier against infestations and ensure ongoing protection.

The client is strongly advised to assess the property for any timber elements that may be in direct contact with the ground and ensure prompt action is taken to remove or treat them effectively. Regular inspections, proactive maintenance, and consistent termite treatment are essential steps in minimising the risk of termite attack and protecting the structural integrity of the property. Taking these preventive measures is crucial for maintaining a termite-free environment and avoiding potentially costly damage and future repairs.

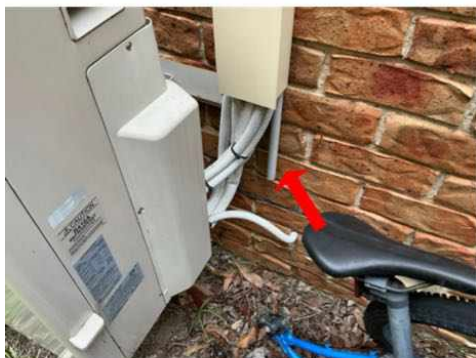
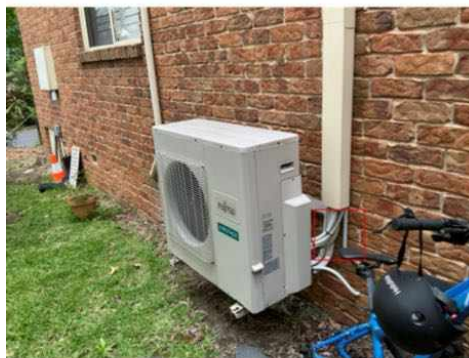
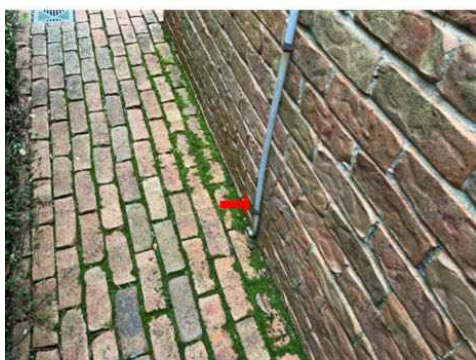
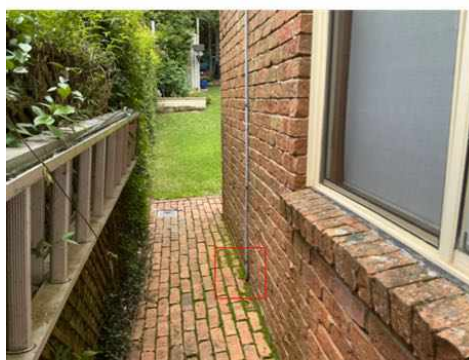
Finding 6.04

Building:	Main Building
Location:	Exterior walls - right side
Finding:	Overflow Disconnected - HWS/AC/Gas - Conducive Conditions to Termites
Information:	The overflow to this service was found to be disconnected from stormwater drainage and is creating excessive moisture in the surrounding area.

Such leaking creates an environment that is conducive to an array of defects, including water damage to associated building elements and the attraction of termite or timber pest infestation. These damp conditions can lead to secondary defects such as rot, rust, or corrosion of associated building elements, the formation of fungal decay, or even the creation of potential slip hazards. When coupled with poor site drainage, pooling of water may also attract termite activity to this area.

It is highly recommended that a licensed plumber be appointed to connect the overflow in order to prevent such an environment from being created. These minor works should be carried out as soon as possible.

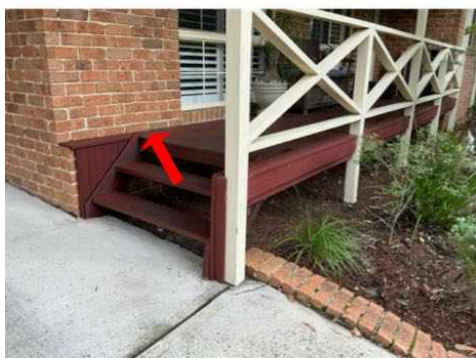
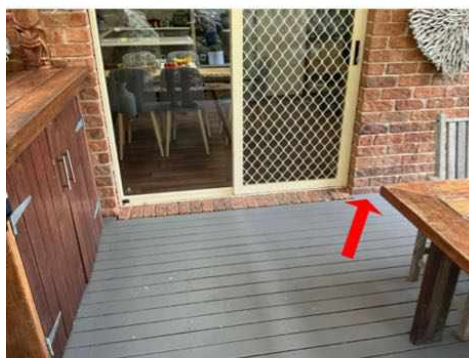
Finding 6.05

Building:	Main Building
Location:	Both Decks
Finding:	Timber Directly Attached to Building
Information:	At the time of inspection, timber materials were noted to be directly attached to the external wall of the dwelling. This practice is considered a conducive condition for termite activity, as it provides both a potential food source and concealed entry point for termites into the structure.

It is recommended that the timber be removed, isolated, or appropriately treated to reduce the risk of termite infestation. A licensed pest management specialist should be consulted for further assessment and advice in line with AS 3660.2 (Termite Management).

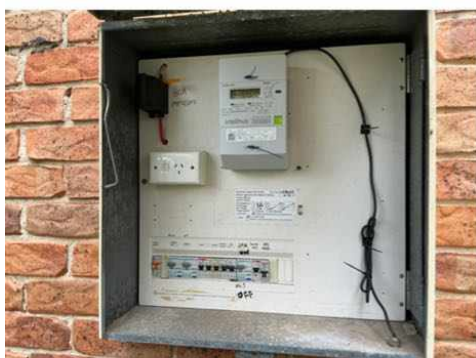
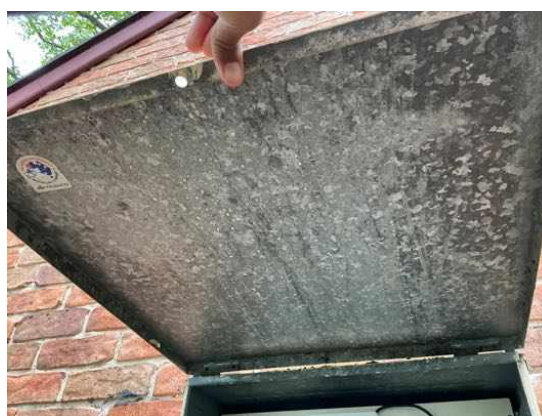
During the inspection, there was no indication that a termite management system had been installed, nor was there any evidence to suggest that preventative measures had previously been undertaken. The client is encouraged to seek further advice from a licensed pest controller regarding the costs and procedures involved in the application of a termite barrier. Prioritizing this step in the short term is strongly advised to ensure long-term protection.

Information: The application of a post-construction chemical termite barrier is strongly recommended for all properties, especially if there has been any history of live termite activity on-site. These barriers are highly effective in protecting timber building elements throughout the property by preventing termite attacks. It is also advisable to install a durable notice within the switchboard unit, indicating the presence of any termite barriers for future reference.

Additionally, the client may want to consult with the vendor to determine whether regular Timber Pest inspections, as per AS4349.3 or AS 3660.2, have been conducted in the past. This will provide further insights into any past termite management practices and help inform the appropriate course of action.

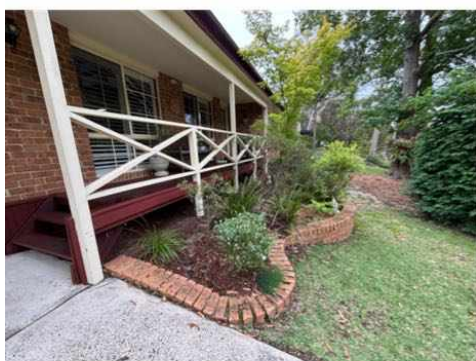
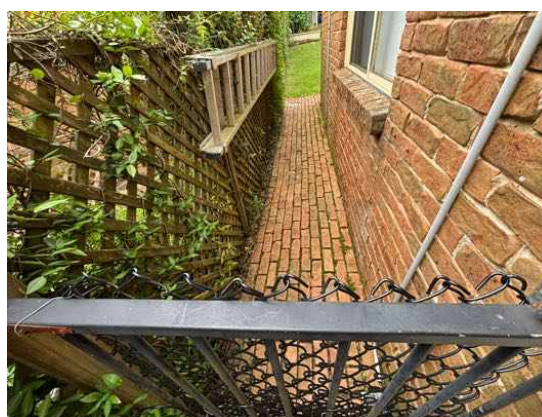
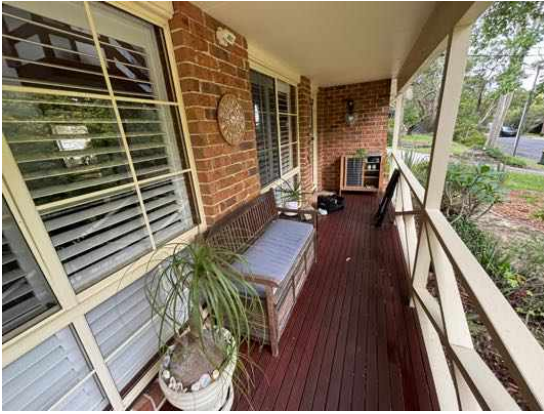
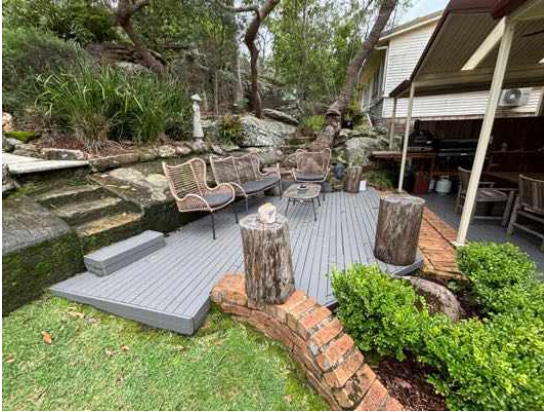
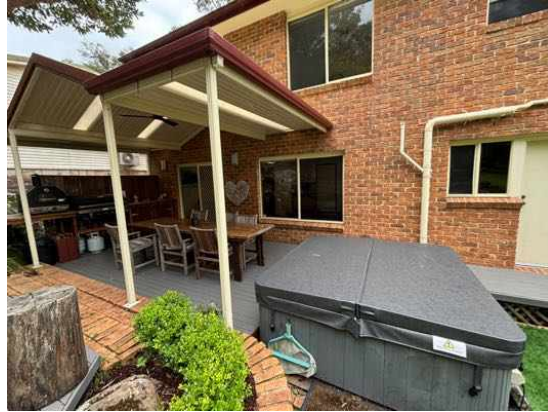
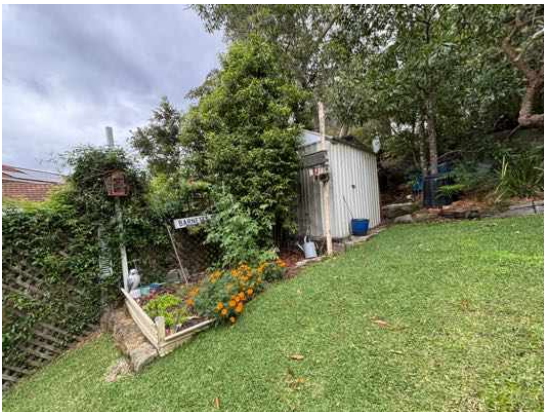
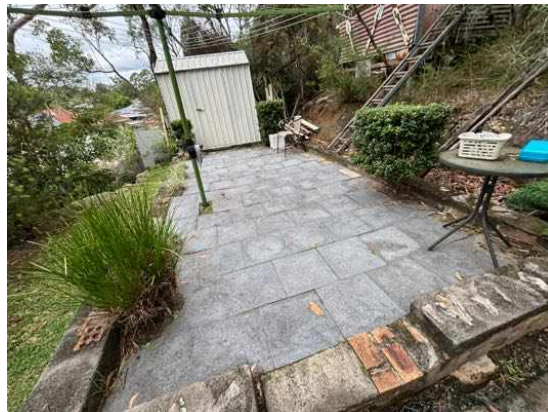
Building: Main Building
Location: All External Areas
Finding: Obstructions and Limitations - External Areas
Information: The attached photographs provide a visual representation of the obstructions and limitations that impeded a full inspection of the external areas of the property at the time of assessment. These obstructions, which may include vegetation, stored items, debris, or other physical barriers, can obscure potential defects and prevent a thorough evaluation of the property's condition. Obstructions of this nature can conceal a wide range of issues, such as structural damage, water ingress, pest infestations, or deteriorating building materials, which may not be visible during the initial inspection.

It is essential that these obstructions be cleared to allow for a comprehensive inspection of the external areas. Removing these barriers will enable a more accurate assessment of the property's condition and allow any hidden defects to be identified and addressed promptly. Failure to do so could result in undetected issues worsening over time, potentially leading to more costly repairs in the future.

Therefore, it is strongly recommended that the obstructions be removed and a re-inspection be scheduled once the affected areas are made fully accessible. This will ensure a complete evaluation of the property's exterior and provide the client with a clear understanding of any potential issues that may have been concealed during the initial inspection.
