Building and Timber Pest Inspection Report

Inspection Date: Fri, 27 Mar 2026

Property Address: 131 Woodcourt Rd, Berowra Heights NSW
2082, Australia

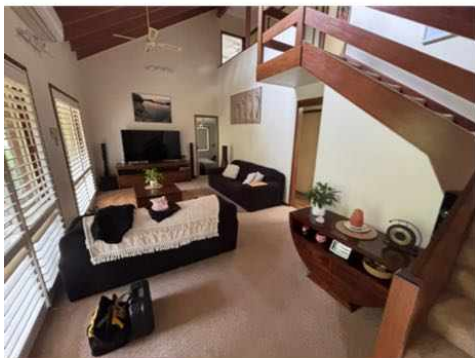
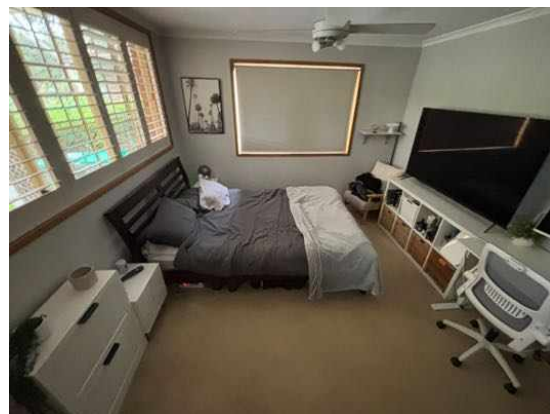
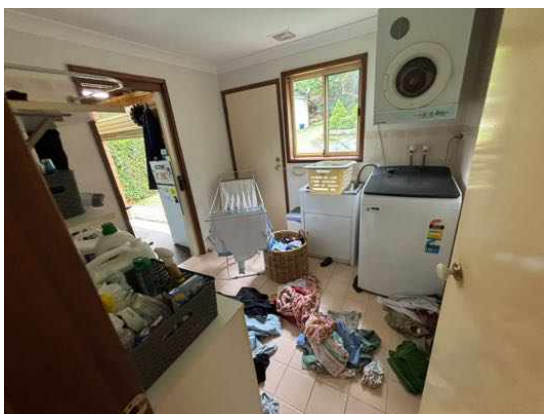
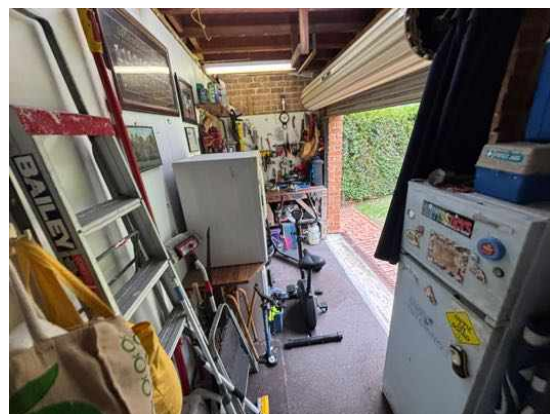
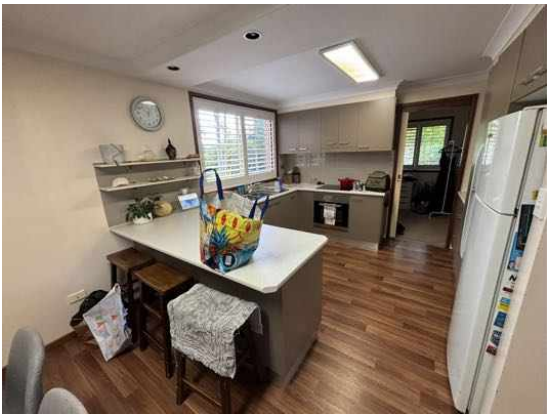
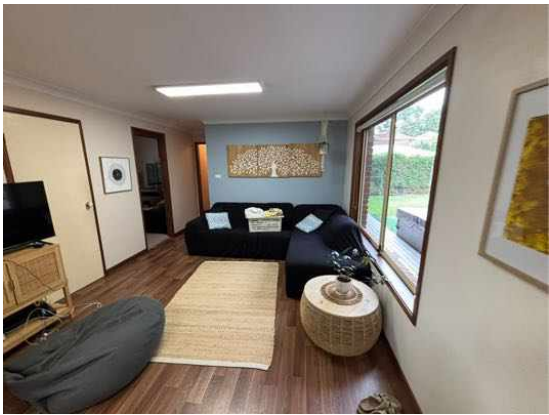
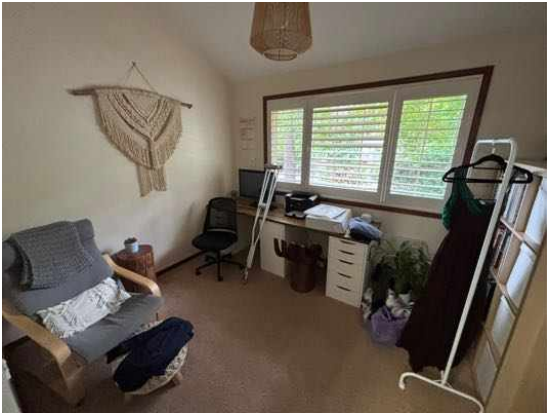
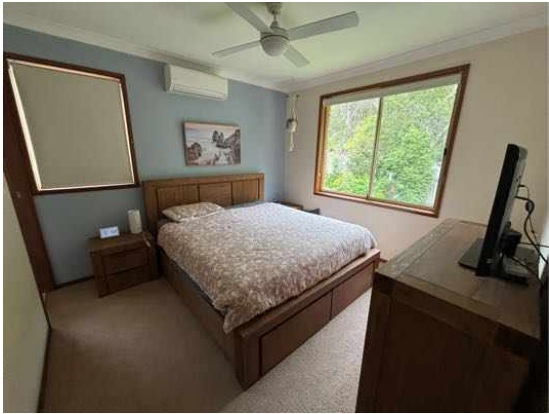
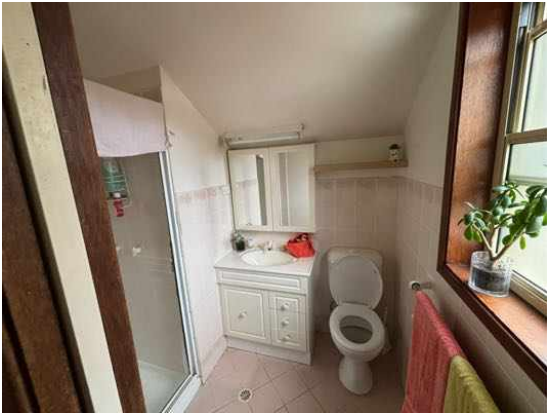
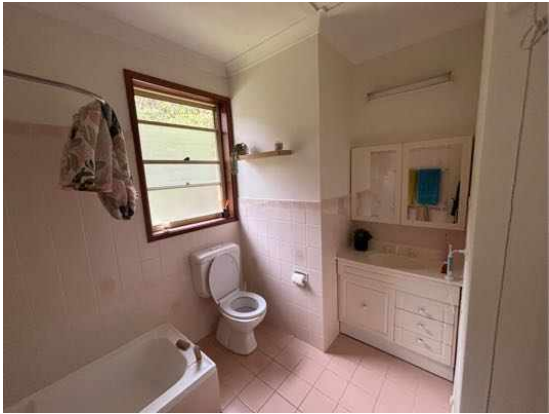
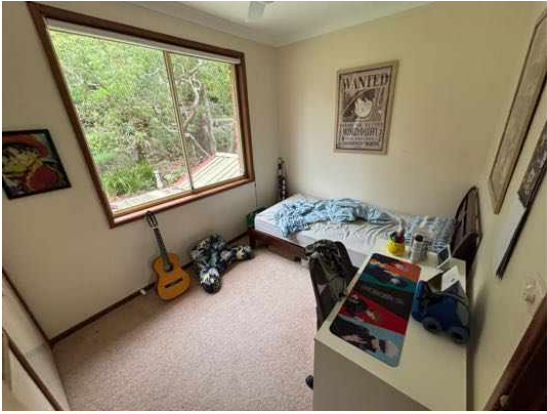
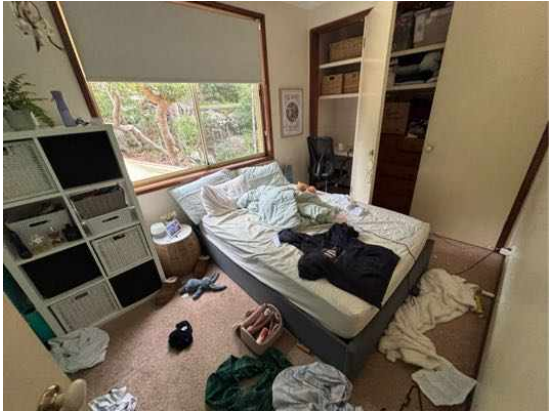
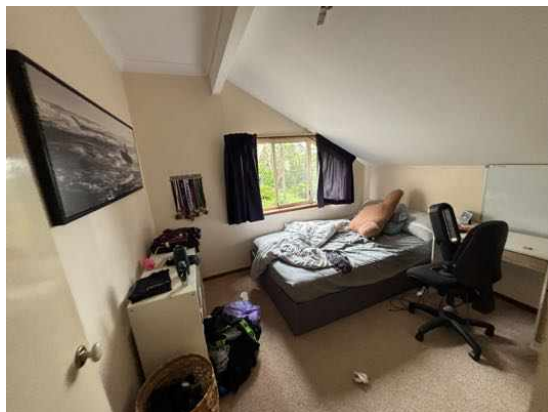
Building:	Main Building
Location:	All Internal Areas
Finding:	Obstructions and Limitations - Internal Areas
Information:	The accompanying photographs provide clear evidence of the obstructions and limitations that restricted a comprehensive inspection of the internal areas of the property at the time of assessment. These obstructions, which may include furniture, personal belongings, stored items, or structural elements such as wall coverings and built-ins, significantly hindered the ability to thoroughly evaluate these areas. It is important to note that such obstructions can potentially conceal a wide array of defects, ranging from hidden structural damage, water leaks, pest infestations, or

electrical issues, to deteriorating materials that may not be visible during the initial inspection.

The presence of these impediments means that critical areas of the property were not accessible, and therefore, any underlying defects that may affect the integrity and safety of the property could remain undetected. These hidden defects, if left unaddressed, could worsen over time and may result in costly repairs or pose potential safety hazards to the occupants.

It is highly recommended that all obstructions be cleared to facilitate a complete and thorough inspection of the internal areas. Once the obstructions have been removed and full access is available, a re-inspection should be carried out to ensure that any previously concealed issues can be properly identified and rectified. This follow-up inspection will provide a more accurate assessment of the property's internal condition and help the client make informed decisions about any necessary repairs or maintenance.

In summary, the limitations encountered during the inspection highlight the importance of ensuring full access to all areas of the property to accurately assess its overall condition. A re-inspection is strongly advised once these areas are made accessible.

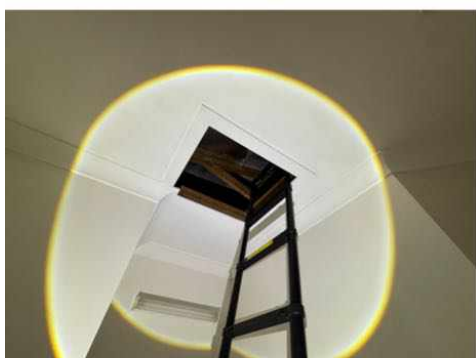
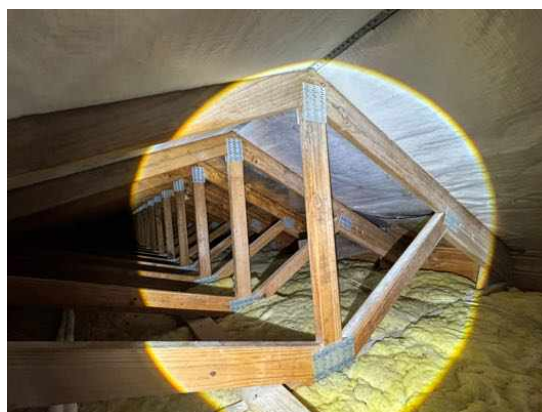
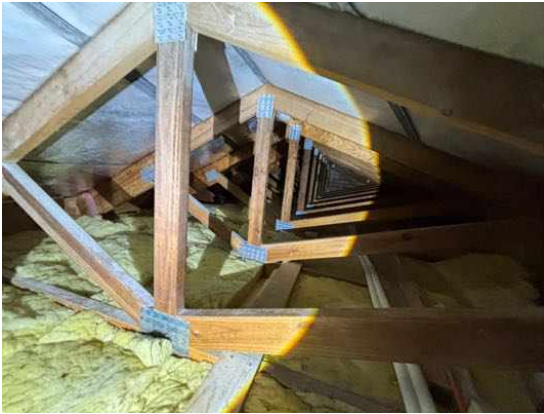
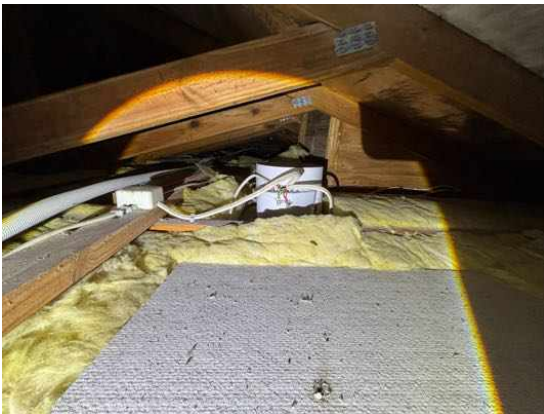
Building: Main Building
 Location: Roof Void
 Finding: Obstructions, Limitations, and General Roof Space Condition
 Information: The photographs provided document both the general condition and the obstructions and limitations that were present in the roof cavity of the main building at the time of inspection. These obstructions—such as insulation materials, stored items, structural elements, or electrical wiring—restricted safe and adequate access to key areas within the roof space. As a result, a comprehensive inspection of all components could not be completed.

Obstructions of this nature may conceal a variety of potential defects, including damaged framing, compromised insulation, evidence of moisture ingress, pest activity, or electrical hazards. While no major issues were observed in the visible areas, the presence of these limitations means that some defects may remain undetected.

It is recommended that these barriers be removed or repositioned to facilitate full and safe access to the roof space. Once clear, a follow-up inspection should be conducted to allow for a thorough assessment of all concealed areas. This will help ensure that the condition of the roof cavity is accurately evaluated and any hidden issues are appropriately identified and addressed.

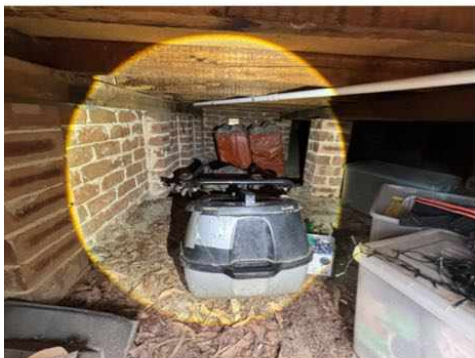
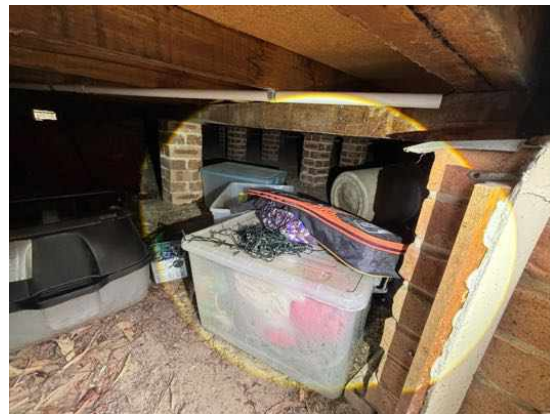
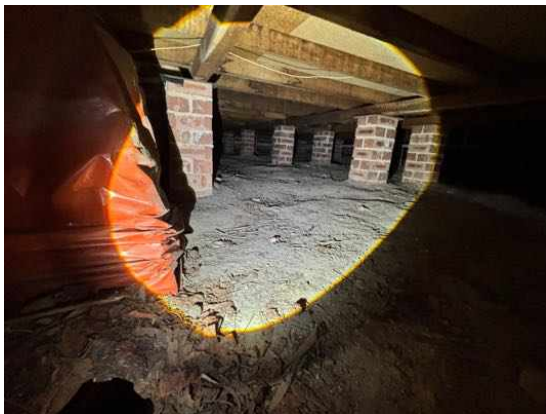
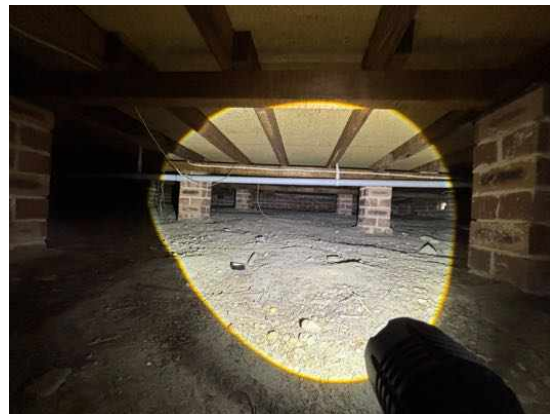
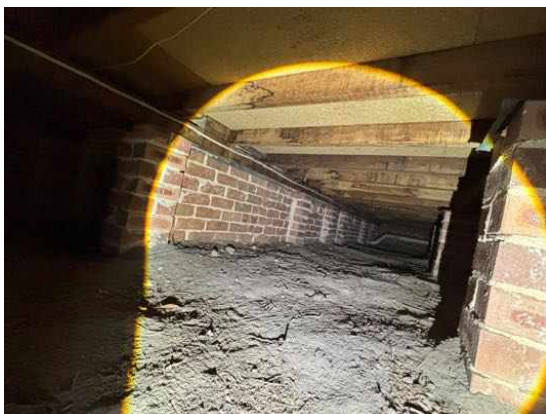
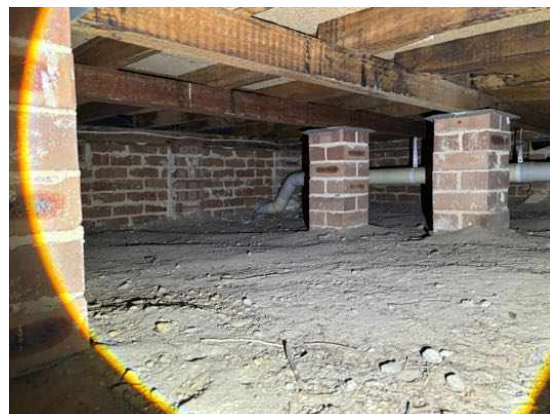
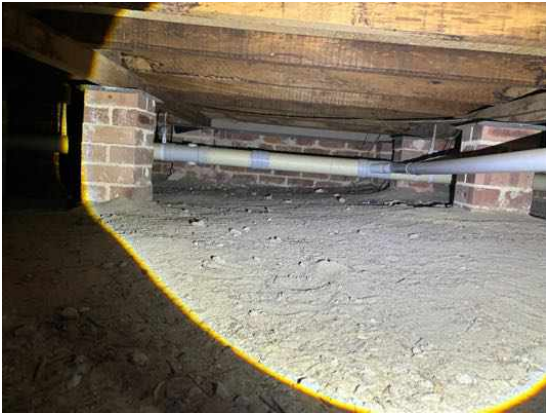
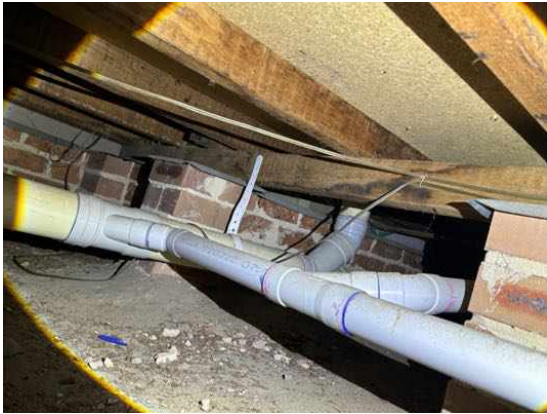
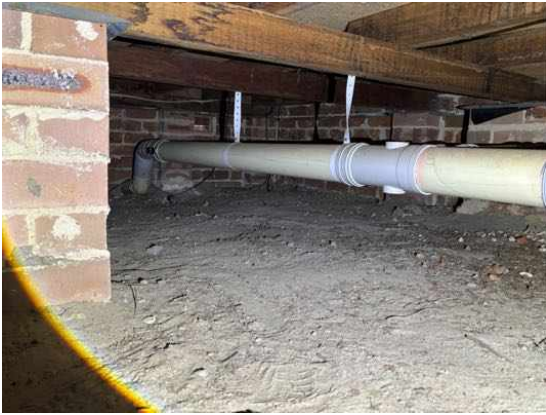
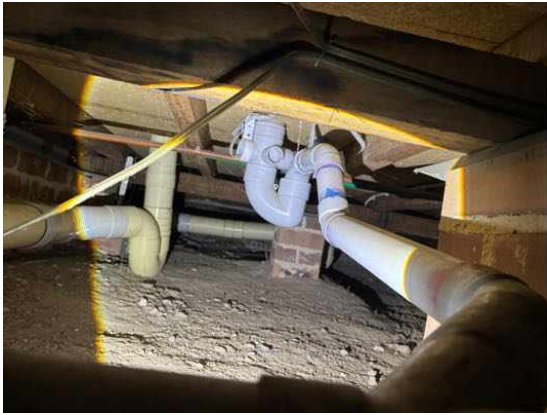
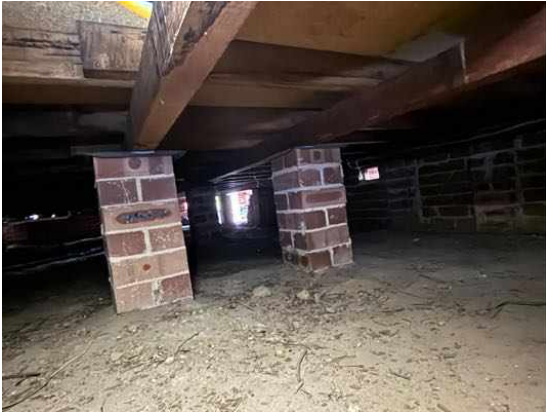
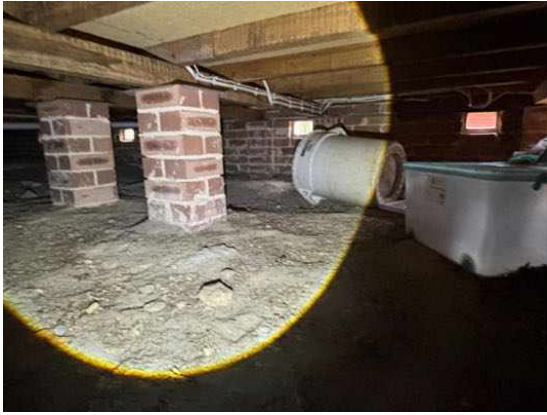
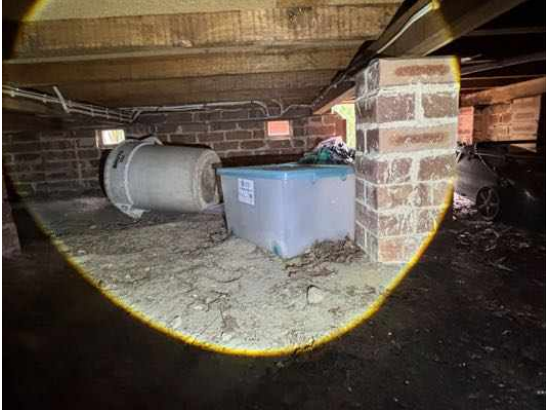
Building:	Main Building
Location:	Subfloor
Finding:	Obstructions, Limitations, and General Subfloor Condition
Information:	The attached photographs illustrate the obstructions and access limitations that restricted a full inspection of the subfloor area of the main property at the time of assessment. Items such as stored materials, construction debris, low-hanging services, and insulation impeded movement and visibility within key sections of the subfloor. In addition, the limited crawl height further restricted safe access to inspect critical structural components.

important elements such as floor joists, bearers, stumps, drainage, subfloor ventilation, and signs of moisture or pest activity. These obstructions may also conceal defects such as timber decay, water ingress, termite damage, inadequate support, or ventilation issues that are not immediately visible during a limited inspection.

While no major concerns were identified in the accessible areas, a full and unobstructed inspection is necessary to properly assess the overall condition of the subfloor. It is recommended that obstructions be removed and access improved where possible. Once adequate clearance is provided, a re-inspection should be arranged to ensure that any concealed defects can be identified and addressed accordingly. This will assist in providing a more comprehensive understanding of the subfloor's condition and reduce the risk of unforeseen issues.

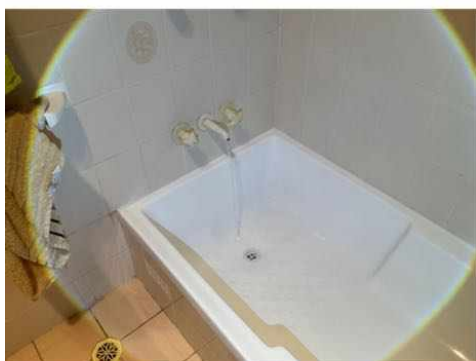
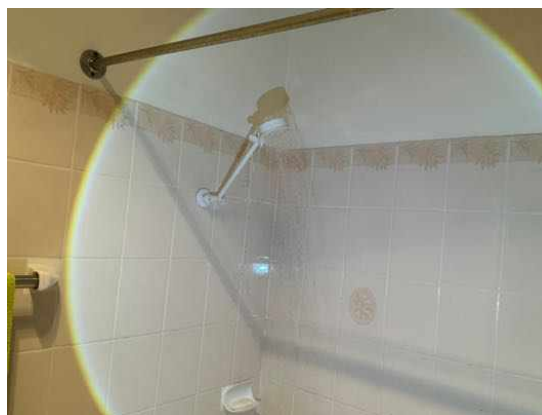
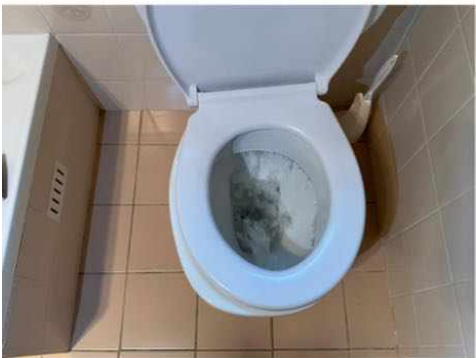
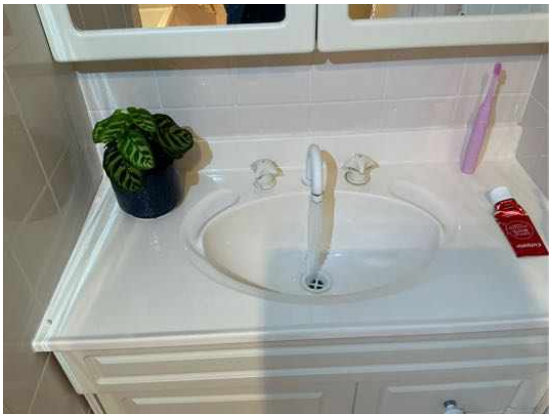
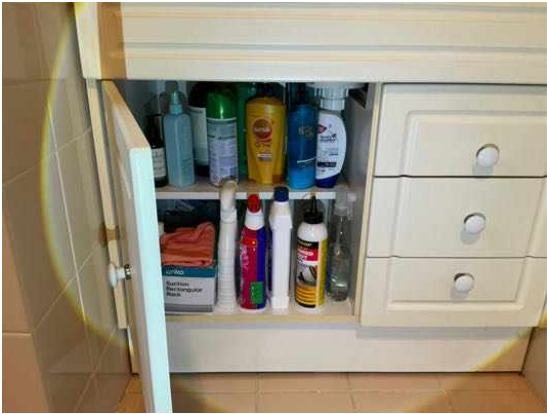
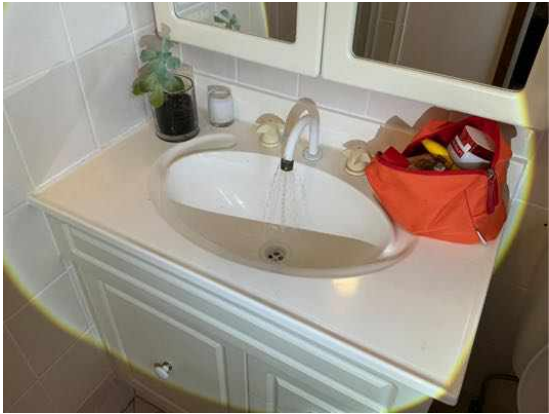
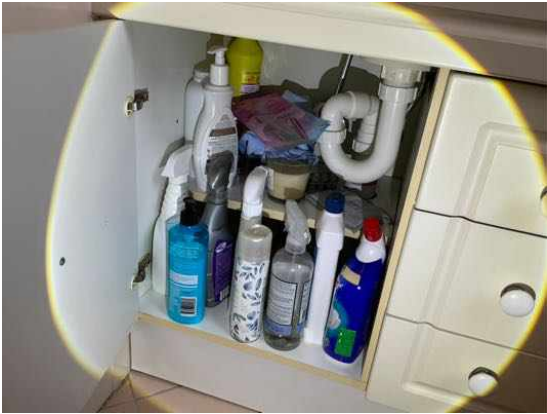
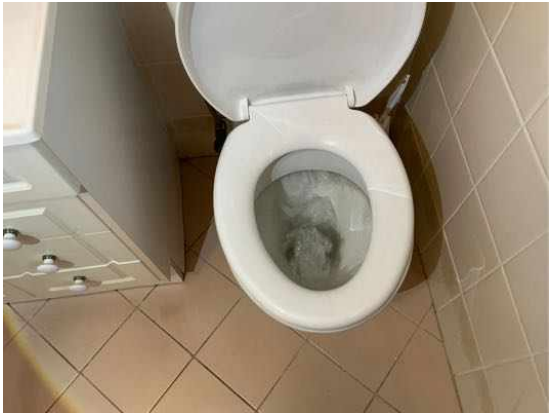
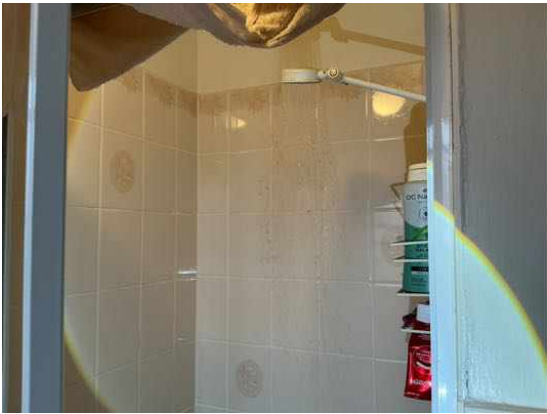
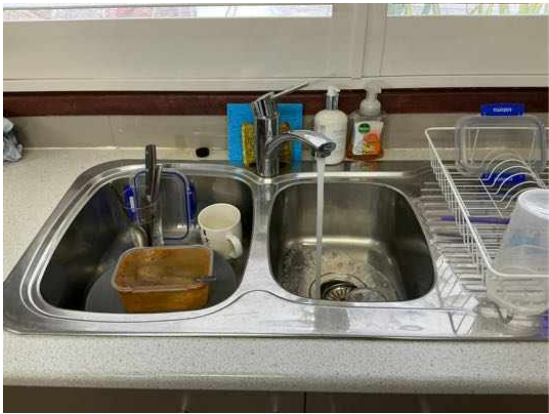
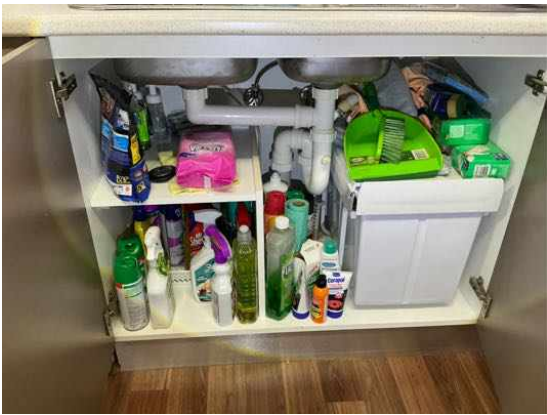
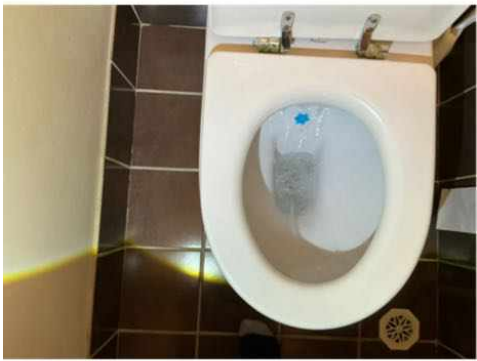
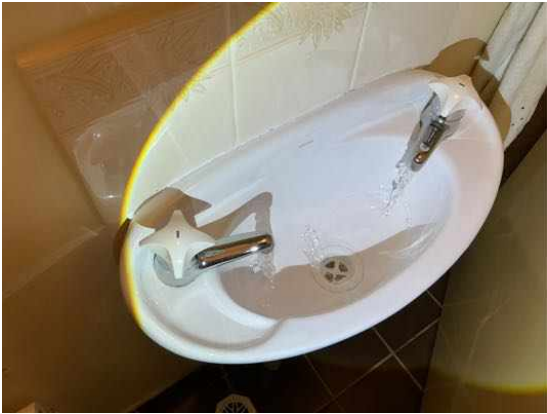
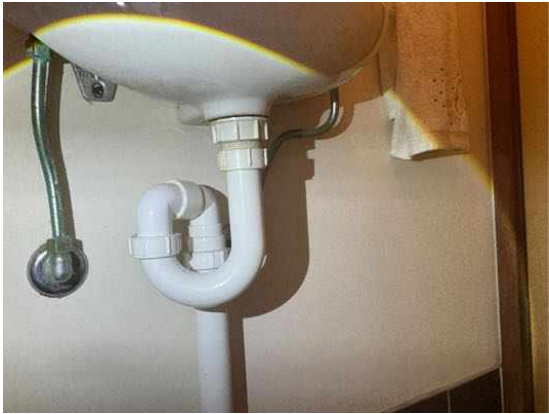
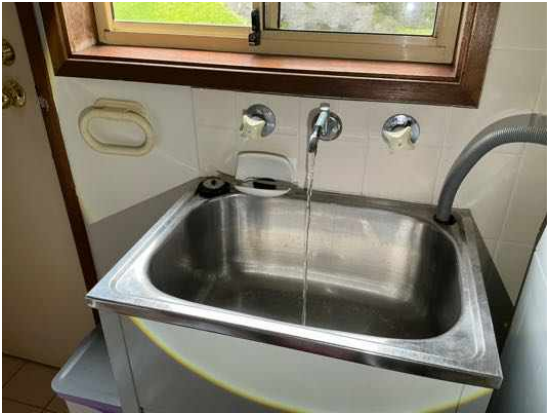
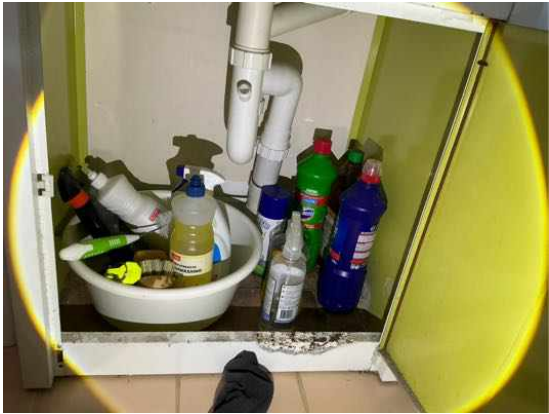
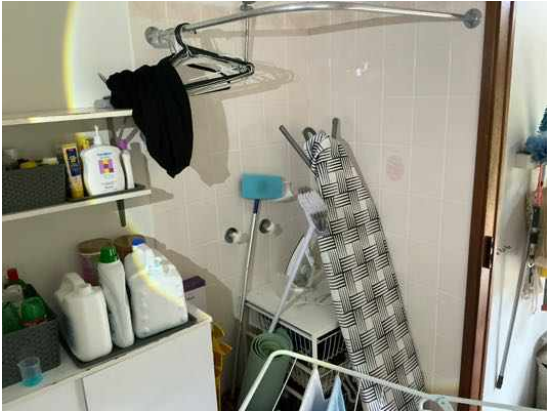
Building:	Main Building
Location:	All Areas
Finding:	FYI - Taps, Drainage & Toilets Tested and Cabinetry Obstructions
Information:	During the inspection, all accessible taps, drainage systems, and toilets were tested for water flow and drainage efficiency, and checked for any visible signs of leakage. At the time of the inspection, no issues were noted in these areas. Unless highlighted in a separate defect statement, no immediate remedial work appears necessary. Supporting images may be found in the additional photos section for reference.

It is important to note that while a visual inspection of cupboards and cabinetry beneath sinks and vanities was undertaken, stored personal items and fixtures presented obstructions that limited full visibility of the internal areas. As per standard inspection practices, inspectors are not permitted to move or disturb personal belongings during the inspection process. Therefore, only visible and accessible sections were inspected, and concealed water damage or plumbing defects may not have been detected.

Given this, a re-inspection is recommended after all obstructions have been cleared to allow for a comprehensive assessment of these areas. Regular maintenance and monitoring of plumbing and drainage systems is also advised to ensure ongoing functionality and early detection of potential issues.

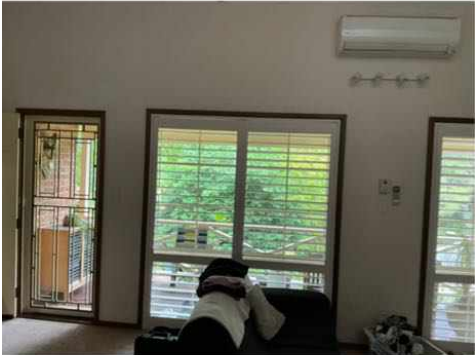
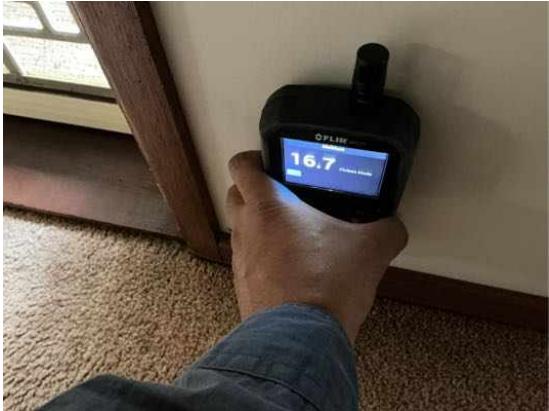
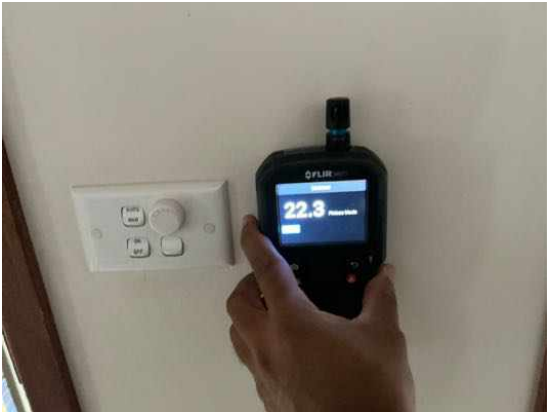
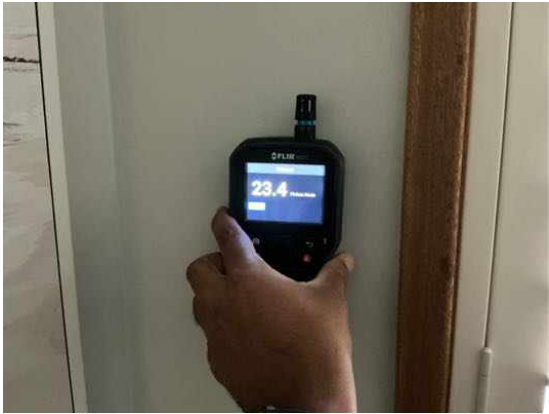
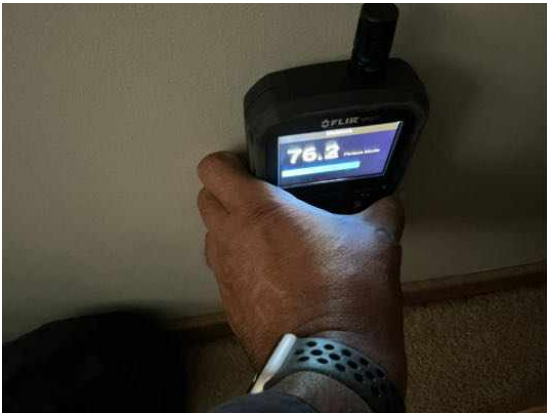
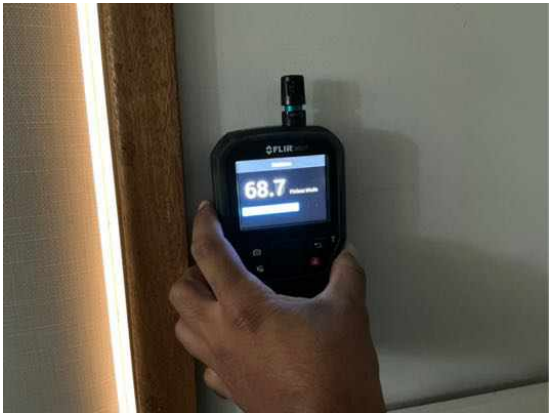
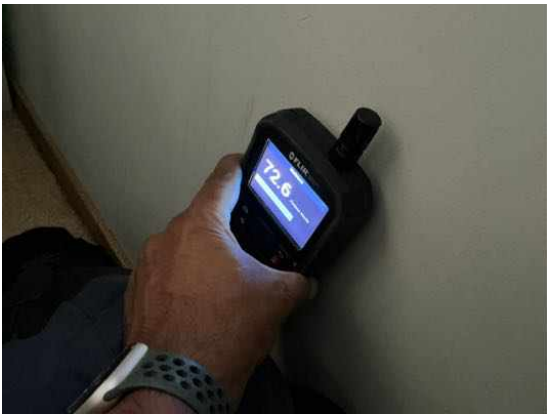
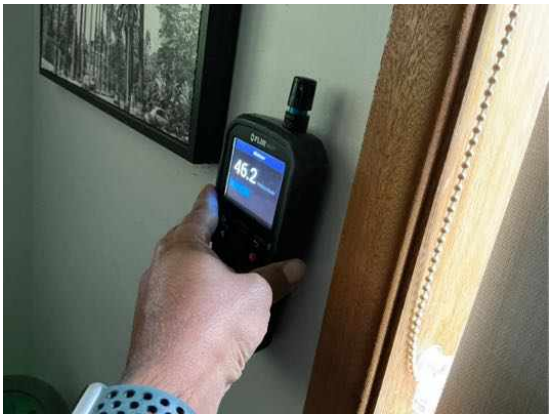
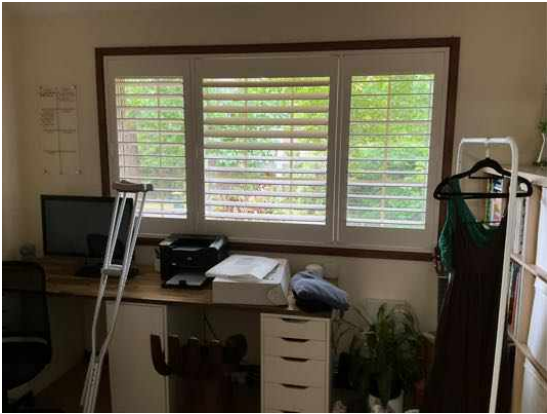
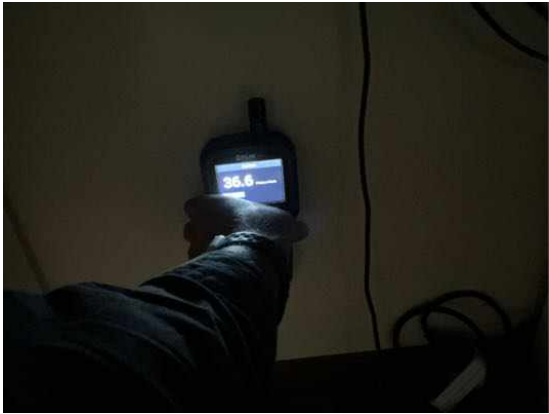
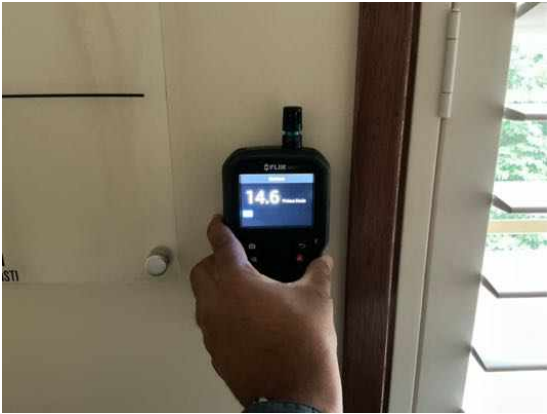
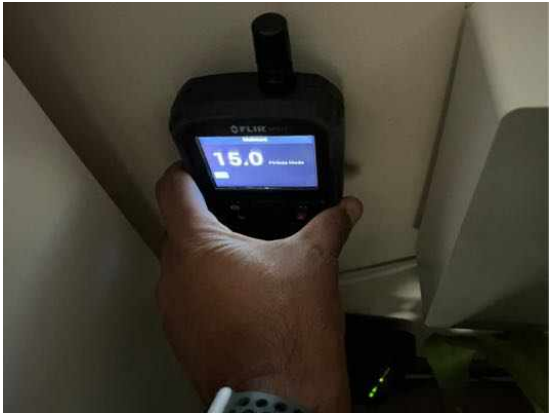
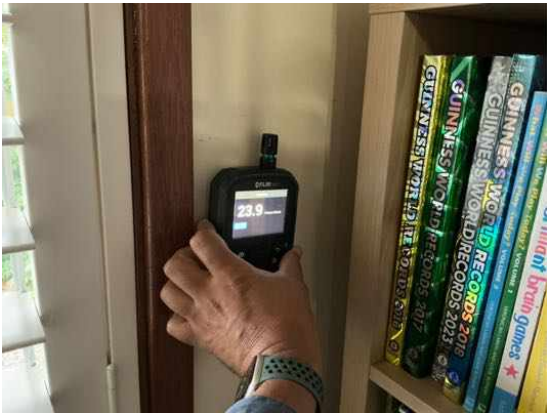
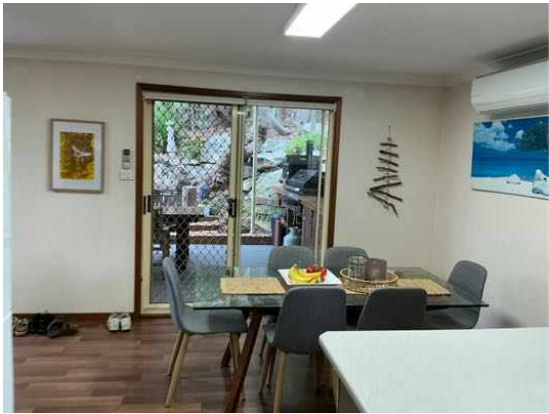
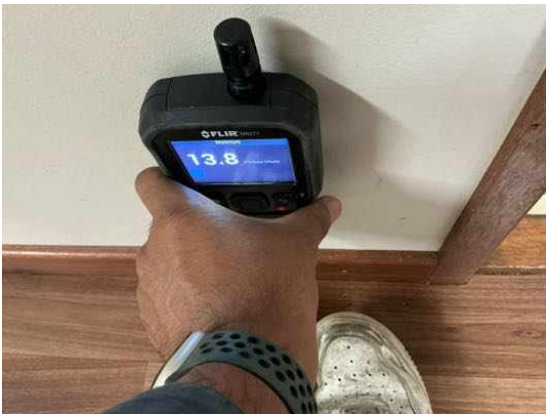
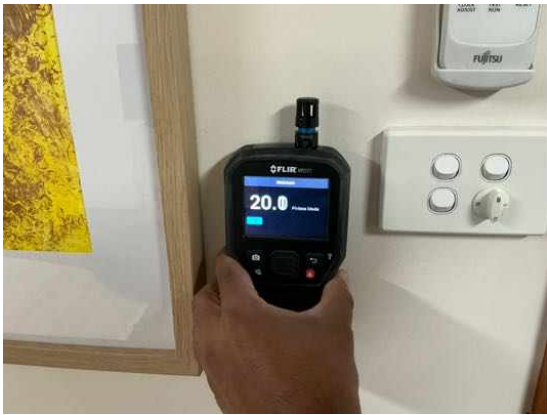
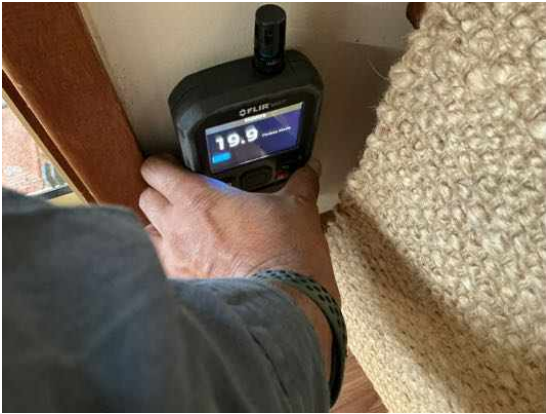
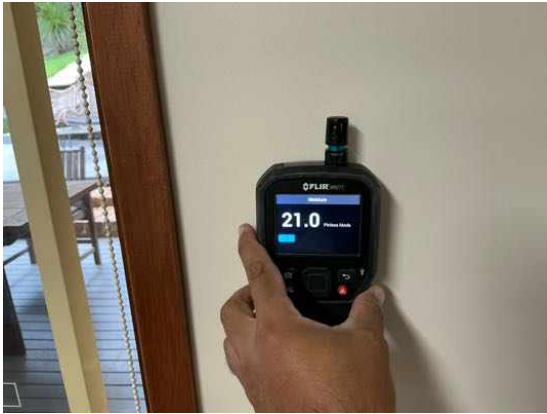
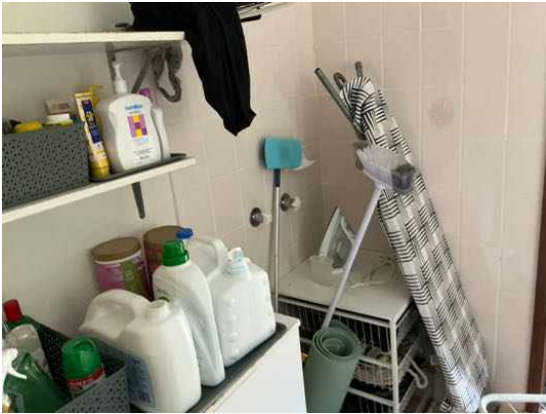
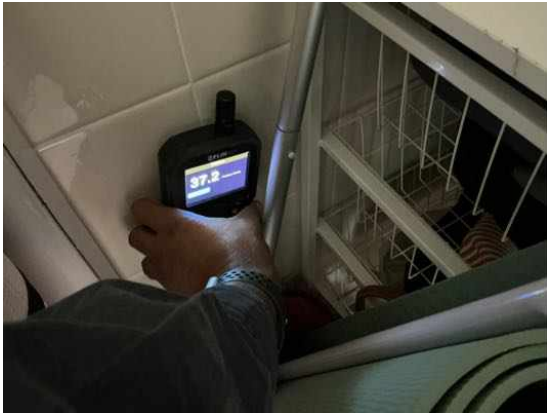
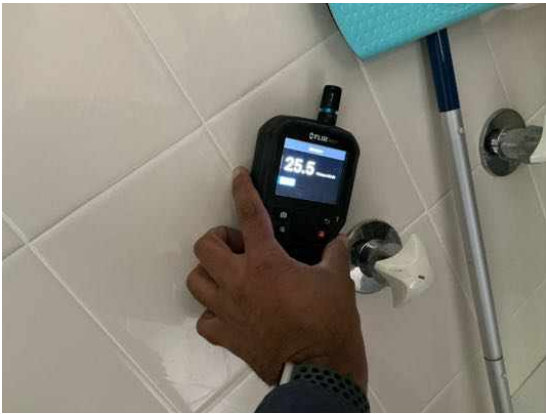
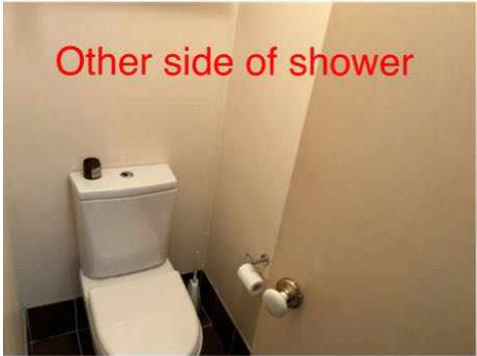
Building: Main Building
Location: All Areas
Finding: Additional Photos - Moisture Meter Readings
Information: Additional moisture meter reading photos have been provided for the property to offer further clarity on areas tested during the inspection. These photos are intended to give a visual reference for the specific locations where moisture levels were measured. These readings were taken at the time of the inspection to assess any potential moisture-related issues within the property. Any defects related to moisture that were identified during the inspection have been separately mentioned in the defect statements within the report.

It is important for the client to understand that moisture levels can fluctuate over time due to various factors, including changes in weather, humidity, and environmental conditions. While the readings reflect the property’s moisture levels during the inspection, they may not represent future conditions, and increased moisture could lead to issues such as dampness, mould growth, or deterioration of building materials if left unmonitored.

For further clarification or additional information regarding the moisture readings, the client is encouraged to contact the building inspector directly. Regular monitoring of moisture-prone areas is recommended to ensure any emerging concerns are addressed promptly, particularly during wetter seasons or in high-humidity conditions.
